Historic Scotland
Properties in Care
Minor Archaeological Works
2007

Dryburgh Abbey Tree Hole

PIC Index No: 90103
Project: HSCO-90103-2007-01

Watching Brief

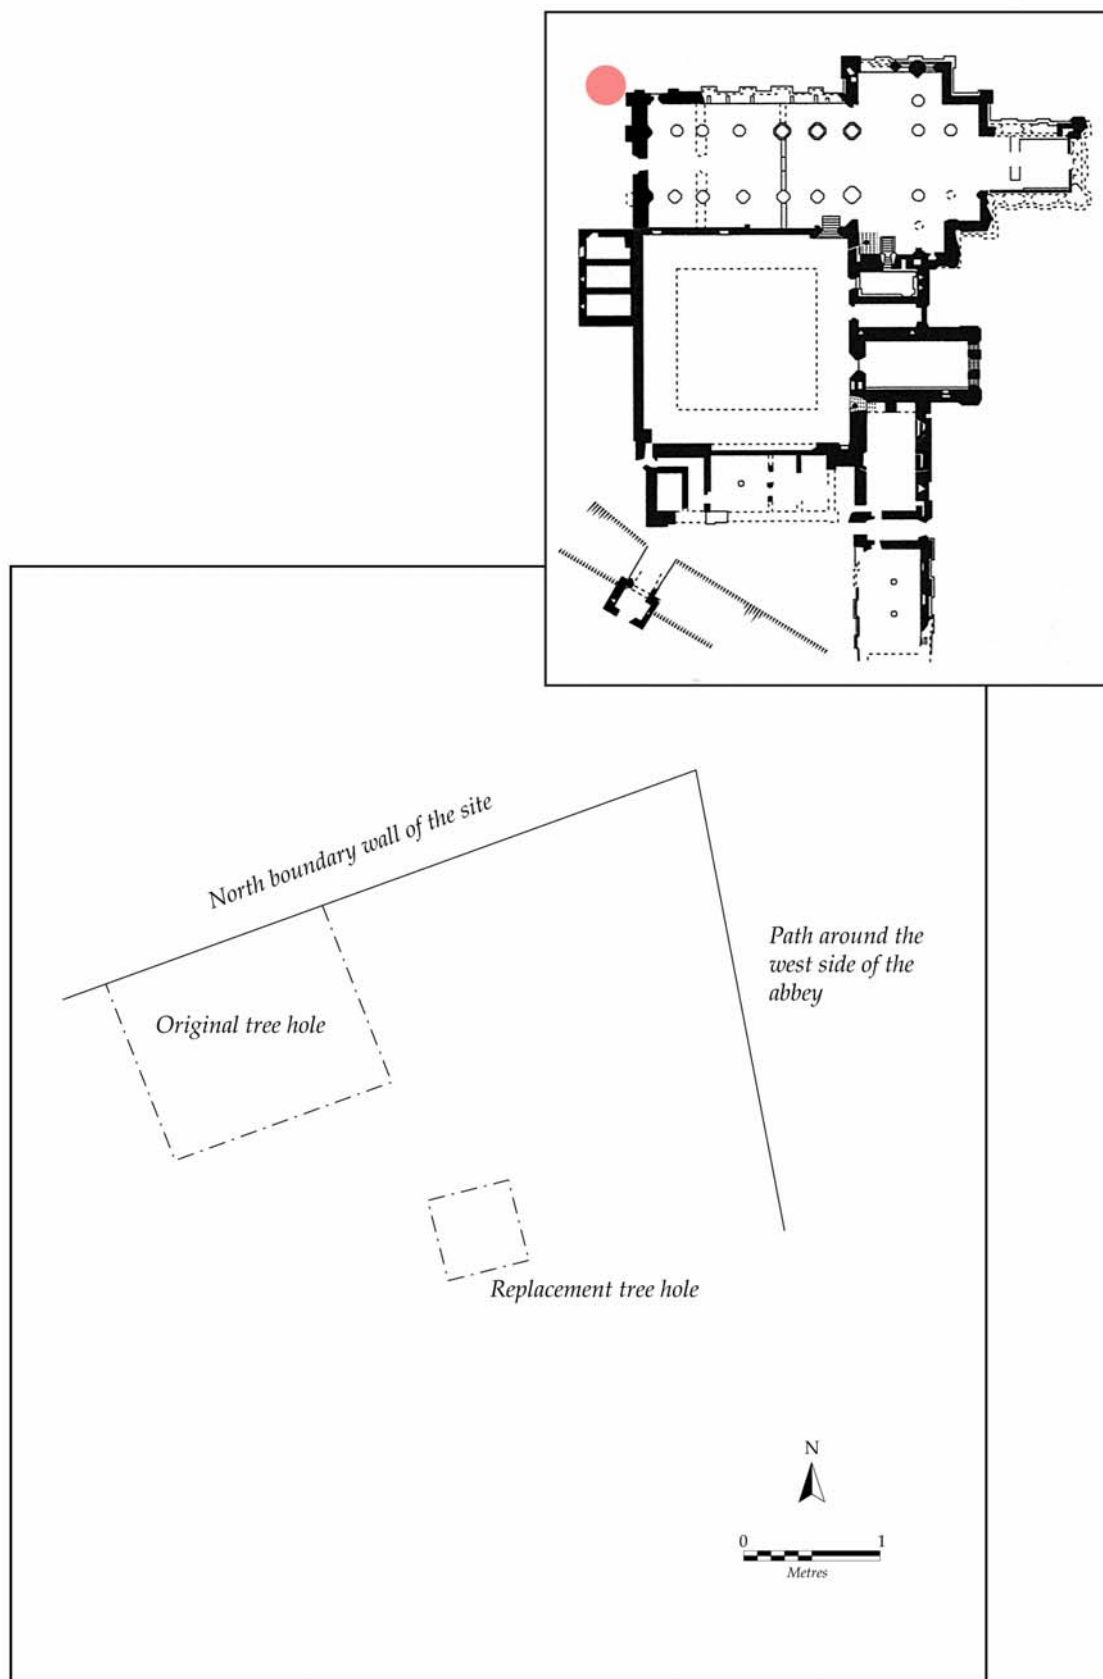
Figure 1: Location Plan

Under the terms of the call off contract Kirkdale Archaeology were asked to monitor the removal of a diseased laburnum tree and excavation of a small hole to take a replacement at Dryburgh Abbey. The affected tree was situated just to the W of the Abbey Church, on the W side of a path around this side of the site. The tree was directly against the N boundary wall of the site, some 3 m W of where the path and wall meet at the NW corner of the Church. The replacement holes NE corner was 2.4 m W and 2.4 m S of this same junction.
