Historic Scotland
SCPP Archaeological Works
2008

Stirling Castle Palace
West Range French Drain
Extension to Trench 24

Project. SCPP-2008-06

Archaeological monitoring
June & July 2008

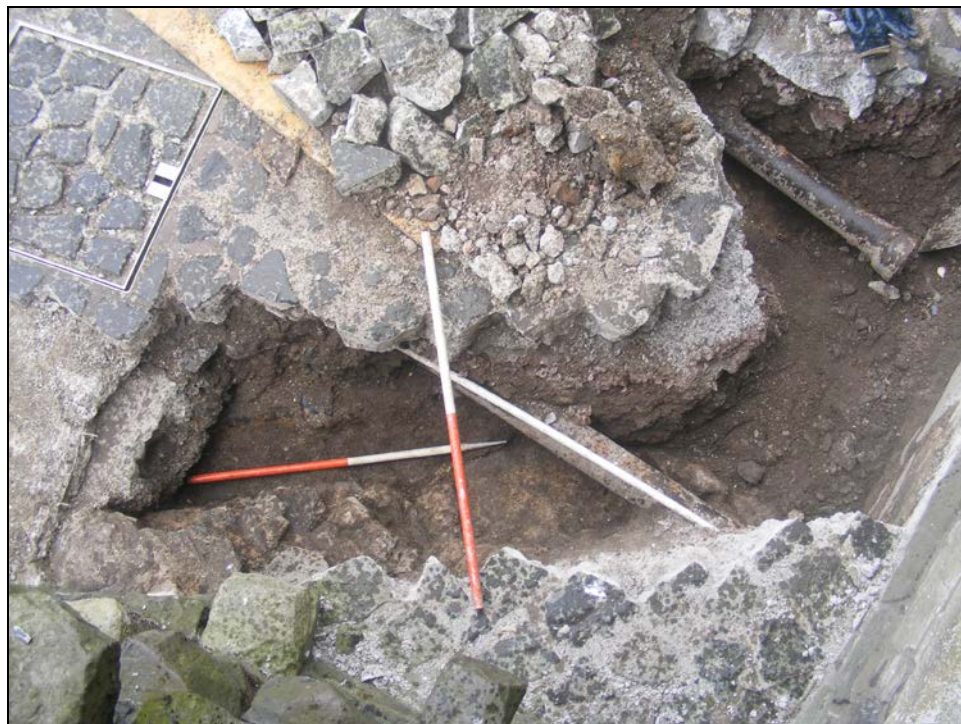
Figure 1: Photograph of the extension to Trench 24 (N to top)

Work started at the N end, where the bedrock is only 200-400 mm below the ground surface. This is the case for the first c 2m of the trench, until wall line **F14092** crosses the trench E-W. This wall seems to sit along a drop in bedrock, at no point to its S was bedrock seen. A little to the S of **F14092** wall **F14029** also crossed the trench E-W, and this in turn lies just to the N of further E-W wall **F14031**.

To the S of **F14031** there is a gap of just over 6 m until a further wall **F14118** crosses the trench. Between these two the footings below the Palace (**F14196** and **F14121**) project slightly into the excavated area. After **F14118** further wall footings **F14117** again project into the trench. At their S end **F14117** overlies **F14114**, the badly disturbed remains of a wall that runs E-W, while the S end of this phase of work is marked by E-w wall line **F14073**.

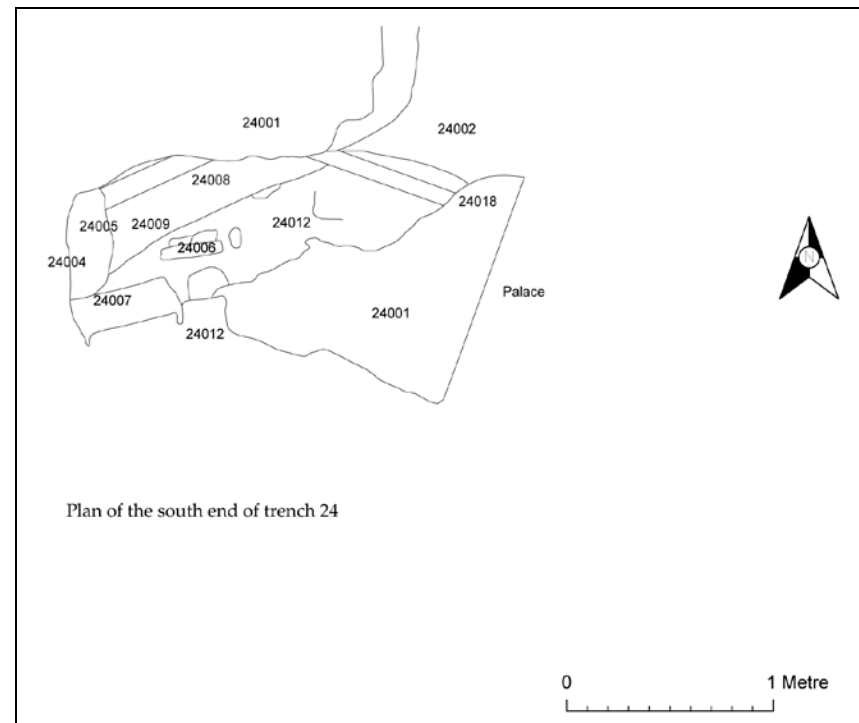
Figure 2: Plan of the extension to Trench 24

There was a short break in the work until the cobbles had been lifted over the area of the old trench 18. The track here averaged 700 mm wide, and dropped to the S such that at its N end it was only 300 mm deep, reaching a maximum depth of 650 mm at its S end. This meant that only at the S end was anything except the backfill of trench 18 removed. The most Northerly feature noted was **F24010**, a cast iron pipe crossing the trench at an angle close to ESE-WNW. At the S end of the area of trench 18 three further pipes were unearthed: **F24006**; **F24008** and **F24018**. All three of these were cut against **F24012**, the foundations of the angled wall with a ragged N end at the very S end of the area, numbered as **F18018** in the previous excavation. At the SW end of the trench **F24004**, the concrete channel built to take the electricity cables, crossed **F24012**. **F24012** was exposed for a maximum width of 1.65 m E-W, perhaps 100 mm wider than was previously seen. A large (500 by 250 by 200 mm) sandstone block in **F24012**, in the extreme SW corner, may represent a 'facing stone', no others were noted on the W side, these presumably lie under **F24004**. The wall was built of a mix of medium sized sandstone and dolerite chunks, bonded by copious amounts of hard pale yellow mortar, rich in small rounded inclusions.

In the event **F24004** was not removed, with the decision made instead to feed the new drain through existing pipe **F24010**, but a small area had already been opened up to the W

of **F24004**. This measured 1.15 m E-W by 1.2 m N-S, and was entirely within the backfill of trench 21. This was centred on **F24015**, the vertical pipe against the S wall of the Ladies Lookout, through which it feeds. This had been dug into the top of **F24017**, the wide curving wall forming the foundations for the Ladies Lookout S wall, and numbered as **21185** in the original excavation. No new observations were made in this area.

Although already excavated, a small addition to the W side of wall **F24012** (same as **F18018**) was recorded during this exercise. Monitoring was also necessary to avoid damage to the walls already revealed and recorded. The opportunity was also taken to re-photograph masonry within the trench.

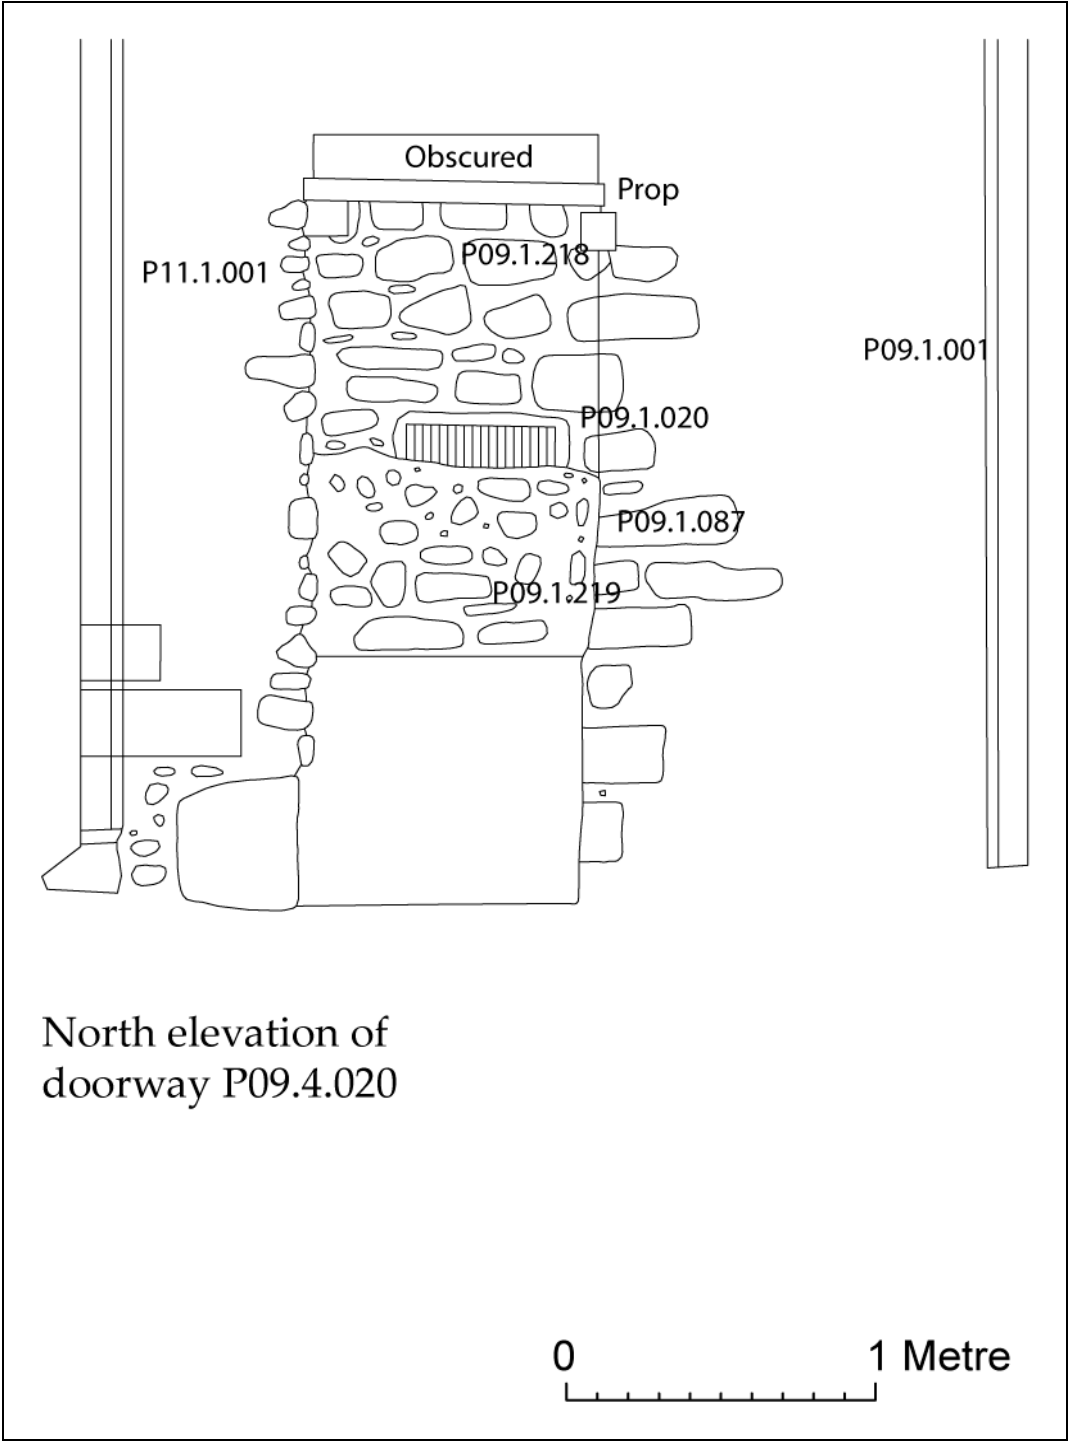
Figure 1 Drawing #1

No	Description
P09.1.001	Main build of wall. 1540 palace build.
P09.1.020	White emulsion paint in window recess P09.1.013, uppermost paint layer. Mid 20 th Century – Present coat of paint.
P09.1.087	Sandstone blocking, dressed, blocking cut P09.1.088 at W end of wall. Early 20 th Century blocking of doorway.
P09.1.218	South edge of doorway between P09 and P11 cut back to the south face of the north wall. The current work to rebuild the original door has disturbed an area measuring 900mm E-W by 2.55m high. This feature is in the upper 1.00m of the disturbance. The stonework here is cut back to form a fairly flat face, level with the rest of the north wall. Appears to have removed material from P09.1.087. 2008 disturbance of 19th Century blocking.
P09.1.219	Howk into the wall face below P09.1.218, measures 900mm E-W and over 600mm high. It was seen to this height but below this new door build has been constructed. This cut upto 150mm deep into the wall face and shows the uncoursed, subrectangular blocks of the wall core (120mm by 80mm on average). Pointed with hard pale grey gritty mortar. 2008 howk into 19th Century/20th Century blocking of a doorway in the north wall.

P09.4.020	Doorway to N of wall P09.4.001. Has been partially smashed away and later blocked, relates to doorway which opened out to Lion's Den Walkway. Doorway is probably an original 1540 palace feature.
P11.1.001	Lower wall fabric composed largely of blonde sandstone blocks, many of which are dressed and may be reused. Also contains rougher blocks of grey bedrock in discrete patches. This fabric rises to a height of 3m 60 - 3m 90 above floor level, above which is wall fabric P11.1.144, which is much rougher random build and is mainly bedrock. Horizontal course separating the lower and upper wall. W end abutts W wall (P11.4). Original palace build. There is a break in building campaign between P11.1.001 and P11.1.044, construction post dates W wall P11.4.

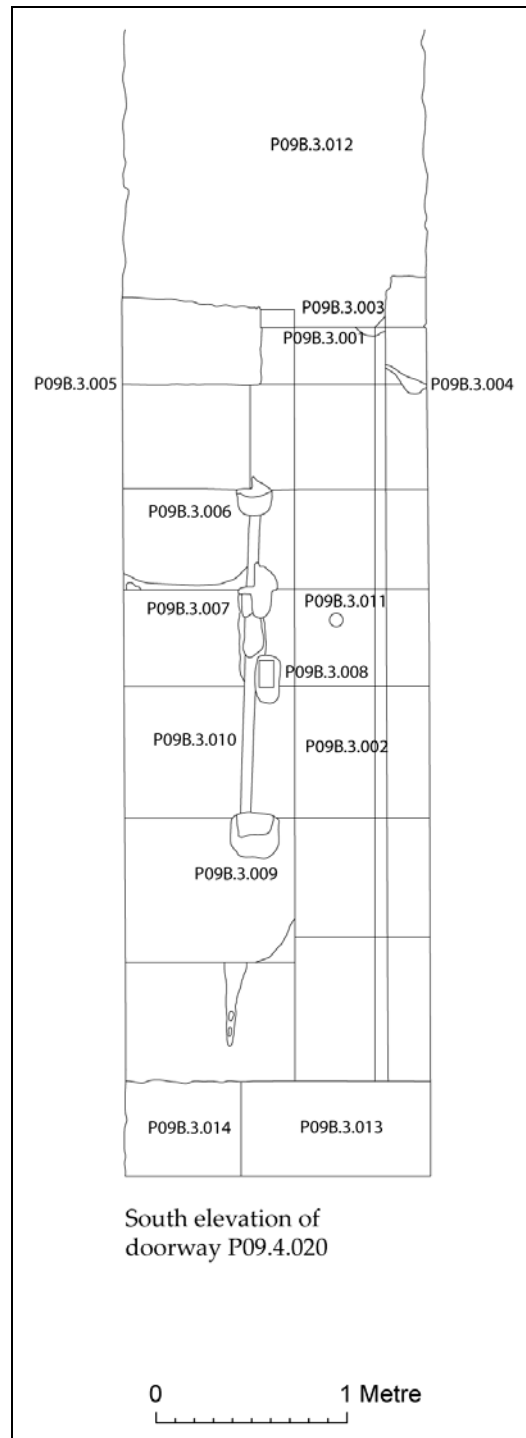
Figure 2: Drawing #2

No	Description
P09B.3.001	Door aperture between P09 and P11, recently partially unblocked. Doorway has a depth of 800mm and a height of 1.98m. Door within the aperture was hinged to the N, secured to the S and opened to the E. Circa 1538 - 1542 palace doorway.
P09B.3.002	A quoins of door aperture P09A.3.001. Roll moulded (110mm diameter) to the W with a 30mm across chamfer to the E. The margins are then flat and vertical for 210mm after which the flat E portion is rebated back by 110mm. Formed of large blocks of blonde ashlar sandstone dressed with tight vertical toolmarks. Upper portions to E and W have been clawed back - see P09A.3.004 and P09A.3.005. Cuts and scars related to door furniture can be seen on the rebated E portion with a single dook on the W portion. Part of a circa 1538 - 1542 palace doorway.
P09B.3.003	Blonde sandstone lintel over margins P09A.3.002. This originally carried the return of the roll mould running up the S Quoins but this has been clawed back - see P09A.3.004. Lintel was 310mm high by 440mm thick and carried wall build P09A.3.012 above. Sits on margins P09A.3.002. 30mm wide chamfer on lower W face and has a 60mm high rebate behind. Part of a circa 1538 - 1542 palace doorway.

P09B.3.004	Cut through the roll mould and chamfer of door quoins P09A.3.002 and lintel

No	Description
	P09A.3.003. 120mm wide x 310mm high. The reasons for this clawing are unclear, perhaps a wooden lintel was installed at a lower level when this doorway was connected to the walkway in the Lion's Den. Late 18th Century - 19th Century
P09B.3.005	Cut through upper E portion of quoins P09A.3.002, at a similar level to cut P09A.3.004. Sandstone margins have been clawed back to a depth of 190mm. Cut is 370mm across x up to 240mm high. Possibly a 19th Century alteration for recessing a wooden lintel.
P09B.3.006	Cut through quoins P09A.3.002 80mm across x 75mm high x 110mm deep. Roughly square. Cut which along with P09A.3.009 was used to hinge a metal bar to stop the lock receiver (P09A.3.007 or P09A.3.008) breaking out from the stone. Scar of metal bar is P09A.3.010. Possibly 1538 – 1542.
P09B.3.007	Cut through quoins P09A.3.002 up to 140mm high x 60mm across and crosses line of scar P09A.3.010. 800mm deep. Probably the cut for the original bolt receiver of the circa 1540 doorway. Sits behind scar P09A.3.010 as the metal bar within the scar would have helped to secure the lock receiver. Possibly 1538 – 1542.

P09B.3.008	Cut through quoins P09A.3.002 roughly vertical rectangular - sits immediately to W of scar P09A.3.010. 800mm deep. Either a drawbar hole or a different phase of lock receiver to P09A.3.007. Possibly 1538 – 1542.
P09B.3.009	Roughly square cut 130mm across x 60mm deep on quoins P09A.3.002 at lower end of scar P09A.3.010. Hole cut to hinge bottom of a metal strengthening bar represented by scar P09A.3.010. 1538 – 1542.
P09B.3.010	Scar 30mm across x 790mm high x 20mm deep running on a slight diagonal up quoins P09A.3.002 in between cuts P09A.3.006 and P09A.3.009. Scar of a recessed metal stop bar hinged by P09A.3.006 and P09A.3.009 and used to stop the locked door from breaking out of the stonework. 1538 – 1542.
P09B.3.011	Circular cut 40mm across x 55mm deep on W side of quoins P09A.3.002. Presumably relates to some form of door furniture, possibly a catch for a chain like that attached to the W face of the door between P07 and P09. 1538 – 1542.

P09B.3.012	Random rubble sandstone and bedrock wall build over aperture PD.3.001. Bonded in lime mortar. 800mm thick. Circa 1538 - 1542 palace wall build.
P09B.3.013	Sandstone sill on W side of door aperture P09A.3.001. 240mm high x 510mm thick - this does not extend through the full door thickness (800mm). Has rubble build P09A.3.014 to the E. 1538 - 1542 door element.
P09B.3.014	Sandstone rubble build forming the rear 290mm of the sill of the door aperture. Bonded in lime mortar. Unclear why the stone sill P09A.3.013 does not penetrate the full wall thickness. Perhaps the stone sill could be seen from P09 but the floor level in P11 was higher and the rubble build wasn't visible. 1538 – 1542.
P09.4.020	Doorway to N of wall P09.4.001. Has been partially smashed away and later blocked, relates to doorway which opened out to Lion's Den Walkway. Doorway is probably an original 1540 palace feature.

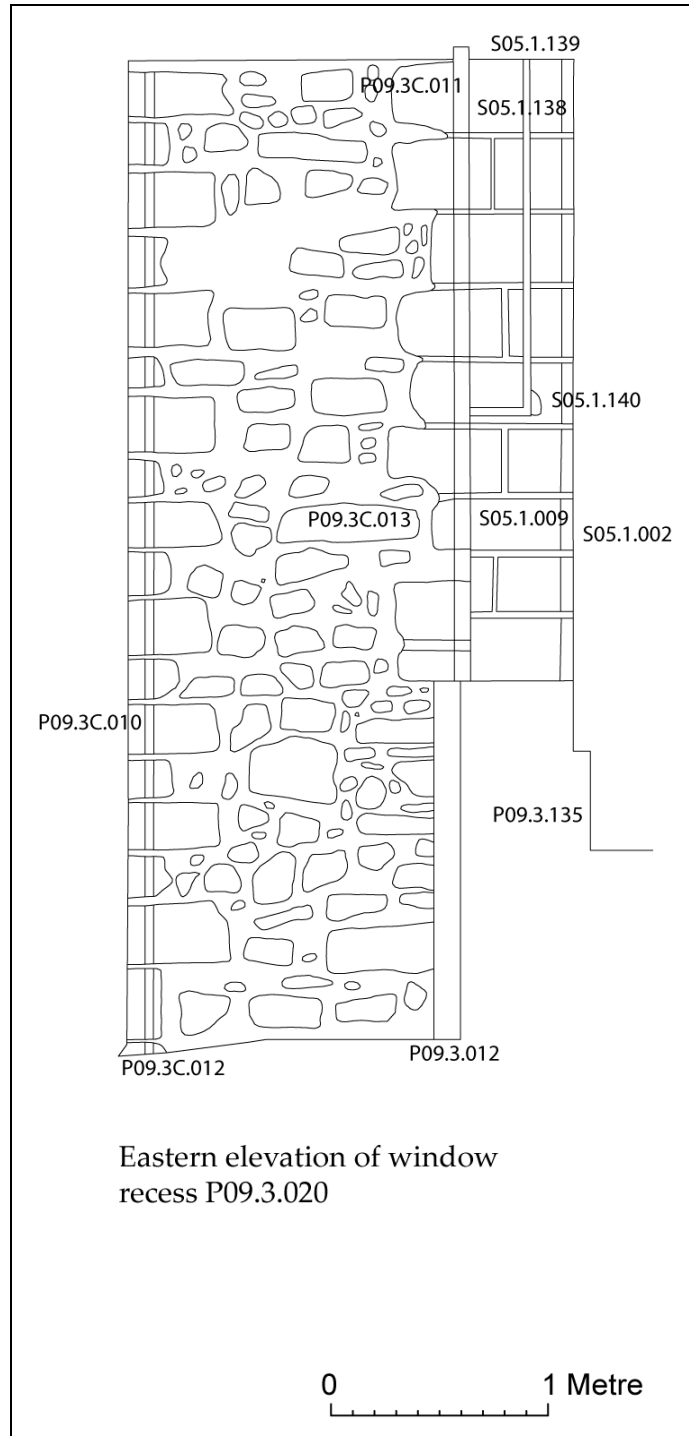
Figure 3: Drawing #3

No	Description
P09.3.012	Back wall of W recess, brick rebuild of handmade bricks 2cm x 9cm and grey cement/mortar. Also contains occasional stones in build. Probably part of the conversion to house a sash window in the Late 17th Century - Early 18th Century, forming a wider base on the inside for the larger frame. The brick build wall is 60mm thick and there is 50mm of hard pale grey mortar to the south of it and to the north of it there is the original palace wall face P09.1.135. Late 17th Century - Early 20th Century

No	Description
P09.3.020	W window recess. 1540.
P09.3.135	Original wall of window back of W embrasure P09.3. Cut through by P09.3.138 and P09.3.134. Base of window back below brick blocking P09.3.012. 1540.
P09.3C.010	Roll moulded quoins at wall edge. 1540.
P09.3C.011	Quoins at window edge of wall. 1540.
P09.3C.012	Foundation platform on which main wall build sits, clawed back at reveal. Overall height 200mm. Foundation platform for walls originally built to rough size and subsequently clawed back flush with general wall face. Late 15th Century - 1540
P09.3C.013	Very rough masonry build seen over most of Reveal C, except for quoins down the edge. Mix of white and grey very roughly shaped in fixed blocks, slabs of all sizes. 4.6m high x 1.1m wide. Main wall build, general build type in this room i.e rough. 1540.
S05.1.002	Aperture of west window, 290cm high x 180cm across. 1540.
S05.1.009	East jamb of aperture S05.1.002. Ashlar in build/out build pattern in sandstone with every 2nd block also being part of the edge roll-moulding. Contains holes to house metal yetts S05.1.013. Chamfered on east edge. Sketch of profile on reverse of context sheet. 1540.

S05.1.138	East reveal of window S05.1.002 measures 470mm N-S, the south 60mm of which is chamfered out to the east at approximately 45 degrees. At the north end this reveal is rebated by approximately 60mm to meet P09.3C.011. Part of the original 1540 palace construction.
S05.1.139	L-shaped scar in S05.1.138. Emerges from the north margin 1.25m above the base, extends 270mm south (40mm wide by 15mm deep) then runs up to the top of the reveal 20mm wide by 15mm deep. Original glazing groove. 1540.
S05.1.140	Small infilled hole (up to 90mm high by 40mm N-S) immediately south of the junction between the horizontal and vertical section of glazing groove S05.1.139. Appears that this was to take a fitting at the base of the original window. Similar features, some filled and other not can be seen at either side of all the windows of S05. The hole is probably 1540. The fill may have been added when the window was converted to sash and case or at any time after.

The opportunistic recording of the East elevation of window recess P09.3.020 did not alter the existing interpretation of the sequence of the window recess which is that the recess is mainly original palace build with brick modifications possibly in the Late 17th Century to support the sash windows inserted at this time, or possibly in the Early 20th Century to hold radiators (but possibly also related to the replacement of sash windows at this time – P09.3.014 is an example of an Early 20th Century replacement).

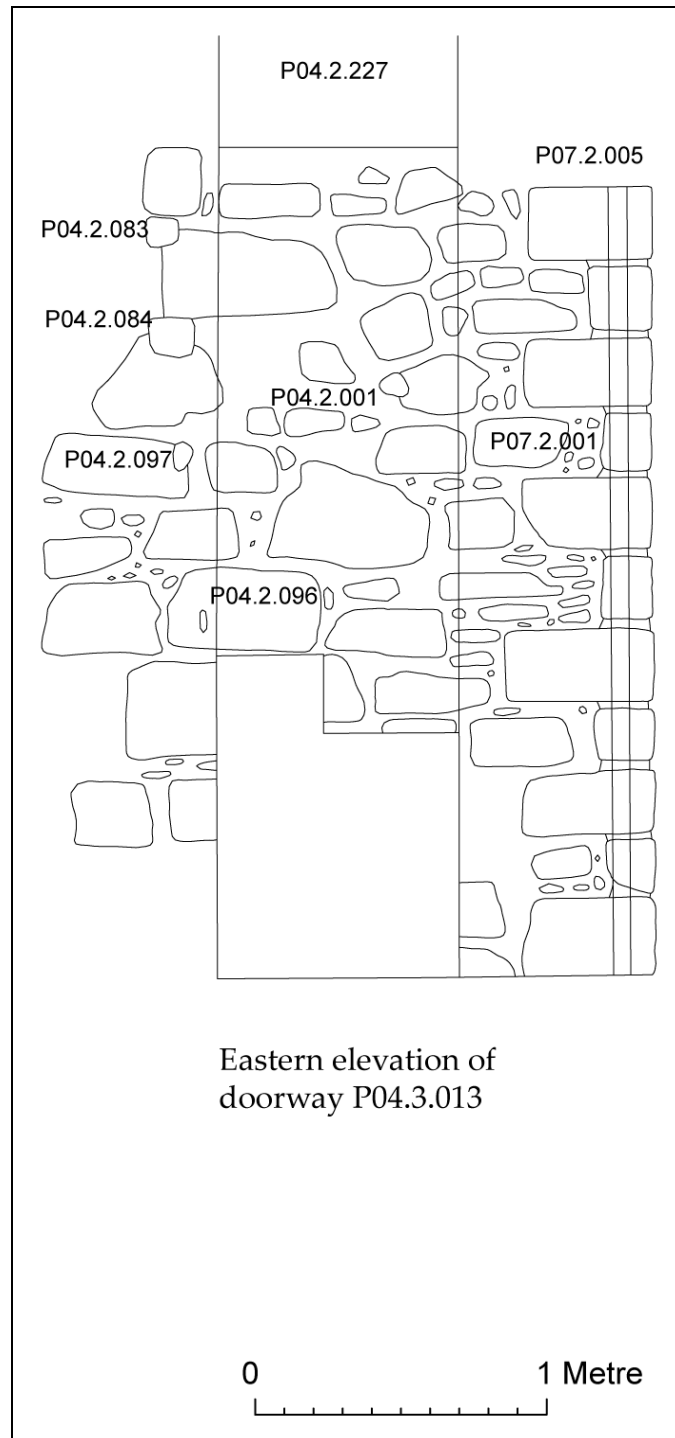
Figure 4: Drawing #4

No	Description
P04.2.001	Lower stretch of walling inbetween window bays P04.2.003 and P04.2.017. Generally yellow sandstone blocks but some blue/green and occasional dolorite chunks. Uncoursed but some are squared off sandstone finely dressed. Frequent use of pinnars - small stones and slates used. Lower part of E wall of kings bedchamber. Almost certainly contemporary with P04.2.002 above, just higher quality build. 1540.
P04.2.083	1 of 4 concrete filled repairs to S of window bay P04.2.017 in sets of 2 pairs arranged one above the other. Crudely infilled by dark grey cement but originally roughly 100mm square. Upper, very large type B2 filled with cement. " Dumbell Dooks". Infilled holes, function unknown. Appears in pairs- similar arrangements noted between window bays (P04.2.071 - P04.2.074) as well as in both actual window bays, the N wall and the Wwall. Likley to be some form of military fixture. Late 18 th Century – 19 th Century.

P04.2.084	1 of 4 concrete filled repairs to S of window bay P04.2.017 in sets of 2 pairs arranged one above the other. Crudely infilled by dark grey cement but originally roughly 100mm square.

No	Description
	<p>Lower, very large type A1 filled with cement.</p> <p>" Dumbell Dooks". Infilled holes, function unknown. Appears in pairs- similar arrangements noted between window bays (P04.2.071 - P04.2.074) as well as in both actual window bays, the N wall and the Wwall. Likely to be some form of military fixture. Late 18th Century – 19th Century.</p>
P04.2.096	<p>1 rectangular dook in a series of 4 vertical rows of rectangular dooks to the S of window bay P04.2.017. Generally infilled or partly infilled by pale grey mortar 20-30mm wide, 60-80mm high. Chiselled into stonework of P04.2.002. The northern 2 rows (P04.2.088-P04.2.095) are regular arrangements of 4 holes, the 2 central rows are closer together than the top and bottom. To the S there is a row of 3 holes P04.2.085-P04.2.087, while at the S end of the wall only 2, P04.2.096 and P04.2.097 were noted. 1 hole P04.2.088 cuts G1 block P04.2.067, one of a series of squared stone blocks set in to the wall.</p> <p>Type D1 filled with plaster.</p> <p>Part of dook group P04.2.176 . 4 vertical(ish) columns of rectangular holes, often cut straight into stones. Appears (where it survives) to consist of 4 holes in a row, with the central 2 close together (150mm-200mm) and the top and bottom further apart (the top row 400mm up the bottom 300mm down). This pattern is repeated to the N of window P04.2.017 (P04.2.098-P04.2.106) as well as running into the window bays and along the N and W walls. A similar pattern can be seen in the Queen's bed chamber. The regularity in shape and spacing of the dooks indicates a requirement for uniformity - likely to be either wood pannelling or shelving. One example P04.2.088 cuts square stone block P04.2.067 - a relationship mirrored in the W wall. Note P04.2.114 is a square hole at the top of one of these four lines - could be part of the series, simply a different shape. Late 18th Century – Early 20th Century.</p>

P04.2.097	<p>1 rectangular dook in a series of 4 vertical rows of rectangular dooks to the S of window bay P04.2.017. Generally infilled or partly infilled by pale grey mortar 20-30mm wide, 60-80mm high. Chiselled into stonework of P04.2.002. The northern 2 rows (P04.2.088-P04.2.095) are regular arrangements of 4 holes, the 2 central rows are closer together than the top and bottom. To the S there is a row of 3 holes P04.2.085-P04.2.087, while at the S end of the wall only 2, P04.2.096 and P04.2.097 were noted. 1 hole P04.2.088 cuts G1 block P04.2.067, one of a series of squared stone blocks set in to the wall.</p> <p>Type D1 filled with wood but covered with plaster.</p> <p>Part of dook group P04.2.176 . 4 vertical(ish) columns of rectangular holes, often cut straight into stones. Appears (where it survives) to consist of 4 holes in a row, with the central 2 close together (150mm-200mm) and the top and bottom further apart (the top row 400mm up the bottom 300mm down). This pattern is repeated to the N of window P04.2.017 (P04.2.098-P04.2.106) as well as running into the window bays and along the N and W walls. A similar pattern can be seen in the Queen's bed chamber. The regularity in shape and spacing of the dooks indicates a requirement for uniformity - likely to be either wood pannelling or shelving. One example P04.2.088 cuts square stone block P04.2.067 - a relationship mirrored in the W wall. Note P04.2.114 is a square hole at the top of one of these four lines - could be part of the series, simply a different shape. Late 18th Century – Early 20th Century.</p>

P04.2.227	<p>Scar on the east wall where historic Scotland have removed some masonry at the east side of the doorway between P04 and P07. The affected area measures 850mm N-S and up to 2.80m in height. At the time of recording 1.20m had</p>

No	Description
	already been rebuilt hiding the base of the wall. The stone work has a rough finish with many tool marks. Some stones jut out west from the stone face but these are to be cut off as part of the ongoing work. June/July 2008 disturbance of wall fabric to create a new reconstructed palace doorway.
P04.3.013	Door aperture 1970 built reflecting original 1540 layout.
P07.2.001	Original wall rubble. Random block of sandstone forming an arch around the newer repaired wall P07.1.003. 1540.
P07.2.005	Ashlar quoins up side of chimney breast. 12 courses can be seen and appear to have chamfered edge. Closer inspection indicates this is damage to the edge and is probably recent as the surface is rough and appears fresh. 1540

Very little original masonry from the door between P04 and P07 was identified other than the face of the original wall fabric (P04.3.001/P07.1.001) of the palace hidden behind the 1970'sw rebuild. Unfortunately the possible block of original roll mould P07.1.045 was already hidden behind the base of the new East margin at the time of recording.

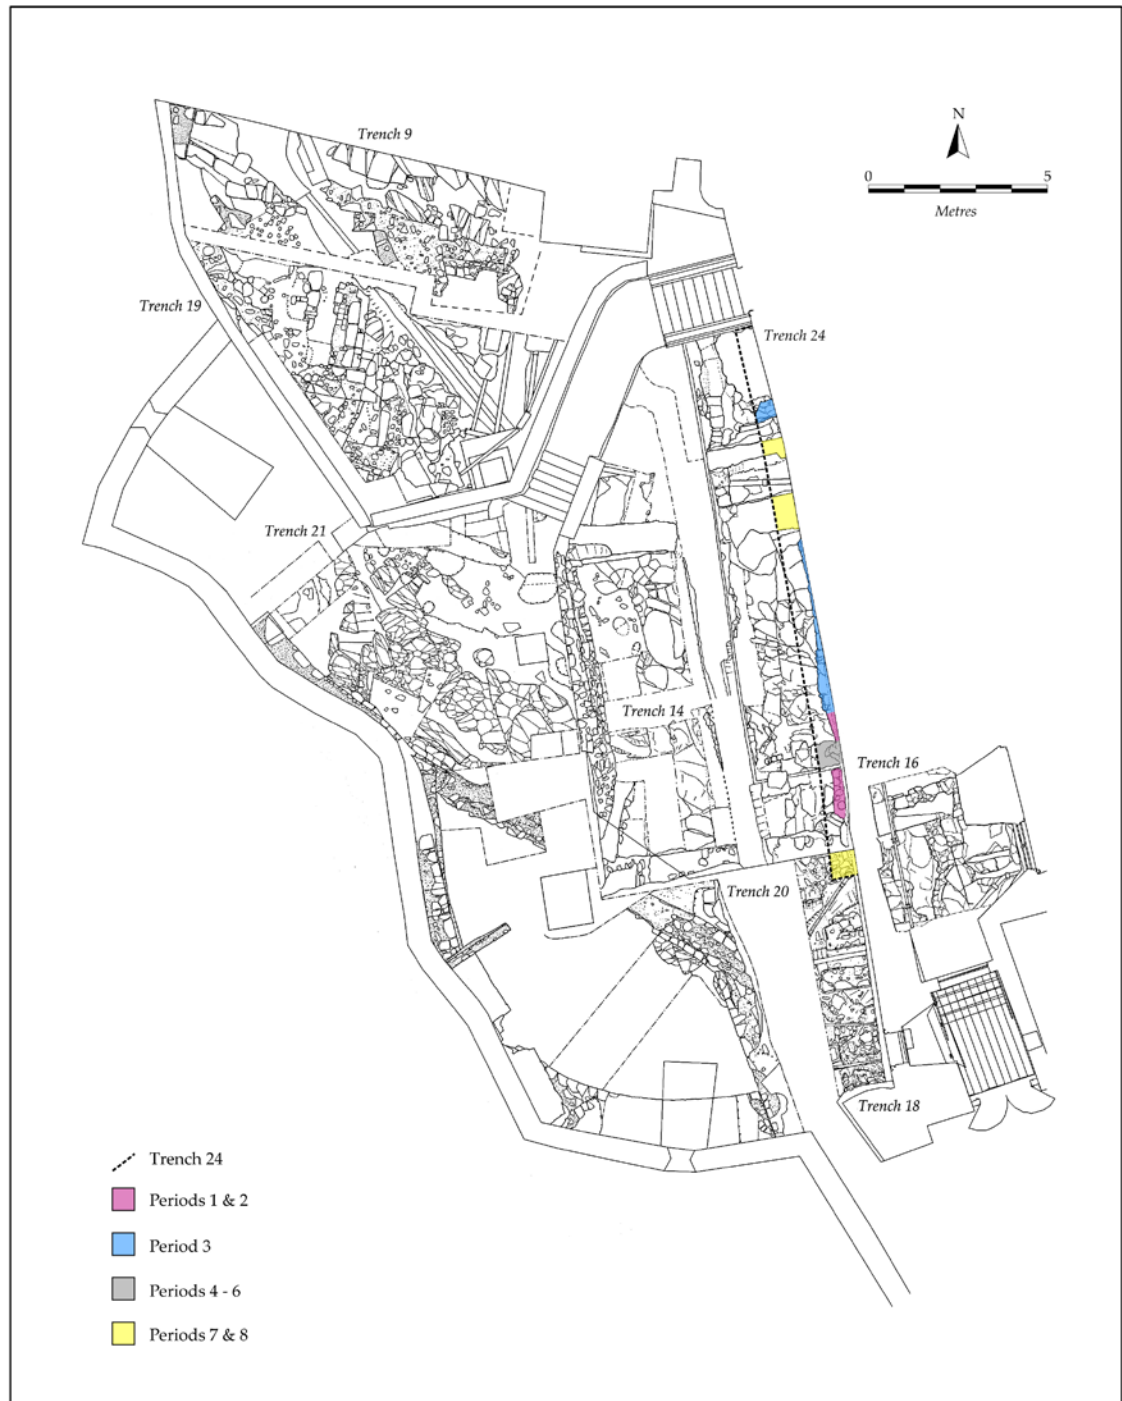
Figure 1 - Phased Plan of Walls in Trench 24

Work commenced at the N end of Trench 24 in the backfill of the previously excavated Trench 14 immediately against the W wall of the Palace, approximately 500mm wide and dug to the same depth as Trench 14 (which was dug to bedrock). The backfill was removed to reveal bedrock, the buried masonry of the W range of the palace as well as a number of buried structures to the W of the W range all of which were previously identified and recorded during the excavation of Trench 14. At the N end of the trench bedrock is around 0.7m deep. Moving S along the trench walls **14092**, **14029** and **14030** were re-revealed perpendicular to the W range, walls **14196** and **14121** were re-revealed roughly parallel to the W range under the palace wall, wall **14118** perpendicular to the W range, wall **14114** roughly parallel to the W range under the palace wall and finally wall **14073** perpendicular to the W range. Excavation ceased at the southern limit of Trench 14 to consider the feasibility and practicalities of inserting a French drain along this route given the concentration of walls crossing the trench in the case of **14092**, **14029**, **14030**, **14118**, and **14073** and reducing the width of the trench in the case of **14196**, **14121** and **14114**.

At the N end the proposed depth of the trench is 1.4m deep, however bedrock is around 0.7m deep at this point. Several walls cross and reduce the width of the trench in the re-excavated section of Trench 14, these range from early pre-palace Period 1 and 2 structures to 18th century and 19th century Period 7 and Period 8 ablution house walls (Figure 1).

The proposed route of trench 24 through Trench 18 will encounter further such walls. It would also cut across a previously unexcavated section of the ladies lookout. Cutting such a narrow trench across this area is inadvisable and a larger excavation across this area may be more

appropriate to join the data from Trench 18 to Trench 20.

Another, option might be to use one of the existing historic apertures through the West Range wall and to create a route through the vaults for the drain. Further research and discussion would be required to determine the feasibility of creating such a drain through the West Range vaults.
