**31 Kirkgate, Holme-next-the-Sea,
Norfolk**

**Monitoring of Works under Archaeological
Supervision and Control**

ENF 139098

**John Percival
February 2016**

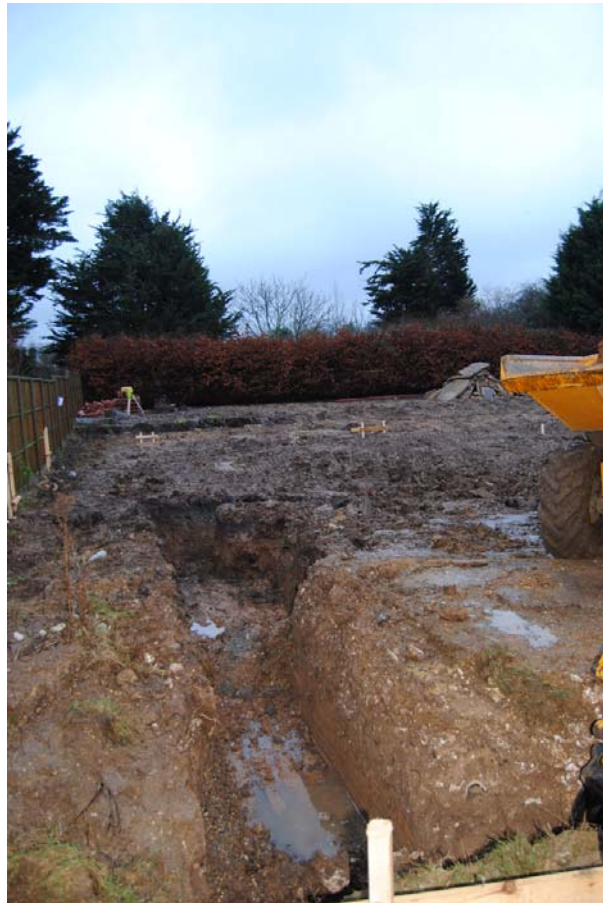
Plate 1. Typical deposits, looking south.

The footing trenches (Fig. 2, Plates 1 and 2) were excavated by machine, a JCB type wheeled excavator fitted with a 900mm bucket. The footing trenches were between 0.9m and 1.1m wide and 1.0m deep. Undisturbed 'natural' geological deposits consisting of very dense boulder clay (see above) was seen in the sides and base across all of the footing trenches.

Across most of the footing trenches the boulder clay was directly overlain by between 0.4m and 0.6m of mixed clayey loam topsoil containing frequent lumps of chalk.

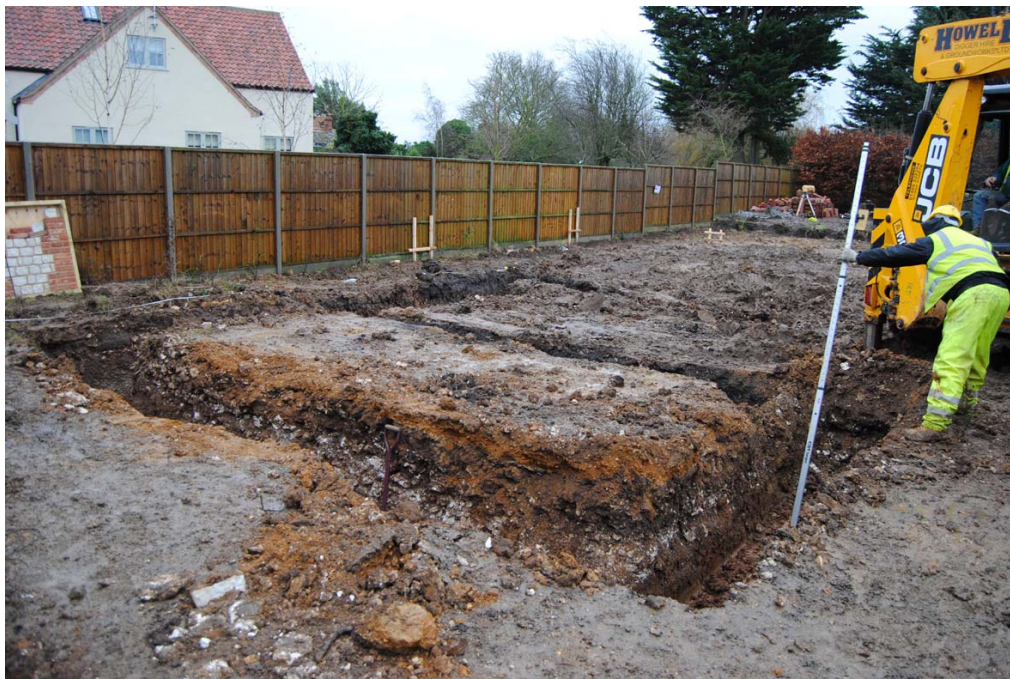
Plate 2. Showing chalk rubble make-up for driveway, looking south-east.

In the area that had been occupied by the asphalt driveway for the bungalow a layer of compacted chalk rubble 0.4m thick was overlain by 0.1m gravel bedding for the asphalt. The disturbance and truncation caused by the construction of the driveway was more severe than that caused by the construction and demolition of the bungalow itself.
