Archaeological Watching Brief

Emergency Repairs to Flood Defences

Iken Marshes

HW Report No. 136

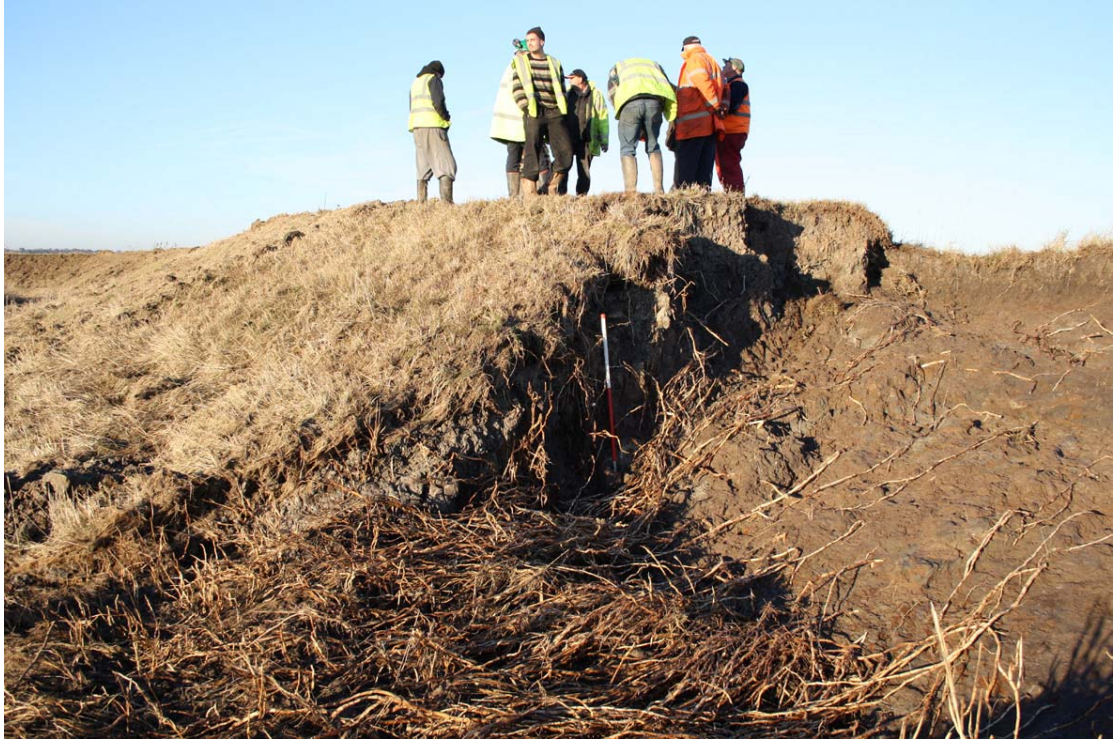
The breaches in the sea bank were monitored (Fig 2, A, Plate 1). It was thought that the earlier post-medieval build of sea wall may have been revealed however, the material swept away during the flood event was from the top and back of the bank only, the front and core of the bank were not revealed. No distinct differences in build were noted. It is therefore thought that the elements of the bank revealed date from the 1950s onwards.

Plate 1. Showing breach in sea wall, looking north-west.

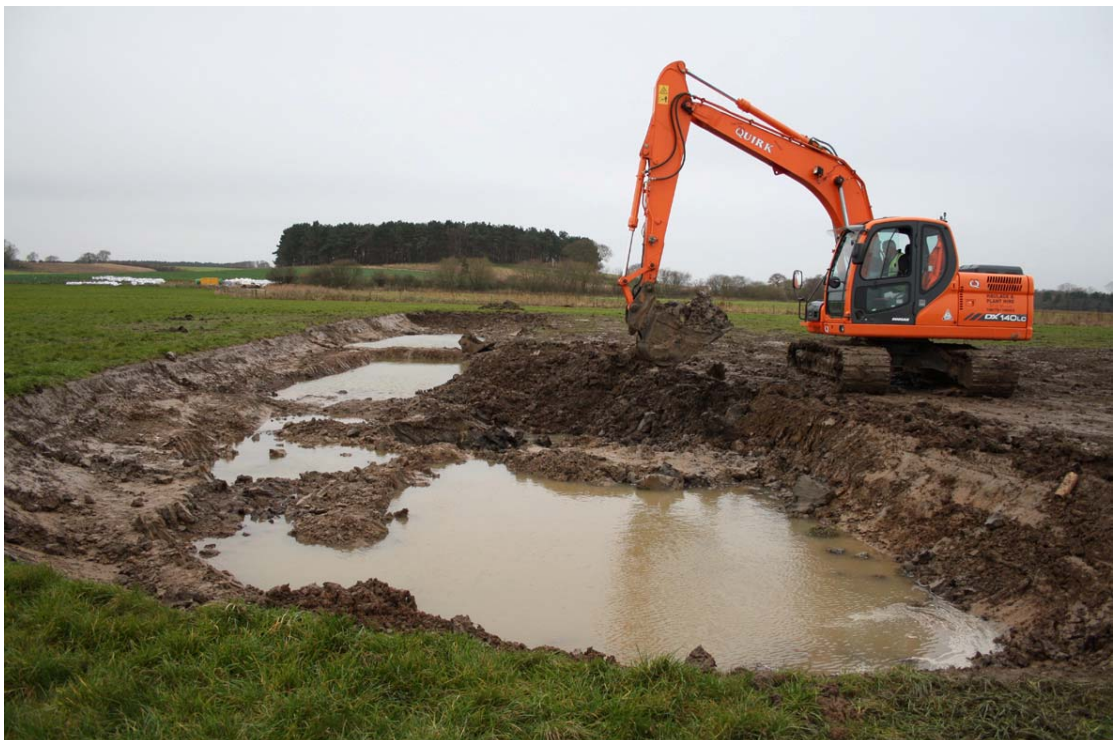
Material to repair the bank was taken from the marsh, from an area c.50m long and c.10m wide and 1.5m -2m deep (Fig 2, B, Plates 2 and 3). The topsoil across this area was relatively shallow (c.0.1m deep), below this lay a subsoil of mid orange brown slightly silty clay c.0.4m deep. This overlay the natural of a mid brownish orange slightly silty clay. Clay field drains on a north-south alignment were seen to run across this area.

Plate 2. Sourcing of material, looking south, Yarn Hill is wooded are in background.

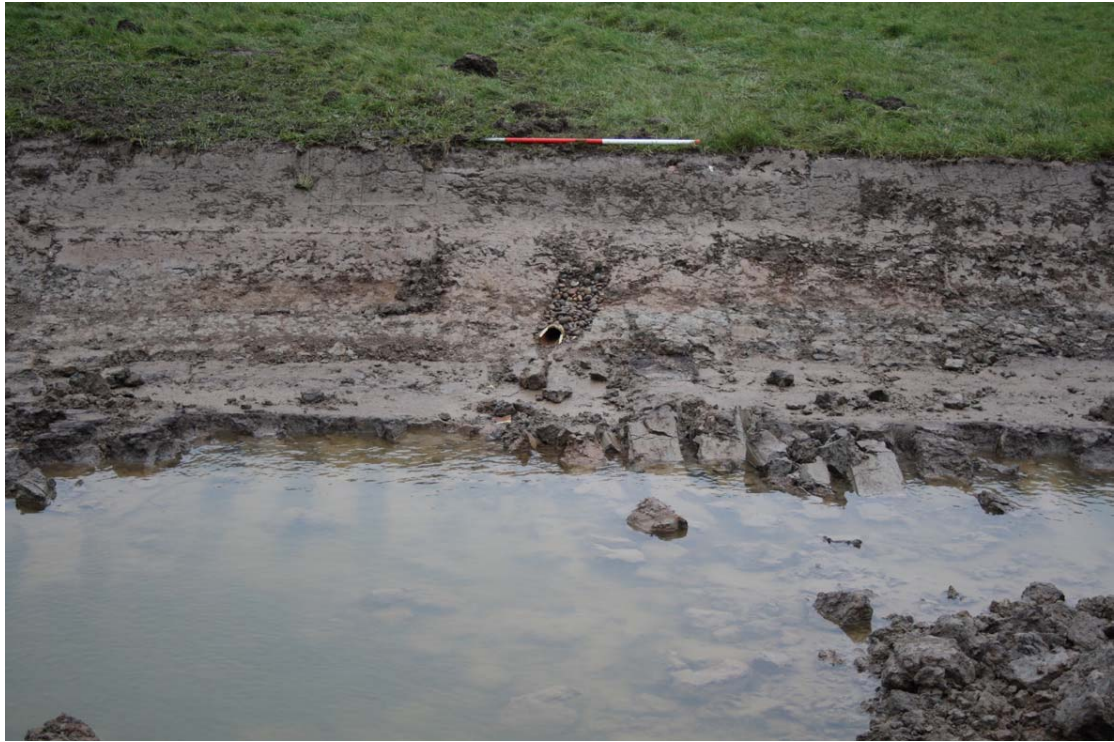
Plate 3. Sourcing of material, typical section with field drain, looking south-east.

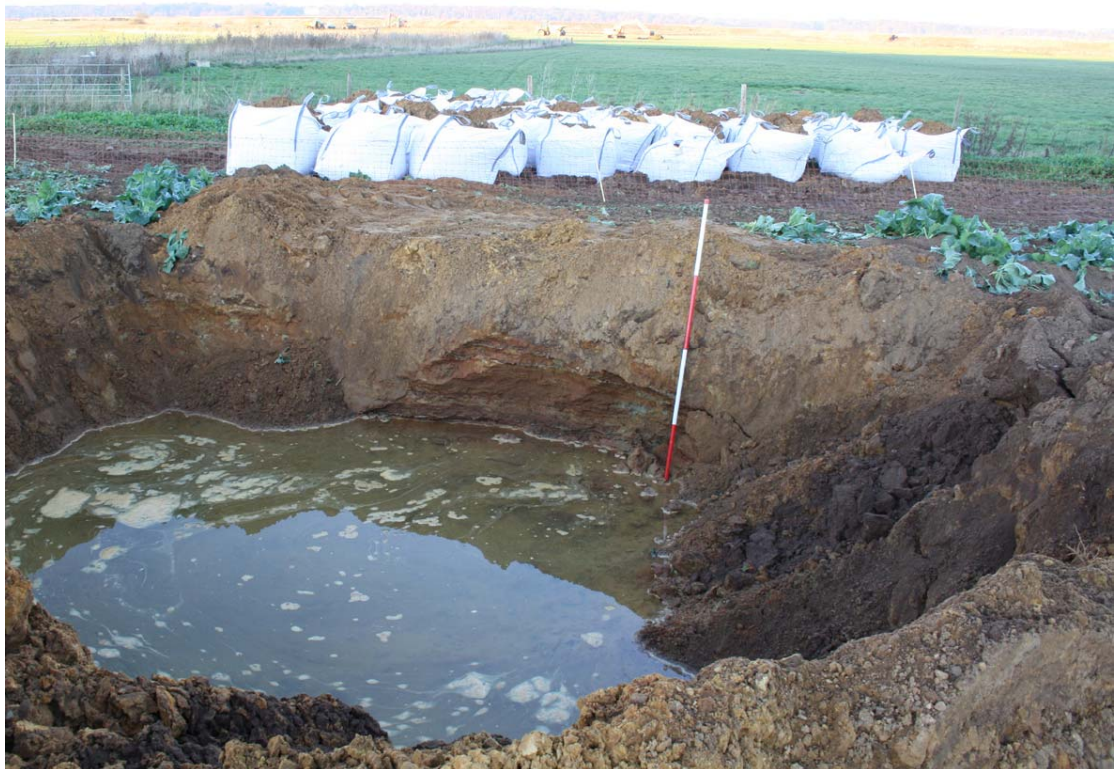
Two pits, which lay closer to Yarn Hill, had been excavated by the landowner prior to the storm in order to fill sand bags. These were located just above the 0m contour where the ground begins to gently rise towards the base of Yarn Hill (Fig 2, C, Plate 4). The natural subsoil here was noticeably different from that on the marshes being orange silty sand. Within the natural sand distinctive laminations were visible including narrow bands of yellow sand and

grey silt/clays. Over the natural lay a thick topsoil (c.0,5m deep) of mid orange brown slightly silty loamy sand. The two pits were irregular rectangles measuring c.12mx5m and 6mx8m) and between 2 and 2.5m in depth.

Plate 4. Pit located towards base of Yarn Hill, looking north.
