**Waldringfield  
Tidal Defence Repair and Wildlife Pond**

**Archaeological Monitoring**

**ESF 22926**

**HW Report No. 173**

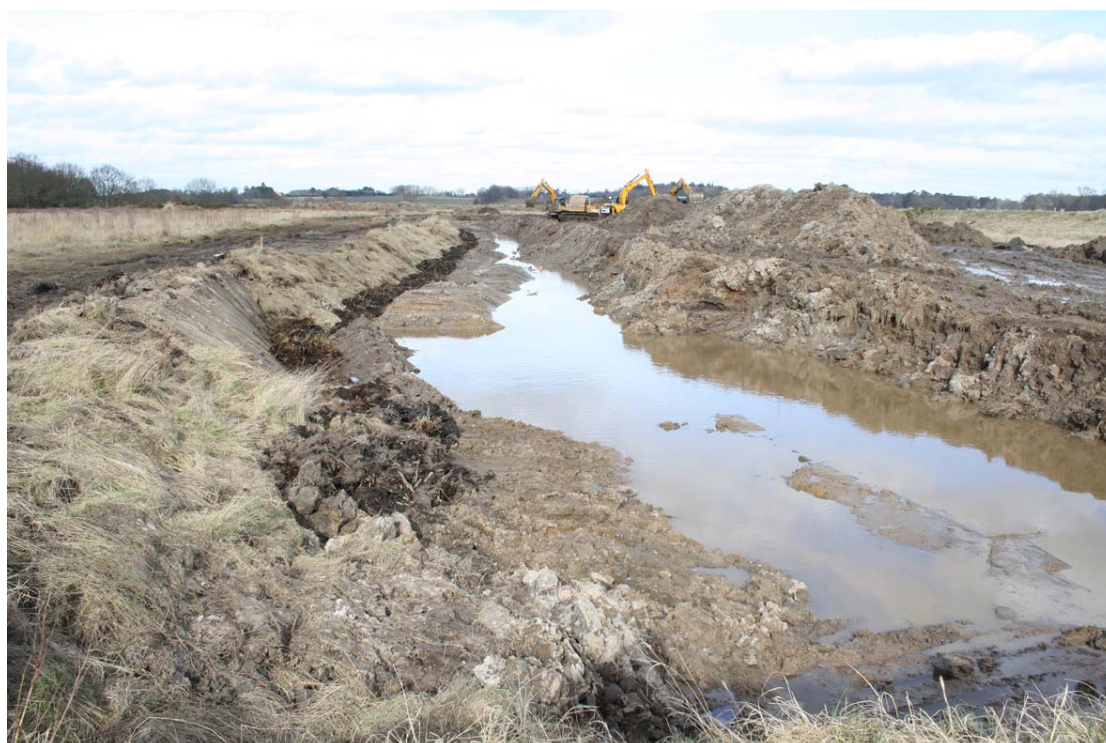
Fig. 2. Excavation of dyke, looking north.

The revealed deposits were consistent along the length of the dyke and within the pond. The lowest deposit was orange/grey silty sand, observed at an

approximate depth of 0.5m. Above this was c.0.3m of orange/grey silty clay over which sat c.0.2m of dark brown clayey loam topsoil.

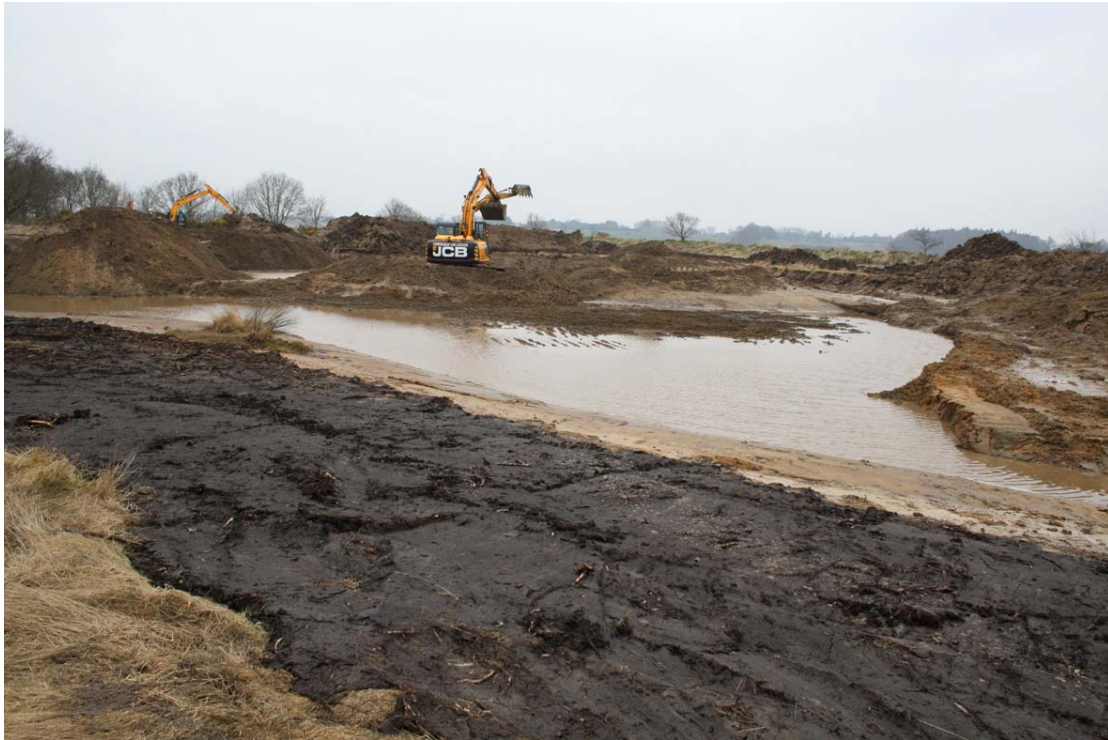
Fig. 3. Excavation of pond, looking north-east.

No archaeological features or deposits were seen during the excavation works and no artefacts were recovered.
