**Brook House, 32 Beach Road,  
Holme-next-the-Sea,  
Norfolk**

**Monitoring of Works under Archaeological  
Supervision and Control**

**ENF 140683**

**HW Report No. 203**

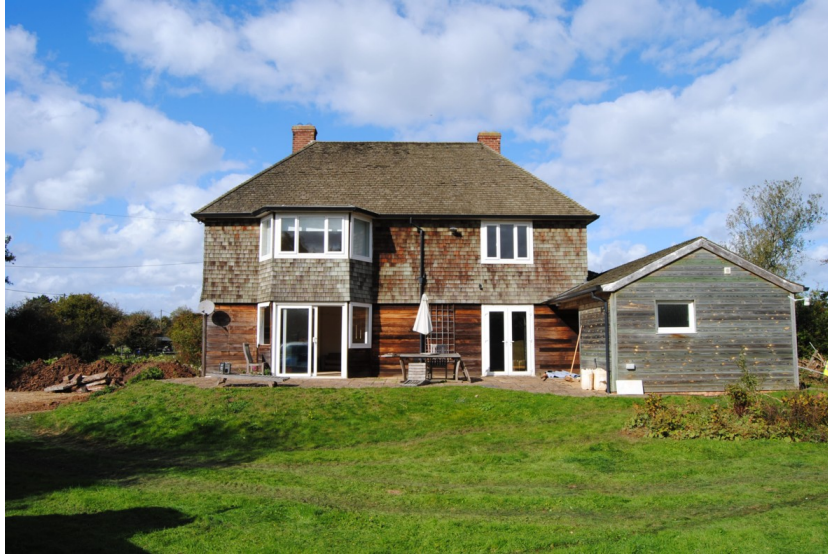
Plate 1. Brook House at start of works.

The main body of Brook House was built in c.1939 and was of unusual construction being a soft-wood timber framed building with cedar and beech tile cladding. The eastern wing of Brook House is an extension constructed of similar materials to the original fabric and dates to the 1990s (Plate 1).

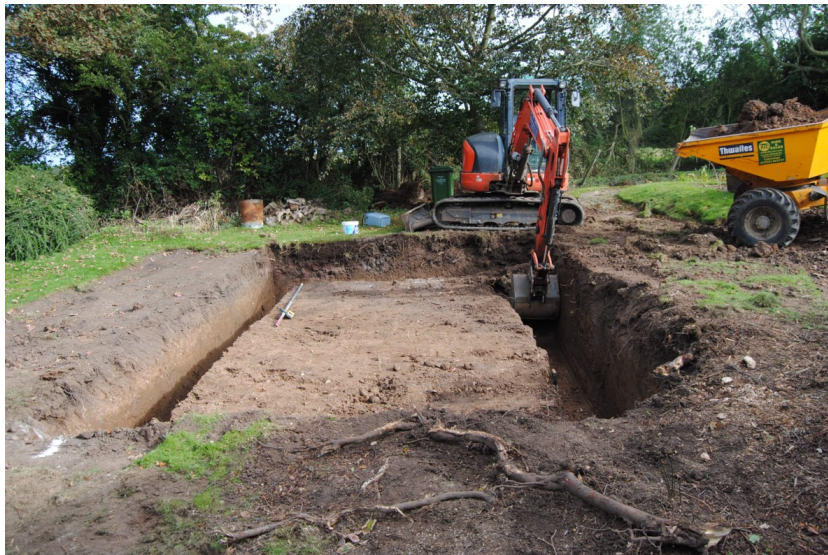
Plate 2. Footings of Workshop.

The footing trenches for the studio/workshop were between 1.3 and 1.5m deep. Dense orange boulder clay 'natural' was overlain by 0.4m of mottled grey slightly silty-clay containing occasional small fragments of chalk and soft red brick (Plate 2). This material was water lain or heavily water affected flood deposit disturbed or reworked to some extent during the construction of Brook House. The grey slity-clay was in turn overlain a 0.4m thick layer of mid orange-brown clay containing frequent flecks of chalk and occasional small fragments of Fletton type bricks of mid-20<sup>th</sup> century date and fragments of

soft, red post-medieval type bricks. This deposit was essentially redeposited clay 'natural', probably excavated during the construction of Brook House in c.1939 and dumped to form the outer parts of an artificial mound on which Brook House sits. A 0.5m thickness of dark brown silty-loam topsoil occupied the upper part of the studio/workshop footing trenches. This material was either redeposited or imported and the result of landscaping within the last 20 years of so.

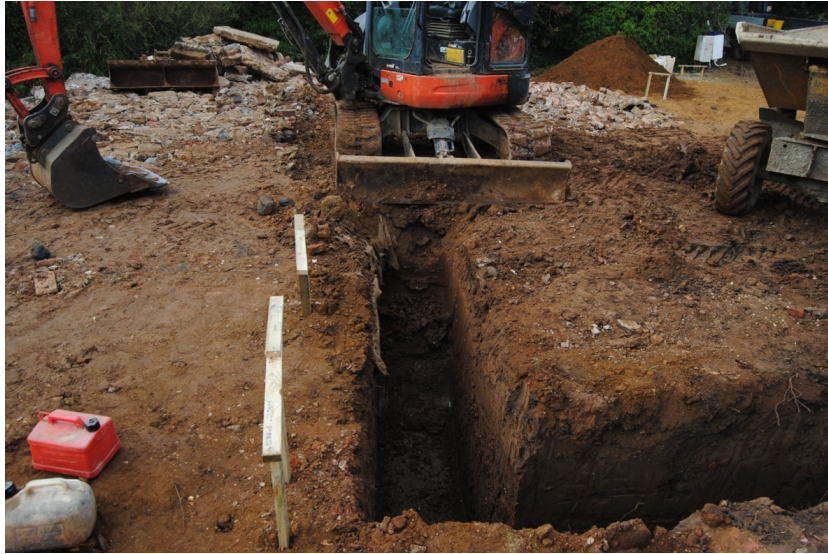
Plate 3. Footing of west extension.

The footing trenches for the extension east of Brook House were either 1.9m deep or between 1.6 and 1.7m deep. Brown or orange-brown chalk-flecked boulder clay 'natural' was seen at a depth of 0.9m. The boulder clay was overlain by 0.70m of grey slightly silty water deposited or affected clay (Plate 3). This material contained occasional fragments of unfrosted sandy soft red bricks of post-medieval appearance ill-sorted towards its upper horizon. There was something of a concentration of this brick rubble towards the north-western part of the footing trenches (Plate 4). The upper parts of grey silty-clay flood/marsh deposits were heavily disturbed and reworked during the construction of Brook House in c.1939.
