**River Nar Restoration
West Lexham**

**Topographical Survey
and
Monitoring of Works under Archaeological
Supervision and Control**

**Heather Wallis
October 2017**

HW Report No. 207

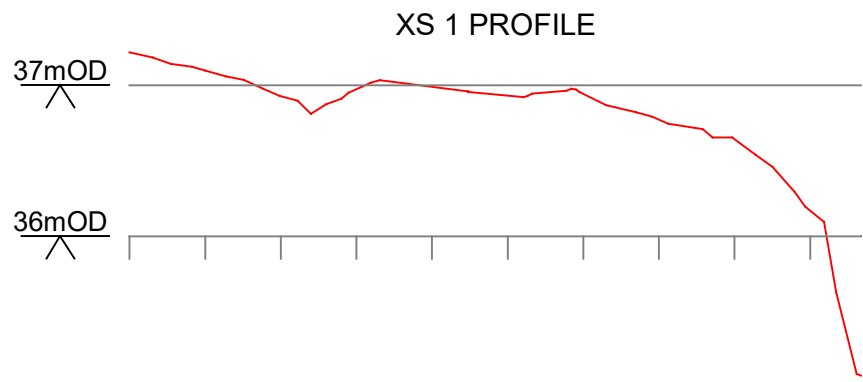
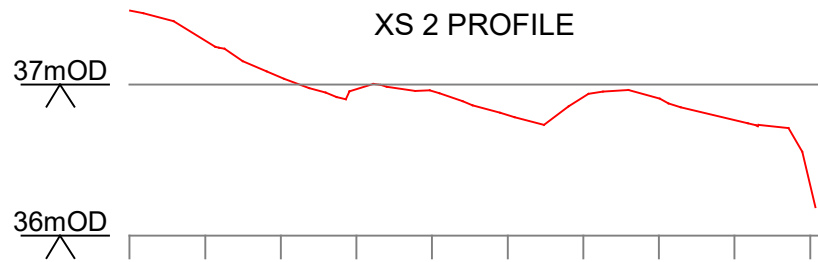
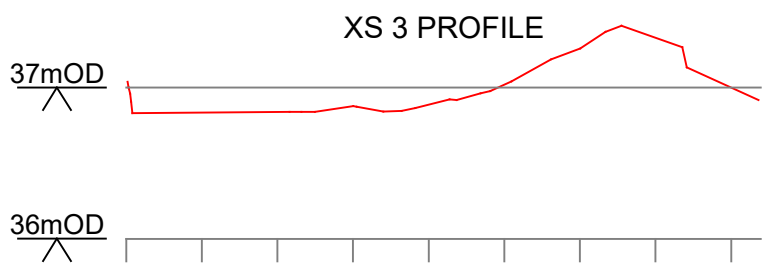
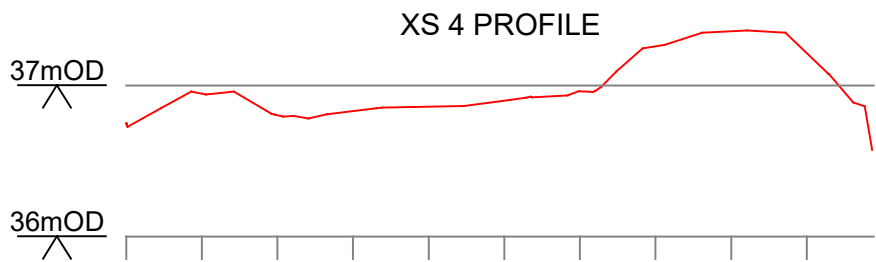
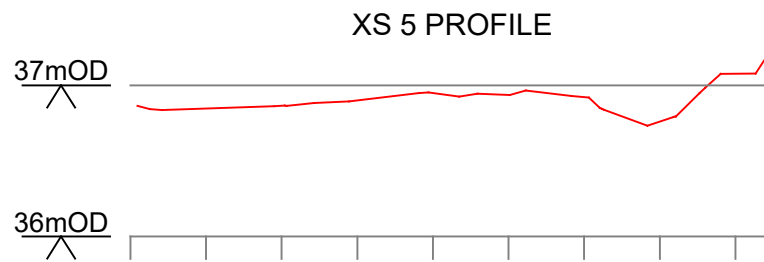
Figure 5. Contour survey cross-sections. Vertical scale x10.

The results of the survey are presented in Figs 4-6. These show two parallel channels and low banks which form the eastern end of the floated water meadow complex. Their remains are slight with the height difference between hollows and the tops of the banks being just 0.15m. To the east of these a raised track crossed the area on a north-west to south-east alignment, from a river crossing to the north.

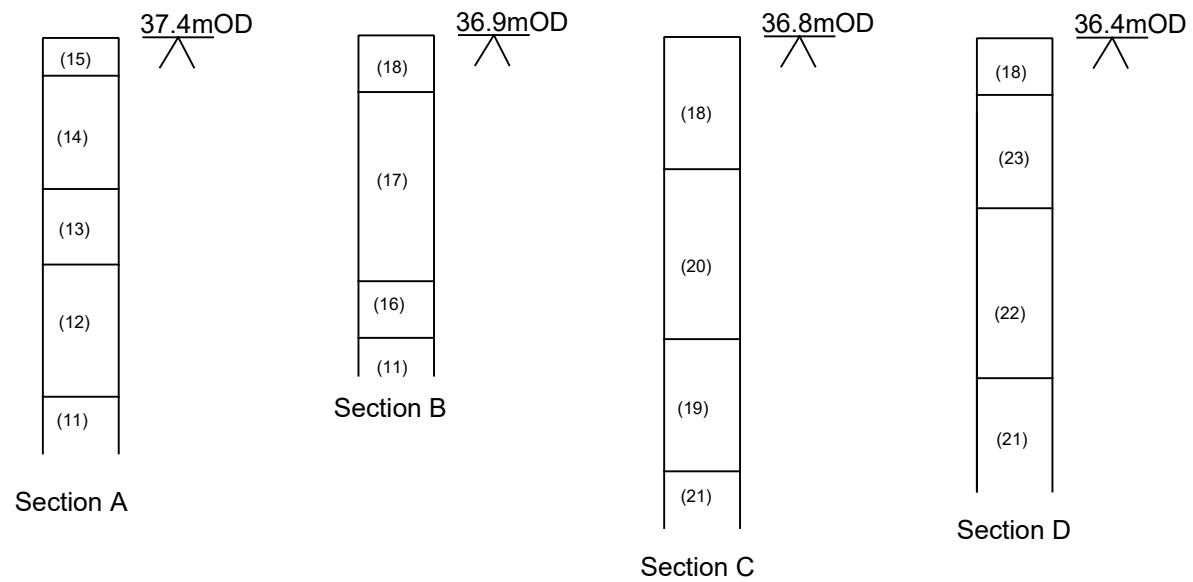
Figure 6. Representative sections along new channel.

The excavation of the new river channel was undertaken by machine using a flat-bladed ditching bucket (Plate 3). The new channel was up to 5m wide and it varied in depth between c.0.9m to c.1.5m depending on the localised surface level and the required fall across the length of the cut. There was some variation in the deposits along the length of the channel and four measured sketch sections were recorded to reflect these changes (Figs 6 and 7).

Section A – across trackway

Above the lowest natural gravel (11) was a deposit of orangey brown slightly silty moist sand (12) over which was a layer of crushed chalk (13) (Plate 4). The crushed chalk was only present in the area of the track and varied in depth between 0.1 and 0.2m. Over this lay 0.3m depth of large gravel/medium sized flints in orange brown silty sand (14). Sitting above this was 0.1m of smaller gravel in grey sand (15). A thin layer of turf had developed over this.

Section B – to west of trackway

On top of the natural gravel lay a dark brownish grey silt with some very fine sand (16). Over this a 0.5m deep deposit of dark brownish grey sandy silt with occasional small flints (17) was recorded. It is thought this may be the natural silting of a hollow adjacent to the trackway. The uppermost deposit was a dark brownish grey loamy silt topsoil (18).

Section C – close to raised earthworks

Above natural orange gravel (21) lay 0.35m depth of mid brownish orange sandy silt (19) over which was 0.45m of mid orange brown slightly clayey silt (20). This deposit was thickest in the southern section but not as apparent in the northern section (Plate 5). It is therefore possible that this was part of the raised earthwork bank. Above this was the topsoil (18)

Section D – western end

Over the natural gravel (21) lay greyish brown silty gravel (22) above which was a greyish brown slightly clayey silt with some fine sand content (23). Above this lay the topsoil (18) (Plate 6).

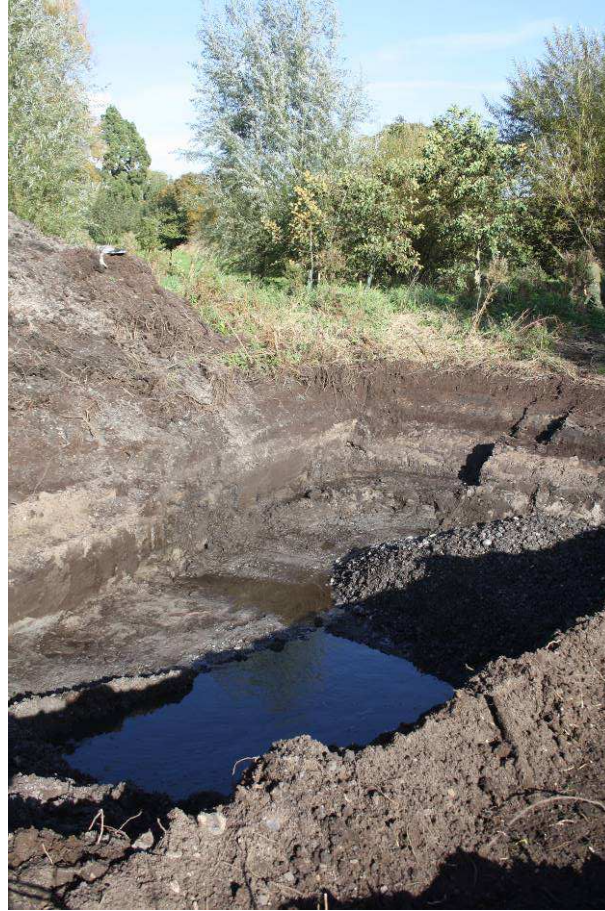
Plate 1. Borrow Pit 1. Feature (08) in section. Looking north-east.

The underlying natural, a grey silty/sandy gravel (05) was noted at a depth of c.1.6m. Over this was a layer of natural yellowy grey sand (04) with some

coarse gravel and a pale yellowish grey sand with peaty and silty lenses (03). A linear feature (**08**) aligned north-east to south-west, was seen cutting through this. This feature was cut from a depth of 0.8m and was c.0.8m deep and 2m wide. It's lowest fill, which extended across the base of the feature and up its sides was mid brown silty peat (06). Above this was dark grey clayey silt (07). Both deposits are thought to have accumulated naturally within the feature. The upper fill was grey brown clayey silt (09) with sand and gravel lenses and patches. This is likely to have been deliberate backfill.

The feature (**08**) was parallel to the floated meadow earthworks and may originally have formed part of these meadows which were constructed between 1803 and 1811. The upper fill and overlying subsoil and topsoil which probably derived from cleaning of the adjacent river and/or lake were deliberately deposited to infill this channel.

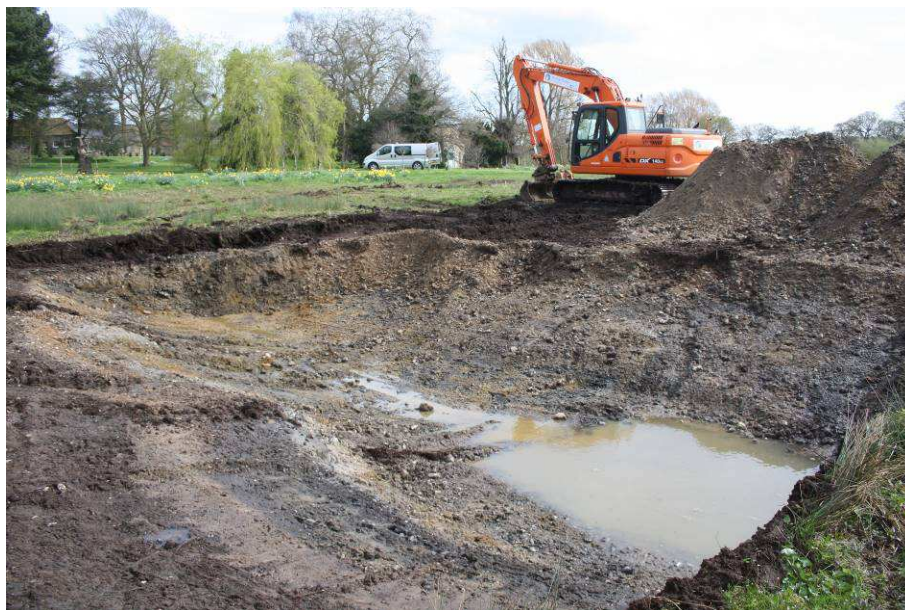
Plate 2. Borrow Pit 3. Looking north-east.

At the south end of the excavation clean orange gravel (24) was noted at a depth of 0.7m, while at the north this deposit was just c.0.4m below the present

ground surface. Over this lay c.0.1m of dark grey silty gravel (25) which was only present towards the south end of the scrape. Above this was mixed orange brown gravel and silt (26) between 0.1 and 0.2m deep. The overlying topsoil was between 0.3 and 0.4m deep and was a dark brown peaty silt (27).

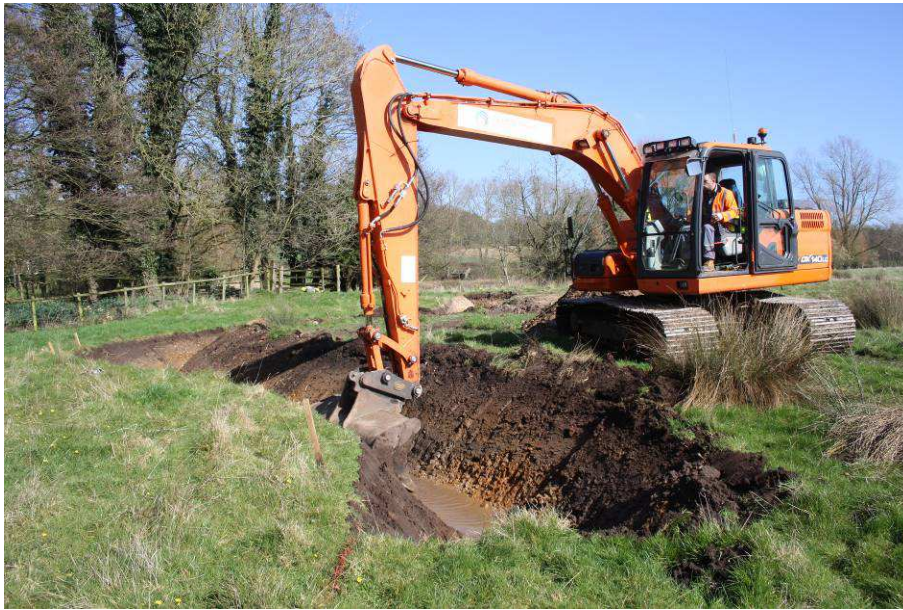
Plate 3. New channel. View of works. Looking north-east.

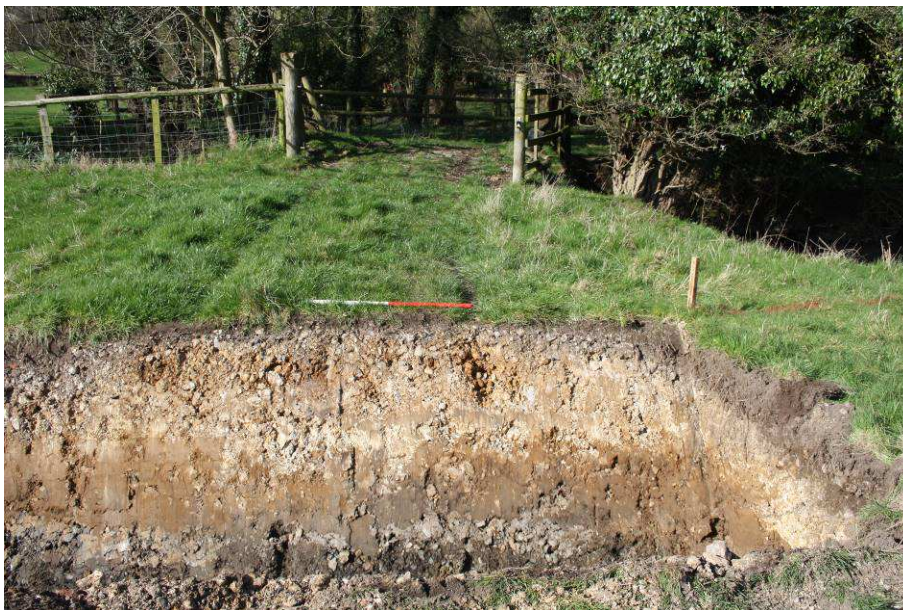
Plate 4. New channel. Section through track. Looking north-west.
(Opposite Section A)

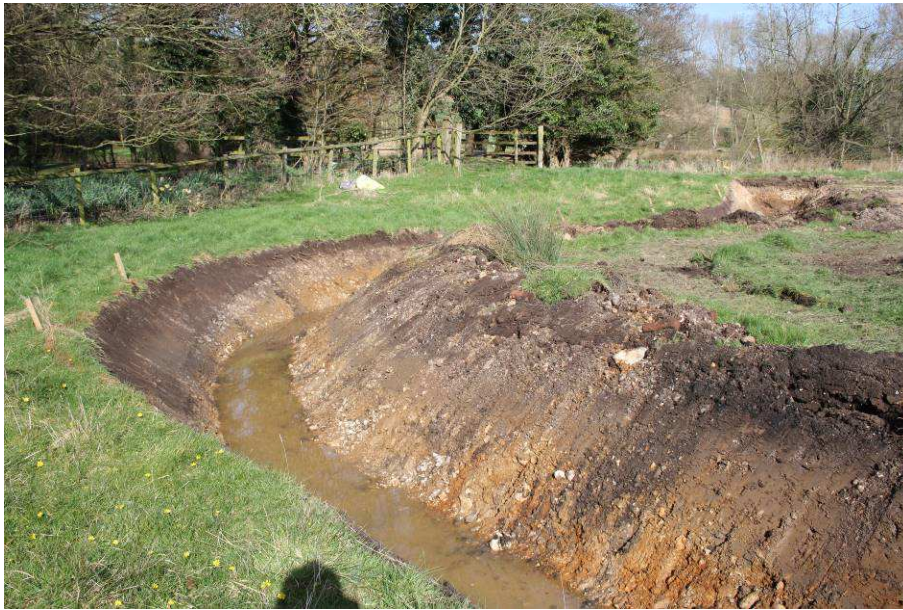
Plate 5. New channel. Section close to earthwork bank. Looking north-east.
Right hand side of cut shows Section C deposits.

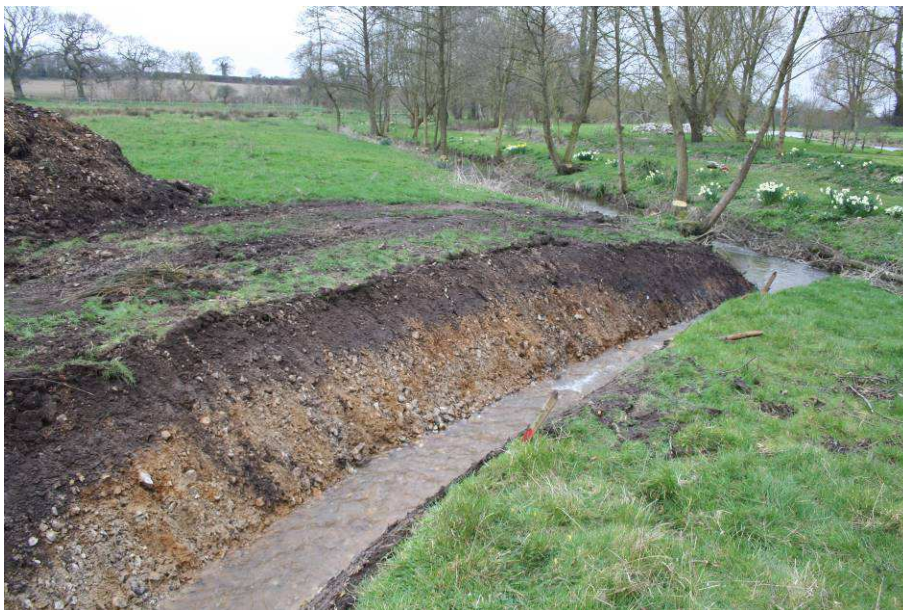
Plate 6. New channel. Section where channel joins river. Looking south-west.
Left hand side of cut shows Section D deposits.
