All Saints' Church

Carleton Rode

Monitoring of Works in North and South Aisles

HW Report No. 226

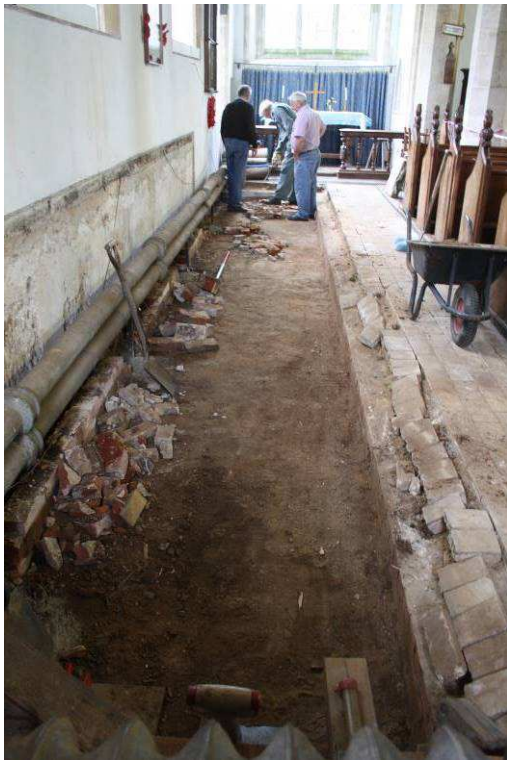
Plate 1. North aisle, looking east.

No notable features were revealed by the works in the north aisle (Plate 1). Deposits under the old raised wooden floor consisted of mid orange brown sandy silt with occasional chalk fleck and lighter orange brown sandy silt. These deposits were very dry and heavily compacted.

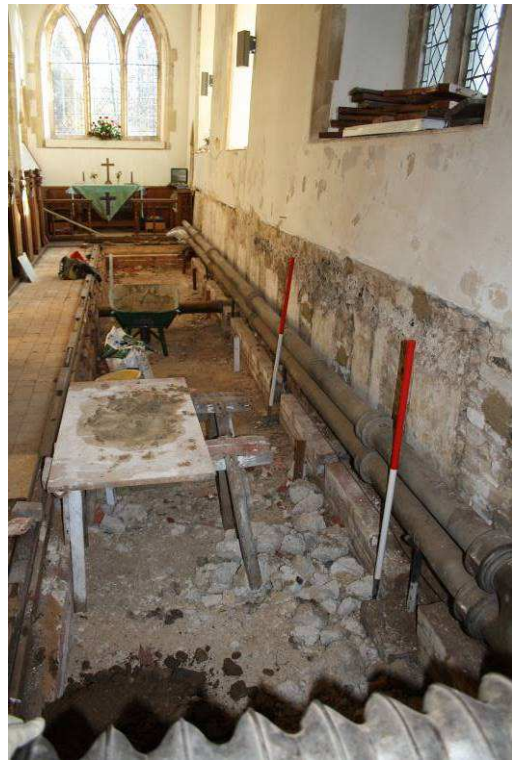
Plate 2. South aisle, looking east.

Deposit below the former floor were again unremarkable and similar to those in the north aisle (Plate 2). The most interesting element of this work was the elevation of the south wall which had previously been hidden behind a wooden wall plate (Plate 3).

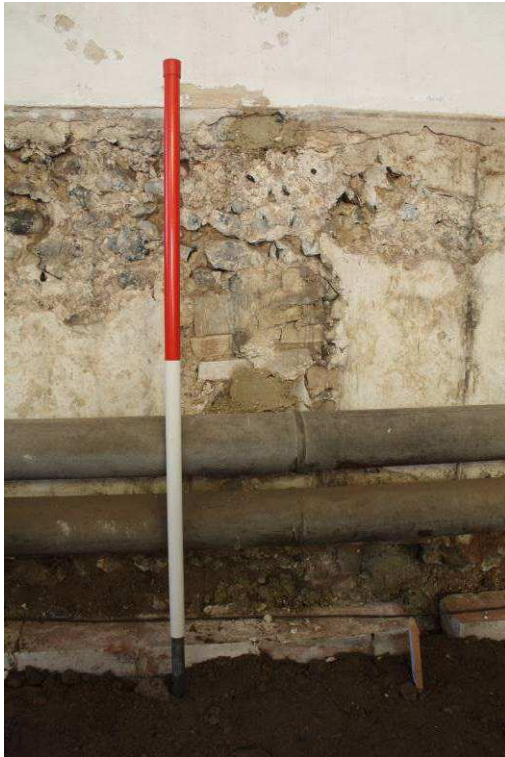
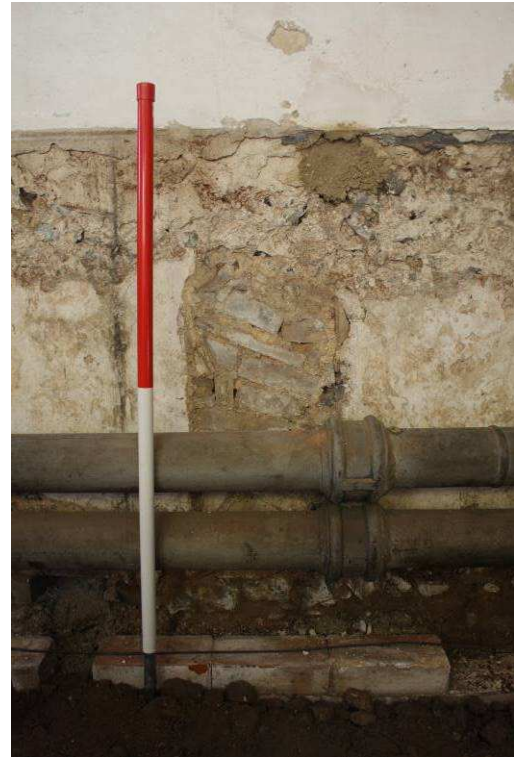
This elevation revealed the former plastered wall. In some places the plaster had crumbled revealing the flints of the south aisle wall. There were also other regularly spaced areas where there was no plaster. Here flint and brick were present representing the positions of an earlier set of pews (Figure 2; Plates 4 to 15 (some areas of recent infilling are also visible in these photos)). The scars representing these early pews were between 0.28m and 0.46m wide and the spacing between the centre of the scars was c.0.75m. Evidence for eleven pews and a front rail was recorded.

Interestingly, at the east end the marks of the front rail and first pew were very ephemeral however, the scars became clearer and deeper towards the west end of the aisle. The shallower scars at the east end revealed the flint structure of the south aisle wall. In the western end deeper scars were present. These scars had been infilled with bricks when the early pews were removed, and the more recent pews inserted. The scars had been hidden by the wooden wall plate which had been erected with the most recent set of pews. The deeper scars to the west end can be accounted for by as the width of the aisle is not consistent along its length. At the east end the width available for the pews was 1.73m while at the west it was only 1.60m, indicating that the south wall of the church is not exactly parallel with the main axis of the church.

Plate 5. South aisle, pew scar 1, looking south, scale 1x1m.

Plate 6. South aisle, pew scar 2, looking south, scale 1x1m.

Plate 7. South aisle, pew scar 3, looking south, scale 1x1m.

Plate 8. South aisle, pew scar 4,
looking south, scale 1x1m.

Plate 9. South aisle, pew scar 5,
looking south, scale 1x1m.

Plate 10. South aisle, pew scar 6,
looking south, scale 1x1m.

Plate 11. South aisle, pew scar 7,
looking south, scale 1x1m.

Plate 12. South aisle, pew scar 8,
looking south, scale 1x1m.

Plate 13. South aisle, pew scar 9,
looking south, scale 1x1m.

Plate 14. South aisle, pew scar 10,
looking south, scale 1x1m.

Plate 15. South aisle, pew scar 11,
looking south, scale 1x1m.
