**Archaeological Watching Brief behind Nos 55-57  
North Quay, Great Yarmouth**

**Heather Wallis  
October 2009**

**HW Report No. 103**

<b>Project name</b>	<b>55 North Quay</b>
<b>Client</b>	<b>Wellington Construction Ltd</b>
<b>NHER</b>	<b>51512</b>
<b>Grid reference</b>	<b>TG 5210 0773</b>
<b>Date of fieldwork</b>	<b>April 2008 to February 2009</b>

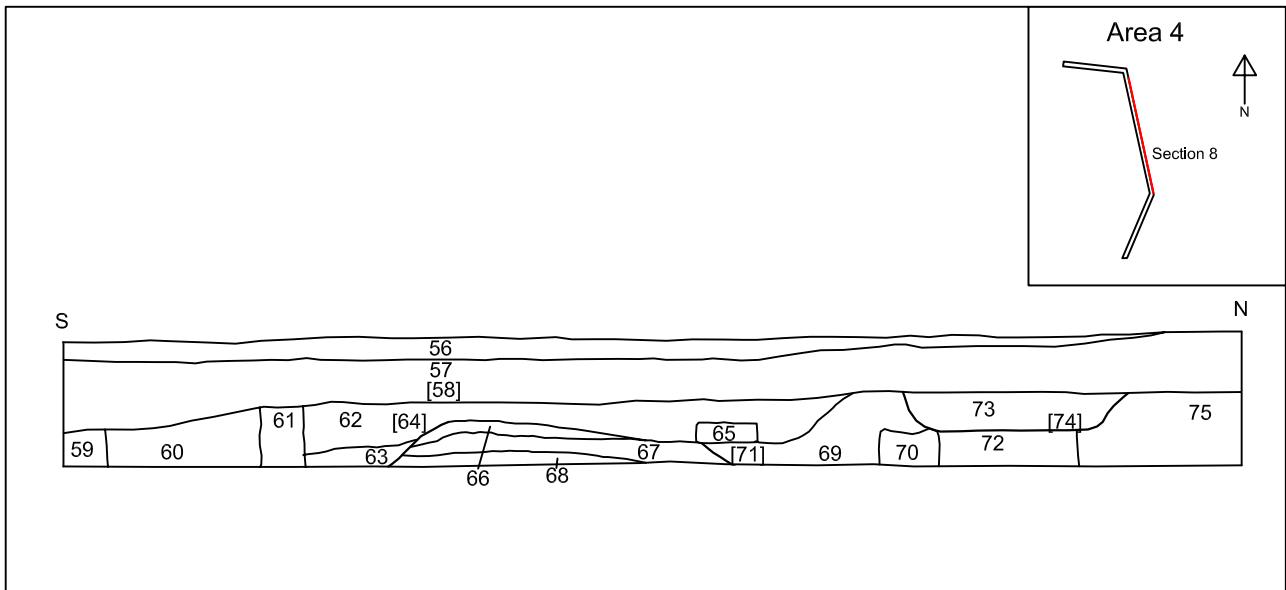
Fig. 5 Area 4 Section 8. Scale 1:50

The earliest feature in this trench was wall 70. This was constructed mainly of flint with the occasional brick fragment all set in a creamy lime mortar. It ran on an east to west alignment, was 0.4m wide and both sides of the wall had been constructed of faced flints. This wall had not been seen in Area 1 or Area 3 trenches to the east suggesting that it terminated before reaching them, but was identified in Area 6 (100) to the west. Running parallel to and about 3.8m to the south of this was wall 61, a continuation of wall 25 as described in Area 1.

Between these two walls a series of layers was recorded, the lowest being a pale yellowy/cream sand with some mortar and silt (68). Above this was a dump consisting of creamy mortar lumps, flecks and fragments with frequent flint and the occasional brick/tile fragment (67) of 16th- to 17th-century date. This was sealed by a clean pale creamy yellow sand (66).

These deposits were cut by two features ([64] and [71]). The first of these was filled with a light cream and dark brown mix of mortar and loam which charcoal fleck, frequent flints and occasional fragments of ceramic building material (63) while the second was filled with very dark brown/black sandy loam with occasional fragments of ceramic building material and mortar fleck (69).

Three later walls all on an east to west alignment were also identified. Wall 72 was made up of a soft red brick and was built up against wall 70. Wall 65, 1.2m to the south was, made of red brick in a white mortar. Only two courses remained. A further 3.9m south was wall 59 which was of a similar construction. It is likely that these three walls were of broadly contemporary date.

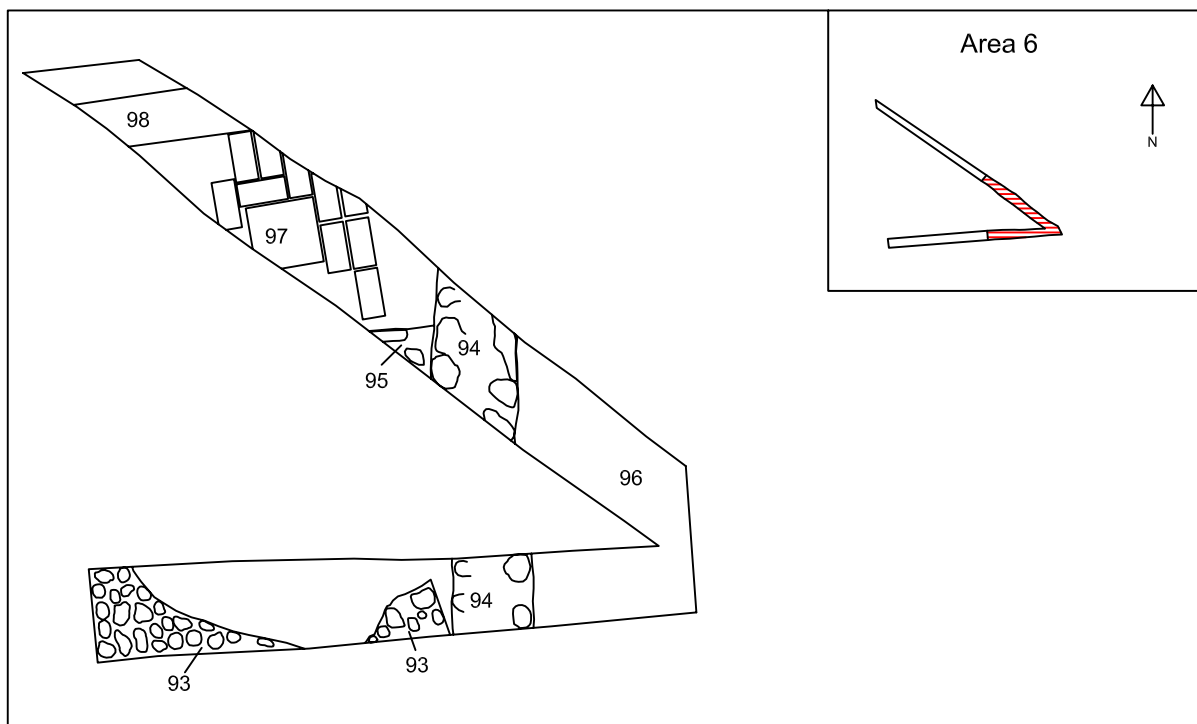
Fig. 6 Area 6 Plan. Scale 1:50

Three walls primarily of flint construction were noted in this area. Towards the north was east to west wall 100 (see Fig.10), a continuation of wall 70 in Area 4. This wall was made up of flints with some brick set in a creamy lime mortar. A red brick skin had been added to its northern face at a later date. Located further south was north-south wall 94, which was made up almost entirely of flint with the inclusion of only a few pieces of soft hand-made brick all set in a creamy lime mortar. This was a continuation of wall 80 seen in Area 5 and, as in that location, had been rendered on its eastern face.

Aligned perpendicular to this were two east to west walls (98 and 95). The first of these was also recorded in Area 1 (25) and Area 4 (61) and part of it remains upstanding to the west. It was made of flint and brick and was probably contemporary with wall 94. In contrast wall 95 was of a later date being constructed of a hard dark red brick of a sandy fabric set in a grey/white lime mortar. Between these three walls (98, 94 and 95) a floor surface (97) was revealed. This was made up of series of square and rectangular thick ceramic tiles of an 18th- to 19th-century date.

Between walls 95 and 94 part of a cobbled yard surface (93) was revealed while to the east of wall 94 a deposit of demolition debris (96) was seen. This may have been the same as or at least contemporary with 24 in Area 1.

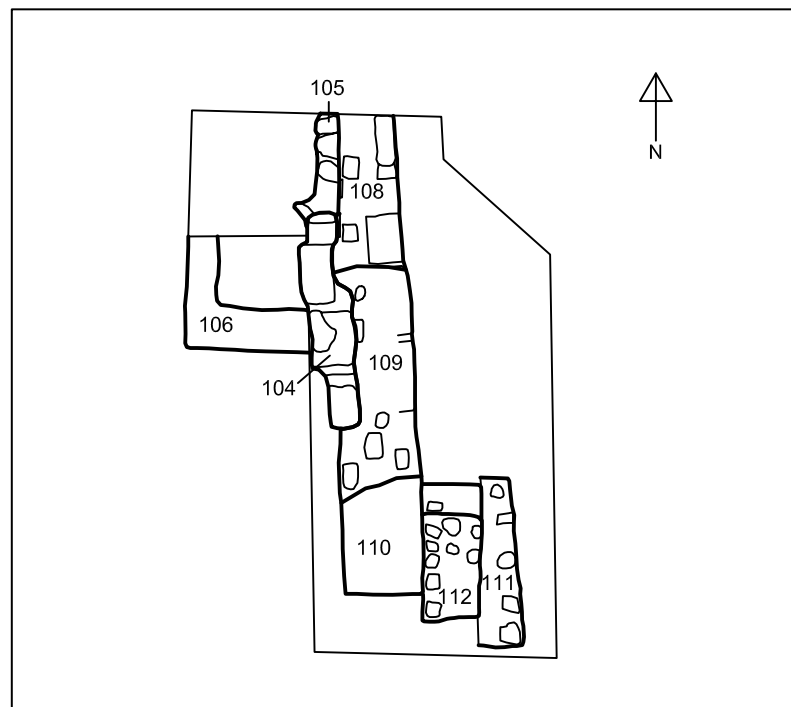
Fig. 8 Area 8 Plan. Scale 1:50

Topsoil was removed and footing trench dug to support walls for a refuse area to the east of the site. Although this was on the highest part of the site, archaeological features were revealed immediately below the topsoil. The earliest deposit seen was a orangey brown silty clay (116). Built into this was a north to south wall (108, 109 and 110). Three different elements of build were noted in this wall which was recorded for a total length of 3.2m, and extended beyond the north edge of the area under investigation. The northern part of this wall (108) survived to a height of c.0.7m. The lower 0.35m was constructed of very large flints set in a hard creamy/off-white mortar. The upper part of this wall was constructed of brick (0.27 x 0.05m) and tile. The bricks were hand-made and unevenly fired some being yellow, some orange and others red in colour. The alignment of this wall was continued by wall 109 which was constructed of brick set in generous amounts of a creamy coloured mortar (109) while in the southern part (110) no bricks were visible, the construction made up almost entirely of creamy, yellow mortar. A small recess was apparent in the west face of the wall. Plaster was noted on parts of the west face, while the east face had been roughly rendered.

A possible buttress was noted on the northern side of this wall alignment at its southern end. Two builds were noted the earliest (111) was constructed of coursed brick, with occasional medium flints set in a creamy white mortar. This buttress was 1.20m wide and projected 0.7m from the main north to south wall. The upper build of this was constructed of flint and brick, including pieces of brick, and set in a white mortar within which small lumps of lime were easily visible. This was similar to the mortar used in wall 104 (see below). This later alteration to the buttress was 0.85m wide and projected just 0.4m to the north.

On the south side of the main wall alignment an L-shaped piece of masonry was recorded (106). This was brick built. The bricks measured 0.23 x 0.115 x 0.05m, were coursed and set in a creamy mortar which was sparingly used. This build (107) also infilled the recess noted in earlier wall 109. Within the area defined by wall 106, archaeological deposits were investigated to a depth of 0.4m, although they extended to a greater depth. The lowest deposit seen was a dump of off-white mortar (115) probably resulting from demolition. Above this was a series of alternate layers of brown clayey silt and black organic matter (114), which was sealed by mid brown/grey clayey silt with frequent charcoal fleck, moderated flints, brick fragments and mortar fleck.

Sitting above these deposits and also overlaying walls 106, 107 and 109 was wall 104. The remains of this was made up of three large blocks of re-used masonry, two of limestone and one of granite. These were set in a white mortar with large pieces of unslaked lime visible. To the north of this, and

probably contemporary was a footing made up of a single layer of flints set in a white mortar (105). This abutted wall 108.

It is thought that some of the earliest elements of this alignment may have originated during the medieval period while this area was part of the Carmelite friary. The later alterations and additions were probably post-medieval and relate to the later use of the area.

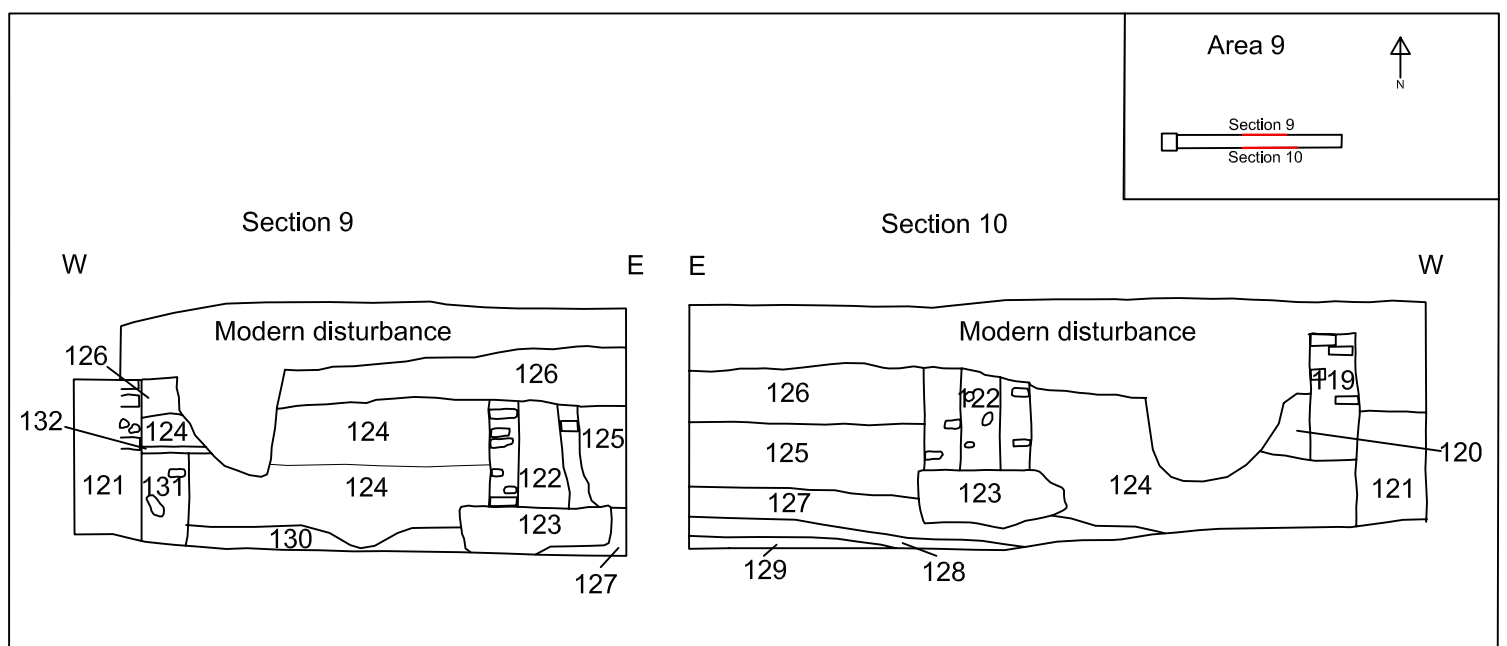
Fig. 9 Area 9 Sections 9 and 10. Scale 1:50

Both north and south facing sections of this trench were recorded as the deposits were seen to differ between them. The lowest deposit in the north facing section was a clean mid orange/brown clayey silt (129) above which was a was an orangey/yellow sand (128). In the south facing section the deposit at the equivalent stratigraphic level was a dark grey/brown loam with frequent sand and grit (130). Sealing deposits 129 and 128, and with no direct relationship with 130 was deposit 127, a clean orangey/brown clayey silt. Deposits 127, 128 and 129 all dipped to the west. Cutting these was the foundation (123) for a north to south wall (122). The foundation was largely made up of compacted dark orange/brown clayey silt with very frequent brick fragments and mortar lumps. Part of the footing (as seen in the south facing section) was of mortared brick rubble. It is possible that this was a later underpinning event. The wall above this footing was c. 1.1m wide and survived to a height of 1.1m. Each face was constructed of hand-made brick in a creamy mortar. The core of the wall was made up mainly of a loose mortar although medium rounded flints and broken bricks were also included. About 3m to the west of this a further wall was recorded. This was made up of two elements, the main wall (121) and an additional area of masonry (131) which may have been a buttress or part of an earlier wall. Wall 121 was of a similar build to wall 122 with brick and flint facing and mortar rubble core. It was c. 0.8m wide and extended to a greater depth, the base not being revealed as it lay beneath the level of excavation. This was on the same alignment as wall 10 in Area 1.

The deposits between these walls mainly consisted of demolition debris. Two distinct layers (124a and 124b) were identified separated by a thin spread of sand which sat directly on top of wall/buttress 131. The lower of these deposits was very coarse demolition debris with many large fragments, some formed by bricks still mortared together. The upper deposit was similar but also contained a notable element and grey/brown clayey silt.

To the east of wall 122 a mid orange/brown clay/sand/silt with some mortar fleck had built up. This may have been previous topsoil.

A later wall was also recorded running parallel and adjacent to wall 121. This was made of red bricks in a white mortar, and was constructed on demolition debris 124.

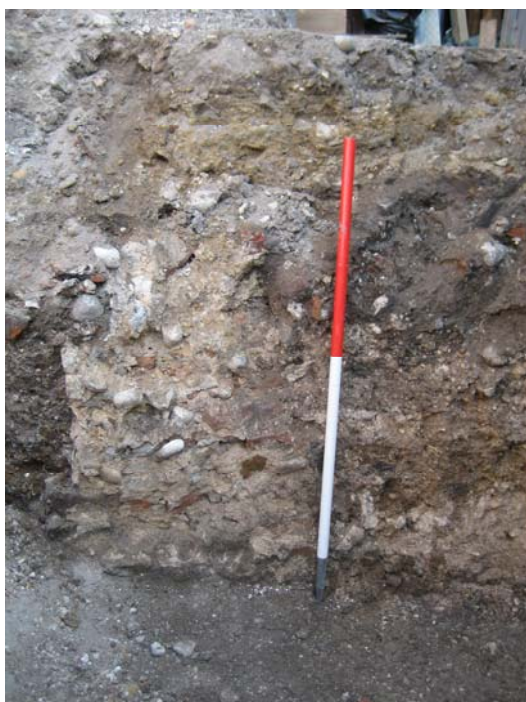
The earliest deposit in this trench (09) was a mid brown slightly sandy clay with moderate charcoal fleck and pebbles. It is thought that the footing trench for wall (10) was cut through this deposit. The wall itself may be of a late medieval date. It was constructed of medium sized flints and both whole and broken bricks set in a creamy lime mortar. The proportion of mortar to other materials was noticeably high. This wall ran on a north to south alignment. The eastern face had been damaged by the machining and so was not visible in the section. It is likely some of the damage to the lower part occurred in antiquity. On its western side the wall was stepped and rendered.

Plate 1. Area 1a Section 1 Wall 10

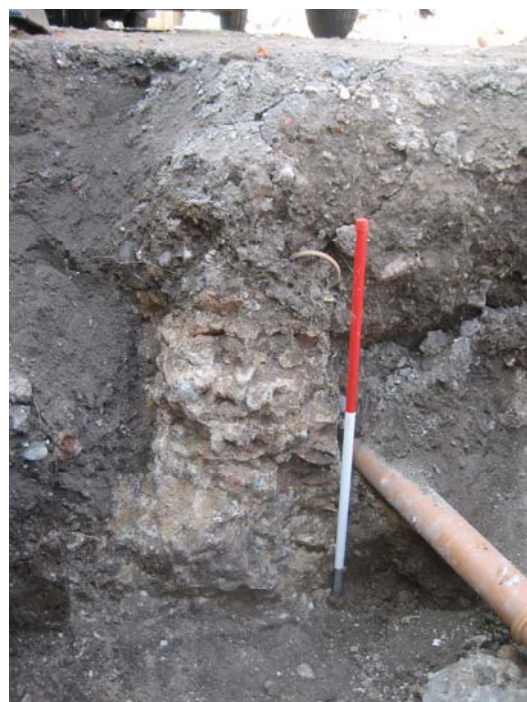
Plate 2. Area 1a Section 3 Wall 10

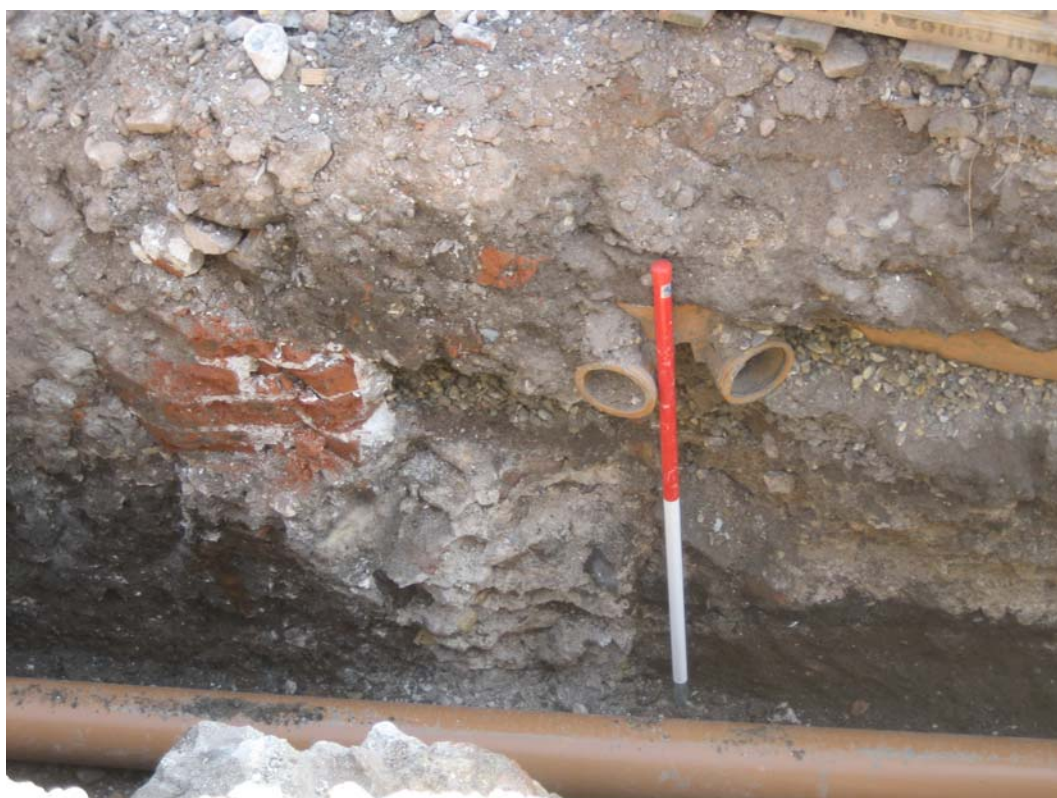
The earliest deposit recorded in section was a dark brown clay (22) which was probably the equivalent of deposit 9 seen in Area 1a. Cut into this was wall 25. This ran on an east to west alignment and broadly aligned with the remains of an upstanding wall extending to the east of the present buildings. The above ground elements of this wall have been dated to the 16th century (Darren Barker pers.com.). The lower, excavated part of the wall was constructed of small and medium sized nodular flints along with some large pieces of brick, all set in an off-white lime mortar with occasional pebbles. Abutting this and running at right-angles to it was wall 26, which was made of similar material, though the mortar was creamier in colour. At the point of abutment complete bricks had been used. It had been rendered on its east side.

had been disturbed in the post-medieval period (146) and a redbrick wall (147) constructed.

Plate 3. Area 1b Section 4 Flint construction wall 10 and Red brick wall 147

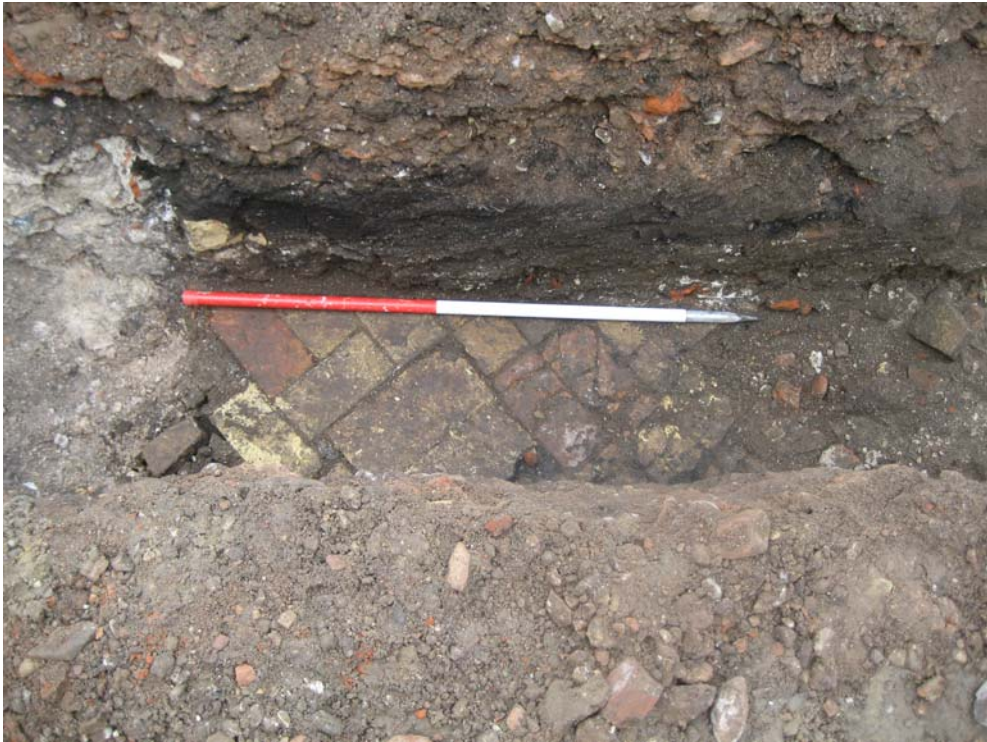
Plate 4. Area 6 Floor surface 97

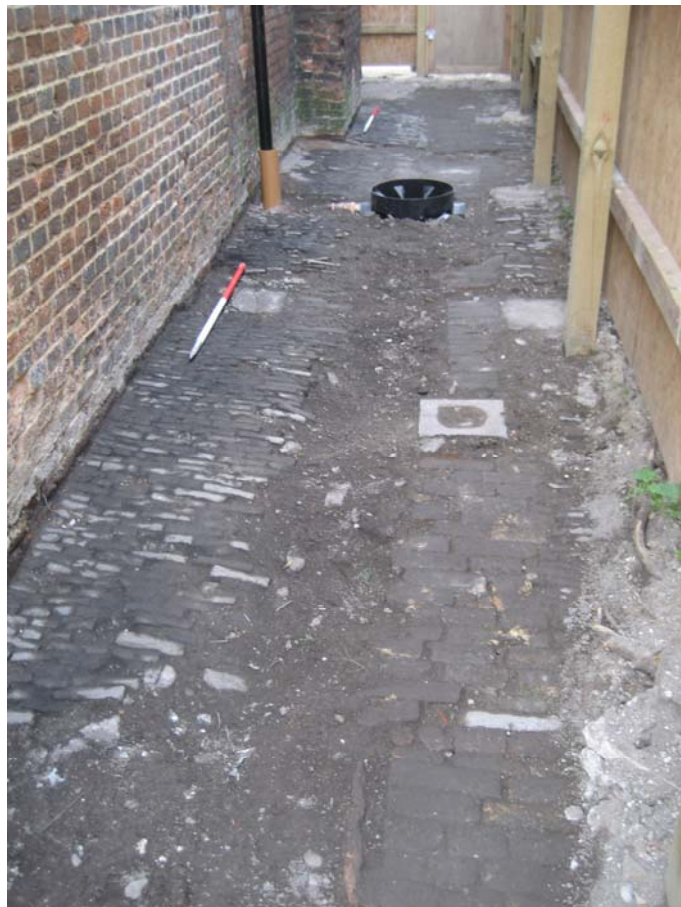
Modern soils were removed to the north of the existing buildings revealing an earlier yard surface. Two different sized ceramic paving blocks were apparent along with other areas of disturbance. The earliest sets were small (103) (0.15-0.16m long, 0.06-0.07m wide, 0.03-0.04m deep) and were often uneven in shape and size, some being trapezoidal. Smaller pieces, some only 0.05m long were used to infill smaller gaps in the surface. The paving blocks had a dark grey/black surface colour while the fabric was a yellowy poorly mixed fired clay.

This was disturbed and repaired with larger paving blocks (102) and occasional larger slab. This patch of repair covers a central linear area running east to west and is probably the result of the insertion of a drain. These larger blocks were also dark grey on the surface but of a yellowy fabric. They were very regular in shape and size the majority measuring 0.23x

Plate 5 Area 7 Small paving blocks (103) to left, large blocks (102) to right

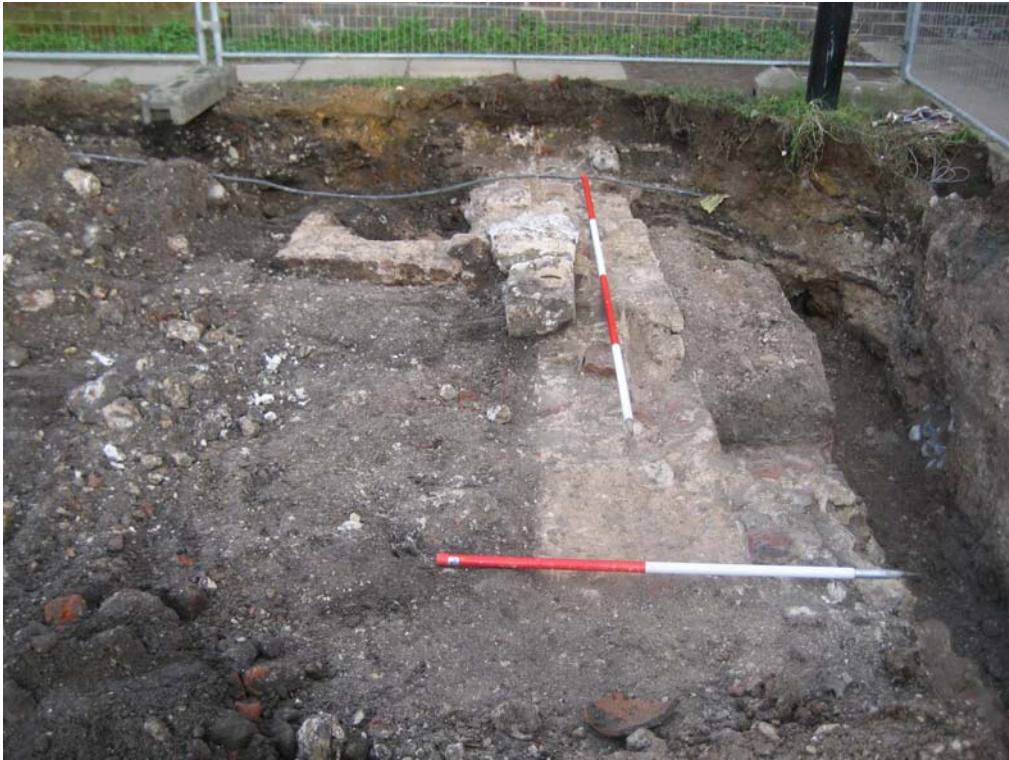
Plate 6. Area 8 Looking north

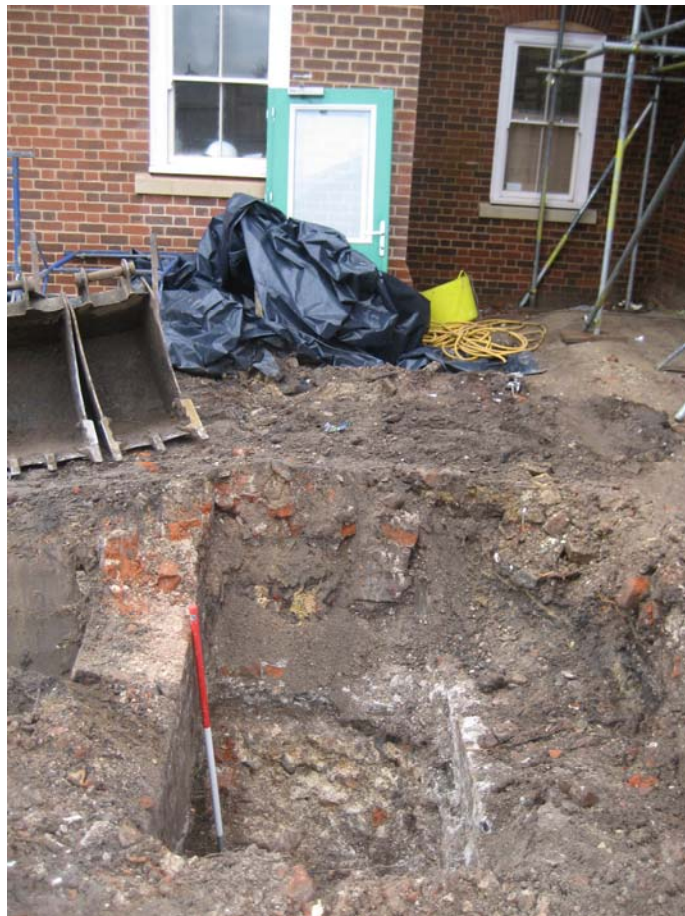
The lowest noted deposit in this was a dark grey/brown clayey silt (144). The relationship of this deposit with wall 134 was unclear. Wall 134 ran on a north to south alignment. The lower part of this was built mainly of flint with the occasional brick set in a soft lime mortar. This is part of wall 80 seen in Area 5. Abutting this and running perpendicular to it was wall 133, built of coursed brick and flint in a creamy lime mortar. The upper parts of both walls (134 and 133) were of a later brick construction. Wall 135 also abutted wall 134, this was of red bricks in a hard lime mortar. A further modern wall (136) was also noted. Built up against wall 134 was a deposit of fine mortar demolition debris (143), notable for the total absence of more substantial building material such as brick, tile or flint. This was sealed by a deposit of clayey loam (142) which may have once formed a topsoil. Other deposits were of a modern origin.

Plate 7 Area 9b Flint constructed wall 137 in lower part of section
