**Thurne Dyke to Oby Dyke  
Compartment 8  
Broadland Flood Alleviation Project**

**Monitoring of Works under Archaeological  
Supervision and Control**

**ENF 124828**

**HW Report No. 194**

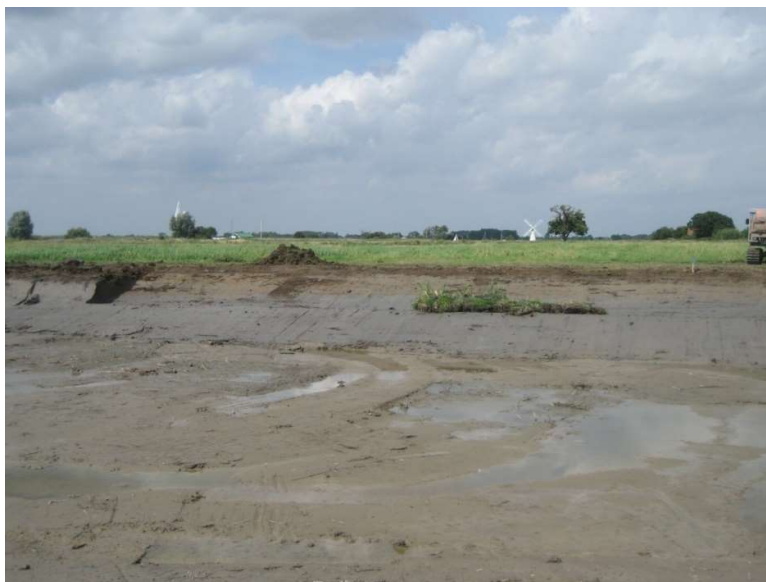
Below a thin topsoil the underlying silty clays were revealed (Plate 1). The deepest revealed deposit was grey-blue silty clay above which was a brown-orange silty clay. These deposits were fairly consistent across the area of the new lake. No distinct variation was noted in the area of possible extraction pit identified on aerial photographs, although the material was slightly softer at the west end of the lake.

Plate 1. Typical deposits within pond, looking north towards Thurne Mill.

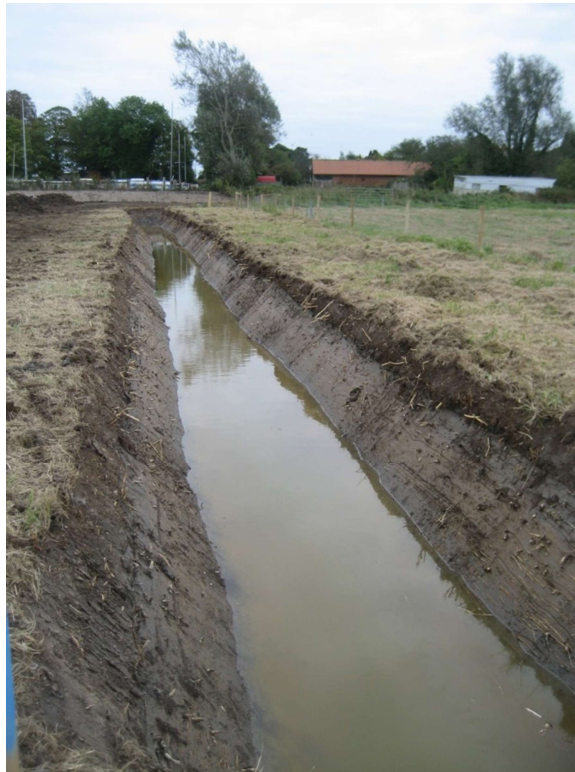
Similar deposits were noted in the excavations of the **dykes**. In some areas, at the north end of the site, the upper parts of the silty clays were full of reed (Plate 2). This appeared to be of relativity recent origin and suggests that up until recent times some parts of the site may have been naturally more low lying than others.

Plate 2. North arm of dyke, looking east, and showing reed content in upper silty/clay deposits.

Despite areas of possible clay extraction being identified from aerial photographs, these were not apparent in the excavations of the lake and dykes. It is probable that these features identified from aerial photographs were areas of naturally low lying ground which have naturally silted up. The presence of reed in the northern part of the site suggests that this area was probably slightly lower, and therefore wetter, into relatively recent times.
