HOAR OAK VALLEY, EXMOOR FOREST, SOMERSET:
AN EARLY 19TH-CENTURY LABOURERS' COTTAGE
ON JOHN KNIGHT'S EXMOOR FOREST ESTATE

Exmoor Moorlands Landscape Partnership Scheme
Project Report

By Hazel Riley

Date of report: July 2012
Copyright: © The author

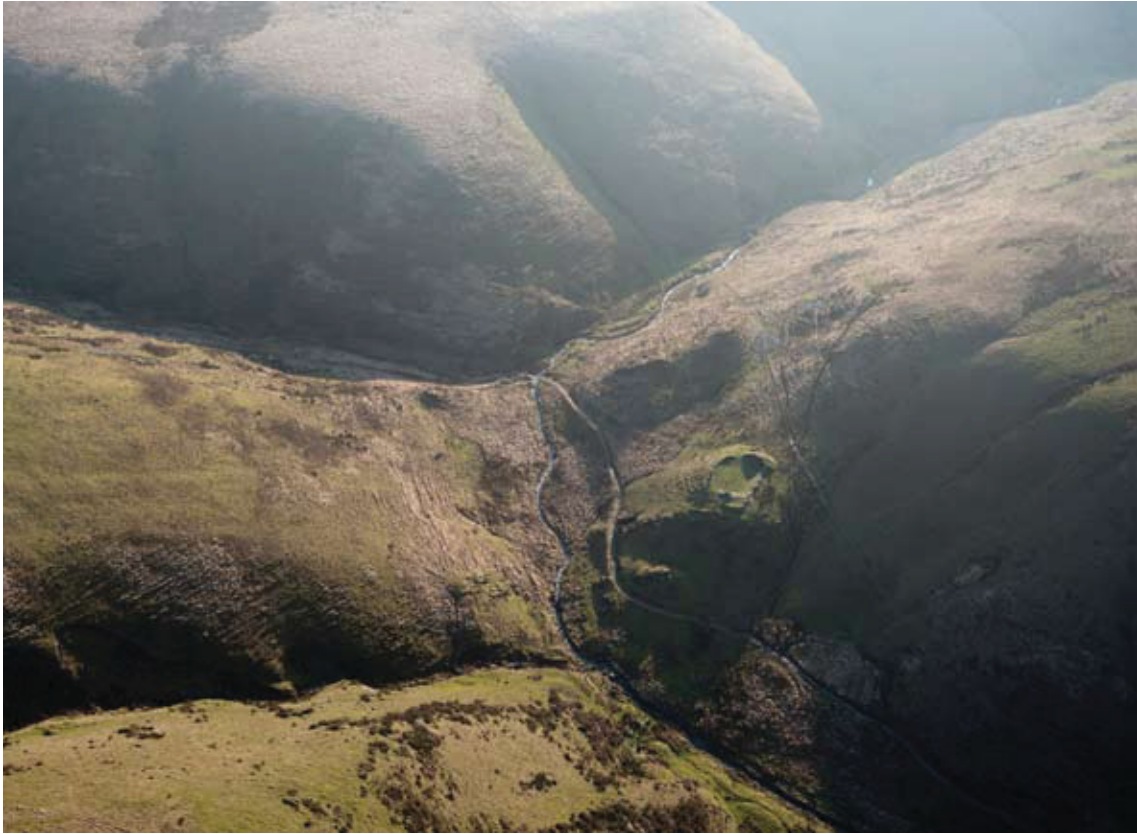
Fig 2 (above) Air photograph of the site looking north up the Hoar Oak Valley (NMR 26882/2) (© English Heritage)

The knoll just below the confluence of Long Chains Combe and the Chains Combe forms a conspicuous topographic feature in the Hoar Oak Valley (Fig 7). It is up to 0.9m high and the top forms an area of level ground 24m NE/SW and 17m NW/SE, close to the stream and to the well marked packhorse route along the Hoar Oak Valley.

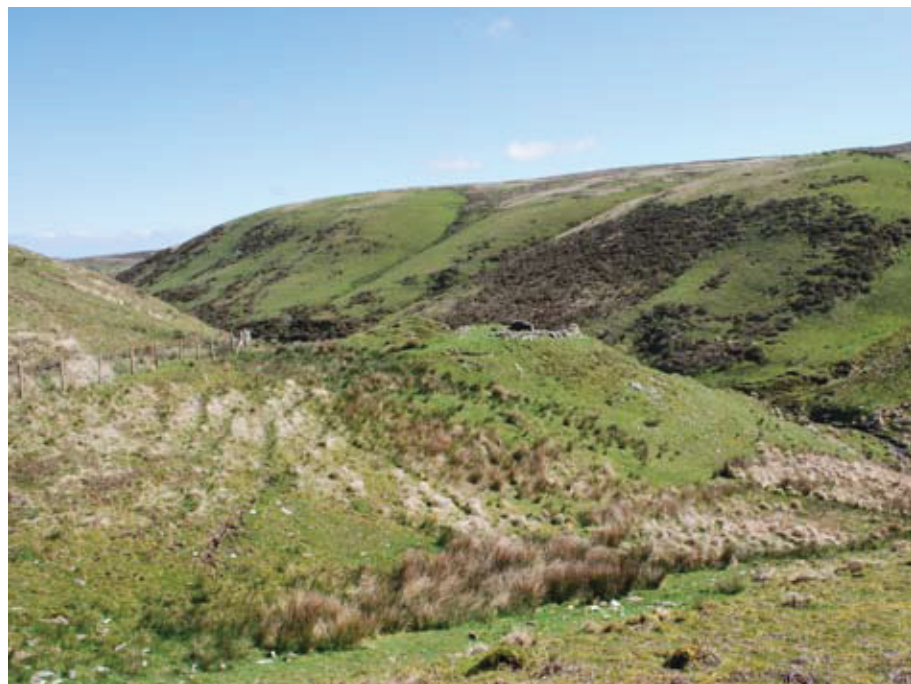
Fig 7 The knoll from the south and the gatepost factory

Oak Valley, lies a few hundred metres down the valley where the hillside is strewn with large stone slabs (Fig 7). These are roughouts for stone gateposts which were used across Knight's Exmoor estate. (Riley and Wilson-North 2001, 139-141; figs 5.22; 5.23).

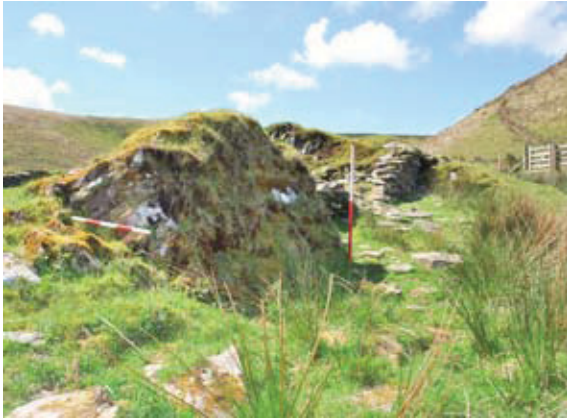
Building A is a rectangular structure which measures 12.8m NE/SW by 6.7m NW/SE (externally). The NW side of the building is formed by a ruined drystone wall which is 0.7m wide and 0.8m high. The inner face of the wall is obscured by fallen stone, creating a bank 2m wide and 0.8m high. The wall has been reinforced by a stone buttress and the remains of this measure 2m x 1m x 1.4m high (F). This is built just above a very boggy area on the north edge of the platform (Fig 8). Traces of mortar on the NE part of this wall also indicate repairs to the building.

*from top Fig 8 Buttress on NW wall Building A
 Fig 9 NE wall of Building A
 Fig 10 NW wall Building A
 Fig 11 Building B*

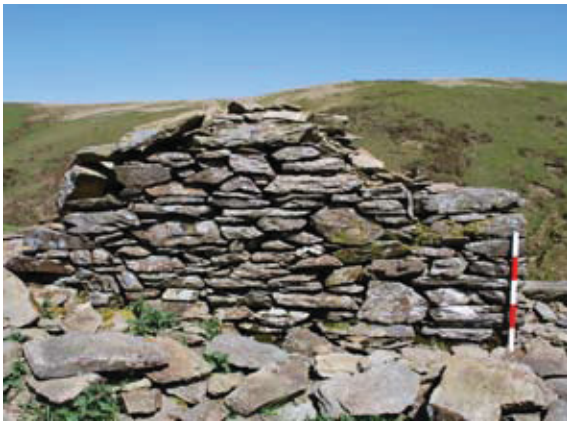
The NE side of the building is formed by a ruinous drystone wall. Its north end is a stony bank, 2.5m wide and 0.5m high and this also forms the SW wall of building B; to the south it survives as a well built wall up to 1m high (Fig 9). The SE side of building A is formed by a scarp, 8m long and 0.25m deep. The SW side has been disturbed by the small structure D, but the corner of the building can be seen on the outer face of the NW wall (G) (Fig 10)

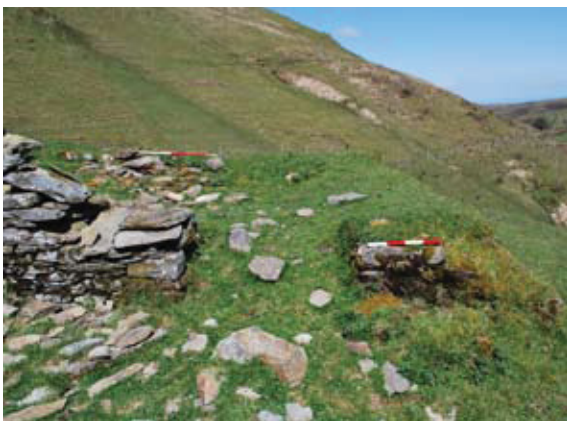
Building B is 5m square (externally) and has walls of stone rubble, 0.8m wide, 1m high, with external wall facing visible on the NW and NE sides. Part of the SW side stands to a height of 0.8m. An entrance gap 1m wide lies on the SW side of the building (H) (Fig 11). A gap on the NW side suggests that there was access to this building from building A. A joint (J) in the outer face of the wall indicates that this small square building was built up against building A.

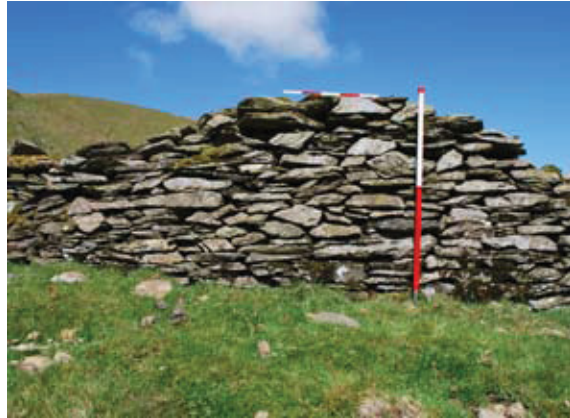
A gently curving drystone wall (C) lies on the south side of the knoll and follows its shape (Fig 12). The wall is 18m long, 0.75m wide, up to 0.9m high and forms an enclosure or yard, 13m long and 5m wide, in front of building A. A small part of the wall has been rebuilt (K). An entrance (L) at the NE corner gave access from the yard to building B; just to the south of this a small gap (M) is a more recent break in the wall. The main entrance to the yard and building A was at the SW corner, where a track with a stone retaining wall leads up to a gap between the wall and the rock outcrop (N).

*Fig 12 (top) Outer face wall C
Fig 13 (above) Structure D*

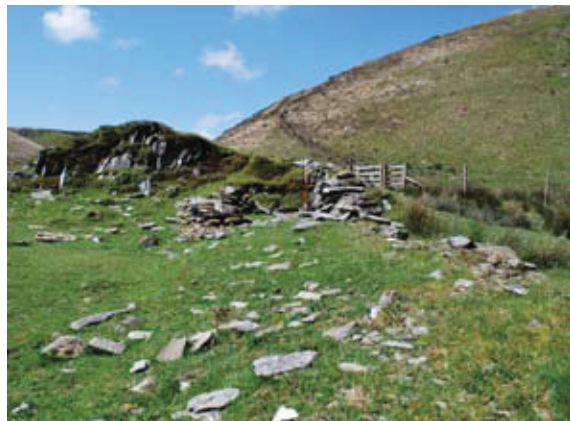
Structure D lies on the SW end of building A and is 3m NW/SE, 3m NE/SW and 0.8m high (externally) (Fig 13). It is formed by a drystone wall which fills the gap between the corner of building A and the rock outcrop on the NW side. A rather irregular drystone wall forms the SE side, the SW side uses the rock outcrop and the NW side is open.
