AN HISTORICAL AND ARCHAEOLOGICAL STUDY OF TARR STEPS, EXMOOR NATIONAL PARK

PROJECT REPORT

Date of report: July 2013
Copyright: © The author

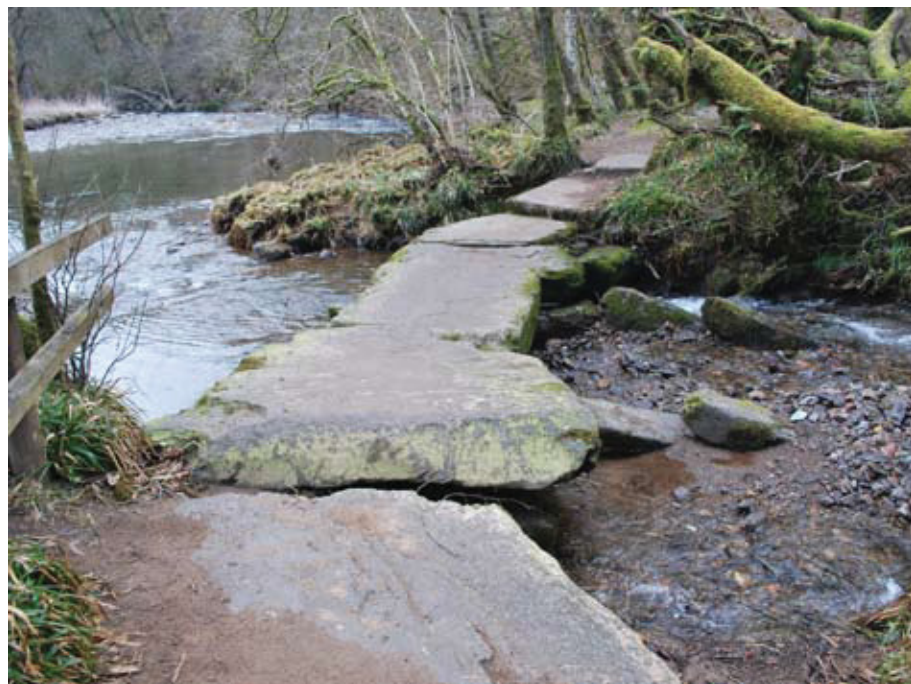
Fig 3 Clapper bridge across West Water at its confluence with the Barle (19/3/2013) (Hazel Riley)

Tarr Steps is a clapper bridge (see below), constructed entirely of stone, across the River Barle. A ford across the river lies immediately upstream of the bridge (Frontispiece). Tarr Steps is built of local stones, identified in 1884 as gritstones from the Pickwell Down basement beds (PSANHS 29 (1884), 62-6). Large slabs of this stone are available in the immediate vicinity of Tarr Steps, both in and around the river bed and as outcrops of rock on both sides of the Barle between Tarr Steps and the footbridge by Westwater Copse. These have been used to create walkways or causeways alongside the river as well as three small clapper bridges (Figs 3 and 4).

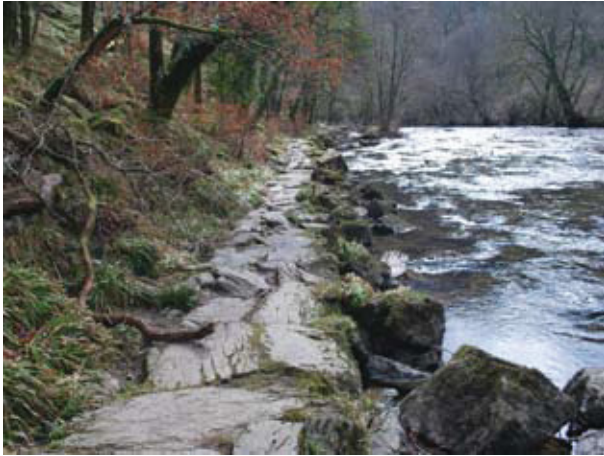
Fig 4 Stone causeway on the left bank of the Barle below Watery Lane (19/3/2013) (Hazel Riley)

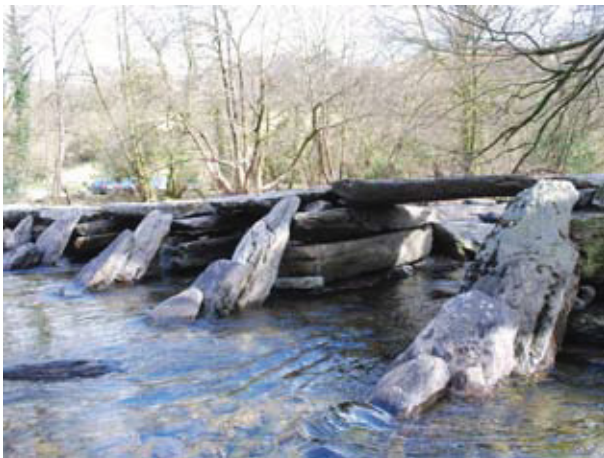
Fig 5 Detail of the bridge showing the clapper stones, piers and raking stones on upstream side (19/3/2013) (Hazel Riley)

The bridge has three distinct components: the large flat stone slabs or clappers which form the causeway; the piers which rest on the river bed and support the clapper stones, and the raking stones, which are stones placed against the piers to protect them against the direct action of the river currents (Fig 5). A stone causeway leads from the tarmac roads on both sides of the river (Fig 6).

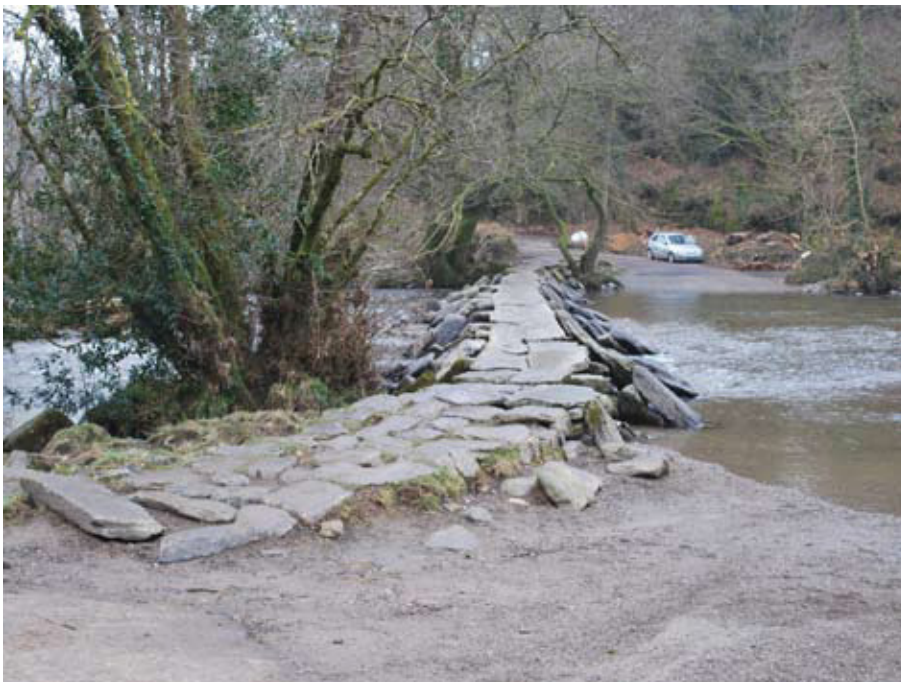
Figure 6 Stone causeway approach to Tarr Steps on the Dulverton side of the river (19/3/2013) (Hazel Riley)

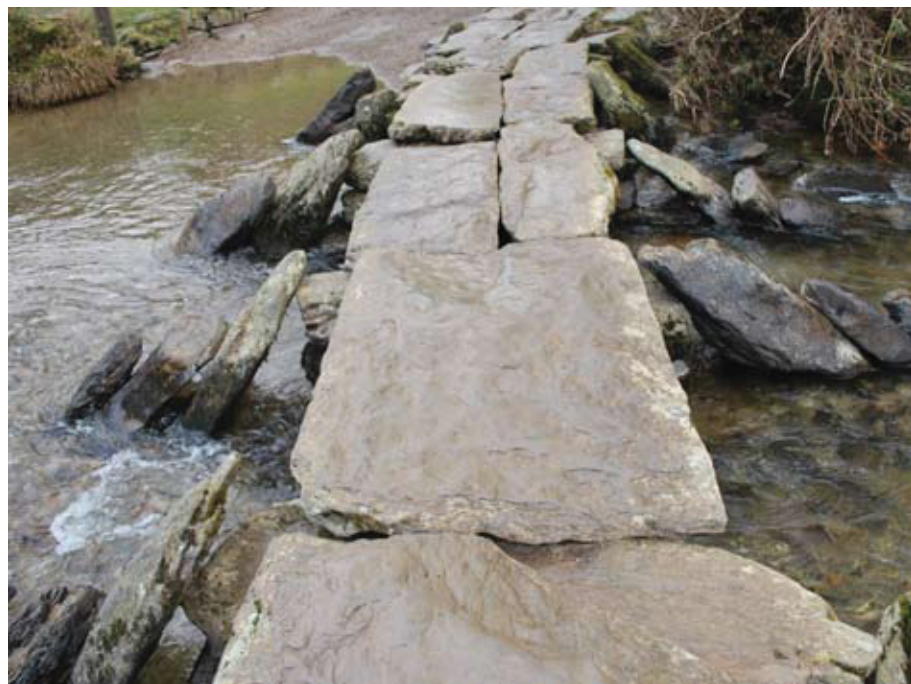
Fig 7 Single and double spans of clapper stones at the Dulverton side of Tarr Steps (19/3/2013) (Hazel Riley)

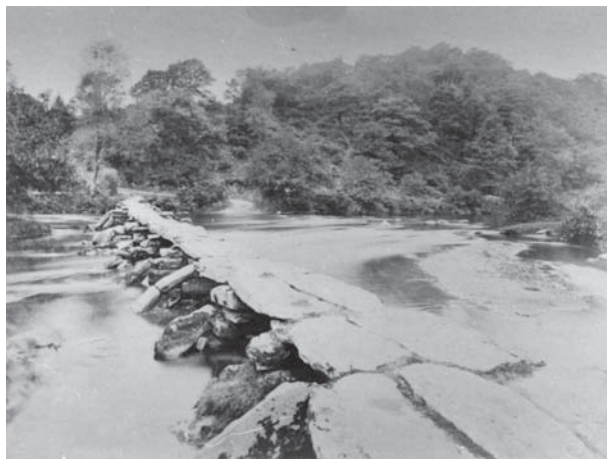
*Fig 19 Tarr Steps by
Rober Gillo, c 1870
(SRO county neg no
361)*

(Strickland 1988). This is a view taken from the Dulverton side of the river, looking across Tarr Steps, which is the focal point of the picture. The stone piers, raking stones and clapper stones are all in place, although the paired stones in the foreground are displaced to a certain degree.

The earliest photograph of Tarr Steps is probably that taken by Robert Gillo (Fig 19). Gillo had a photographic studio in Bridgwater (c 1861-1881) during which time he travelled widely across Exmoor and West Somerset taking photographs for his business

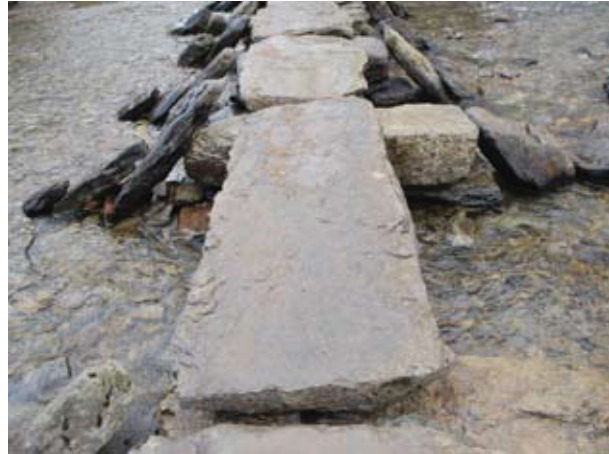
Fig 22 (above) The large slab in the central pier used to mark the parish boundary (19/3/2013) (Hazel Riley)

One feature of Tarr Steps which is shown well in 19th- and early 20th-century photographs is the central span. Sweetapple-Horlock, writing in 1928, described a central stone, laid crosswise, which marked the parish boundary. The clapper stones at this point, instead of being reasonably level, definitely tilt upwards at this point. These features can be seen in the photographs of the bridge before the damage of 1939-40, a good example is one from a collection of 'Photographs of views of Somerset, Devon and elsewhere late 19th century' (SRO A\CRZ/3/6.10) (Fig 20) and those taken by Alfred Vowles between 1911-1914 (in SRO collection A\BMS Box 1)(Fig 21). Since the damage to the central part of Tarr Steps in January 1940 subsequent reconstructions have failed to reinstate both the central slab laid crosswise and the distinctive 'arching' of the causeway at the centre (compare Figs 20 and 21 with 29 and 31. The central slab has now become part of the central pier and seems to have been used like this since 1941 (Figs 28; 22).

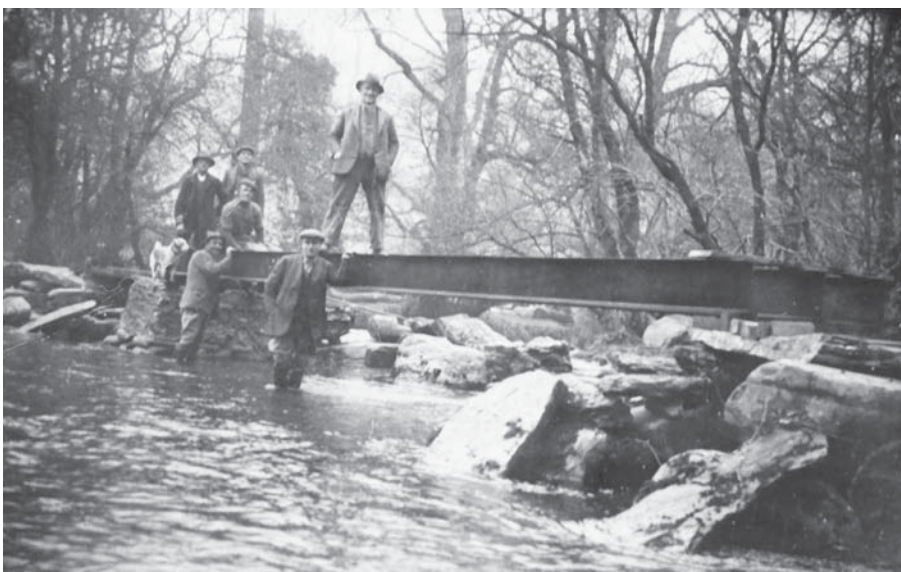
Fig 26 Steel girder and concrete repairs, March 1941 (SRO county neg no 34308)

Tarr Steps was repaired in March 1941 by the construction of a steel girder bridge, approached by concrete ramps, built directly on the remaining clapper stones. This is shown in several photographs taken by Alfred Vowles (Fig 26). A plan and cross sections of eight of the piers, surveyed in 1949 before reconstruction work, document this work and also show the construction of the piers and raking stones before Tarr Steps was washed away in 1952 (Figs 27 and 28). It can also be seen in photographs of volunteers

Event: Temporary repairs carried out to Tarr Steps. A temporary crossing provided at Tarr Steps by long steel girders. Public able to cross by the bridge on 20th March 1941. The girders spanned the central part of Tarr Steps and were approached by a concrete ramp which was laid onto the clapper stones on each side.

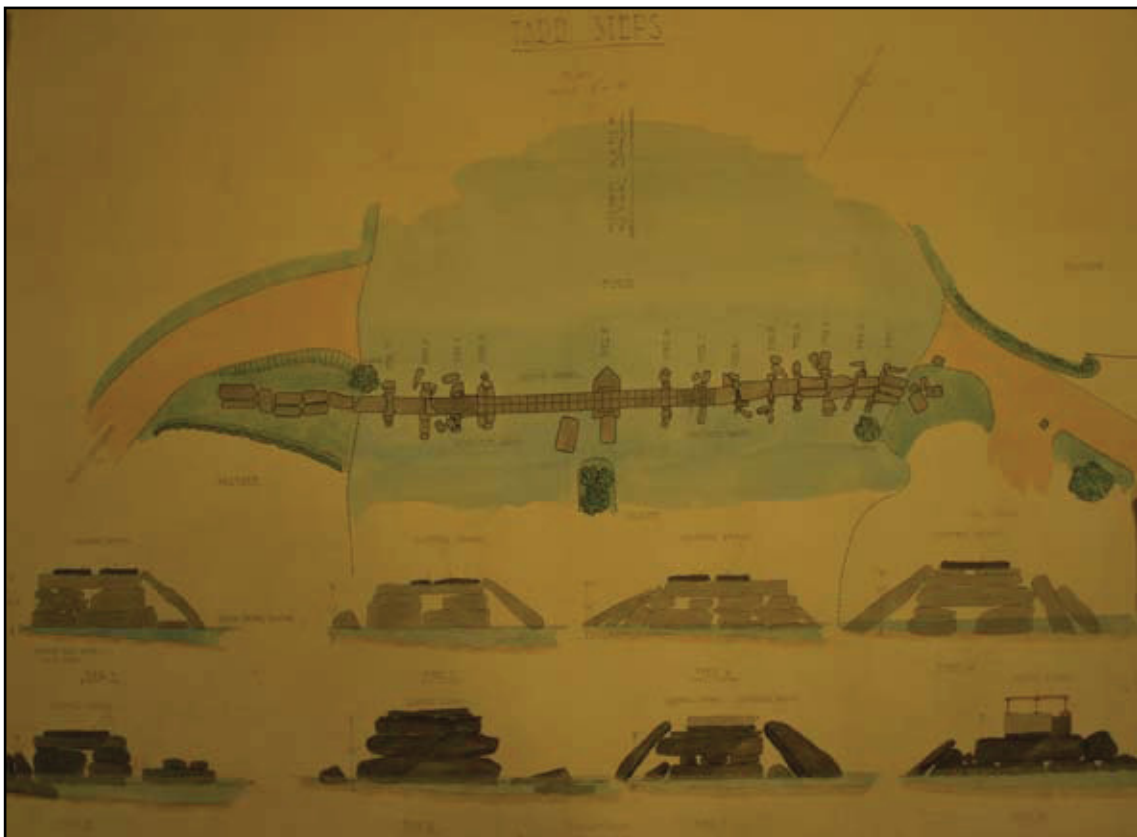
Fig 28 (below) Plan and elevation drawings of Tarr Steps, surveyed in 1949 (SRO A\BHN/3)

A tradition exists locally that the stones which make up Tarr Steps are numbered. The present County Bridges and Structures team have not seen numbers actually on the clapper stones, but say that 'each spanning stone is uniquely referenced meaning that they know in detail what the stones look like and where they should go' (Radford 2013). A lantern slide in the SANHS collection shows that the stone piers, not the clapper stones, were numbered. Underneath a photograph of Tarr Steps which has been inked over, the numbers 1-16 are written under each pier, beginning with pier 1 on the Hawkridge side of the structure. The photograph was taken in the late 19th/early 20th century, but it is not known when the numbers were added (SRO SANHS lantern slide neg no 10425). The survey carried out before the 1949 reconstruction numbers the piers, beginning from the Dulverton side, and showing piers 1-13 as several of the central piers were washed away in January 1940 (Figs 27 and 28).

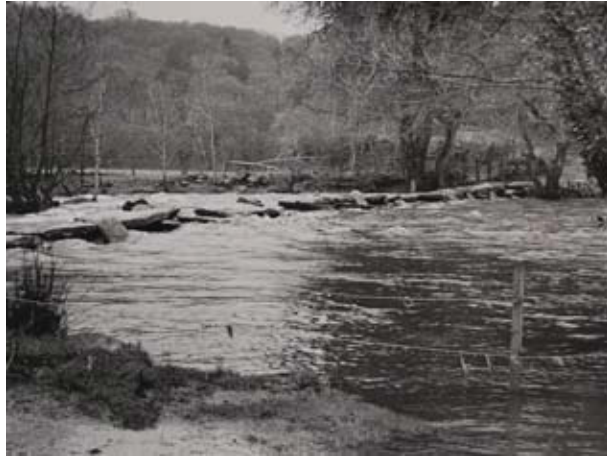
Fig 33 Tarr Steps after the December 2012 flood damage (Shirley Blaylock)

On the 22nd and 23rd December 2013 the debris arresting cables upstream from Tarr Steps were destroyed by floodwater and several large trees crashed against the bridge, removing about half of it (Fig 33). Locals said that this flood was the worst that had been encountered since August 1952. Somerset county Council bridge engineers agreed that the 2012 floods had caused the worst damage to Tarr steps since August 1952. Somerset County Council and Crestmoor Construction rebuilt the bridge in February 2013, using an inflatable boom to divert the river and a small JCB to lift the stones (Fig 34).

Event: Large trees brought down the river Barle by floodwater destroy the debris arresting cables and crash against Tarr Steps, causing damage to about half of the bridge on the Hawkridge side of the Barle. Several clapper stones are dislodged and piers damaged. Some of clapper stones can be seen in the river near pier stones. Locals say that this was the worst flooding encountered since August 1952.

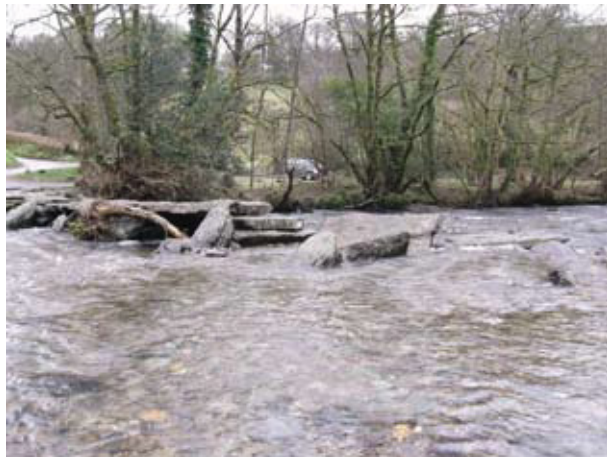
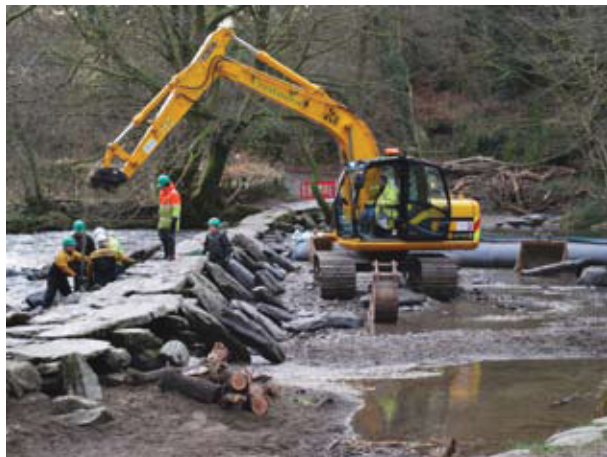
Fig 34 Rebuilding Tarr Steps in February 2013 (Hazel Riley)

Event: Crestmoor Construction and Somerset County Council repair the damage to Tarr Steps. An inflatable boom was used to hold the river water away from the repair site and this was kept in place by straw bales to prevent damage to the stones. A JCB with a sling on the bucket was used to help reposition the stones.
