**SURVEY, EXCAVATION AND ASSESSMENT OF  
ARCHAEOLOGICAL FEATURES IN THE NORTHERN  
PART OF ASHCOMBE AND RECORDING A 19th-  
CENTURY BRIDGE AT SIMONSBATH  
PROJECT REPORT**

**By Hazel Riley**

Date of report: May 2015  
Copyright: © The author

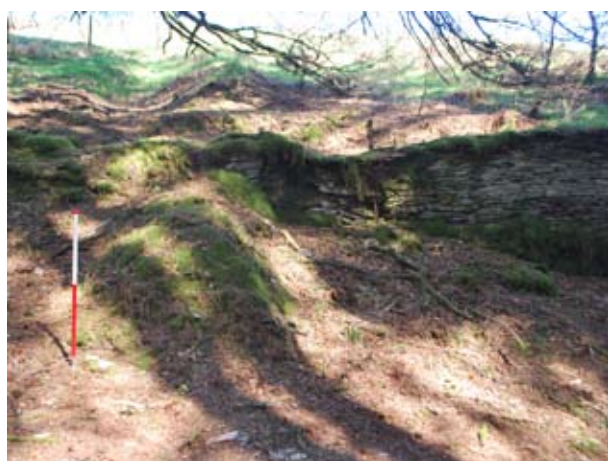
At the northern end of Ashcombe, on the east side of Ashcombe Water, a substantial earthen bank with a ditch on both sides is clearly overlain by John Knight's boundary wall (AC24) (Fig 4). The bank is also cut by the path around Ashcombe (Figs 4 and 5). This is a survival of the pre-19<sup>th</sup> century landscape, when the area was part of Simonsbath Farm, established in the mid-17<sup>th</sup> century. The 1818 Inclosure map for Exmoor Forest shows the enclosures of Simonsbath Farm to the west of Ashcombe Water, but no features to the east which would correspond to this boundary are depicted. This boundary does seem to relate to a boundary which is mapped on the west side Ashcombe (Fig 6). A similar boundary was recorded in the 2014 garden survey and was interpreted as enclosure and access relating to Simonsbath Farm (Riley 2014a,15).

Fig 4 (above left) The bank at the NE end of Ashcombe (Hazel Riley)

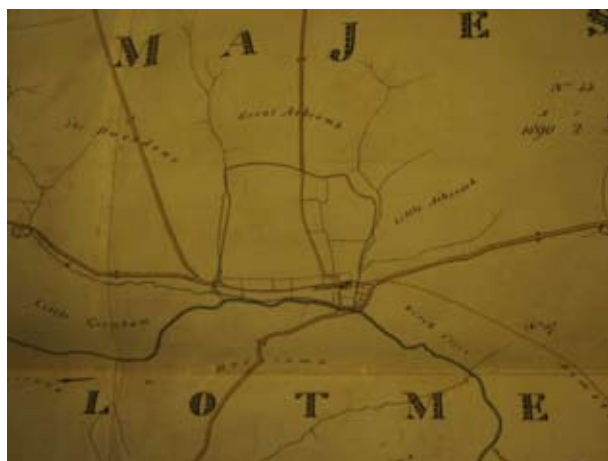
Fig 5 (above) Plan of the bank at the NE end of Ashcombe (1:500)

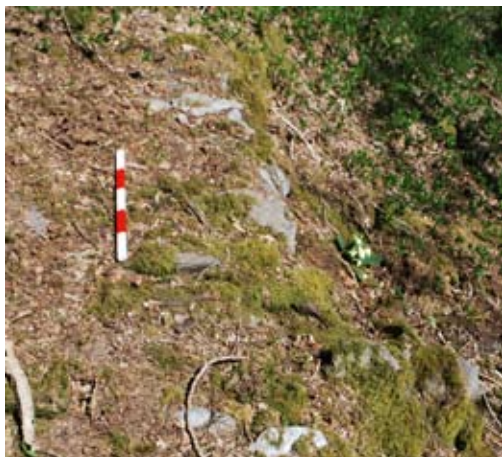
stone steps connects the two paths (AC25) (Fig 7). The clearance has also allowed the path to be followed on the ground right around Ashcombe. On the west side of Ashcombe, the path is a substantial terraced walkway which runs from the boundary of the Garden by the River for some m where it joins the leat (AC13, below) (Fig 8). The recent clearance work shows that the path here was well constructed with a stone retaining wall on the down slope side and extra stonework where water runoff down the steep valley side was a problem (Figs 9, 10, 11)

*Fig 7 (above right) Flight of stone steps connecting the lower terraced path to the main path around Ashcombe (Hazel Riley)*

Description and interpretation:A flight of seven stone steps give access from the lower terraced path to the main walk around Ashcombe.The steps are 3.8m long and 1.7m wide.

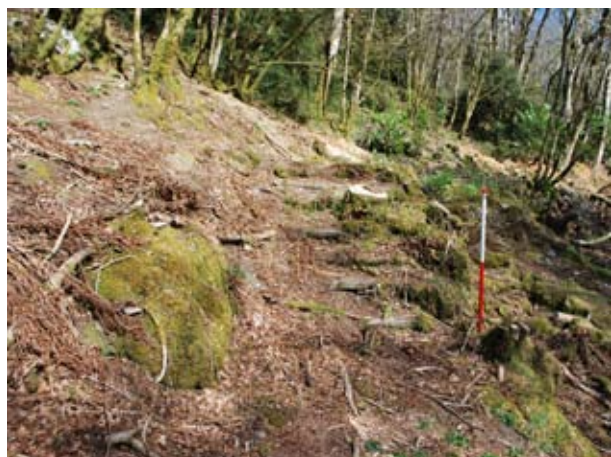
*Fig 8 (right) Looking north along the terraced path on the west side of Ashcombe (Hazel Riley)*

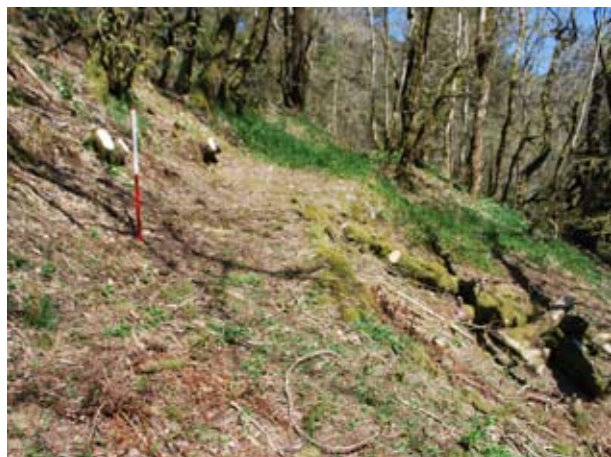
*Fig 9 (top) Detail of the retaining wall on the downslope side of the terraced path on the west side of Ashcombe (Hazel Riley)*

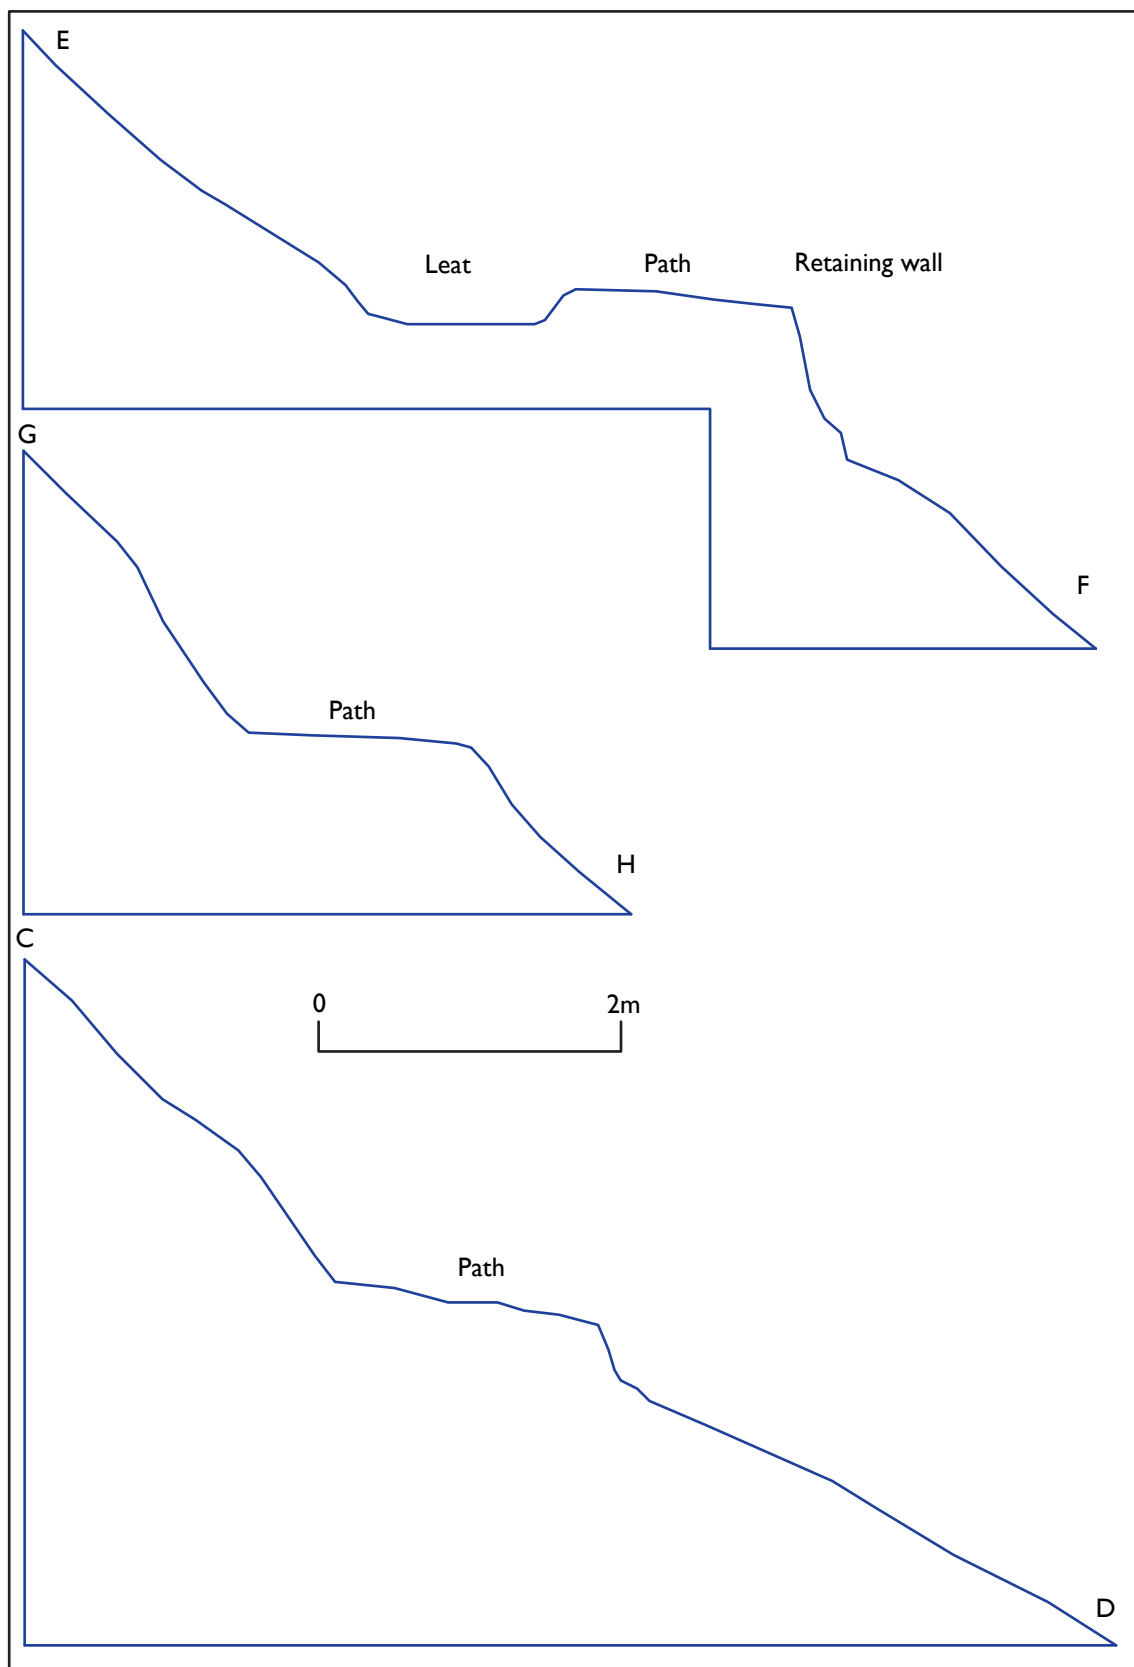
The terraced path runs up to the leat and joins it to run along the side of the leat. It is difficult to say from the field evidence whether the leat or the path is the earlier feature; there is no sign of the course of the terraced path below the leat, suggesting that the leat may have already been in existence when the path was constructed and the awkward junction may conceal a flight of stone steps like those to the south (Riley 2014a, fig 16). This junction of path and leat was clearly an important feature in the designed landscape of Ashcombe (below).

Fig 11 Profiles across the terraced path (C-D and G-H) and the leat (E-F)

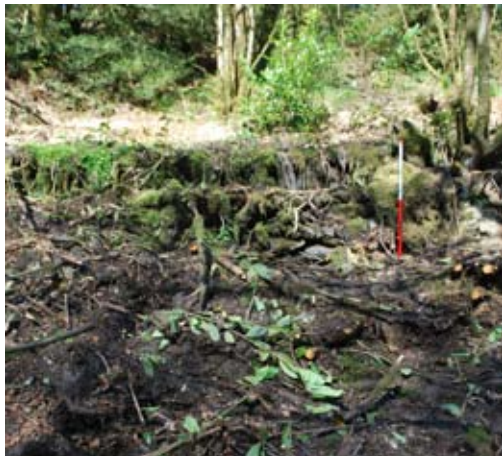
*Fig 10 (above) Stonework below the terraced path where water runoff crosses it (Hazel Riley)*

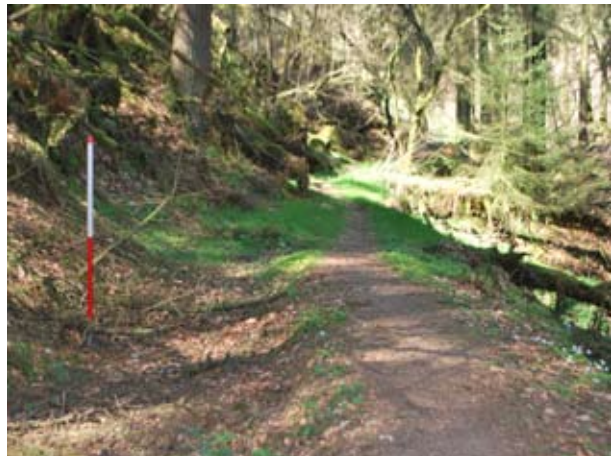
To the north of this junction, the path runs along the east side of the leat, using the retaining bank (Fig 12). At the northern end of the combe, the remains of the bridge which took the path across the stream were recorded as part of the 2014 garden survey (Riley 2014a, figs 19 & 20).

*Fig 12 (above right) The leat and terraced path on the west side of Ashcombe (Hazel Riley)*

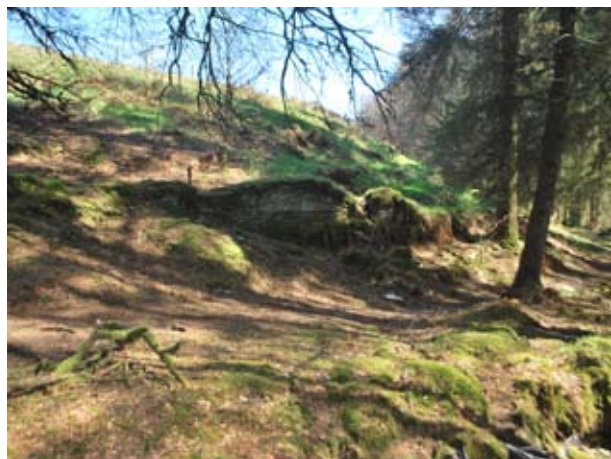
The path on the east side of the combe is less clear on the ground. At the NE end of Ashcombe the path from the bridge is visible for some 37m (Fig 13). A later farm/forestry access track and turning place overlies the 19<sup>th</sup>-century path (Fig 14). The remains of the path are visible between the modern track and the river. The 1<sup>st</sup> edition map shows a path leading from Ashcombe out into the open land on Great Ashcombe, some of the first land enclosed and improved by John Knight (Riley 2015). The remains of a terraced path and the original gap in John Knight's boundary wall are still visible (Fig 15).

*Fig 13 (right) The path and John Knight's boundary wall at the NE end of Ashcombe (Hazel Riley)*

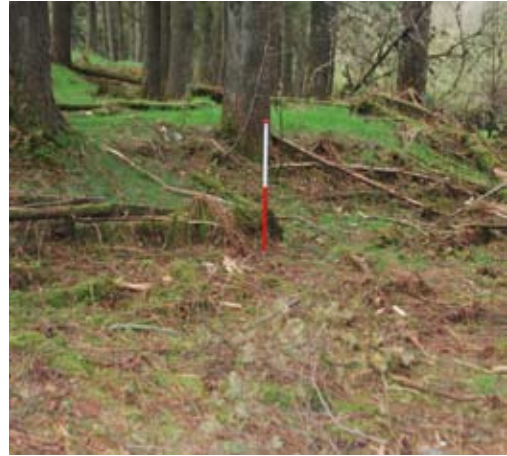
*Fig 14 (above right) A modern access track & turning place overlaid the 19th-century path (Hazel Riley)*

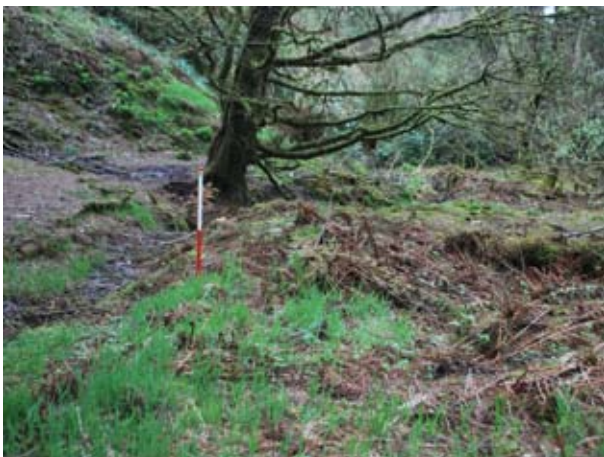
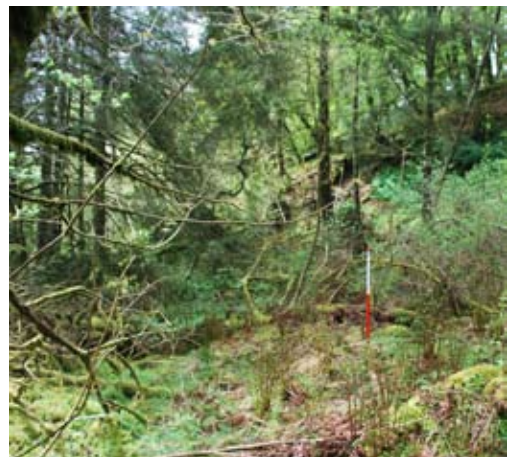
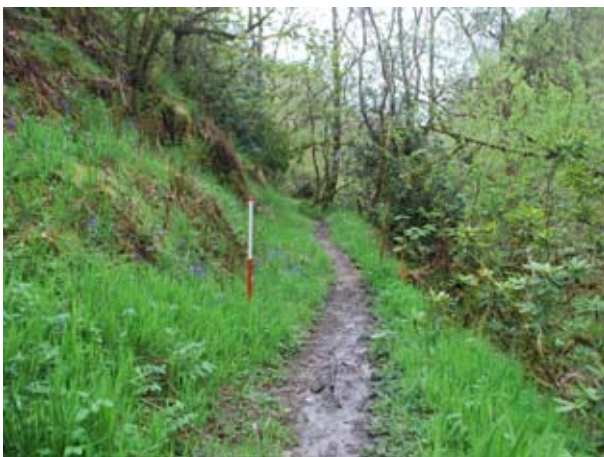
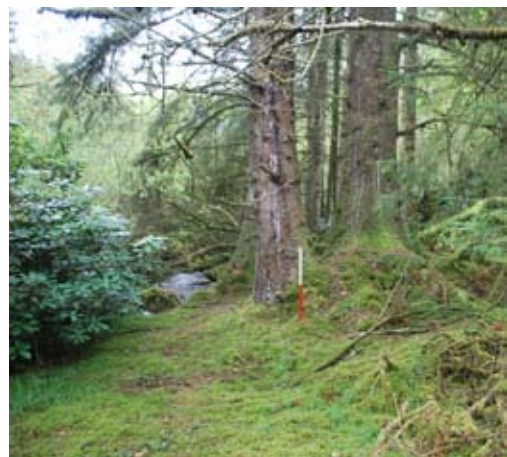
*Fig 17 (below) The hollow way leading to Ashcombe Water (Hazel Riley)*

*Fig 15 (above) The gap in John Knight's boundary wall where a path leads from the pleasure grounds in Ashcombe to recently enclosed fields (Hazel Riley)*

*Fig 16 (below) The remains of the 19th-century path in the east side of Ashcombe (Hazel Riley)*

*Fig 19 (bottom left) Terraced path on east side of Ashcombe (Hazel Riley)*

To the south of this, the current path rejoins the 19<sup>th</sup>-century terraced path, where it is similar in appearance to the path on the west side of Ashcombe (Figs 11 & 19). In general, the path survives in poor condition compared to that on the west side of the combe, this is due to the very wet nature of the valley sides here. Only a few, short lengths of retaining wall are visible (compare Figs 19 & 20 with Figs 8 & 9), but the presence of numerous flat slabs laid on the path as repairs suggests that some retaining walls have been robbed out recently (Fig 21). The path leads into the Garden by the River where runs past the large quartz outcrop close to the ENPA car park (Fig 22). The construction of the parking areas has destroyed the rest of the path, but the 1<sup>st</sup> edition map shows that it doglegged down to cross Ashcombe Water north of Whiterocks Cottage.

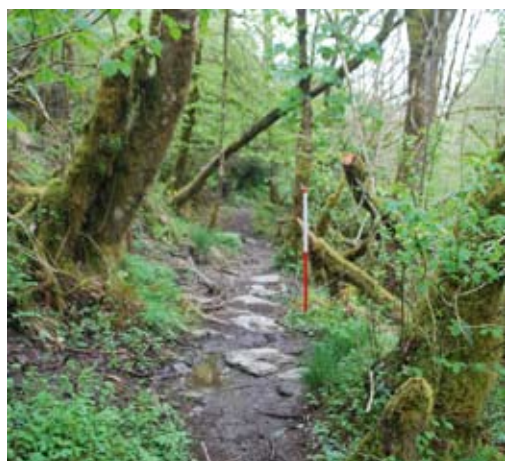
*Fig 20 (above right) Terraced path with fragmentary retaining wall on east side of Ashcombe (Hazel Riley)*

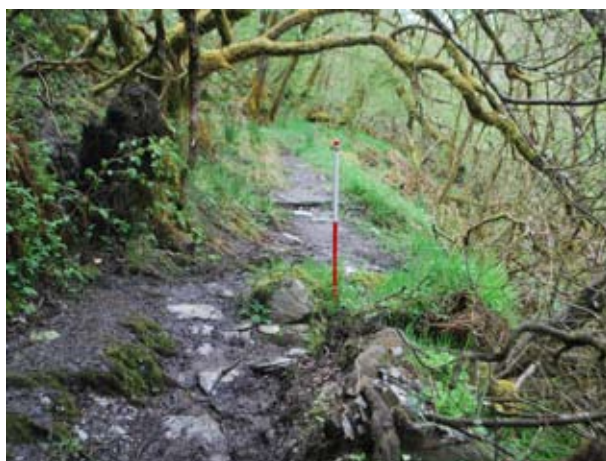
*Fig 21 (above) Recent repairs to the path, east side of Ashcombe (Hazel Riley)*

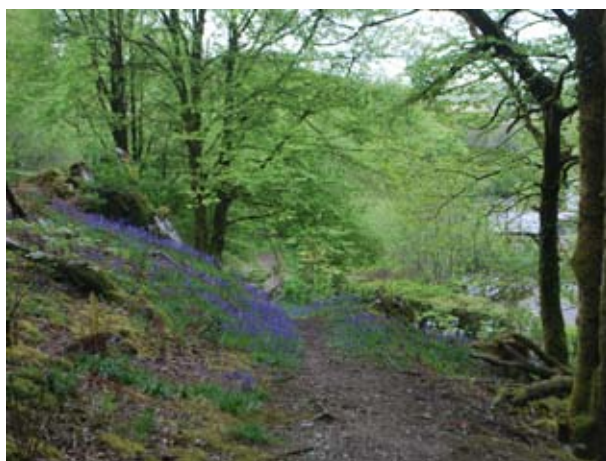
*Fig 22 (left) The terraced path and quartz outcrop by the ENPA car park (Hazel Riley)*

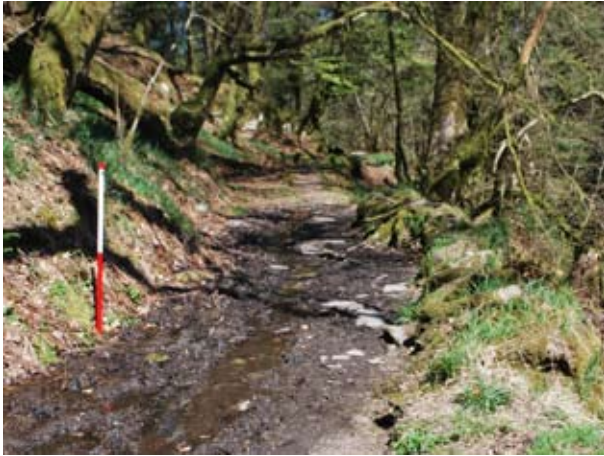
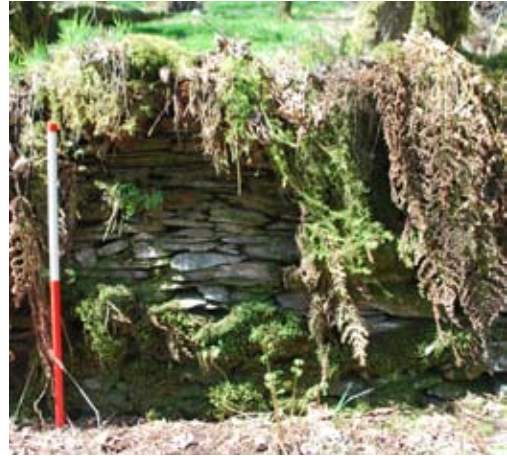
A substantial leat, AC15, runs from the north boundary of Ashcombe along the west side of the combe. The southern part of this was surveyed and described as part of the 2014 garden survey (Riley 2014a). South of the junction of the leat and terraced path, the leat comprises a silted up channel, cut into the valley side, with a substantial retaining wall on the downslope side (Figs 11, 23 & 24). North of this junction the path around Ashcombe uses the edge of the leat (Fig 12). The leat takes water from Ashcombe Water at the northern end of Ashcombe; the water is piped and the channel has been infilled from here for about 90m.

*Figure 23 (above left) The silted leat channel, south of the junction of the path and leat (Hazel Riley)*

*Figure 24 (above right) The retaining wall, south of the junction of the path and leat (Hazel Riley)*

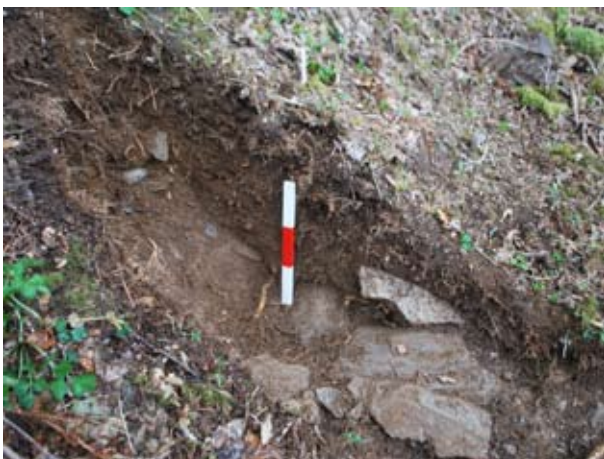
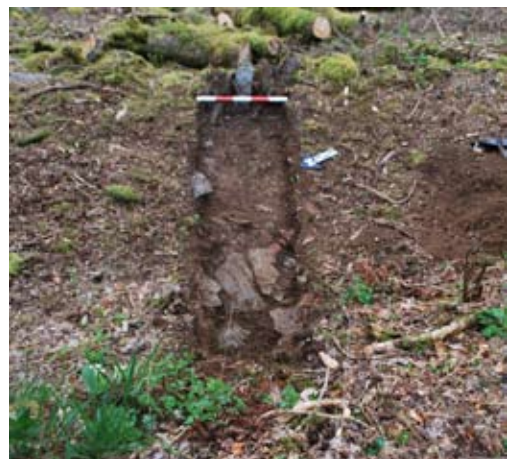
Two trenches were excavated across the terraced path on the west side of Ashcombe to investigate the structure of the terrace and the nature of the surface of the path (Front cover and Fig 3). The southern trench showed that the path was 2.2m wide and formed by cutting into the valley side to a depth of c 0.4m and using this material to form the path. There was very little stone used on the surface of the path, but a well built retaining wall was uncovered on the eastern side of the path (Figs 25-28). A clay field drain was set into the path, under tumble from the cut, showing that the path was a well designed and constructed feature (Fig 29).

*Fig 26 (below right) Trench A from the west (Hazel Riley)*

*Fig 27 (below left) Cut for the terraced path, Trench A (Hazel Riley)*

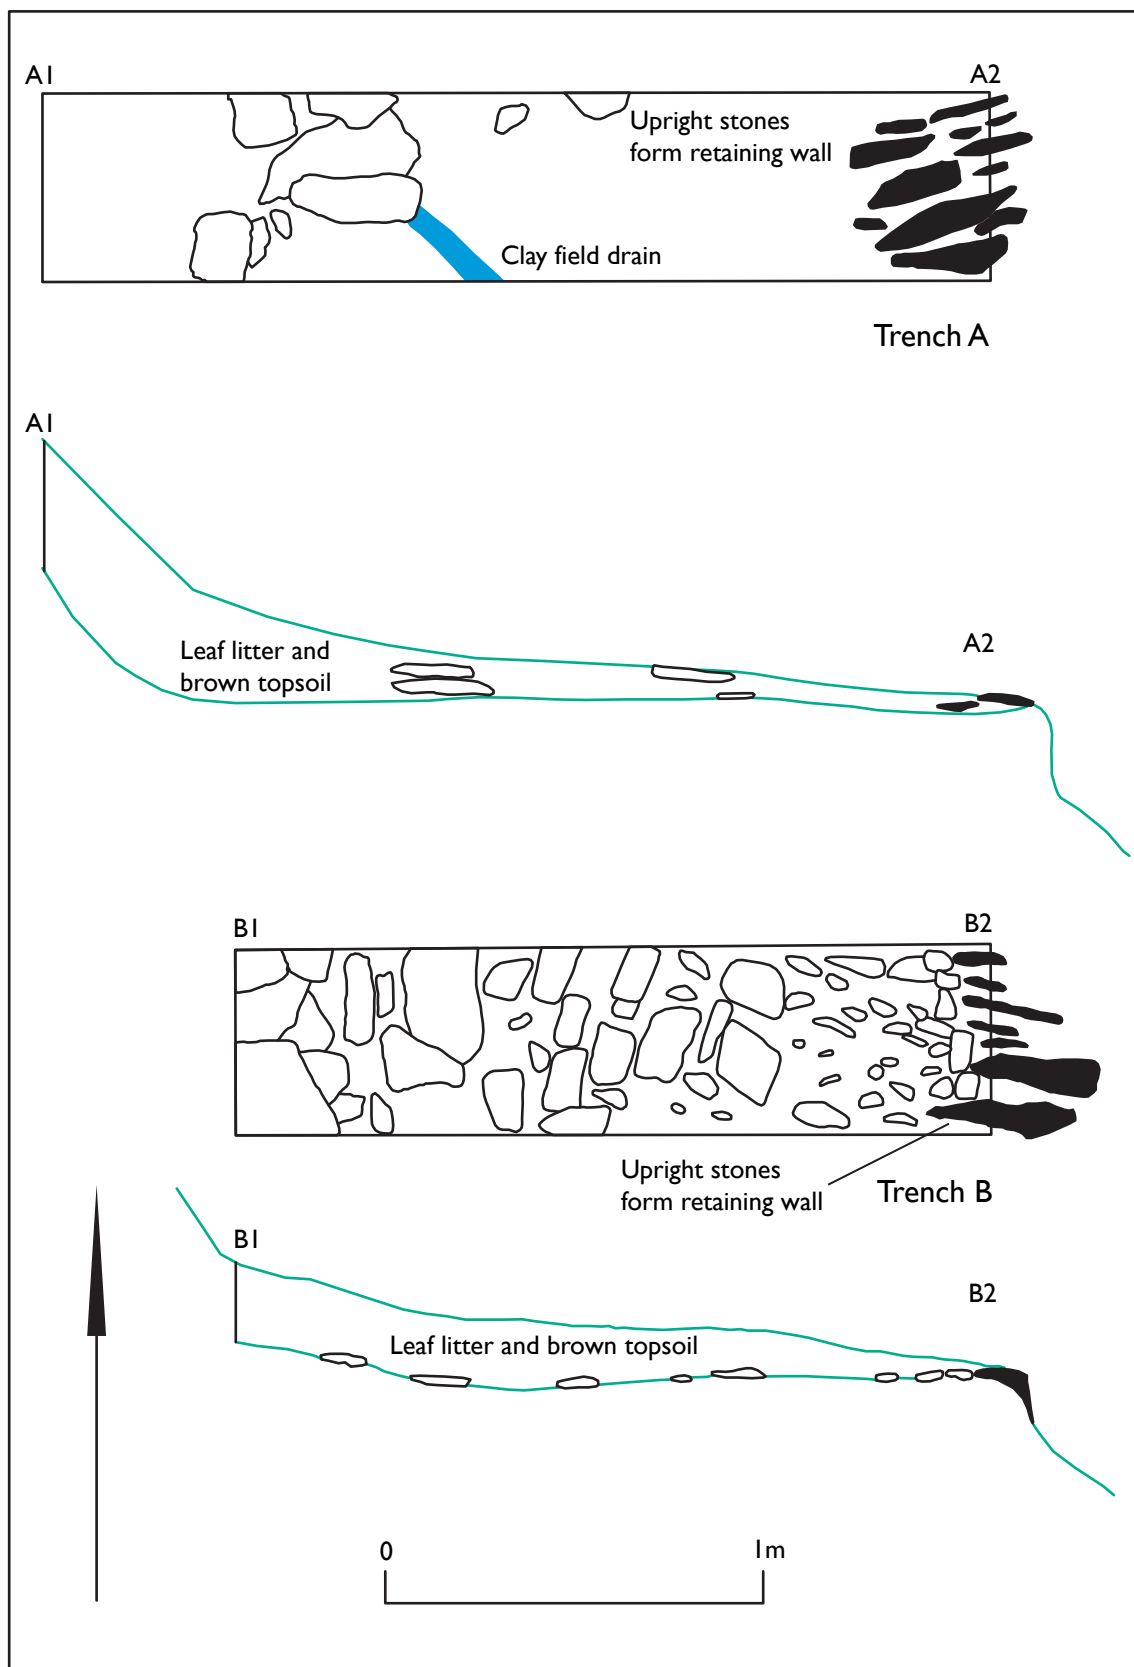
Trench B was dug 8m to the north of Trench A. The path here was constructed in the same manner as Trench A, but was paved with numerous large stone slabs, probably originally covered with earth to form a level surface to walk on (Figs 25, 30, 31).

Fig 25 Plans and sections, Trenches A and B (1:20)

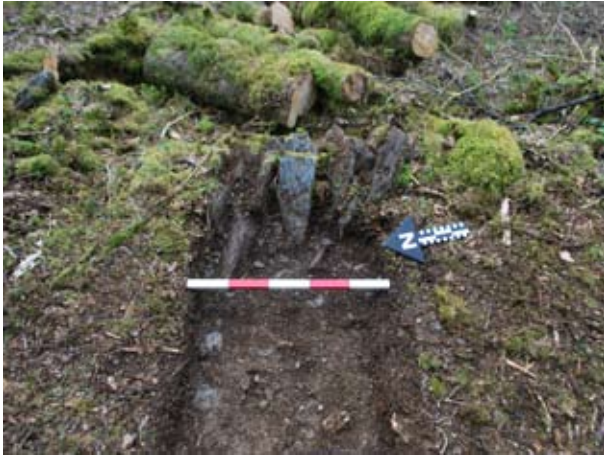
*Fig 28 (above) detail of retaining wall, Trench A (Hazel Riley)*

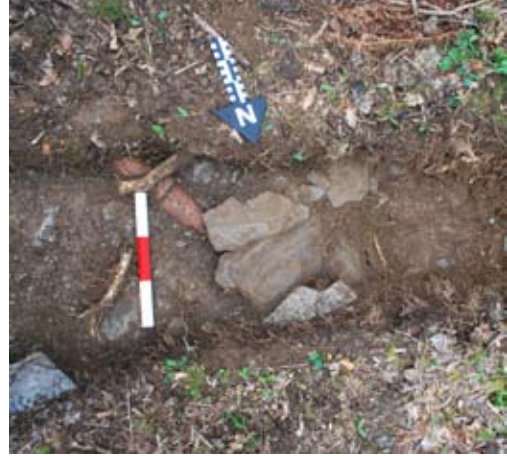
*Fig 31 (below) Retaining wall, Trench B (Hazel Riley)*

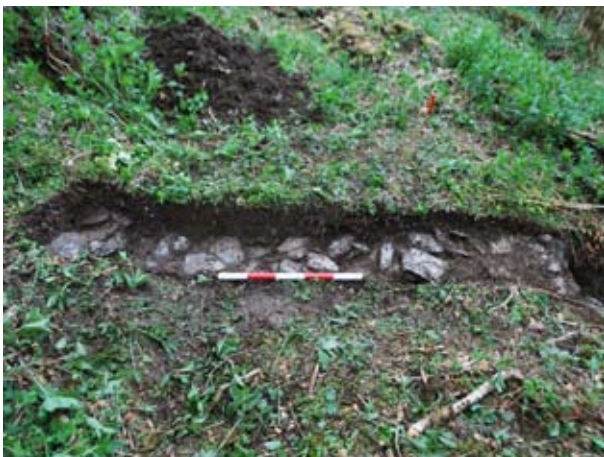
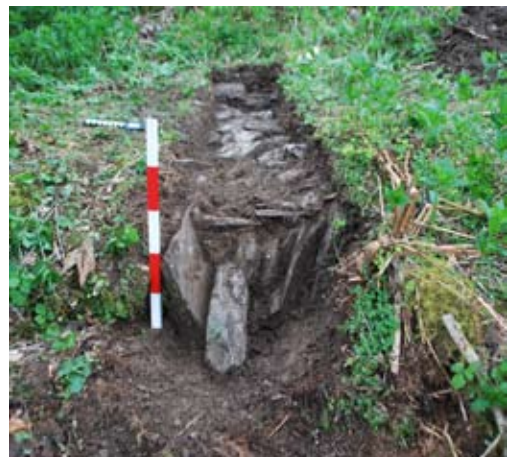
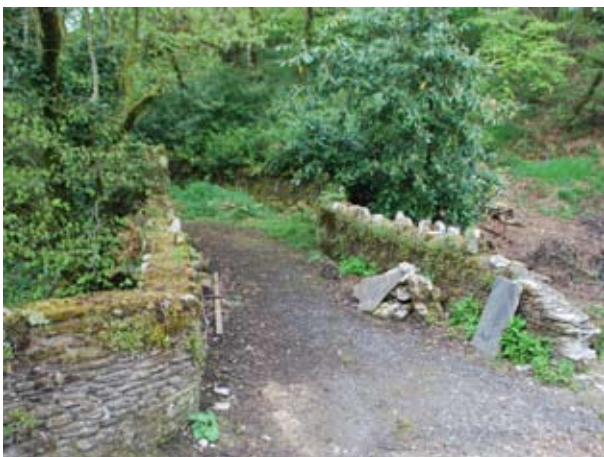
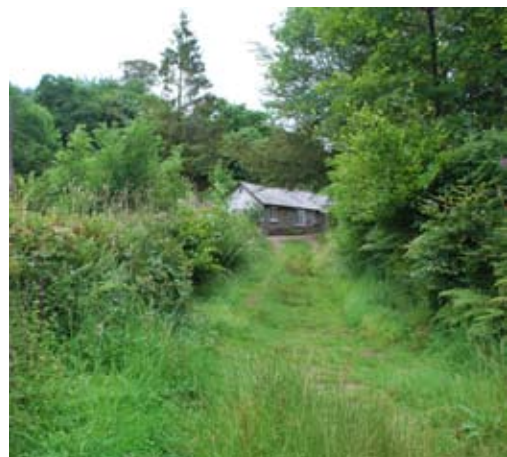
*Fig 29 (above right) Detail of the clay field drain, Trench A (Hazel Riley)*

*Fig 30 (below) Trench B from the south (Hazel Riley)*

*Fig 33 (bottom left) The bridge at the entrance to Simonsbath House (Hazel Riley)*

*Fig 35 (right) The northern face of the bridge showing damage to the arch by large ash sapling (Hazel Riley)*

2.18m wide and 4.4m long. A large ash sapling has displaced one of the keystones on the northern side of the bridge. This is one of several bridges over Ashcombe Water built by John Knight in the 1830s and formed part of a designed landscape around Simonsbath. The bridge was in good repair in the early 20<sup>th</sup> century (photograph in Burton 1994, facing p 26) and was probably damaged in the 1952 floods.

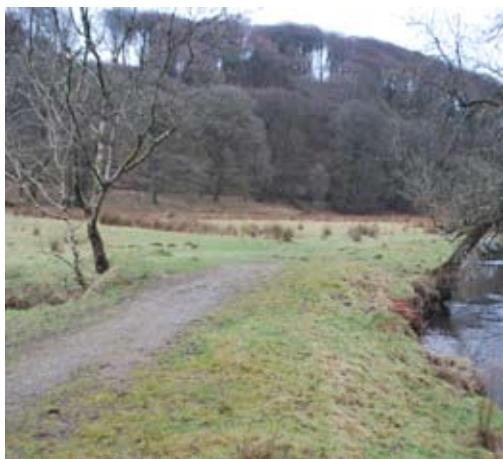
*Fig 34 (above right) The southern face of the bridge at the confluence of Ashcombe Water and the River Barle (Hazel Riley)*

The remains comprise the bridge abutments, arch and the roadway. The arch rises from 0.6m high at the abutment end to 1m high at the central keystone; the span is

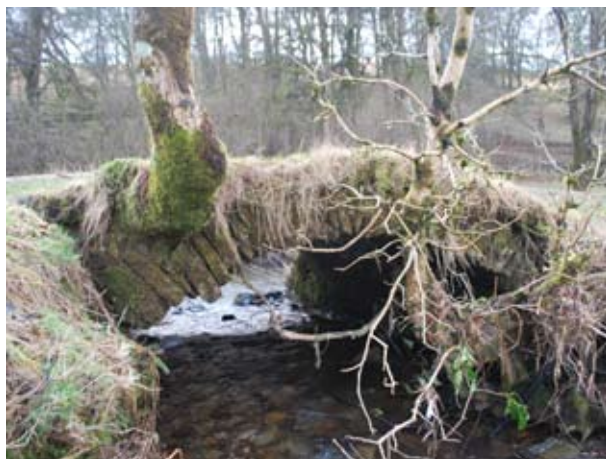
The OS 1<sup>st</sup> edition map shows several paths and tracks which cross Ashcombe Water and its tributaries (Fig 3). Two bridges took the terraced paths over the river in Ashcombe; further downstream a bridge formed part of the entrance to John Knight's unfinished mansion behind Simonsbath House. At the confluence of Ashcombe Water with the River Barle a bridge, AC28, took the old road from Simonsbath Bridge, running along the north bank of the river for some 100m before turning north to the village centre (Fig 32).

*Fig 36 (top) The old road to Simonsbath on the north bank of the River Barle (Hazel Riley)*

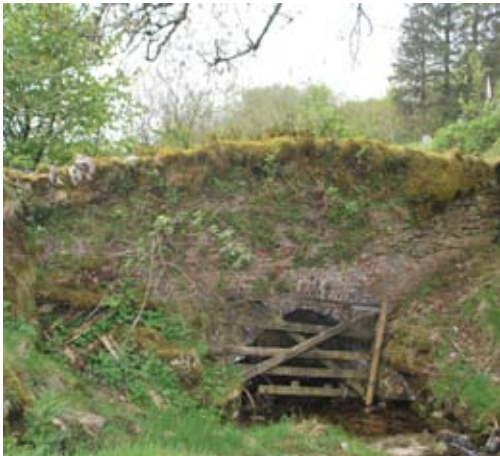
The extreme weather conditions which caused the Lynmouth Flood Disaster in August 1952 also affected the Barle and its tributaries. The top of Simonsbath Bridge was washed away and water from Ashcombe quickly flooded the Exmoor Forest Hotel. The floodwaters also damaged or destroyed all of the 19<sup>th</sup>-century bridges in Ashcombe (Siruat nd; information from Rob Wilson-North). The bridge at the entrance to Simonsbath House was substantially rebuilt after this (Fig 33) but part of the bridge over the old road by the River Barle has survived. The structure survives as the bridge abutments, the arch, and the roadway over the bridge. A substantial ash sapling on the north side of the structure has caused damage to the arch (Figs 34-36). A photograph from the early 20<sup>th</sup> century shows the bridge taken from the south bank of the River Barle. It was constructed of several courses of flat slabs of local shillet with upright shillet slabs and some quartz blocks forming a decorative parapet (Fig 37).

Historic photographs and the 1<sup>st</sup> edition map show that the area between Simonsbath House and the River Barle was open meadow or pasture, with a few scattered trees, perhaps suggestive of parkland in front of the house (Figs 3 & 37). This stone bridge was probably built to replace a muddy track over a ford which would spread across the fields in muddy conditions. The bridge which takes the road to St Luke's Church over a tributary of Ashcombe Water is similar in construction and stands in good condition (Fig 38). This bridge was presumably built by 1856 when St Luke's was consecrated, and it seems to echo the style of the structures built a few decades earlier as part of John Knight's designed landscape at Simonsbath. The possibility that the bridge by St Luke's is actually part of John Knight's designed landscape at Simonsbath should also be considered: the walls on each side of the road to the church are built differently to the bridge and meet it somewhat awkwardly.

*Fig 37 (left) Simonsbath House and the bridge in the early 20th century (from Burton 1994, facing p 26)*
