TRERYN DINAS CLIFF CASTLE
ARCHAEOLOGICAL SURVEY
Scheduled Monument 1006733

PROJECT REPORT

Date of report: November 2015
Copyright: © The author

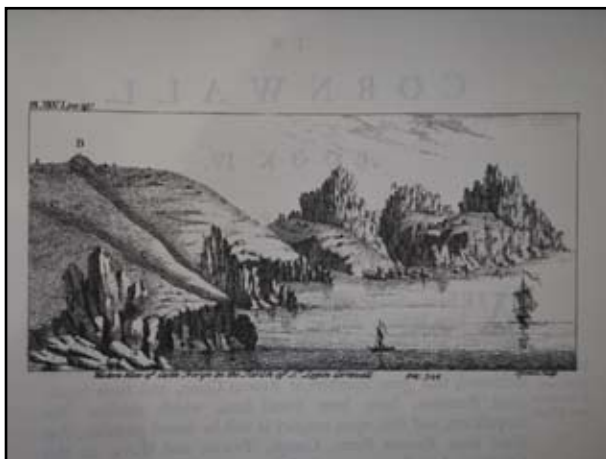
Figure 5 (left) 'Western View of Castle Treryn' (Borlase 1769, plate XXVI, 297)

The letters A-C refer to an engraving (reproduced here as Figure 5), which shows the three main elements of Treryn Dinas and how they use the natural features of the promontory. The engraving also shows one of other features described by Borlase - a stone circle. He observed 'one of the Danish vallums B, cutting one of the Druid holy circles and passing quite through it' (1769, 351). Polwhele refers to Borlase's description of Treryn Dinas (1803, 113).

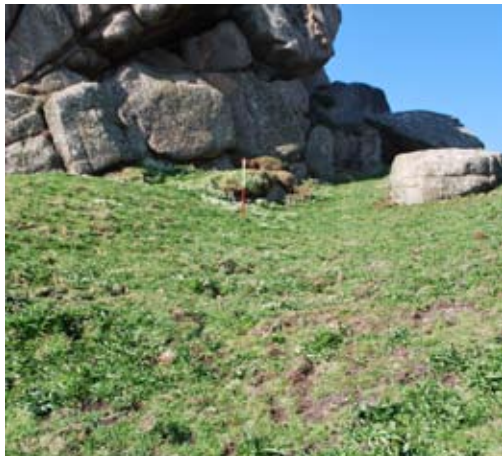
Fig 15 (above right) The outer ditch running into the zawn on the NW side of the inner rampart (Hazel Riley)

Seven areas of erosion caused by the ponies which graze the site were mapped to the north and south of this inner rampart (Fig 37). The damage is most severe NW of the inner rampart on the side of the ditch, across the south end of the SE building, and on the probable ditch and bank SE of the inner rampart (Figs 15, 19, 38).

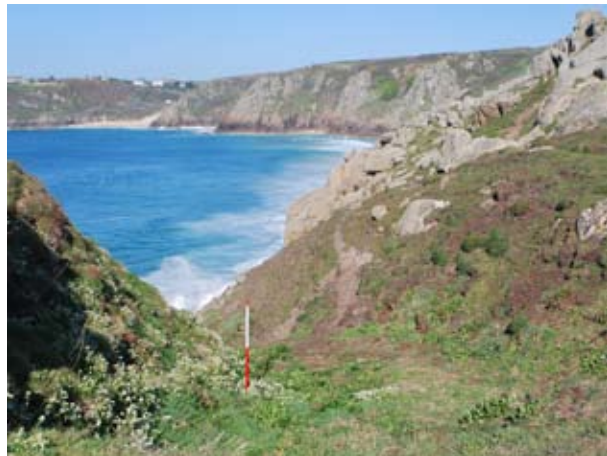
The rampart (C) is a substantial structure, constructed of earth and granite, and faced on the northern side with granite blocks (Fig 16). It is 30m long, 6m wide and 1-2m high on the outer (north) face. This encloses a space 15m NS by 35m EW which is sheltered by, and dominated by, the granite outcrop to the south. The west and east sides are bounded by the cliff edge. A ditch (D), 14m long, 2m wide and 0.8m deep, with a bank 2m wide and 0.7m high on its NE side, runs from the base of the granite outcrop NW/SE to the cliff edge (Front cover, Fig 17). This feature could be a natural hollow, caused by the underlying trend of the bedrock, and earth fast boulders lie on its NW side, but it does serve to enclose the east side of this area.

Fig 16 (right) The outer face of the west end of the inner rampart (Hazel Riley)

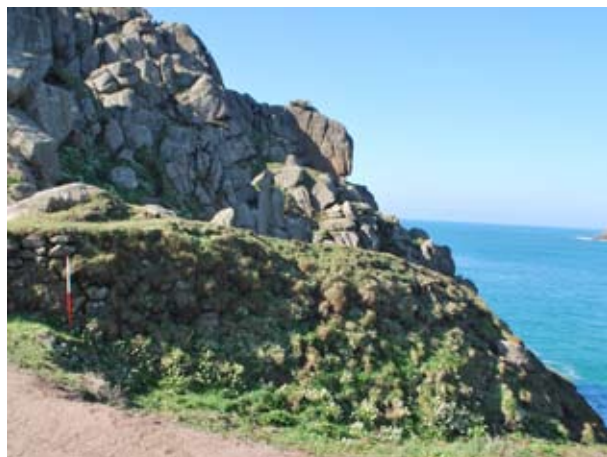
Fig 17 (above left) The ditch and bank on the SE side of the inner rampart (Hazel Riley)

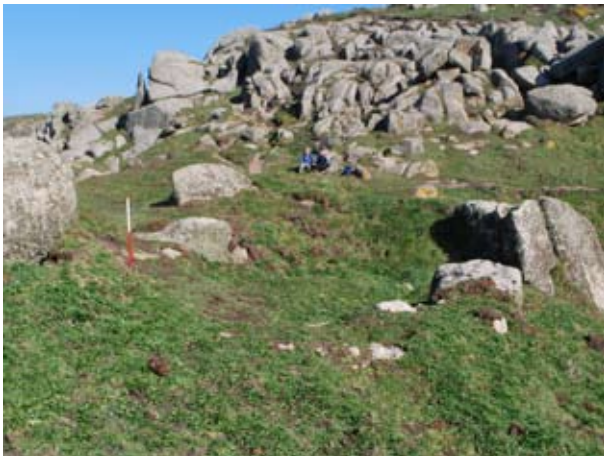
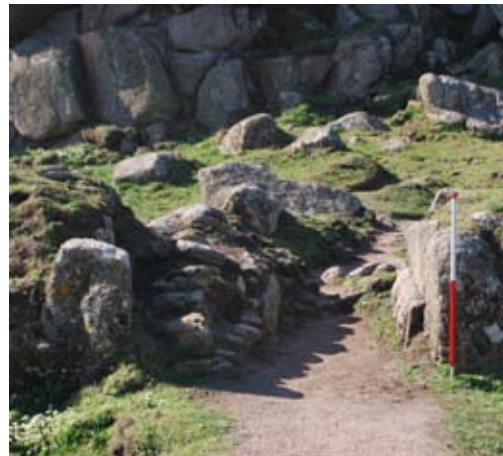
Fig 18 (above) The entrance passage through the inner rampart (Hazel Riley)

Fig 20 (left) The remains of the building SW of the inner rampart (Hazel Riley)

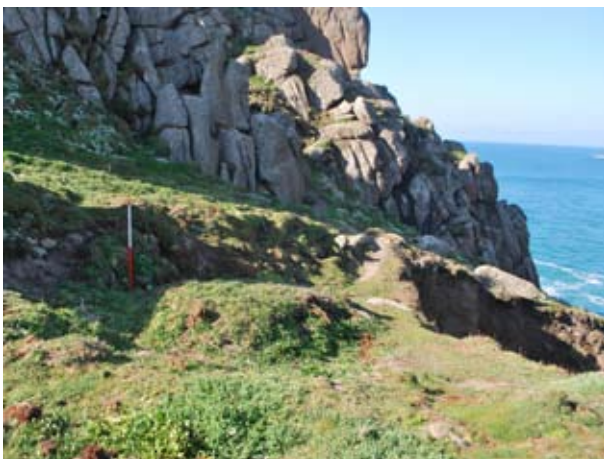
The remains of two buildings lie to the south of the inner ramparts. The SE building (E) is ovoid in shape, oriented NS, lies 10m from the present day cliff edge and is 11m long and 8m wide. It is defined by stony walls, 2m wide and 1m high, incorporating several earth fast granite boulders (Fig 19). The inner face of the rampart is used for the north wall of the structure. A small oval mound occupies most of the interior. The SW building (F) lies on the edge of the cliff at the SW end of the inner rampart. It is ovoid in shape, 8m long, 5m wide and is defined by a stony bank to the east, a scarp to the south, while the rest of the structure has been removed by erosion of the cliff edge. A small oval mound lies in the centre of the structure (Fig 20). These structures are depicted as earthworks rather than buildings on the OS 1st edition maps and are named as 'Watch Houses', showing that they were ruinous at the end of the 19th century and that they were probably considered to be part of the prehistoric elements of the site. The morphology of the remains and the context of these structures in the wider historic landscape of Treen Cliff and West Penwith suggests that they represent the remains of two huer's huts. Some 500m to the east of Treryn Dinas is Cribba Head, overlooking Penberth Cove. Here the remains of a small structure, is known locally as a huer's hut, associated with the fishing industry in the cove, where lookouts spent many hours watching the seas for the approach of the pilchard shoals (Tangye 1994). Treryn Dinas is an obvious site for such structures: high above Porthcurno Cove with extensive views along the coastline to the west and east. The structures may have been open to the elements, as many of the pilots' look-outs on Scilly were, for example.

Fig 19 (above left) The remains of the building SE of the inner rampart (Hazel Riley)

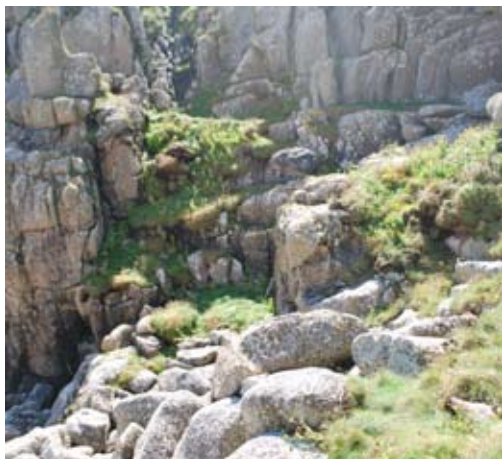
A hut circle [1] and a platform [2] discovered by Adam Sharpe in 1992 (above) lie to the west of the Logan Rock at SW 39683 2004 and SW 39683 1983. The hut circle is some 3m in diameter, with earth fast granite blocks forming the entrance which faces west to the sea. The platform is c 7m diameter and makes use of several granite outcrops (Figs 21, 22). A similar feature [3] lies on the east side of the Logan Rock (Fig 23). These are small structures, built close to the cliff edge, and make sense as places to be, amongst the dramatic natural landforms and close to the sea, rather than as places to live, either permanently or seasonally. They are presumably prehistoric in origin, but the structures may also have been used as lookouts or shelters in the historic period, like the huer's huts by the inner rampart.

Fig 21 (above right) A hut platform on the cliff edge, SW of the Logan Rock (Hazel Riley)

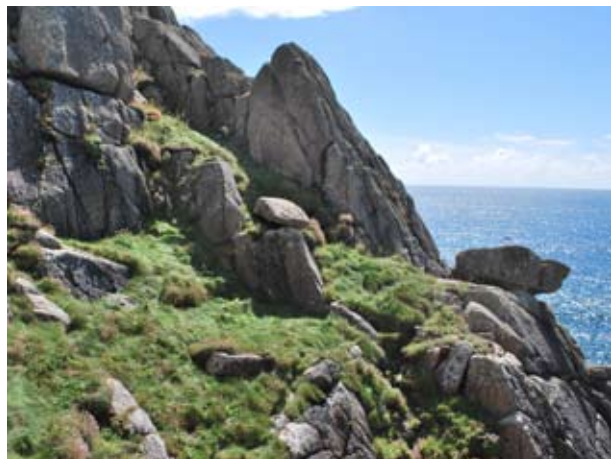
Fig 22 (right) A possible hut circle west of the Logan Rock (Hazel Riley)

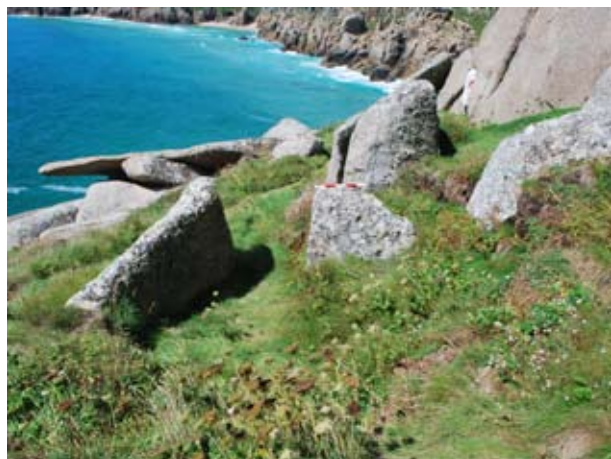
Fig 23 (above) A possible hut platform east of the Logan Rock (Hazel Riley)

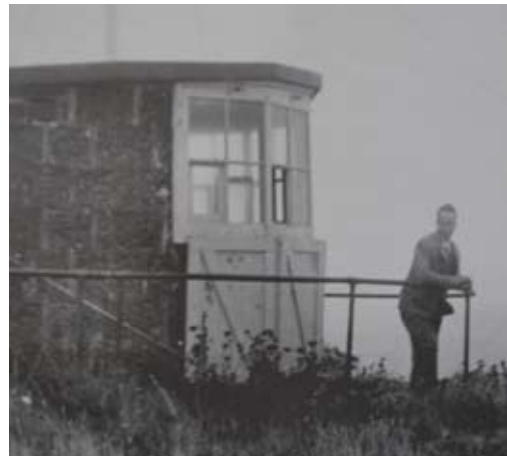
There were two Coastguard stations in the parish of St Levan. The larger, constant watch station was at Tol-Pedn, where a look-out was kept 24 hours a day throughout the year. The smaller station was at Treen, where the look-out building was on the promontory between the inner rampart and the middle rampart (St Levan Local History Group 2004, 104-107). A platform, 7m NW/SE and 0.5m high, with an emergency telephone point marks the site of the station (Figs 12 and 25), which was demolished sometime after 1974 when the Treen Coastguard Station was closed. In the 1950s, the Coastguard look-out building was a solid, block structure with a flat roof and windows with wooden shutters surrounded by an iron rail (Fig 26).

Fig 25 (above left) The site of the Treen Coastguard look-out (Hazel Riley)

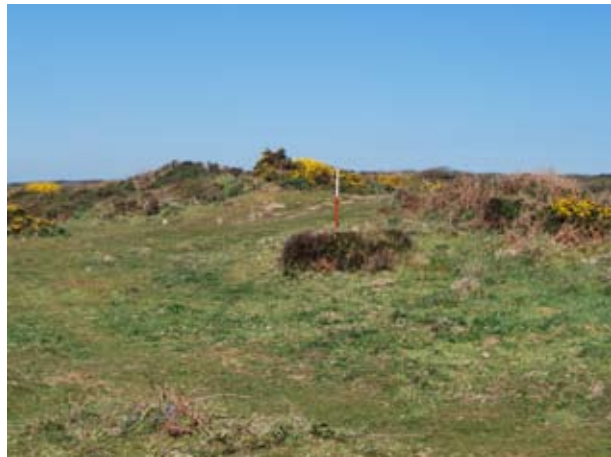
Fig 28 (left) The inner bank of the central enclosure merges with granite outcrops on the cliff edge (Hazel Riley)

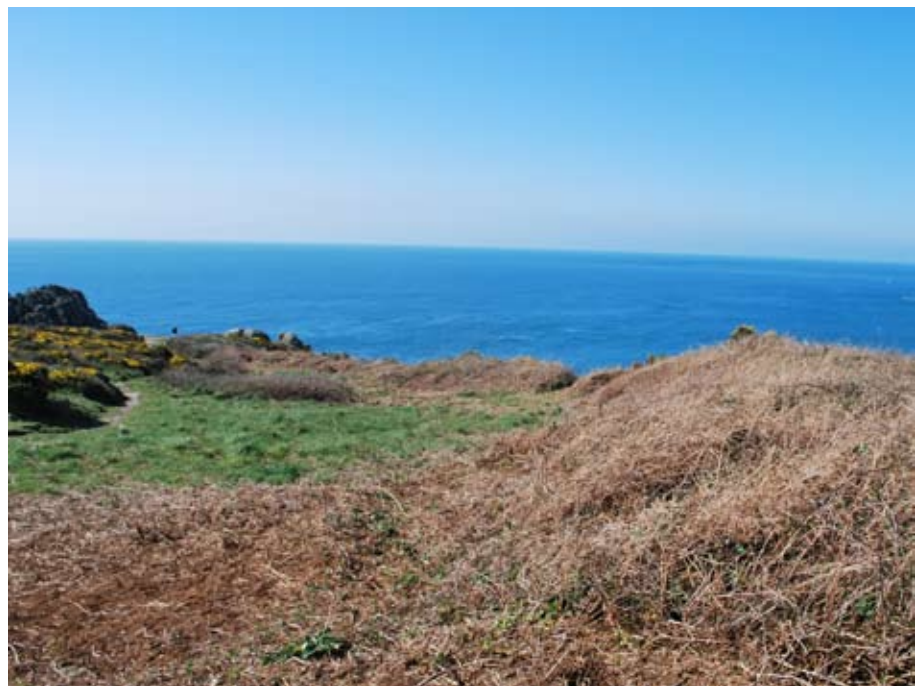
Fig 29 (above left) The inner bank of the central enclosure (1m scale) (Hazel Riley)

The enclosure formed by the inner bank [G], the cliff edges, and the main areas of outcropping granite, is oval in shape and roughly 0.8ha in area. A mosaic of bracken and bramble scrub, gorse and granite outcrops make the identification of any features in the interior difficult, but to the south of the inner bank a small platform [H], formed by a scarp and the inner face of the bank, may be the site of a building. The remaining ramparts are rather different in form to the inner bank, being regularly spaced banks and ditches with much less stone evident. A bank [J], 8m wide and 1.6m high with ditches to the south and north [K & L], lies to the north of the inner rampart. A counterscarp bank [M], 3.5m wide, 0.2m high, with a ditch, [N] 3m wide and 0.2m deep, lies to the NE. The area between the inner rampart and the ditch [K] forms a rather awkward terrace (Fig 30), suggesting that the ditch is a later element. A substantial bank and ditch [O & P] runs from the cliff edge for some 56m to meet the SW side of the inner bank (Fig 31). The junction of these elements suggests that this bank and ditch are some of the latest features of the central enclosure.

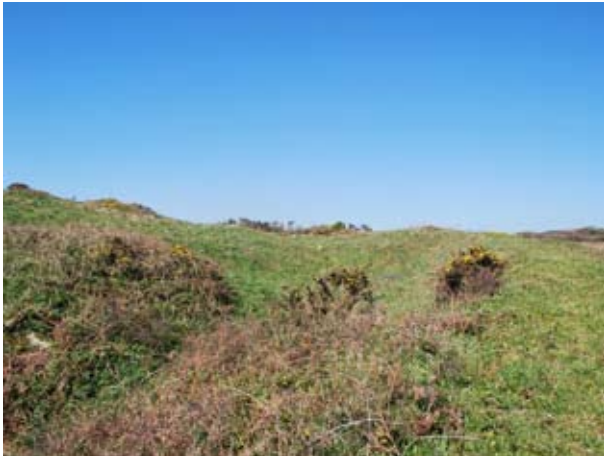
Together with the inner bank, these elements form ramparts 44m wide and up to 2m high, which can be seen when approaching the site from the north and west, and were clearly a substantial and impressive feature in the landscape. The removal of material in the historic period makes the identification of the original entrance gap through the middle ramparts difficult. The present day, well-used path, crosses the outer bank, runs on the edge of a well defined ditch terminal and runs over the innermost bank (Figs 29 & 39). On balance, this may be (approximately) the route of the original entrance.

Fig 30 (above left) The outer elements of the middle ramparts (Hazel Riley)

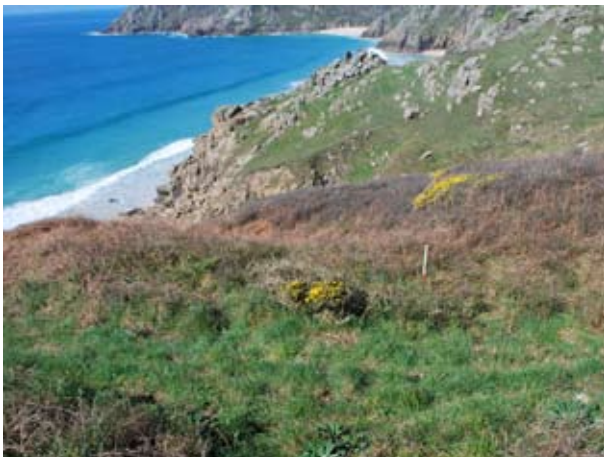
Fig 31 (left) The SW end of the middle rampart runs down the steep coastal slopes (Hazel Riley)

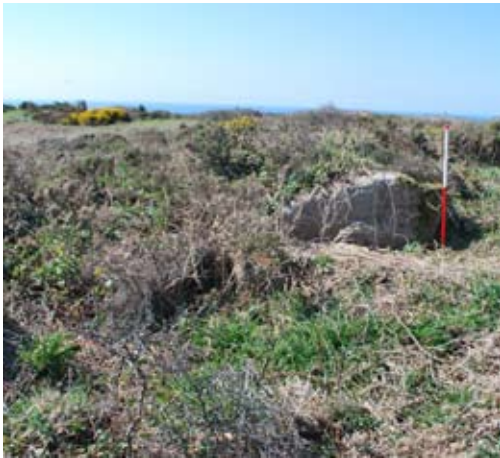
The northern ramparts take the form of a single bank [Q] which runs SW/NE across the neck of the promontory: a total length of 287m. The bank is up to 5m high and 13m wide. There is a ditch [R] on the northern (outer) side of the bank along the eastern part of the ramparts; to the SW a ditch [S] lies on the southern (inner) face of the rampart. The bank is most impressive at the central part of the site, where an entrance gap [T] takes the path onto the promontory (Fig 33). This entrance is the original entrance to the site, with well formed rampart and ditch terminals.

Fig 32 (above right) The northern rampart curves to the SW and merges with the cliff edge (Hazel Riley)

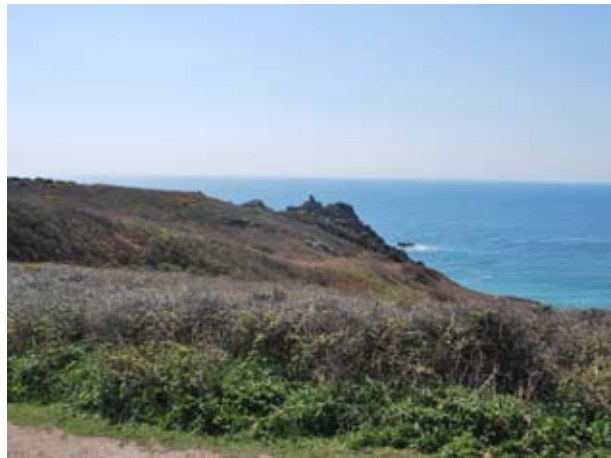
Fig 33 (right) The entrance to the promontory fort and the inner face of the northern rampart (Hazel Riley)

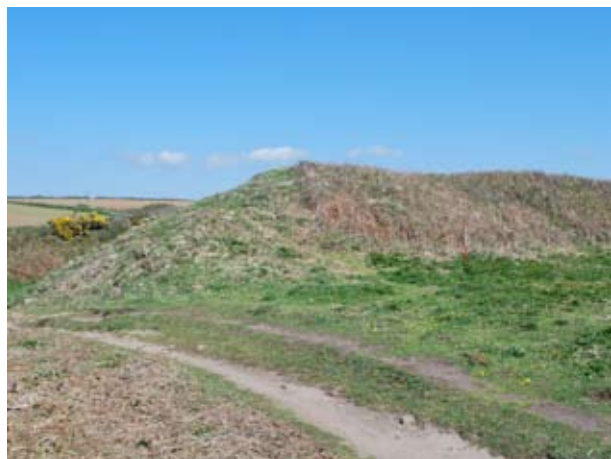
The interior of the enclosure, now largely clear of scrub, contains a small hollow [U], 3m in diameter and 0.3m deep, with a mound to the SE. This is probably the site of stone extraction. A mound [V], 8m long and 5m wide, with a hollow at its NW end in front of two granite slabs, is probably also a result of stone extraction. The exact form of the feature is obscured with vegetation but this may be site that was identified as the site of a cist at Treryn Dinas (Fig 34) (Cornwall and Scilly HER 26971).

Fig 34 (above) Mound between the north and middle ramparts

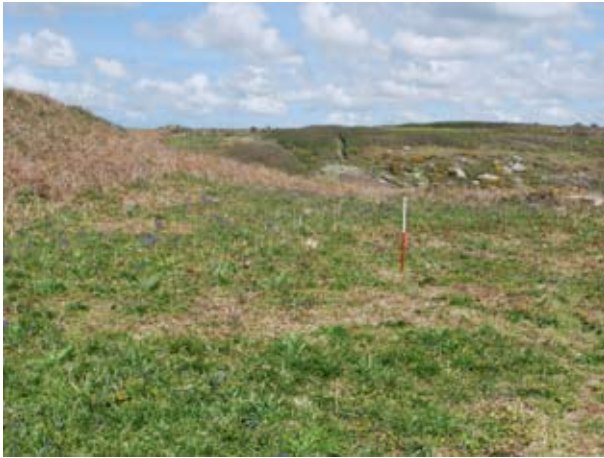
A slight scarp [W] runs SE/NW from the outermost ditch of the middle ramparts for some m towards the mound described above. Whilst it is tempting to interpret this as part of a pre-promontory fort field system, it may be following the trend of the underlying bedrock. A second scarp [X] presents similar problems of interpretation: a scarp lies at the inner face of the northern rampart at the point where the rampart changes in direction and character. A stony scarp lies in the ditch by the outer rampart face. Both elements are overlain by the rampart (Figs 35 and 36). This may be the underlying trend of the bedrock but the possibility exists that this could be an element of a pre-promontory fort field system. A field system, transcribed from air photographs and interpreted as prehistoric (Cornwall and Scilly HER 53340), lies to the NE of the northern rampart in the fields between Treryn Dinas and Treen. The area between the promontory fort and the field system is presently covered with gorse and bramble scrub, making further investigation impossible.

Fig 35 (above left) The scarp below the inner face of the northern rampart (Hazel Riley)

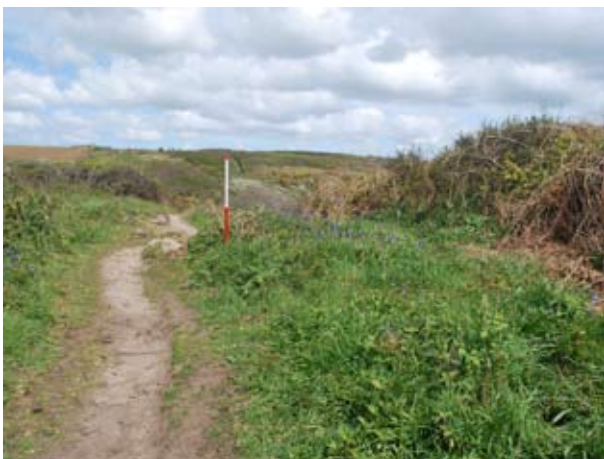
Fig 36 (left) The scarp in the ditch below the outer face of the northern rampart (Hazel Riley)

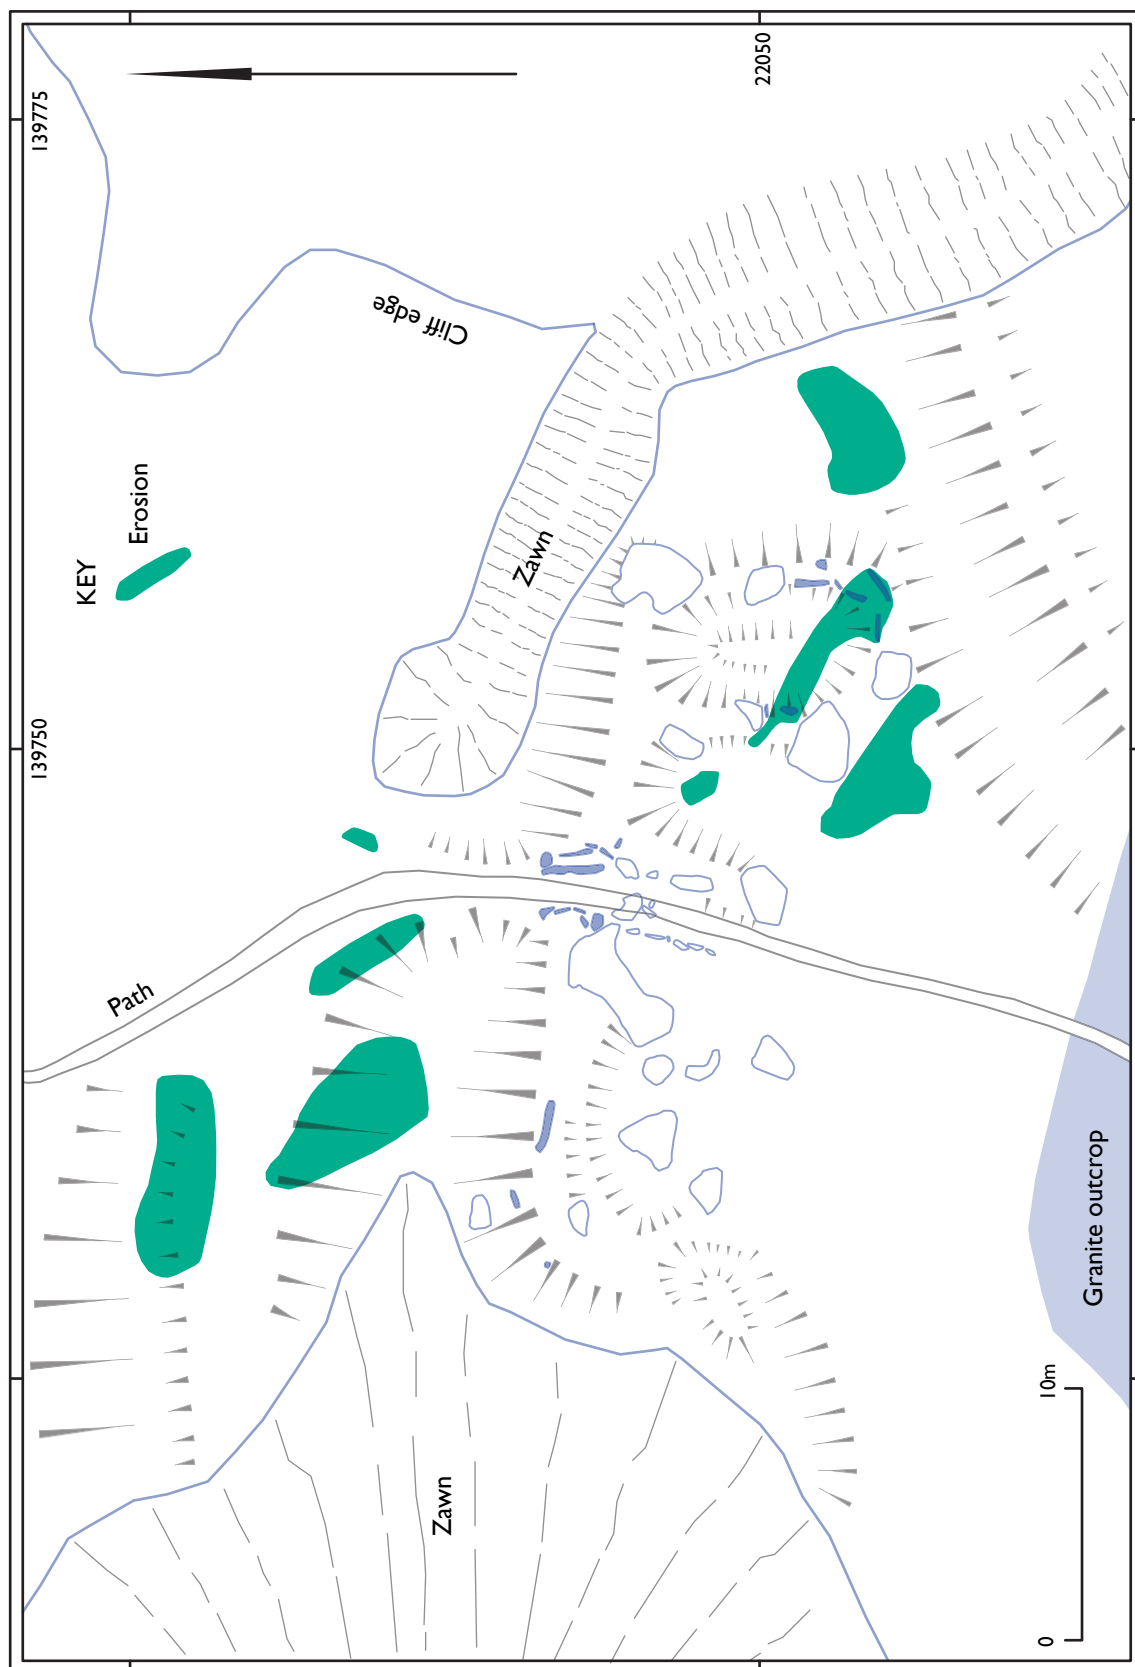
Fig 37 Areas of erosion recorded in April 2015 on and around the inner rampart

which have not been evident for many years. At the same time, however, parts of the site have also been opened up to erosion as ponies have scuffed the ground, especially in the short turf areas either side of the inner rampart, an area which is both archaeologically and botanically very sensitive (Fig 37). This is the part of the site that is also very vulnerable to on-going coastal erosion.

Owing to the impacts of stock erosion, the National Trust obtained Scheduled Monument Consent to position a temporary electric fence when necessary. The purpose of this is to restrict animals from damaging the most sensitive southern parts of the headland, especially around the inner ramparts, and to help increase their benefits in the scrubber and bracken-infested northern parts. Stiles will be provided where needed to ensure that visitors can continue to access the southern part of the headland.

in the summer of 2015 the fence was erected against the northern face of the inner rampart, where it proved very unobtrusive.

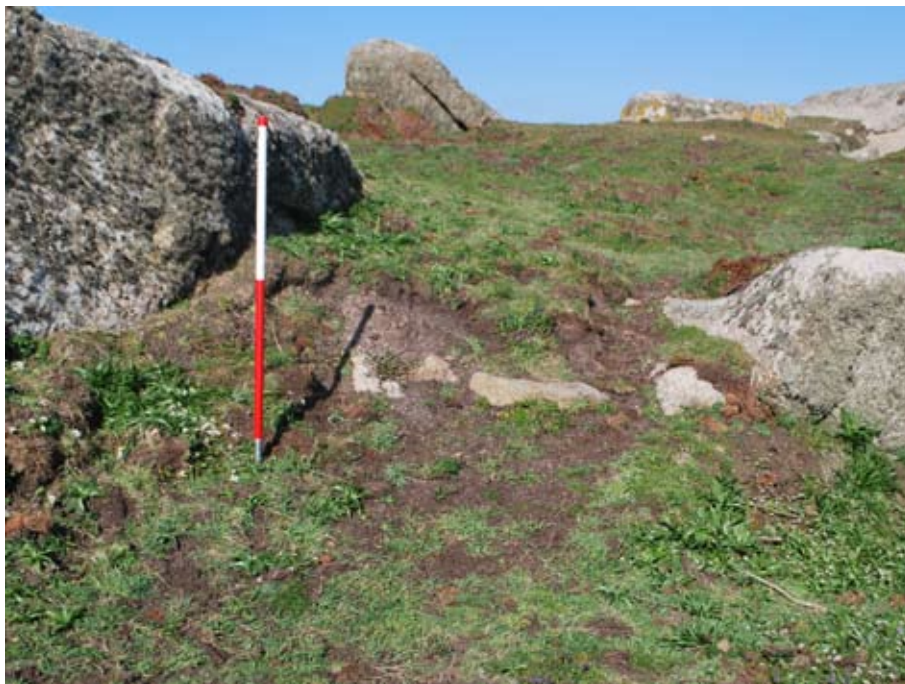
Fig 38 Detail of the erosion on the building SE of the inner rampart (Hazel Riley)

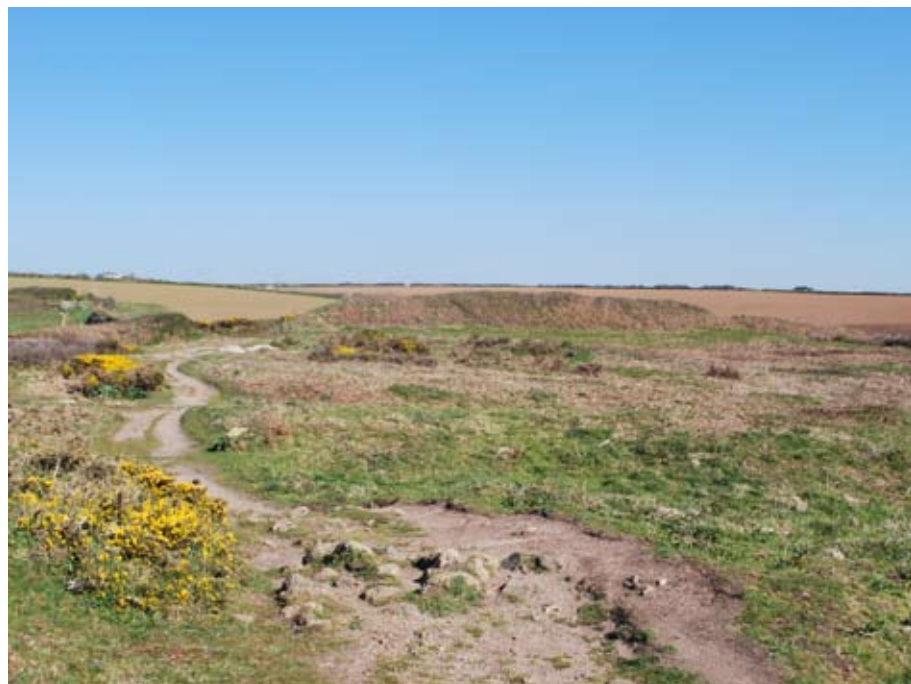
Treryn Dinas is relatively easily accessible via a short walk from a car park in the hamlet of Treen. There is a camp site close to the cliffs to the NW of the site. The promontory is a very prominent landscape feature (forming a backdrop from the nearby Minack Theatre, for example) and is well known because of the stories surrounding the toppling and re-erection of the Logan Rock in the 19th century. As a result, this is a more than usually frequented part of the cliffs of Penwith. Many visitors walk out to the site, and the effect of this has been the development of a worn path along the spine of the promontory.

Fig 39 Erosion along the path across the outer enclosure and inner rampart (Hazel Riley)
