SURVEY AND WATCHING BRIEF, SIMONSBATH SAWMILL, EXMOOR

PROJECT REPORT

By Hazel Riley

Date of report: July 2016

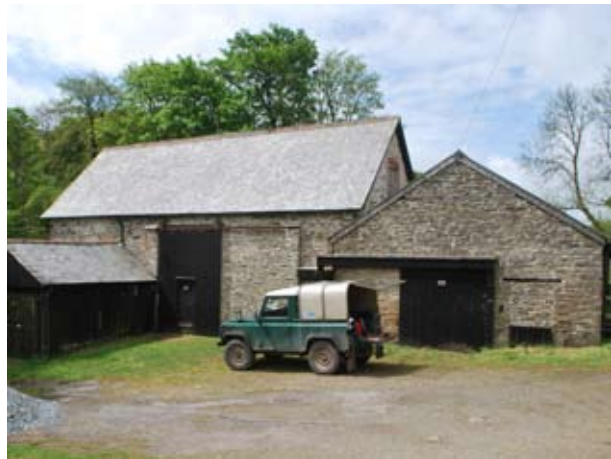
Fig 3 (above
right) The sawmill
and threshing
barn (Hazel
Riley)

3.2 The buildings on the site comprise two main elements. The north wing consists of the carpenter's shop to the west and the sawmill to the east. The south wing is an agricultural building, used for threshing, grinding and chaffcutting, with a chaff house at a lower level under the south end (Figs 3 and 4). Map evidence indicates that the south

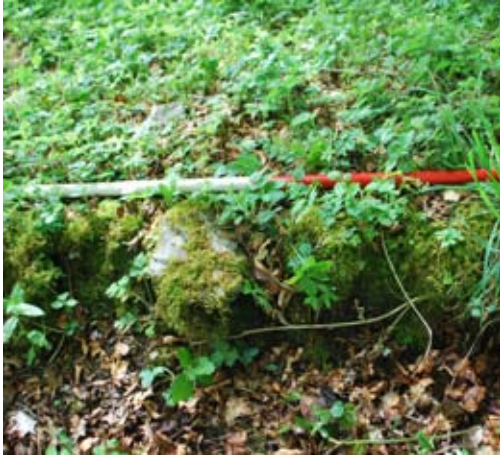
Fig 9 (above right) Leat north of the creosote shed, 1m scale (Hazel Riley)

6.2 The leat channel is 2m wide and 0.5m deep; some stone facing is visible at the west end of the channel. A bank 1-3m wide and up to 1m high lies on the south (downslope) side (Figs 9 and 10). The leat terminates at a recently constructed sump or tank, capped with concrete and a metal grille which holds runoff from the road above (Fig 11). Comparison with the 1st edition map shows that this structure lies on or close to the line of the aqueduct or launder which carried the water to the sawmill's water wheel until the end of the 19th century when it was superseded by a turbine (Figs 5 and 7).

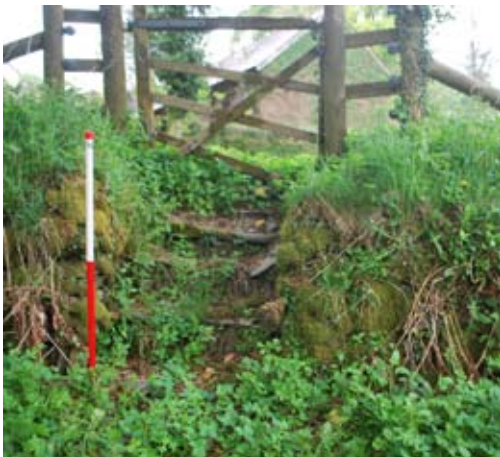
Fig 12 (below right) Path cut by the leat, 1m scale (Hazel Riley)

6.3 A hollow, 5m long, 2m wide and 0.5m deep runs down to the leat and is cut by it. This seems to be a path: stone steps allow access through the stone wall which bounds the northern side of the sawmill yard (Figs 12 and 13). This wall is a massive structure, over 2 m high at its SE end, carefully faced with slabs of local stone (Fig 14).

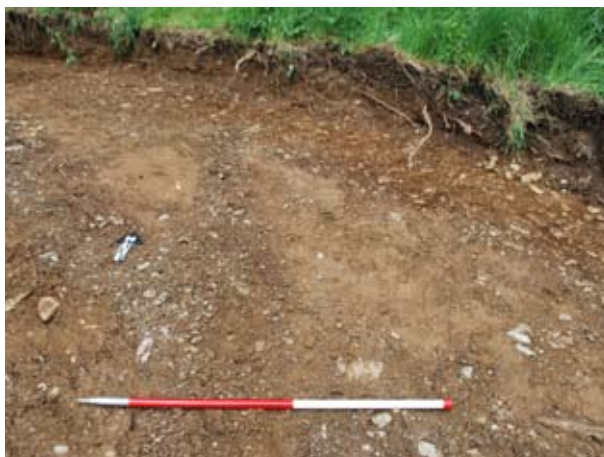
Fig 15 (left) Graded access track to the creosote shed, 1 m scale on F2 (Hazel Riley)

6.4 The watching brief on the graded access track located two features, F1 and F2, and three large stone slabs (Fig 15). These are shown on the survey plan (Fig 7). F1 is a rectilinear feature, 3.5m long, 0.4 m wide, cut into the subsoil and filled with a brown soil with a very high percentage of gravel; this was interpreted as a land drain and was

not investigated further (Fig 16). F2 is a broad feature, cut into the subsoil and filled with a mixture of re-deposited soil, stone and demolition rubble (Figs 7 and 15). Three stone slabs, one with a fleck of mortar on it, lie at the northern side of the trench, within the fill (Fig 17). This feature is interpreted as a large trench, associated with the runoff holding tank and site drainage, filled with demolition material and domestic rubbish. It was not investigated further.

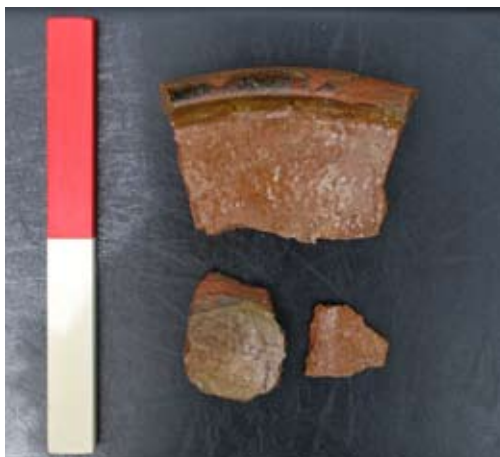
Fig 18 (below) Pottery found in F2, 0.2m scale (Hazel Riley)

6.5 Three sherds (one rim and two body sherds) of pottery were found in the fill of F2, close to the three stone slabs (Fig 18). The rim and one body sherd are probably from the same vessel - a glazed earthenware bowl or storage jar. This sort of pottery is typical of the sort of pottery used in a West Country domestic context in the 19th century (Riley 2010, figs 14a;b).

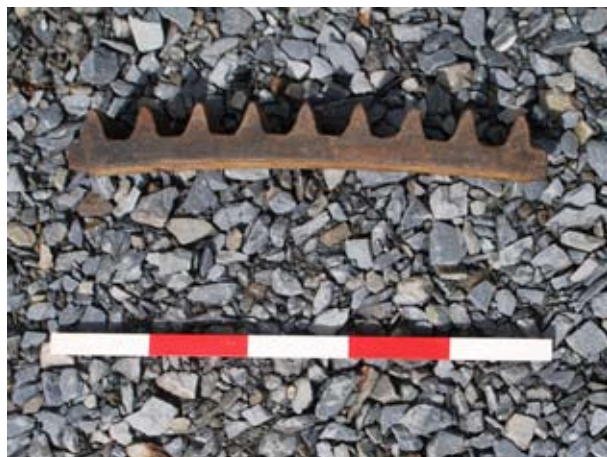
Fig 19 (below right) Section of (?) rim gear for the sawmill water wheel (Hazel Riley)

6.6 A metal casting was also found during the course of these groundwork but its context is unclear (information from S Blaylock and G Wills). However, the nature of the groundwork makes it unlikely that it was found in an undisturbed archaeological deposit. The casting is a section of gearing, slightly curved, 455mm long, 55mm wide and 60mm thick, with 9 teeth, 30mm high, spaced at 25mm intervals (Fig 19). It has been suggested that this is a section of the rim gear for the original water wheel, and that the curvature indicates that it drove a water wheel some 12 feet in diameter (information from G Wills).
