AGRICULTURAL RECLAMATION AT LARKBARROW
FARM, EXMOOR
Exmoor Mires Partnership ELB17
PROJECT REPORT

Date of report: February 2017
Copyright: © The author

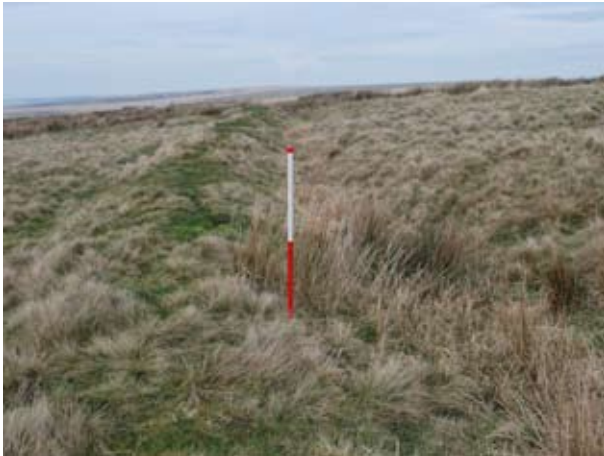
Fig 5 (above left) The contour leat on the NW side of Swap Hill (1 m scale) (Hazel Riley)

5.1.1 The leat is well preserved on the NW side of Swap Hill. Here, it comprises a well defined channel, 3.2m wide, 0.8m deep with a substantial bank, 3m wide, 0.9m high on its downslope side. North of the enclosure boundary, the leat is different, it survives as a shallow channel, 2m wide, 0.5m deep with a slight bank, 1.5m wide and 0.25m high (Fig 4a,b; Figs 5 & 6). The leat ends to the west of an enclosure boundary.

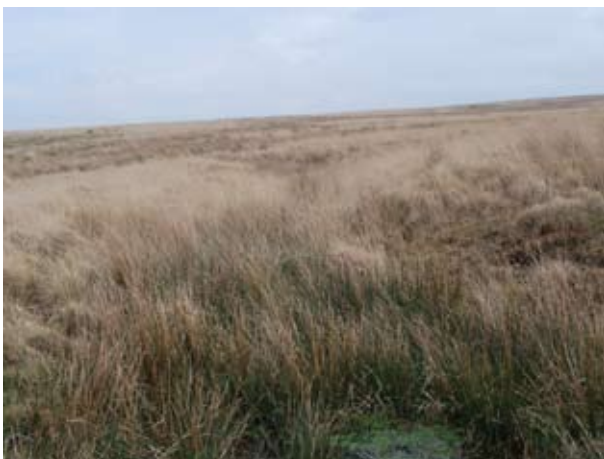
Fig 7 (left) The contour leat modified and used as a drainage channel (Hazel Riley)

5.1.2 The field evidence shows that this leat is earlier than a herringbone drainage system and the long, straight enclosures SW of Larkbarrow Farm. The enclosure banks block the leat, rendering it useless for water carriage. The leat channel has been incorporated into the drainage system and survives as a wide ditch, 5m wide and 1m deep to the east of the enclosure bank between Beckham and Swap Hill (Fig 4c; Fig 7).

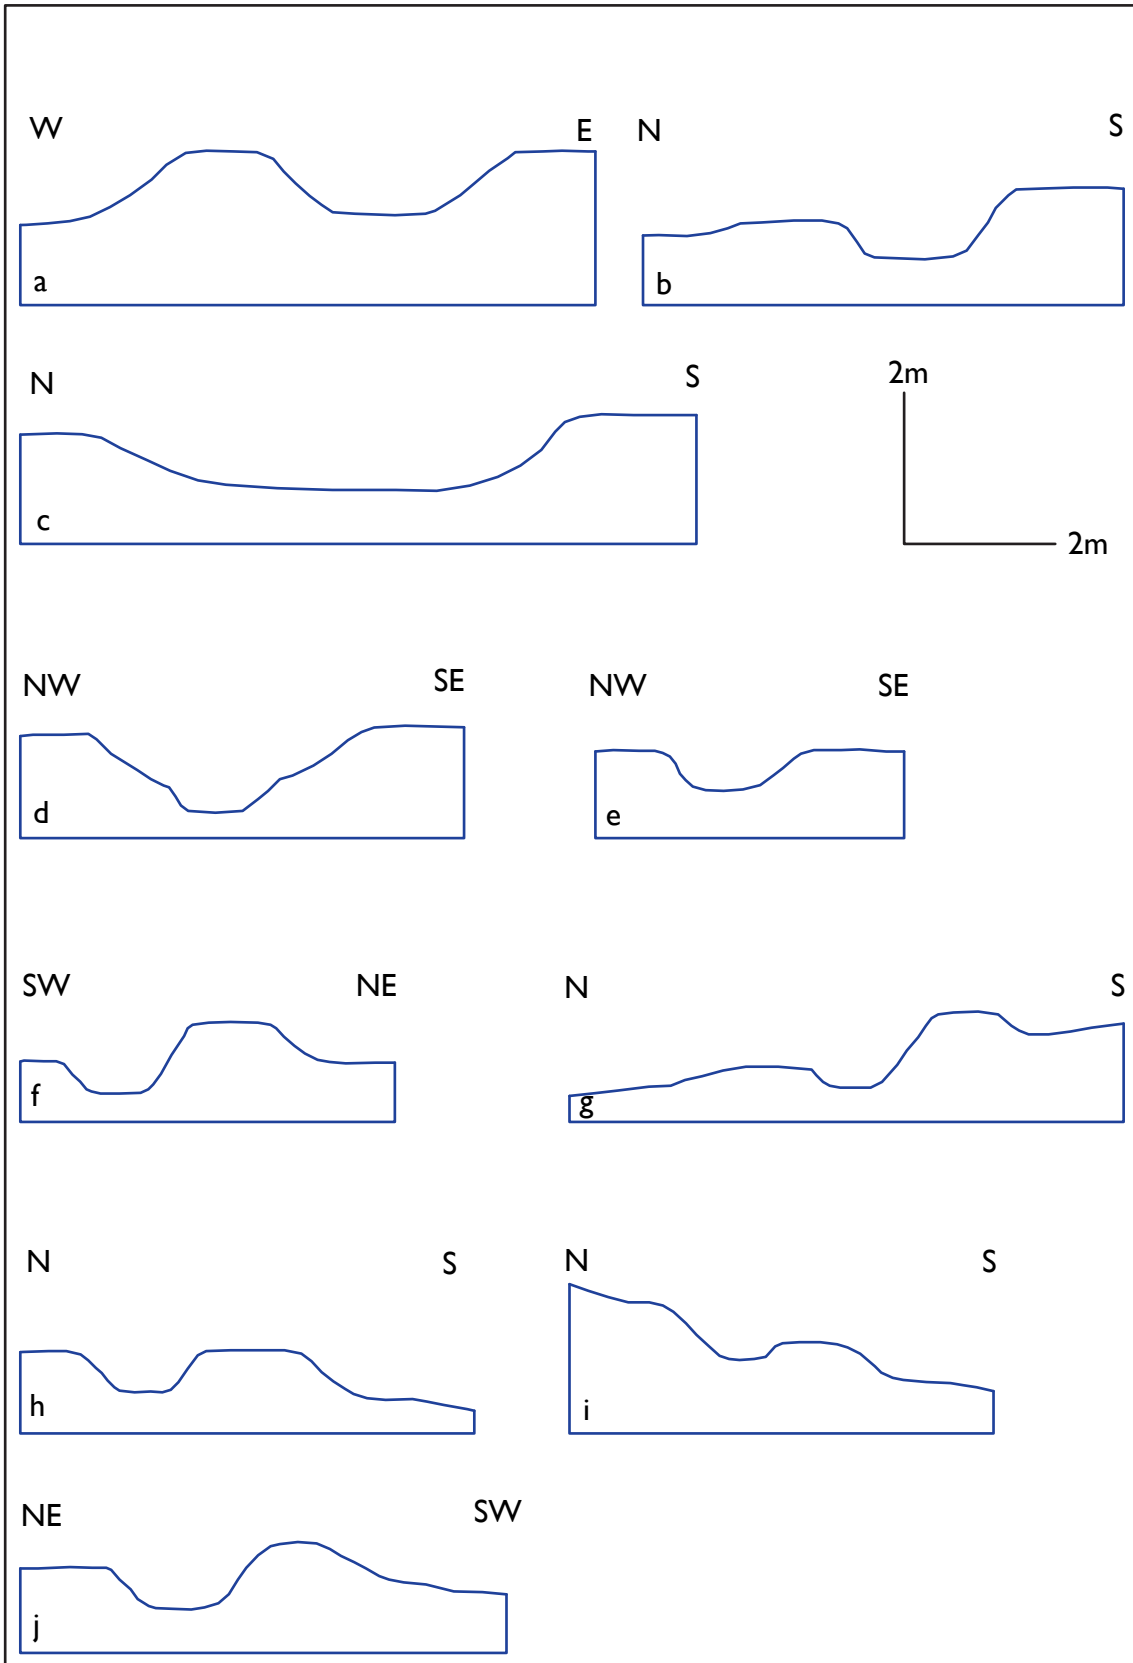
Fig 4 Profiles of leats, drains and field gutters 1:100 scale

4.2 The fieldwork was carried out between 20th January and 1st February 2017. The features were located, photographed and recorded. Measured profiles were drawn across several leats, field gutters and drainage ditches and the locations of these profiles were obtained using the EMP hand-held GPS (Figure 4).

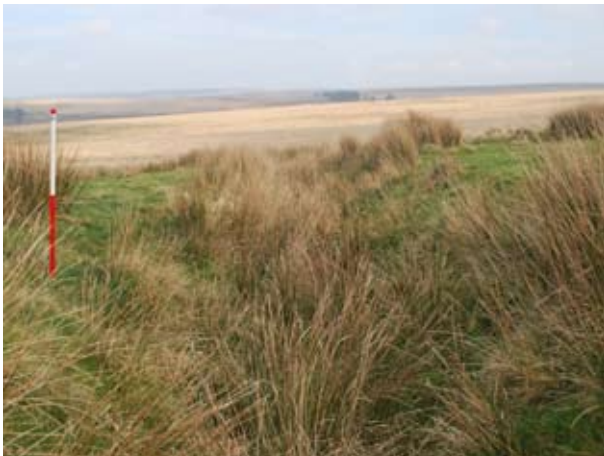
Fig 8 (above left) Main drain of herringbone ditch system, SW side of Swap Hill (1 m scale) (Hazel Riley)

5.2.1 One, at the SW corner of Swap Hill, is designed to drain the headwaters of a tributary stream of Long Combe (ELB1702). The main ditch is a well defined channel,

3.3m wide, 1m deep with a break of slope which probably indicates cleaning of the channel (Fig 4d; Fig 8). The feeder drains are smaller: 1.7m wide, 0.5m deep (Fig 4e; Fig 9).

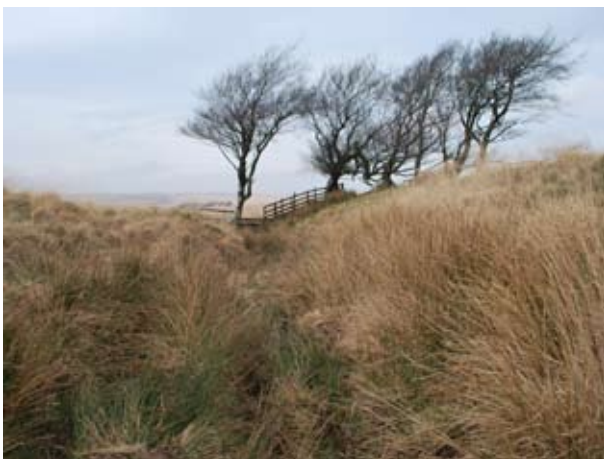
Fig 10 (left) Drainage system and enclosure boundary (Hazel Riley)

5.2.2 This system is clearly later than the contour leat (ELB1701). The enclosure boundary allows the water to drain through it, suggesting the ditches were in existence at the time the enclosures were laid out or the bank was modified to allow water flow (Fig 10).

6.3.1 The blocking of the herringbone drain system ELB1702 will have an adverse impact on the condition and visibility of the long leat ELB1701 which is one of the earliest of the reclamation features. It will also damage the integrity of the drainage system which is itself an artefact of 19th-century reclamation and documented in Robert Smith's correspondence to Frederic Knight.

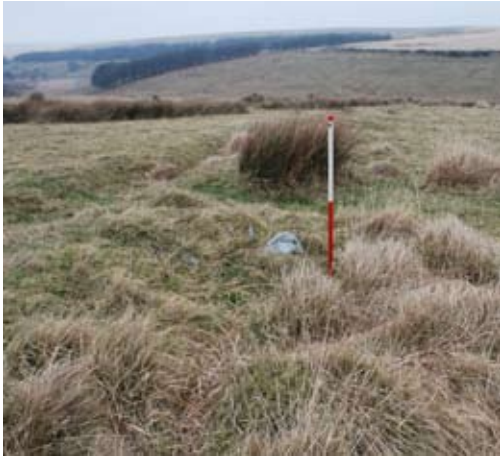
Fig 11 (above right) Main drain of herringbone ditch system SW Larkbarrow Farm (1m scale) (Hazel Riley)

5.2.3 The second system lies within a large regular enclosure to the SW of Larkbarrow Farm (ELB1703). The main channel is 1.3m wide, 0.5m deep, with a bank, 2m wide and 0.4m high on its NE side (Fig 4f; Fig 11). The presence of the bank suggests cleaning out. The ditch takes water from the SW corner of this enclosure and channels it into the ditch of the enclosure boundary and so into Long Combe.

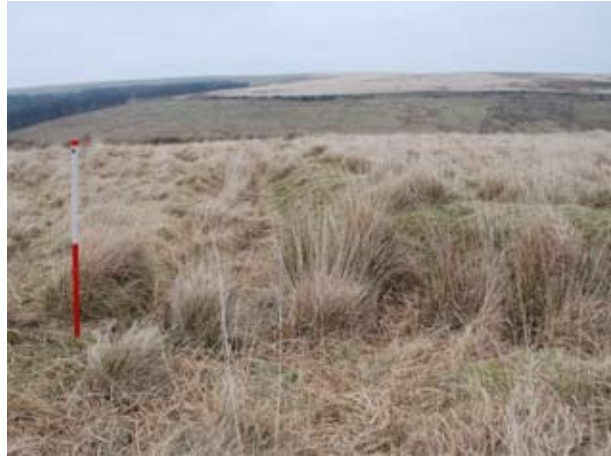
Fig 12 (above) Clearance cairns on edge herringbone ditch system (1m scale) (Hazel Riley)

5.2.4 Some 12 small piles of stone lie against the bank on the edge of this drain (ELB1704). A typical example is 1m diameter and 0.4m high (Fig 12).

6.3.2 The blocking of the herringbone drain system ELB1703 will have an adverse impact on the condition and visibility of the previously unrecorded stone clearance cairns which lie on its edge (ELB1704). It will also damage the integrity of the drainage system which is itself an artefact of 19th-century reclamation and documented in Robert Smith's correspondence to Frederic Knight.

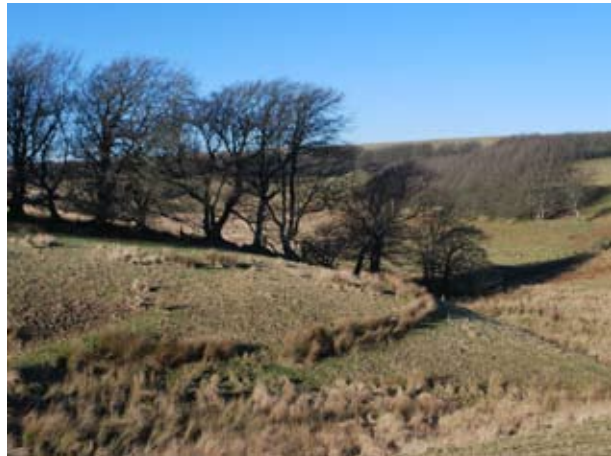
Fig 14 (below) The top leat south of Larkbarrow Farm (1m scale) (Hazel Riley)

5.3.1 The two leats lie in large regular enclosures on the north facing side of Long Combe (ELB1705) (Front cover). The lower leat takes water from the stream in Long Combe to the holding of Toms Hill (Fig 13). The upper leat takes water from the stream in Long Combe towards the boundary with Tom's Hill. It ends to the east of that boundary. The leat survives as a well defined channel, 1m wide and 0.25m deep. It has a bank 2m wide and 0.2m high on its downslope side and a bank 1m wide and 0.3m high on its upslope side (Fig 4g; Fig 14). The presence of the upper bank may indicate that this feature was intended as one of the in-by enclosure boundaries which also functioned as water carriages (Section 6.2.3).

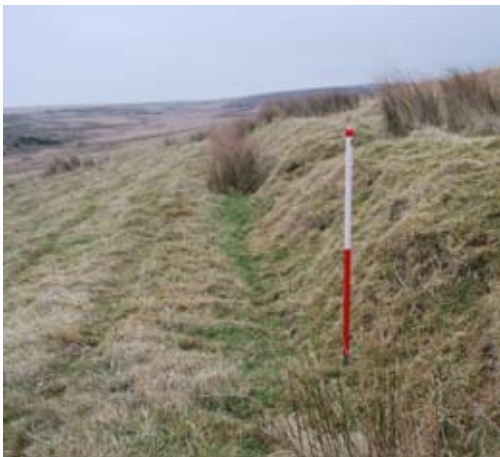
Fig 15 The lower leat is blocked by the boundary between Larkbarrow and Tom's Hill (1m scale) (Hazel Riley)

5.3.2 The lower leat (Fig 15) is overlain, and blocked, by the enclosure boundary between Larkbarrow and Tom's Hill holdings. The spoil from a quarry (MSO10162), probably for stone for the enclosure bank, overlies the leat channel to the east of this. The upper leat is overlain and blocked by the regular enclosure boundaries south of Larkbarrow Farm (Front cover).

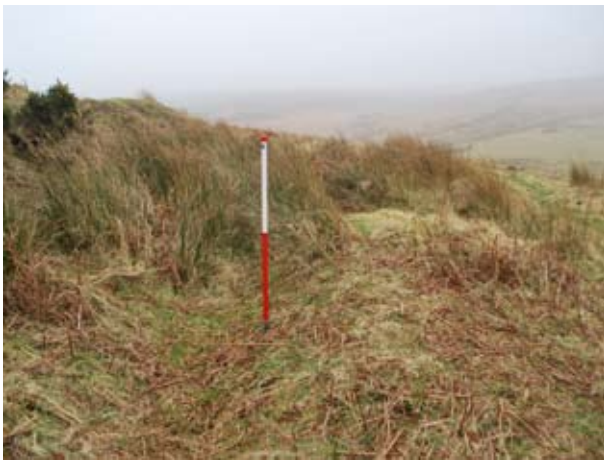
Fig 16 (above left) Headmain channel east of Larkbarrow Cottages (1m scale) (Hazel Riley)

5.3.3 A field gutter system lies on south facing slopes to the SW of Larkbarrow Farm (ELB1706). It consists of a headmain channel with 4 gutters below; a further channel takes water from the stream in Long Combe into the Tom's Hill holding. The headmain channel is 1.4m wide, 0.6m deep with a bank 2m wide, 0.5m high on its downslope side (Fig 4h; Fig 16). The gutters are narrow channels, cut into the hillside, some 0.6m wide and 0.2m deep with banks 1.2m wide and 0.4m high on their downslope side (Fig 4i; Fig 17).

5.3.4 The headmain channel is overlain by the enclosure boundary on the edge of the track to Tom's Hill for much of its length; both the headmain and the field gutters are overlain by the enclosure surrounding Larkbarrow Cottages (Fig 17). The relationship between the leat and Larkbarrow Farm is unclear due to the very wet nature of the area but it may have been intended to take waste water from the farm yard.

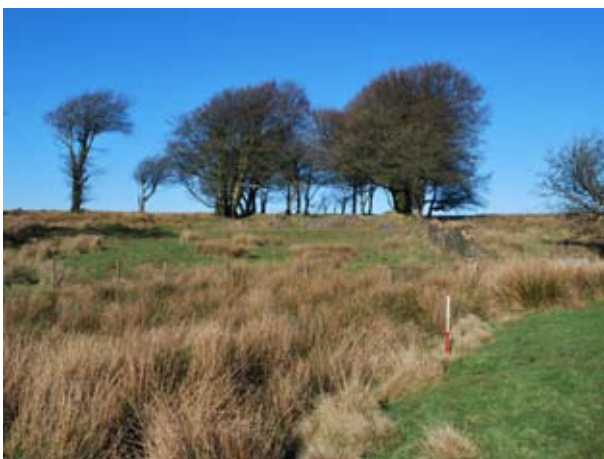
Fig 18 (left) The leat south of Larkbarrow Farm (1m scale) (Hazel Riley)

5.4.1 The leat takes water from the very wet area below Larkbarrow Farm to the stream head. It may also have been intended to take waste water from the farm yard but the relationship is unclear. The leat comprises a well defined channel, 1.8m wide, 0.6m deep, with a bank, 2m wide and 0.5m high on its downslope side (Fig 4j; Fig 18).

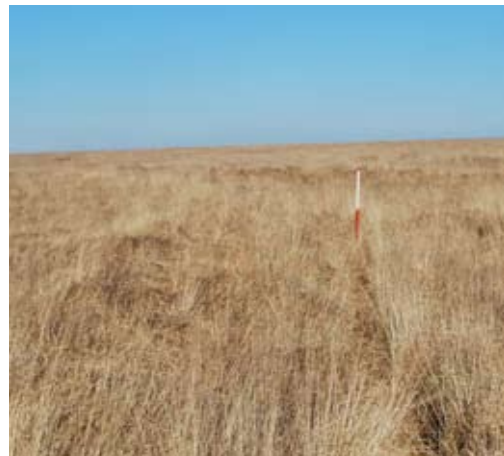
Fig 20 (above right) Disused turbary in moor grass, Kittuck (1m scale) (Hazel Riley)

5.5.1 The ditches on Kittuck were difficult to record in the deep moor grass and no relationship between the turbary and the drainage could be observed on the ground (Fig 20).

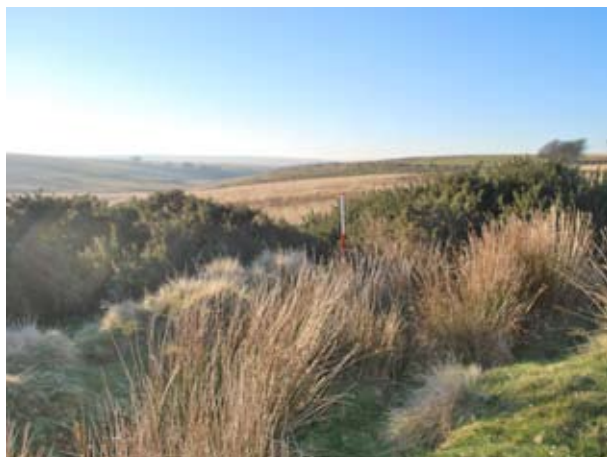
Fig 19 (right) The leat and enclosure boundary at the head of Long Combe (1m scale) (Hazel Riley)

5.4.2 The leat runs through a long, enclosure boundary. The bank stops on both sides of the leat to allow the water to flow through it and is either later than the leat or has been modified to allow water flow (Fig 19).

6.3.3 The blocking of part of the field gutter system at Long Combe Head (ELB1707) will have an adverse impact on the visibility and condition of this monument which is an example of 19th-century moorland reclamation 'in action,' as recommended by Robert Smith and documented in his correspondence to Frederic Knight.

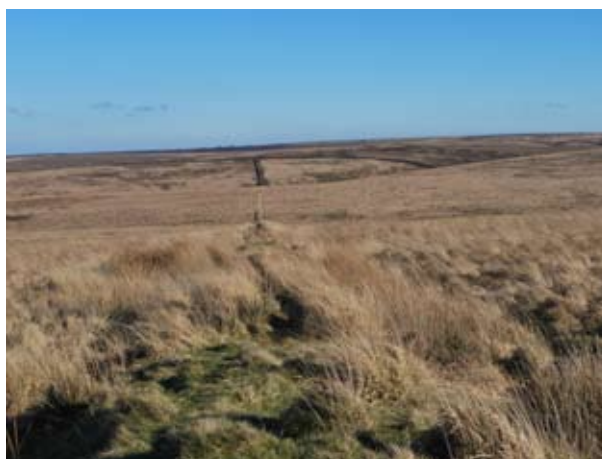
Fig 22 Enclosure boundary on Kittuck, built in 1850 (Hazel Riley)

6.3.4 The blocking of the enclosure boundary ditch on Kittuck will have an adverse impact on the visibility and condition of this monument which is an artefact of 19th-century reclamation documented from c 1850 (Fig 22).
