THE ARCHAEOLOGY OF THE 19th-CENTURY DESIGNED LANDSCAPE AT ASHLEY COMBE AND CULBONE CHURCH, EXMOOR NATIONAL PARK Project Report

Project Report

Date of report: December 2017 Copyright: © The author

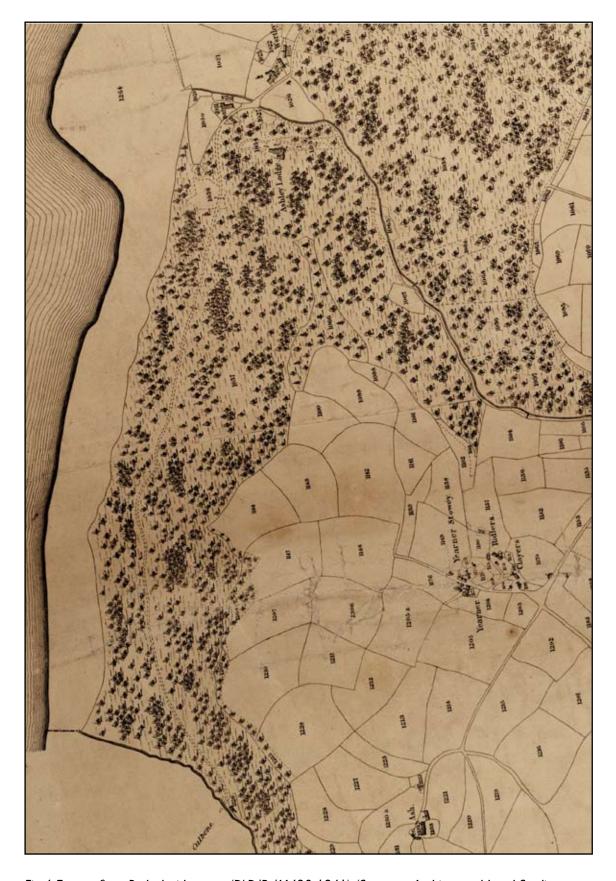
Fig 4 Extract from Porlock tithe map (D\D/Rt/M430 1841) (Somerset Archives and Local Studies Service, South West Heritage Trust)

- 3.1.5 William and Ada spent their honeymoon at Ashley Combe and from 1835 to 1840 the house was extended and improved, gardens created and landscaping of the steep woodlands between Ashley Combe and Culbone Church carried out (Debois Landscape Survey Group 2015). The tithe map for Porlock (1841) shows the footprint of the house, now called 'Ashley Lodge,' a number of paths and rides to the north and south of the house, a road from Worthy to Culbone, and an irregular enclosure to the west of Ashley Lodge (Fig 4).

6.1.3 The enclosure was built before 1841 as it is shown clearly on the tithe map (Figs 4,19). The tithe map also differentiates between the composition of the woodland inside the enclosure with a mix of conifers and broad-leaved trees inside the enclosure but only broadleaved trees in the woods outside the enclosure (Fig 19). Only the south and east sides of the enclosure are shown on the 1st edition map and a drive clearly cuts through the south side of the enclosure, showing that the enclosure was not in use by the end of the 19th century. Although the OS map of 1804 is at a small scale, the enclosure is not shown suggesting that it is not an agricultural enclosure (Fig 3). The cartographic and field evidence, together with its location at a high point, combine to show that this enclosure is very likely to be the place 'above the house' where planting took place in 1835, and represents a pinetum and arboretum as suggested by John Phibbs (Debois Landscape Survey Group 2015, 7). The estate records mention planting 'many cypress in the wood above the house & some sycamore' in January 1835, and 'many pinaster Sc pine, larch and larcio &c in the wood above the house' in December 1835 (SRO 1740-1841).

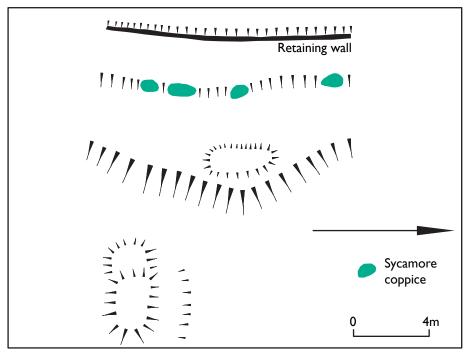
Fig 17 (left) Plan of platform and mounds CW035)

6.1.2 An outcrop of rock runs along the centre of the enclosure; a quarry pit at its west end was probably the source of stone for the enclosure wall. A mound of stones may represent unused building stone, but the possibility remains that this area, within the enclosure, was utilised as part of the designed landscape (below, 8.1). The mounds identified during the 2002 survey lie at the west end of the enclosure, centred at 285317, 148039. A low mound, 4m long, 2m wide and 0.3m high lies on a platform, 14m long, 3.5m wide and 1m high. A second mound, 4.7m long, 2.8m wide and 0.8m high lies to the SE of the platform (Figs 17, 18). The function of the mounds and platform is unclear and the area is somewhat obscured by scrubby vegetation at the time of the

survey. It could represent the remains of a viewpoint or structure associated with the designed landscape of Ashley Combe; OS maps dating from 1962-3 show a sub-rectangular close to this site (OS 1:10 560 map, 1962-3).

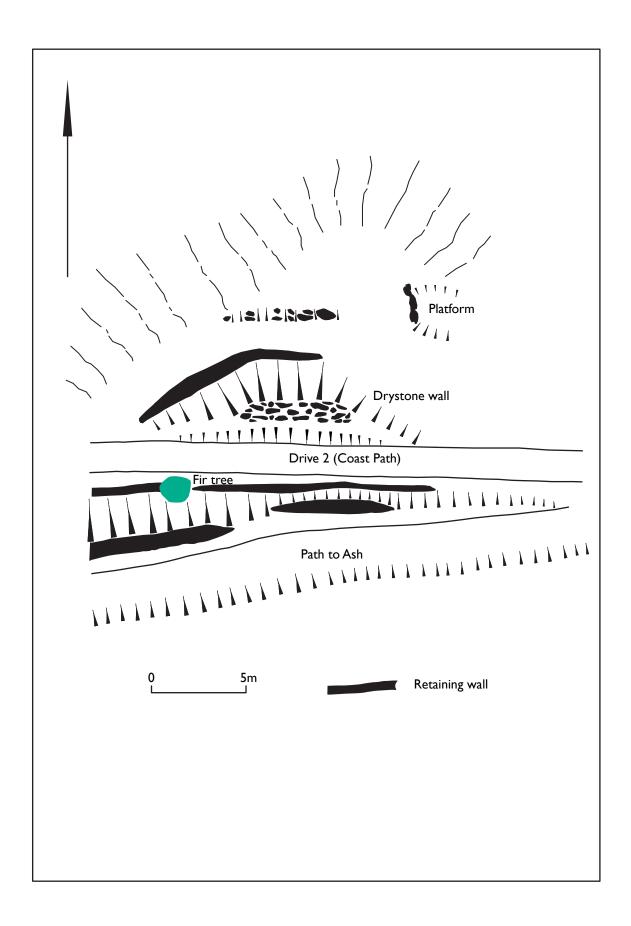
Fig 21 Viewpoint 1 1:200 earthwork survey

A semi-circular flat-topped mound, 16m E/W, 4m N/S and 1m high, with a drystone retaining wall on its north side and a drystone wall on its south side, enhances a naturally occurring promontory (Figs 21,22,23). A small, sub-rectangular platform with a drystone wall at its west side on the NE side of the promontory may have been for a seat (Fig 24).

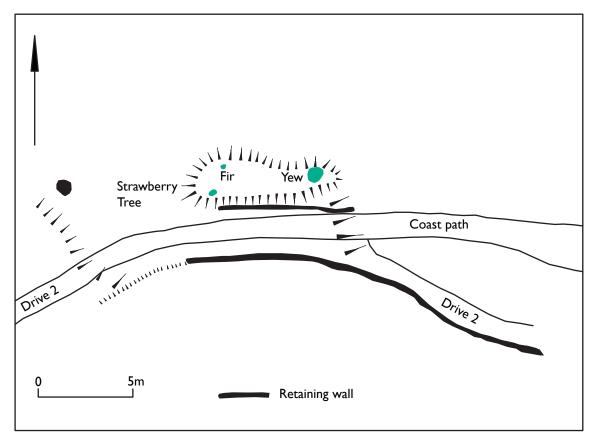
Figure 26 Viewpoint 2 1:200 earthwork survey

6.2.2 Viewpoint 2 lies at 284481,148346, where the drive turns sharply to the SW to make the descent into Culbone (Fig 6). A flat-topped mound, 8.2m long, 3.3m wide and up to 1.3m high, has a yew tree and a strawberry tree growing on it (Figs 25, 26).

A retaining drystone wall lies on the south side of the platform. The other side of the drive has a retaining wall and the drive has the effect of being sunken below the viewpoint (below, 6.3.2) (Fig 31).

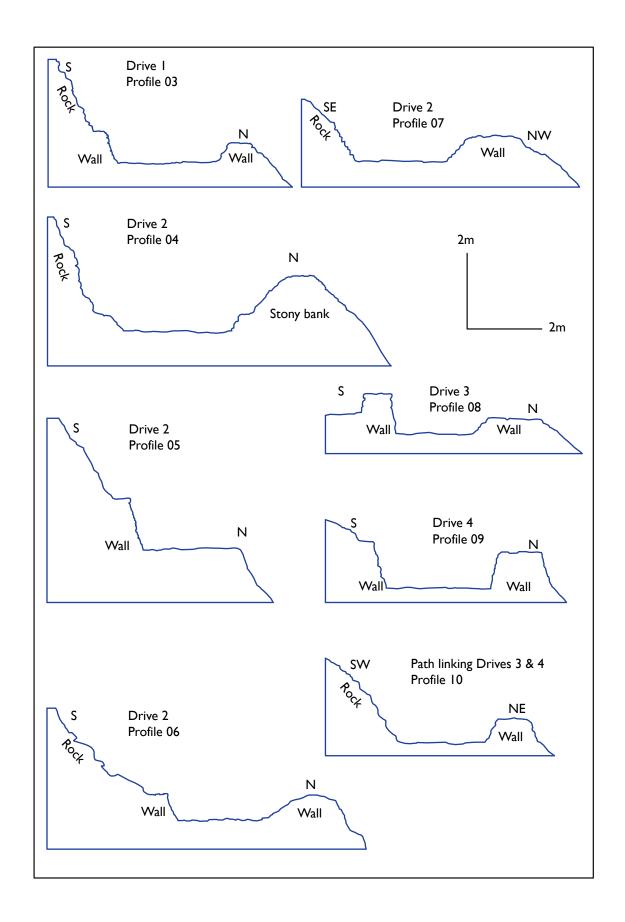
Fig 31 Profiles across Drives 1-4, see Fig 6 (PR03-10) for locations

- 6.3 The carefully designed and well built drives and paths form the most extensive remains of the designed landscape associated with Ashley Combe.
- 6.3. I A drive from Yearnor (Drive I) runs through the farm and fields, then descends through the woods before turning into a tunnel to reach Ashley Combe (Fig 6). This survives in very good condition for much of its course. From Yearnor to the edge of the woods it is visible as a level, grass covered track with a retaining wall on the edge of a pasture field (Fig 27). In the woods the drive is characterised by the presence of drystone walls on both sides. A good example of this can be seen at 285630, 148054, where a path up to the enclosure CW001 crosses this drive. Here, the retaining wall on the upslope side is built at the base of a rock outcrop, it is bulit of small, horizontally laid stone blocks and is Im high and 0.3m wide; the wall on the downslope side is 0.5m high, Im wide and the level drive is 2.5m wide (Figs 28-30). To the north of this, as the drive descends towards Ashley Combe and as it approaches the junction of several paths and drives at 285597, 148166, the path is hidden to the east by a stony bank, 2.5m wide, 1.5m high and 34m long, with retaining walls on both sides (Figs 31, 32).

- 6.3.2 A drive from the entrance to Yearnor Wood east of Yearnor (Drive 2) runs along the boundary of the woods with the enclosed farmland to the west. It descends to run along the side of Culbone Combe and reaches Culbone Lodge west of the church where a path to Ash Farm continues under a tunnel (Figs 6, 33). This drive is characterised by the presence of retaining walls along much of its course. A good

example is at the junction of this drive with a path at 285219, 148102 (Fig 34). Here, the drystone wall, built of pitched, small stone blocks, is 1.4m high and the level drive is 2.5m wide. Before the path leaves the edge of the farmland and turns to descend through the woods, it is flanked by drystone retaining walls with bare rock outcrops on the upslope side. The presence of several yew trees on the edge of the drive here serve to emphasise this point on the drive. The upslope retaining wall is 0.8m high, the level drive is 2.5m wide and the downslope drystone wall is 2m wide and 0.7m high (Figs 35, Between Viewpoint 2 and Culbone, Drive 2 is characterised by the presence of a bare rock outcrop on the upslope side, I 00m long and over 3m high and the level drive

is 2.4m wide. The junction of Drive 2 with a path up to Ash Farm is marked by a retaining wall 7m long and 0.6m high (Figs 36,37,31).

6.3.4 Drive 4 is the lowest of the drives through the woods. It runs from the north side of Ashley Combe, over Tunnel I, then along the top of the cliffs for some 1.2km before turning to run along the side of Culbone Combe, where it crosses the stream via a bridge to run past Culbone Cottage, along the north side of the churchyard to join Drives 2 and 3 at Culbone Lodge (Fig 6). Like Drive 3, Drive 4 is also largely inaccessible due to vegetation and landslips but between 285101, 148395 and 285256, 148370 ϵ 57m be reached (Fig 40). Here, the drive is characterised by a drystone retaining wall on the upslope side and a substantial drystone wall on the cliff side. The retaining wall, built of pitched, small stone blocks, is 1.2m high, the level path is 2.7m wide and the cliff side wall is 0.9m high and 1.2m wide (Figs 41, 31).
