ARCHAEOLOGICAL RECORDING AND EVALUATION  
AT A LIMEKILN, WORTHY, PORLOCK, SOMERSET,  
EXMOOR NATIONAL PARK

PROJECT REPORT

Date of report: October 2018  
Copyright: © The author

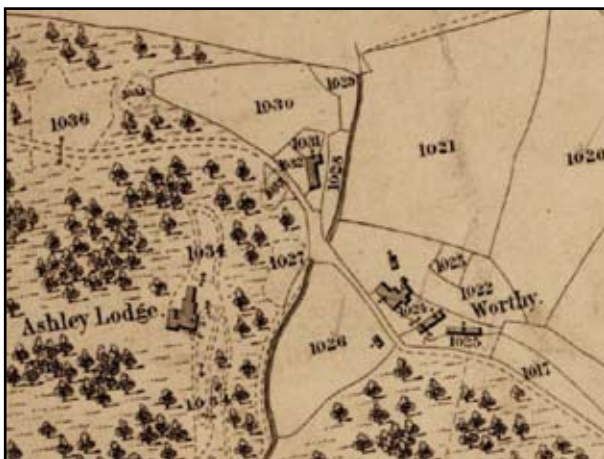
Fig 2 (left) Survey location and topography

2.2 The limekiln at Worthy is located on the coast by a stream at the end of a valley which runs north from Worthy Combe and the hamlet of Worthy to the pebble beach at the Gore, west of Porlock Weir, Porlock. It lies within Exmoor National Park and is centred at SS 8583 4832 (Figs 1 and 2).

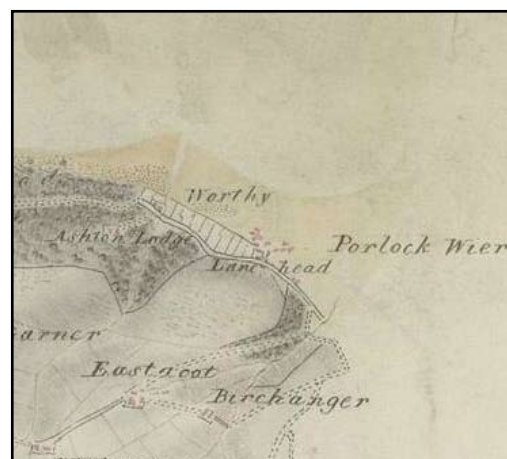
Fig 3 (above) Extract from OS map North Molton 1804 (bl. ac.uk)

3.1.2 The limekiln is not depicted on the 1804 Ordnance Survey (OS) map or the Porlock tithe map of 1841 (Figs 3 and 4). The plot where the limekiln now stands is named as a garden on the tithe map; it was owned and occupied by the Earl of Lovelace (William King). The limekiln and associated structures are first shown on the OS 1<sup>st</sup> edition map (surveyed 1888, published 1889), the OS 2<sup>nd</sup> edition map (revised 1902, published 1903) depicts the kiln and labels it 'Old Limekiln', suggesting that the Worthy limekiln was built after 1841 and fell into disuse before 1902 (Figs 5 and 6).

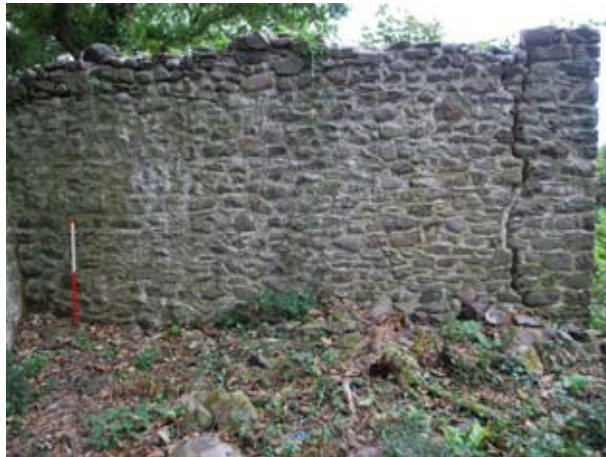
*Fig 9 (right) The SE wall of the limekiln (1m scale) (Hazel Riley)*

6.2 The limekiln is built primarily of large beach cobbles and lime mortar with ashlar blocks of local sandstone forming the corners. The walls are 0.5m thick, with evidence of repair and re-pointing in places. The NW and NE walls are 7.1m long and 3.5m high, the SE wall is 6.2m long and 2.5m high, the SW side of the kiln is built into the base of a steep bank. Several build lines are visible in the SE and NE walls, with the top line corresponding to the base of a low parapet wall around the top of the limekiln. Two large cracks, probably caused by tree root damage, are visible in the SE and NE walls of the limekiln (Figs 9 and 10).

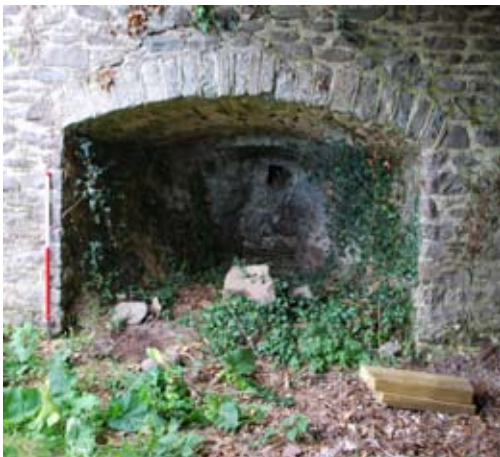
Fig 11 (left) Draw hole access tunnel in NW wall (Hazel Riley)

6.2.1 The NW wall contains the draw hole access tunnel (Fig 11). The entrance to the tunnel is formed by an arch, 2.45m wide and 1.8m high, supported by stone voussoirs (Fig 12). The tunnel, which is 3.1m long, gives access to the draw hole where the finished product – quicklime – was dug out from a grate at the base of the combustion chamber. The draw hole is supported by a relieving arch of fire bricks, 1.4m high and 1.2m wide. Above the draw hole is a poking hole which allowed the lime burner to insert an iron rod into the charge, either to loosen it up or check if calcination was complete (Holley 1997, 28) (Fig 13).

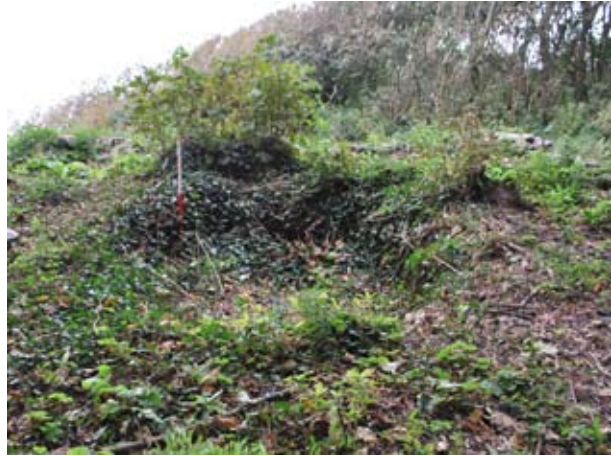
Fig 14 (above) Top of the combustion chamber (1m scale) (Hazel Riley)

6.2.2 On the top of the kiln are the remains of the top of the stone-lined combustion chamber, 2.5m in diameter and infilled to a depth of 0.8m (Fig 14). Fragments of coal are visible scattered across the top of the limekiln. It is surrounded by a parapet wall, 0.5m wide and up to 0.6m high, which served to stop the lime burner falling from the kiln while working (Figs 14 and 15).

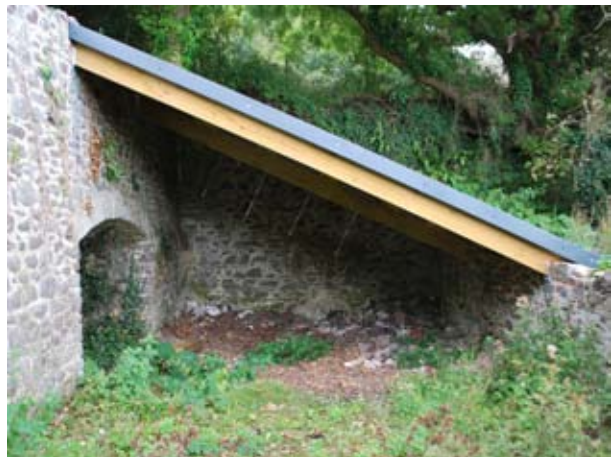
Fig 16 (right) The lime store on the NW wall of the limekiln (Hazel Riley)

6.3 On the NW side of the limekiln is an open fronted, rectangular structure, 5m N/S and 7.5m E/W, formed by the NW wall of the limekiln, and stone retaining walls to the SW and NW. It has a recently installed steel sheet roof (Fig 16). The walls are of stone rubble with lime mortar and are 0.5m thick; the SW wall butts up against the top of the NW wall of the lime kiln and slopes down to the NW wall which is 1.2m high.

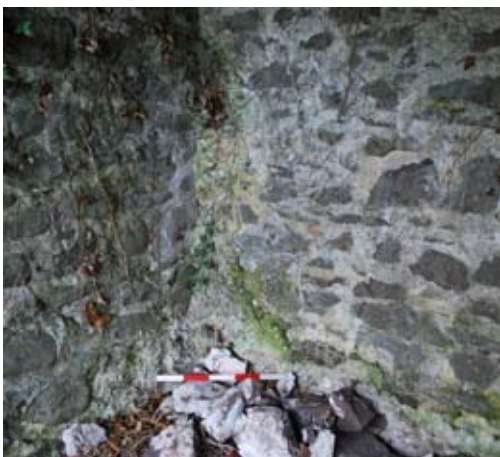
Fig 17 (below right) Blocked opening in the NW wall of the lime store (1m scale) (Hazel Riley)

6.3.1 Midway along the NW is a blocked opening, 1.3m wide. It appears to be an original feature, with ashlar blocks at each end (Fig 17). Its function is unclear. It is unlikely to have been an entrance or window given that the structure is only 1.2m high here and is open fronted. It may have been a storage alcove or it could have been designed to aid the flow of air into the kiln draw hole.

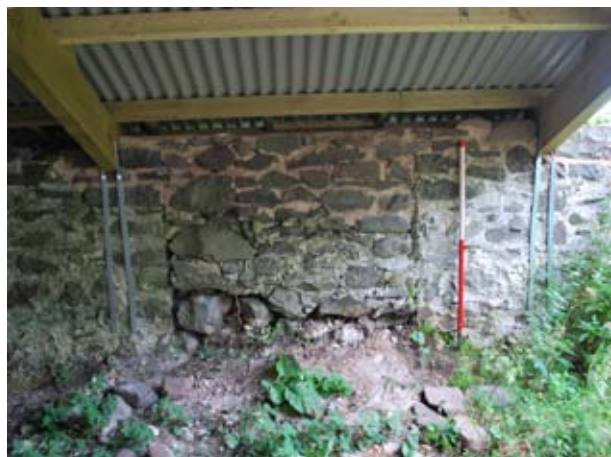
Fig 18 (below) Lime in the southern corner of the lime store (0.5m scale) (Hazel Riley)

6.3.2 The structure is shown as a roofed building on both the 1<sup>st</sup> and 2<sup>nd</sup> edition OS maps (Figs 5 and 6). The newly installed roof obscures any features relating to the original roof. The remains of lime can be seen in several places against the walls, suggesting that quicklime was stored here after removal from the kiln before collection (Fig 18). Shelter from the weather was important to

avoid the quicklime slaking and so adding to its volume during transport. The structure would have also provided shelter for the lime burners.

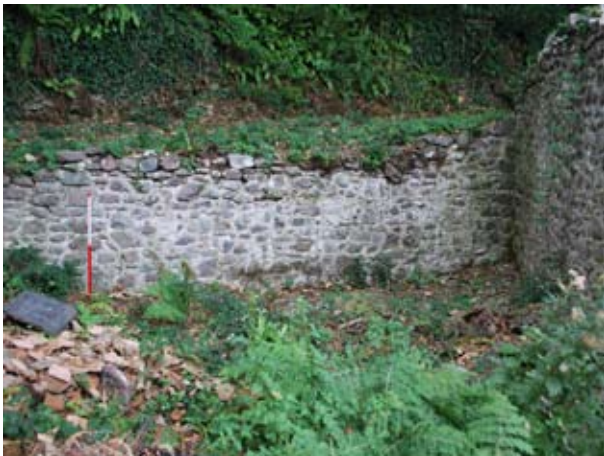
Fig 19 (left) Storage area to the SE of the limekiln (1 m scale) (Hazel Riley)

6.4 On the SE side of the limekiln a triangular area, 6.5m NW/SE and 5.5m SW/NE, is formed by the SE kiln wall, the stone retaining wall of the kiln access ramp to the SW, and a stony scarp to the SE. This may have been a storage area for limestone and coal. Piles of building rubble have been dumped in the area (Fig 19).

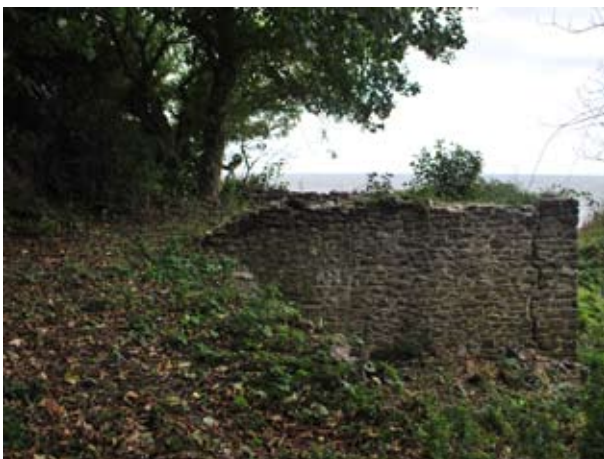
Fig 20 (below) Access ramp to the combustion chamber from the seaward side (1 m scale) (Hazel Riley)

6.5 Access to the combustion chamber on top of the limekiln was by two ramps. From the seaward side there was access by a steep path, 3m wide and 8m long, along the NW and SW sides of the lime store. A short stub of wall on the seaward side of the NW wall of the lime store, just visible by the encroaching shingle ridge, may be the remains of a retaining wall for this access ramp or a buttress for the lime store wall. Access from the south side of the limekiln was by a gently sloping track, 12m long and 3.7m wide, with a retaining wall 7m long, up to 1.6m high and 0.4m wide, which led from the Worthy track to the combustion chamber (Figs 20 and 21).

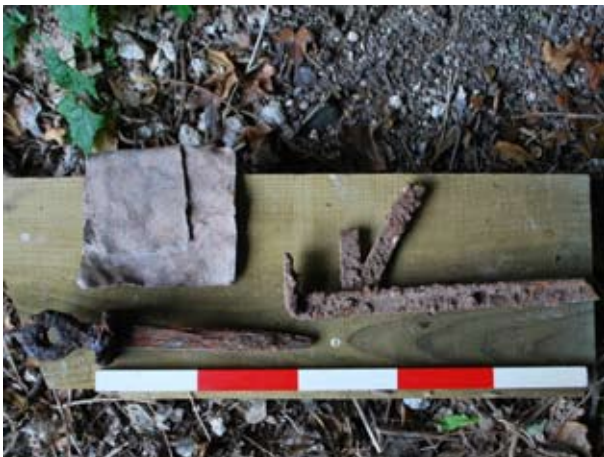
6.8 Several objects which may have been found during the installation of the new roof had been placed inside the draw hole access tunnel. These included an iron bar which could be part of the draw hole grate (Fig 26). The slate found in the evaluation trench probably came from the original roof of the lime store (Fig 27).

Fig 26 (below left) finds from the vicinity of the limekiln with part of iron bar from draw hole grate on right (0.5m scale) (Hazel Riley)

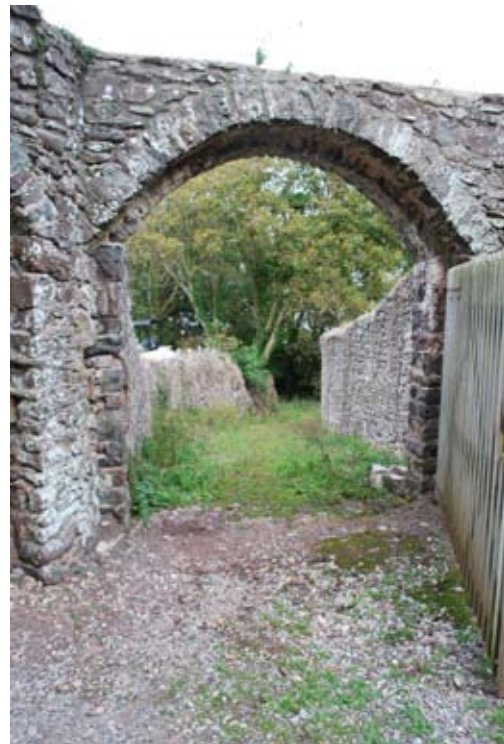
*Fig 28 The archway at the southern end of the track to the limekiln (Hazel Riley)*

7.8 The limekiln, while firmly rooted in the economy of the Ashley Combe Estate, was incorporated into the 19<sup>th</sup>-century designed landscape. The round headed archway and stone walls at the end of the track to the limekiln and the beach echo the tunnels and arches found in the vicinity of Ashley Combe House (Fig 28). The track past the limekiln was an easy route to the beach and Rockford Cottage, an isolated building which may have been a bathing house or boat house for the estate.
