**ARCHAEOLOGICAL SURVEY: SOUTH REGIS  
COMMON, CHALLACOMBE  
Exmoor Mires Partnership CSR18  
PROJECT REPORT**

Date of report: January 2019  
Copyright: © The author

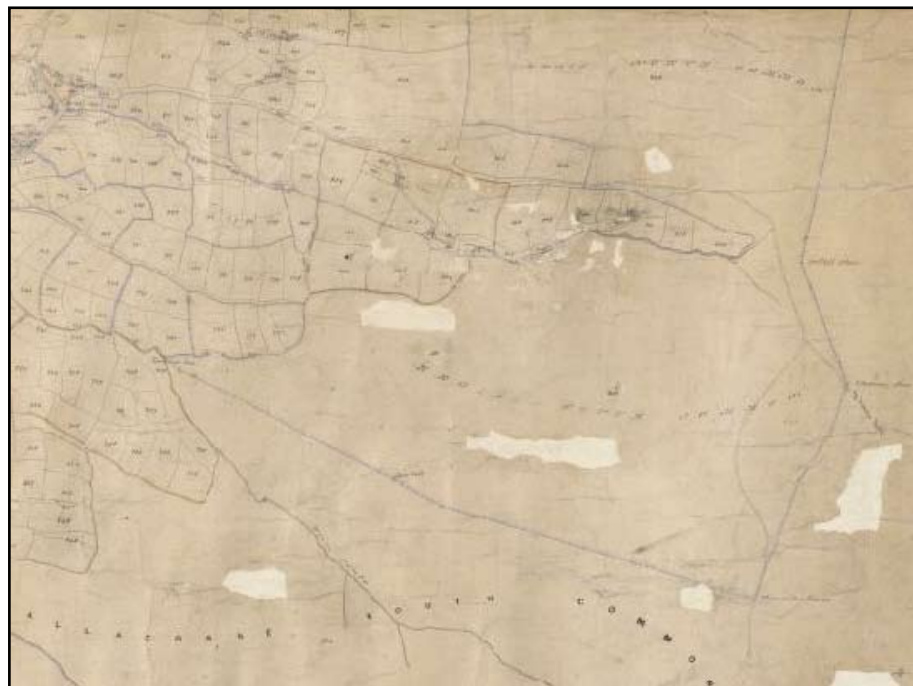
Fig 4  
Extract from  
Challacombe  
tithe map  
1840 showing  
Regis Common  
South and  
North (Devon  
Heritage Centre  
DEX/4/a/TM  
Challacombe)  
(Reproduced  
with the kind  
permission of  
the South West  
Heritage Trust)

2.3 At the end of the 18<sup>th</sup> century, South Regis Common was unenclosed moorland (OS Map 1804 Barnstaple bl.ac.uk) (Fig 3). The tithe map for Challacombe shows that South Regis Common was common land, part of Regis Common South (Challacombe

tithe map 1840 and award 1839) (Fig 4). The common was enclosed in 1862 (below, 5.4.6); the 1<sup>st</sup> edition map shows the extent of the enclosures (OS 1<sup>st</sup> edition 6" map Devon IO.NE; 11.NW surveyed 1887, published 1888) (Fig 5).

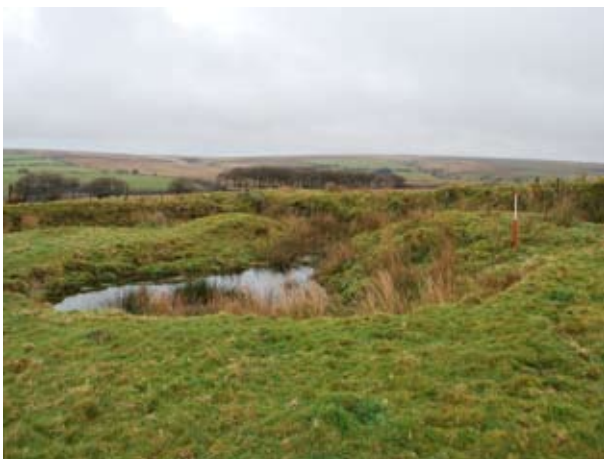
Fig 8 CSRI8018 Disused stone quarry (1m scale) (Hazel Riley)

DESCRIPTION AND INTERPRETATION A small, disused quarry lies to the SE side of South Regis Common, close to the junction of two field boundaries (Fig 8). The quarry pit is 12m NE/SW, 9.2m NW/SE and up to 1.5m deep. Two stony mounds to the NW of the pit are probably mounds of spoil from the quarry. To the east of the field boundary is a similar, larger quarry which is shown on the 1<sup>st</sup> edition OS map (1888) as 'Old Quarry.' The quarries are most likely to be stone quarries associated with the mid-19<sup>th</sup>-century enclosure of the commons.

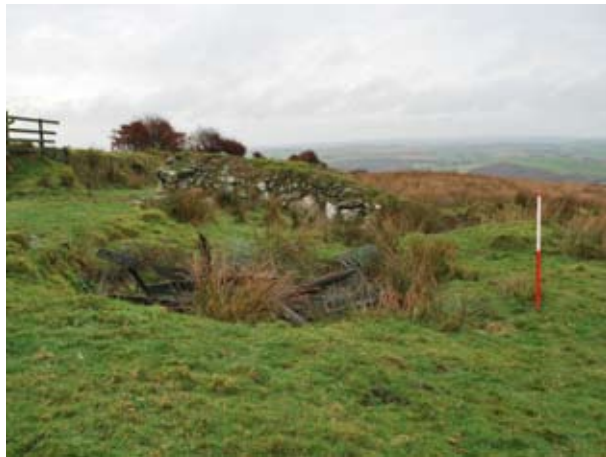
Fig 9 (above) CSR18019 Disused stone quarry (1m scale) (Hazel Riley)

INTERPRETATION A small quarry lies on the south side of South Regis Common, close to the junction of two field boundaries (Fig 9). The quarry pit is 5.2m N/S, 5m E/W and up to 1.1m deep and is now filled with old fencing wire and stakes. The quarry is shown on the 1<sup>st</sup> edition OS map (1888) as 'Old Quarry.' It is most likely to be a stone quarry associated with the mid-19<sup>th</sup>-century enclosure of the commons.

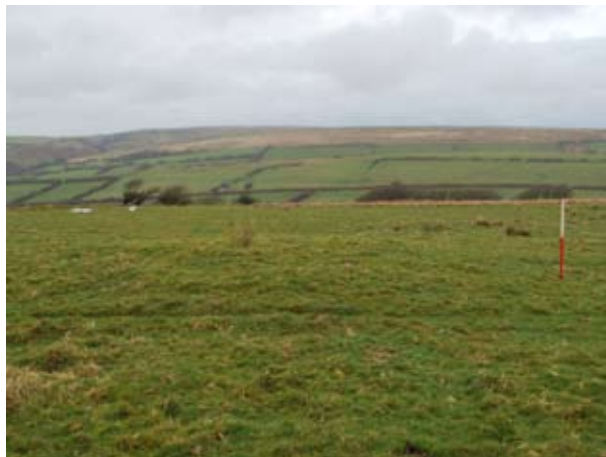
Fig 10 (below) CSR18020 Round barrow (1m scale) (Hazel Riley)

INTERPRETATION A large barrow lies on the south side of South Regis Common (Fig 10). The barrow comprises a turf-covered, stony mound which appears to have been ploughed over. The mound is 11.3m in diameter and up to 0.9m high; a sheep path clips the south edge of the mound.

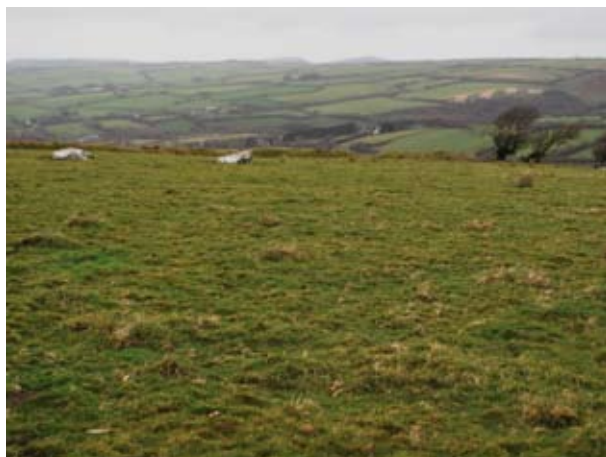
Fig 11 (below) CSR18021 Site of alleged ring marks identified on aerial photographs (Hazel Riley)

INTERPRETATION Two ring marks were identified on aerial photographs dating from 1947; nothing is visible on the ground in the vicinity of the given grid reference (Fig 11).

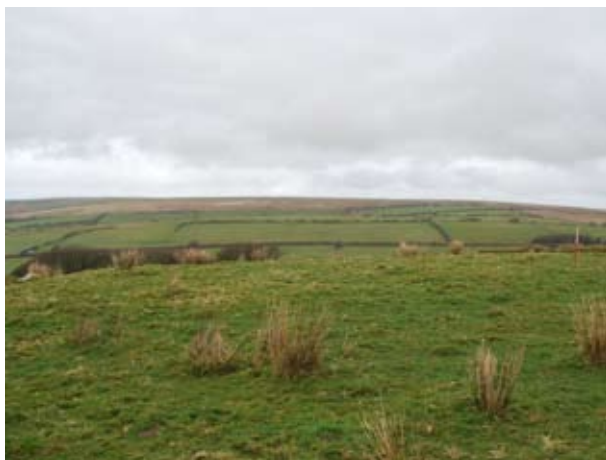
Fig 12 (left) CSR 18022 Large round barrow (1m scale) (Hazel Riley)

DESCRIPTION AND INTERPRETATION A large round barrow lies on the southern side of South Regis Common; it has been cut by an E/W field boundary on its northern side (Fig 12). The barrow comprises a substantial, grass-covered stony mound, 22m E/W, 17m N/S and up to 0.8m high. The mound is flat-topped with a central hollow, 5.5m E/W, 5.3m N/S and 0.3m deep, indicative of an unrecorded excavation. A large quartz block is incorporated into the western side of the barrow. It is 1m long, 0.6m high and 0.4m thick and may mark part of the barrow's original stone kerb.

6.1 The large prehistoric barrow CSR18022 lies on the edge of the boundary CSR18034 which is included in the restoration proposals (Fig 7). The barrow is an important part of Exmoor’s prehistoric funerary landscape and is vulnerable to damage from the restoration of the boundary. It will have an adverse impact on the survival of the monument in terms of its morphology and structure. It will also have an adverse impact on the visibility of, access to, and landscape setting of this site. The boundary should be excluded from the restoration proposals and an exclusion area should be put in place to safeguard the monument.

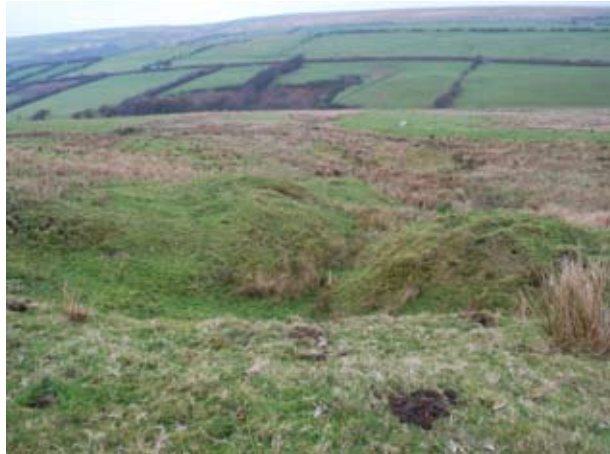
*Fig 14 CSR18 Large disused stone quarry (1m scale) (Hazel Riley)*

INTERPRETATION A large disused quarry lies on the east side of South Regis Common, close to the junction of two field boundaries. The quarry has overall measurements of 21m N/S, 19m E/W and is up to 3m deep, with spoil mounds flanking the entrance at the northern end (Fig 14). The quarry is shown on the 1<sup>st</sup> edition OS map (1888) as 'Old Quarry.' The quarry is most likely to be a stone quarry associated with the mid- 19<sup>th</sup>-century enclosure of the commons.

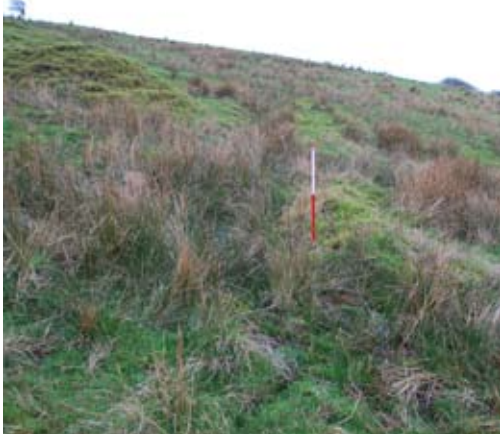
*Fig 15 (below left)  
CSR18025 Drainage ditch  
Fig 16 (below) CSR18026  
Hollow way (1m scales)  
(Hazel Riley)*

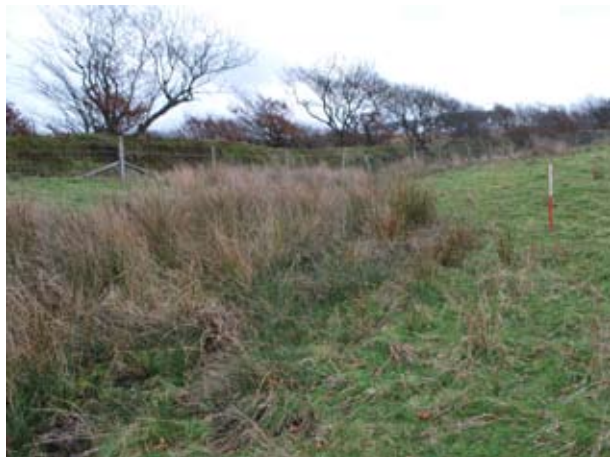
rush-filled hollows, some 3-4m wide and 0.75m deep. The hollow ways are clearly overlain by one of the enclosure boundaries (Fig 16). They run NW/SE from Old Close Bottom across South Regis Common up onto the summer grazing on the Royal Forest and are similar to examples to the west (Riley 2017, CSR17005; 008).

6.2 The hollow ways on the NE of the survey area (CSR18026) are part of Exmoor’s earlier medieval landscape (Riley 2016) and measures should be put in place to safeguard them from damage resulting from the proposed restoration works along the relict field boundary CSR18027 which lies on the west edge of the hollow ways.

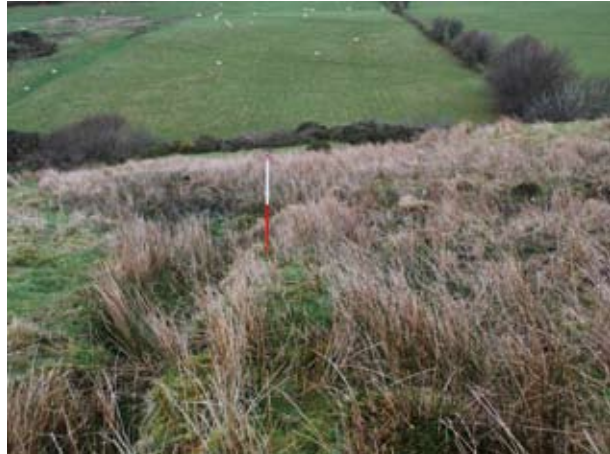
*Fig 19 CSR18029  
Drainage ditches (1m  
scale) (Hazel Riley)*

INTERPRETATION Two drainage ditches on the north side of South Regis Common, 0.9m wide, 0.5m deep with banks, 0.8 m wide, 0.4m high on their east sides, channel water towards Old Close Bottom (Figure 19). They were probably constructed in the later part of the 19<sup>th</sup> century following the enclosure of the commons.

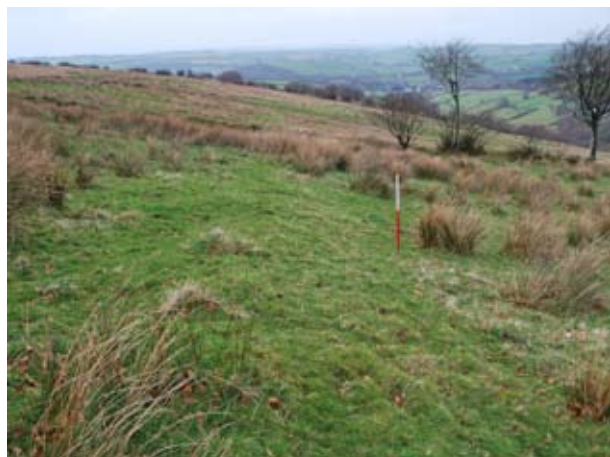
*Fig 21 (below) CSR18031  
Northern side of enclosure  
(1m scale) (Hazel Riley)*

formed by the field boundaries to the west and south and by flat-topped, stony earthwork banks, 1m wide, 0.75m high, to the east and north (Fig 21). The entrance was probably at the NE corner. The enclosure was probably constructed in the later part of the 19<sup>th</sup> century following the enclosure of the commons.

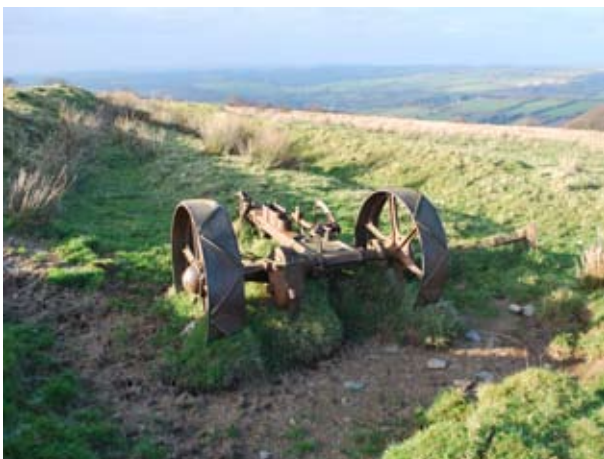
Fig 23 (left) CSR18033 Land drive finger bar mower (Hazel Riley)

These mowers were made in the late 19<sup>th</sup> century and the early part of the 20<sup>th</sup> century. They were originally intended to be drawn by two heavy horses but were often adapted to be pulled by tractors.

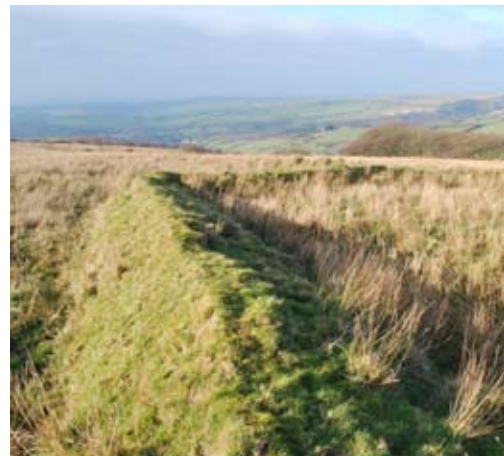
Fig 24 (right) CSR18034 Relict field boundary (1m scale) (Hazel Riley)

5.4.4 The two E/W internal boundaries are similar in form (CSR18034). Both comprise a turf-covered bank, 1.3m wide, 1.3m high, stone-faced in places, with a ditch, 1.5m wide, 0.7m high, to the south. The northern boundary is topped with a beech hedge at its west end. The boundary which separates the two rectangular enclosures is similar to these E/W boundaries. It is formed by a turf-covered, stony bank, 1.5m wide, 1m high, with stone facing evident in places, and a ditch, 1.5m wide, 0.5m deep, to the east. The bank is topped with a beech hedge at its north end and the ditch is deeper with erosion gullies in places. The boundaries contain several gateways with stone facings, which appear to have been cut through the banks after their construction (Fig 28).

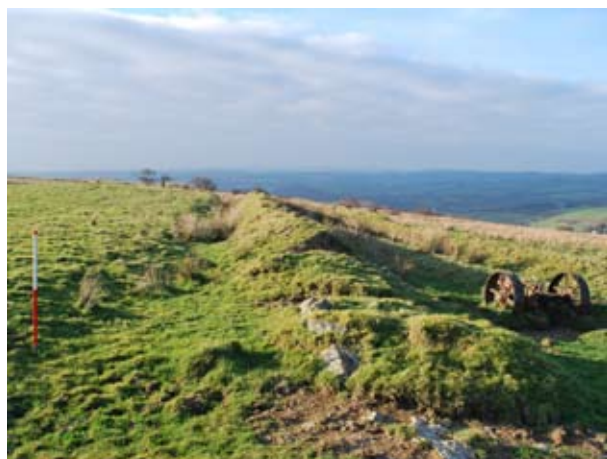
Fig 25 (above right) CSR18035 Relict field boundary (Hazel Riley)

DESCRIPTION AND INTERPRETATION A relict field boundary runs N/S across the north side of South Regis Common, dividing the wetter area occupied by the drainage system CSR18023 from drier ground to the east (Fig 25). The boundary has a pronounced angle at its south end where it turns to join the E/W boundary (CSR18034). The boundary is formed by a flat-topped bank, 1m wide, 1.5m high, with a ditch, 1.1m wide and 0.3m deep on its east side. The field boundary was probably constructed in the later part of the 19<sup>th</sup> century following the enclosure of the commons.

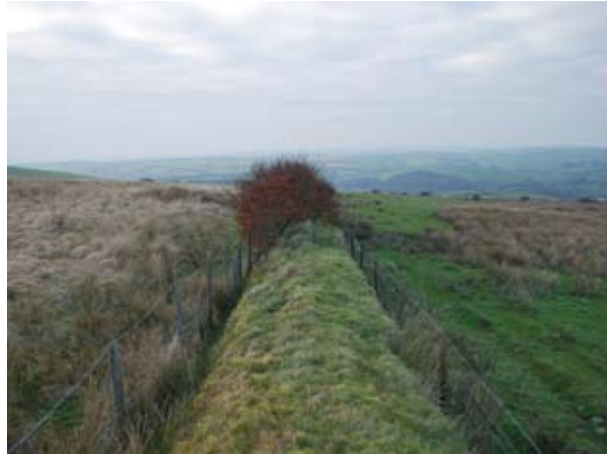
INTERPRETATION Two large rectangular enclosures on South Regis Common are formed by substantial stone-faced banks, 1.4m wide, 1.4m high, with beech hedge banks topping much of their length. The northern boundary, however, is formed by the steep valley of Old Close Bottom.

These boundaries are the original enclosures of South Regis Common, documented in 1862 (below, 5.4.6).

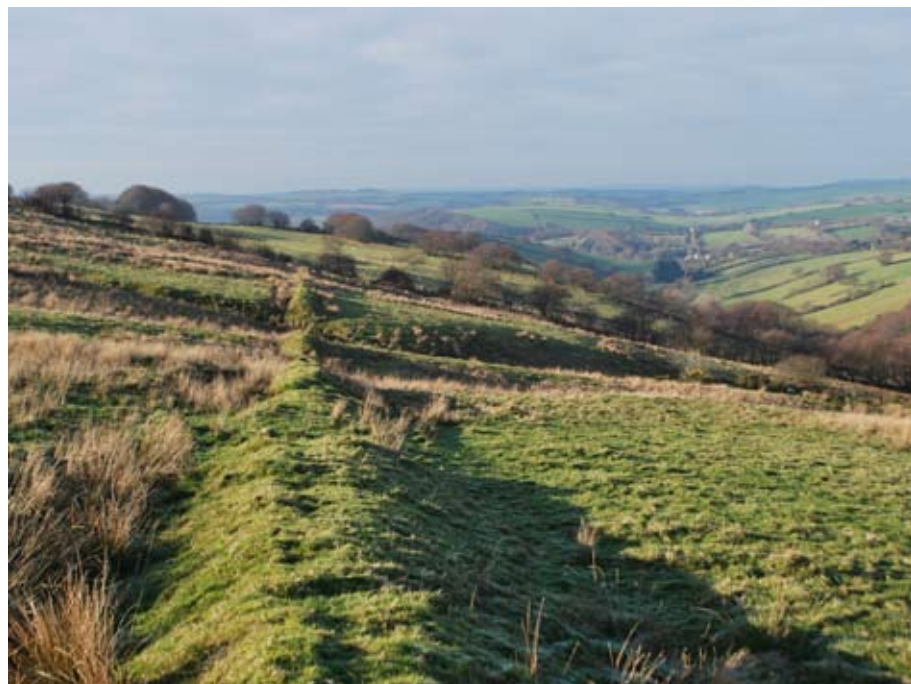
Fig 27  
CSR17006  
E/W internal field  
boundary (Hazel  
Riley)

5.4.2 Both the west and east enclosures contain several internal boundaries. The west enclosure was divided into four rectangular fields by three E/W boundaries; none of these are currently maintained (CSR17006). The two internal boundaries to the north are similar in form. The northernmost boundary is formed by a substantial, turf-covered stony bank, 1.3m wide, 0.9m high, with a ditch 1.3m wide, 0.6m deep to the south. At the western end the boundary is cut by a drainage channel, CSR17007. The boundary to the south of this is formed by a turf-covered, stony bank, 1m wide, 1.6m high, with a ditch, 2m wide, 0.8m deep to the south; it is also cut by the drainage ditch CSR17007 (Fig 27). The southernmost boundary is different in form. It comprises a broad, flat-topped stony bank, 3.4m wide, 0.9m high, with a substantial ditch, 1.7m wide, 1.4m deep and a further intermittent bank, 1m wide, 0.4m high, to the south.
