Archaeological Monitoring during redevelopment of The Bridge Restaurant, Norwich Road, Wroxham, Norfolk

Report No: 96

Archaeological Monitoring during redevelopment of The Bridge Restaurant, Norwich Road, Wroxham, Norfolk.

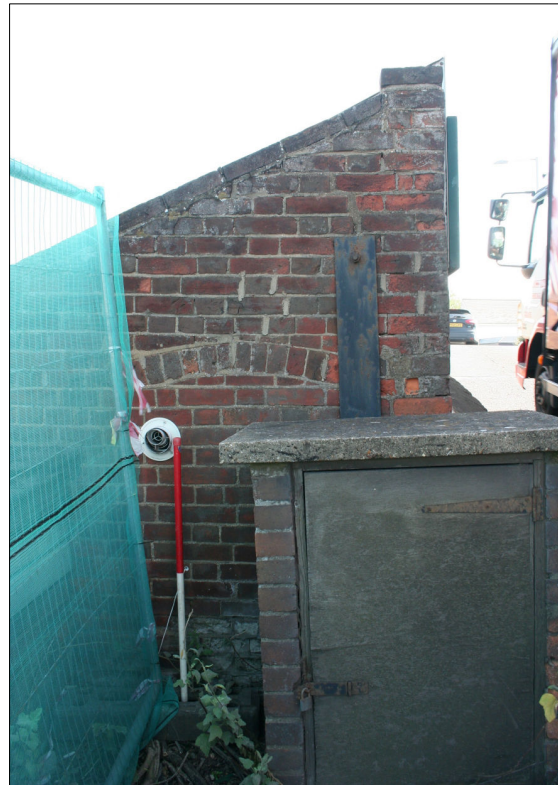
Plate 3: Blocked ‘window’
Looking ENE [1x1m Scale]

A brick blocked arched ‘window’ in the upper part of the building measured over 1.5m in height and could have served as an upper access into this relatively high building (c. 4m with a penticed roof). Alternatively, the aspect of this opening and its position immediately adjacent to the bridge is suggestive of a possible toll or watchman’s house. Meyton Bridge at Little Hautbois, further up the River Bure (c. 6km north-west) was photographed by George Plunkett in 1965, (image ref: [4916]1965-07-31). The current brick bridge (NHER 7685: EH SM listing: 1003694) may have been standing from c.1630 but the western brick parapet terminates at each end with a post-medieval alcove covered by a tiled roof, and formerly containing a seat, described by Plunkett as possibly for the use of toll-collectors or watchmen (<http://www.georgeplunkett.co.uk/Norfolk/bridges.htm>). The dimensions and

relative position of this shelter at Meyton Bridge echoes that of the building and portal opening at Wroxham Bridge.

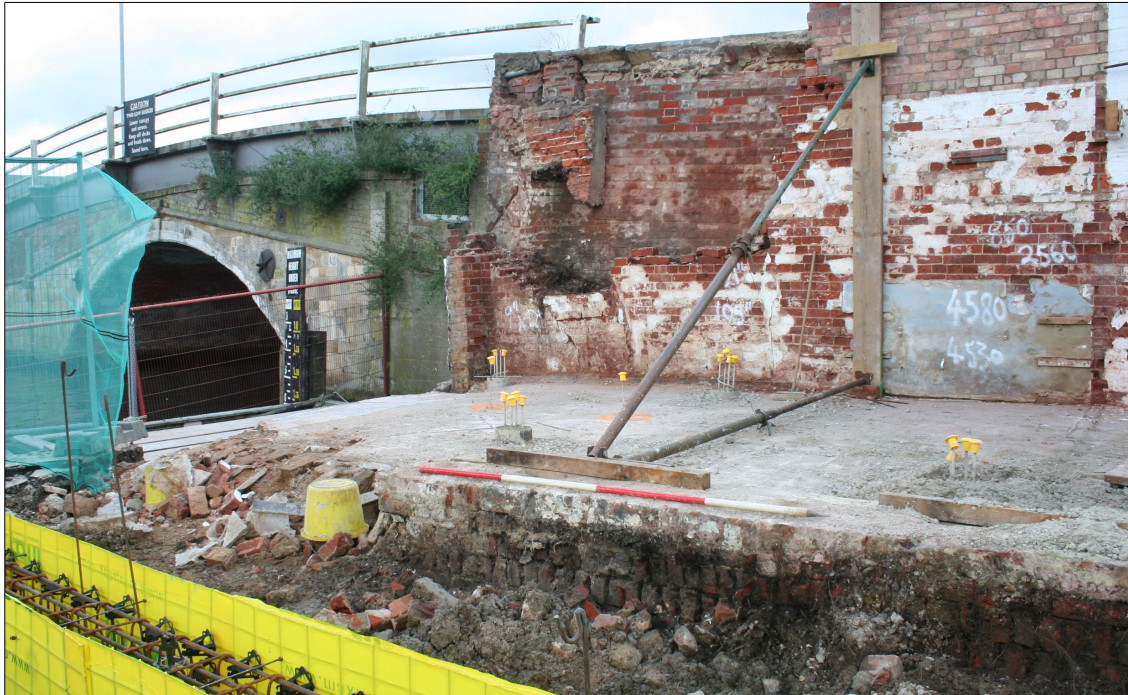
Plate 4: Brick Raft (04) below C19th building (looking SE) [1x2m Scale]

Following demolition of the 19th century brick building (see Plate 1) reduction of the footprint of this structure partly revealed a fine-silt covered brick floor (02) directly below the modern concrete floor. The bricks were unmarked and unfrogged of standard Norfolk-red type and the fine-silt layer above (03) can be interpreted as a flood deposit. Further groundworks here showed that the floor was part of a brick platform or raft which made use of a calcareous off-white mortar (04). The platform was four thick and was much cracked and warped.

The brick platform was built upon an imported layer of mid orangey-yellow clay-rich sand (05) of 0.3m depth, which contained occasional chalk lumps and flints. This make-up sealed a waterlogged make-up deposit of mid-grey silty-clay with occasional 19th century brick fragment inclusions (06).

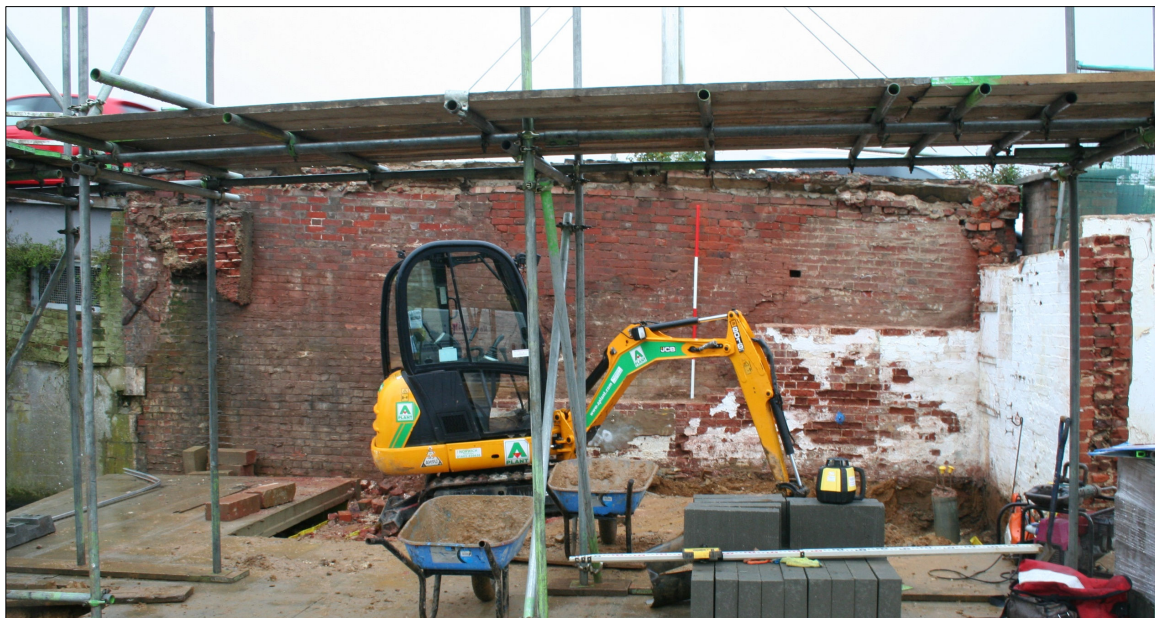
Plate 5: Exposed bridge fabric (looking SE) [1x2m Scale]

Prior to any structural assessment for remedial works by the Highways Agency or their agents, the partly exposed north-western elevation of Wroxham Bridge was examined and rapidly recorded as part of this monitoring brief, in consultation with Historic England and the Historic Environment Service. The 19th century building line was shown to be just 100 to 150mm from the 19th to 20th century bridge fabric (unattached).

The 19th century brickwork was shown to include two well corroded iron ties similar to those elsewhere on the bridge. A large portion of the upper (parapet) area of the brickwork showed signs of outward bowing and cracking (as wide as 80mm), with the area above rebuilt with modern brick with cementitious mortar. This is conjectured to be repair work following a vehicle impact to the bridge.

The 19th century bricks are a particularly hard-fired form of sandy red brick common to the region, laid in English cross-bond with heavily bleeding mortar (this elevation was constructed tight against the pre-existing brick building). Bricks generally measured 230mm by 105mm with a thickness of 650mm.

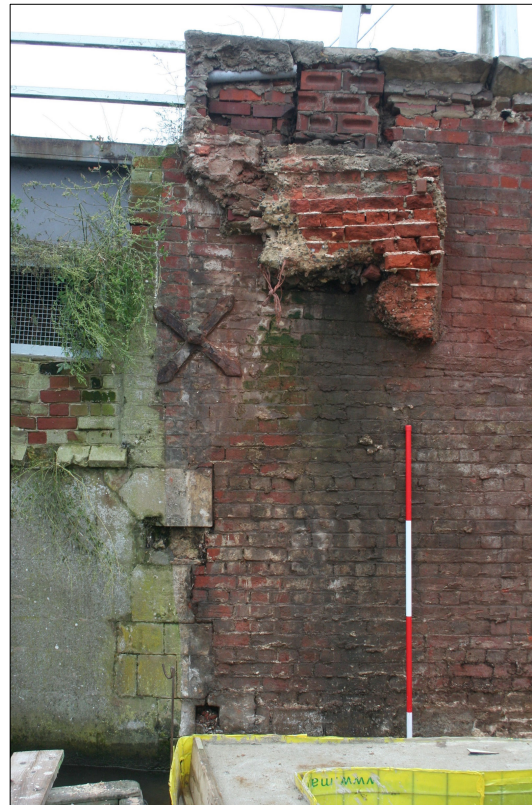
Plate 6: Exposed bridge fabric (looking SE) [1x2m Scale]

Just above the current waterline were three courses of brick and stone which included hard-fired estuarine-clay, 17th to 18th century brick and neat ashlar blocks with traces of a hard lime mortar, which are suggested to include part of the 1600s fabric. A square void for a possible putlog was also noted. Ashlar work above this level had been re-faced in modern times to repair the weathered stone, with a cement render obscuring much of the facework but scored to imitate ashlar.
