# Archaeological Monitoring at Manor Farm Barns, Back Lane, Martham, Norfolk.

Prepared on behalf of Mr.J.Clark

Giles Emery November 2017

Report No: 102

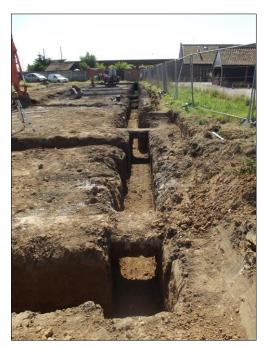
Plate 2. General footing trench shot (looking SSE)

The objective of the archaeological monitoring was to record any archaeological evidence revealed during the groundworks. The groundworks were excavated using both a 2.5-ton and 14-ton 360° machines using a combination of toothed and toothless ditching buckets as ground conditions dictated. A hand breaker was used to assist in the removal of various concrete foundations which crossed the line for the new footings trenches. Spoil was bunded on site using a 3-ton dumper during the course of the works.

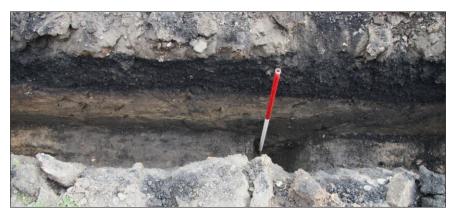
Plate 3. Ditch [15] below clinker make-up. (looking SSE) [1x1m Scale]

Two wide V-shaped profile late post-medieval ditches were recorded, within the confines of the footings trenching. Ditch [15] shared a similar orientation to the southern drainage and field boundary ditch for a possible paddock or small field shown on the 1840's tithe plan, but was located slightly further north than expected and may be an additional drainage ditch. The boundary ditch is shown on the 1st Edition OS plan but is gone, presumed infilled, by the time of the 1906 OS plan. The recorded ditch contained a dark-grey infill of clay-silt (16) with lenses of pale silts and organic stained silts, with occasional coal and charcoal pieces. This was sealed below a sterile yellowish-grey clay-sand (17), possibly the remnants of bank material pushed into the ditch prior to levelling. Large fragments of household ceramics and two glass bottles were collected from the fill, which appear to have been dumped as clearance rubbish. A second ditch ([18]) also contained a lower dark-grey clay-silt fill (19), sealed below a redeposited clay-silt (20) and may be on a juxtaposed orientation to the other.

A variety of late 19<sup>th</sup> to early 20<sup>th</sup>-century find were collected from the lower fill (16) of the infilled drainage ditch [15], for identification prior to discard:
