**Norwich Cathedral Close, the
rediscovery of the Medieval Bell Tower:
Archaeological Monitoring during the
installation of a new electricity supply for
No.71 The Close, Norwich Cathedral.**

Giles Emery BA, MCIfA
May 2020

Report No: 142

Archaeological Monitoring during the installation for a new electricity supply of No.71 The Close, Norwich Cathedral. NR1 4DD.

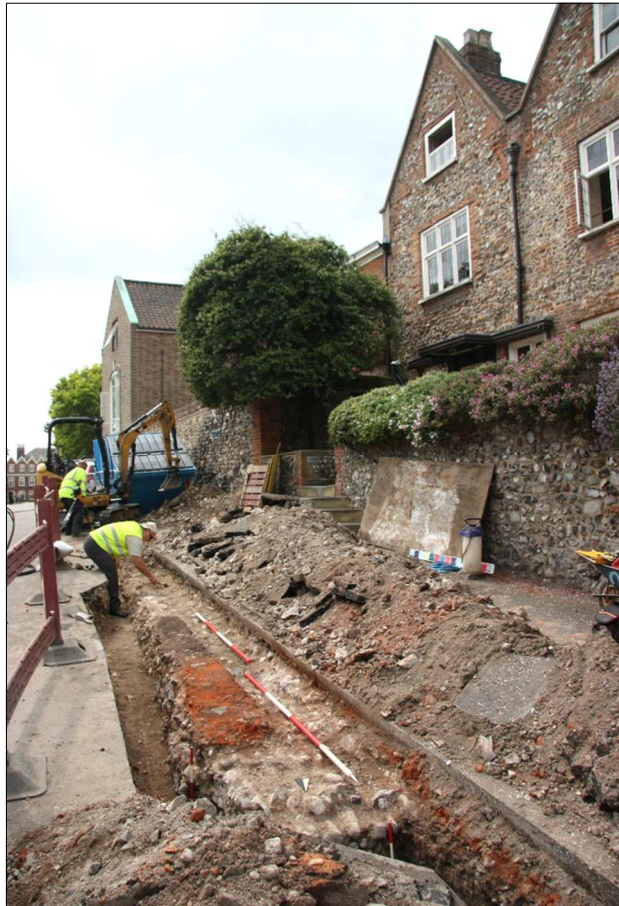
*2x2m Scales

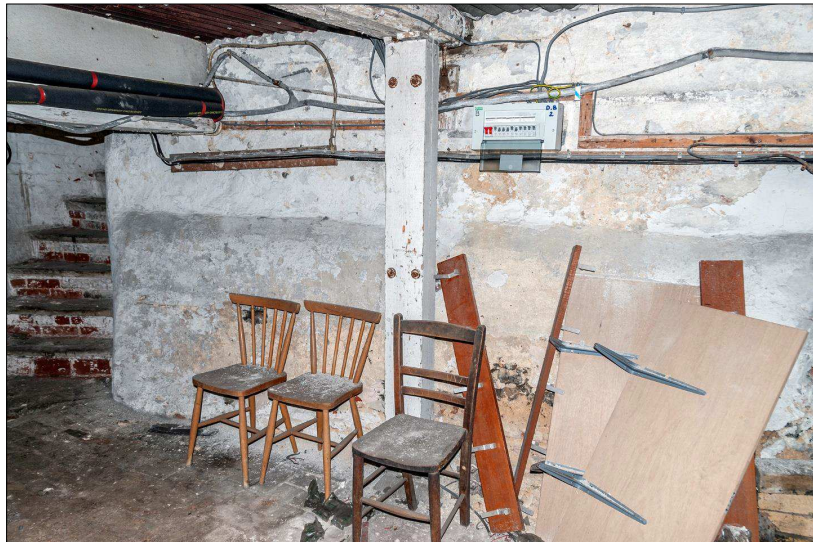
Plate 3. North wall of cellar below No.71, incorporating remains of the north wall of the medieval bell tower.
(Photo by Dr R.B.Harris, 2007)

In the early 17th century, the site of Nos.71-3 The Close was that of the tenement of Sir William Denny. A three-storey prebendary house was then built at No.71 The Close in 1626-8, or soon thereafter which along with its 18th century extensions forms the current Grade II* listed building (English Heritage ref. 228979). This replaced the ruinous tenement of Sir William Denny (who had moved to the house incorporating the Hostry arch), although material was to be salvaged for the new building (Whittingham 1985). It is unclear as to whether the pre-1626 building had been built over the demolished bell tower or had been built against it, although remains or the bell tower footings are incorporated into the extant cellar of No.71 (Plate 3).

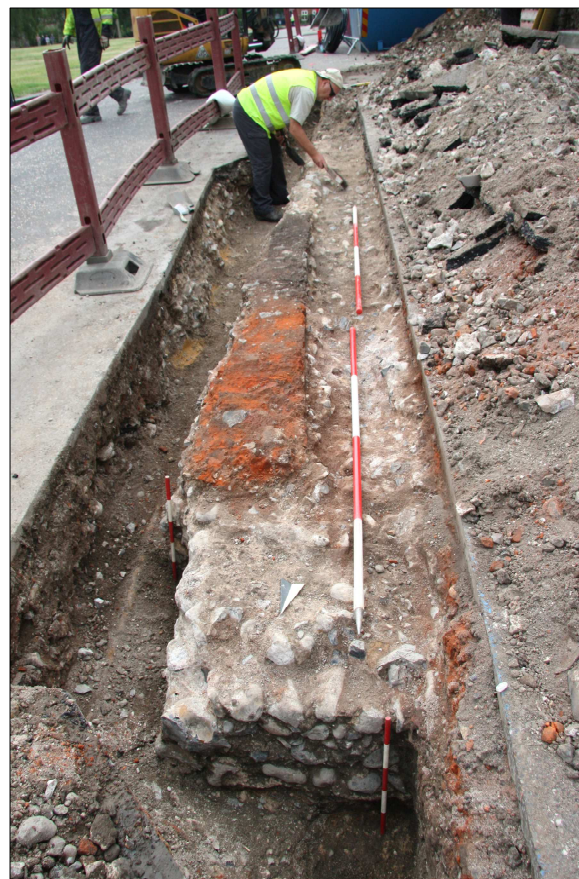
To everyone's surprise, the flint and mortar masonry footings (09) for the medieval bell-tower were uncovered just below the sloping asphalt surface of the modern road, sealed only by a layer of between 100mm to 200mm of modern brick rubble. The masonry consisted of a hard, pale yellow, gritty sandy-mortar with irregular flints. It had suffered significant damage during the excavation the 1956 water pipe trench, which contained a mix of soil and flint & mortar rubble.

Plate 4. Bell Tower Footings. (Looking S)
[10.5m & 2x2m Scales]

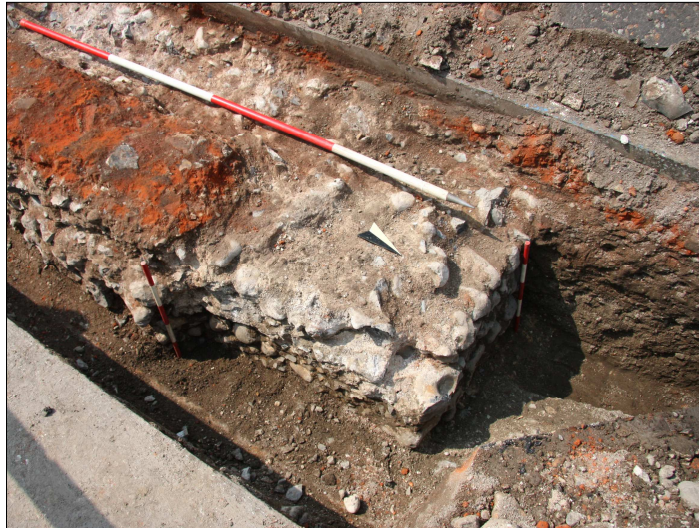
At the northern limit of the medieval footings, were the remains of a flint and mortar buttress. Its position corresponds very well to the 1881 plan by J.H.Brown, which recorded a buttresses stairwell positioned here (Figure 2). The buttress footing (31) was constructed of a hard, greyish-white gritty-sandy mortar with large flints and survived to a depth of 0.6m. The buttress fabric was built within a construction trench ([29]) which contained banded deposits of soft white mortar and a firm brownish-grey silty-sand (30). This trench truncated a probable subsoil horizon (27) of soft but compacted mid to dark greyish-brown fine silty-sand with occasional charcoal flecks, of a depth greater than 0.35m. A small lead plumb bob of medieval date was recovered from this layer.

Plate 5. Bell Tower – Buttress. (Looking SW)
[1 & 2m Scale]

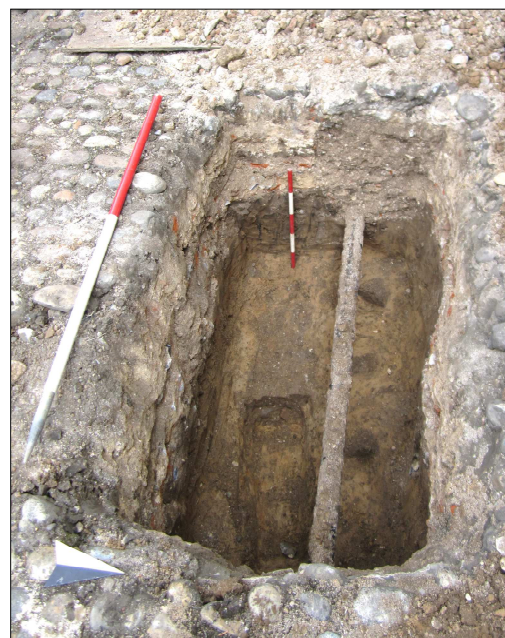
Plate 6. Electricity Main Trench with postholes [17], [19] & [20]. (Looking W)
[1x1m Scale]

The shallow concave V-shaped bases of three small oval posthole features were identified in the base of the machined trench (surviving only to a depth of c. 80mm, sealed below the make-up layers, which may have cut down through the subsoil and into the natural sand ([17], [19] & [21]). They ranged from 0.2 to 0.3m in length and were spaced c. 0.3m apart on a straight WSW to ENE alignment. They each contained a similar mid-yellowish brown silty-sand (18), (20) and (22) respectively). No dating evidence was evident within them, although the relatively clean nature of their fills indicates that they pre-date the post-medieval period and are suspected to be of Saxon to Medieval date.

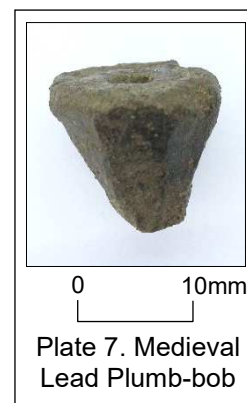
Context No.	Material	Object	Object Date
27	Lead	Weight – plumb bob	Medieval
A small and relatively crude conical shaped weight, base diam. 14mm, height 13mm, weight 9.93g. The sides are knife trimmed from tip to base making an octagonal edged base. Has a very narrow vertical central suspension hole running centrally from top 0.5mm to base 2mm. Probably suspended 'inverted' as a small 'plumb-bob' although could also have served as a small balance weight. Several similarly shaped and vertically perforated lead weights are recorded on the PAS database as probable plumb bobs of medieval to post-medieval date. Unperforated examples of various sizes are more likely to be classified as standing weights, such as several conical and pyramidal weights classified by Egan e.g. Fig.239; 1036.(Egan 2010).			
36	Copper-alloy	Pin	Medieval to Post-medieval
A near complete drawn copper-ally pin, it is bent and missing its head. Length 38mm, diam. 1mm. Weight 49g. The size and form characterise this is a dress pin and similar types from Norwich have been identified as late medieval to post-medieval in date by Margeson (11, 1993)
