Archaeological Monitoring at 61 Duke Street, Norwich, Norfolk.

Report No: 14

Archaeological Monitoring at 61 Duke Street, Norwich, Norfolk. NR3 3AP.

Location:	61 Duke Street
Grid Ref:	TG 2288 0910
NHES Event No:	ENF125463
Dates of work:	16 th November 2010 & 11 th March 2011

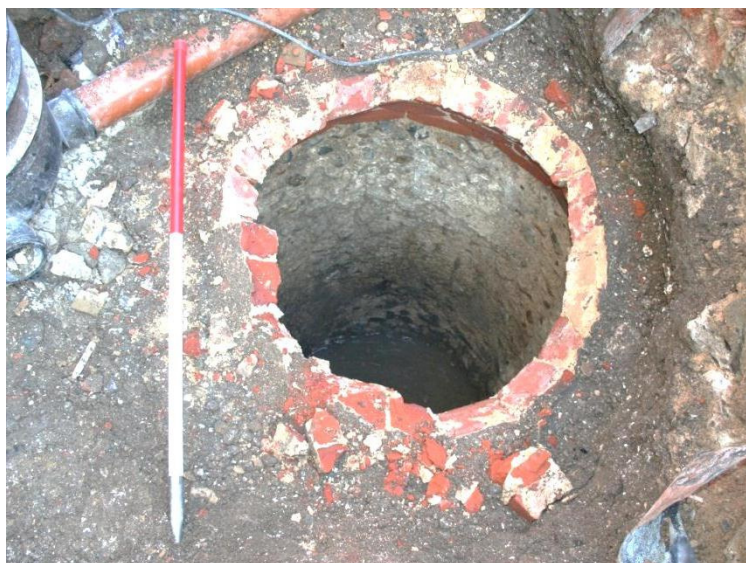
During the demolition of a small outbuilding an open well was discovered in the north-east corner of the footprint which had been bridged by the build. The well was capped briefly with brick and cement mortar while demolition work continued. This temporary cap was later removed and the well examined in more detail. It was constructed of flint and mortar and measured 2m deep to a hard infill hidden below 0.35m of dirty, noxious water. It was of fine construction using small flint cobbles bonded with a hard sandy white mortar with traces of a lime wash still visible in patchy areas. Only four small fragments of brick were noted within the fabric of the construction, these were handmade pink and yellow estuarine clay of a late medieval to post-medieval date. The top of the well was reduced slightly to accommodate the new footings and the void infilled with a suitable aggregate.

Plate 2: Flint lined well (looking north-east) [0.5m Scale]

No soil horizons of archaeological significance were disturbed during the excavation of the extension footprint however an open well of fine flint construction was discovered. The well is difficult to assign to a specific period but is suspected to pre-date the 19th century house based on its fine flint construction, close proximity to the house foundations within what was formerly a confined alley and the fact that no well or pump is marked on the 1st edition OS plan of 1885. This well may have been set within a more open yard area or gardens with a frontage further to the west area as surmised to exist here prior to the 19th century creation of Duke Street.

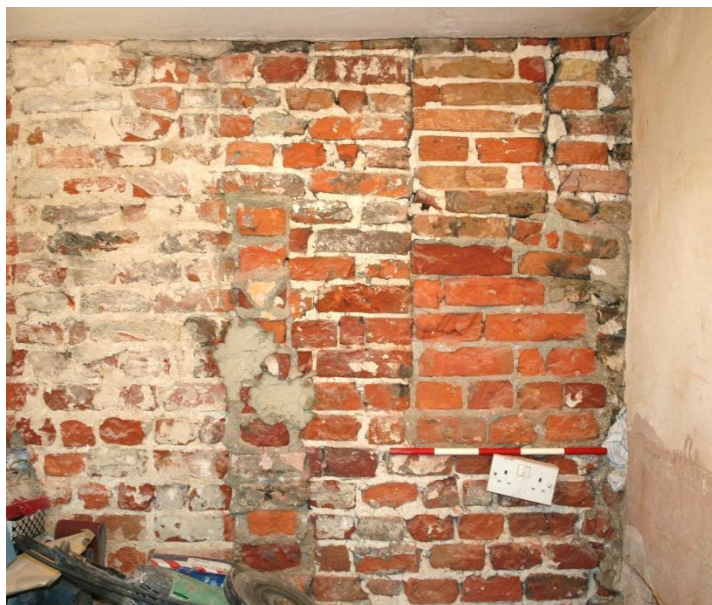
In the north-west corner of the kitchen a clear joint in the brickwork betrays a former opening infilled by brick and mortar of the same fabric and form as the internal wall and either modified or left open as a possible niche/cupboard before being infilled by more recent brickwork. The scar of a former internal wall could also be seen.

Plate 4: Brick infilling in the NW corner of the kitchen (looking west) [0.5m Scale]

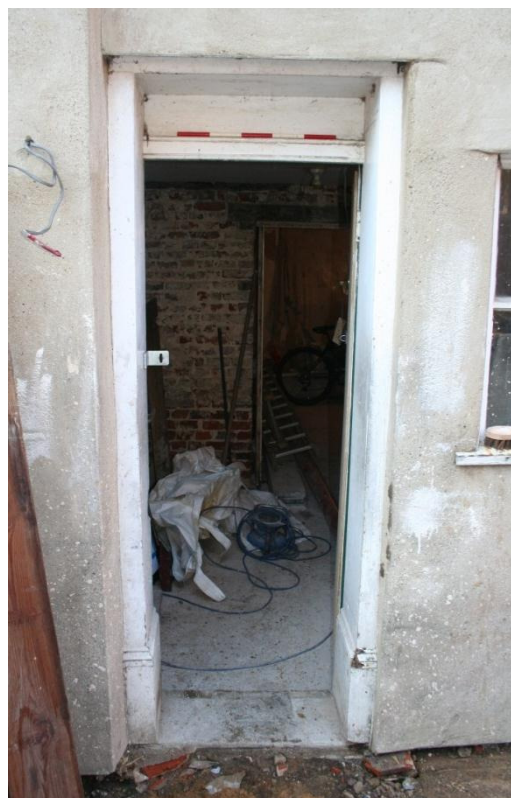
The timber doorway lining at the rear of the property was a simple 19th to early 20th century type with a rectangular blocked fanlight and minimal molding.

Plate 5: Rear doorway surround (looking west) [0.5m Scale]

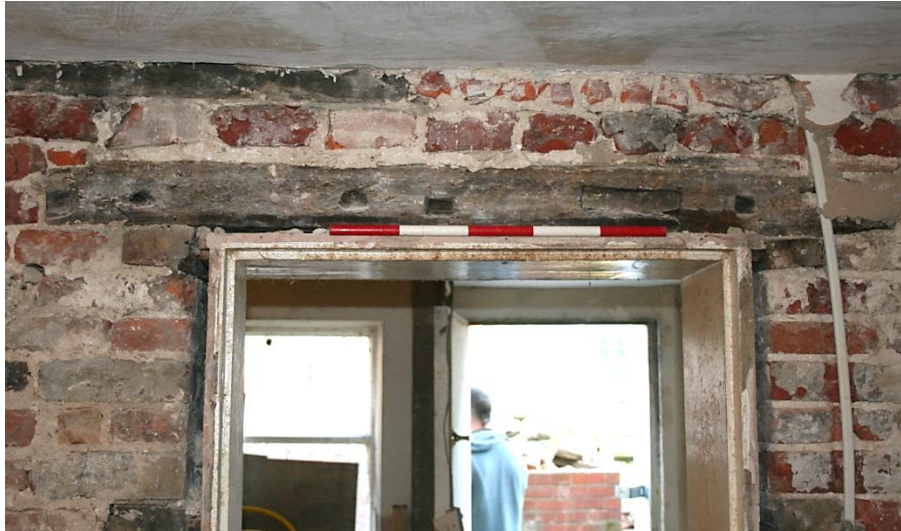
The lintel of the kitchen to reception room doorway was formed of two parallel timbers. Both were reused pieces of oak with insect damage;

Piece A on the reception room side (Plate 5)

This 1.25m length of reused timber is an oak base plate which once formed the bottom member of a stud wall or window assembly. It has sockets for seven studs - two of which are square, one rectangular, one upright plank (sawn end still in place) and three simple sockets. It also has a single chamfered edge and measured 0.16m deep by 0.10 wide.

Plate 6: Base plate used as a lintel
(looking east) [0.5m Scale]

The fabric of the house incorporates a large number of reused post-medieval bricks along with examples of structural timbers from an earlier building; a section of oak post and a base plate for a stud wall have been utilised as a lintel and a slightly curved timber used as a beam, exposed in a rear bedroom on the first floor.

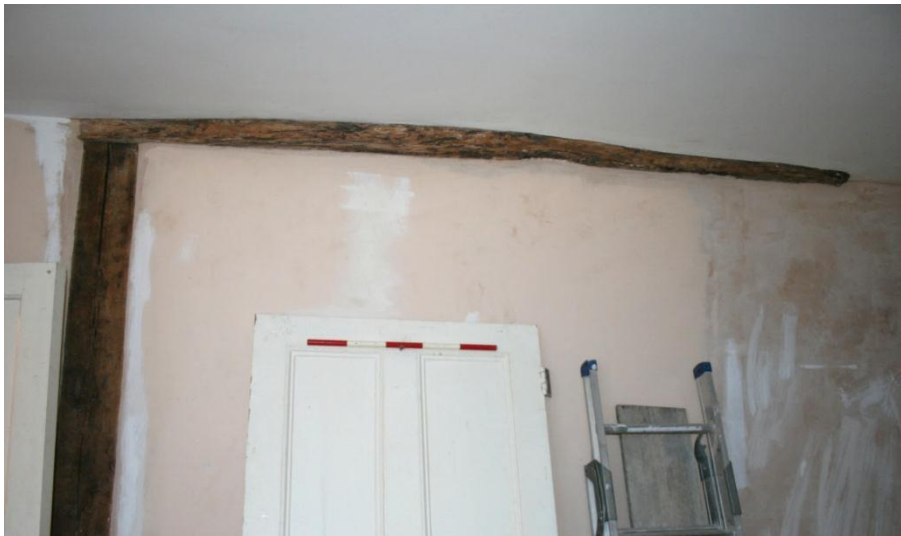
Timbers were exposed as decorative features in the rear bedroom on the first floor - a square cut upright post supports a rough cut slightly bowed/smoothly curved timber used as a beam which may be a reused timber from a roof frame or brace of a structure predating the existing 19th century house.

Plate 7: Exposed Beam
(looking west) [0.5m Scale]
