# Archaeological Auger Survey and Monitoring during renewal and extension works to Brundall Gardens Marina, Postwick Lane, Brundall, Norfolk.

Prepared for Samuel Dacre

July 2014

Report No: 46

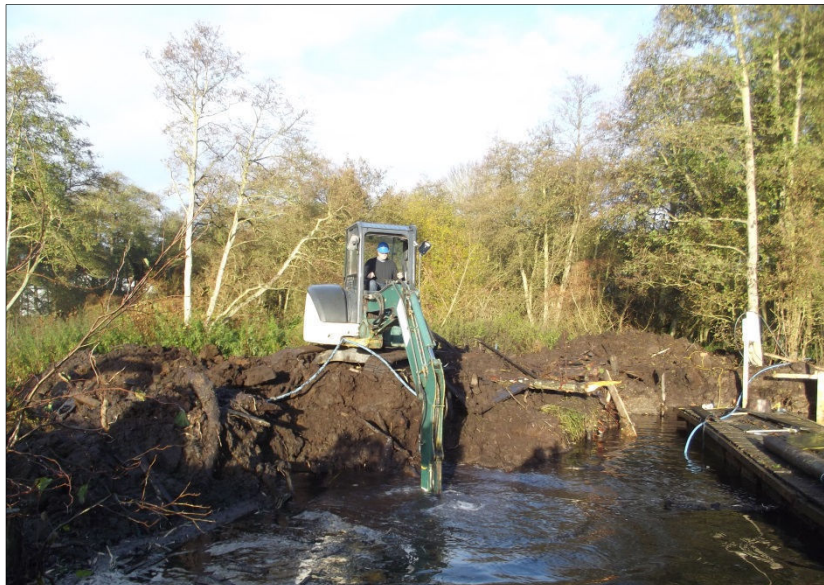
Plate 5: Wet-machine work in the New Basin (NE corner), looking North

Excavation of the new marina basin was carried out with a variety of differently sized 360° tracked excavators fitted with toothed buckets. After the first dozen or so machine bucket loads of material had been removed from the area of the new basin, all attempts to stop the newly excavated areas from becoming inundated were abandoned. This meant that many areas of the new marina basin could only be excavated at low tide, resulting in a greatly increased work programme. This also meant that the excavator bucket and arm were underwater for much of the time. It was possible to observe material in the excavator bucket as it broke the water surface but not always possible to examine spoil heaps due to the extremely wet and muddy nature of the peats and silts being excavated. In areas of the new basin, where access allowed, risings from the new basin were moved away from site by dumper.

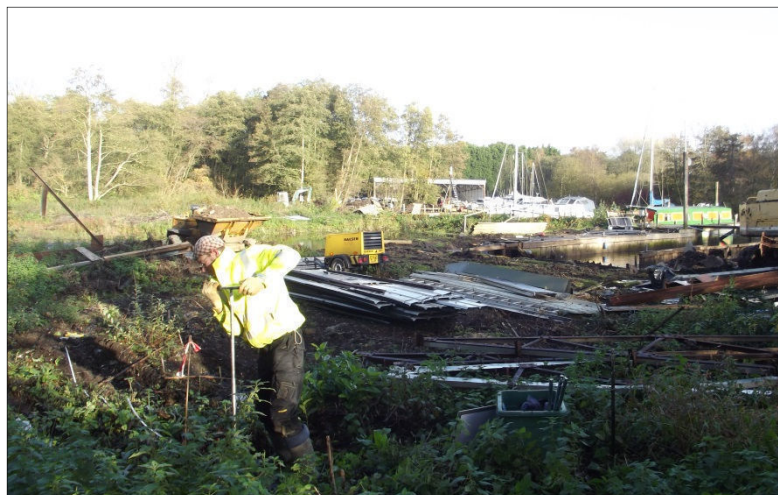
Plate 6: Hand auger survey (A2) looking North

A single transect hand auger survey was conducted across the area of the New Basin, with auger points located at 5m intervals where possible. The flooded concrete carp ark in the centre of the area was avoided but, despite this, a dataset was compiled from a total of ten auger points that showed fair consistency across the site.

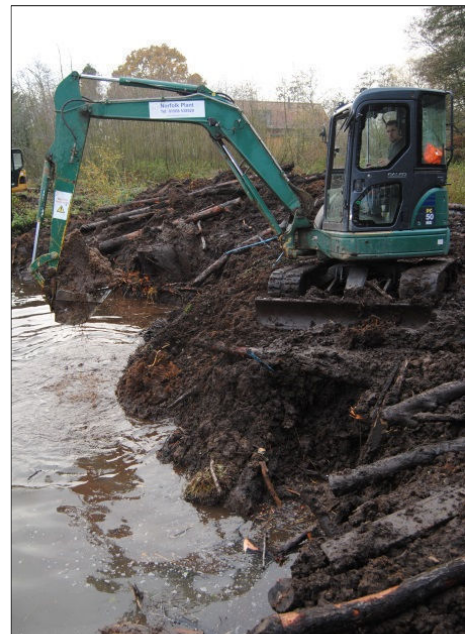
Plate 7: Wood debris in the northern part of the basin, looking SW

The northern part of new basin area, north of the existing east-to-west aligned drainage channel, had been least affected by 20<sup>th</sup> century construction activity. The sequence of peats and silts found during the auger survey here began just below a thin layer of surface silts. As this area had been wooded until relatively recently, the surface deposits were thickly littered with tree stumps, trunks, branches and similar debris (Plate 7).

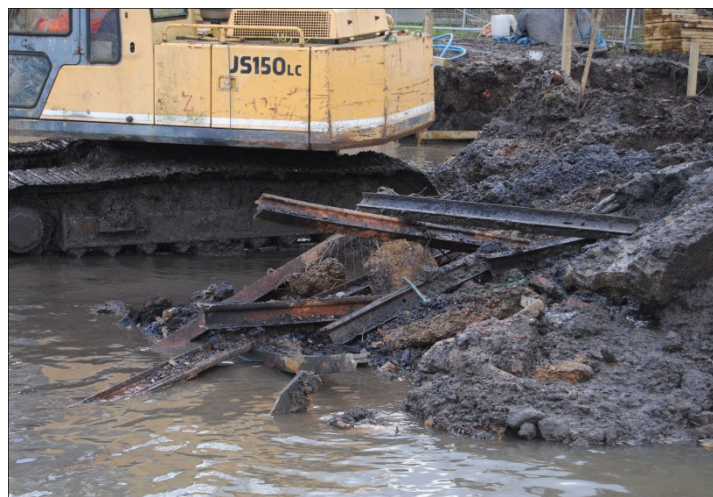
Plate 8: Rails after removal from the Hotel foundations, looking SW

Below the concrete surface of the flooded car park, a thin spread of brick rubble overlay compressed peat and the same sequence of peats and silts as seen in the auger survey. The concrete mass base forming the foundations of the Riverside Hotel were found to lay approximately 0.5m below the existing ground surface, they measured c. 0.7m thick. As well as being reinforced with conventional steel mesh, the base also contained long and substantial pieces of reused steel (Plate 8). These steel members had an 'H'-shaped section with one long side of the H being concave. Subsequent enquiries via the Norfolk Industrial Archaeology Society have concluded that the rails are most likely from a street tramway and could have come from Norwich, Yarmouth or Lowestoft if acquired locally. In the early 1920s both the tram system and narrow gauge railways serving WWI production facilities in Norwich were being dismantled and are possible sources.

The concrete footings for the hotel included re-used tram rails, which may coincide with the dismantling of the street tram ways of Norwich, Yarmouth and Lowestoft in the early 1920s. Below the concrete foundations of the hotel and their associated clinker layer, compression of peat deposits was extreme. Taking into account rising high tide levels in the late 20<sup>th</sup> century and relative ground levels across the marina basin extension area it is likely that the concrete hotel foundations had subsided into the peats below by at least 0.5m, possibly up 1.0m.

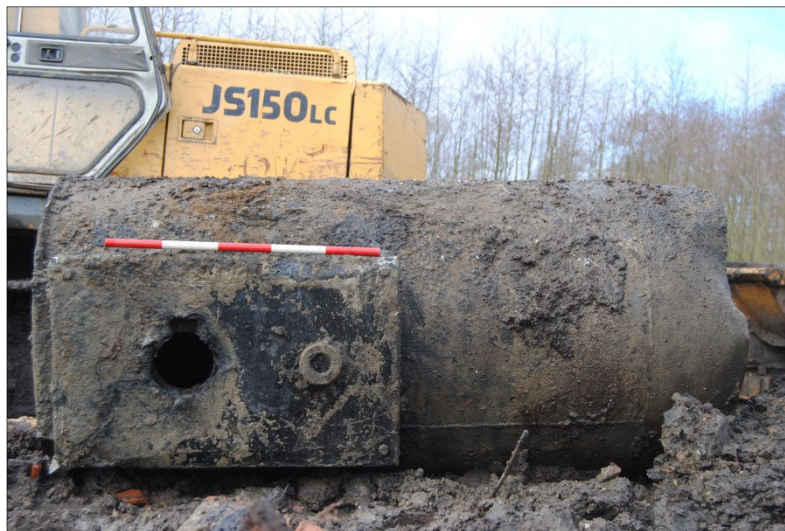
Plate 9: Boiler – side view. [1x0.5m scale]

North of the hotel foundation, adjacent the western end of the boathouse, the body of a steam boiler was found at a depth of over 1.0m into the churned peats and silts (Plates 9 & 10). The boiler was 1.4m long and 0.6m in diameter. It is likely that the boiler functioned in upright, vertical position, rather than horizontally in the manner of a steam locomotive boiler. No obvious signs of where the chimney or firebox might have been attached were noted.

The Brundall gardens boiler is too big to be from a small steam launch and too small to be steamship of any size. At the time of its discovery, the boiler was assumed to be part of the original hot water/heating system of the Riverside Hotel, perhaps replaced and discarded during the 1970s renovation. Subsequent enquiries via the Norfolk Industrial Archaeology Society have concluded that, despite the fire tubes, it seems to be a horizontal hotel laundry or central heating boiler of post WWII date, due to the very thin boiler plating and the welded seams, indicating that the boiler would not be strong enough to withstand steam pressure.

North of the hotel foundation, adjacent the western end of the boathouse the body of a steam boiler was found at a depth of over 1.0m into the churned peats and silts (Plate 8). The boiler was 1.4m long and 0.6m in diameter (Plate 9). It is likely that the boiler functioned in an upright, vertical position, rather than horizontally in the manner of a steam locomotive boiler. No obvious signs of the where the chimney or firebox might have been attached were noted. It was identified with the assistance of the Norfolk Industrial Archaeology Society as a horizontal hotel laundry or central heating boiler of post WWII date.

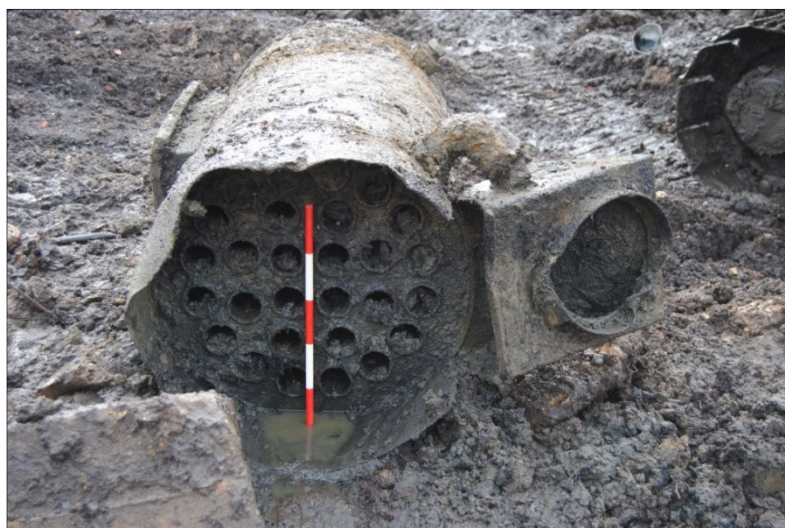
Plate 10: Boiler – base view. [1x0.5m scale]
