Archaeological Monitoring during the construction of a Hydrotherapy Pool at Hill Farm House, Roughton, Norfolk.

September 2014

Report No: 52

**Archaeological Monitoring during the construction of a
 Hydrotherapy Pool at Hill Farm House,
 Thorpe Market Road, Roughton, Norfolk, NR11 8TB.**

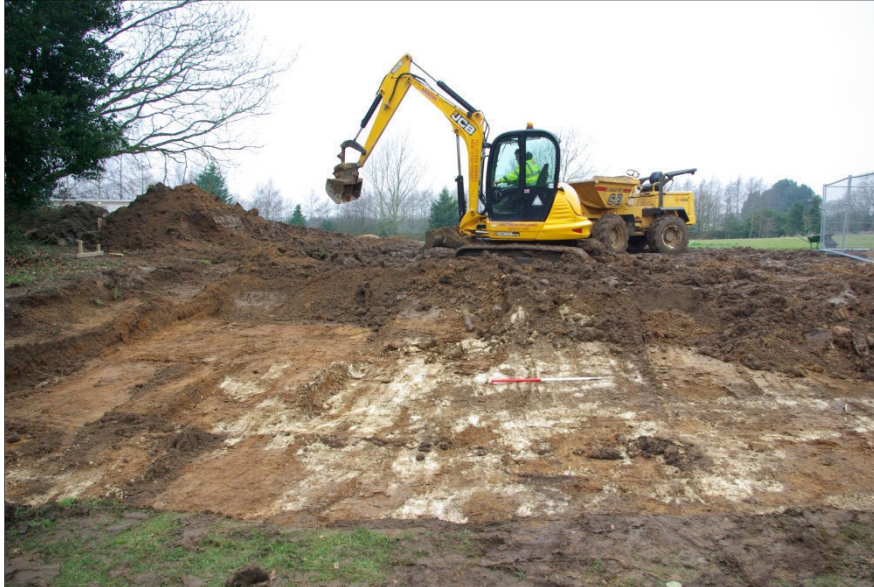
Natural geology (07) was revealed at a depth of c.0.3m across the site, observed to slope gently from north to south. The geology comprised of glacial drift deposits of sand and gravels below fine sand loess with erratic patches of soliflucted chalk and sandy-clays. In the area of the extension link, the deposits were particularly soft and prone to collapse with depth, which resulted in much wider footing trenching following initial reduction work.

Plate 2: Natural geology within pool area (looking W) [1x1m Scale]
