Archaeological Monitoring for a Swimming Pool at Stow Bedon Hall, Lower Stow Bedon, Norfolk.

Prepared for Williams Construction Solutions Ltd

John W Percival
April 2015

Report No: 57

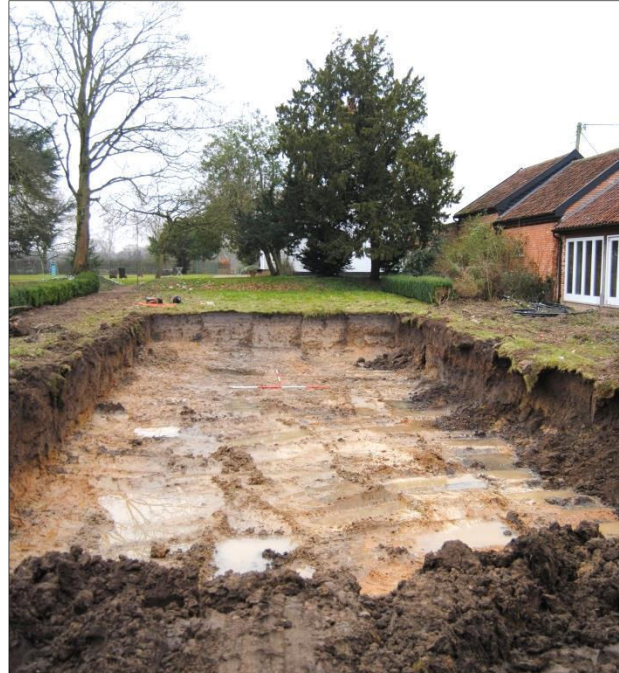
Plate 2: Swimming Pool footprint (looking SW)
[1x1m & 1x2m Scales]

Initially, the swimming pool area was excavated under archaeological supervision to the depth of geological deposits at a depth of between 0.8m and 1.3m to allow investigation and recording of archaeological features. The water table was encountered c. 1m below the existing ground surface making working conditions difficult. Following the archaeological work, secondary excavation of the waterlogged clays was undertaken to a final formation depth of c. 2.4m at the eastern (deep) end.

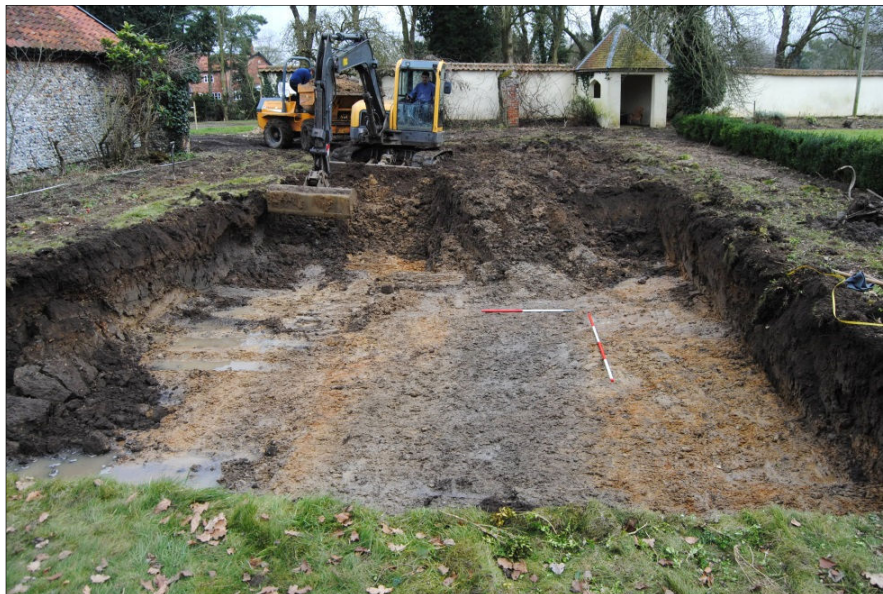
Plate 3: W. half of pool area - Ditch [07] (looking NE) [1x2m & 1x1m Scales]

A south-west to north-east aligned ditch ([07]) was identified which was sealed by the subsoil (02) and which ran the length of the swimming pool area. The ditch measured between 1.3m and 1.5m wide and was c.0.4m deep.

Where investigated by hand excavation towards the western end of the swimming pool area, it had a gently concave profile and contained two fills. Its upper fill (06) was a mid-brownish grey sandy clay containing occasional stones and flecks of charcoal. The lower fill (05) consisted of a more homogenous grey-brown sandy-clay containing moderate small stones.

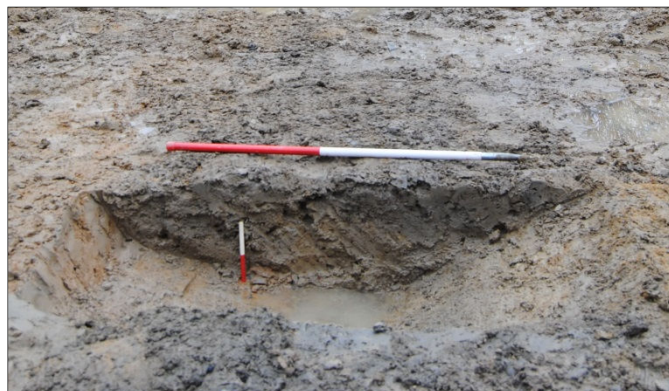
Plate 4: Ditch [07] (looking NE)
[1x1m & 1x0.2m Scales]

A single struck flint of probable Neolithic or Bronze Age date was collected from the upper fill (06).
