Archaeological Monitoring & Targeted Excavation at St Nicholas Chapel, King's Lynn, Norfolk.

Prepared on behalf of The Churches Conservation Trust

Giles Emery
July 2016

Report No: 77

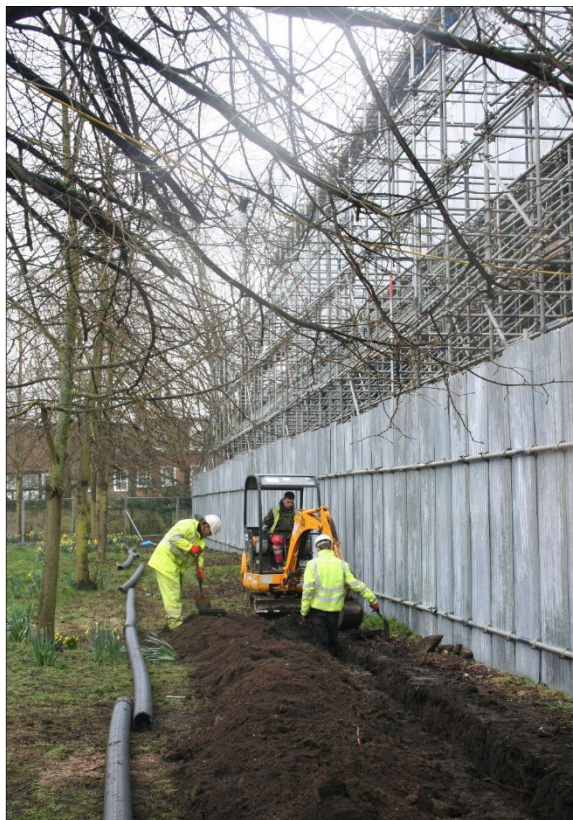
Plate 2: General working shot of cable trench work (looking E)
Plate 3: General shot of service trenching in relation to the tower (looking N)

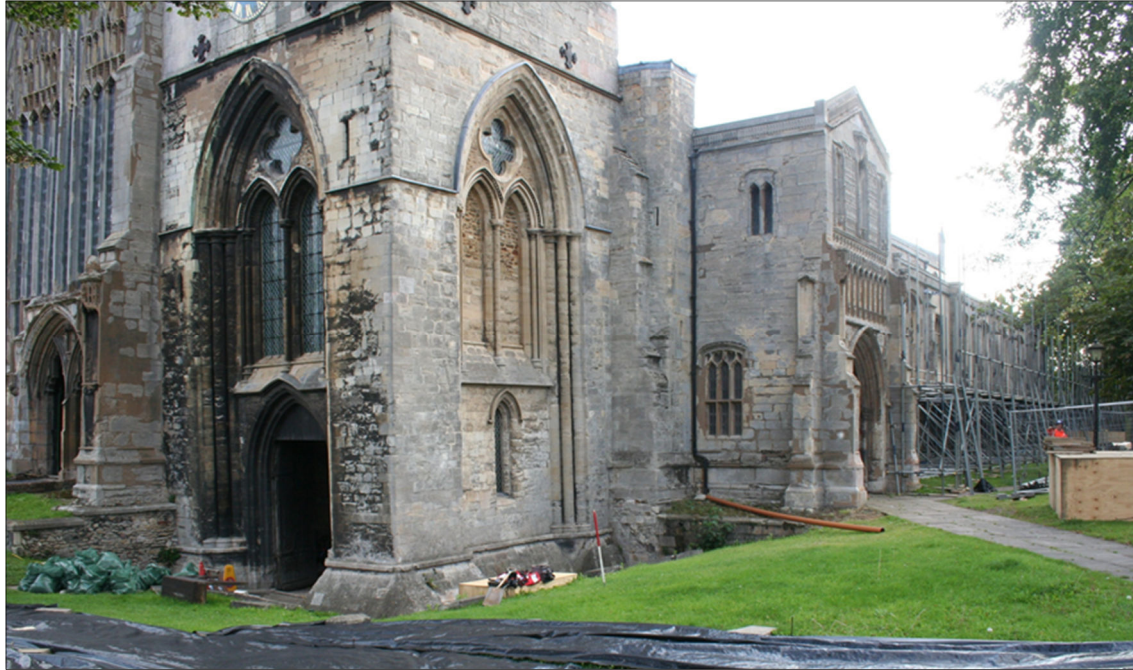
Plate 4: General shot of drainage moat area (looking NE)

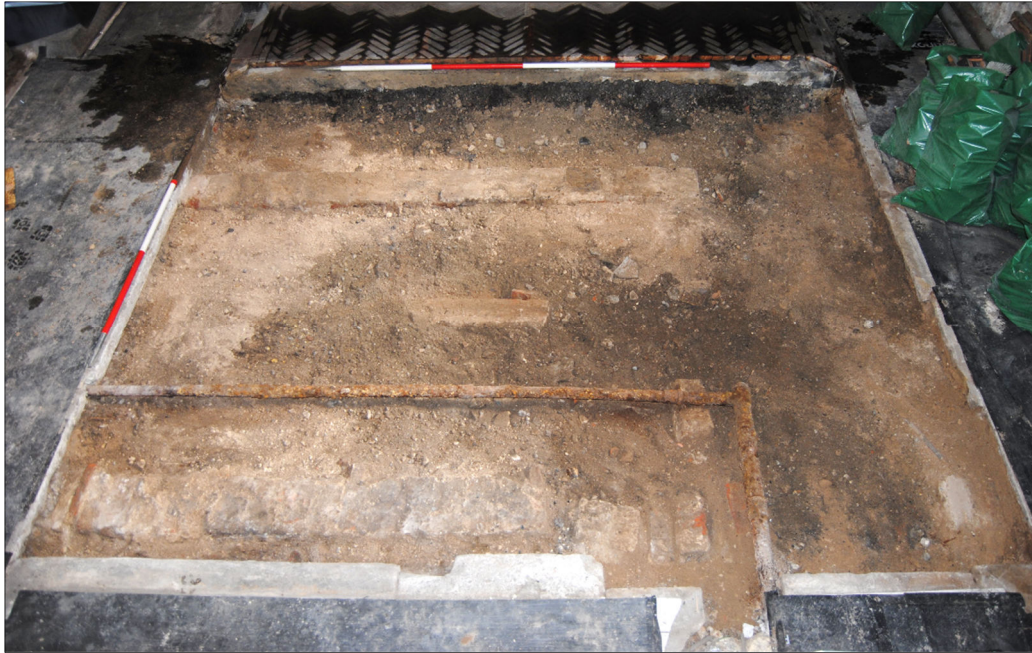
Plate 5: Re-flooring work Area D (looking E) [1x1m & 1x2m scales]

Four areas of early 20th century concrete flooring were uncovered within the western end of the nave, below where several large wooden pews were removed. These surfaces were broken out to allow for reinstatement work, which exposed the edges of several ledger stones which form part of the current flooring.

The majority of a re-laid ledger stone was temporarily exposed in Area A, of which only part of the inscription was readable. The stone was dedicated to a Thomas Hankinson who died in June 1822, who served as Chapel Warden from 1798 to 1800 (as listed within the chapel). While the edges of several other ledger stones were exposed, only partial snippets of inscriptions were on show, which include a dedication to a 'MICHAEL' and a 'MARY' in mid-18th to 19th century script seen along the northern edge of Area D.

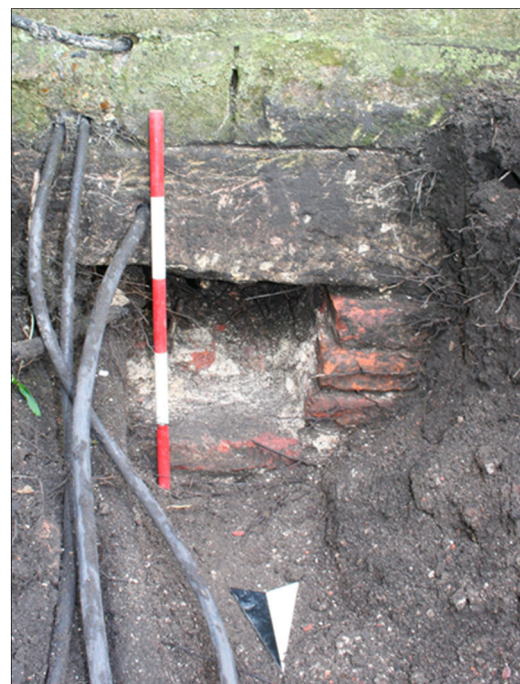
Overall, the scaffold pits showed a consistent form to the masonry below the level of the visible stone ashlar work. Medieval bricks were exposed on both the north and south sides, made from a dense, orange to purple estuarine clay bonded with a fine white, chalk-rich mortar (the bricks measured c. 60mm thick, by 250mm in length and 130mm wide).

Plate 6: Medieval brick footings (224)
(looking S) [1x0.5m scale]

The brickwork was offset to the stonework above by between 50mm and 20mm along the south side of the Chapel. A maximum of two to three courses was generally exposed, although five courses were exposed by the electricity trench dug close to the north-east corner of the chapel (see Figure 6).

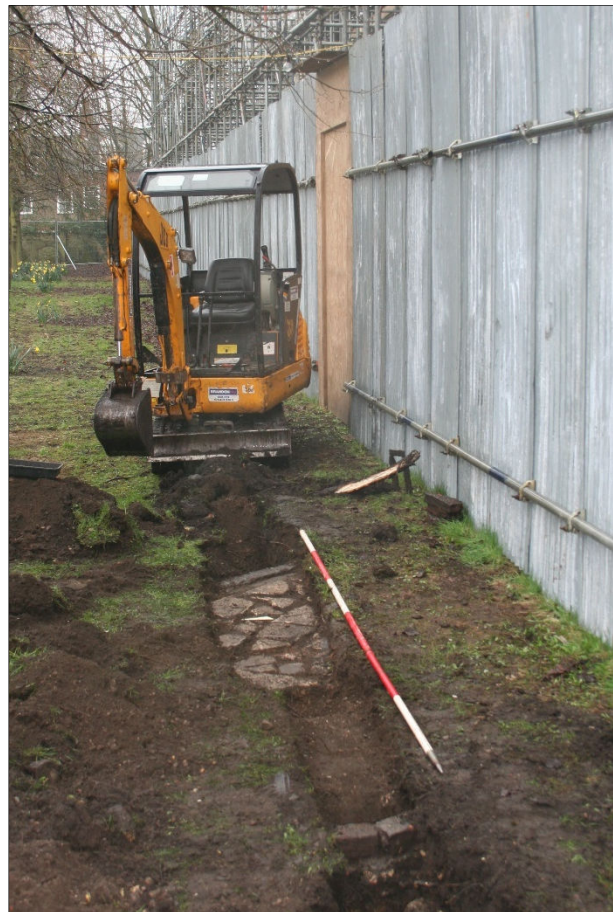
Three courses of bricks set with an ash-mortar were present, set above a shallow base of rough flints and brick fragments. Between the walls was a modern drainage pipe trench ([215]) backfilled with sand and gravel (216). This modern service trench had truncated the surface of what appeared to be 'crazy paving', but which transpired to be irregular shaped fragments of hard limestone set within soil to form a roughly paved surface. Upon closer examination, all of this stone proved to be the smashed remains of grave stones, some of which could be identified as 18th century in date by their form. Lettering was partly legible on two of the pieces, upon which the name 'MARTHA, DAUGHTER OF' could be read.

Plate 7: Buried pathway (213/214)
(looking E) [1x2m scales]

Although the brick edged path may be dated to the initial beautification of the site in 1749, the infill of this slightly sunken path with broken grave stones most likely dates from the late 19th century or later, when nearly all the remaining upstanding grave-markers were relocated to the perimeter of the chapelyard.

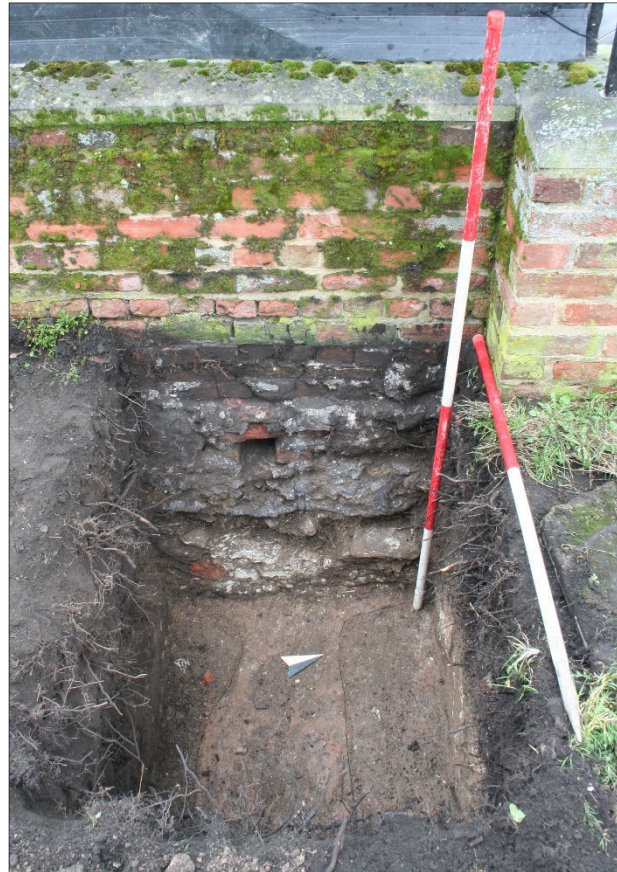
Plate 8: Cable connection trench
(looking W) [1x1m & 1x2m scales]

Dating these three unexcavated graves is problematic given the residuality of any inclusions within their fills, although given their general character and stratigraphic position a broad medieval to early post-medieval date range can be assigned to them.

A yellowish-white chalky-mortar rich deposit (202) was noted below the base of the 18th century footings which may relate to the demolition of its precursor and its own construction. Sealing this debris, and the burials below was a 0.3m deep mid-orangey-brown make-up layer of well-mixed clay-silt, with frequent fragments of medieval to post-medieval brick and tile (201). This material has been interpreted as the equivalent of an extensive lateral make-up deposit of mid to late 18th century date, as seen within the base of the entire electricity trench along the northern side of the chapel. Above this was an upper soil of soft, dark grey loam (200), also recorded across the northern part of the churchyard as upper soils of 19th to 20th century date.

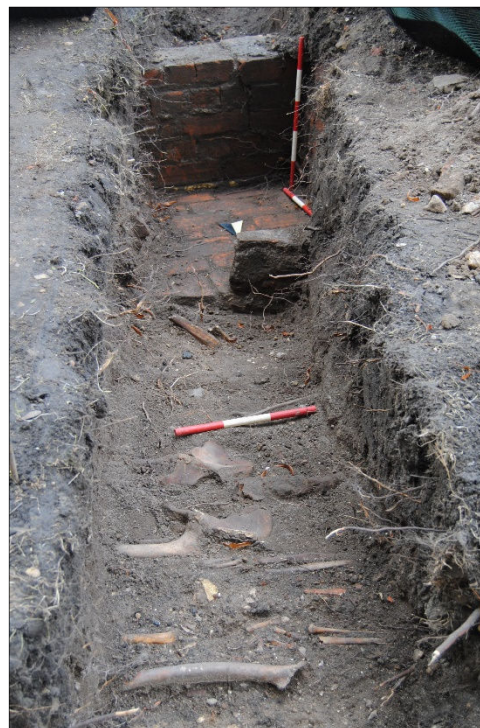
The westerly end of a brick tomb (56) was encountered, the construction of which had truncated away the right side of SK:63. The tomb was built using later post-medieval brick of 18th century date, in the form of mid-orange sandy bricks bonded with a bluish-grey ash rich mortar. It had been partly disturbed on at least one previous occasion, with the loss of the superstructure and the remainder filled with large volumes of highly disorganised chanel within a loose soil (96). Amongst this were several iron coffin fittings and the skulls of a minimum of four adults. Set above the chanel and found directly below the topsoil layer (90), at a depth of 0.45m, was an articulated juvenile (SK:55), with a suggested age range of 10 to 13 years (based upon molar dentition). No coffin nails/fittings were present to suggest that this individual was buried within a coffin, although it is of course possible that the coffin was a long degraded simple pegged box. Either way, the burial does not easily fit with that expected of such a tomb and is a later insert. A further deposit of disorganised chanel was noted against the southern side of the tomb mixed with the upper zone of layer 91, which included a single adult cranium and other large fragments that could suggest a single disturbed and redeposited individual.

Plate 9: Service trench, Brick Tomb (56) and various burials. (looking S) [1x0.5m & 2x0.3m Scales]

The tomb seems most likely to be of mid to late 18th century date; it makes use of similar construction materials to that of the mid-18th century chapelyard walling. It was orientated on a similar ENE-WSW alignment to that of the surviving 17th century stone table tomb (Grade II Listed: English Heritage ID 384264) located c. 4.5m to the south-east, both of which were probably aligned to the original route of the pathway leading from the south-west corner of the chapelyard to the south porch.

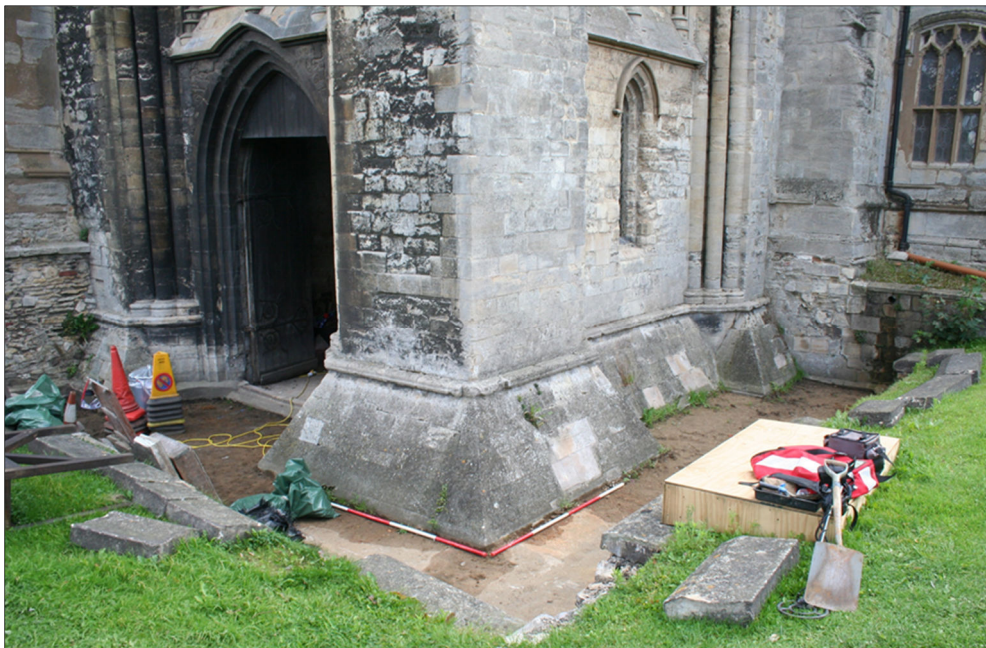
Plate 10: General working shot of moat area (looking NE) [2x2m Scales]

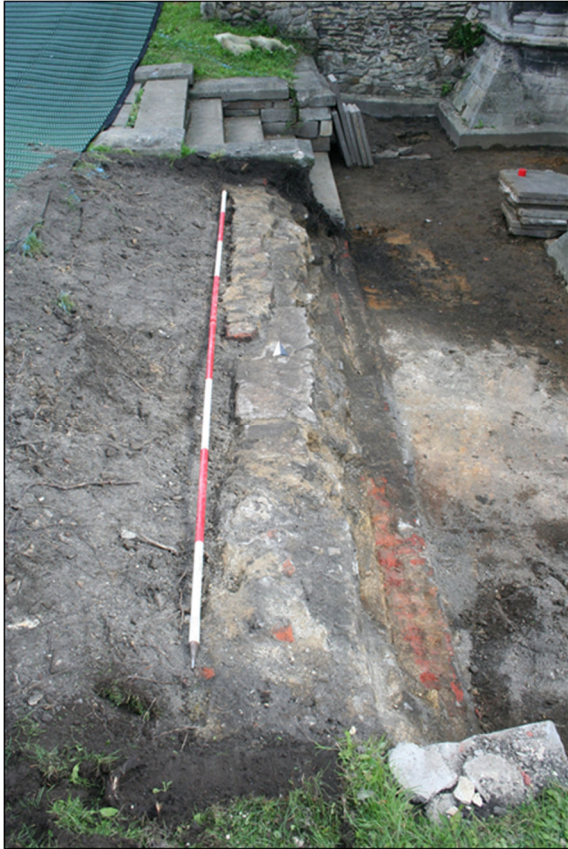
Plate 11: Step trench, C19th retaining wall (looking N) [1x4m Scale]

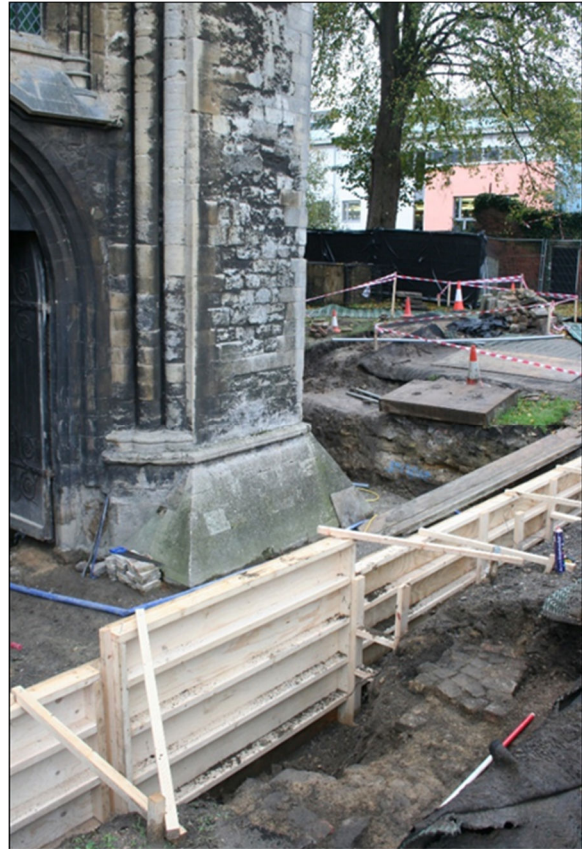
Plate 12: Step trench, C19th step footings alongside 1m Scale (looking SE)

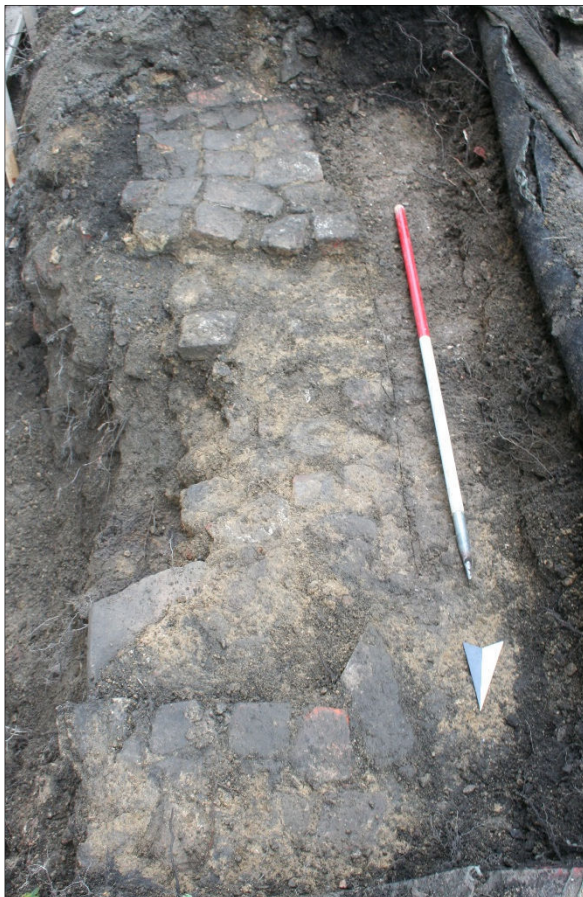
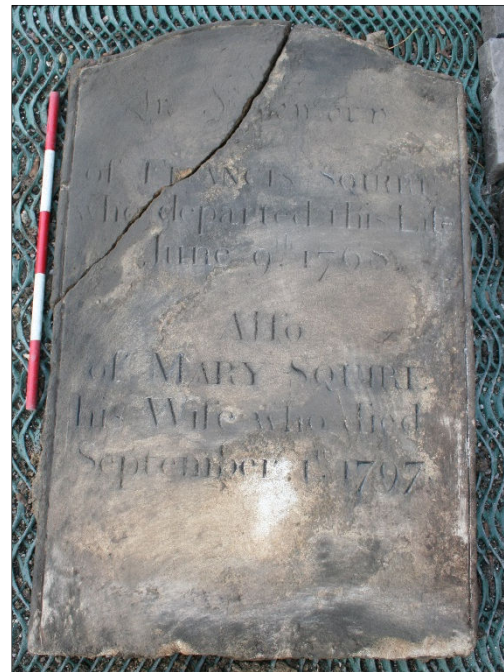
The footings for the steps down to the moat were partly revealed (103), which were constructed from similar materials to that of the moat retaining wall (02). Two face-down gothic style hard sandstone headstones were embedded within these footings. One was recovered from the top of the footing fabric (113), which once recovered could be read as: 'IN MEMORY OF FRANCIS SQUIRE WHO DEPARTED THIS LIFE JUNE 9TH 1768 ALSO OF MARY SQUIRE HIS WIFE WHO DIED SEPTEMBER 1ST 1797. The other formed part of the base of the footings (114) and read ' IN MEMORY SUSANNA CREED THE WIFE [OF] WILLIAM CREED WHO DIED DEC 16TH 179? AGED 29 YEARS ALSO HENRIETTA AND MARY DAUGHTERS DIED INFANTS'

Plate 13 & 14: C19th step footings in place alongside 1m Scale, looking S) & Grave Stone (113) (1x0.5m Scale)

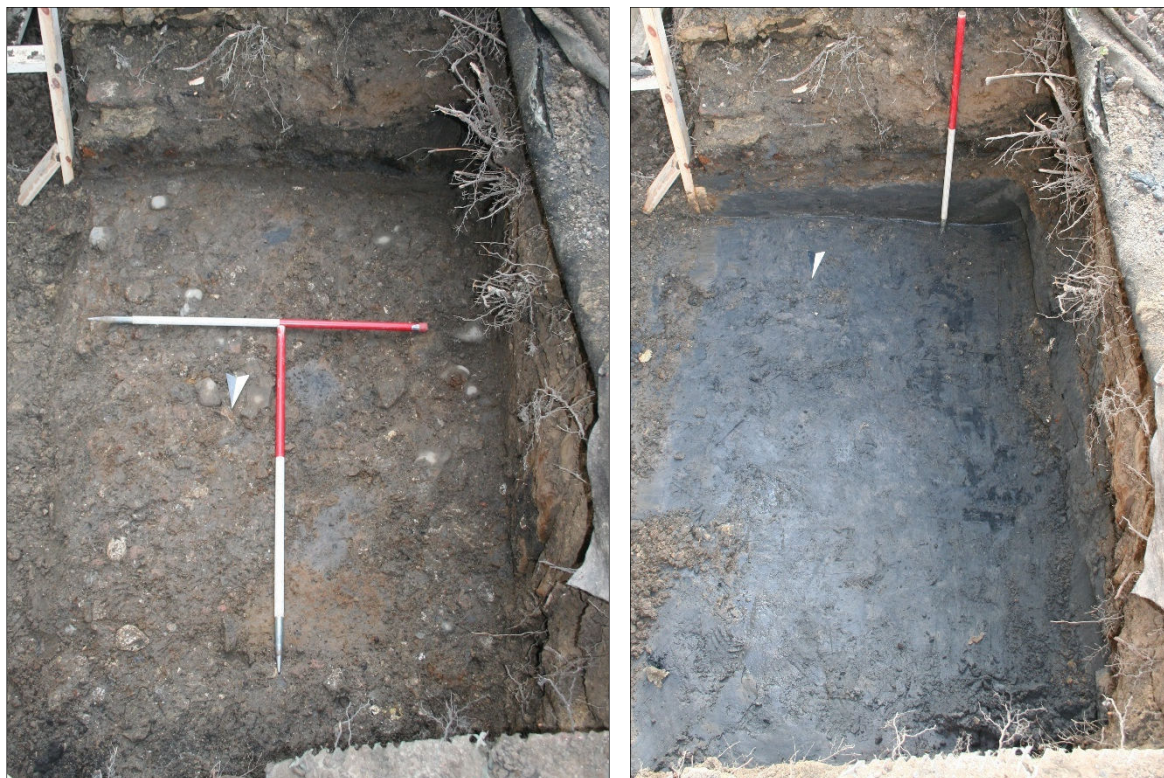
Plate 15: C13th Stone surface (127) (looking S) [2x1m scales]

Plate 16: Medieval silt deposits (129) (looking S) [1x1m Scale]

A thicker layer (c. 250mm) of dark grey clay-silt (119) was next in the sequence, which contained frequent dark orange lumps, of what proved to be fragments of smithing-pan associated with iron working, and moderate amounts of charcoal. Above this was a further make-up layer of mottled clay-silt, of a more friable composition (118) with occasional small limestone chips, oyster shells and degraded smithing pan lumps. These deposit both contained residual pottery sherds of medieval fabrics, with date ranges consistent with 13th to mid-14th century activity.

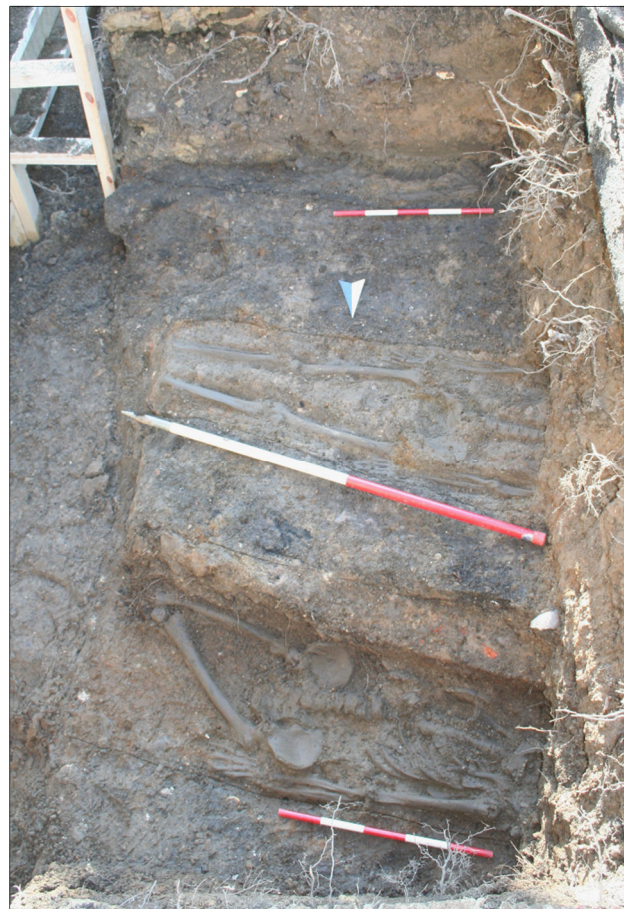
Above the initial medieval burial row, was a further sequence of burials, which do not conform to the earlier ones and which were on a much more accurate east-west orientation. The excavated skeletal remains were slightly better preserved and were those of young children and juveniles (SK:104, 105, 106 & 107). The burial of a partially preserved neonatal burial (SK:108) truncated the lower part of infant remains SK:106. No evidence for coffin nails was found, although the western end of a juvenile (estimate of c. 13 to 16 years based on dentition and bone fusion) which survived disturbance from the construction of the step footings (113) was clearly buried within a rectangular coffin as evidenced by a clear coffin stain (111). Dating these burials is problematic, but given the lack of post-medieval materials in the grave fills, they are suggested to be of later medieval to early post-medieval date.

Plate 17: General shot showing medieval burials (SK117, 116 & 115) (looking S)
[1x1m & 2x0.5m scales]

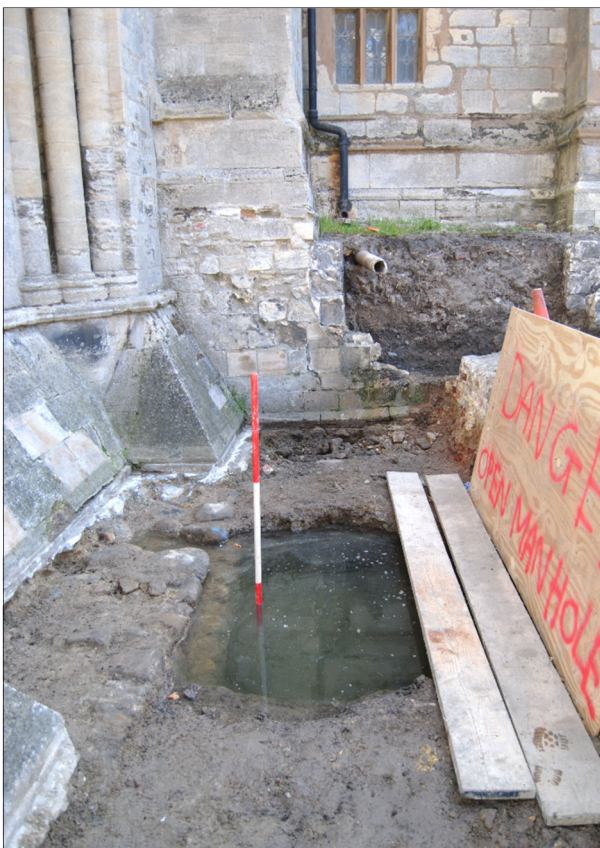
Plate 18: General shot of waterlogged soakaway pit (looking E) [1x2m Scale]
Plate 19: Tower footings (external) (31) (looking E) [1x1m Scale]

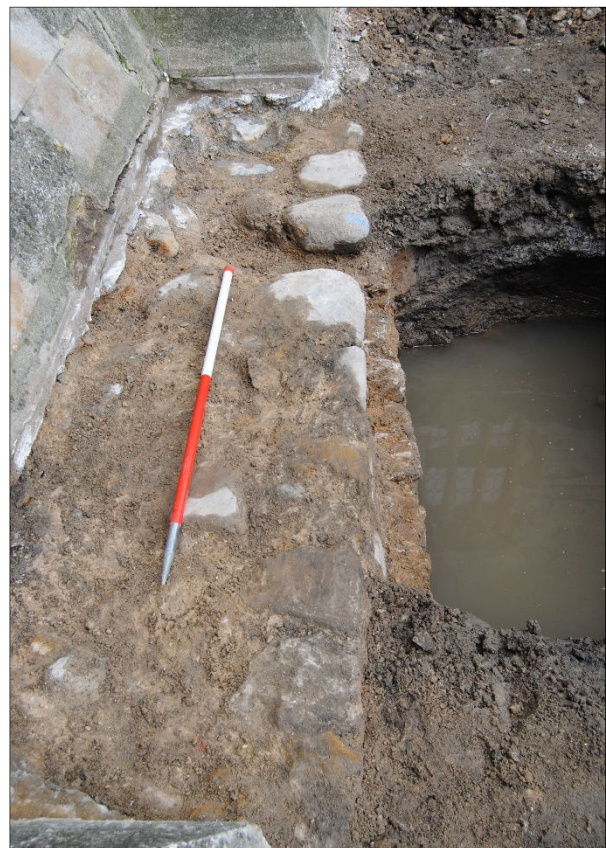
The substantial masonry footings for the tower measure c.3m wide and c.0.7m deep, which has provided a large and cohesive raft-like footprint for the tower. Due to the nature of the wet silts and clay-silts, footing trenches would have been impossible and instead the area can be envisaged to have been prepared as a working platform, with footings built as walls prior to reinstatement of the preferred land surface and raising of the superstructure.

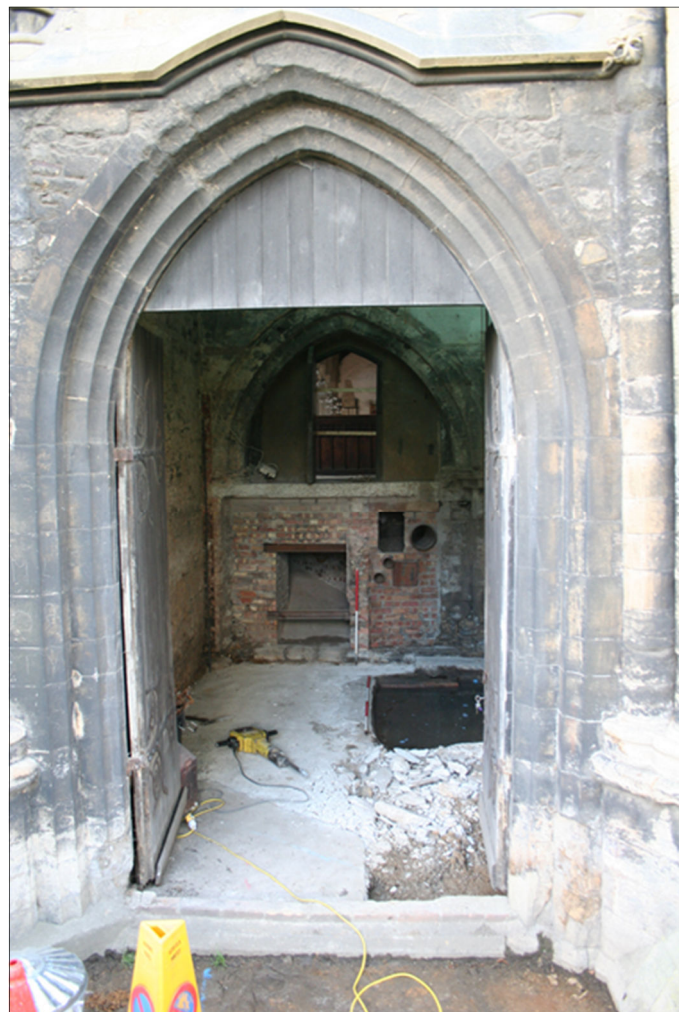
Plate 20: View into the tower (concrete floor in place) looking E) [1x1m & 1x2m Scales]

An initial test trench for the contractors was broken out inside the tower (c. 0.6m by 2m), through the 1930s concrete floor and a slot machined into the silts below to a depth of c. 0.5m. This work immediately released suppressed groundwater – resulting in flooding of the trench to the level of the concrete floor (c. 4.2m OD).

Following removal of the entire concrete floor, which had lain upon a rubble base of up to 0.25m depth), the underlying wet deposits were exposed and rapidly recorded (assisted by constant pumping of the inflow of groundwater). The remains of a 19th century brick drainage sump (18) were noted in the internal north-east corner of the tower, blocked with black silt.

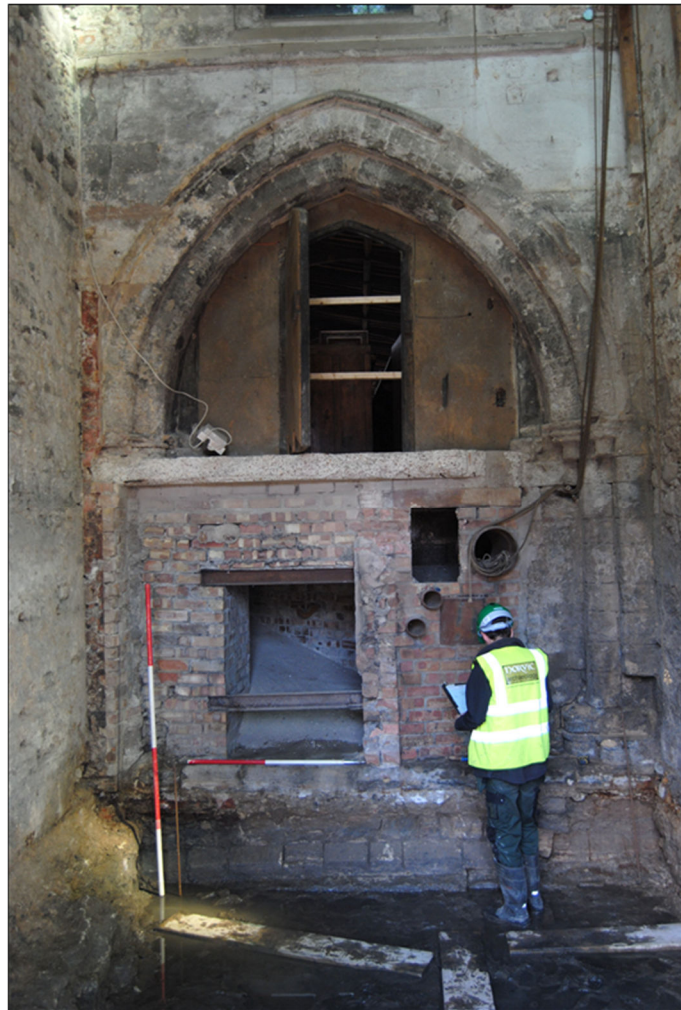
Below the make-up layer (16) was a deeper deposit of firm greyish-brown clay-silt (20) the upper horizon of which (at c. 3.5m OD) was impressed with occasional large, sub-rounded Baltoscandian river cobbles (similar to those used within the tower footings) along with small pieces of limestone. Below this layer of construction residue, the deposit was clean and homogenous.

Plate 21: General shot showing medieval masonry exposed inside the tower (looking E) [1x1m & 1x2m Scales]

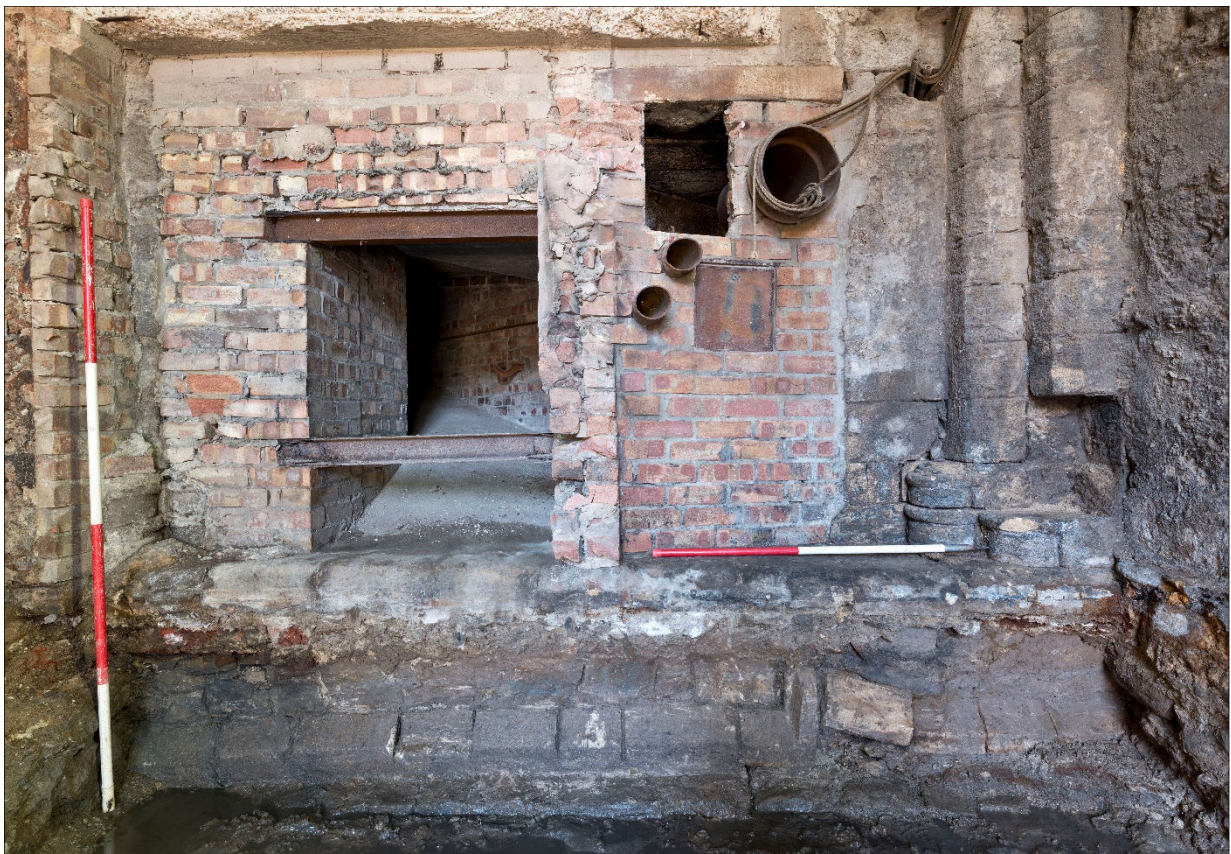
Below the chamfered string course, the stonework was roughly coursed, made from large roughly shaped limestone blocks and limestone rubble. Intriguingly, this masonry was bonded over a pre-existing structure, clearly marked by an earlier course of chamfered stone blocks (c. 0.5m below the upper course at c. 3.7m OD) of notably differing size and shape from that above. These blocks were squatter but taller and notably less abraded, although

Plate 22: Medieval masonry exposed inside the tower (below the modern concrete floor) (looking E) [1x1m & 1x2m Scales]

bonded with a similar mortar type to those above (which although washed out in between much of the stones was as a soft, gritty/ very-sandy, calcareous mortar).

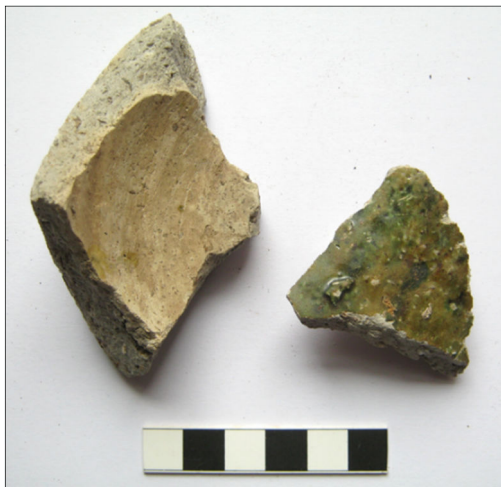
Plate 23: Saintonge gritty ware vessel sherds (126) & (127)]
[1x5cm scale]

The most unusual find was a thick whiteware base in a gritty fabric. The vessel was covered in dark green glaze externally, although the application was haphazard, and the base was partially pierced to aid firing. This appears to be a Saintonge gritty ware vessel, probably a mortar, although it is smaller than examples known from Southampton (Brown 2002, fig. 23, no.215) and has a copper glaze rather than a lead glaze (Plate 23).

The range of medieval wares recovered from the site reflects the proximity of the production centre at Grimston, as well as the town's status as a port. A number of vessels, represented by a few sherds only, probably arrived here via coastal trade, both within England and with the continent. Of most interest are the sherds from a Saintonge gritty ware vessel (Plate 23), which is the first of its kind in East Anglia, to the knowledge of the present author.

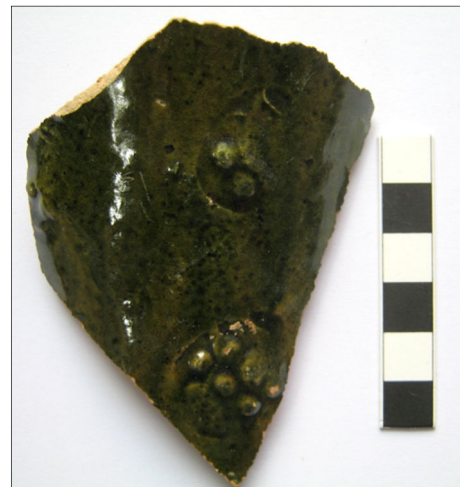
Plate 24: Scarborough ware with applied 'raspberry' stamps (118)
[1x5cm scale]

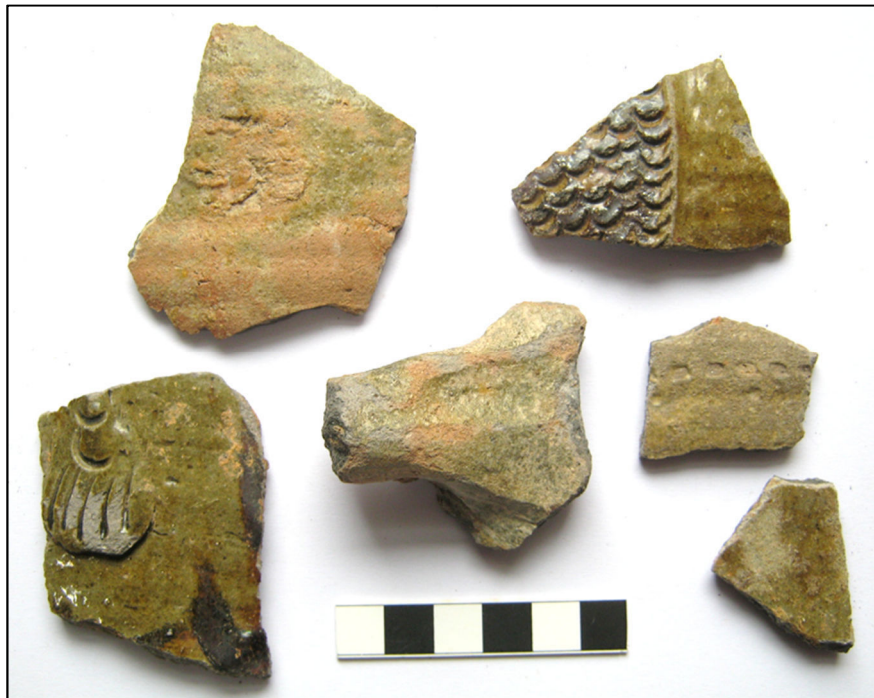
Plate 25: Grimston-type ware (126) [1x5cm scale]

Medieval glazed wares were significantly more frequent than coarsewares (Plates 25 & 26), with the local Grimston type being the most common. No rims were present in this fabric, but there were fragments of five handles and three bases, all from jugs. A body fragment with an applied 'hand' was probably from a face jug. Other decoration included two sherds with broad white slip lines, one with a thin applied strip, two with brown slip lines, one with a delimited area of 'feathers' made using a semi-circular tool, and one with a line of rouletted or stabbed small rectangles. Most sherds were at least partly green glazed, although two from the lower body/base were not.

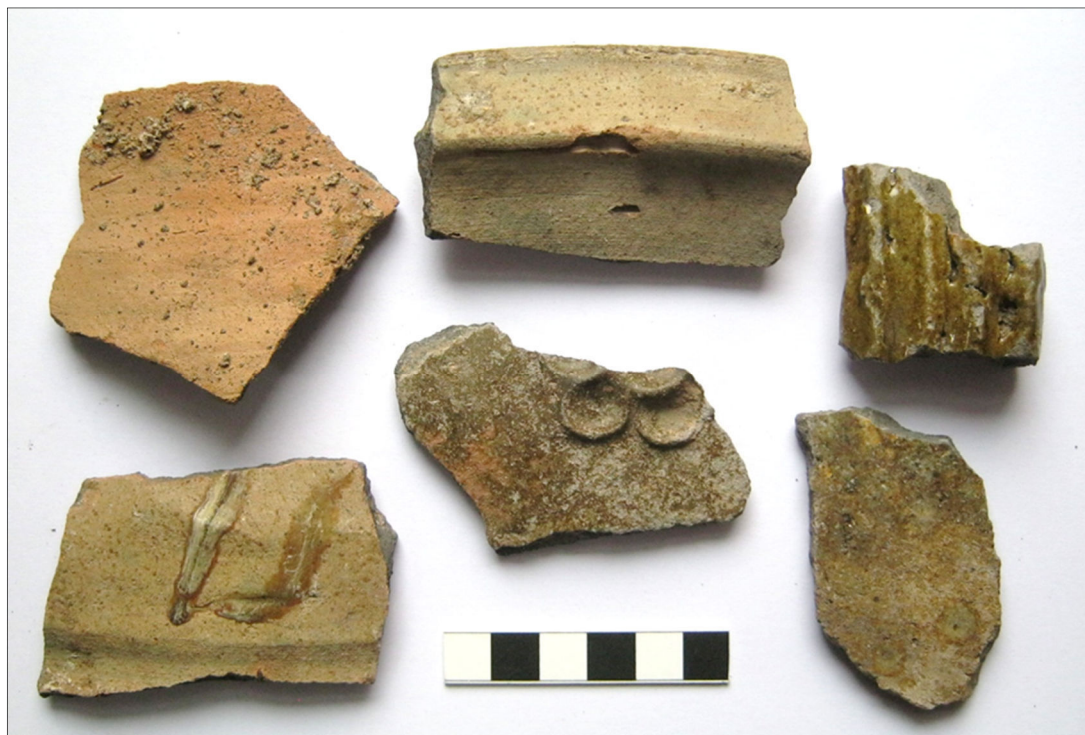
Plate 26: Grimston Coarseware (Top-left) Ely Glazed Ware (Middle) Top + Bottom-left),
remainder Grimston-type wares, all from context (97) [1x5cm scale]

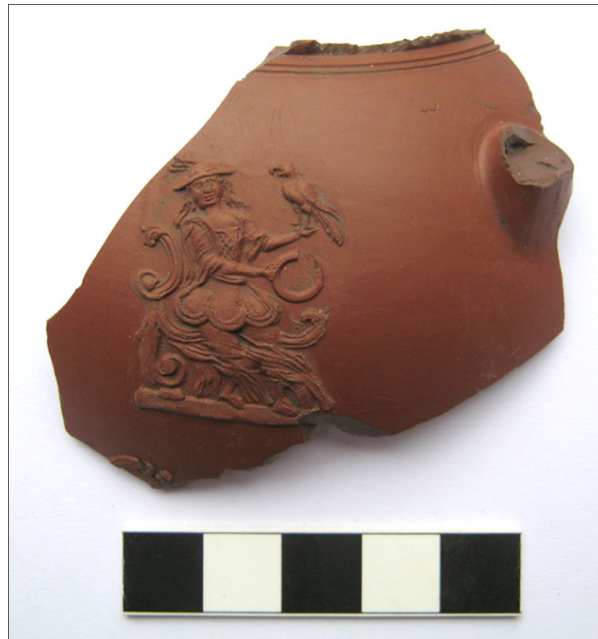
Plate 27: Red Stoneware Teapot sherd ((217)
[1x5cm scale]

Post-medieval wares were typical of the town and again local wares dominated with only a handful of Dutch and German imports. The modern assemblage contained a number of vessels which might be considered relatively 'high status' in the 18th century, such as Staffordshire red stoneware and white stoneware teapots. The majority of this assemblage was collected from soils imported into the cemetery as landscaping material and therefore relate to activities and households elsewhere. Nevertheless, it shows the types of pottery available to the local populace during the periods it represents, and reflects the cosmopolitan nature and relative affluence of the townsfolk in the general area of both the Chapel and the Tuesday Market place.

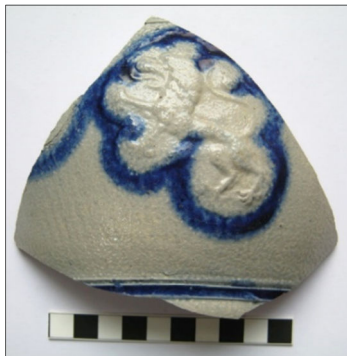
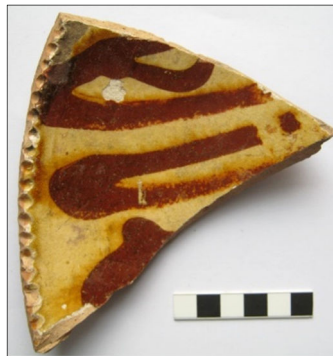
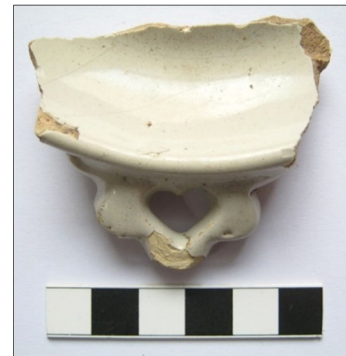
Plate 28 to 30: (218); Westerwald Stoneware Chamber pot (Left), Staffordshire-type Slipware (Mid.), Tin-glazed earthenware (porringer) (Right) [scales in cm units]

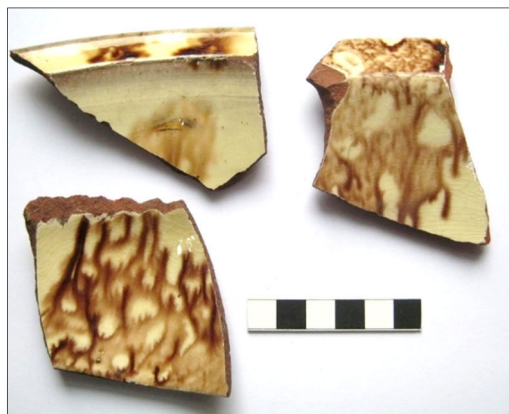
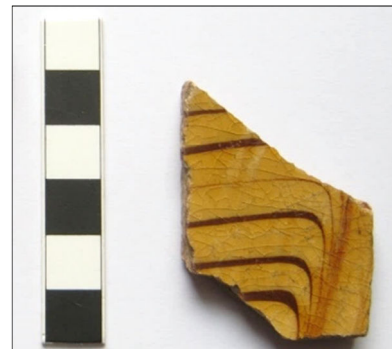
Plates 31 & 32: Late slipped redware x3 (218) and Staffordshire-type Slipware (222)

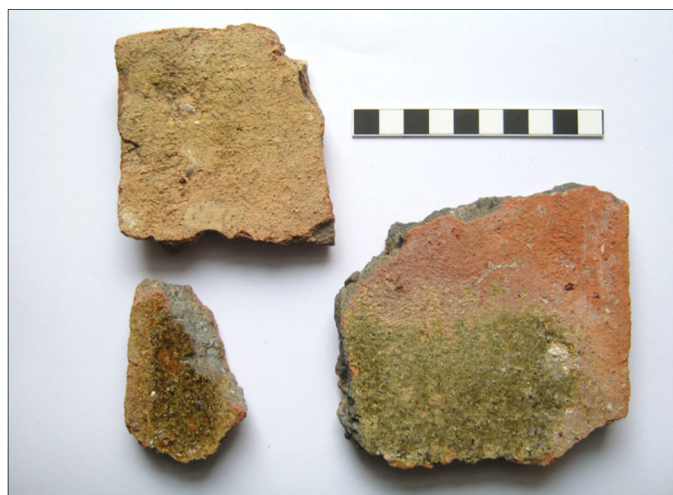
Plate 33: Medieval Roof Tiles fragments from context (74) [10cm Scale]

Most of the medieval roof and floor tile fragments and some bricks were collected from layers and negative features, suggesting that this material was redeposited following demolition of medieval structures and floors. A few early bricks had been re-used in later structures, at least one in association with a later white-firing brick. This was common practice, and is seen in the much larger sample group from Boal Quay (Anderson 2011).

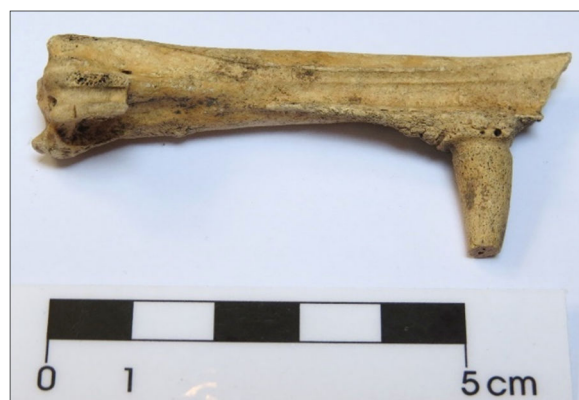
Plate 34. Peacock tarsometatarsus from (218) with trimmed spur tip

Bird bone was represented by fowl in deposits (40) and (218). The fowl tarsometatarsus collected alongside mid-18th century pottery from context (218) is in the size range for Peacock; this bird may have been an ornamental bird or one used for food. The spur of the Peacock had been trimmed at the point, leaving a flat end to the bone (Plate 34), this may have been to prevent the bird harming other birds. A Grey Heron tarsometatarsus and fercula were produced from possible 15th century church make-up (42), the bones had been butchered, attesting to this birds use for food.

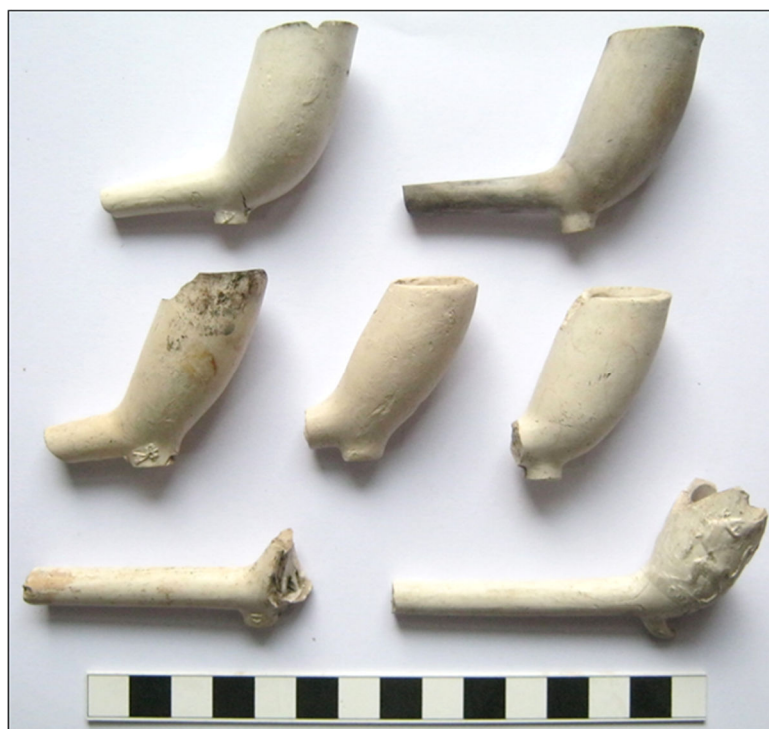
Plate 35: Selection of 18th century pipe bowls [15cm Scale]

Three pipes can be attributed to the Alderson family of King's Lynn, one by Joseph Alderson (trading from 1708 to 1732) and two to his son and apprentice Thomas. A pipe heel marked R/D is most likely that of Robert Dunn (freeman 1708), who owned a messuage or tenement on Purfleet Street (Atkin 123, 1985). This, and the other streets where the Lynn makers worked, are north of the Purfleet, leading to the Tuesday Market; Norfolk Street; King Street, St Ann Street and Sedgeford Lane. Parker (47, 1971) describes the streets around the Tuesday Market as being predominantly occupied by shopkeepers and innkeepers in the 17th century, because the merchants, and therefore industry, had shifted northwards to take advantage of the better navigation on the Ouse.

Although much of the clay pipe collected is residual within later landscaped soils within the cemetery, those collected from a deposit of probable mid-18th century phase of landscaping appears to support the presumption that this activity dates to the initial beautification of the site in 1749, which saw the addition of the gates, piers and railings and the first phase of clearance and relocation of grave markers.
