# West Scafton Colliery, Coverdale, North Yorkshire

## Earthwork Survey and Assessment

Project Ref: SOL1516-9

Report Ref: DOC1516-5

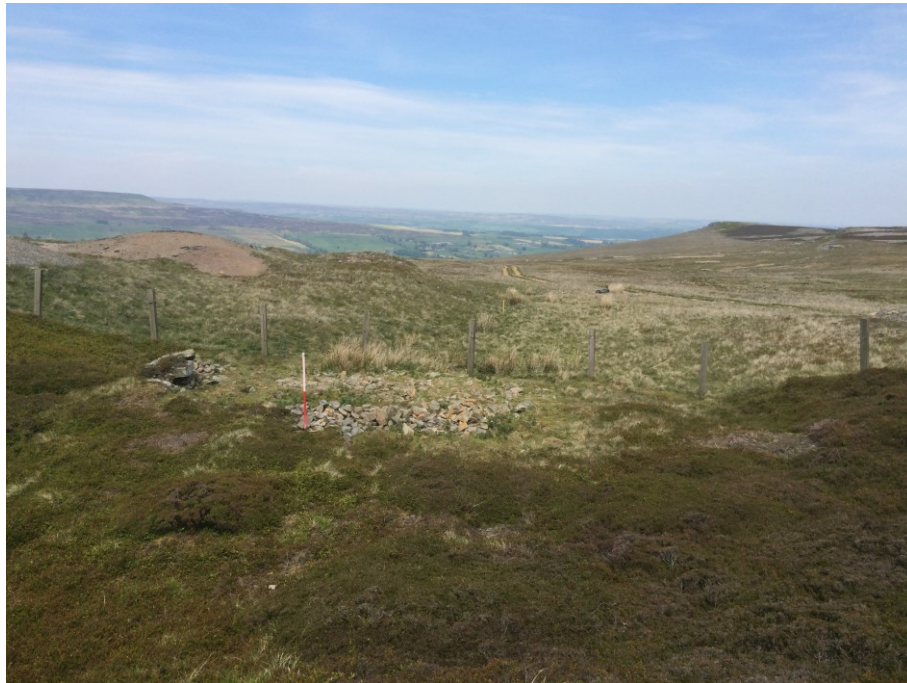
Figure 2 General view across the surviving earthwork remains looking north back towards Coverdale and the Vale of Mowbray beyond

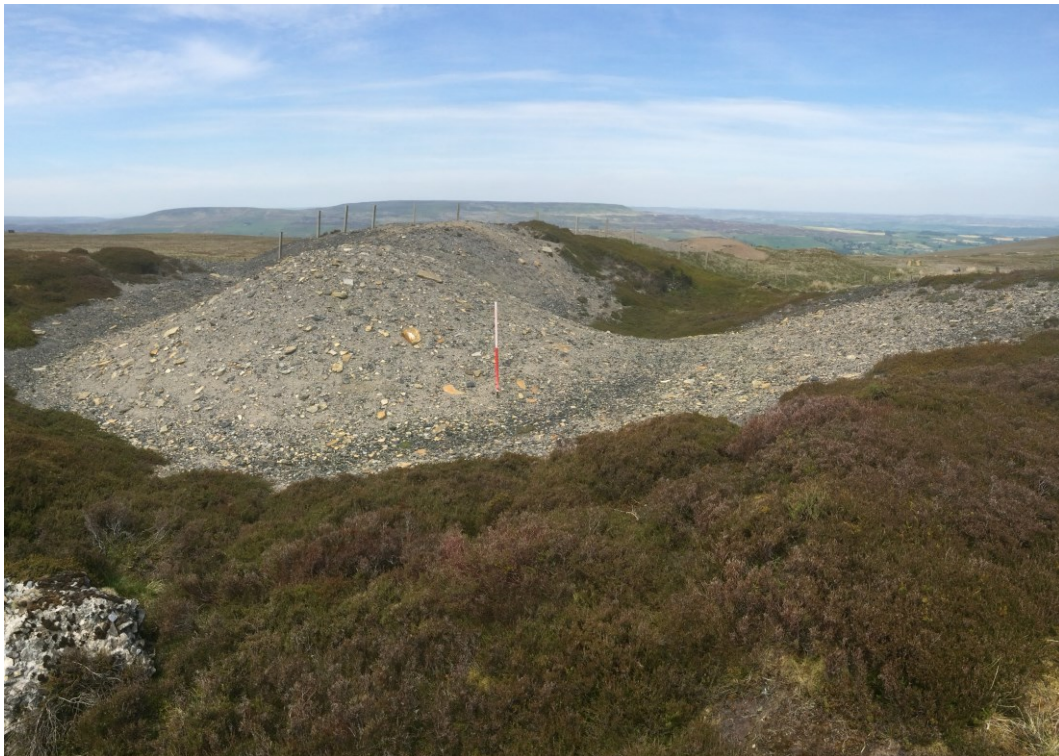
Figure 3 Shaft mound (1) looking north from adjacent to the engine location (scale 1m)

The earthwork remains are centred on an engine shaft sunk, most probably, in the late 18<sup>th</sup> century though only in use for a short time before abandonment in favour of working levels driven further down the hill (see above). The shaft (1) appears now as a conical mound of spoil fully capping the shaft, well defined and c.8.5m in diameter at the visible base. It currently stands c.3m in height from base to the narrow flat top. As with many of the features within the earthwork complex, the spoil is fine and loose and, largely as a result of this, non-vegetated. All non-vegetated areas of the earthworks are shown on Figure 4.

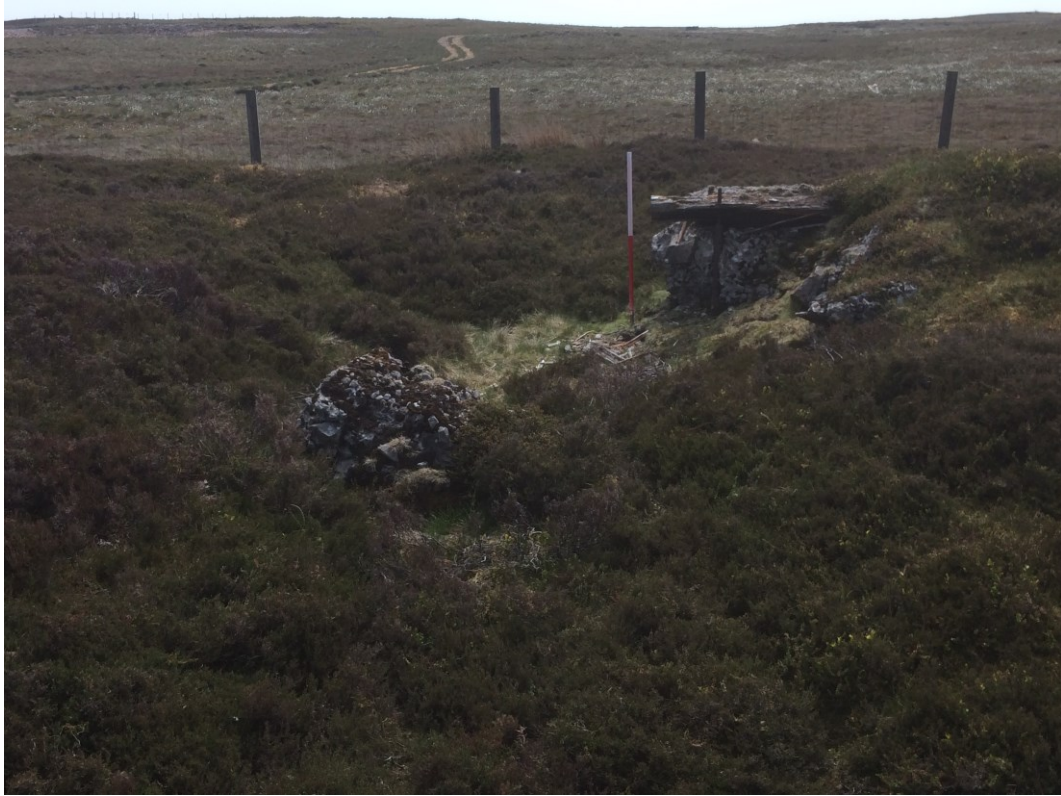
Figure 6 Hollow to the south of the shaft mound still carrying the broken concrete block presumably associated with the early 20th century engine (scale 1m)

To the south of the shaft mound there is a hollowed area surrounded by spoil heaps (2). A single large broken concrete block lay partially across the hollow and most probably represents part of the base for the steam engine installed in the early 20<sup>th</sup> century. The concrete block is coarsely made and cast, and includes a fragmentary wooden beam on the uppermost side with rusted metal brackets still attached in places.

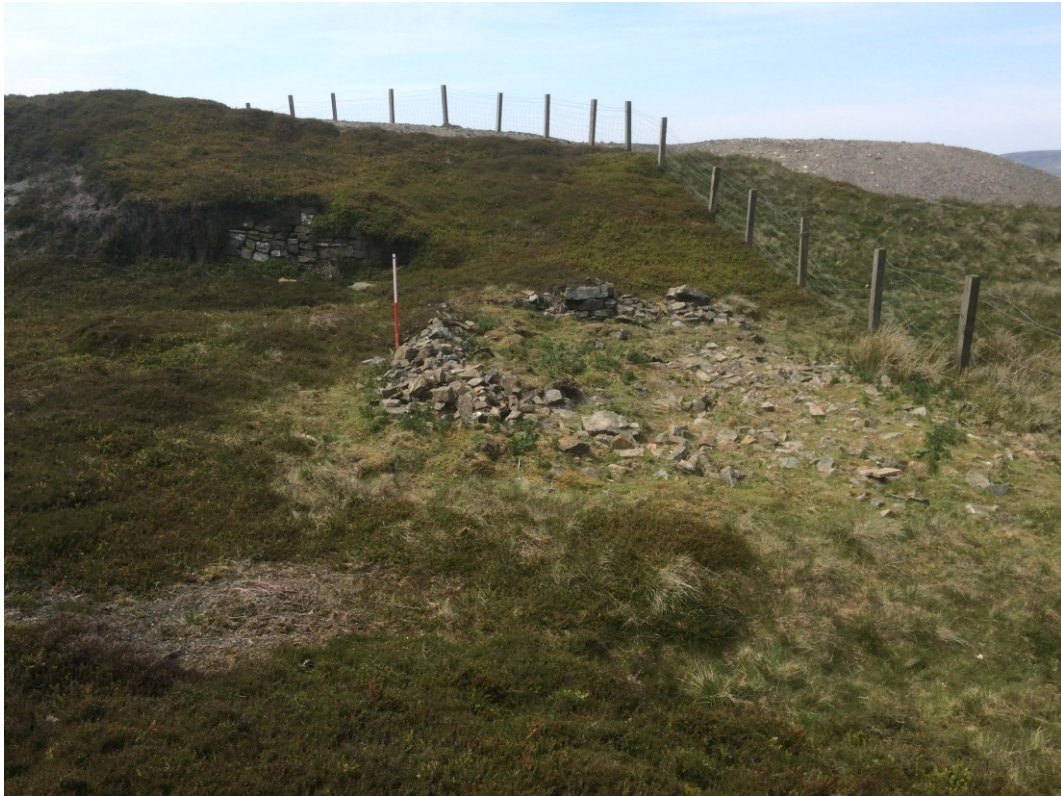
Figure 7 Looking west along the long axis of the ruined building and with the retaining wall visible to the rear left of shot (scale 1m)

The ruined structure comprises a single basal course of stone block walling, truncated to the east end, and measuring c.8.5m x 6m in plan. The construction of the wall appears to have been double skin with rubble core but the structure has been comprehensively demolished and so assigning a specific function to it is difficult.

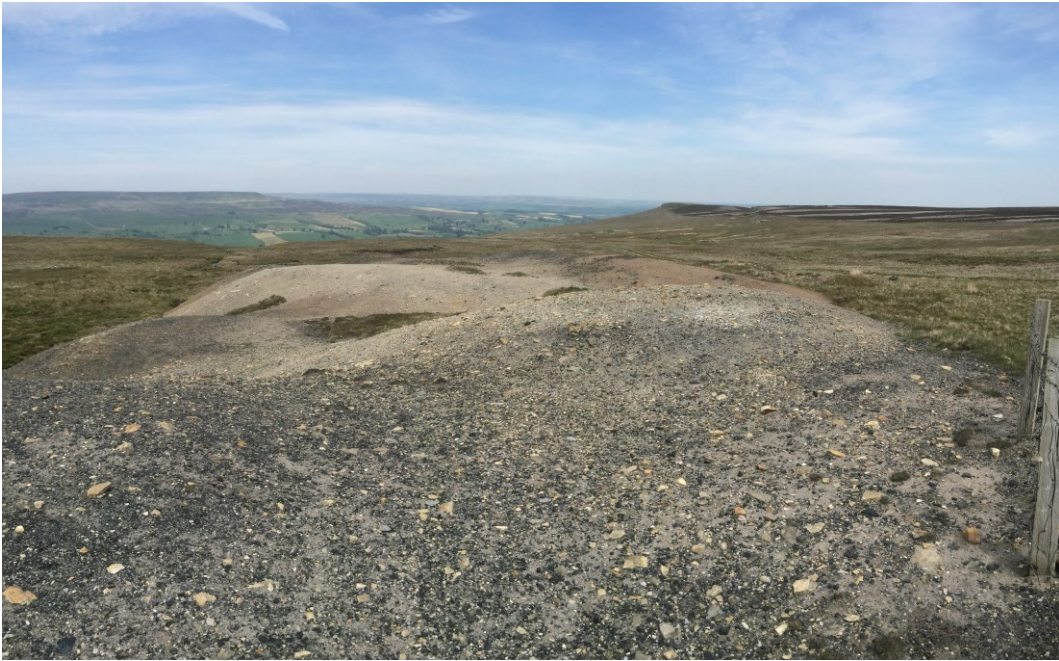
Figure 8 Looking north across spoil heap (7) showing the fine and friable nature of the non-vegetated spoil

The most prominent features within the complex of earthworks are the substantial spoil heaps (5-7) that surround the shaft and ruined building. It is known from documentary records that the 60 Fathom Shaft had saw two periods of working, and so it is likely that worked spoil remains from both the late 18<sup>th</sup> to early 19<sup>th</sup> century period of use and the early 20<sup>th</sup> century reopening. The spoil is fine and loose and appears relatively homogenous in character, with no obvious distinctions to be made between the spoil resulting from separate periods of working. There appears to have been re-working of at least the western spoil heap (6), visible on the survey as a large scooped area from the south-west corner, though pre-dating the erection of the fence around the core remains.

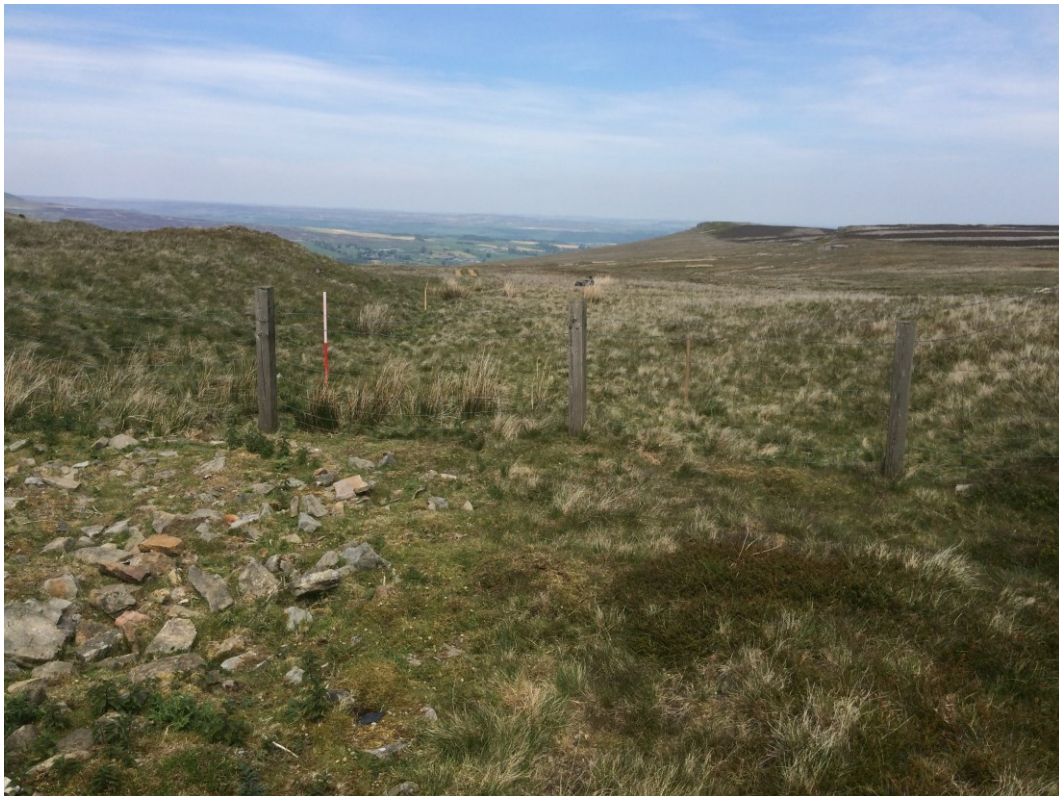
The proposed hut footprint overlies the route of the historic access track, which the survey has demonstrated is built up with stone and aggregate to form a level surface. Any invasive work would impact on this feature as it is a component of the archaeological site, though its archaeological interest is limited. With the hut base being built up above the modern ground level and the old track, this would effectively preserve it in place, and would provide a more secure base for the construction than the fragile spoil heaps to either side.

Part of the eastern spoil heap has spread across the old track and the footprint of the proposed hut, and may require clearing to provide a solid base for construction. This would result in a direct impact, though the archaeological interest and potential information gain from monitoring this work is considered to be negligible given the nature of the deposits. Perhaps more significant is the potential for ongoing erosion of the fragile and friable spoil heaps through increased footfall, particularly with the proposed footprint sitting so tightly against the east and west spoil heaps. This could be alleviated to some degree through relocating the footprint further to the north, avoiding the eastern spoil heap whilst still sitting over the old trackway.

Figure 9 Looking north from within the two main spoil heaps with the ruined building in the foreground. The west edge of the old trackway is visible as a difference in vegetation and the footprint of the proposed hut is shown by three wooden stakes and the 1m ranging rod at the near left corner.

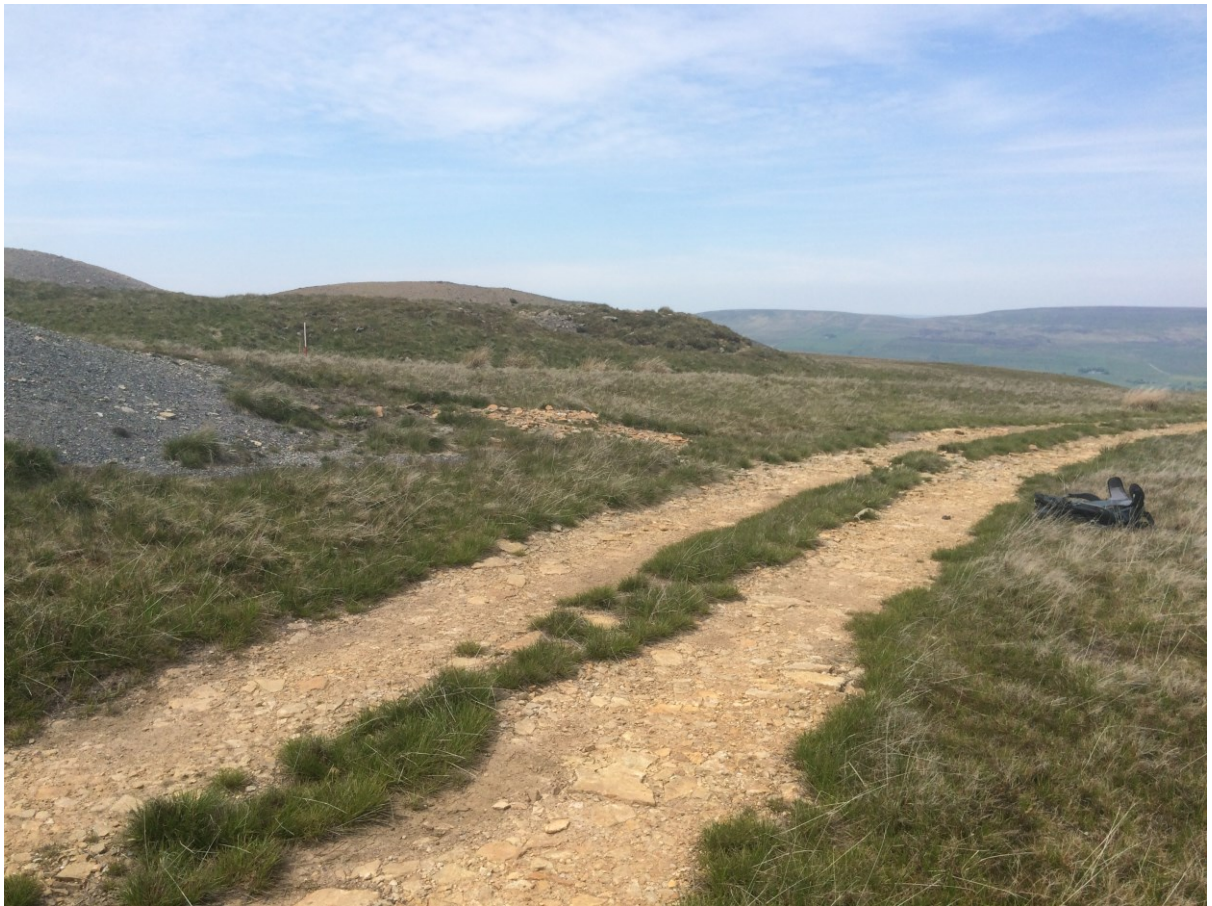
Figure 10 View west across the northern edge of the earthwork remains and the modern track. The ranging rod shows the front edge of the hut on its present footprint. The western spoil heap beyond would continue to provide screening should the hut be brought forward a short distance to minimise potential impacts on the nearer (non-vegetated) spoil heap.

The proposed footprint currently minimises visibility from the wider landscape but also has a direct impact on part of the spread from one of the spoil heaps. As is noted above, a position so close to the spoil heaps also raises the potential risk of increased footfall adjacent to the building and therefore erosion of the more fragile remains. Relocation of the footprint a short way to the north would bring the hut away from the most fragile parts of the spoil whilst still siting it on the hard standing of the old trackway. The fact that the western spoil heap extends further north than the eastern means that it would still provide screening from the most open views should the building be relocated to the north, as is illustrated by Figure 10.
