Scarr House Farm, Muker, North Yorkshire

Historic Building Recording

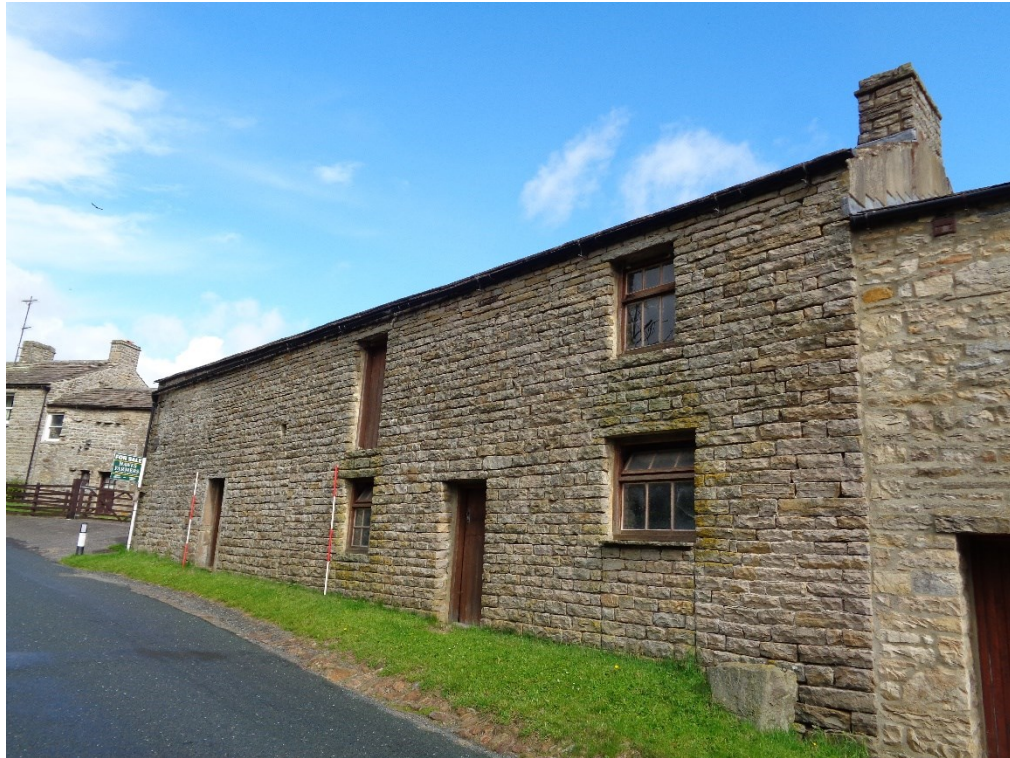
Figure 2 South elevation of Building A, facing north-west. Scale 2x2m

This elevation is the principal elevation of the building (**Error! Reference source not found.2**). The elevation is constructed in well coursed squared masonry. The elevation is made up of an earlier cottage at its eastern extent, which has been latterly adjoined by a barn to the west. The barn includes an original close-boarded doorway within a stone surround at ground floor level giving external access to Room G1 within (Figure 3). To the east of this a clear construction break marks the point at which the barn has been added to the earlier cottage. To the east of the barn, the earlier cottage includes a central, original, ground floor doorway with close boarded door (Figure 4). To the east of the central doorway an original window with a stone sill and lintel is present at first floor level, incorporating a replacement casement window. Below this is another window with replacement frame. This eastern ground floor window has been created by blocking the lower portion of a previous doorway to create the window opening; however, it seems most likely that the doorway itself replaced an original window, most likely of matching proportions to that above it. This would have formed an original 'two over two' arrangement of windows typical for the age of the building. The wide, higher, opening of the previous doorway is most likely to have been created when Room G3 within was converted into a stable, the doorway required to give access for horses to this previously domestic space. The awkward stonework at either end of the lintel, as well as the fact that it does not sit in line with the other ground floor lintels, suggests almost certainly that it has been raised.

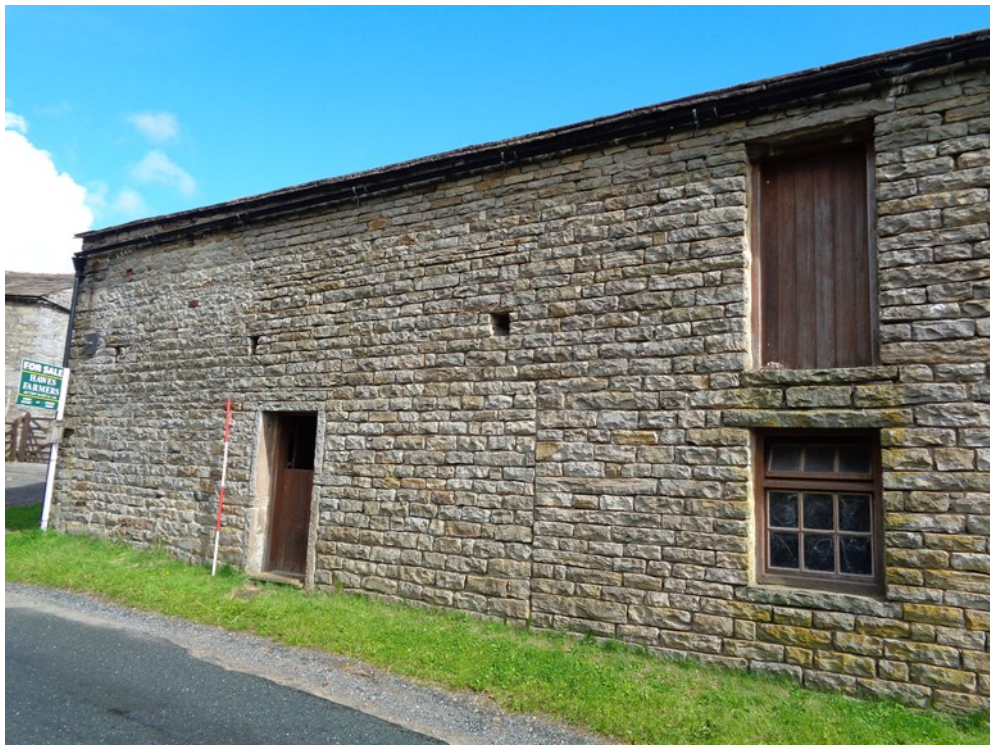
Figure 3 South elevation of Building A, western extent. Scale 1x2m

To the west of the central doorway, the cottage has a further original ground floor window with replacement frame (Figure 3). Above this a first floor hayloft door has been created, giving access to Room F2 internally. This doorway seems certain to have been created from an original window by lowering the sill to create a threshold for the door at internal floor level. This was presumably undertaken to create a new hayloft in Room F2, which was presumably previously used as a domestic bedroom. Above this elevation, the roof is pitched and covered in traditional stone slates. The eastern extent of the roof has a simple stone stack with squared cornice. The other end of the cottage must have previously had a stack, which was presumably removed when the interior spaces were converted for agricultural use, or perhaps during the modern re-roofing of the building.

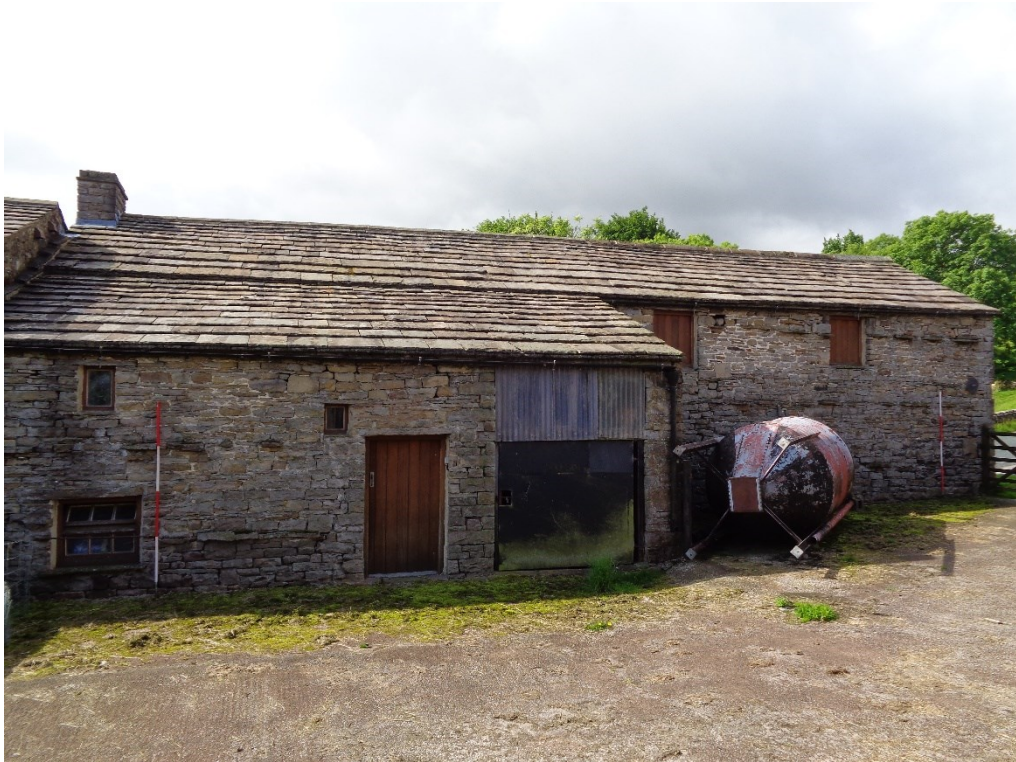
Figure 5 North elevation of Building A, looking south-west. Scale 2x2m

This elevation is the rear elevation of the building (Figure 5). The elevation is generally constructed in roughly coursed masonry of a poorer quality than the principal southern facade. The elevation is made up of an earlier cottage, covered by a lean-to rear extension, at its eastern extent, which has been latterly adjoined by a barn to the west. The barn includes an original close-boarded doorway within a stone surround at ground floor level giving external access to Room G1 within (Figure 6). To the east of this a clear construction break marks the point at which the barn has been added to the earlier cottage. At first floor, the construction break between the barn and the cottage forms the left reveal of a boarded window, which itself has been formed from an original hayloft doorway by blocking the lower portion of the original opening (Figure 6). To the west of this another boarded window is located at first floor level.

Above this elevation, the roof is pitched and both the main roof and the lean-to are covered in traditional stone slates. The eastern extent of the main roof has stone ridge tiles, whilst the western portion has later clay examples, illustrating the two main phases of construction within the linear range.

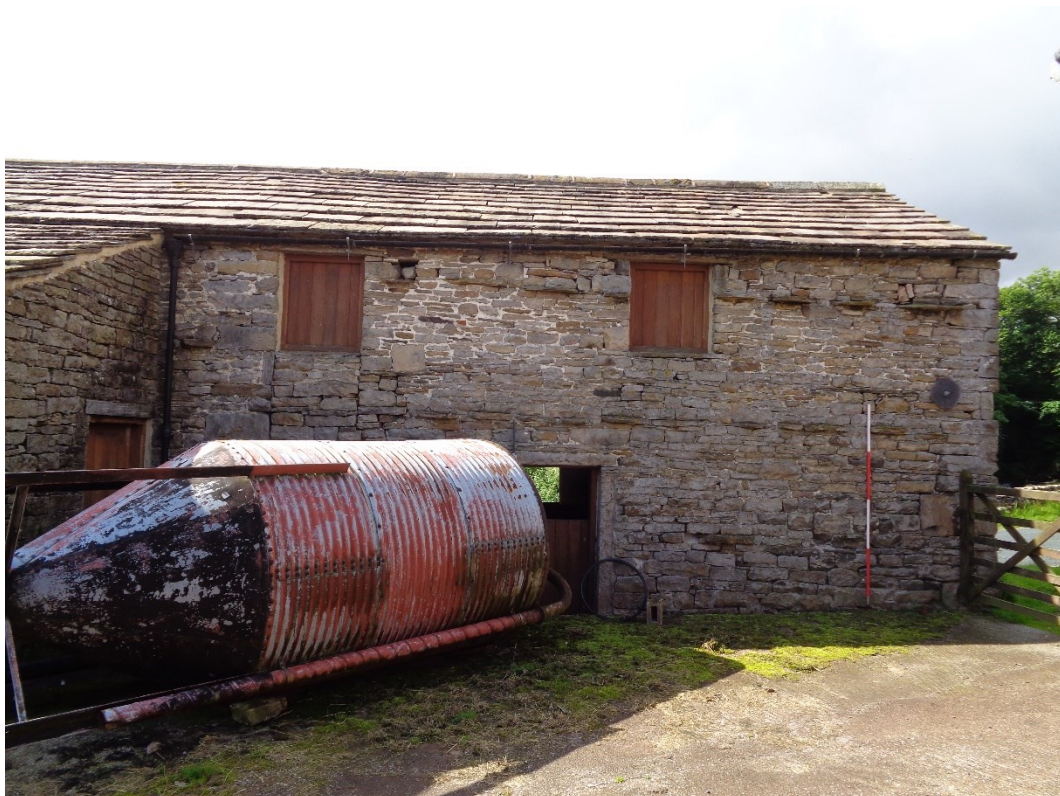
Figure 6 Western extent of North elevation of Building A. Scale 1x2m

The rear elevation of the original cottage has been covered by a lean-to extension, which includes a short section of west facing elevation including a wide door with wooden lintel over (Figure 6). The north facing elevation of the lean-to includes a large inserted opening giving access to Room G6, which was presumably inserted when that room was converted into a sheep dip. The opening is closed by plastic corrugated sheeting and a steel frame door. To the west of this an original doorway has a stone lintel and replacement close-boarded door. Two small windows illuminating Rooms G4 and F3 sit above a larger casement window to Room G5. All are original to the lean-to extension and have replacement frames and lights.

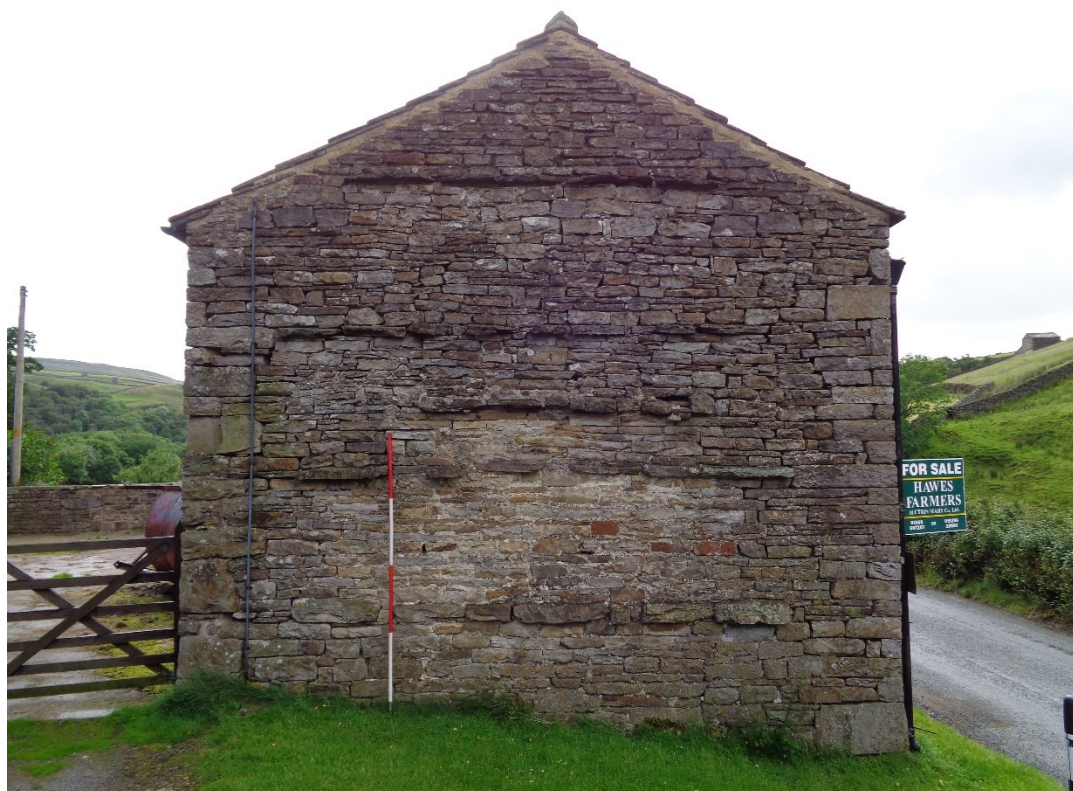
Figure 7 West elevation of Building A, looking east. Scale 1x2m

This elevation is the one visible gable elevation of the building (Figure 7). The elevation is constructed in squared rubble, well coursed, with occasional quoins. The elevation is generally featureless except for occasional projecting courses of stonework, presumably intended to provide a key for an additional building if one was ever added to the linear range.

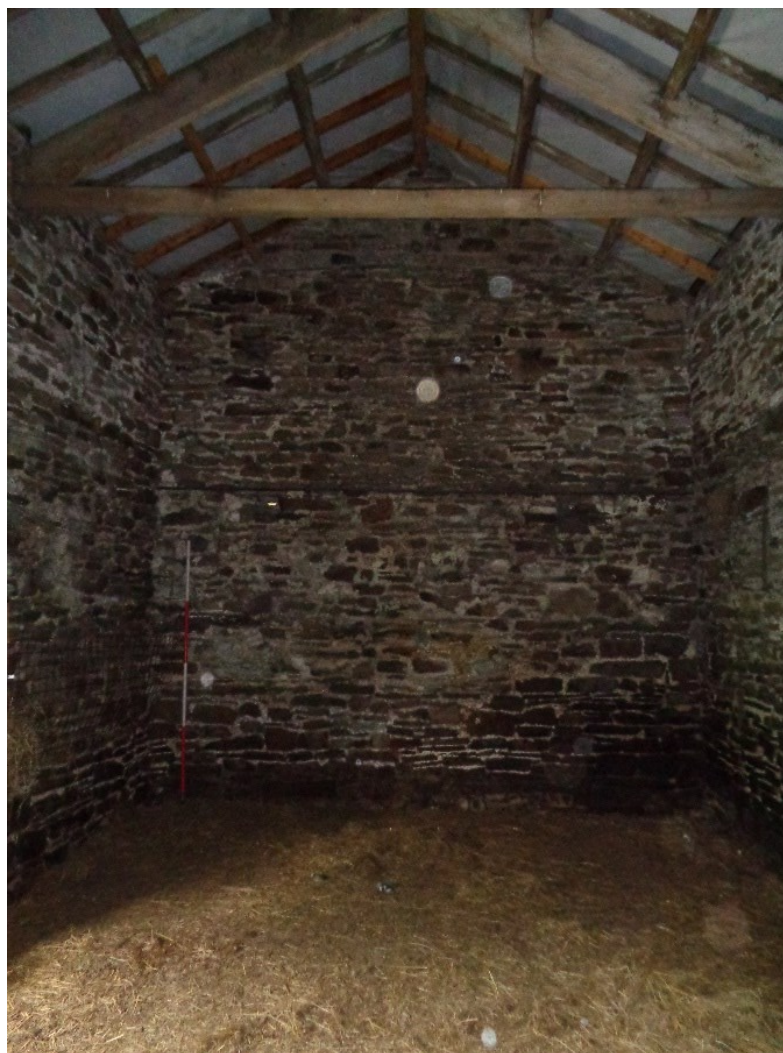
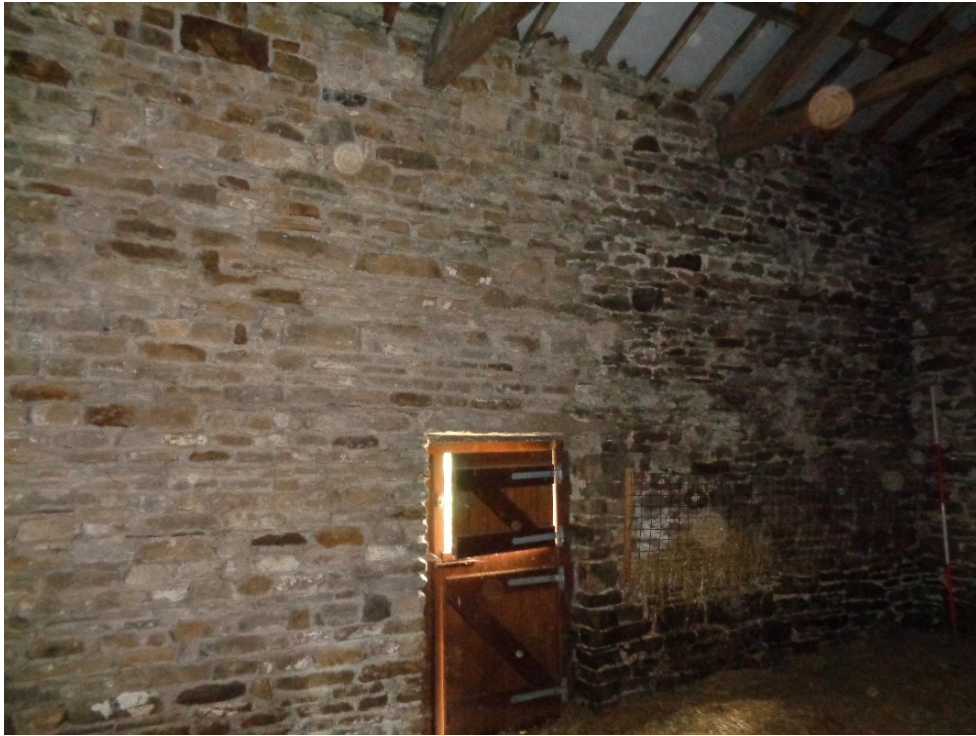
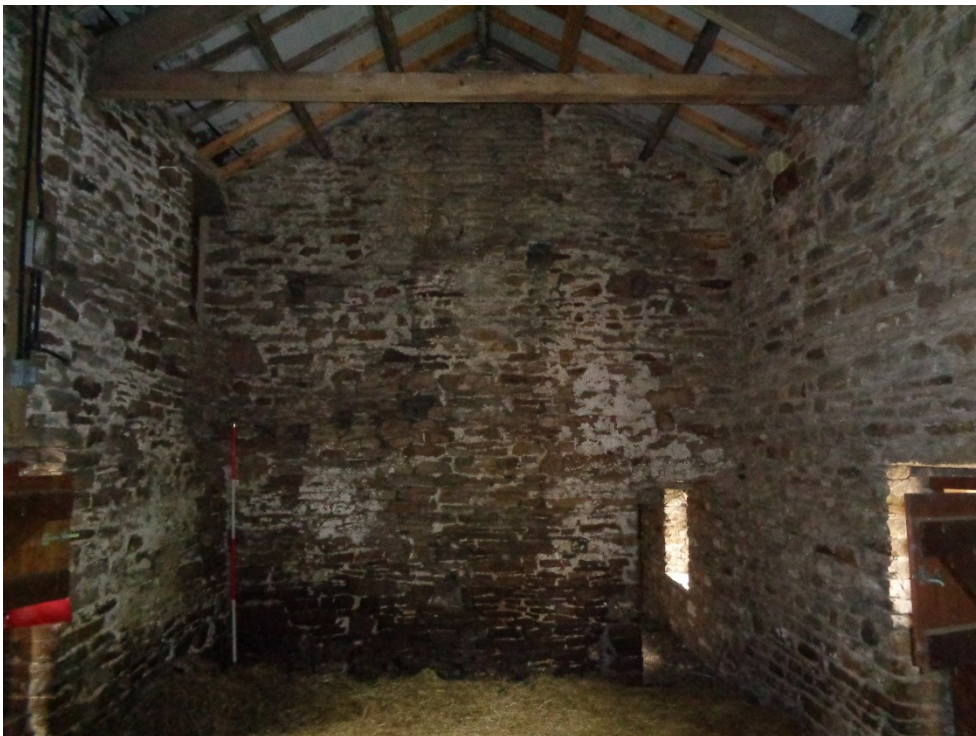
Room G1 is accessed by opposing original entrance doorways at its south and north sides, leading to a single main space. All the walls within the room contain evidence, in the form of joist holes and a step in the stonework, to show that originally the double height space included a first floor hayloft. The west gable wall is featureless except for the aforementioned step (Figure 8). The south wall contains the entrance door mentioned above (Figure 9), as well as a construction break at its eastern extent, illustrating the join between this later barn and the earlier cottage to the east. The east wall is featureless except for an inserted doorway to Room G2 at its south extent (Figure 10). The insertion of the doorway shows that the barn was not joined to the cottage immediately when built, but later. This suggests that the alterations to accommodate stock within the domestic spaces of the cottage did not occur at the same time as the barn was built. The north wall of the room includes an original entrance

The room is open to the roof, which consists of a modern undercovering with replacement rafters over older purlins and two common trusses. consists of squared beams with boards above, whilst the floor is a later concrete insertion. The room as clearly created as accommodation for livestock at ground floor level, with a first floor hayloft above, as is common in this type of farm building.

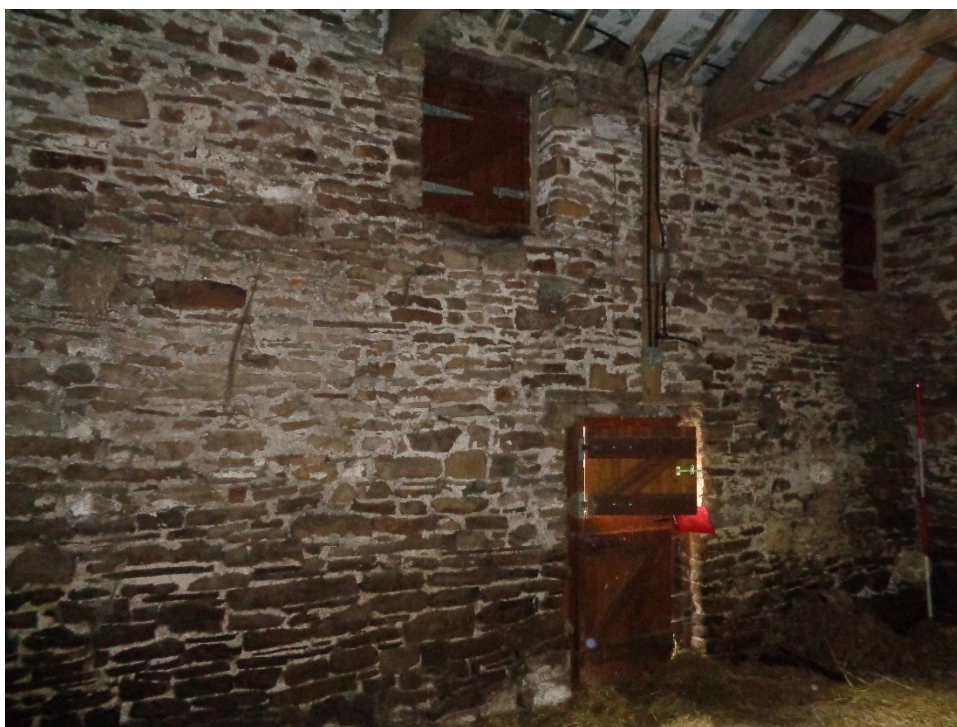
Figure 11 Room G1, facing north-east. Scale 1x2m

doorway at ground floor level, opposite that on the south wall (Figure 11). At first floor level the wall includes a boarded original window to the west and a window to the east, which was originally a hayloft door, but later partially blocked to form a window.

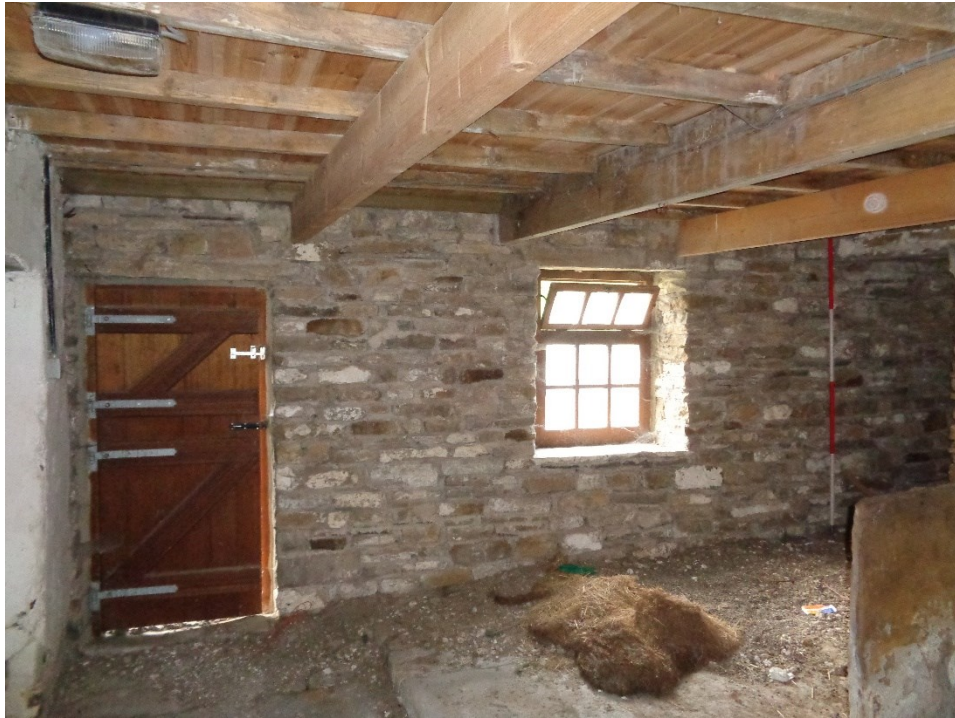
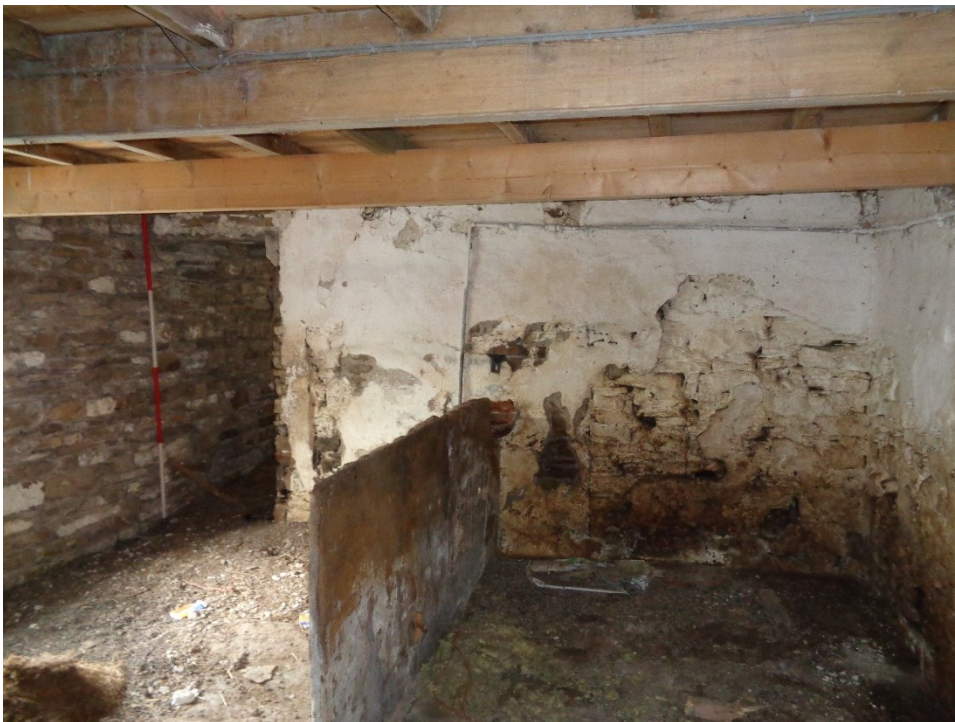
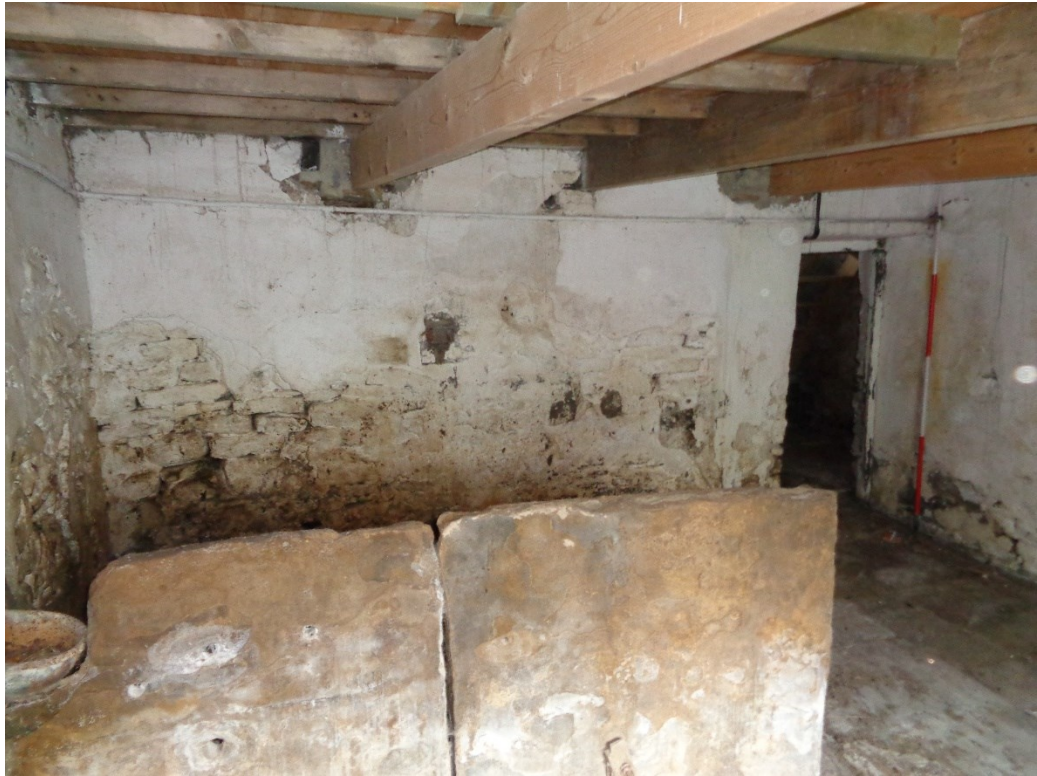
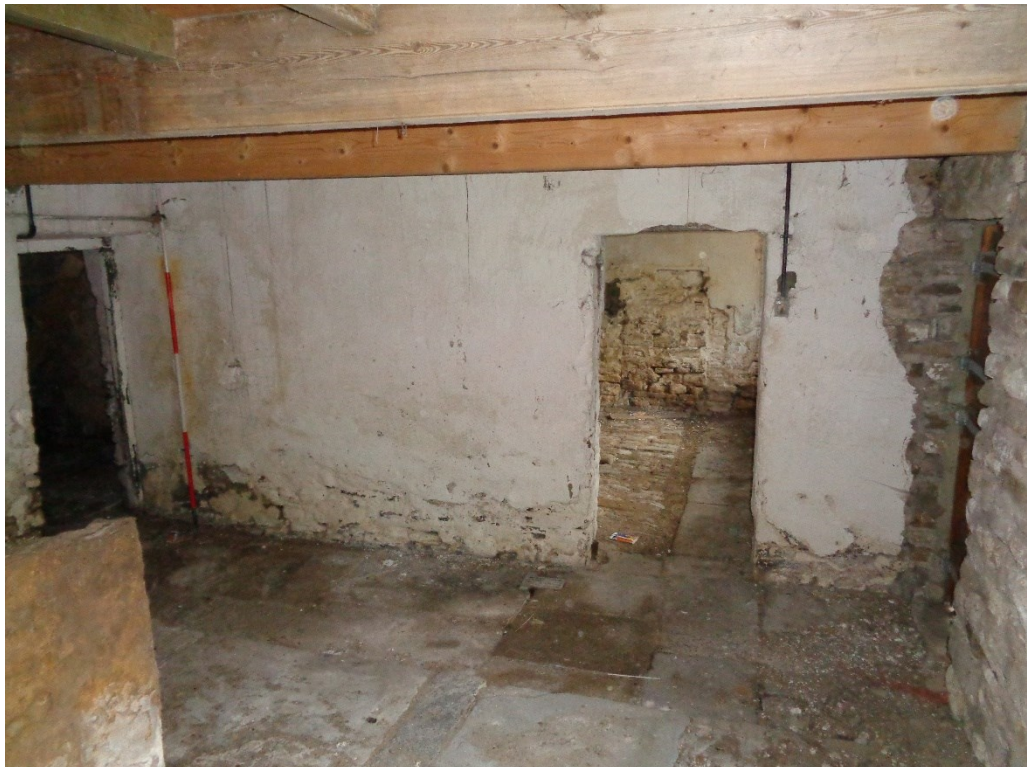
Room G2 sits within the earlier cottage phase of the range, accessed internally by an inserted opening from Room G1 at its west side and doorways at its north, east and south sides from Rooms G4, G3 and the exterior respectively. The south wall of the room includes an original splayed window opening with replaced frame as noted externally, and a wooden boarded exterior doorway to the east of this (Figure 12). The west wall includes a doorway inserted through the original end wall of the earlier cottage, at its southern extent, whilst to the north of this is a blocked fireplace (Figure 13). This original fireplace has been partially covered by the later insertion of two stone slates to act as a boskin, creating stalls within the western portion of the room. The boskin sits within an inserted raised area of stone flagging for the stalls, leaving an area of earlier flooring exposed to create a foddergang between the two doors in the north and south walls of the room (Figure 15). The stone floor of the foddergang is probably the original floor covering of the room. The stone slates themselves are possibly re-used in this context, given the presence of remnant holes for surrounding timberwork (Figure 14), which does not appear to have been present within their installation here. This evidence again clearly illustrates the change in use of this space from domestic to agricultural use during its history. The north wall includes an original doorway at its eastern extent and is otherwise featureless (Figure 14). The east wall contains an original doorway close to its southern extent and is also otherwise featureless (Figure 15). The ceiling in this room is formed of the recently replaced floor construction of Room F2 above. This is the case throughout Building A, where no original floors have survived to be recorded.

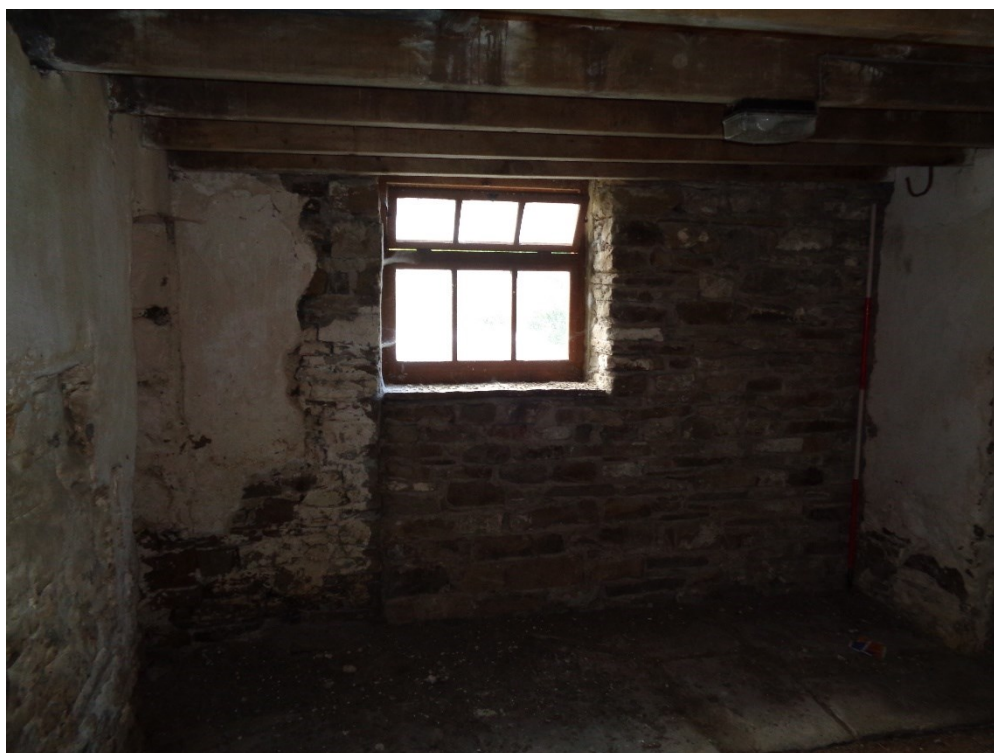
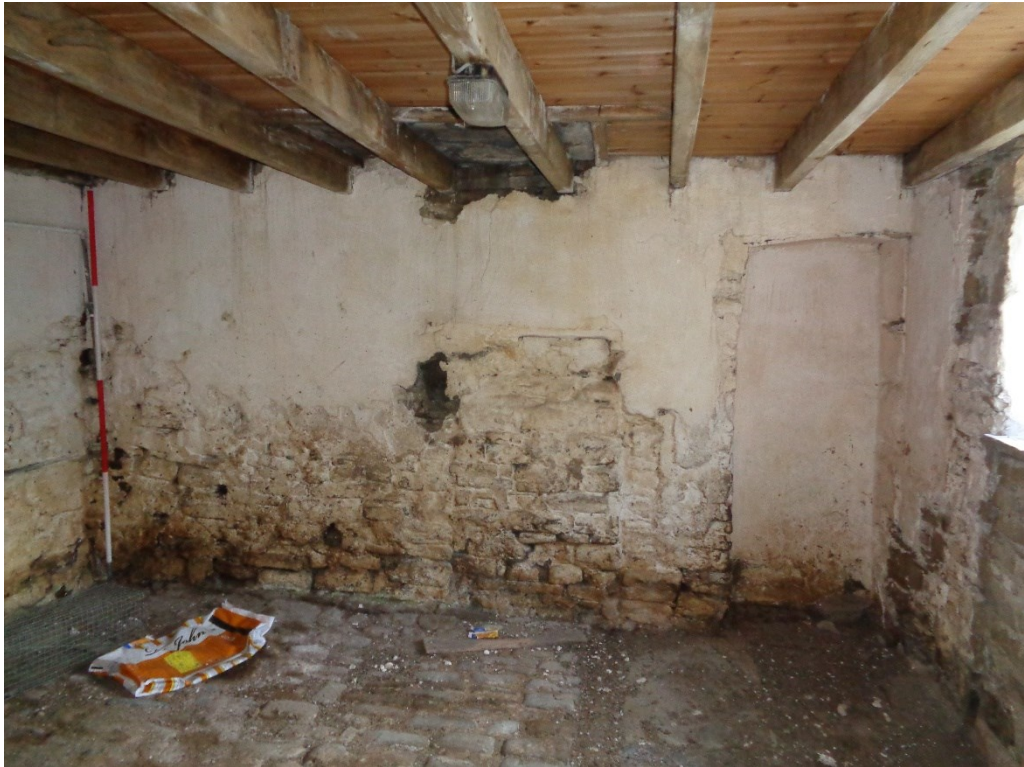
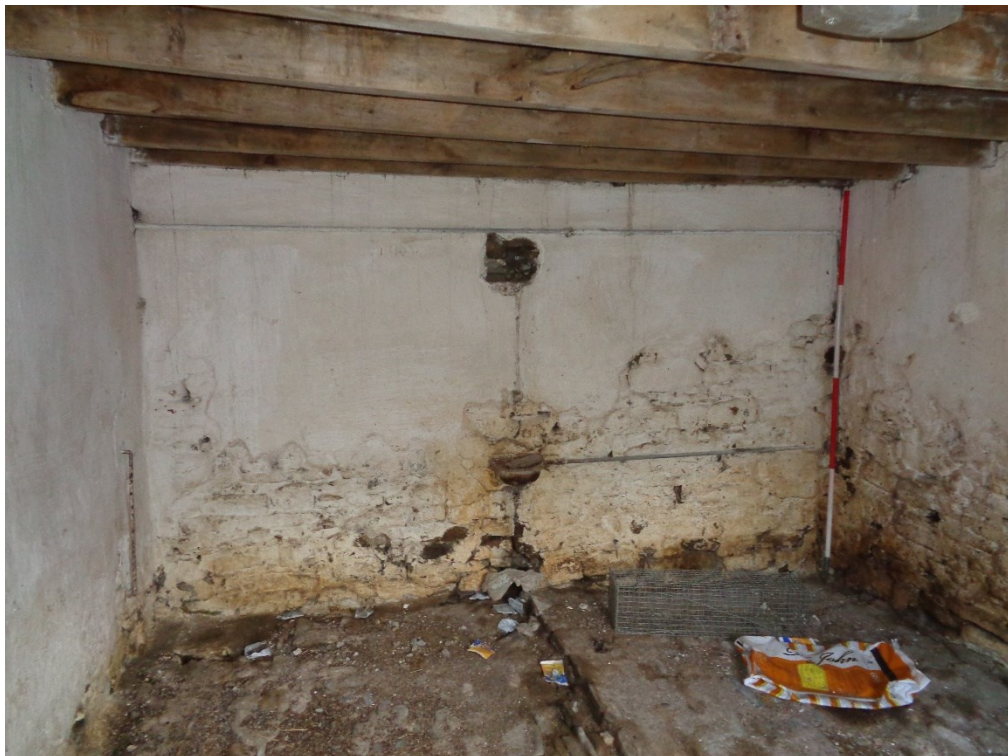
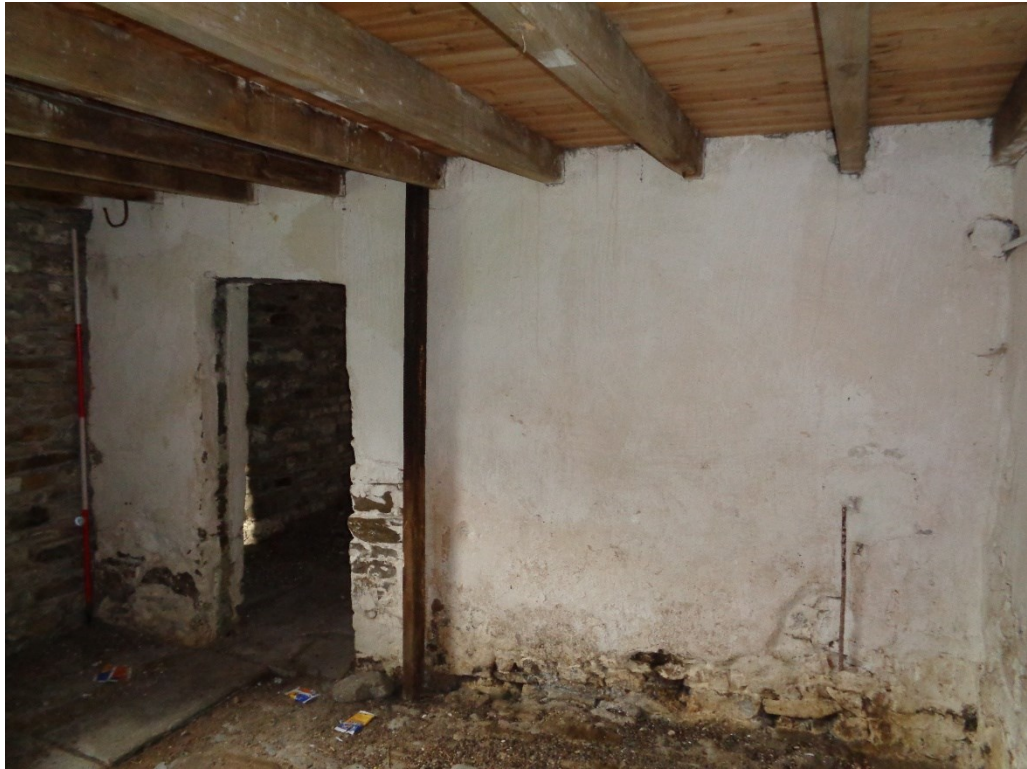
Room G3 sits within the earlier cottage phase of the range, accessed internally by an original opening from Room G2 at its west side. The south wall of the room includes an inserted window opening with replaced frame as noted externally (Figure 16). The window has been created by blocking the lower portion of a previous doorway to create the window opening; however, it seems most likely that the doorway itself replaced an original window, most likely of matching proportions to that in the south wall of Room G2. This would have formed an original 'two over two' arrangement of windows typical for the age of the building. The wide, higher, opening of the inserted doorway is most likely to have been created when Room G3 was converted into a stable, the doorway required to give access for horses to this previously domestic space. The east wall includes an alcove, formerly shelved, within this original end wall of the earlier cottage, at its southern extent, whilst to the north of this is a blocked fireplace (Figure 17). This original fireplace was most likely blocked during the alteration of this room to accommodate two stalls within the northern portion of the room. The timber boskin separating the two stalls has been removed, however its position is visible as a beam slot and post setting within an inserted area of stone cobbling for the stalls, leaving an area of earlier flooring exposed to create a foddergang at the southern extent of the room, separated from the stalls by a stone drain gutter (Figure 20). The stone floor of the foddergang is probably the original floor covering of the room. This evidence again clearly illustrates the change in use of this space from domestic to agricultural use during its history. The north wall is generally featureless (Figure 18), whilst the east wall contains an original doorway close to its southern extent and is also otherwise featureless (Figure 19). The ceiling in this room is formed of the recently replaced floor construction of Room F1 above.

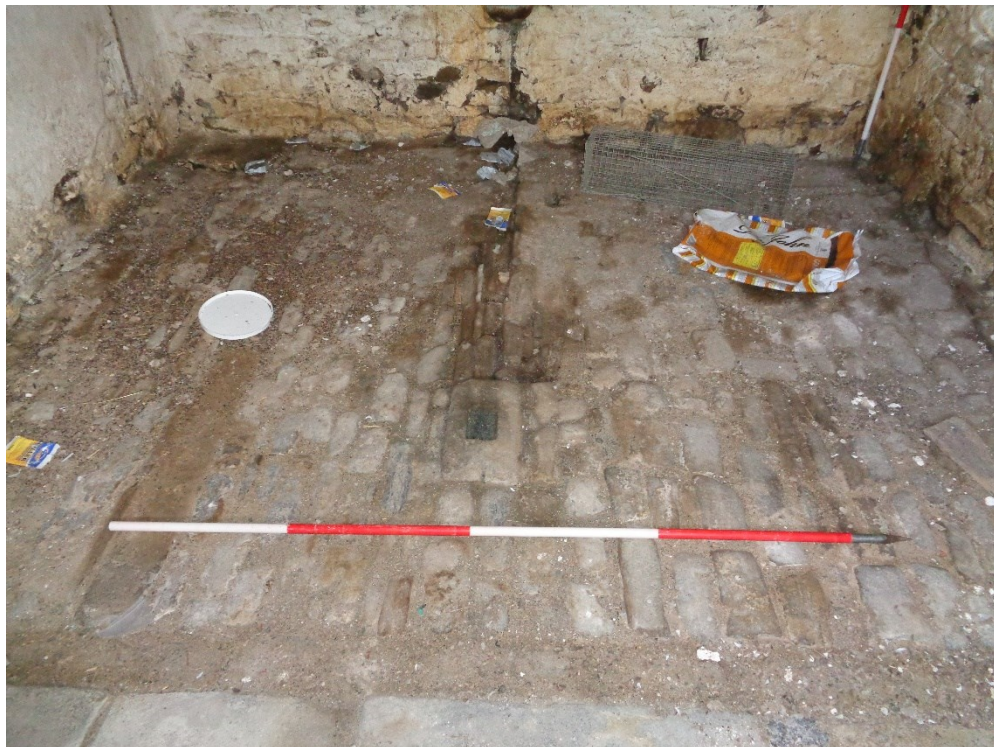
Figure 20 Detail of floor of Room G3. Note central partition for stalling. Scale 1x2m

Later, an important alteration to the buildings, is represented by the re-use of domestic spaces within the cottage for the housing of stock on the ground floor, with further hay storage above in Room F2. The specific alterations to the ground floor rooms suggest that Room G3, which had been a kitchen, was re-used as a stable for horses and Room G2, built as a domestic reception room was re-used as a shippon for cattle.

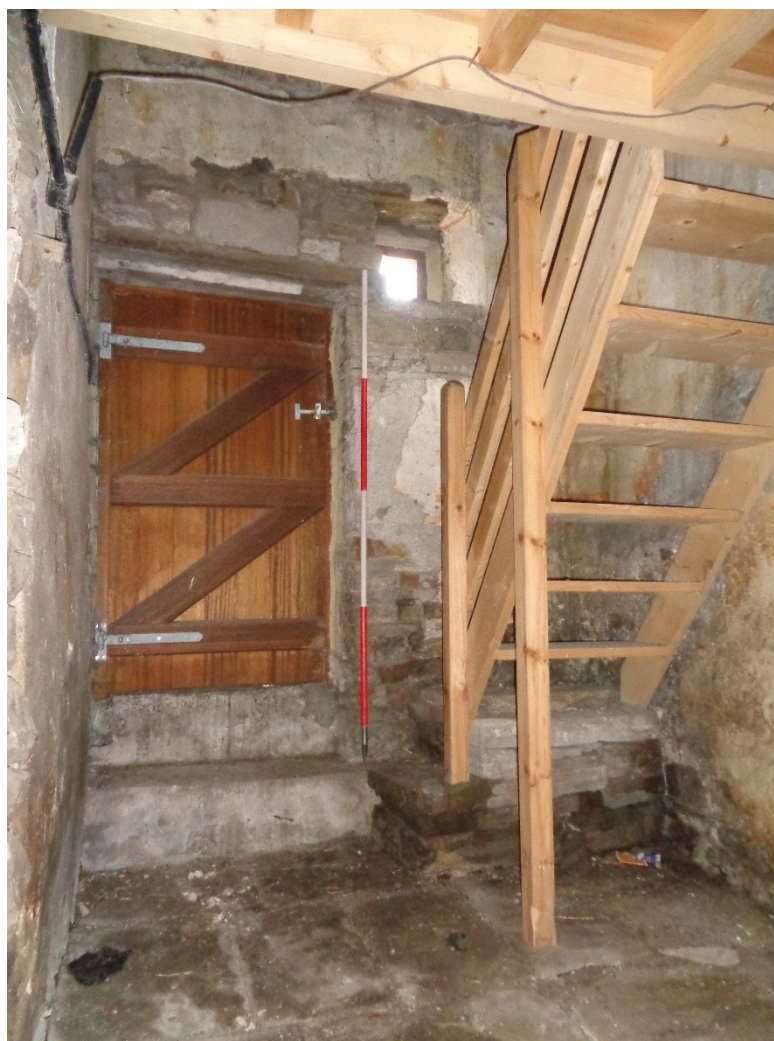
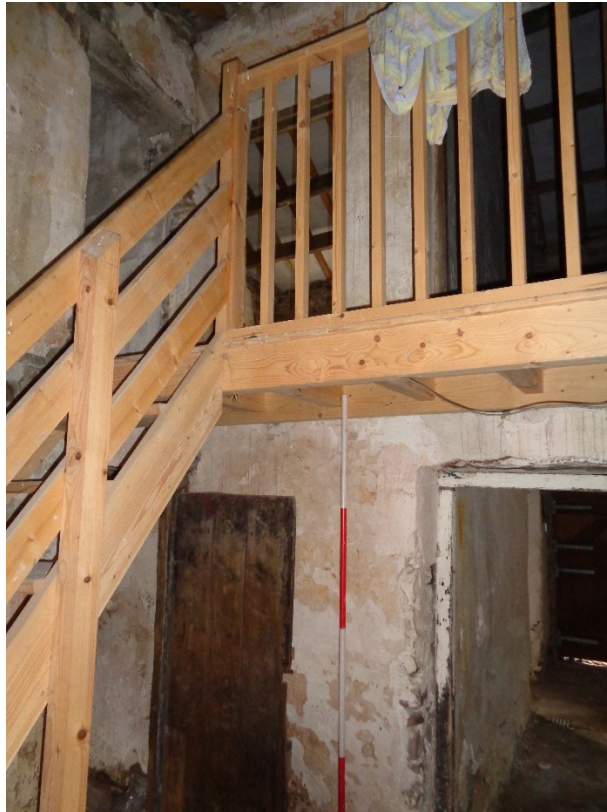
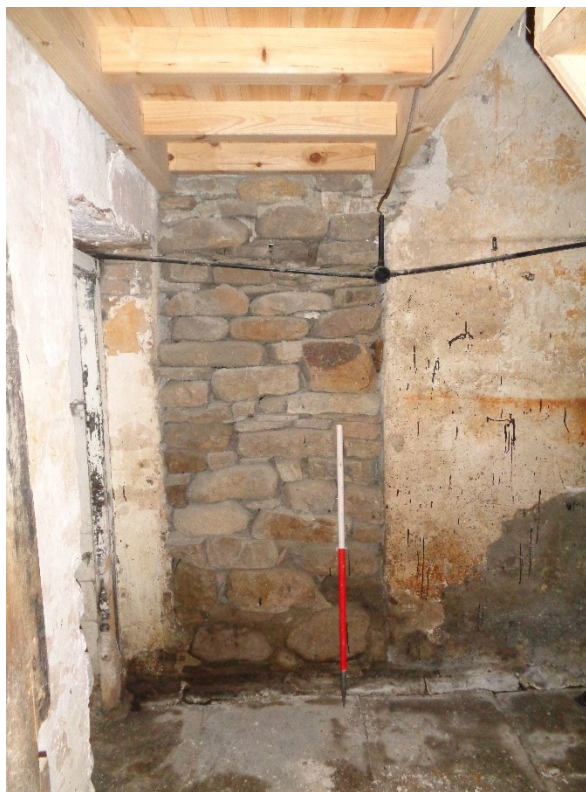
Room G4 is a rear entrance hall and stair within the lean-to extension to the north side of the earliest cottage. The hallway is accessed by a replacement close-boarded door within the north elevation of the building (Figure 21). Two steps lead down from the higher exterior ground level to an original stone floor. The short hall is accessed by a doorway within its south wall from Room G2, which is most likely the original rear door of the cottage (Figure 22), as well as giving access to Room G5 via a doorway in its east wall. The hallway also has an original doorway, now blocked, at its south-west corner, which would previously have given access to Room G6 beyond (Figure 23). The landing and stair are recent replacements, leading to an older, possibly original, stone corner step, a typical feature of stairs within agricultural buildings. At first floor level, the landing gives access to Rooms F1, F2 and F3, combining with the stone corner step to suggest that the layout of the replacement stair and landing is as original.

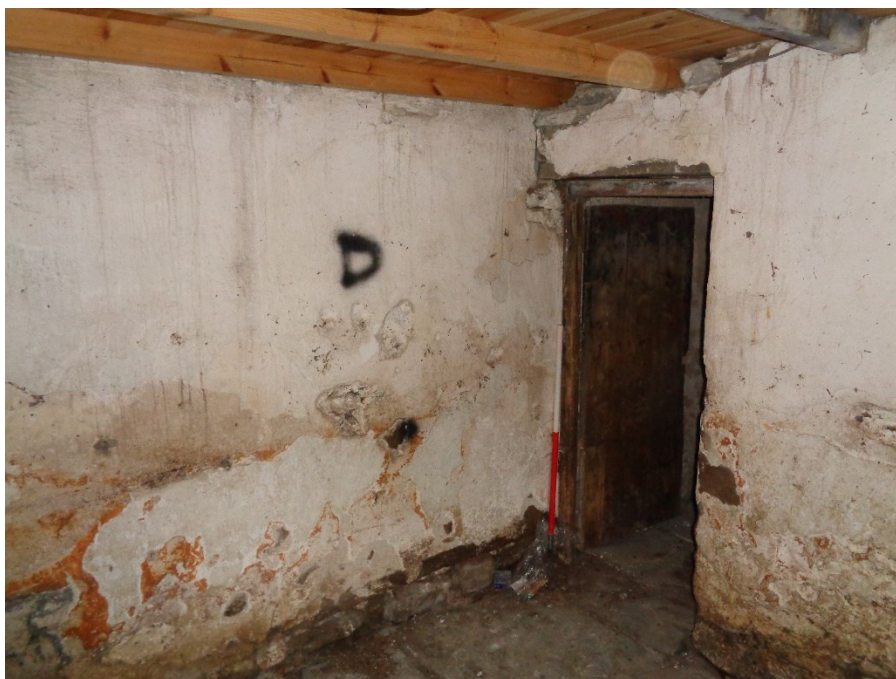
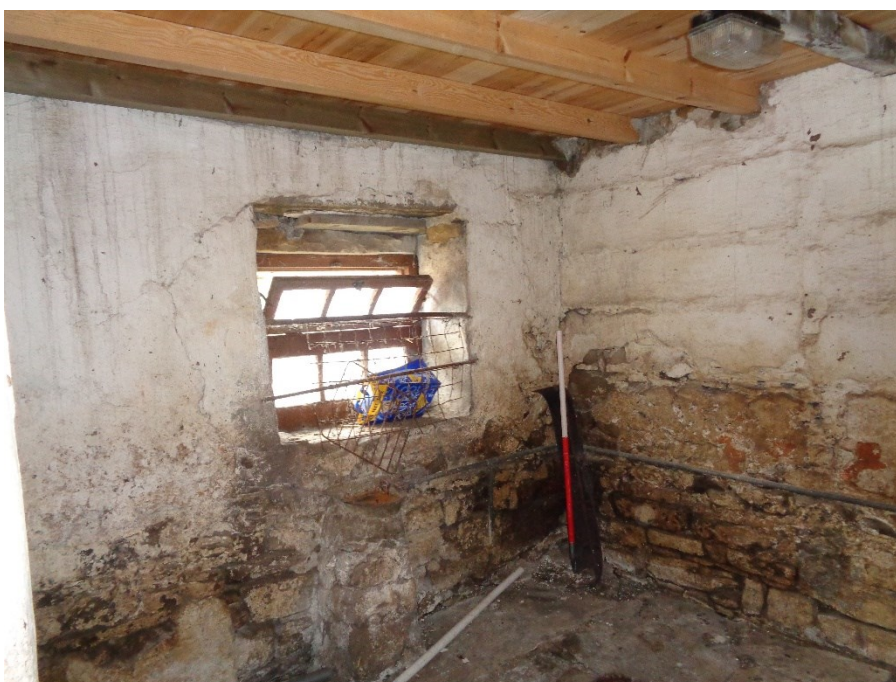
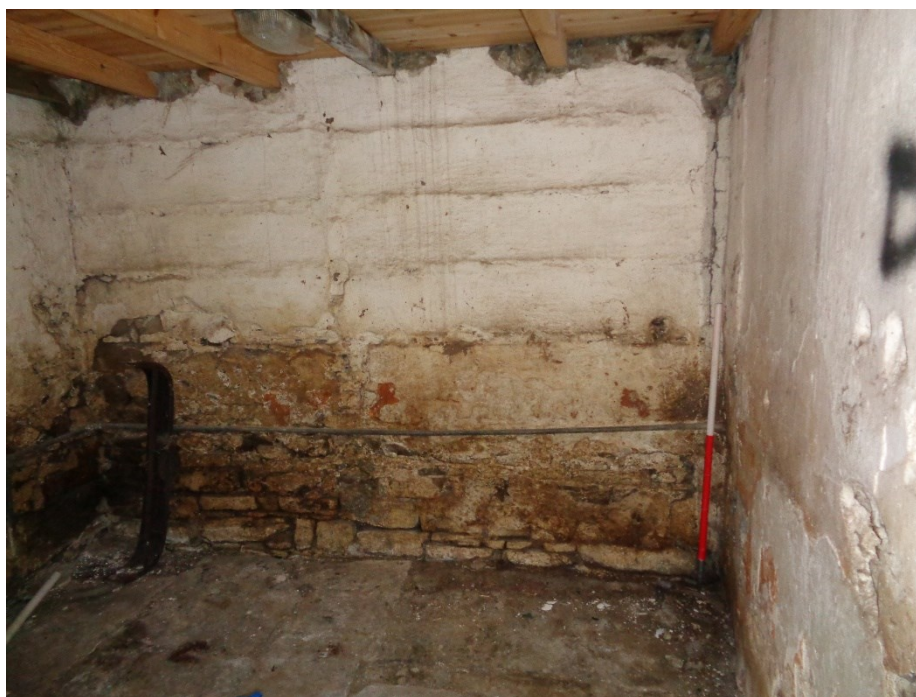
Room G5 sits within the lean-to extension to the north side of the earliest cottage. The room is accessed by an original door at its south-west corner (Figure 24). The north wall of the room has a square window with a replacement frame (Figure 25). The east wall includes horizontal raised stripes within the lime plaster, suggesting that this wall once hosted shelving (Figure 26). Such a typical feature would suggest that it was created as a pantry or scullery for the main cottage.

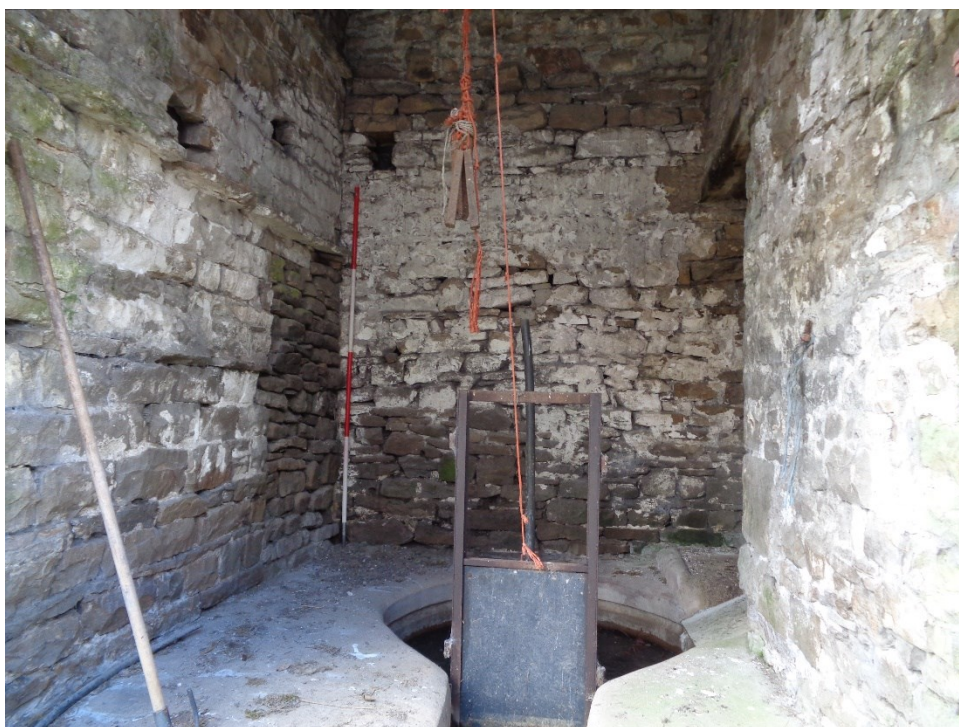
Figure 27 Room G6, facing south. Scale 1x2m

Room G6 sits within the later lean-to extension to the north side of the earliest cottage. This room was accessed internally by a now blocked door from Room G4 at its south-east corner (Figure 27). The room also has a large inserted external opening at its northern side, which has removed most of its northern wall, as well as a probably original doorway at its south-west corner. The floor of the room has been raised and altered to include a modern sheep dip, cast mainly in concrete. This wholesale change, including the large modern opening in the north wall have removed a significant amount of the original fabric of this space, leaving it uncertain as to what purpose it was created to serve. Equally, it is possible that it may represent a further addition to the building after the construction of the rear lean-to containing Rooms G4 and G5.

Later again, predominantly late 20th-century alterations to the farm building include the installation of a sheep dip within Room G6 and the renewal of much of the timberwork throughout the buildings. These changes particularly have removed some evidence which would have provided further information on the structural history of the buildings.
