Scarr House Farm, Muker, North Yorkshire

Historic Building Recording

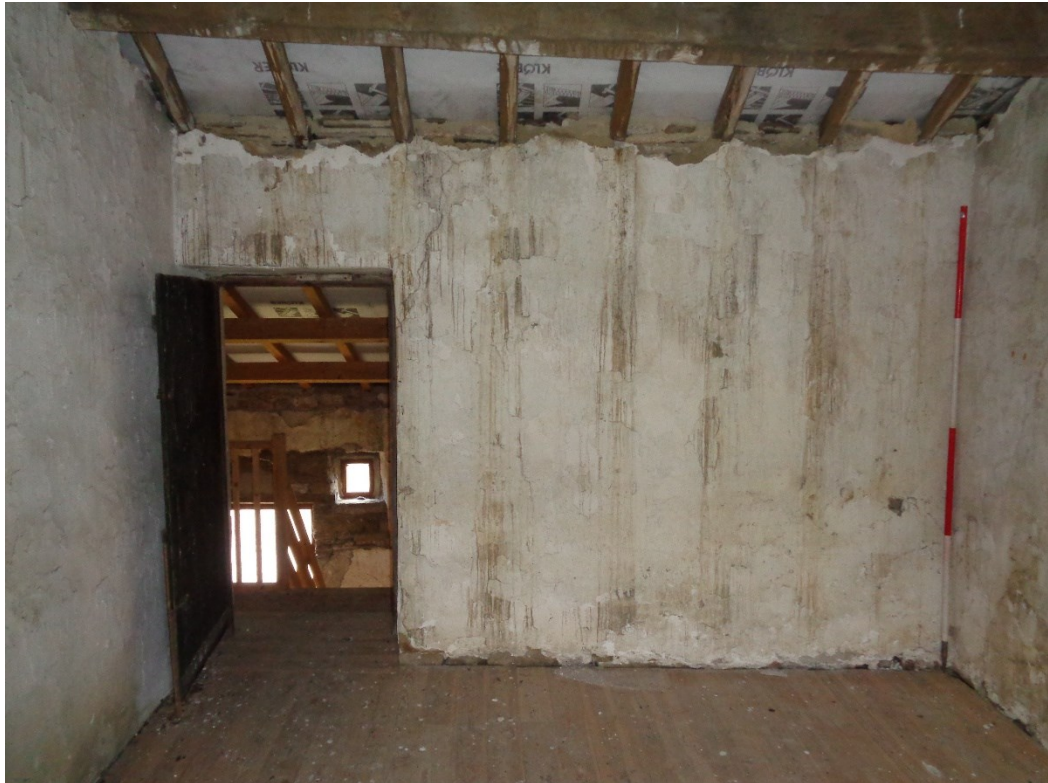
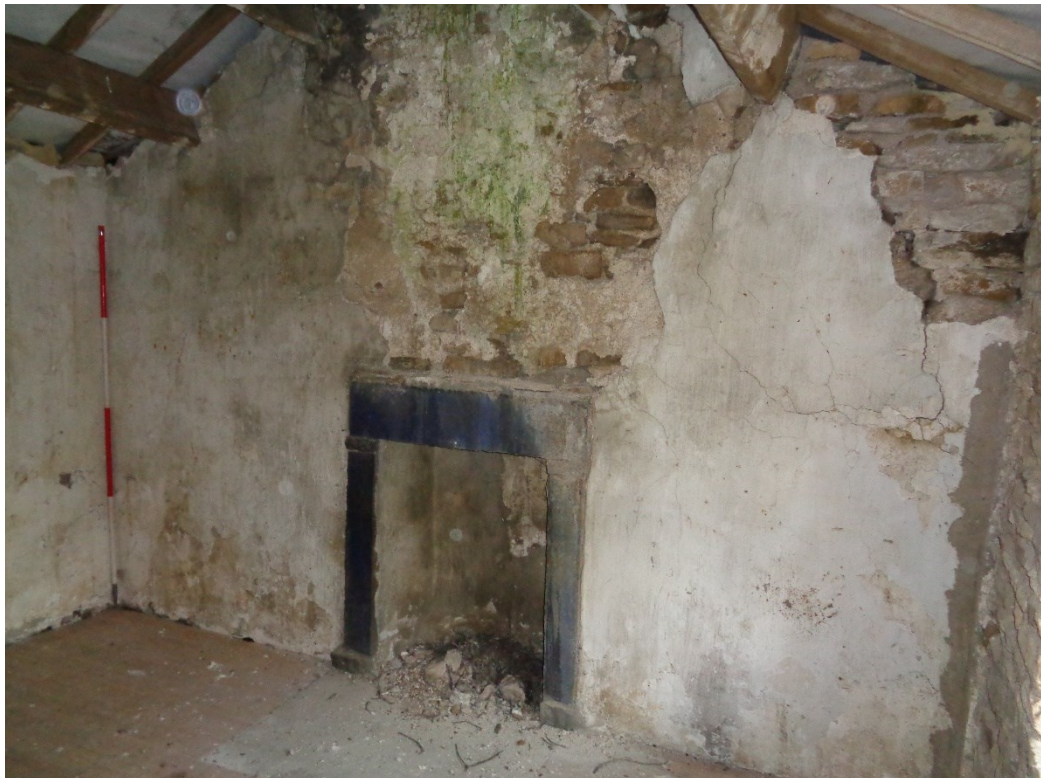
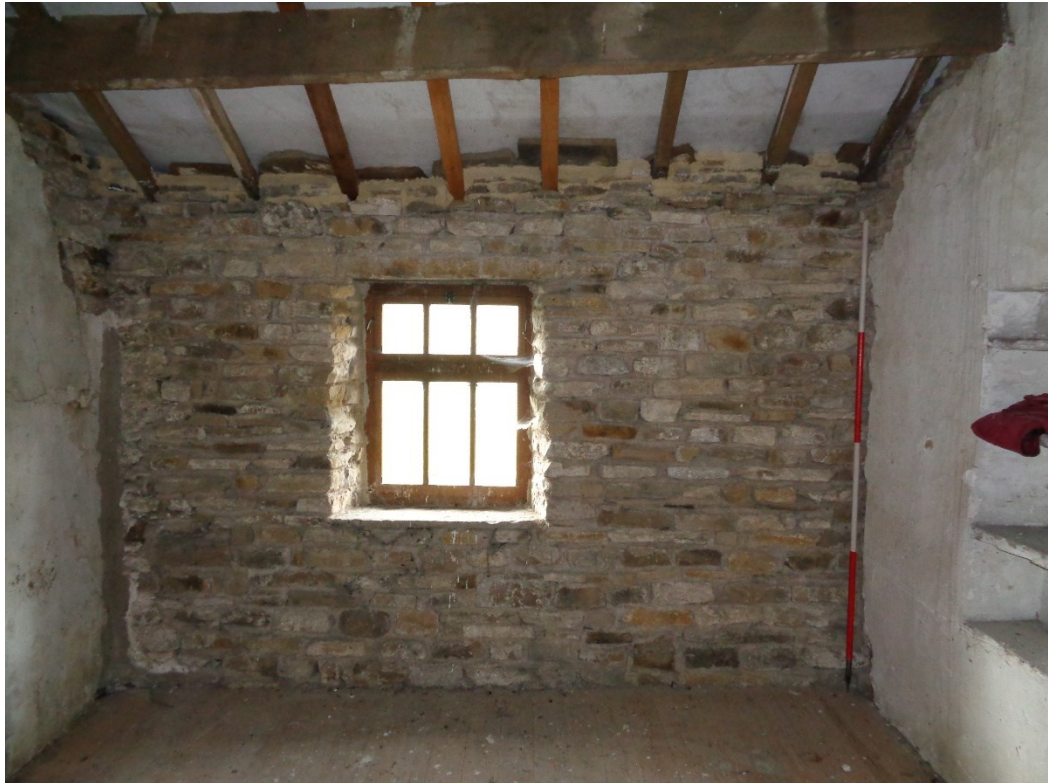
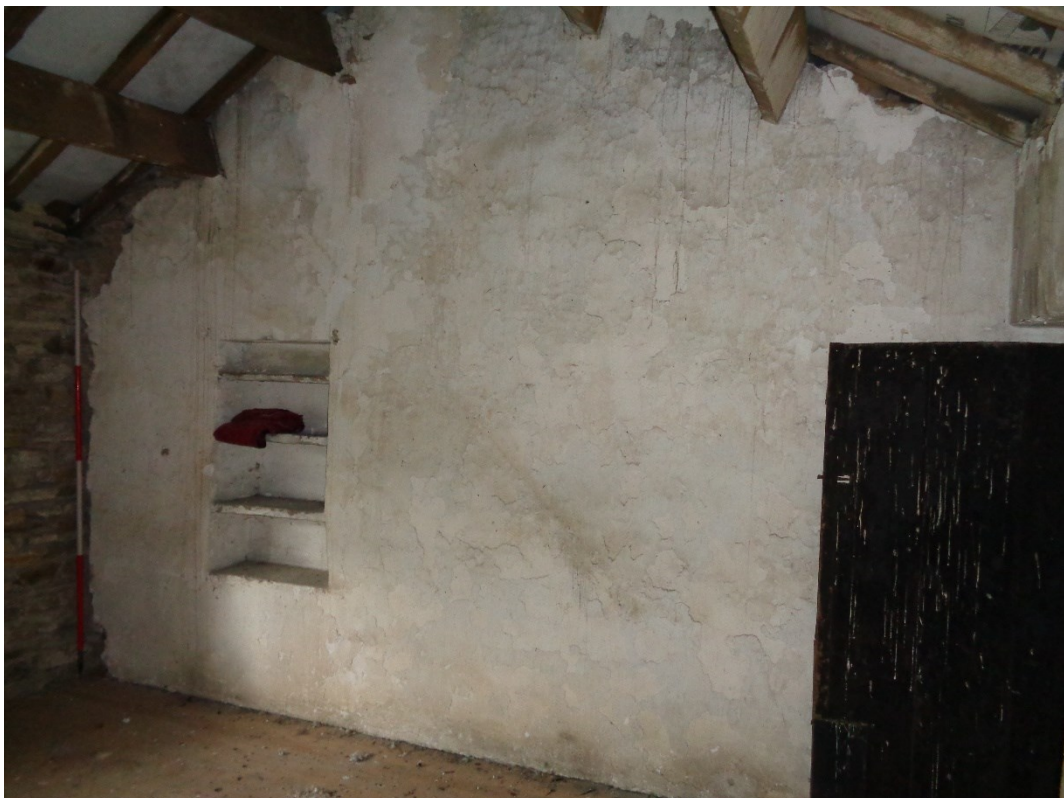
Room F1 was an original bedroom within the earlier cottage phase of the range, accessed internally by an inserted opening from Room G4 at its north-west corner. Aside from this inserted door the north wall of the room is otherwise featureless (Figure 28). The room has an original stone fireplace at the centre of its eastern wall (Figure 29) and a replacement window frame in an original splayed opening within the south wall (Figure 30). The west wall contains an alcove with three inset wooden shelves that has been created within the blocked former opening of a doorway connecting Rooms F1 and F2 (Figure 31). This inserted shelving, and so the blocking of the door, must have been created after the construction of the rear lean-to extension to the north side of the original cottage, given that it would have previously been the only interconnection between the first floor rooms. As all the floors within the building have been replaced it is now no longer possible to be certain of the original access arrangements between ground and first floor before the construction of the rear lean-to extension. It is, however, considered most likely that a stair or ladder gave access between Rooms G2 and F2, as these are the larger rooms on both floors.

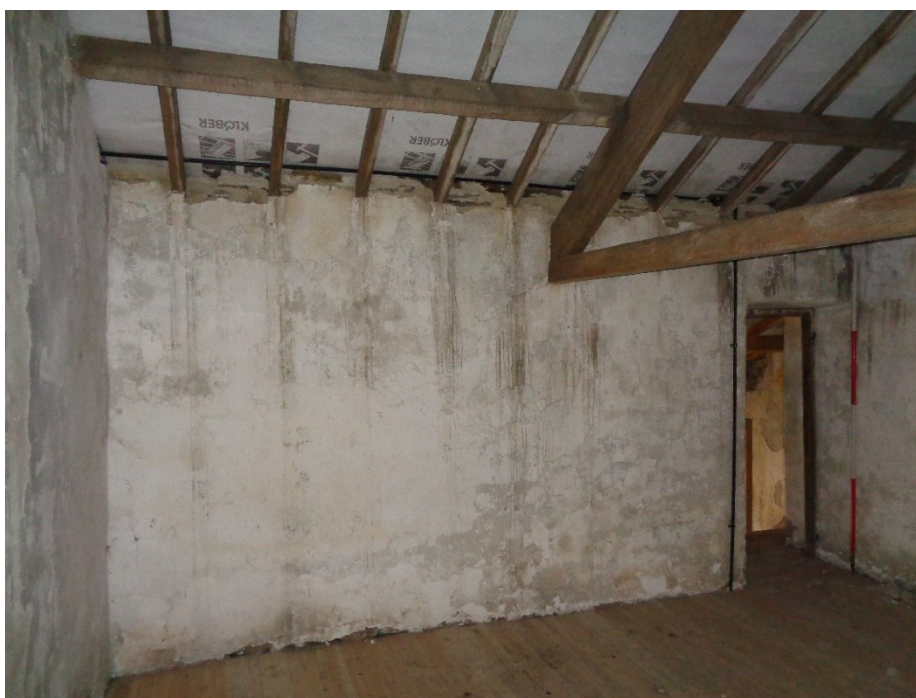
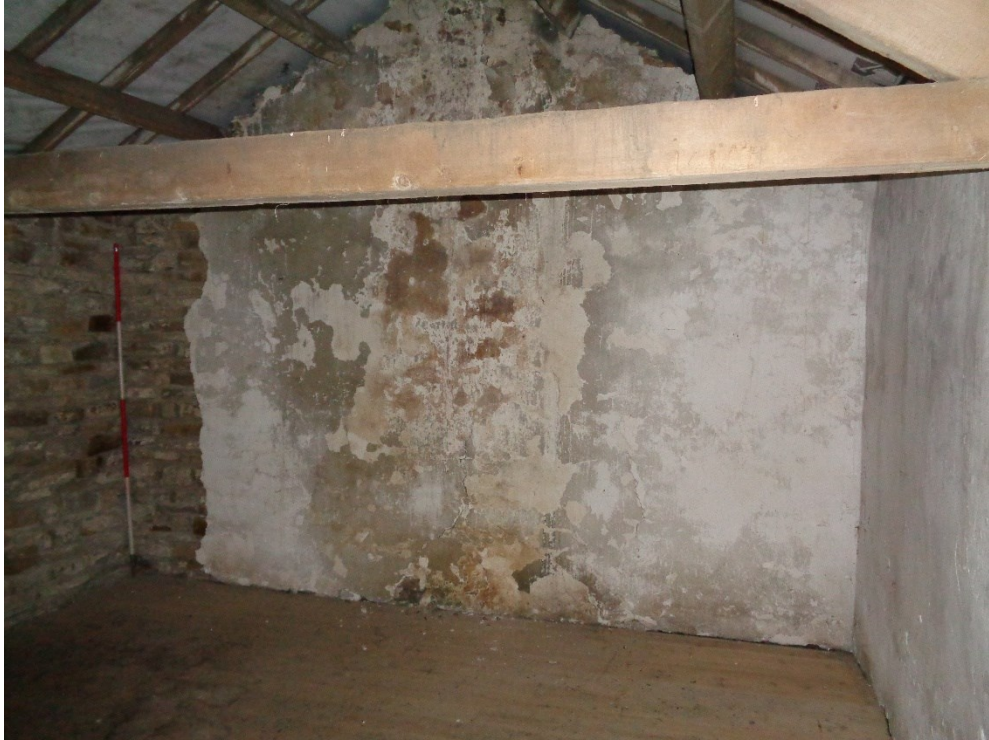
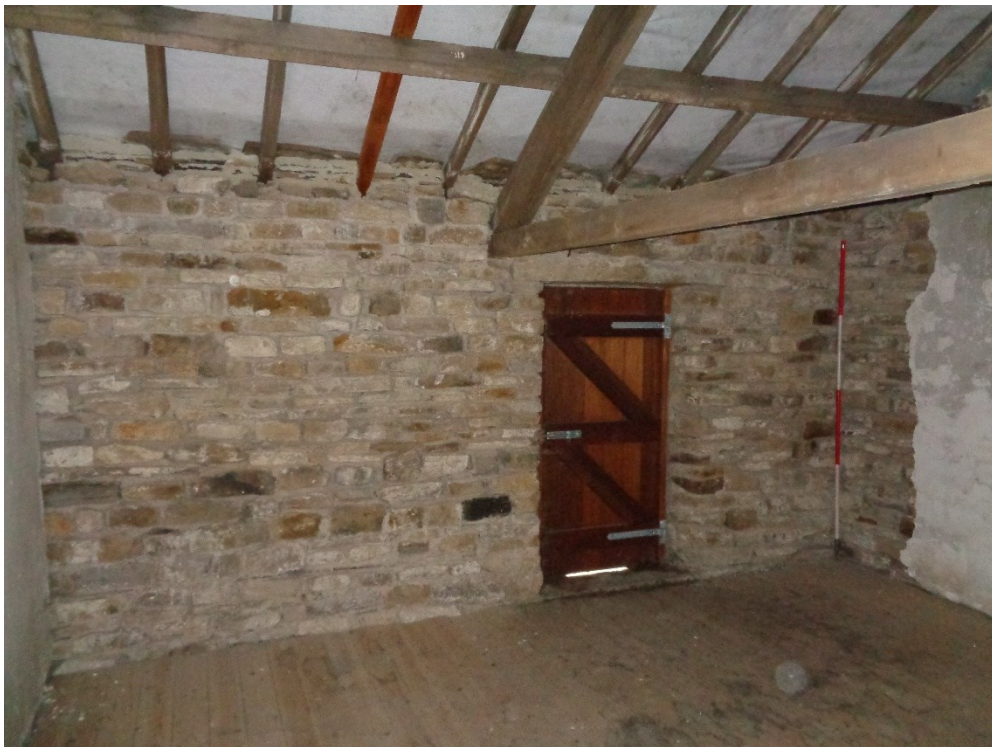
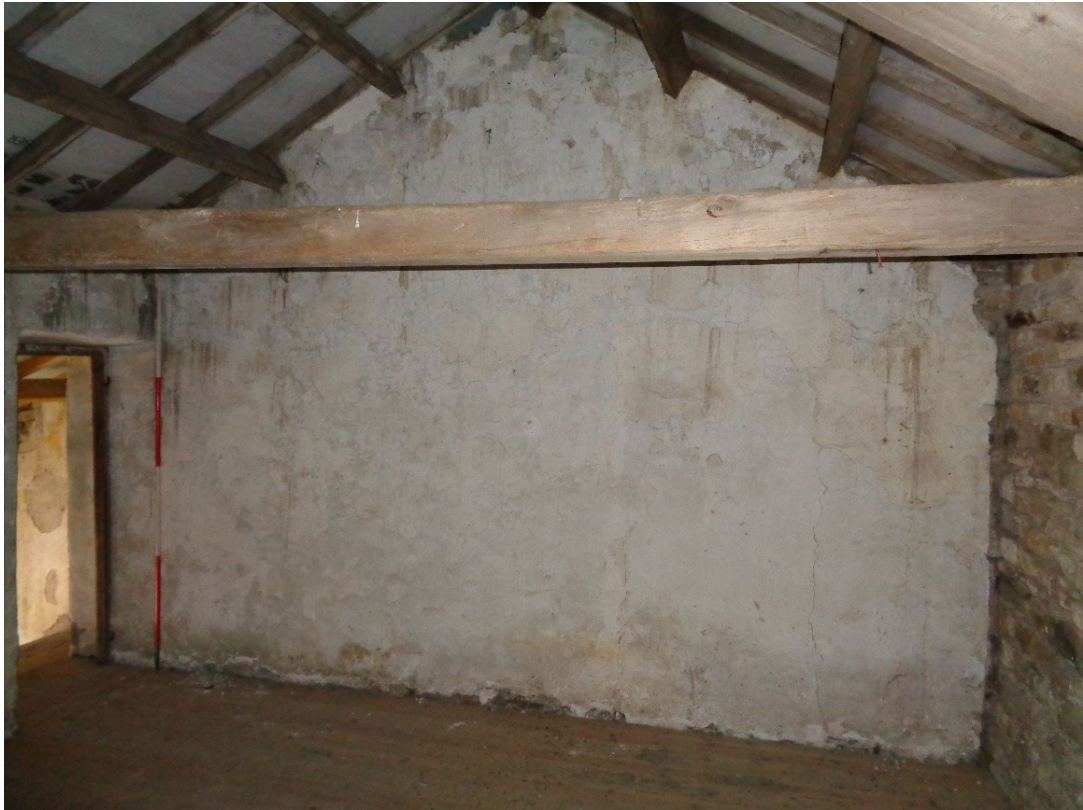
Room F2 was an original bedroom within the earlier cottage phase of the range, accessed internally by an inserted opening from Room G4 at its north-east corner. Aside from this inserted door the north wall of the room is otherwise featureless (Figure 32). The room has a blocked fireplace at the centre of its western wall (Figure 33) and a hayloft door inserted into an original splayed window opening within the south wall (Figure 34). The east wall contains the blocked former opening of a doorway connecting Rooms F1 and F2 close to its southern extent (Figure 35). As all the floors within the building have been replaced it is now no longer possible to be certain of the original access arrangements between ground and first floor before the construction of the rear lean-to extension. It is, however, considered most likely that a stair or ladder gave access between Rooms G2 and F2, as these are the larger rooms on both floors.

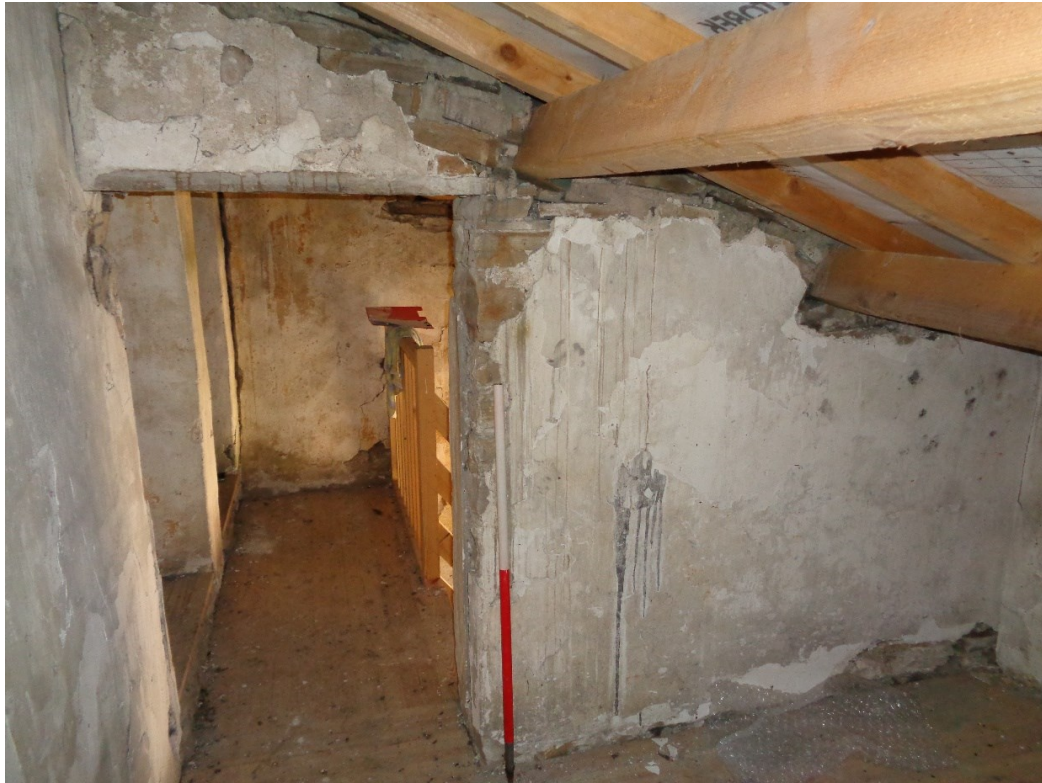
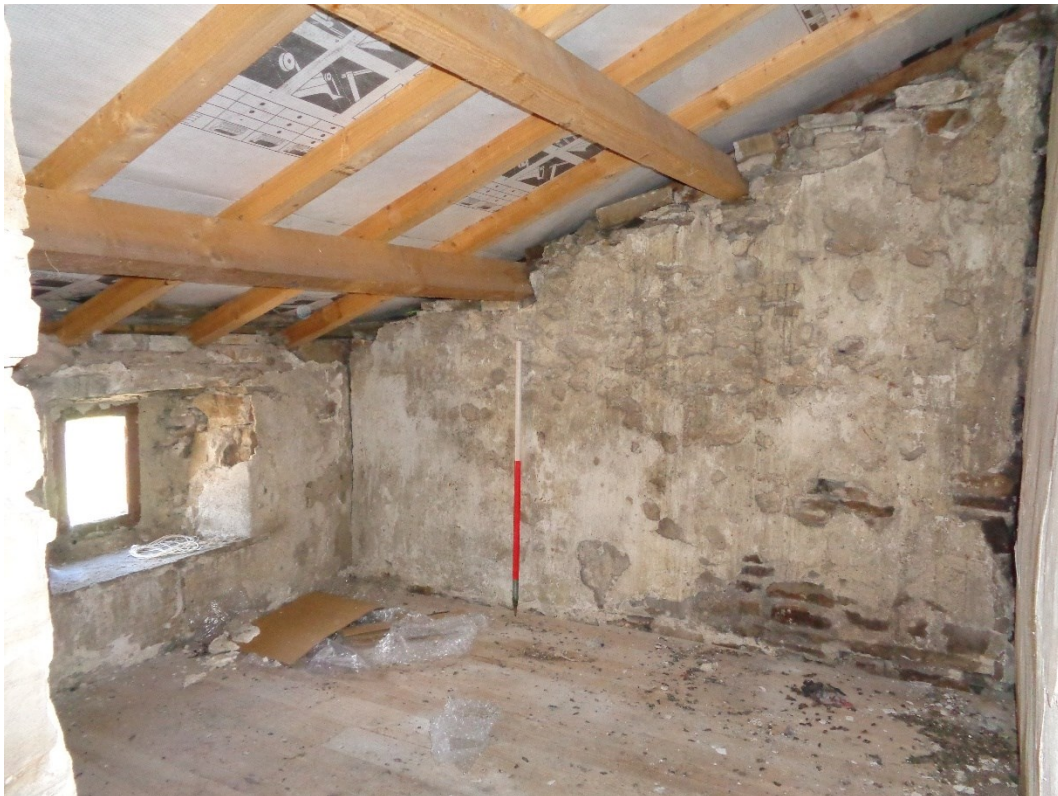
Room F3 sits within the lean-to extension to the north side of the earliest cottage. The room is accessed by an original door at its south-west corner (Figure 36). The north wall of the room has a small square window with a replacement frame, within a wider original splayed opening (Figure 37). The east and south walls are featureless. The room was most likely created as a small bedroom or store.
