Humbleton Farm  
Burtree Gate, Darlington

Historic Building Recording

*Solstice Heritage was commissioned by Darlington Farmers Auction Mart Company Limited to produce an Historic Building Recording of the farmhouse and two adjacent barns at Humbleton Farm, Burtree Gate, Darlington in fulfilment of a condition of planning permission (13/00110/FUL) for redevelopment of the site.*

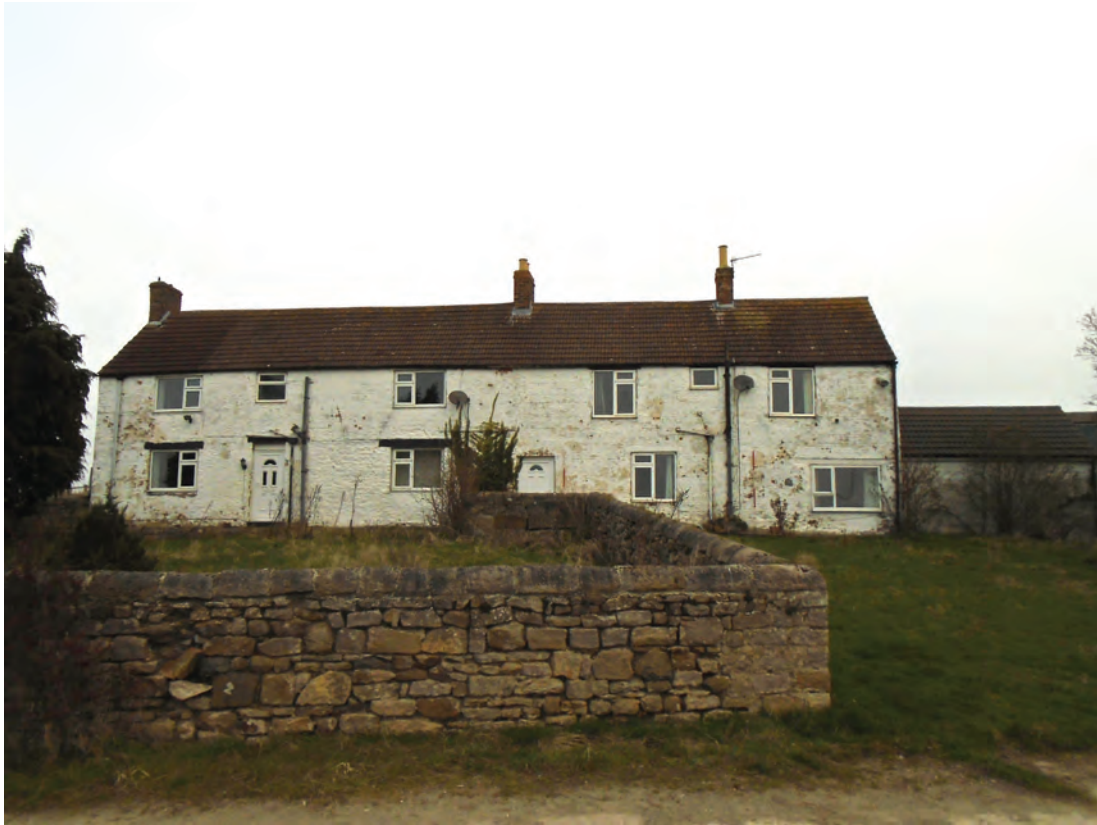
Figure 2 South elevation of Building A, facing north. Scale 2x2 m

This elevation is the principal façade of the farmhouse range (Figure 2). The elevation is constructed mainly of brickwork, with a rubble masonry section at the centre-left, ground floor (Figure 3) (see Appendix 1 for elevations). The elevation has been thickly painted, and so fine structural detail was difficult to discern. This elevation includes four casement windows and two doorways at ground-floor level, with six casement windows at first-floor level. All of the windows in this elevation have replacement uPVC frames, and all of the openings are inserted or enlarged from earlier positions with the possible exception of the small square window opening at first-floor level and lighting Room F2 internally. The single-pitch roof of the building has been entirely re-roofed with modern concrete tiles, with a further phase of re-roofing/repair evident at its western extent (Figure 3). The roof includes three brick stacks, the westernmost of which is the earliest, executed in handmade brick and likely to be of earlier 19<sup>th</sup>-century date. The other two are in later brick and most likely to be of late 19<sup>th</sup>- to early 20<sup>th</sup>-century date.

The earliest phase of construction within this elevation is the section of single-storey rubble masonry extending from the westernmost entrance doorway to the western side of the easternmost doorway. This uncoursed masonry has been broken through centrally to insert a modern, presumably 20<sup>th</sup>-century, casement window with a concrete lintel, which itself has been altered by the removal of an earlier sill, presumably during the installation of the existing uPVC windows. At its eastern extent, the masonry forms the left-hand jamb of the entrance doorway at this side, while at its western extent the other entrance doorway has been partially inserted into it at its eastern side. This western entrance doorway appears to be contemporary with the next phase of the development of the building, comprising the construction of the two-storey brickwork western end of the linear range. This phase appears to have been built to extend the earlier masonry structure to its current western extent and to raise it to two storeys from the current western gable of the building to the eastern extent of the masonry, now marked by a clear construction break above the western side of the eastern entrance doorway. The handmade brick used to effect this scheme presumably dates this development to the early 19<sup>th</sup> century and suggests that the object of the scheme was to create a typical double-fronted, two-storey farmhouse utilising an earlier stone structure of uncertain, presumably domestic, purpose. The current, approximately symmetrical, layout of the windows and door at this western extent of the linear range suggests that they reflect the layout of the windows created as an original part of this build; however, they seem to have been at least enlarged, if not possibly inserted altogether. The fact that the central doorway is original to this phase of brick construction, however, lends weight to the probability that the window positions were most likely created at this time despite being latterly altered.

To the east of this 'farmhouse' section, the linear range is continued by a subsequent phase of brick construction, consisting of a single-phase two-storey extension, also executed in handmade brick (Figure 4). This eastern extension includes the original eastern entrance doorway, which makes use of the earlier stone masonry as its western jamb. The other windows are all modern inserts with concrete lintels with removed sills, again presumably due to the installation of the existing uPVC windows. The possible exception to this is the small square window opening at first-floor level, lighting Room F2 internally. This small window close to the eaves may be original and is also representative of the probable original purpose of this section of the range. At ground-floor level, the easternmost window has been created from part of an original, now partly blocked, doorway, visible as blocking brickwork below the eastern part of the existing window opening. The brickwork above this window also shows significant rebuilding work, probably part of a subsequent alteration to enlarge it from a size similar to that of the window to the west, which exhibits a taller but narrower form.

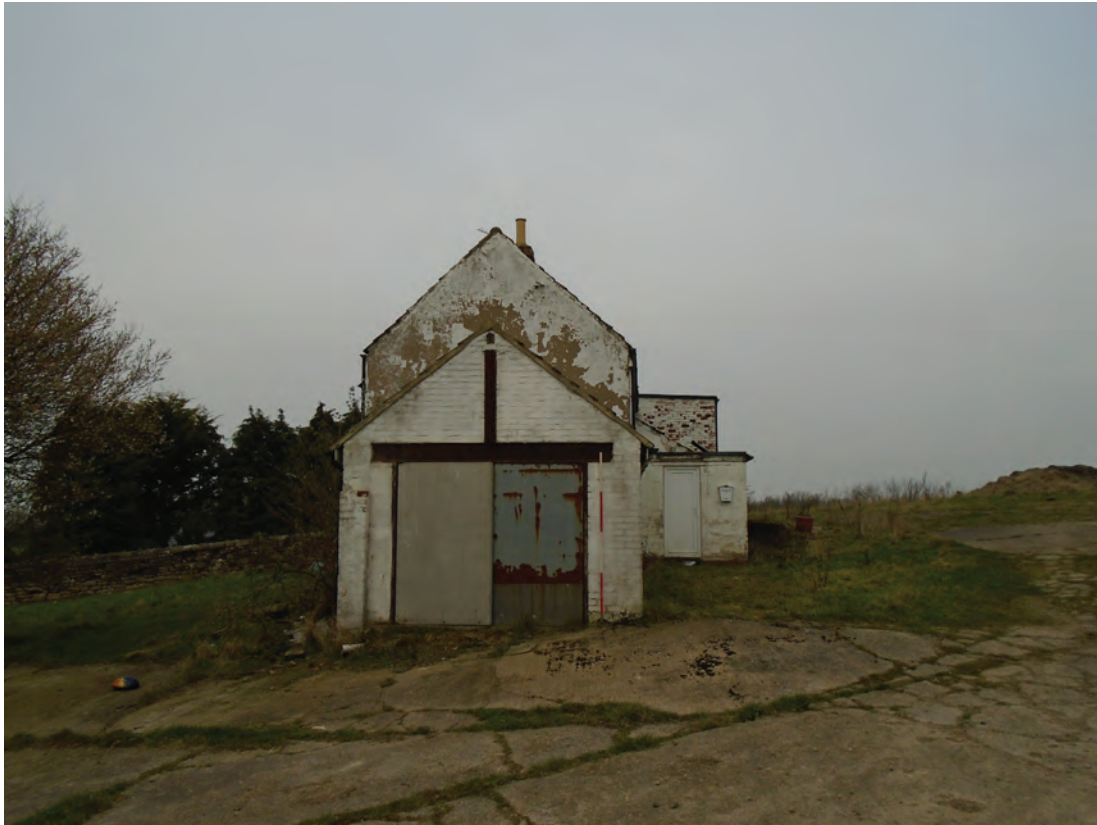
Figure 5 West elevation of Building A, facing east. Scale 2x2 m

This elevation is one of two gable elevations of the building (Figure 5). The elevation is rendered in a cementitious coating and thickly painted, making structural detail difficult to discern. The appearance of the gable elevation, as well as evidence from the other faces of the building, suggests that this elevation consists of the pointed gable end of the brick farmhouse at its southern extent, with a single-range gable topped with an end stack. To the north of this, a single-storey lean-to extension, built in stone, has been latterly raised to two storeys with the addition of a flat-roofed brick first floor.

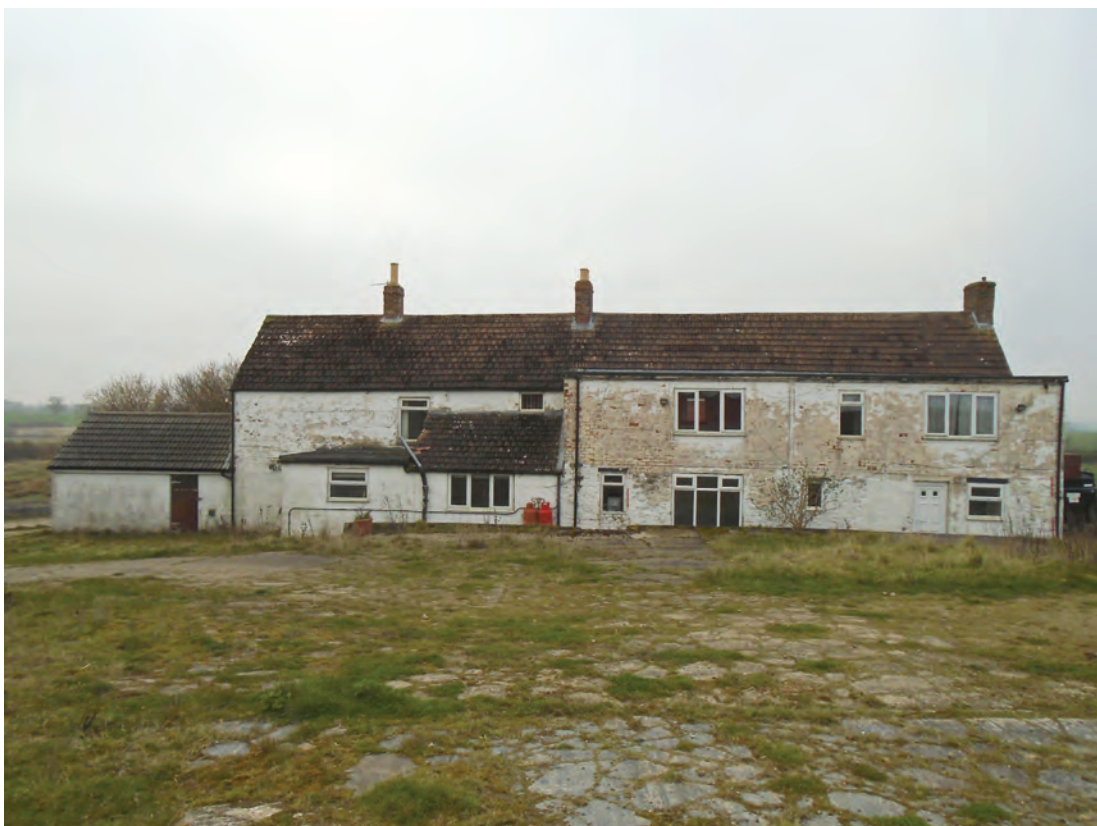
Figure 6 East elevation of Building A, facing west. Scale 1x2 m

This elevation is one of two gable elevations of the linear range (Figure 6). The elevation includes the eastern gable of the probable barn extension to the main farmhouse range, the eastern gable of the modern garage extension beyond that, and the eastern elevations of the single-storey and raised first-floor extensions to the north side of the range. The eastern gable of the two-storey probable barn extension is rendered with a cementitious coating but displays a central blocked opening at first-floor level, visible as an imperfection in the render where paint has differentially weathered. This blocked opening is considered most likely to represent a first-floor hayloft door, reflecting the original purpose of this extension. This blocked opening was not visible internally, where the eastern wall of Room F1 had been boarded over.

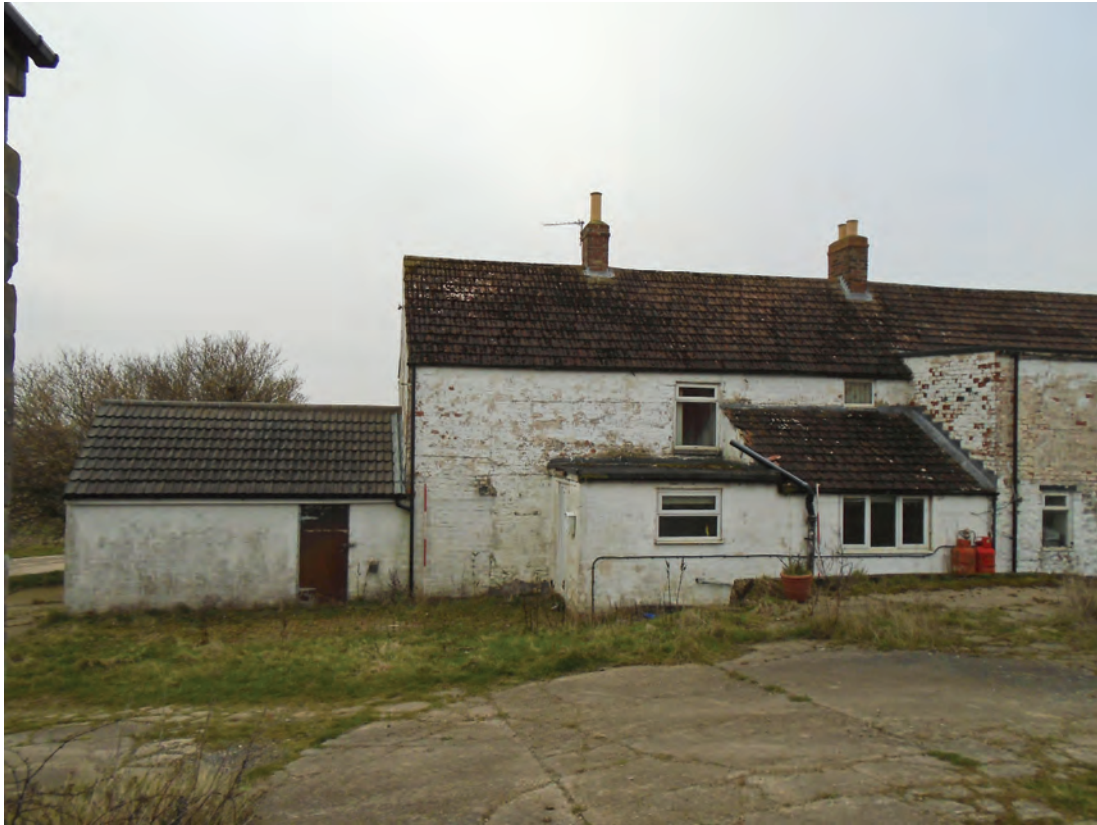
Figure 7 North elevation of Building A, facing south. Scale 2x2 m

This elevation is the rear elevation of the linear range (Figure 7). At its eastern extent, this elevation comprises the north elevation of the modern garage extension, which includes an original entrance doorway set within modern stretcher-bond brickwork (Figure 8). This garage abuts the earlier probable barn, the north elevation of which includes an original, latterly blocked, entrance doorway at its eastern extent. Above and to the west of this is a blocked first-floor window, cut through by a later roof raggle for a continuation of the lean-to roof on the rear extension to the east. The roof of this extension was presumably altered to a flat roof for this portion in order to accommodate the first-floor inserted window above which lights Room F3. Equally, the flat-roof section of the rear extension has a clear construction break at its western extent where it joins the pitched-roof section. This construction break suggests that the flat-roof element has completely replaced a formerly longer rear extension, presumably a continuation of the rear pitched-roof extension, part of which is still present. Both the flat-roof and pitched-roof sections of rear extension contain original casement windows of differing dimensions, again illustrating the two-phase development of this rearward expansion. Above the pitched-roof rear extension, immediately below the eaves, is an original small, square window which mirrors the example noted on the south elevation of this part of the linear range, again suggesting that both elevations contained a row of small ventilating windows at eaves height for a hayloft when this extension was first added. To the west of this window is a short section of exposed construction break, indicating the addition of the probable barn to the farmhouse.

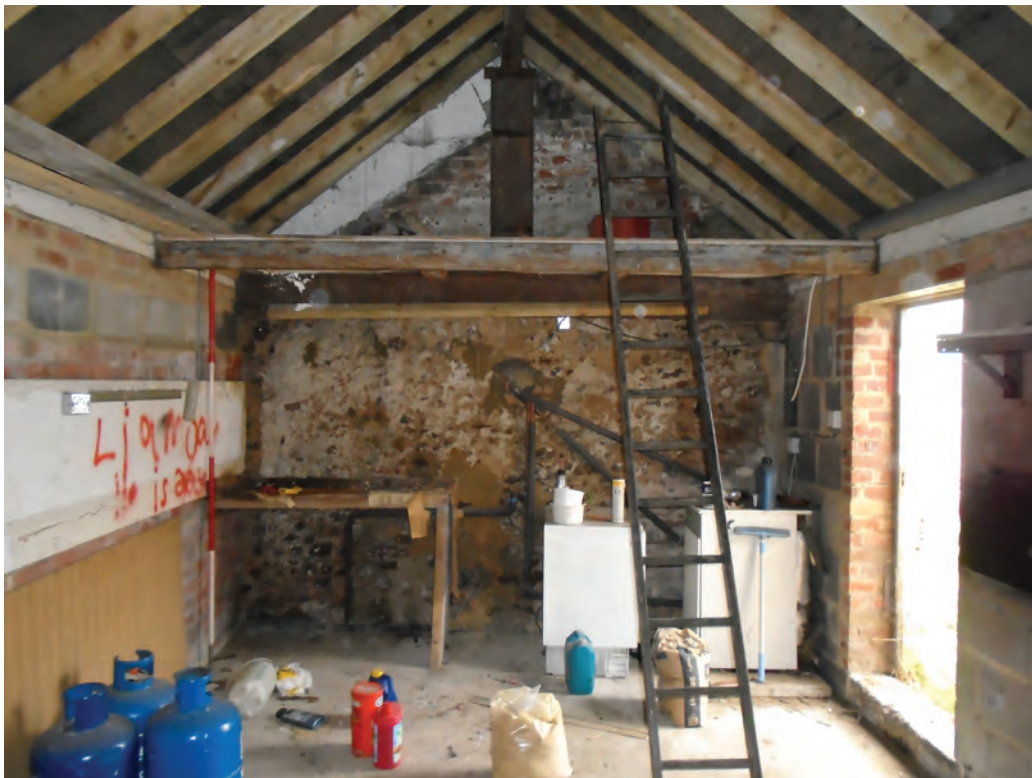
Figure 10 Room G1, facing west. Scale 1x2 m

Room G1 is contained within the modern garage extension at the eastern extent of the linear range. It is accessed by an entrance doorway at its north-western corner leading to a single main space (Figure 10). The west wall includes rubble stonework for much of its lower portion, suggesting that the current garage has replaced an earlier stone building in this location. The south wall includes the blocked doorway noted externally (Figure 11). The north wall is featureless aside from the entrance door already noted. The east wall contains the double door noted externally (Figure 12).

The roof structure within the room has clearly been renewed relatively recently. The room seems to have been created as a garage/workshop with plain blockwork and brick walls and a work bench still present. The date of the existing extension is likely to be late 20<sup>th</sup> century.

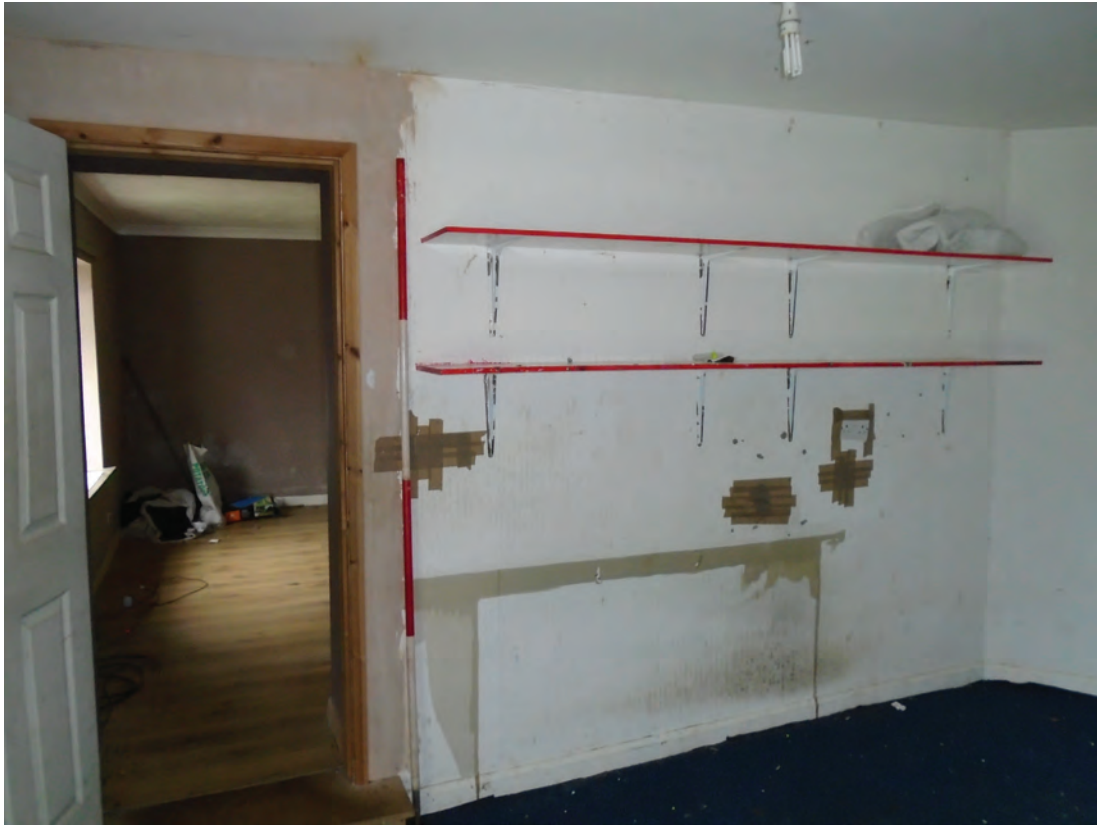
Figure 13 Room G2, looking north-west. Scale 1x2 m

Room G2 is accessed internally by a modern inserted entrance doorway at its south-western corner, leading from Room G3 (Figure 13). Unpainted plasterwork surrounding this doorway suggests that it was inserted relatively recently to incorporate this space into the domestic accommodation. The north wall of the room includes a blocked doorway (Figure 14), again with unpainted plaster, suggesting that the internal door replaced this blocked doorway, which was noted externally on the north elevation of the building, as part of the same phase of works. The south wall of the room includes the inserted casement window, also noted externally (Figure 15). No evidence was noted internally to show that this window had been created from a previous doorway, illustrated externally by the blocking visible on the south elevation of the building. The east wall of the room is featureless.

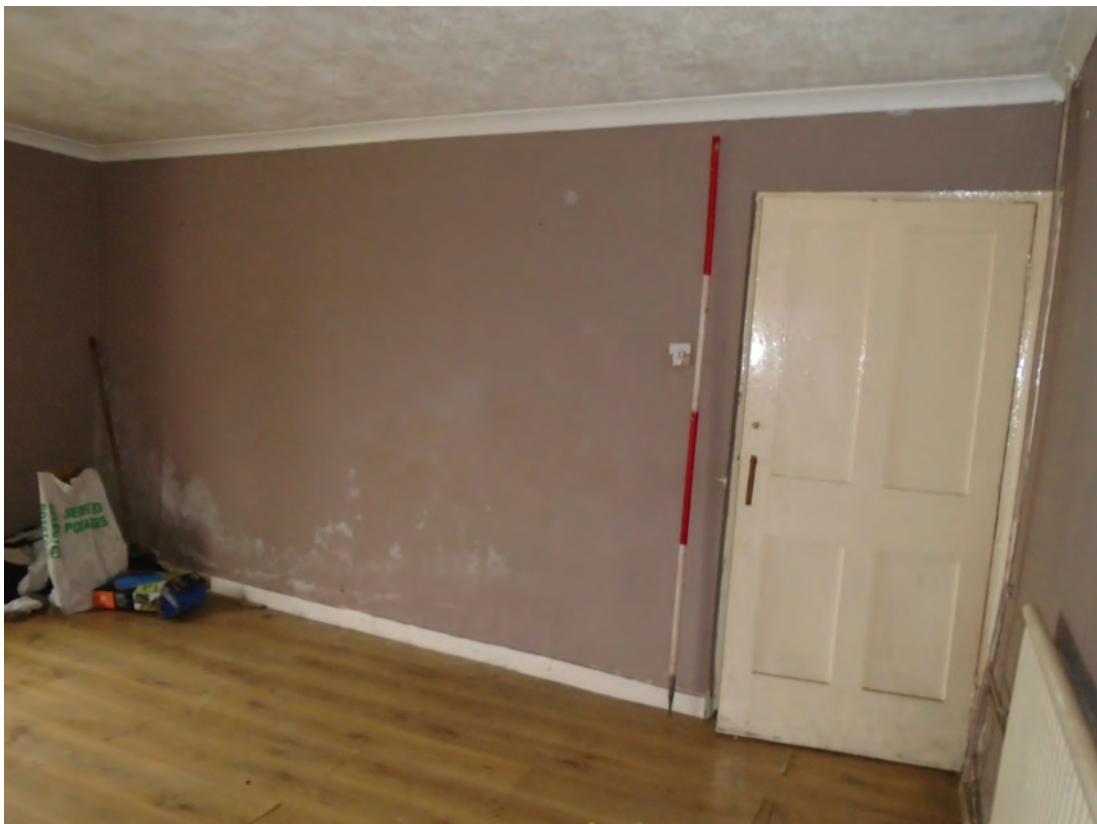
Figure 18 Room G3 looking south-west. Scale 1x2 m

Room G3 is accessed internally by a modern inserted entrance doorway at its south-eastern corner, leading from Room G2, and by another doorway at its north-western corner leading from Room G6. The east wall of the room includes an inserted doorway to Room G2 to the south side of a central chimney breast with a modern inserted brick fire surround (Figure 16). As noted from the brickwork of the chimney externally, the chimney breast is probably an inserted feature. The south wall of the room includes a central inserted casement window, noted externally (Figure 17), while the west wall includes a four-panel door at its northern extent (Figure 18). The north wall of the room is featureless aside from a modern radiator.

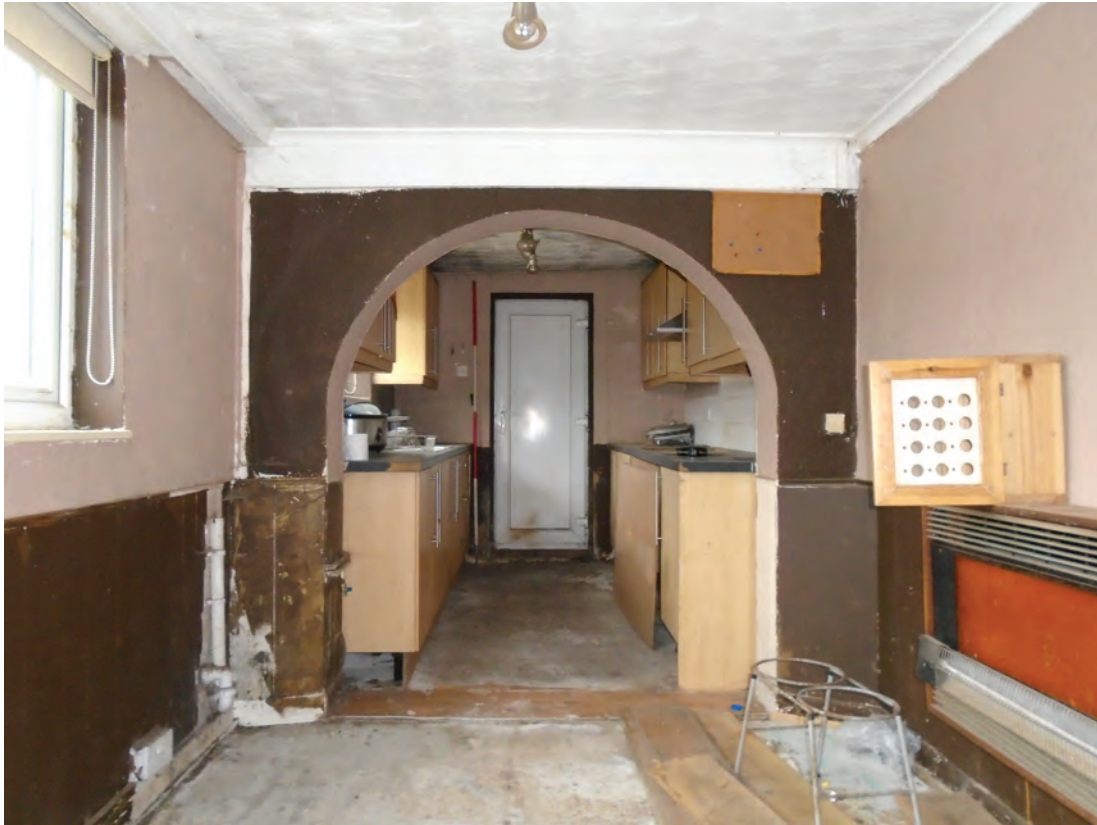
Figure 19 Room G4/G5 facing east. Scale 1x2 m

Room G4/G5 consists of two spaces separated by an archway, which was previously an external wall and is now knocked through to link the two spaces, presumably when Room G4 was added (Figure 19). Room G4 is accessed by an external doorway at its eastern side, while Room G5 has a doorway at its south-western corner leading from Room G6 (Figure 20). A modern fitted kitchen has been installed within Room G4. The north wall of the room includes two casement windows, as noted externally, while the west wall is featureless. The south wall of the room includes a doorway at its western extent. The ceiling of Room G5 is marginally lower than that of Room G4, providing further evidence that the two rooms represent distinctly separate phases of construction.

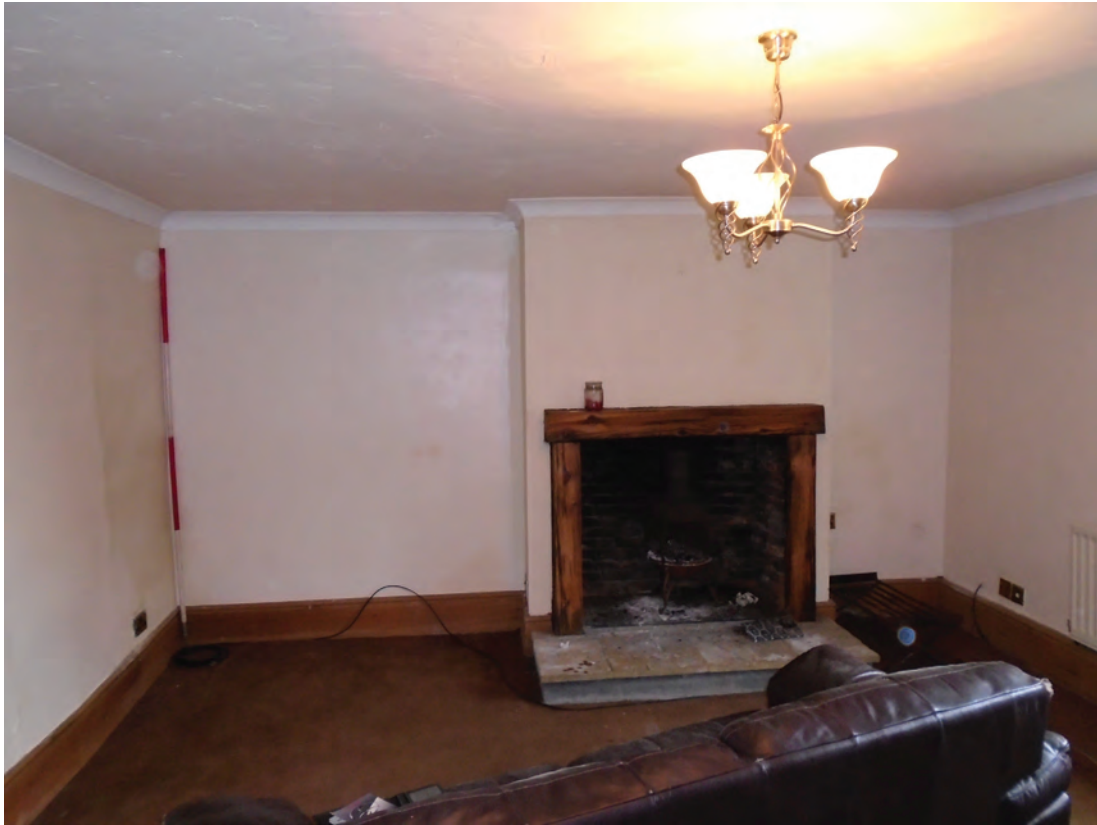
Figure 23 Room G7 facing east. Scale 1x2 m

Room G7 is accessed internally by a doorway at its western side, leading from Room G10. The east wall of the room includes a chimney breast, slightly offset to the south of centre, with a modern surround (Figure 23). The west wall includes a six-panel door to Room G10 and another six-panel door to an understairs cupboard at its northern extent (Figure 24). The south wall of the room includes a central inserted casement window, noted externally (Figure 25), while the north wall of the room includes a blocked doorway, now boarded and plastered over, close to its eastern extent (Figure 26).

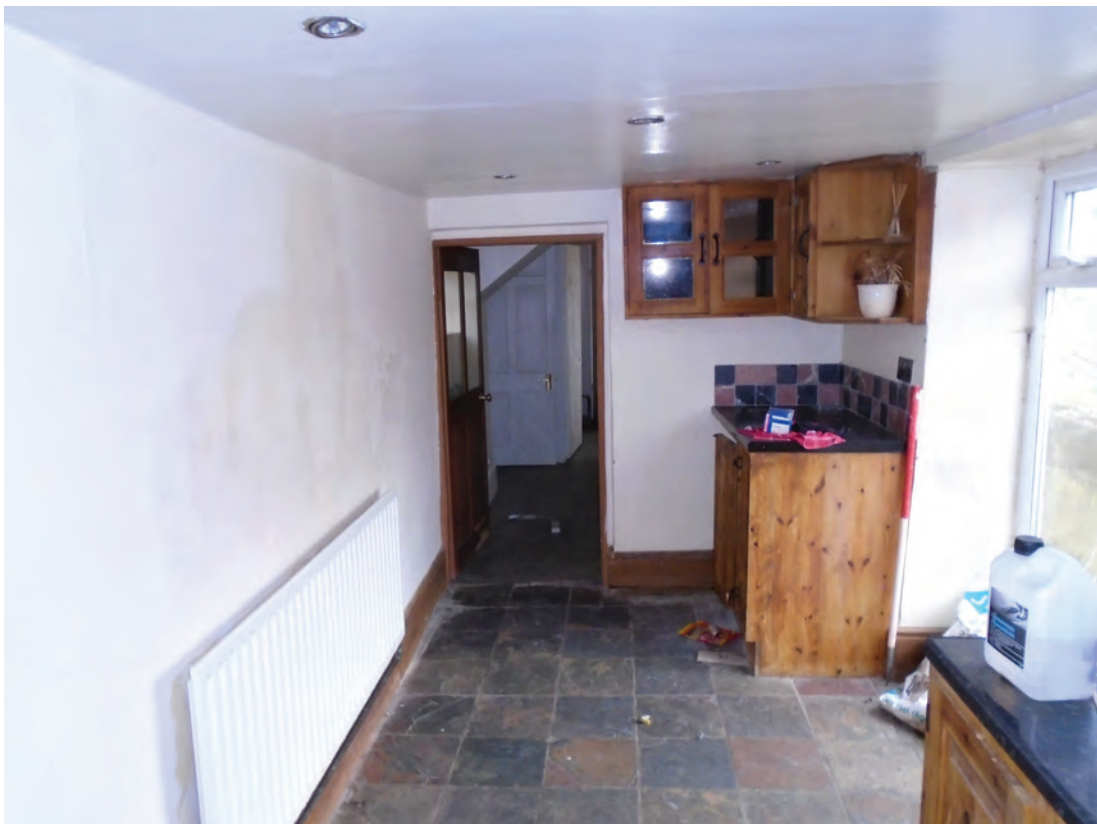
Figure 28 Room G8 facing west. Scale 1x1 m

Room G8 is accessed by a doorway at its south-western corner leading from Room G9 (Figure 28). A modern fitted kitchen has been installed within the room. At the south-eastern corner of the room the blocked door noted in Room G7 has been partially retained as an alcove with shelving and a lower cupboard (Figure 27). The north wall of the room includes a casement window and a full-length window, as noted externally.

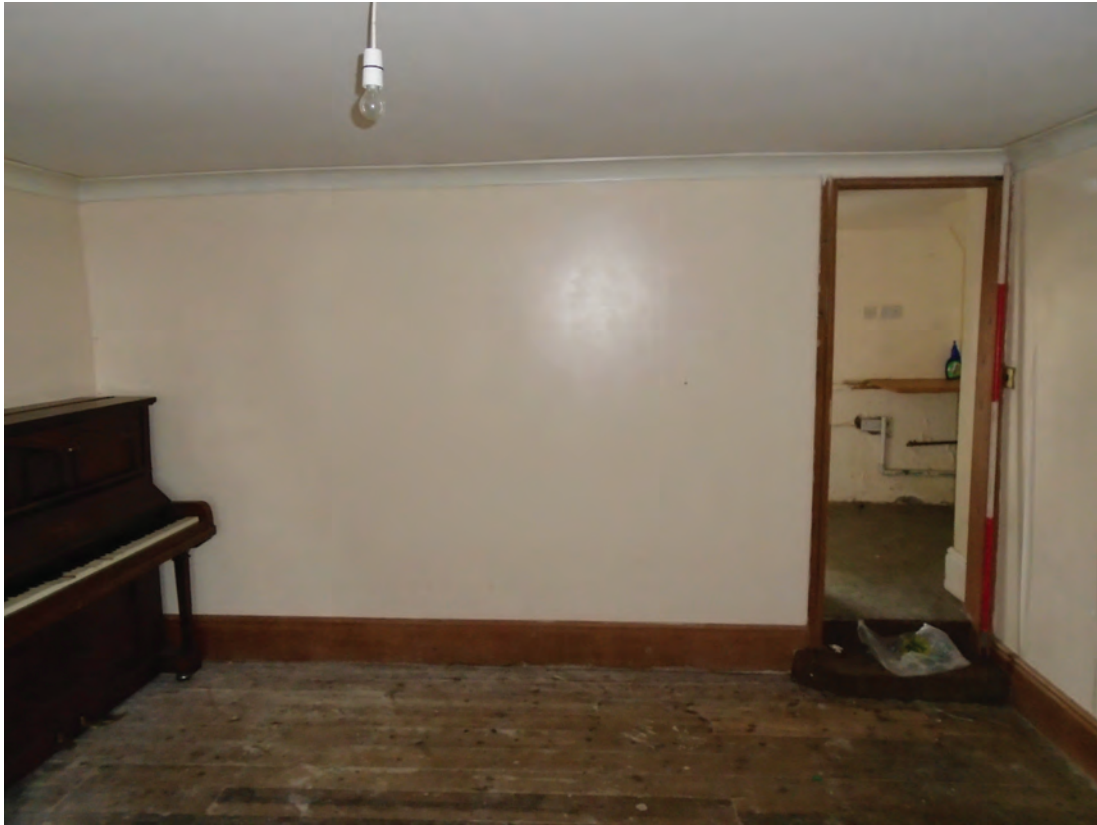
Figure 36 Room G11 looking north. Scale 1x2 m

Room G11 is accessed internally by an inserted doorway at its north-eastern corner leading from Room G9 (Figure 36) and by another doorway placed centrally in its eastern wall leading to Room G10 (Figure 37). The south wall of the room includes a central casement window with replacement uPVC frame, noted externally (Figure 38), with a modern radiator beneath. The west wall of the room includes an offset chimney breast with a modern inserted stone surround (Figure 39). The room has modern applied coving.

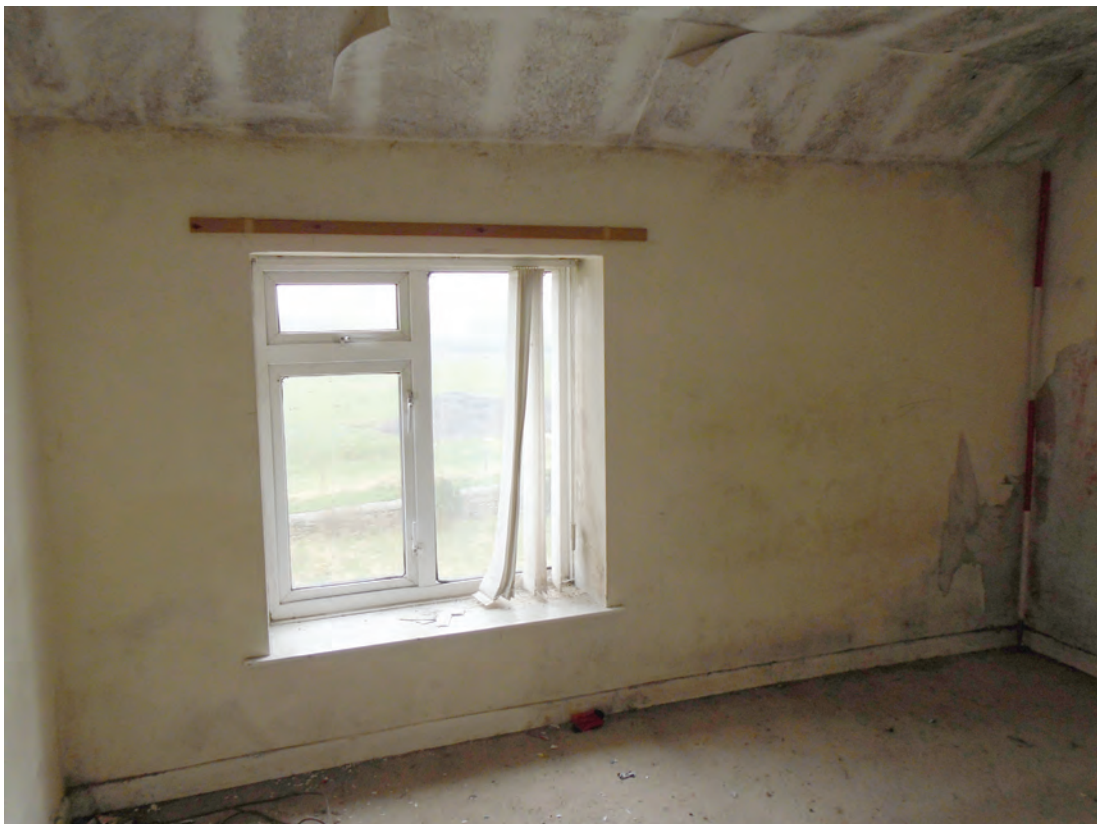
Figure 51 Room F4, facing south. Scale 1x2 m

Room F4 is accessed internally by a door at the eastern extent of its north wall from Room F3. The west wall of the room includes an inserted timber and board construction within the north-west corner of the room, to take the stairs from Room G6 to Room F3, and includes an overstairs cupboard (Figure 49). The north wall of the room includes a doorway to Room F3 at its eastern extent with a modern radiator to the west (Figure 50), while the east wall is featureless. The south wall of the room includes an inserted casement window, as noted externally (Figure 51).

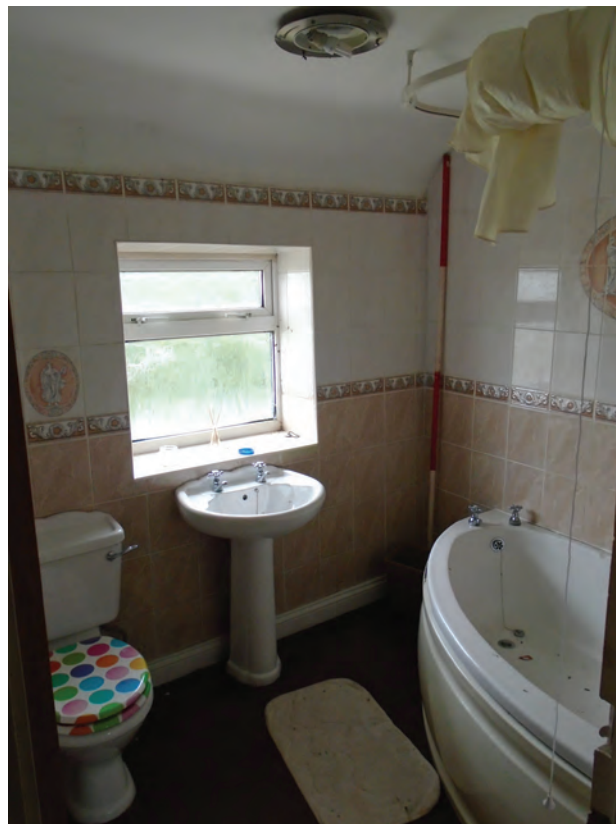
Figure 59 Room F7, looking south-west. Scale 1x2 m

Room F7 is accessed internally by a door at the eastern extent of its north wall from Room F10. The south wall of the room includes a small inserted rectangular window (Figure 59). Aside from this, the tiled room contains a modern bathroom suite with a corner bath at its north-west corner.

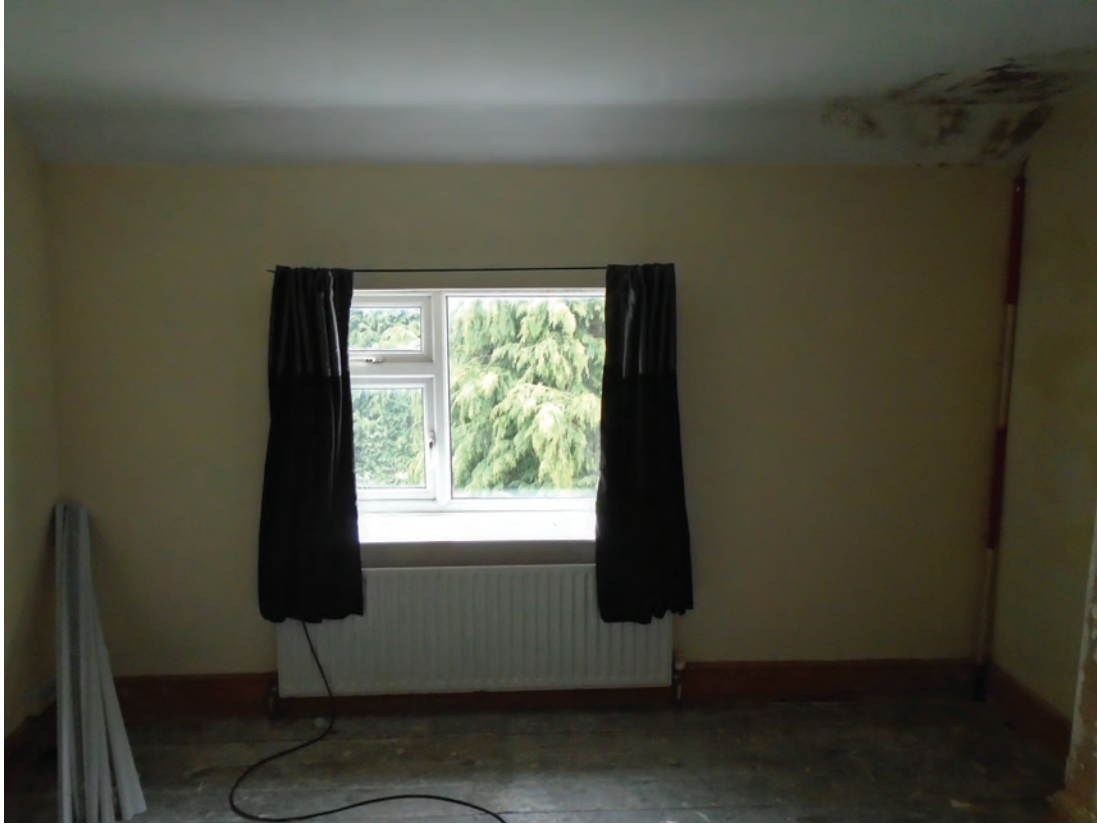
Figure 60 Room F8, facing south. Scale 1x2 m

Room F8 is accessed internally by a door close to the centre of its east wall from Room F10. The north wall is featureless, while the south wall of the room includes an inserted casement window offset slightly to the east of centre and below a sloped section of ceiling following the roofline externally (Figure 60). The west wall of the room includes an offset chimney breast with a blocked fireplace (Figure 61). The east wall of the room has been altered to incorporate a projection housing the bathroom, Room F7; to the north of this is the entrance doorway from Room F10 (Figure 62).

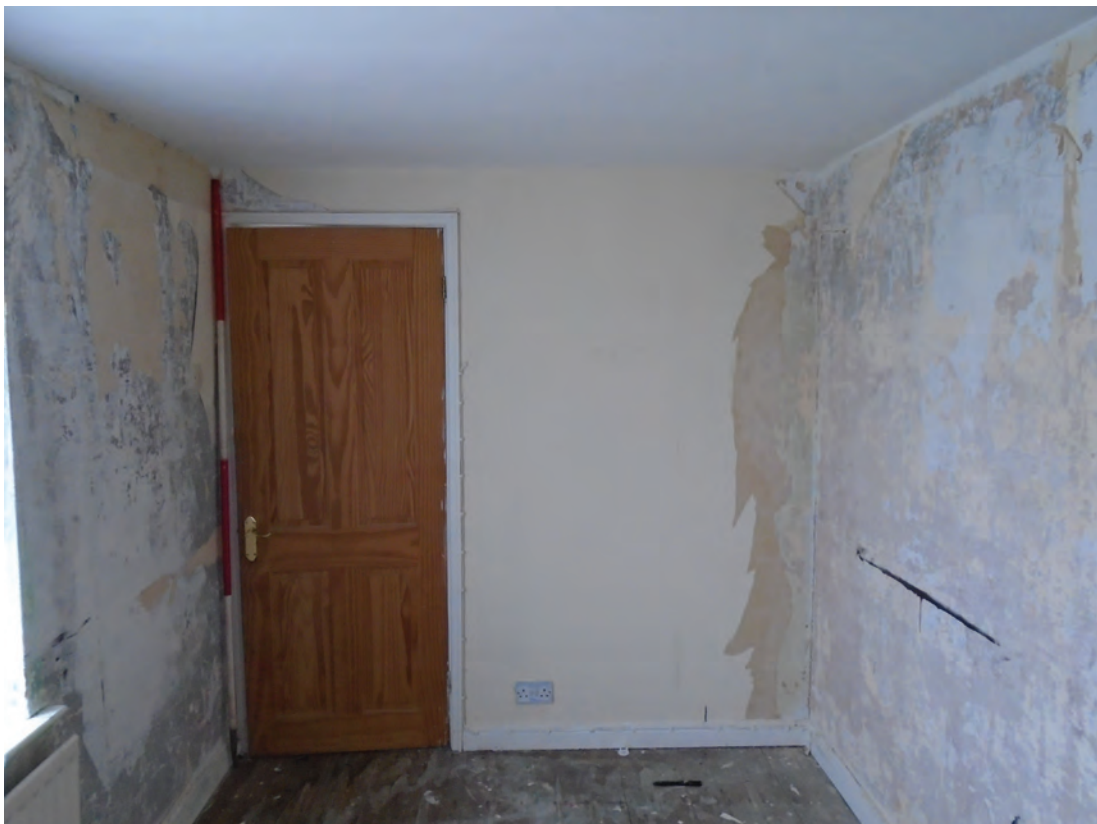
Figure 63 Room F9, looking east. Scale 1x2 m

Room F9 is accessed internally by a door at the northern extent of its east wall from Room F10 (Figure 63). The south wall of the room is featureless, while the north wall of the room includes a central casement window with a modern radiator beneath. The west wall of the room includes a built-in shelving unit of modern design, which covers the entire wall (Figure 64).

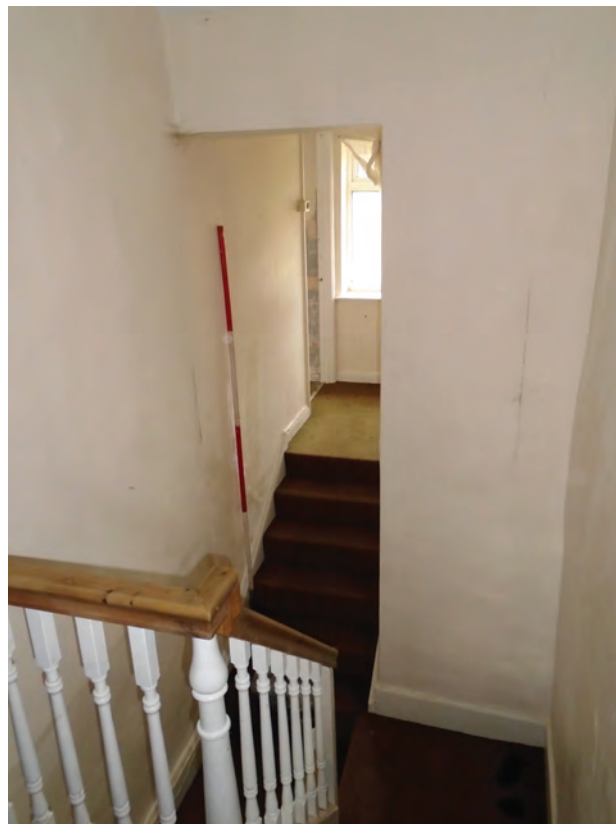
Figure 65 Room F10, looking north. Scale 1x2 m

Room F10 is a dual landing space, accessed from a stair from Room G6 at the western extent of its southern side. The room includes two short stairs, south to a landing giving access to Rooms F5 and F8 and north to a landing giving access to Rooms F9 and F6 (Figure 65). The northern stair passes through an opening created through the earlier rear wall of the linear range, presumably created when the brick upper storey containing Rooms F6 and F9 was added to the single-storey rear stone extension at the north side of the range. The stair has a modern rail and balusters.

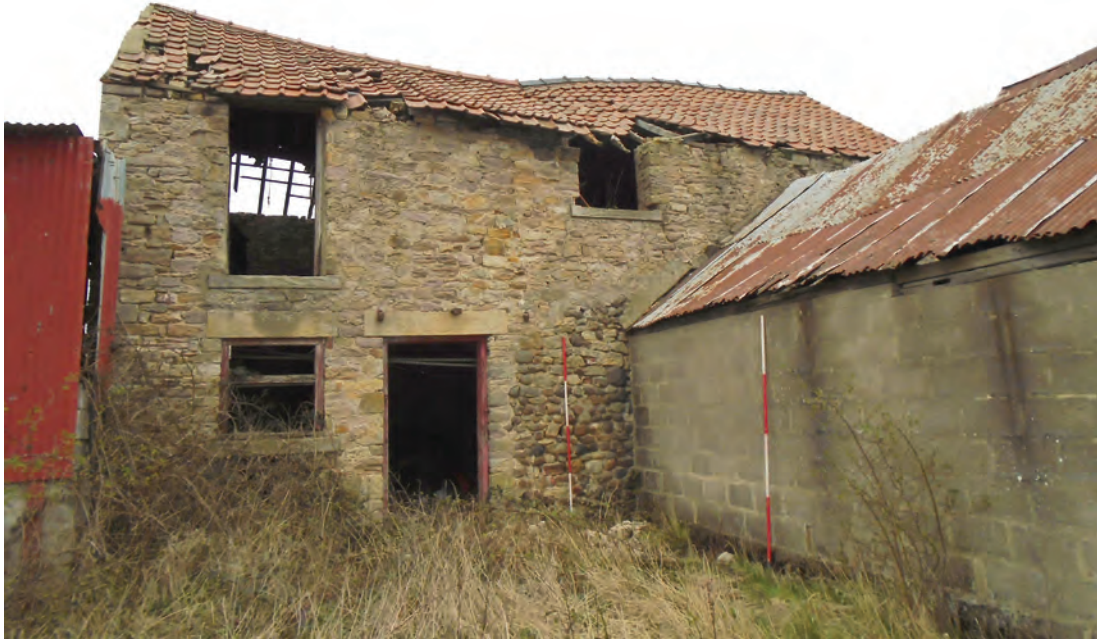
Figure 66 Building B south elevation, facing north-east. Scale 2x2 m

This elevation is the principal façade of the L-plan barn range. The elevation includes the south elevation of the two-storey east-west-aligned barn (Figure 66) and the south elevation of the single-storey north-south-aligned barn which has been added to it (Figure 67).

The two-storey barn is constructed in roughly-coursed rubble with alternating quoins below a pitched pantile roof. This elevation is partly masked by the addition of the single-storey barn at its eastern extent. At ground floor there is an original square window with a flush stone lintel and projecting sill close to the western extent of the surviving building. To the east of the window is an inserted doorway, illustrated by the new stonework to both sides of the opening, which has a flush stone lintel. At first-floor level, the elevation includes a hayloft door centred over the square window below and incorporating a projecting chamfered threshold which may be a re-used window sill. This re-use suggests that the opening itself might not be original, but as no access was possible to the first floor this could not be ascertained for certain. To the east of the door is another square window with a matching chamfered sill, again suggesting the threshold of the hayloft door is a probable re-use, and even that the opening itself may be an earlier window.

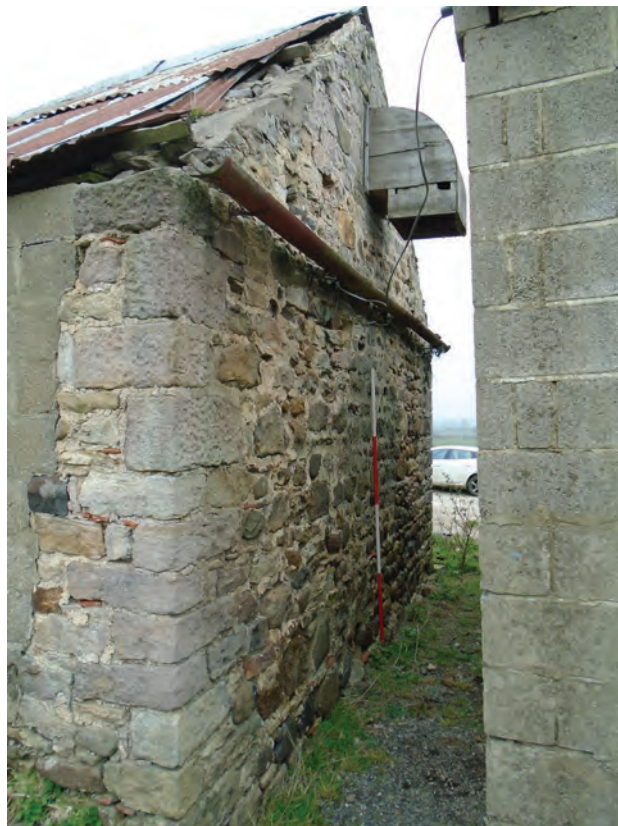
Figure 67 Building B south elevation of southern extension, facing east. Scale 1x2 m

The south elevation of the single-storey barn is also constructed in roughly-coursed rubble with alternating quoins and forms the gable end of the structure. This gable elevation includes a relatively modern wooden vent at high level and is otherwise featureless. The elevation does appear to have seen significant repair and/or repointing at its east and west extents.

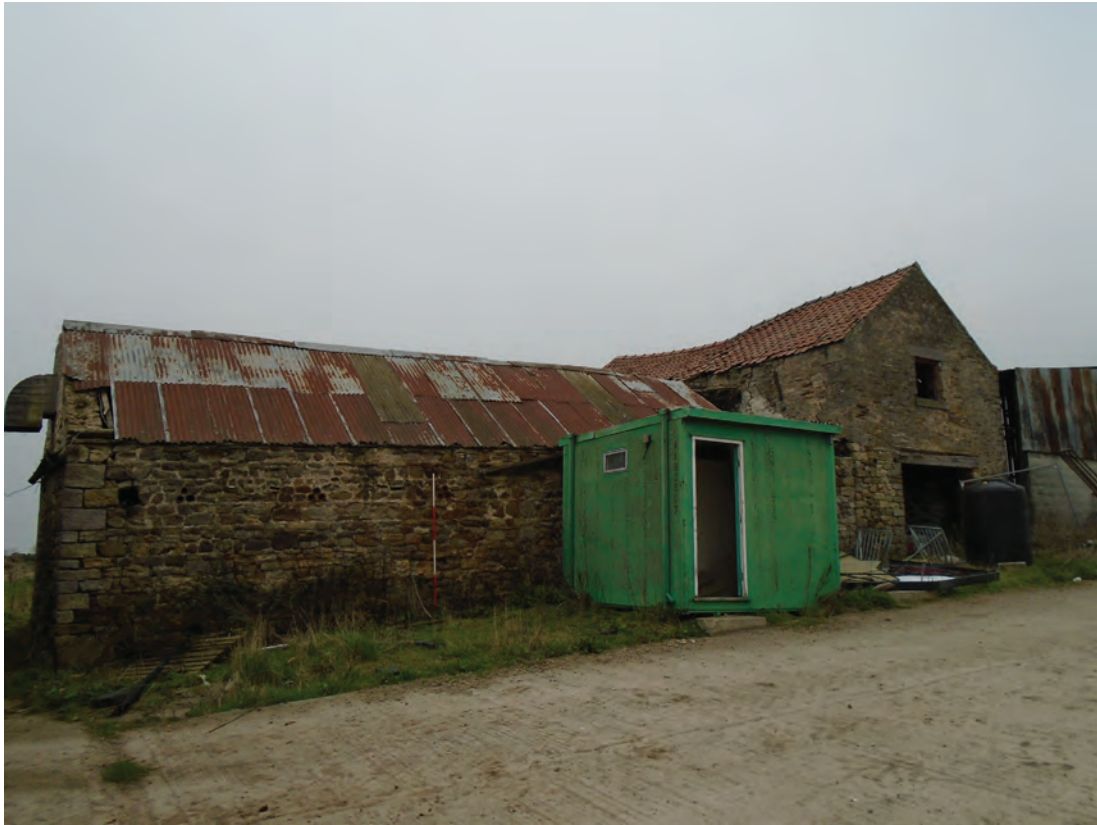
Figure 68 Building B, east elevation, facing north-west. Scale 1x2 m

This elevation is formed by the side elevation of the single-storey barn and the gable elevation of the two-storey barn to the north of this (Figure 68). The side elevation of the single-storey barn includes alternating quoins at its southern extent, whilst to the north of this, small pyramidal arrangements of three clay field drain sections have been incorporated into the construction of the masonry to act as 'breathers' or ventilation for stock accommodation within (Figure 69). There are six such sets of these ventilators within the wall length. The roughly coursed rubble masonry of this barn sits below a pitched roof with a replacement covering of corrugated metal sheeting.

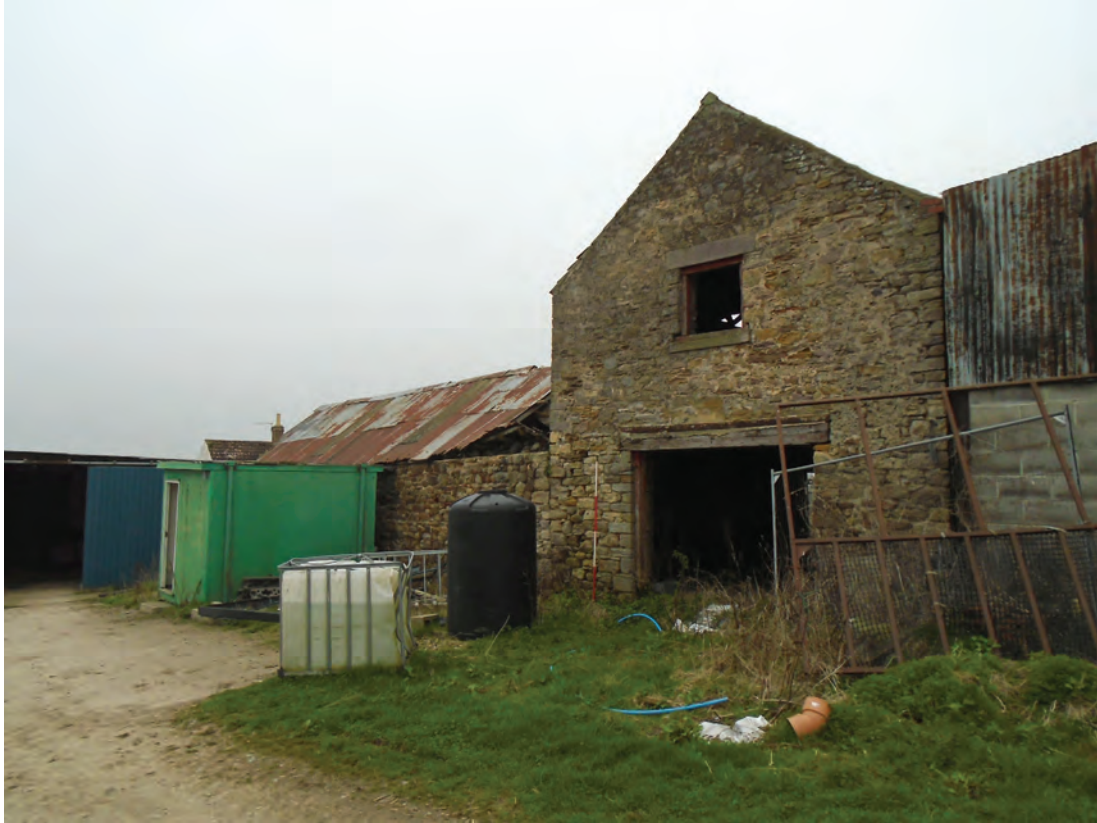
The conclusion of the north-south-aligned range is marked by a clear construction break at its northern extent where it has been butted against the southern face of the two-storey, east-west-aligned range (Figure 70). The gable elevation of the two-storey barn is also constructed in roughly coursed rubble with alternating quoins and includes a central first-floor window with a flush lintel and projecting chamfered sill over a wide cart-entry with a wooden lintel. The first-floor window is original, whilst the cart-entry may have been inserted.

Figure 70 Building B, north extent of east elevation. Note clear construction break between two phases of development. Scale 1x2 m
