Humbleton Farm  
Burtree Gate, Darlington

Historic Building Recording

*Solstice Heritage was commissioned by Darlington Farmers Auction Mart Company Limited to produce an Historic Building Recording of the farmhouse and two adjacent barns at Humbleton Farm, Burtree Gate, Darlington in fulfilment of a condition of planning permission (13/00110/FUL) for redevelopment of the site.*

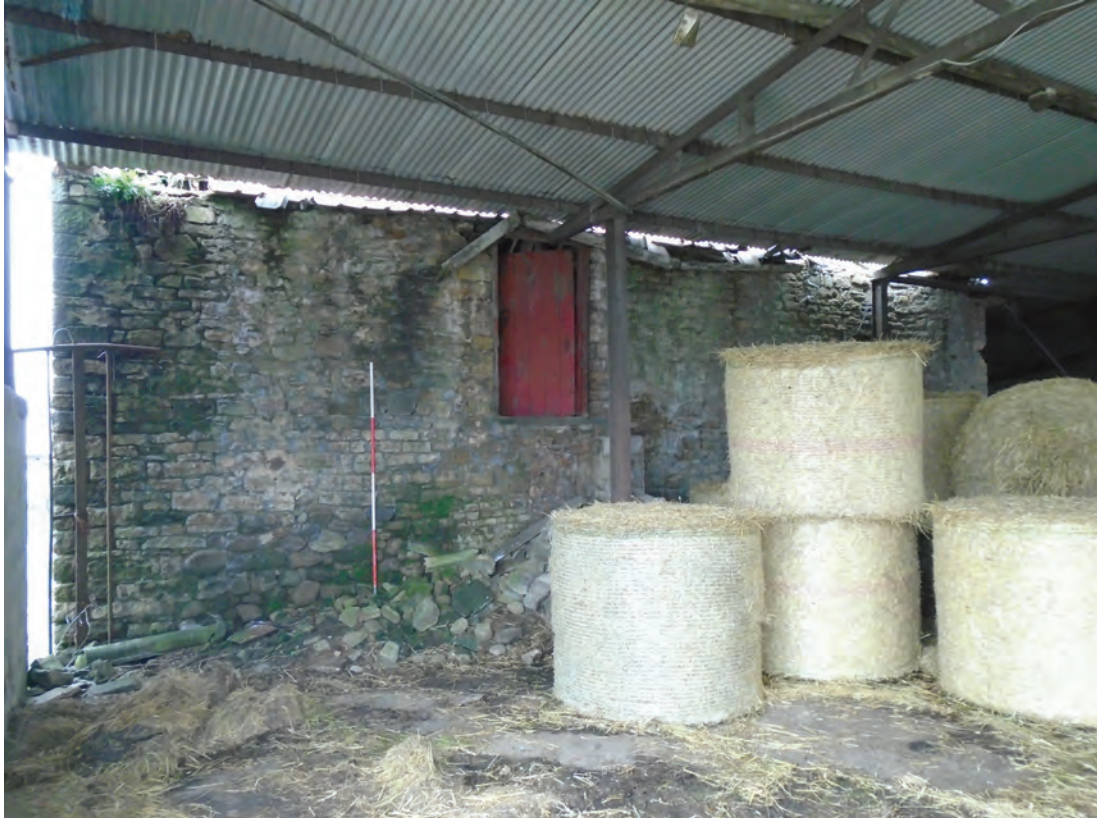
Figure 71 Building B, north elevation. Scale 1x2 m

This elevation is the rear façade of the two-storey barn (Figure 71). The elevation is constructed in roughly-coursed, roughly-squared rubble masonry with alternating quoins below a pantile roof. The elevation itself is now covered by a modern metal and asbestos sheet barn which was not included within this study. The elevation displays a broadly original façade with a first-floor doorway, with a chamfered stone threshold and a wooden lintel, accessed from a now ruinous external staircase of uncertain, and probably later, construction. A ground-floor doorway to Room G3 was accessed internally and considered to be inserted.

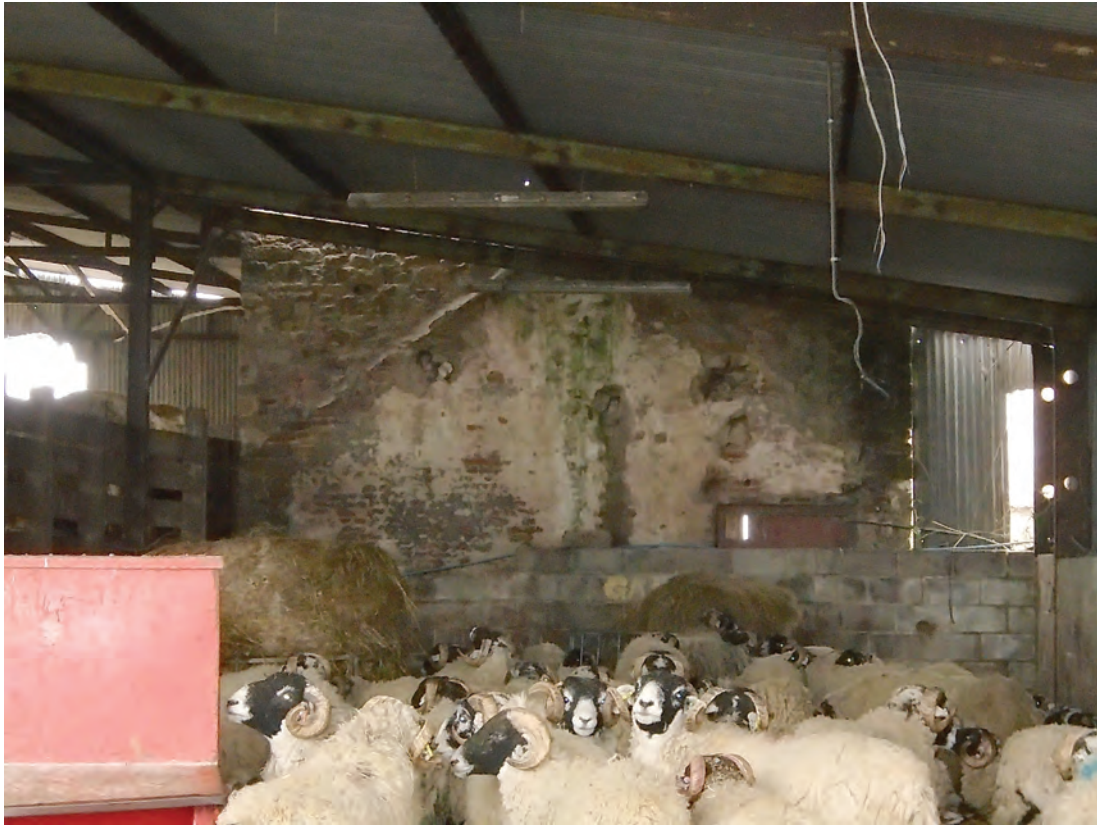
Figure 72 Building B, west elevation of two-storey barn. Note raggle of previous roofline for single-storey extension. No scale

This elevation is formed by the side elevation of the single-storey barn and the gable elevation of the two-storey barn to the north (Figure 72). The side elevation of the single-storey barn (Figure 73) includes alternating quoins at its southern extent, whilst to the north of this, a clear construction break exists with new work in modern concrete blockwork replacing the line of the previously stone wall at this side of the building. The new blockwork most likely relates to the alterations within Room G1, discussed below, and may also explain the wholesale replacement of the roof covering with the existing corrugated metal sheeting.

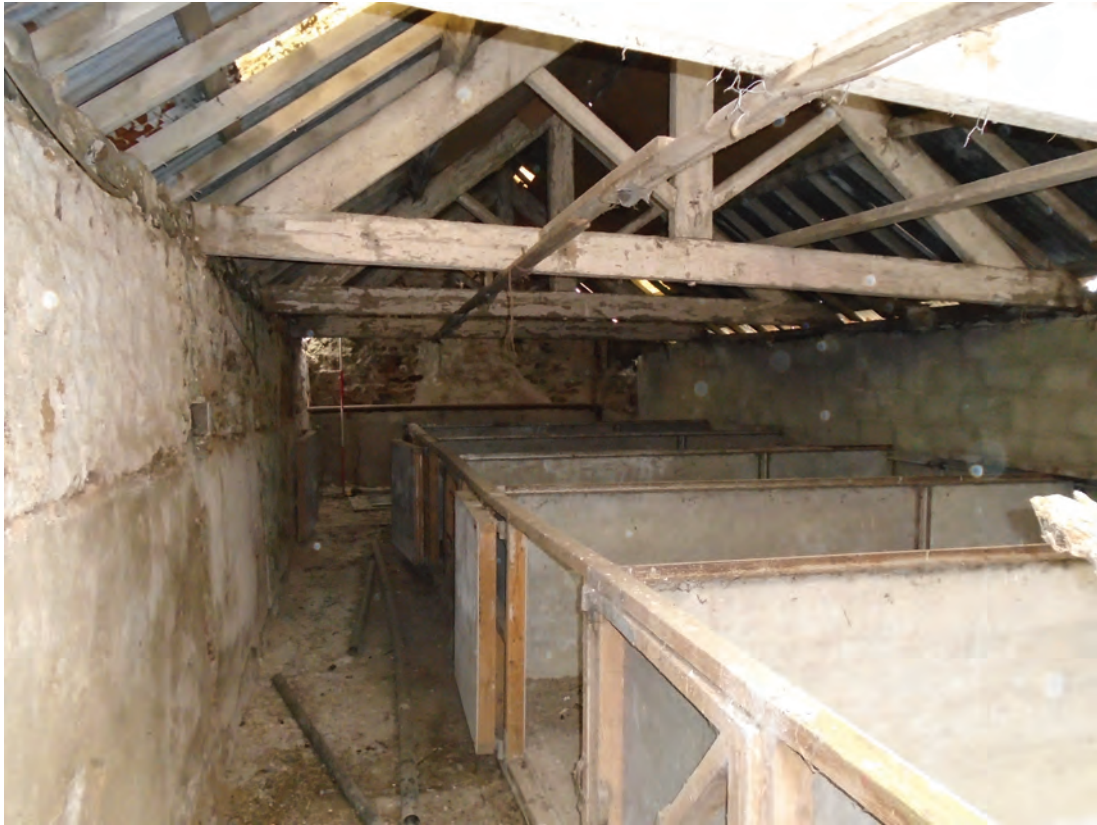
Figure 74 Building B, Room G1, facing south. Scale 1x2 m

Room G1 sits within the later, north-south-aligned phase of the barns, accessed internally by an inserted doorway from Room G2 at the eastern extent of its north wall. The room has modern inserted metal stalling at its west side with a walkway against the east wall (Figure 74). The stalling, and a lower trough at its western side, appears likely to be the reason for the removal and replacement of the west wall of the building. Above, the room is open to the roof, with three principal king-post trusses. Much of the roof structure appears to have been replaced. The south wall of the room is featureless aside from some evidence of repair at its east and west extents. The modern blockwork of the west wall is also featureless, while the north wall has an inserted doorway at its eastern extent (Figure 75). The lower half of the east wall of the room has a surviving cement render applied (Figure 76). The application of this cement render, which is often associated with stock accommodation and/or dairying, has preserved the outlines of previous stalls against this wall, illustrating an earlier internal arrangement. The clay pipe ventilators noted externally in the east wall appear to have been blocked internally at some point.

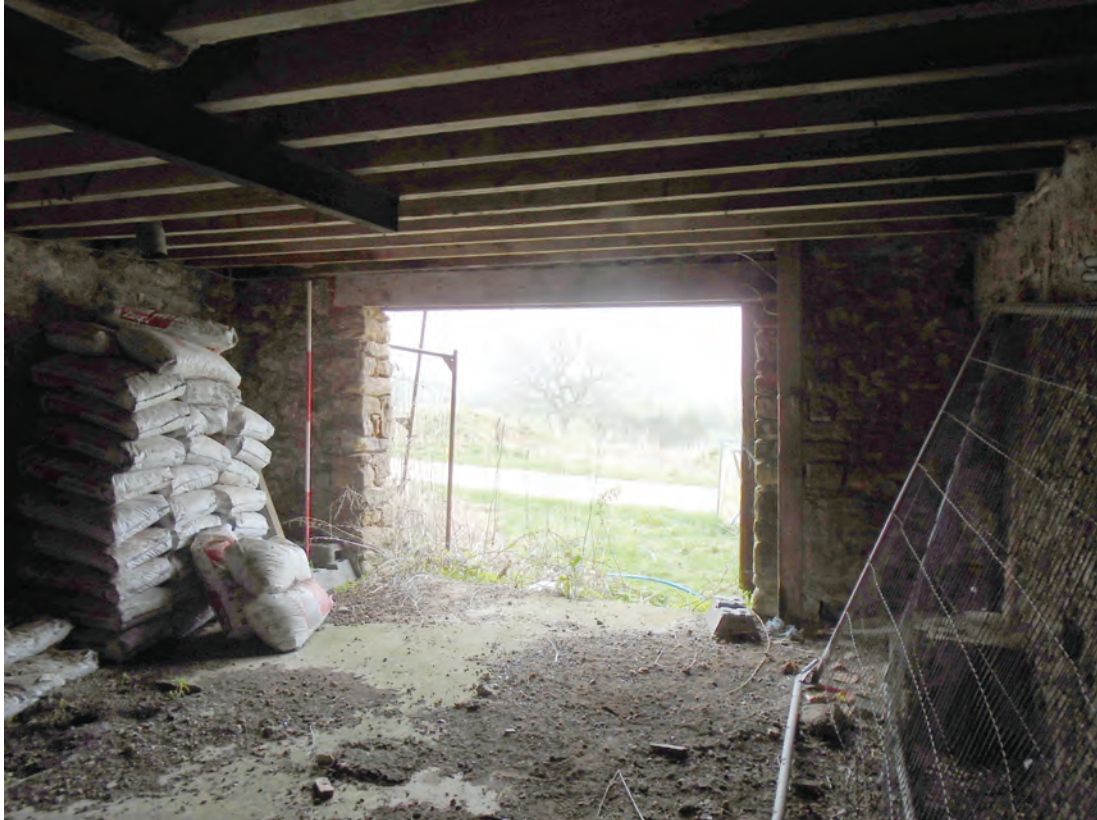
Figure 80 Room G2, facing east. Scale 1x2 m

Room G2 sits within the earlier east-west, two-storey phase of the barns. It is accessed internally by an inserted doorway from Room G1 at the eastern extent of its southern wall, and from a doorway to Room G3 at the southern extent of its west wall. A large cart-entry leads to the outside through the centre of the east wall. The room has exposed replacement wooden squared joists supporting the floor above which have been underpinned further by the insertion of a steel 'I' beam running east to west. The west wall of the room includes an original door opening at its southern extent, although the wall itself appears to be a partial insertion given that it appears to have been increased in thickness by the addition of a brick skin to its eastern face (Figure 77). The south wall includes an inserted doorway, created with brickwork, at its eastern extent and is otherwise featureless (Figure 78). The north wall is also featureless (Figure 79). The east wall contains a large cart-entry opening at its centre, supported above by a squared timber lintel (Figure 80).

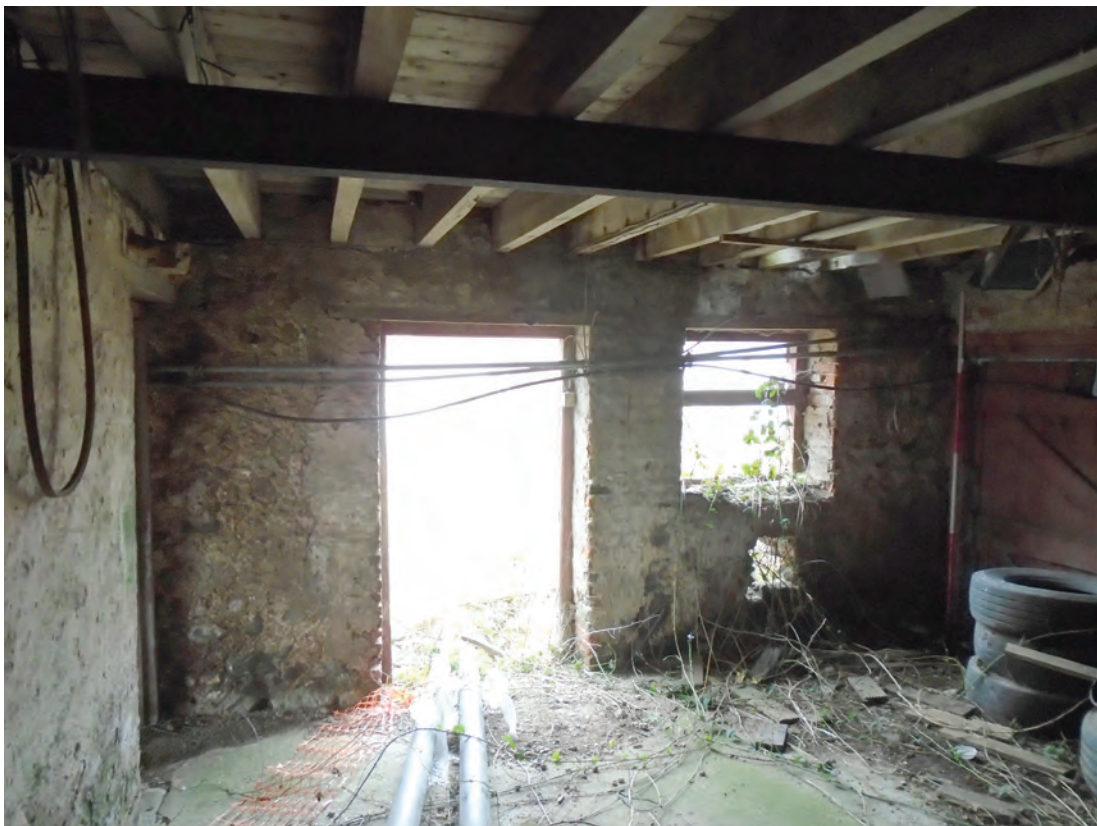
Figure 84 Room G3, facing south Scale 1x2 m

Room G3 sits within the earlier two-storey range of the barns. This room is accessed internally by a door from Room G2 at the southern extent of its east wall and by external doorways within each of its other walls. The room has exposed replacement wooden squared joists supporting the floor above, which have been underpinned further by the insertion of a steel 'I' beam running east to west. The north wall of the room includes an inserted doorway (Figure 81). The east wall includes a doorway at its southern extent (Figure 82). The east wall also includes an original door opening at its southern extent, although the wall itself appears to be a partial insertion given that it appears to have been increased in thickness by the addition of a brick skin to its eastern face (Figure 83). The south wall of the room includes a probably inserted doorway close to its eastern extent, to the west of a square window (Figure 84).
