St John the Baptist Church
Lowick, Northumberland

Archaeological Watching Brief

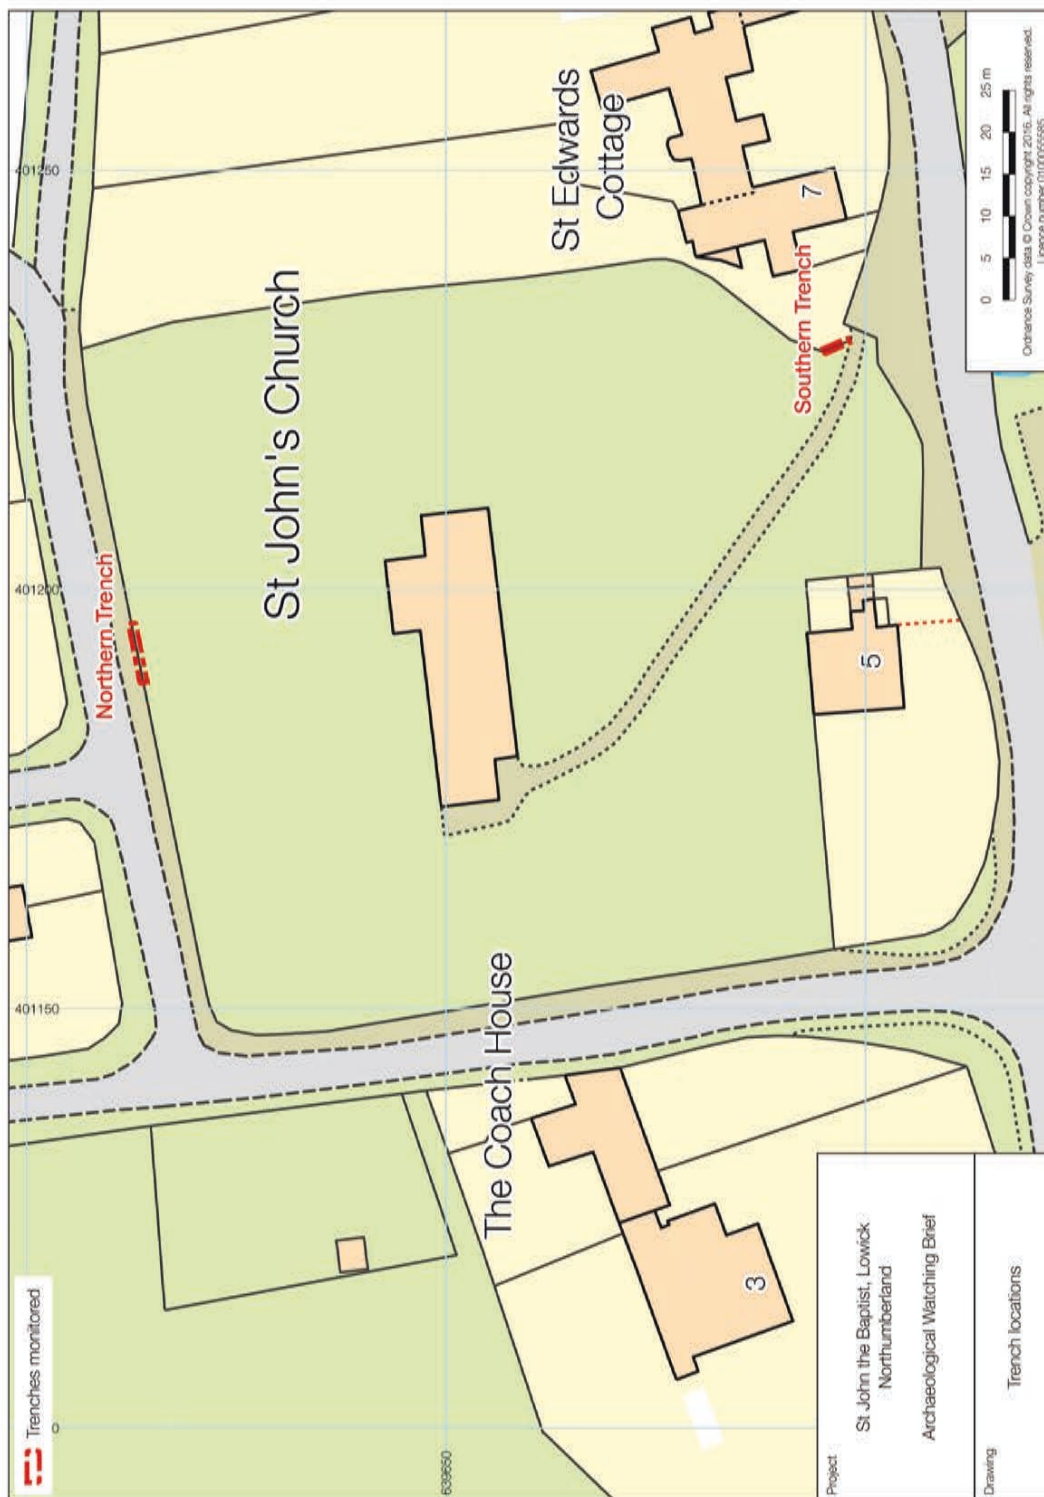
The two sections of failing boundary wall (Figure 2), one immediately to the right of the entrance into the churchyard from Main Street and the other at the north side of the churchyard at its boundary with Church Lane, were taken down by contractors between 10th and 13th April 2017, in advance of rebuilding on the same footprint. New foundations for both sections of wall were excavated to improve the stability of the rebuilt areas. All groundworks were monitored by a suitably qualified archaeologist, and all excavations were carried out by hand. Should archaeological features or deposits have been encountered, these would have been recorded to the standards outlined in the relevant CfA *Standard and Guidance* (2014b). All features and deposits would have been recorded on *pro forma* record sheets, drawn in plan and section at a suitable scale and photographed. No deposits with palaeoenvironmental potential were noted. In addition to any specific features or deposits, a general record of the trench stratigraphy was made on a *pro forma* record sheet.

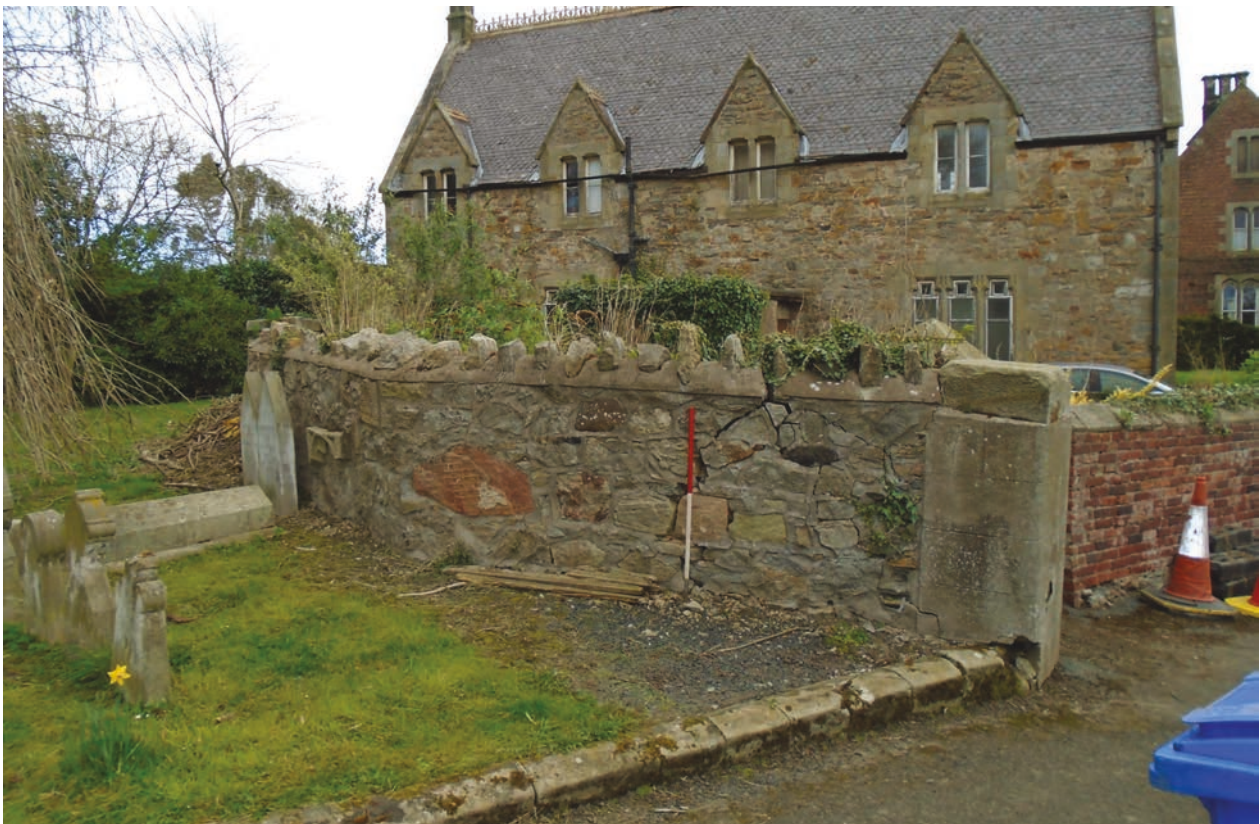
The failing section of wall to the immediate right of the gateway into the churchyard from Main Street (Figure 3) was deconstructed by contractors, by hand, on the 11th April 2017. The wall was found to have no meaningful foundation, instead sitting directly upon the existing ground surface. Three architectural stone elements were previously identified as having been incorporated into the build of the existing wall, and these were carefully removed by hand during deconstruction (Figure 4). Peter Ryder, the diocesan archaeological advisor, has identified these fragments as parts of a probable early 12th-century tympanum, a 12th-century cross slab grave cover and a 15th- or early 16th-century window head (Peter Ryder, pers. comm. October 2015). Nothing was noted upon inspection after removal to cast doubt upon, or add to, this interpretation. The removed fragments were transported to covered storage in the church porch for future preservation and display.

Figure 3 Failing section of wall adjacent to the entrance to the churchyard from Main Street, prior to the commencement of works, looking north-east. Scale 1x1 m

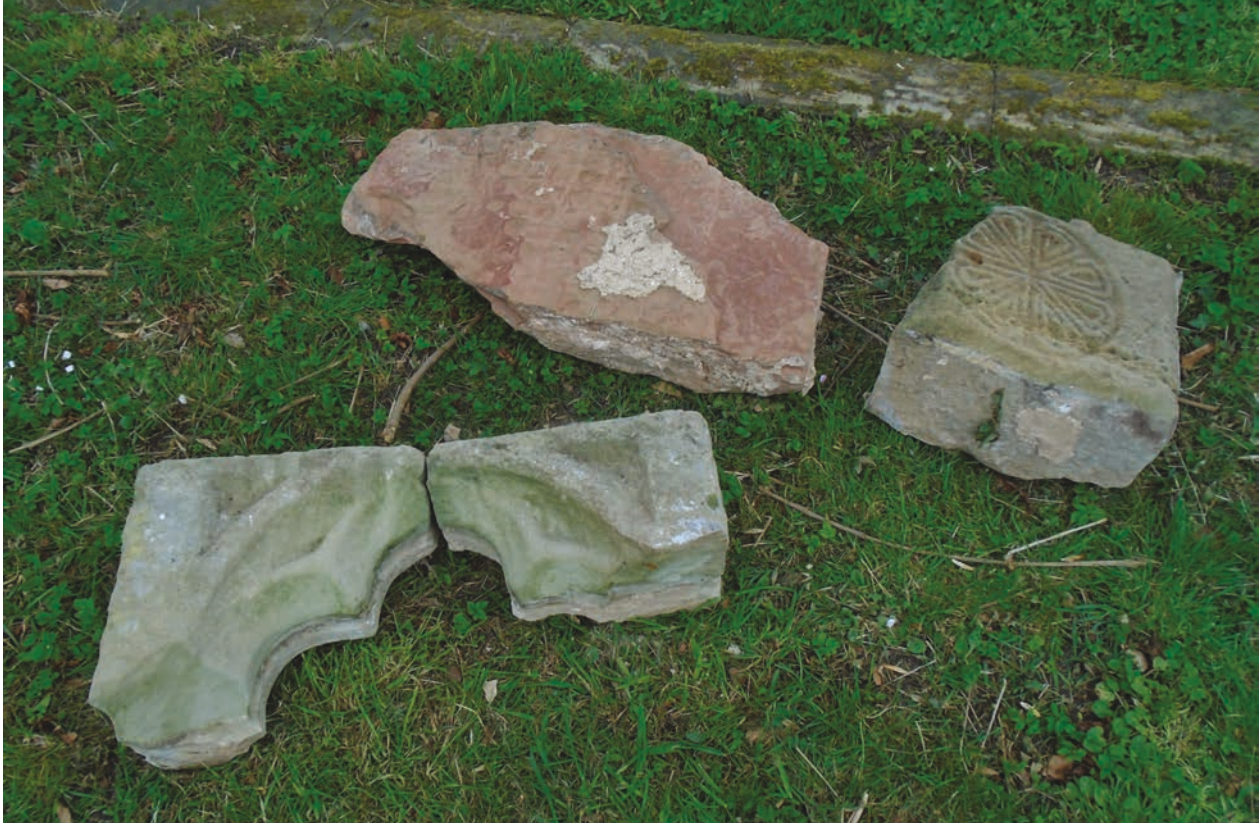
Figure 4 Carved stone elements after removal during deconstruction works. No scale

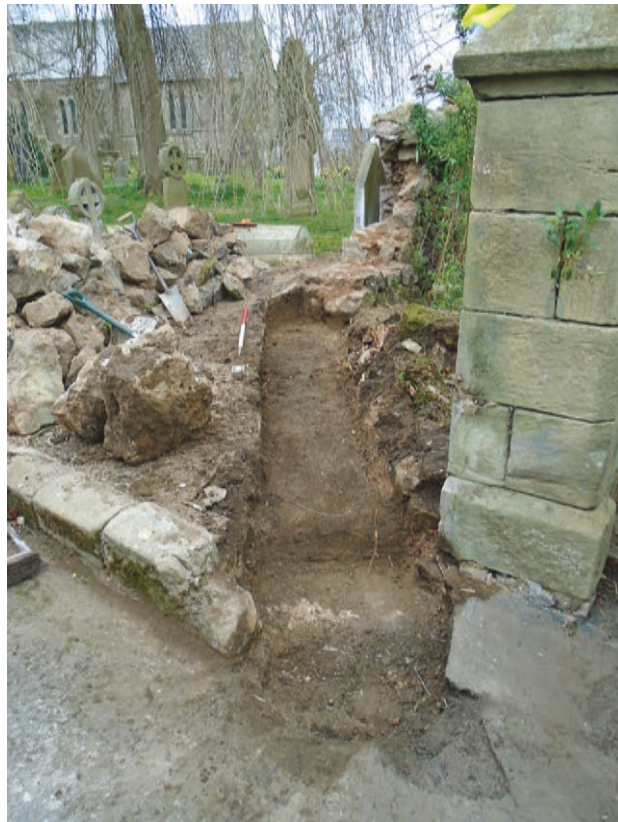
Archaeological monitoring of the excavation of a new foundation for the rebuilt section of wall, on the original footprint of the removed section, was carried out on 12th April 2017. The excavation for the new foundation was c. 0.7 m in width and c. 3.3 m in length (Figure 5). The depth of the new foundation trench measured 0.25 m below the existing ground level. The trench was cut into a seemingly undisturbed mid-brown silty clay subsoil (001), which was not penetrated by the excavation. No archaeological features or finds were noted, including any human remains or further architectural fragments from the build of the wall itself.

Figure 5 Completed excavation for new wall foundation, looking north. Scale 1x1 m

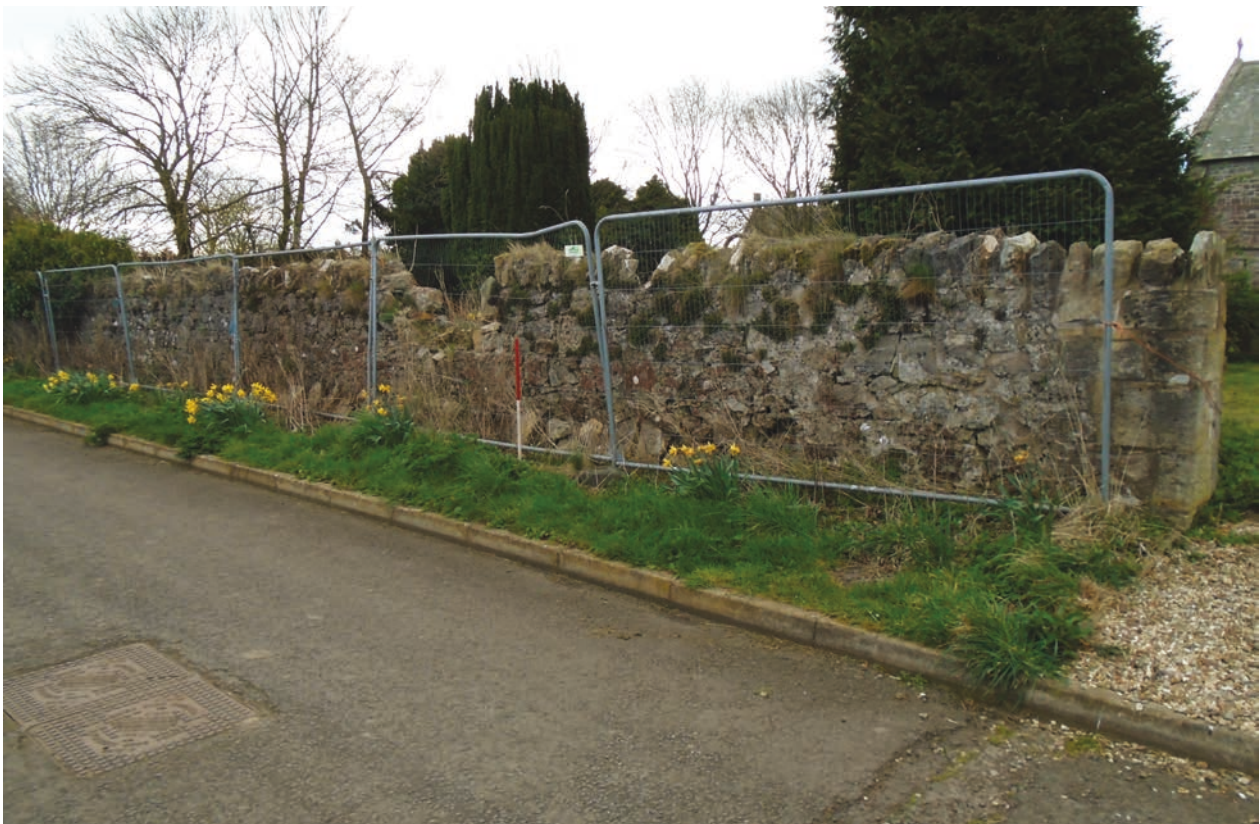
The failing section of wall to the north side of the churchyard, adjacent to Church Lane (Figure 6) was deconstructed by contractors, by hand, on the 11th April 2017. The wall was found to have no foundation, instead sitting directly upon the existing ground surface. No architectural stone elements were identified within the build of this length of wall.

Figure 6 Failing length of wall at the north side of the churchyard, adjacent to Church Lane, prior to the commencement of works, looking south-east. Scale 1x1 m

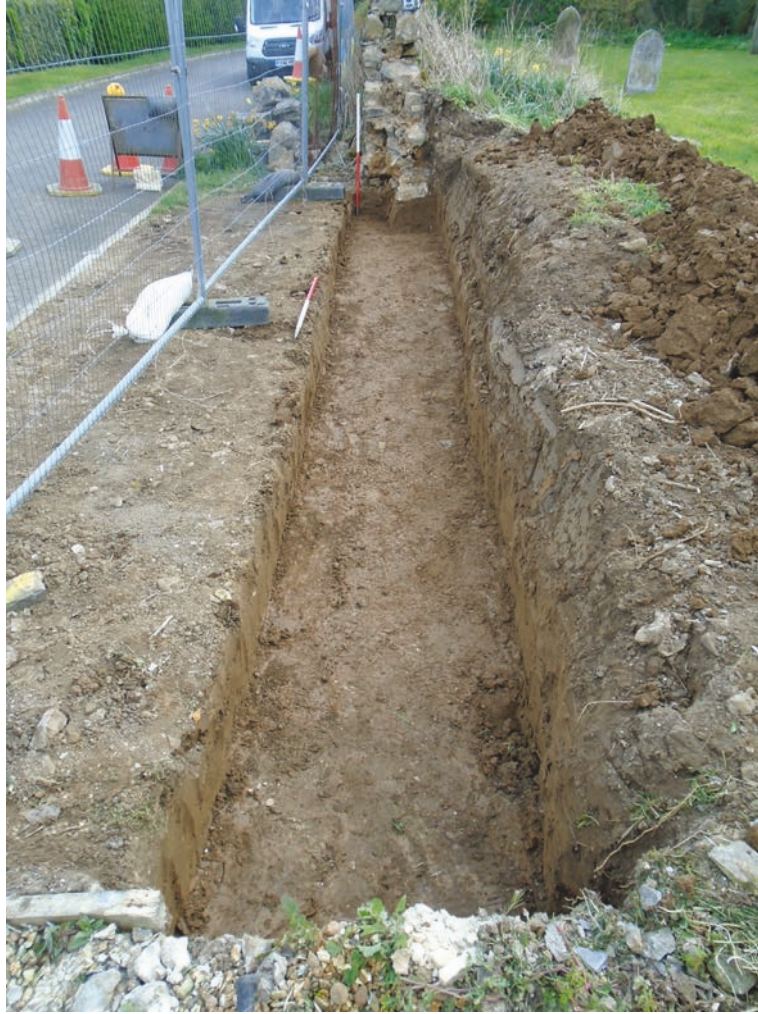
Archaeological monitoring of the excavation of a new foundation for the rebuilt section of wall, on the original footprint of the removed section, was carried out on 18th April 2017. The excavation for the new foundation was c. 0.9 m in width and c. 7.2 m in length (Figure 7). The depth of the new foundation trench measured 0.20 m below the existing ground level. The trench was cut into a seemingly undisturbed mid-brown clay till substrate (002), which was not penetrated by the excavation. No archaeological features or finds were noted, including any human remains or architectural fragments from the build of the wall itself.

Figure 7 New foundation trench for northern section of rebuilt wall, looking east. Note old wall sitting on clay till substrate. Scale 2x1 m
