Yarm Social Centre, Bentley Wynd, Yarm

Historic Building Recording

Solstice Heritage LLP was commissioned by Tracey Blenkinsop of Cranbourne Properties Ltd to produce an Historic Building Recording to comply with Condition 3 of planning permission 17/0392/FUL permitting the demolition of the existing former social club building at Bentley Wynd, Yarm, TS15 9BS.

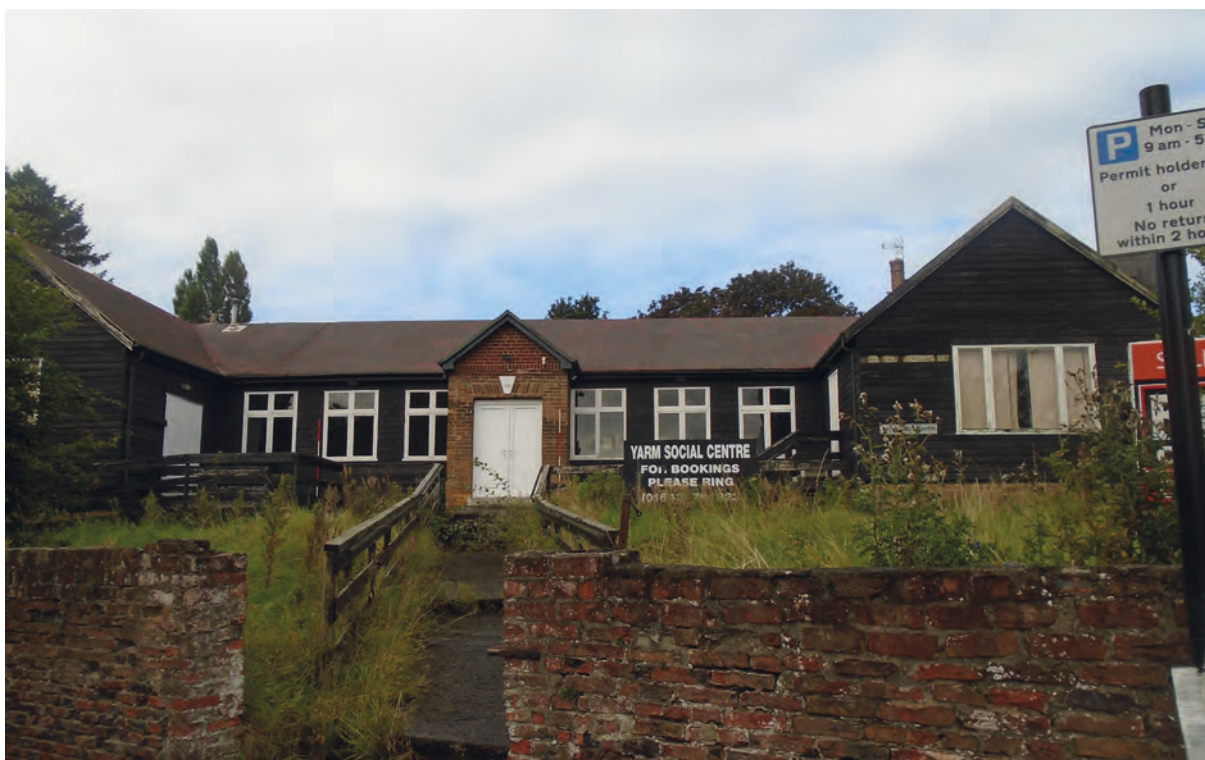
This principal elevation, of five bays, is constructed with a brickwork plinth in a yellow/cream facing brick, supporting a timber frame main construction clad in horizontal shiplap boarding (Figure 2). The elevation includes a central, projecting entrance porch with replacement uPVC double doors (Figure 3). The porch has a flat brick arch with a projecting central keystone, painted white and bearing the engraved date '1938'. The gable of the entrance porch, above the double doors, has been rebuilt in a modern red facing brick, and the barge boards and dormer roof have been replaced, suggesting that the upper portion of this element of the building was originally of a different design.

Figure 2 North-east elevation, facing south-west. Scale 2x2 m

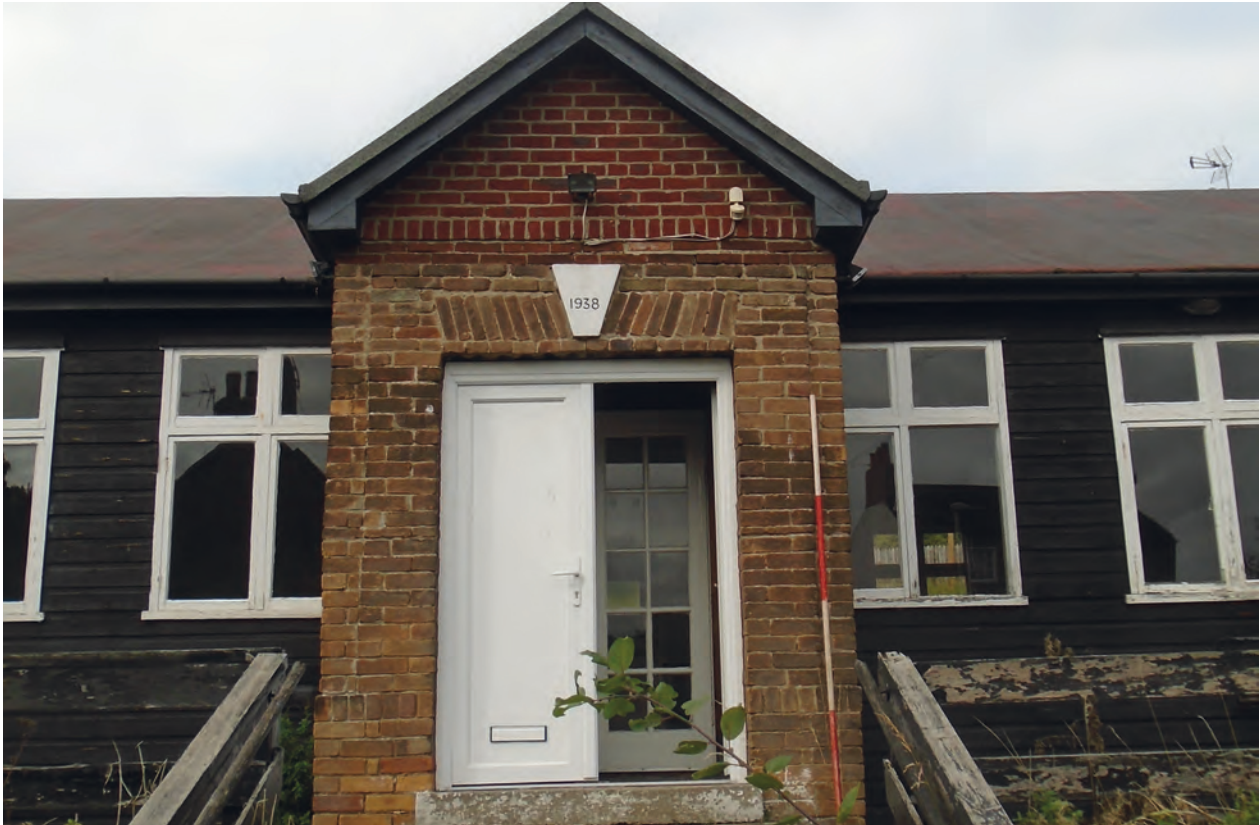
Figure 3 North-east elevation, central entrance porch. Scale 1x2 m

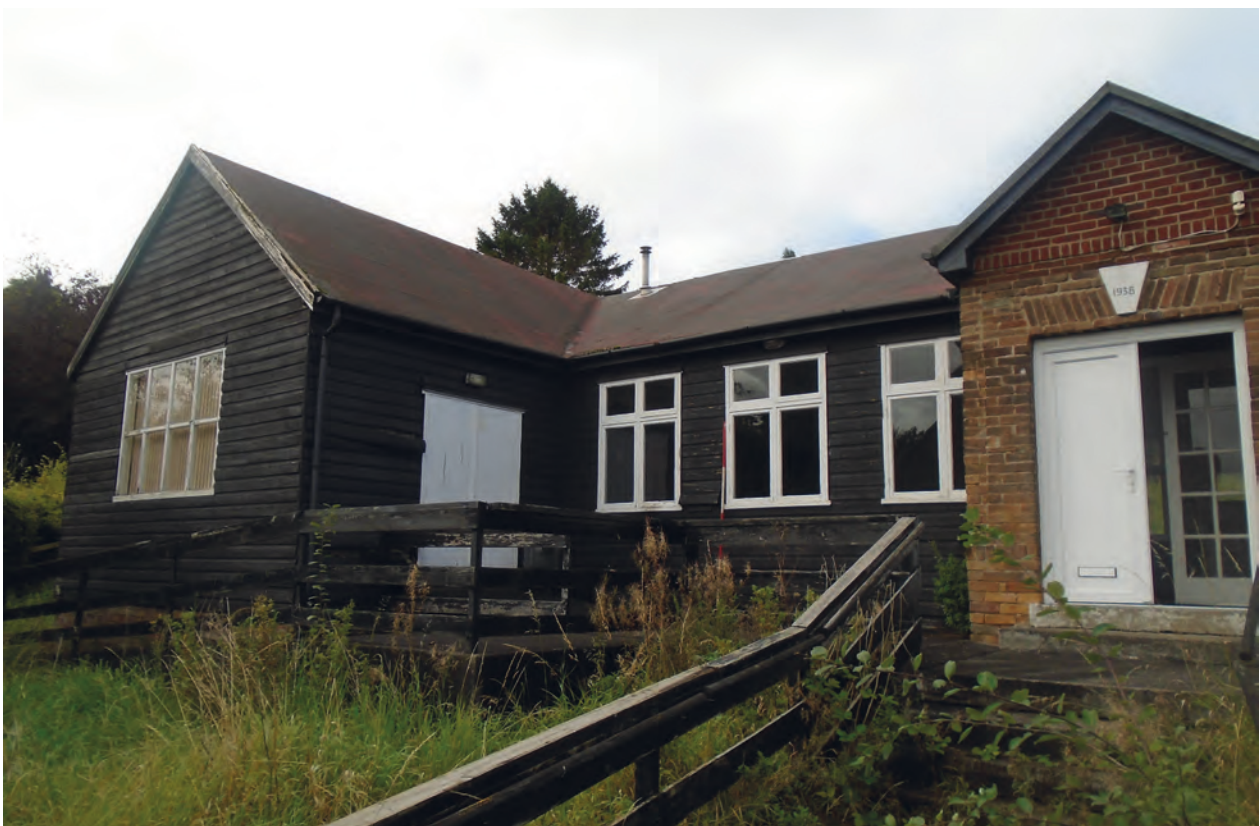
To the left of the porch, the building has a row of three original four-light casement windows which give way to a projecting, gabled end-bay with a central eight-light window (Figure 4). The right return of the end-bay includes a further set of double doors. To the right of the porch, the building includes a matching row of three original four-light casement windows which give way to a projecting, gabled end-bay with a central three-light window, probably a replacement (Figure 5). The left return of the end-bay includes a single door. Most of the pitched roof of the building appears to be covered with the original felt, with only the central porch having a replacement modern felt covering.

Figure 4 Eastern extent of north-east elevation. Scale 1x2 m

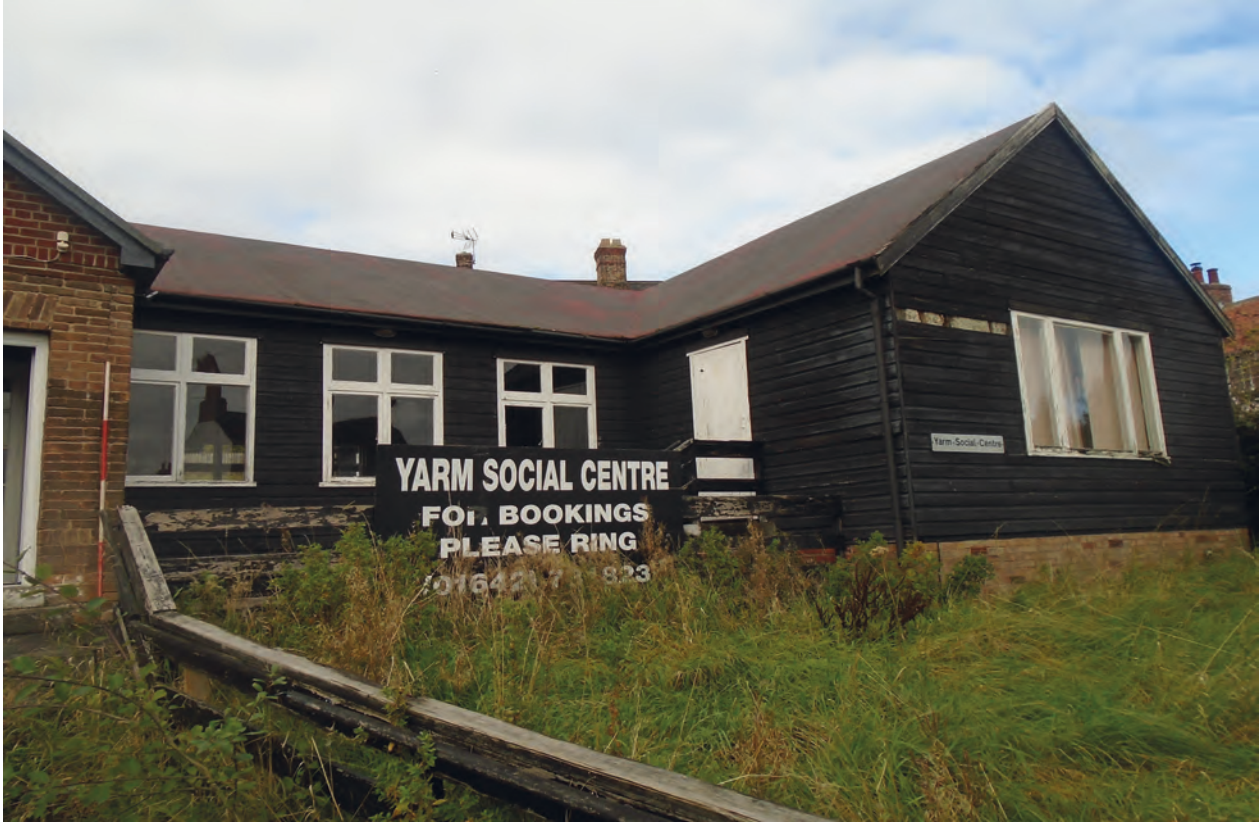
Figure 5 Western extent of north-east elevation. Scale 1x2 m

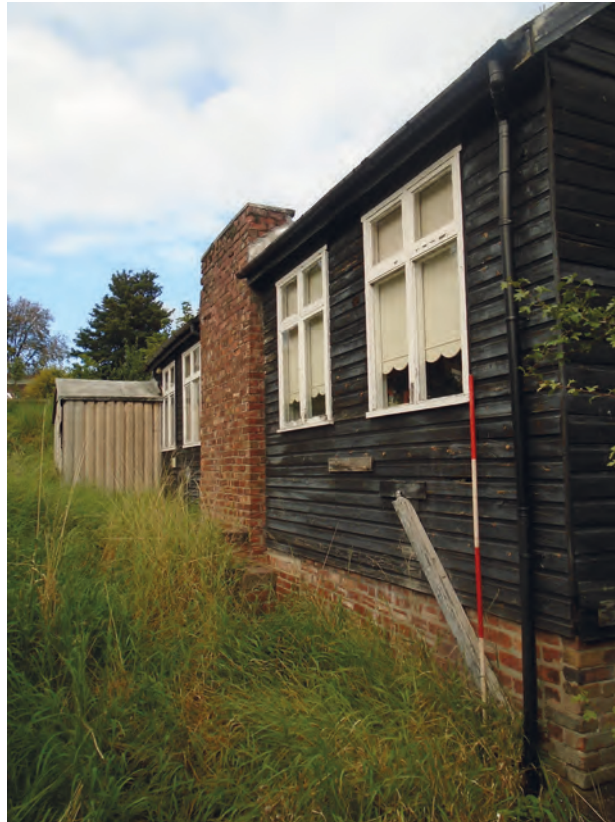
This end elevation, of four bays, includes two pairs of matching four-light casement windows either side of a large, rectangular chimney stack, constructed in low-quality brickwork in a rough English Garden Wall bond (Figure 6). At the western extent of the elevation, an original rear lean-to section is masked by a later side extension constructed in corrugated asbestos sheet with a felt roof and single two-light casement window (Figure 7). The elevation includes an external stair access to a cellar at its eastern extent (Figure 8). The concrete stairway sits behind a low brick parapet wall and gives access to a doorway into the cellar, which has been latterly blocked in brickwork.

Figure 6 South-east elevation, looking west. Scale 1x2 m

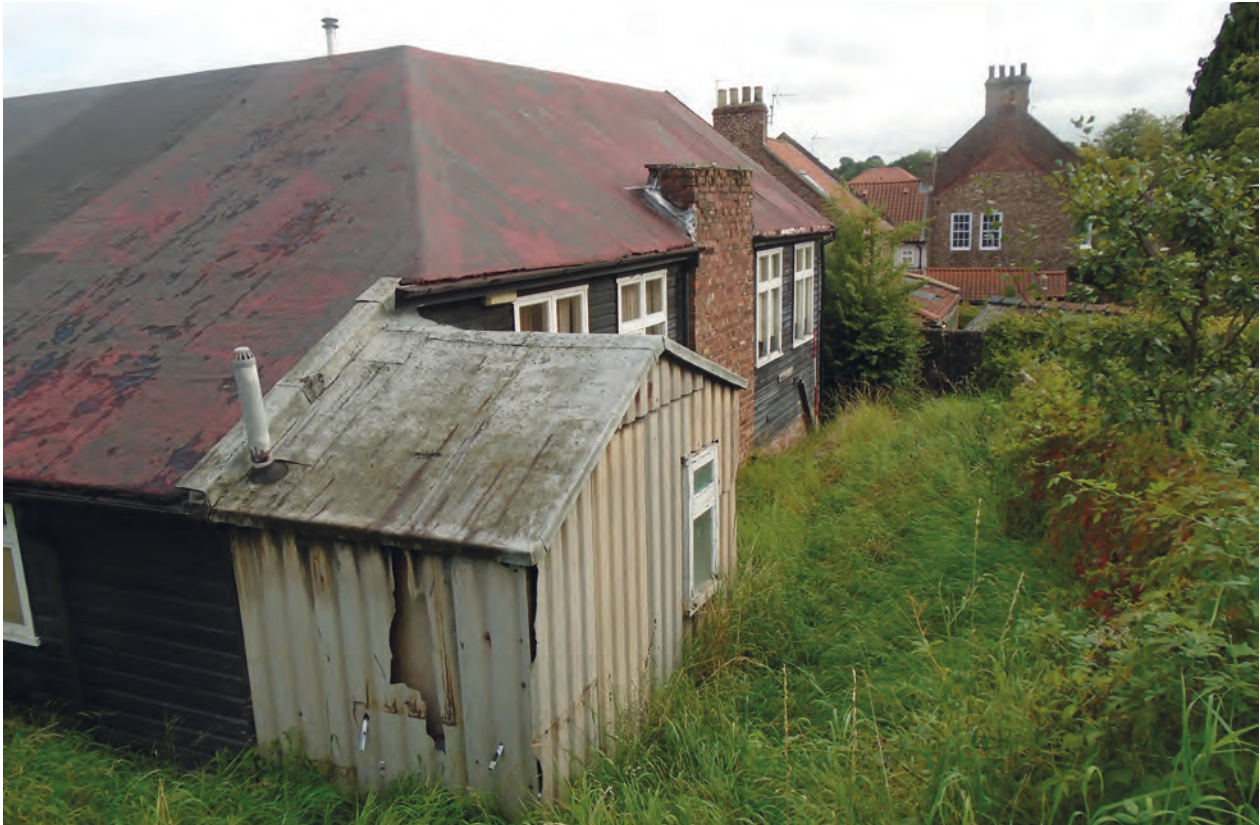
Figure 7 South-east elevation, looking north. Scale 1x2 m

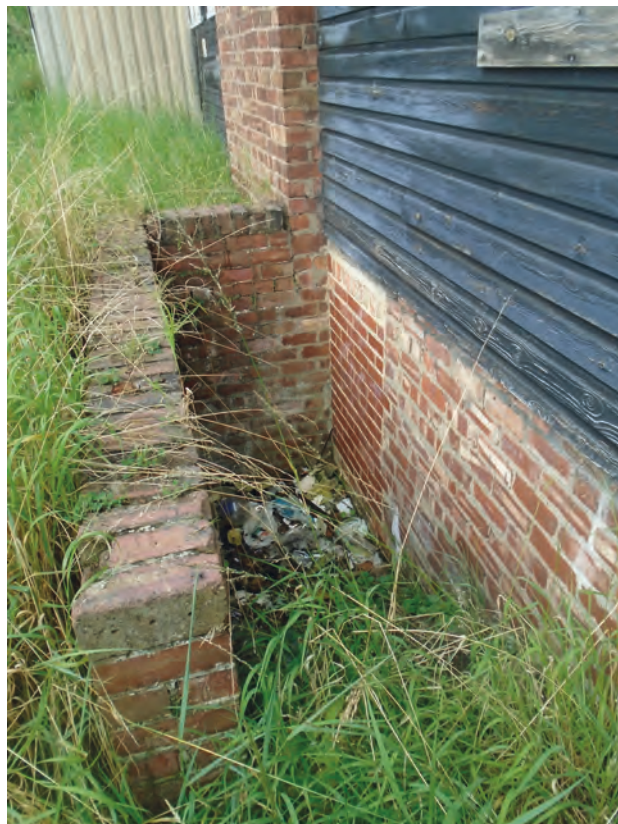
Figure 8 External stair access to cellar with blocked door. No scale

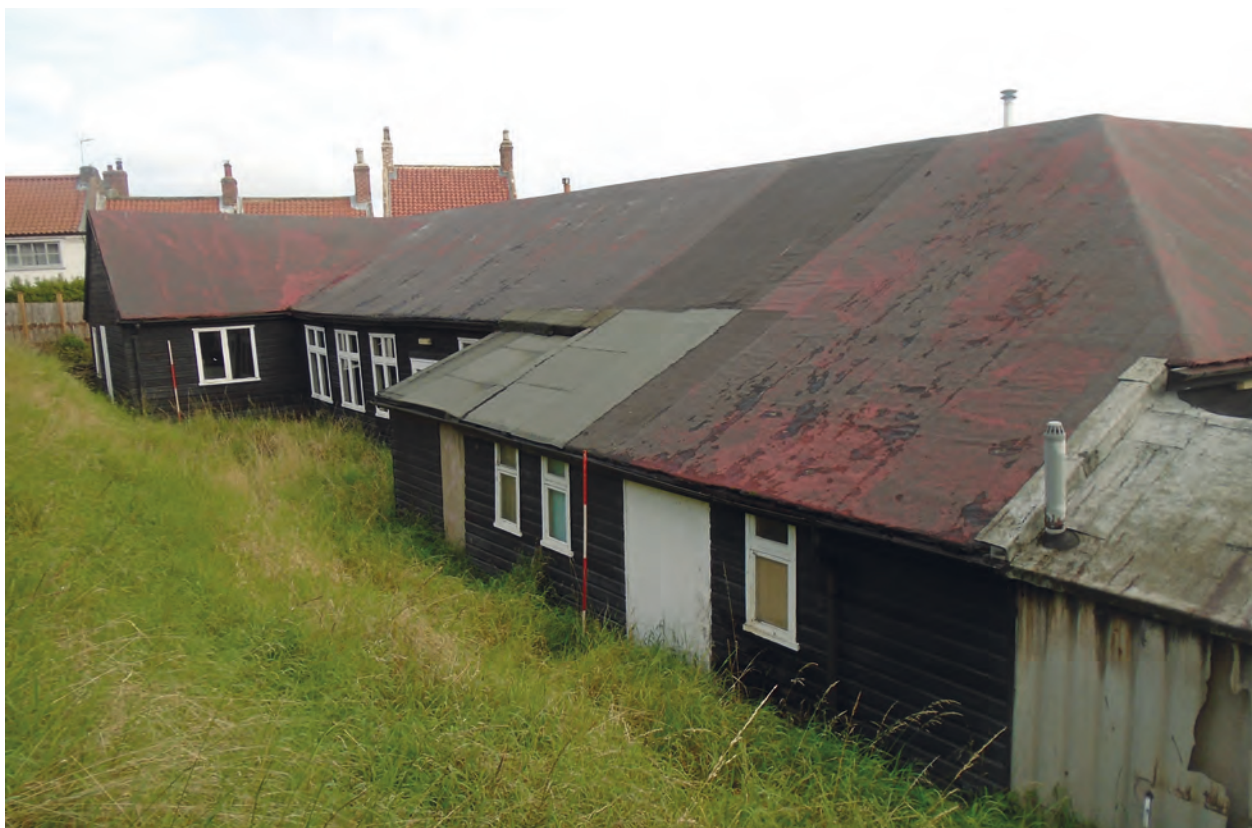
The south-west-facing elevation of the building includes an original lean-to projection at its southern extent with three two-light casement windows and single and double doorways, both boarded over (Figure 9). The northern extent of this lean-to section shows significant repair, and probable slight alteration, to its roof, where a grey, modern felt has been added, similar to that used to re-roof the main front entrance porch.

Figure 9 South-west elevation, facing north. Scale 2x2 m

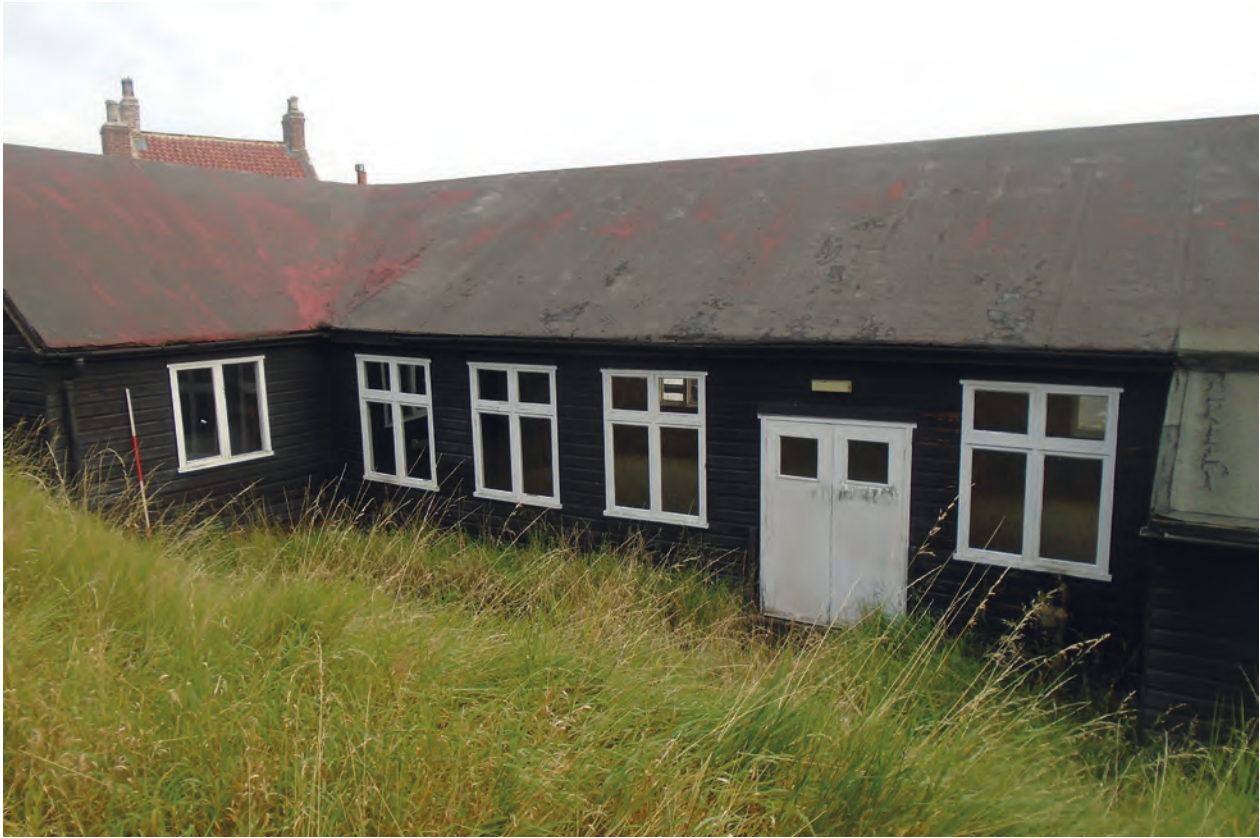
The central, recessed section of the building has a row of four original four-light casement windows, punctuated by a further set of double doors (Figure 10) which give way to a projecting, gabled end-bay with a single window and doorway (Figure 11). The right return of the end-bay includes a two-light casement window.

Figure 10 Central section of south-west elevation. Scale 1x2 m

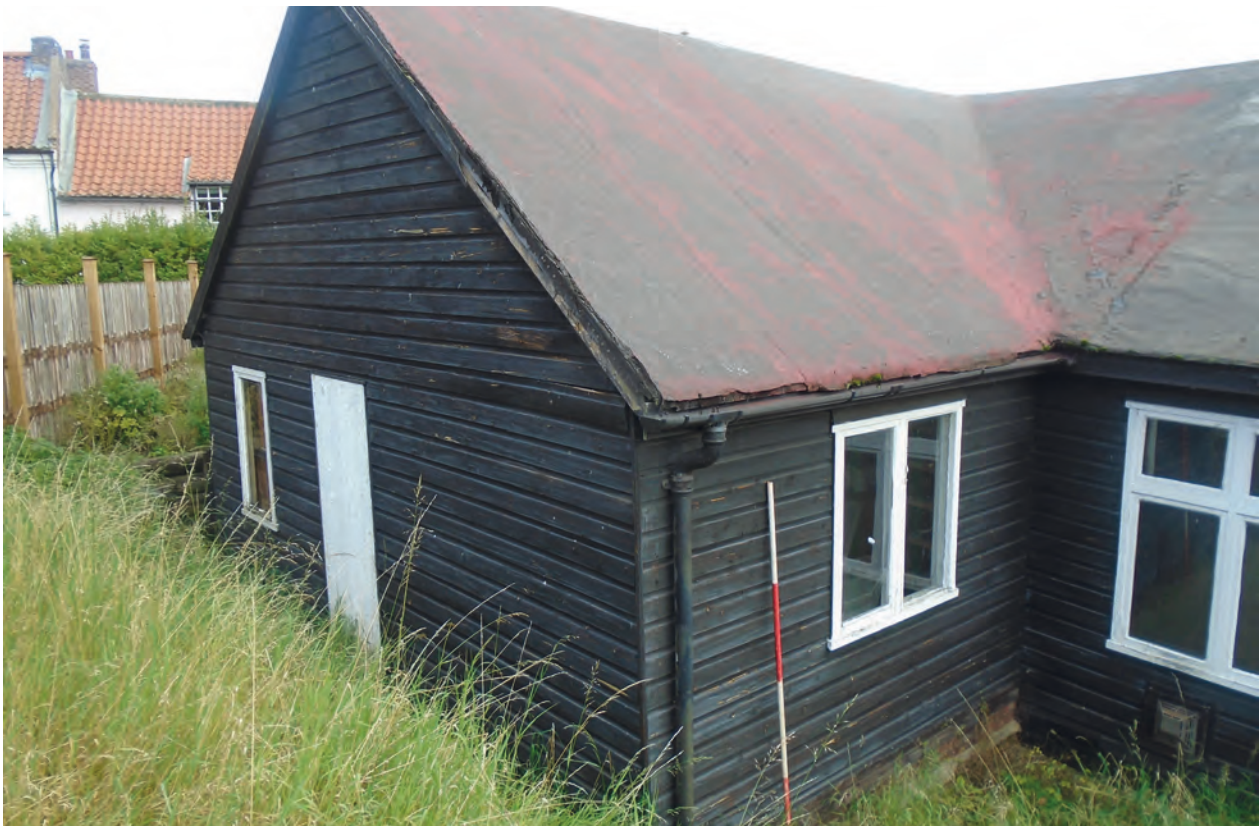
Figure 11 Northern section of south-west elevation. Scale 1x2 m

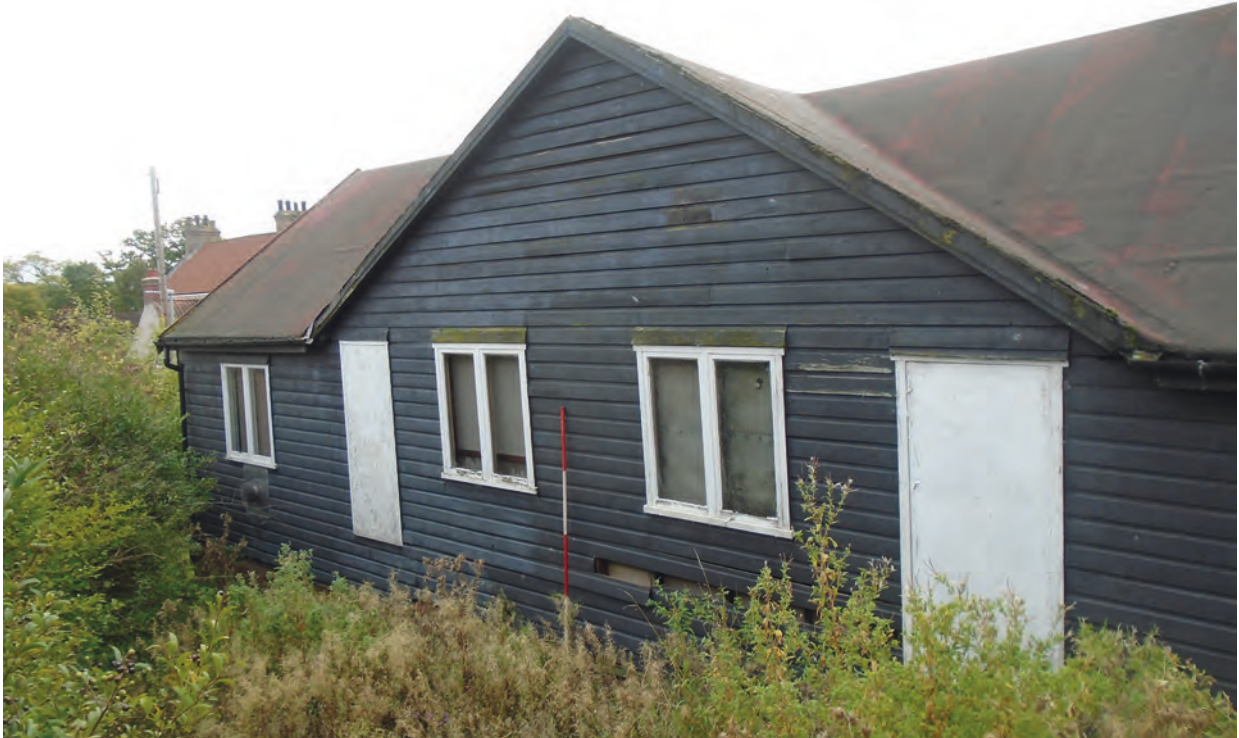
The north-west-facing elevation of the building has a central gabled bay including a symmetrical arrangement of two two-light windows within two doorways (Figure 12). Either side of this central gable are pitched sections of roof, below which sit two flanking two-light windows also arranged symmetrically (Figure 13). The elevation appears to be as originally constructed with no significant alterations visible.

Figure 12 North-west elevation, facing east. Scale 1x2 m

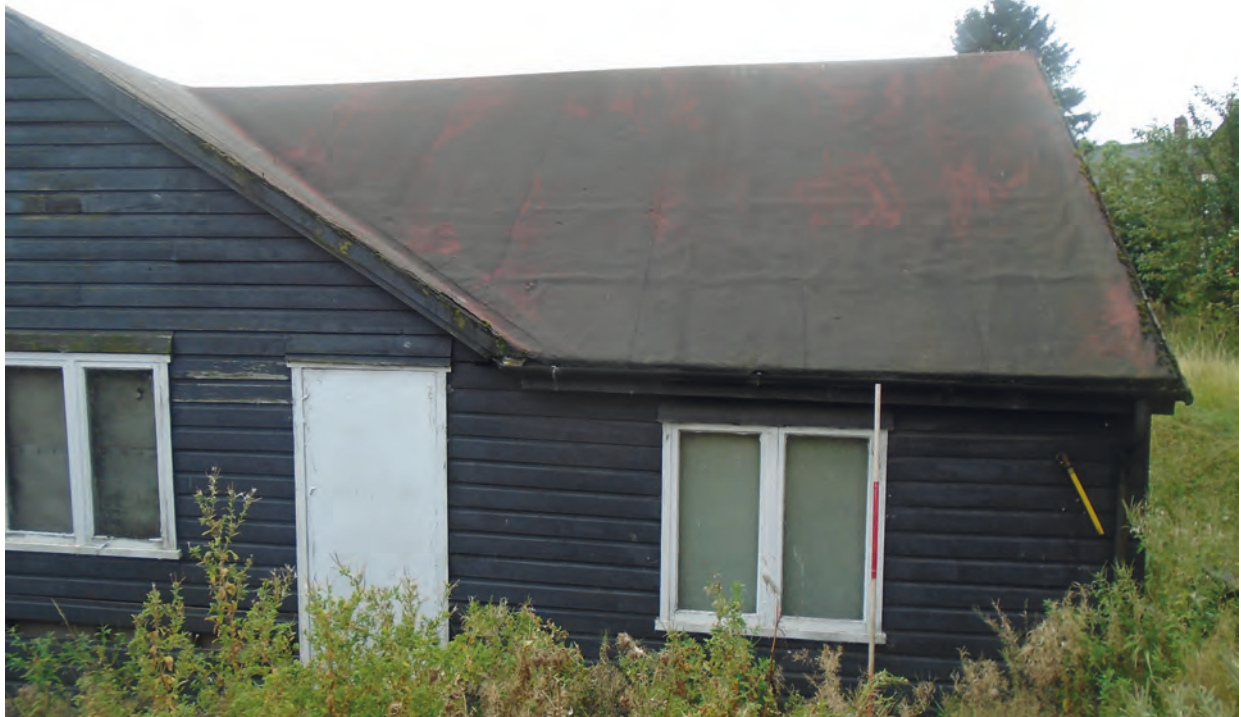
Figure 13 Western extent of north-west elevation, facing south-east. Scale 1x2 m

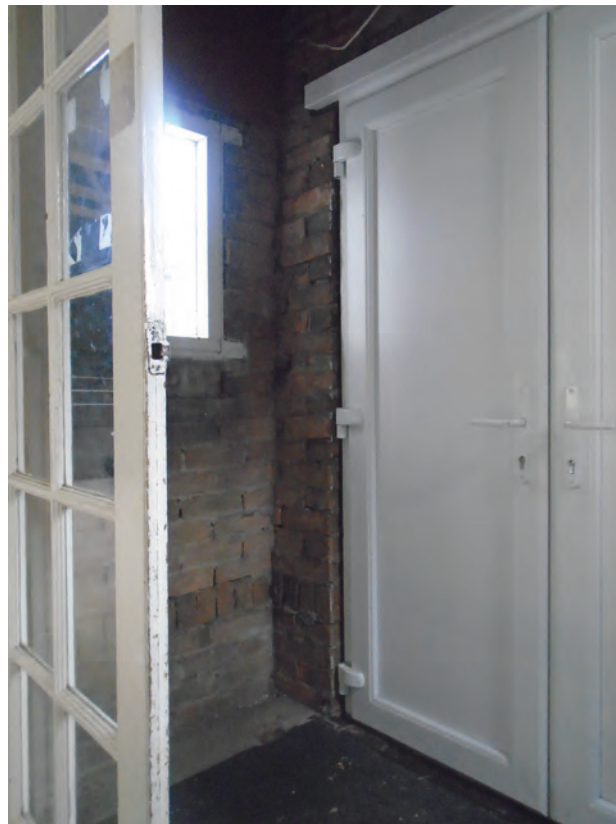
Room G1 sits within the brick entrance porch at the centre of the north-east elevation. The room is accessed by a double doorway with replacement uPVC doors at its north-east side. The internal walls are plain brick and are punctuated at the north and south sides by a pair of single-light windows which light the space (Figure 14). At its junction with Room G2, the room is exited through a pair of glazed wooden doors with ten panes in each door. The ceiling of the room is a plain, unfinished plywood board, again, as externally, suggesting that the roof of the porch has been altered.

Figure 14 Room G1, facing north. No scale

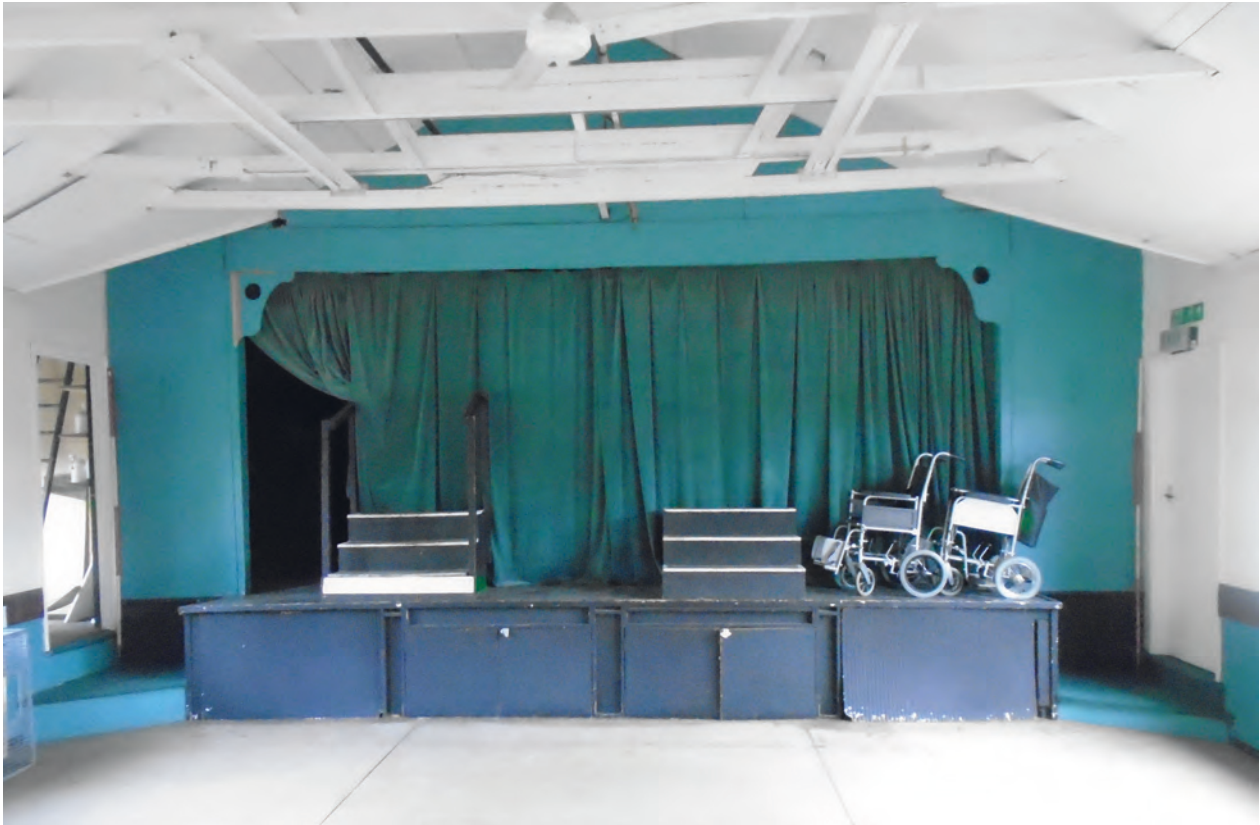
Room G2 is a large central hall with a raised, recessed stage area at its north-west side (Figure 15), which includes access doors to Rooms G4, G3 and G5. The south-west side of the room includes a central double doorway with four four-light casement windows and two other doorways at the north and south extents, leading to Rooms G3 and G6 respectively (Figure 16). The north-east wall includes a central glazed double doorway from Room G1 with a symmetrical arrangement of three four-light casement windows to either side (Figure 17). At the northern extent of this wall is a single doorway leading to Room G5. The south-east wall of the room includes three sets of inserted double-doors alongside a single-pane window into Room G7 (Figure 18). Evidence of locking points within the floor suggest that these doors have replaced an earlier partition, perhaps a folding screen. The ceiling of the room is partially open to the roof structure of raised-chord timber trusses. It seems likely that originally the ceiling was even higher and later boarding has partially enclosed these trusses, presumably to encompass additional roof insulation.

Figure 15 Room G2, north-west wall, including stage. Scale 2x2 m

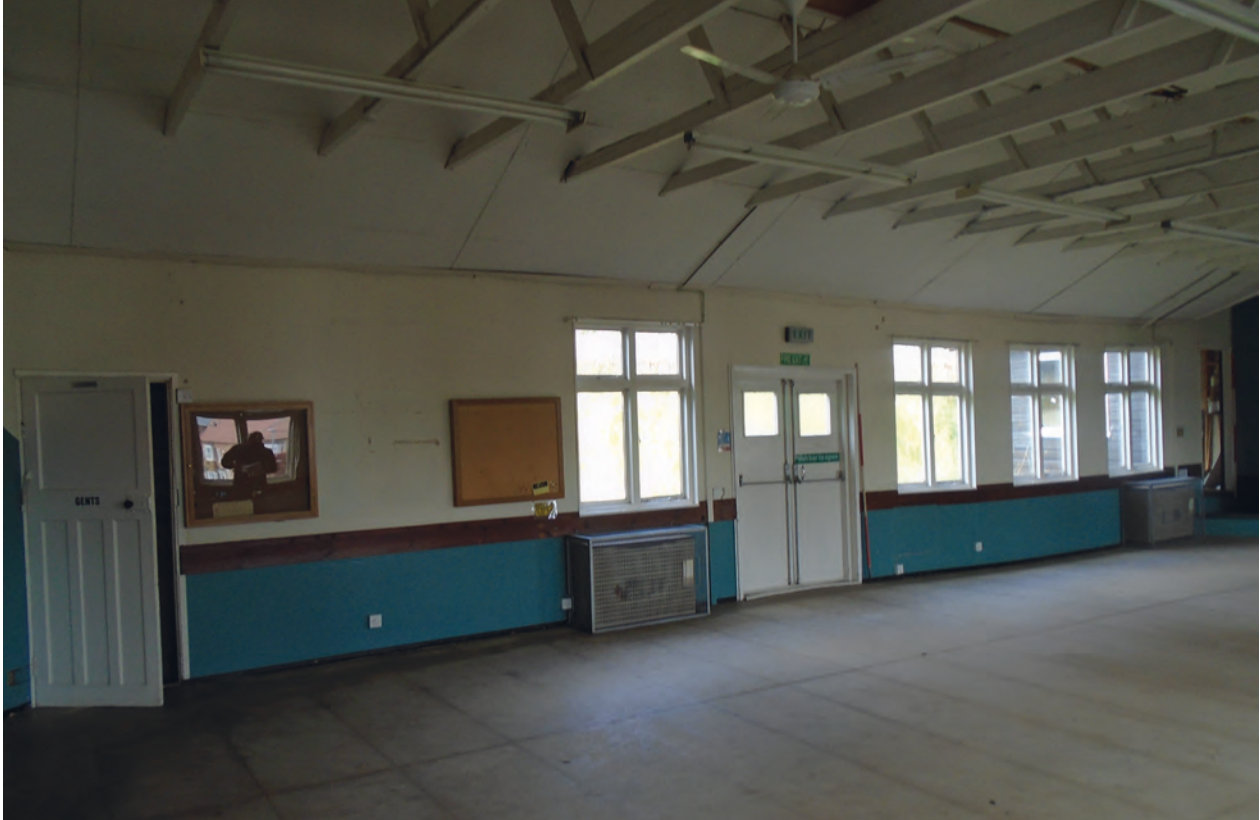
Figure 16 Room G2, south-west wall facing north-west. Scale 1x2 m

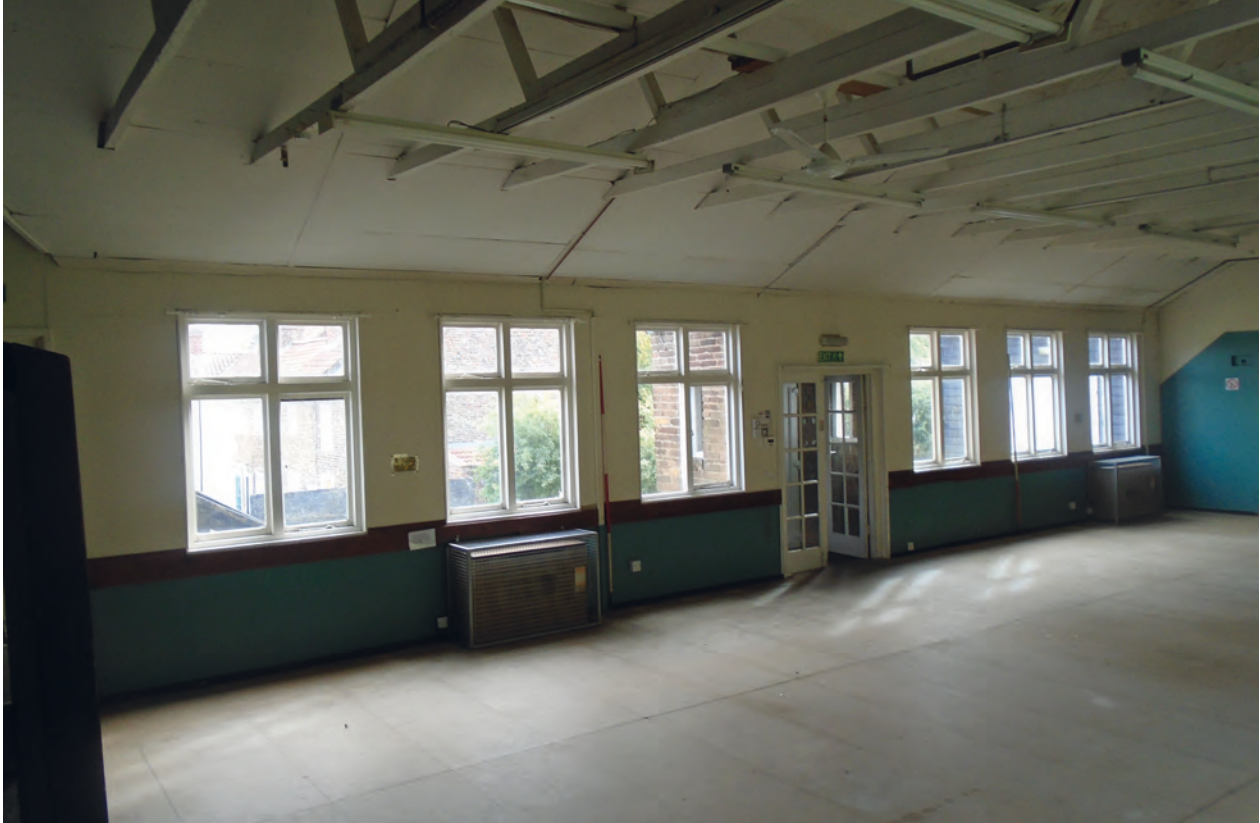
Figure 17 Room G2, north-east wall facing south-east. Scale 1x2 m

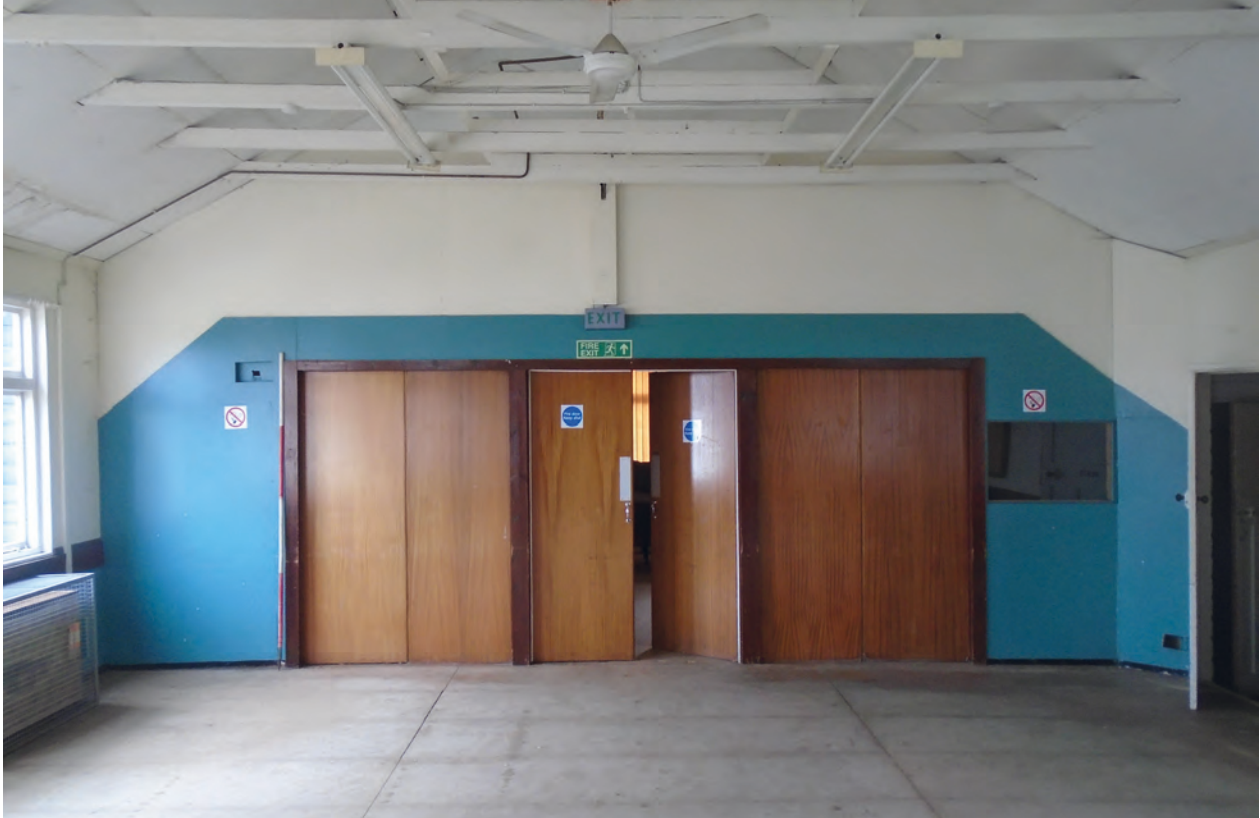
Figure 18 Room G2, south-east wall, including inserted doors. Scale 1x2 m

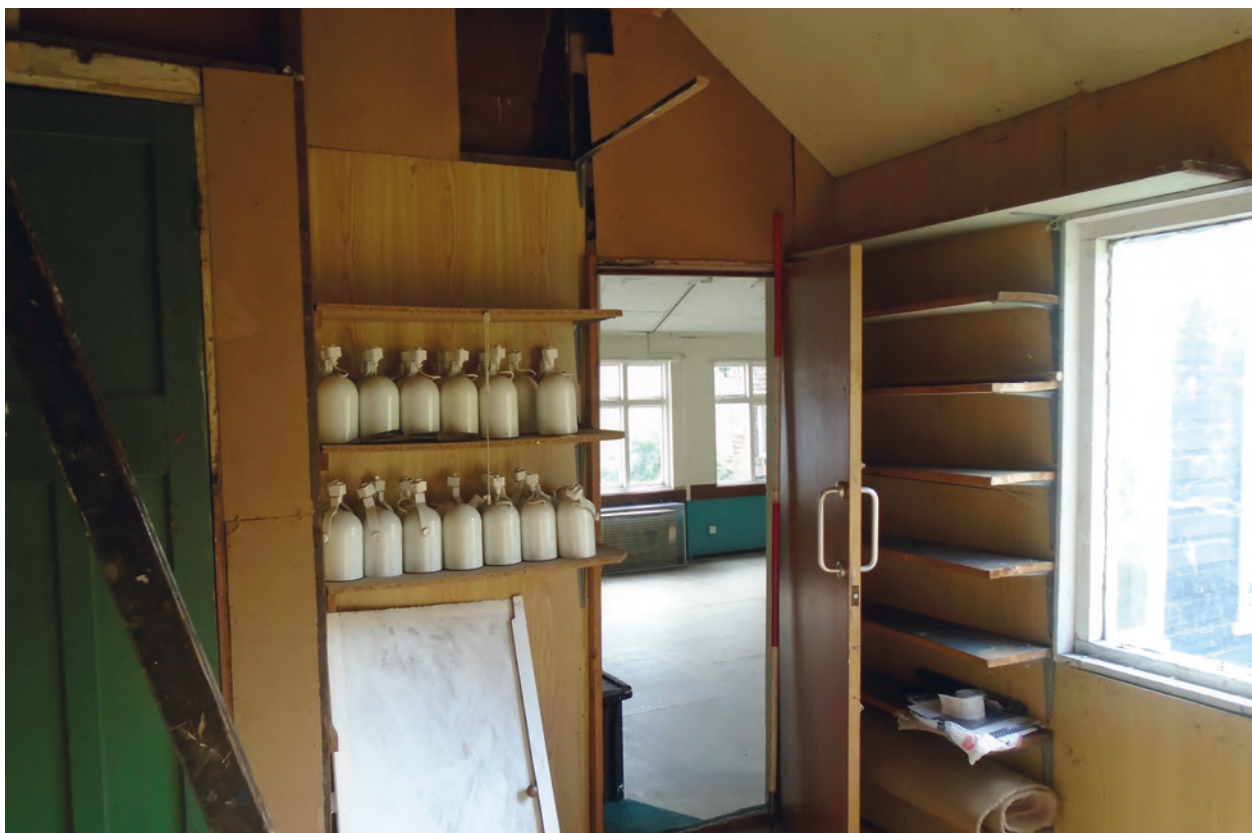
Room G3 is accessed by a doorway at its eastern corner leading from Room G2, with a further doorway at its north corner leading onto the raised stage area, also in Room G2 (Figure 19). The room includes a single window at its south-west side and shelving against its north-east and south west walls. The north-west wall is covered by a latterly installed, open-fronted hanging space (Figure 20). The north-west wall appears to be a later insertion, suggesting that this room and Room G4 were once a single space.

Figure 19 Room G3, facing east. Scale 1x2 m

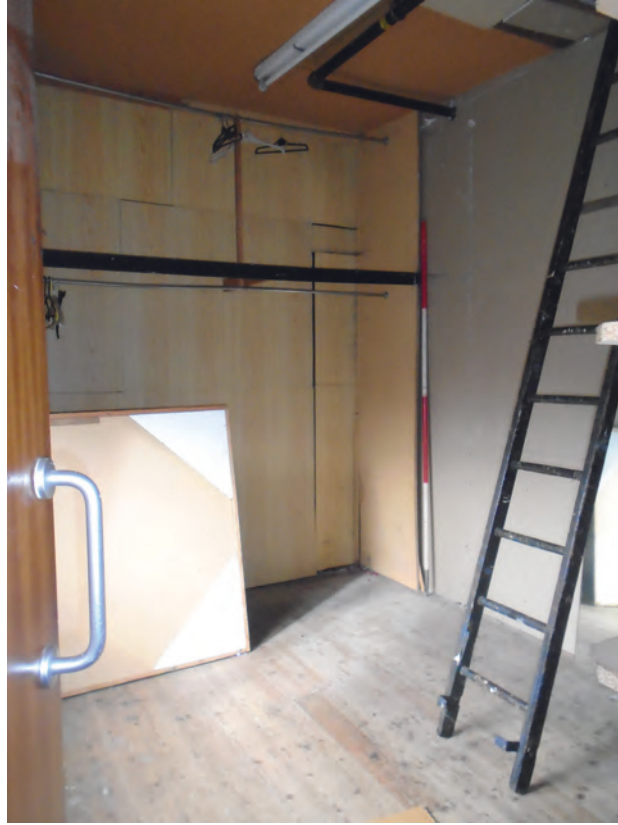
Figure 20 Room G3, facing west. Scale 1x2 m

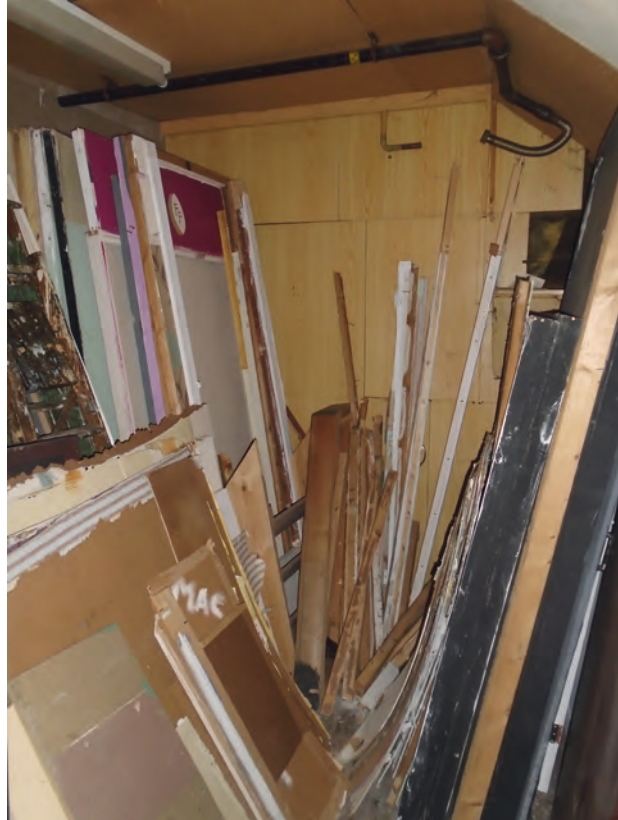
Room G4 is accessed by a doorway at its northern corner leading from the raised stage within Room G2, which has been widened at its southern side. The room includes blocked windows at its north-west and south-west sides and was filled with old drama scenery and timber at the time of survey; as such, it could only be viewed from the doorway (Figure 21). The south-west wall appears to be a later insertion, suggesting that this room and Room G3 were once a single space.

Figure 21 Room G4, looking south-west. No scale

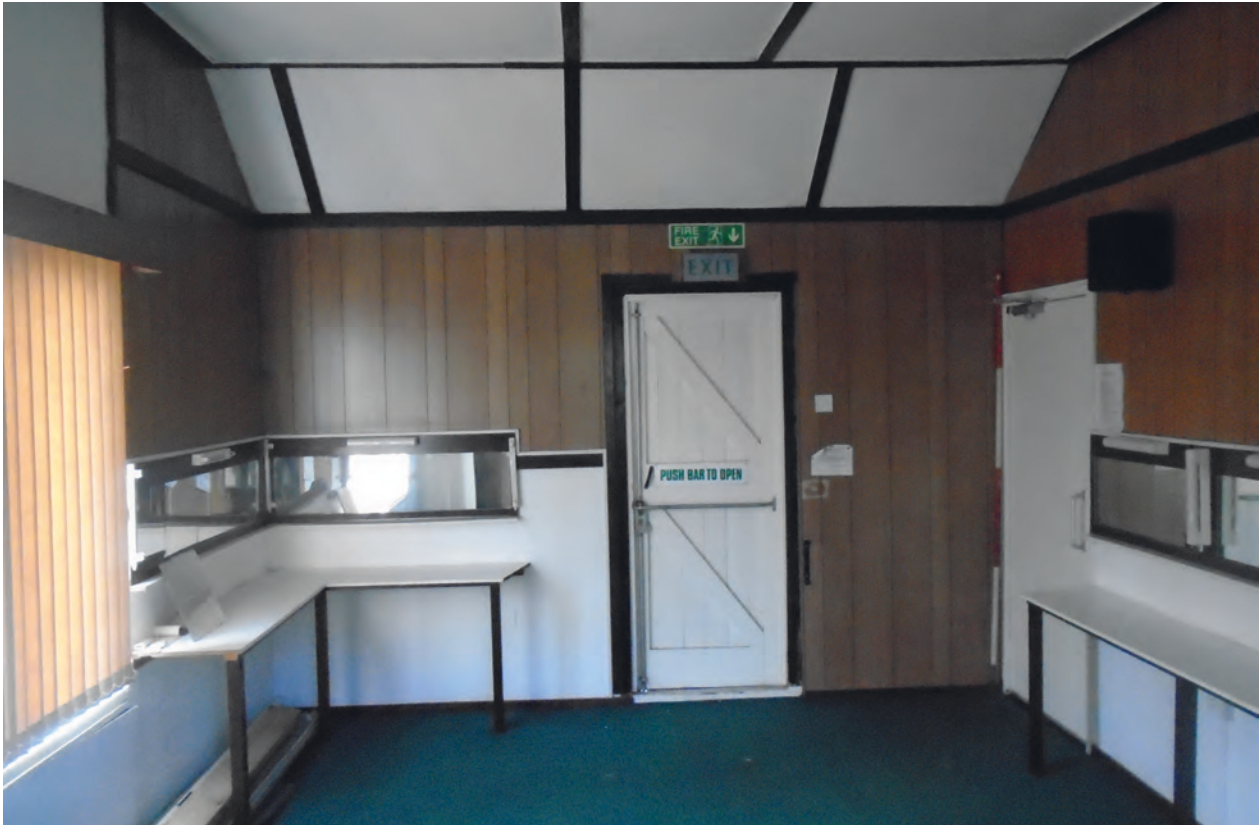
Room G5 is accessed by a doorway at its southern corner leading from Room G2, with a further doorway at its western corner leading onto the raised stage area, also in Room G2, and an external doorway at the centre of its south-east wall (Figure 22). The room includes a large window at the centre of its north-east wall and a smaller, two-light window at the centre of its north-west side (Figure 23). The room also includes latterly installed work-tops with lights and mirrors for use as a dressing room and a meter cupboard at its northern corner. The walls are covered in wood-effect panelling of the c. 1970s-1980s.

Figure 22 Room G5, facing south-east. Scale 1x2 m

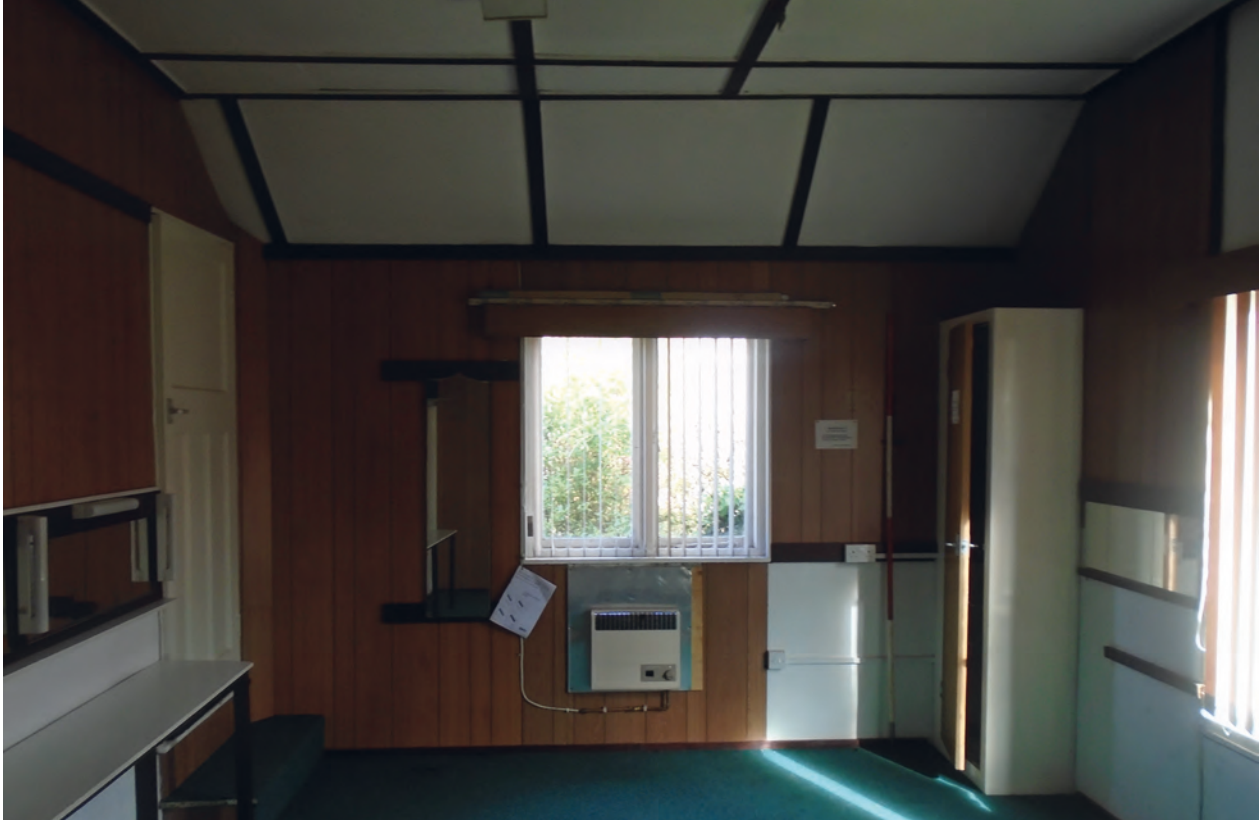
Figure 23 Room G5, facing north-west. Scale 1x2 m

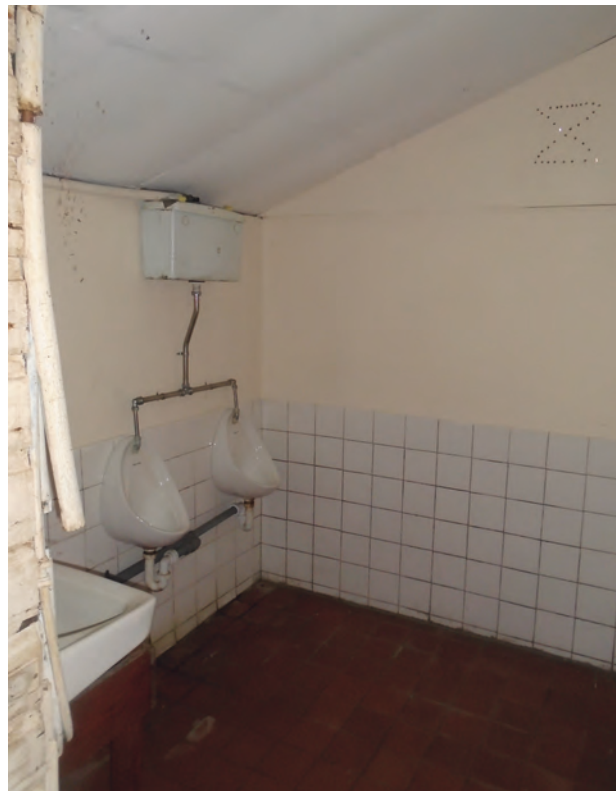
Room G6 is accessed by a doorway at its north-east side leading from Room G2, with a further blocked external doorway, not visible internally, at its south-west side. The room also includes two blocked windows at its south-west wall. The room is divided into three spaces, with a raised urinals and hand basin area to the north (Figure 24), a toilet cubicle in the centre (Figure 25) and a store to the south (Figure 26).

Figure 24 Room G6, looking north-west. No scale
