Yarm Social Centre, Bentley Wynd, Yarm

Historic Building Recording

Solstice Heritage LLP was commissioned by Tracey Blenkinsop of Cranbourne Properties Ltd to produce an Historic Building Recording to comply with Condition 3 of planning permission 17/0392/FUL permitting the demolition of the existing former social club building at Bentley Wynd, Yarm, TS15 9BS.

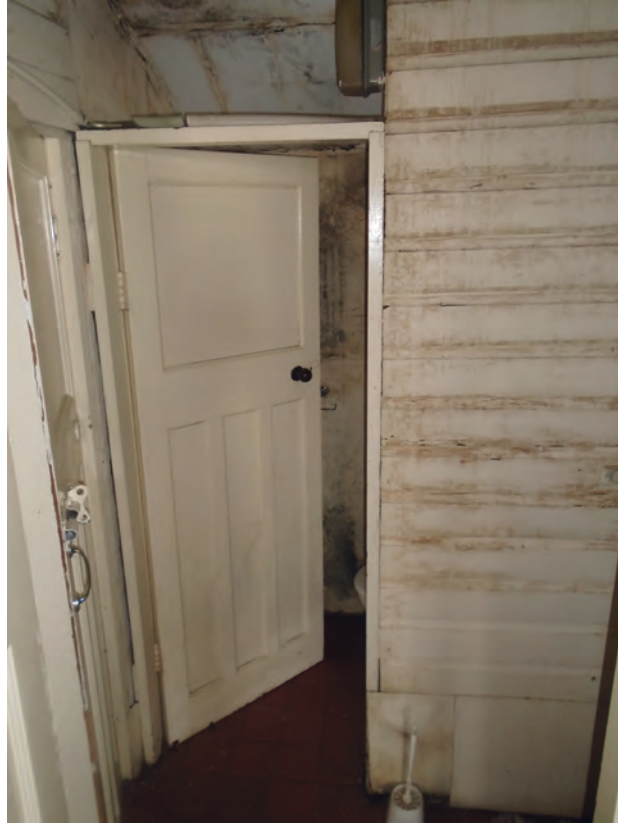
Room G6 is accessed by a doorway at its north-east side leading from Room G2, with a further blocked external doorway, not visible internally, at its south-west side. The room also includes two blocked windows at its south-west wall. The room is divided into three spaces, with a raised urinals and hand basin area to the north (Figure 24), a toilet cubicle in the centre (Figure 25) and a store to the south (Figure 26).

Figure 25 Room G6, central toilet cubicle. No scale

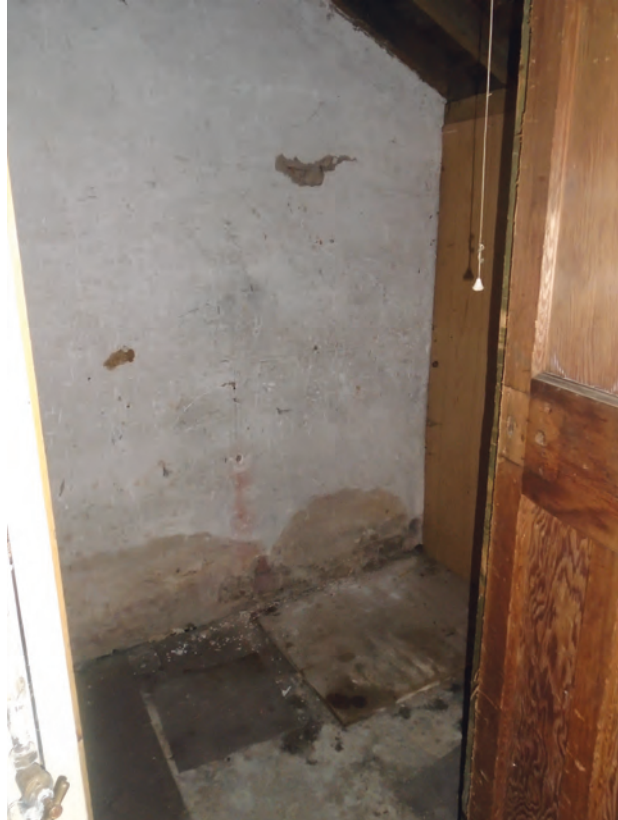
Figure 26 Room G6, looking south. No scale

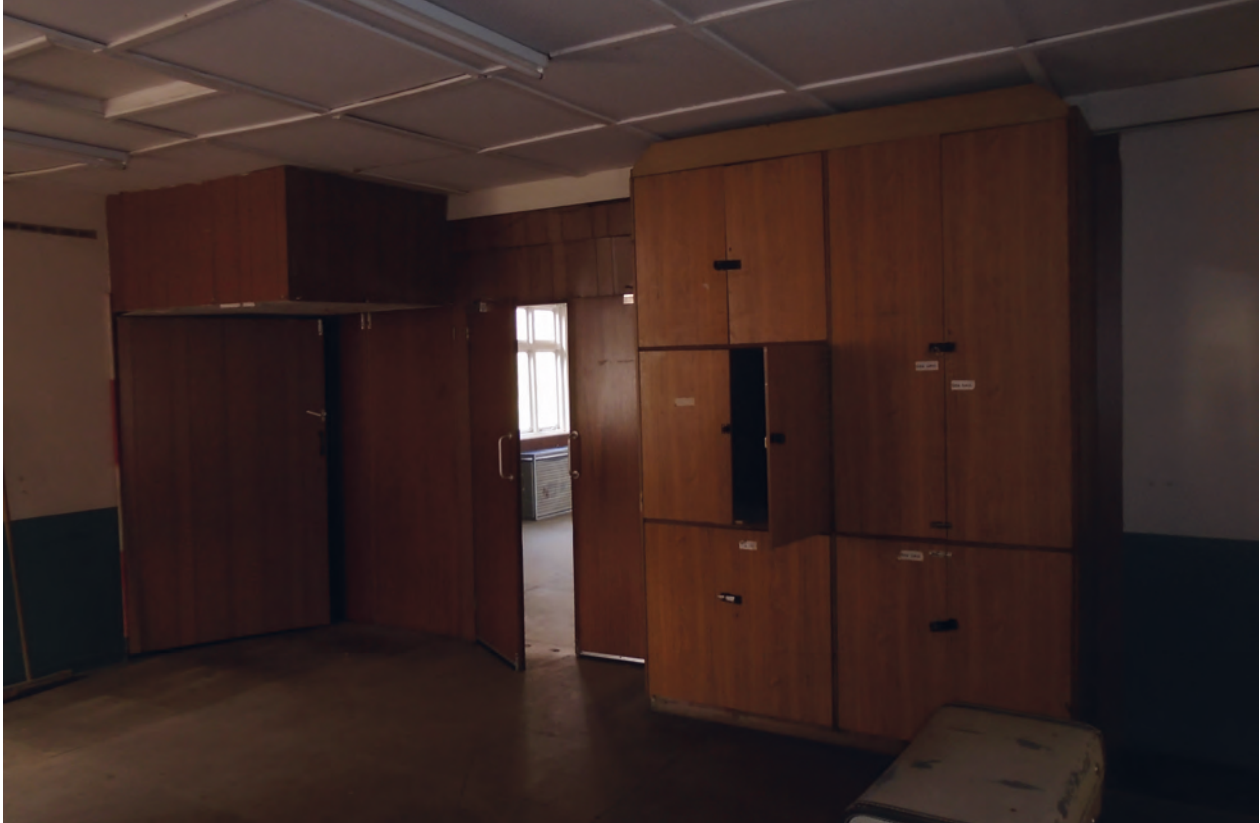
Room G7 is separated from the large central hall, Room G2, by three sets of inserted double-doors alongside a single pane window, which together form the majority of its north-west wall (Figure 27). Evidence of locking points within the floor suggest that these doors have replaced an earlier partition, perhaps a folding screen. Of these three sets of doors, the most easterly set is masked by an inserted set of large cupboards, while the western set is masked by an inserted boiler cupboard. The north-east wall of the room includes a large glazed serving window to the kitchen (Room G8), alongside a set of double doors (Figure 28). The south-west wall of the room is partly masked by the latterly inserted boiler cupboard at its northern extent, and includes a central doorway giving access to Room G9 beyond (Figure 29). The south-east wall includes an inserted doorway to Room G10 at its western extent. To the east of this are two large four-light casement windows which sit between the inserted doorway and a large chimney breast and fireplace at the eastern extent of this wall (Figure 30).

Figure 27 Room G7, facing north-west. Scale 1x2 m

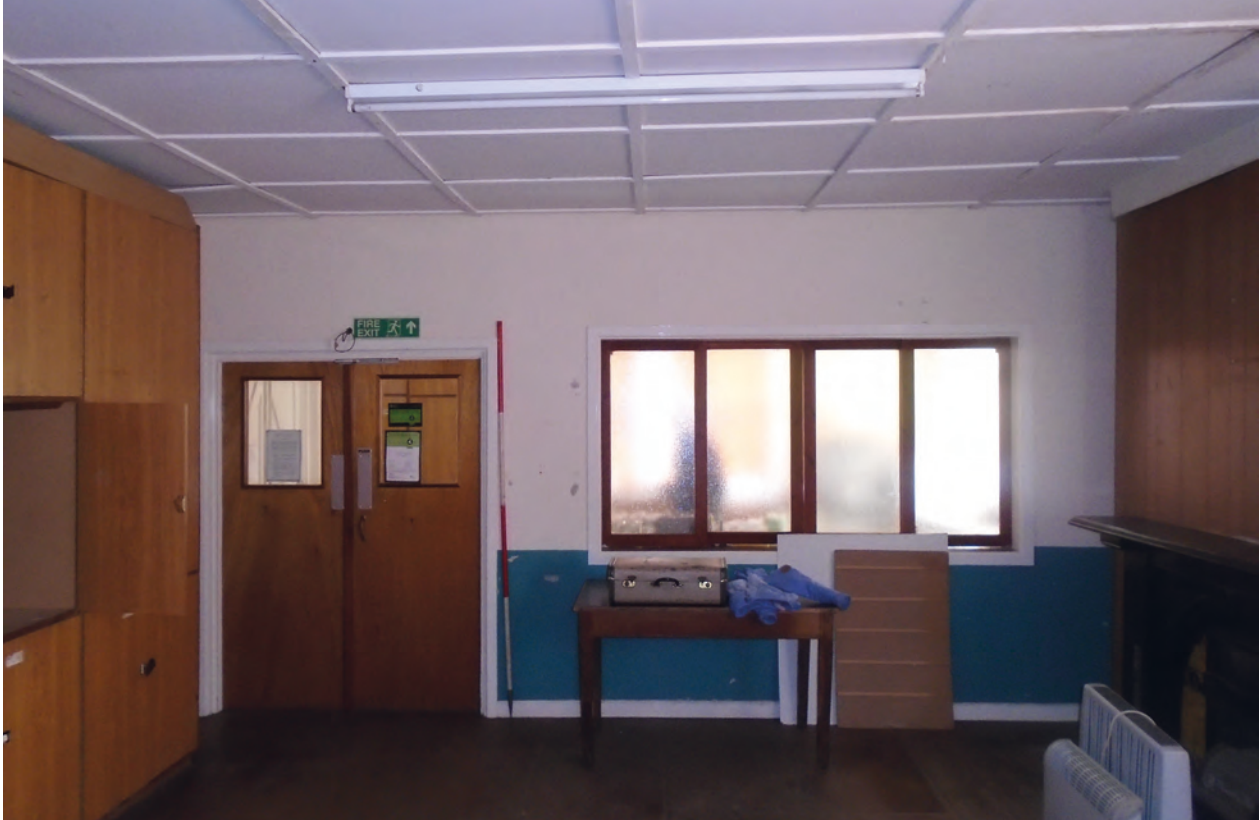
Figure 28 Room G7, facing north-east. Scale 1x2 m

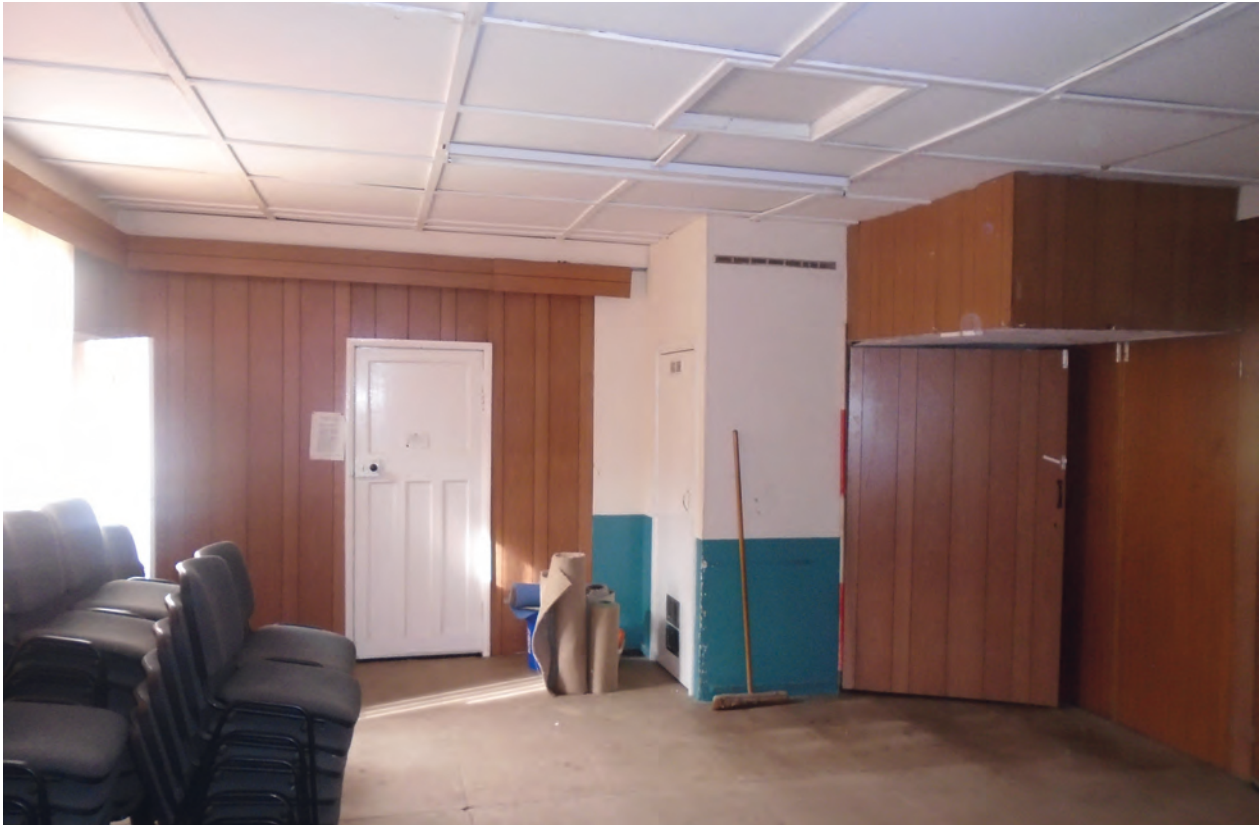
Figure 29 Room G7, facing west. Scale 1x2 m

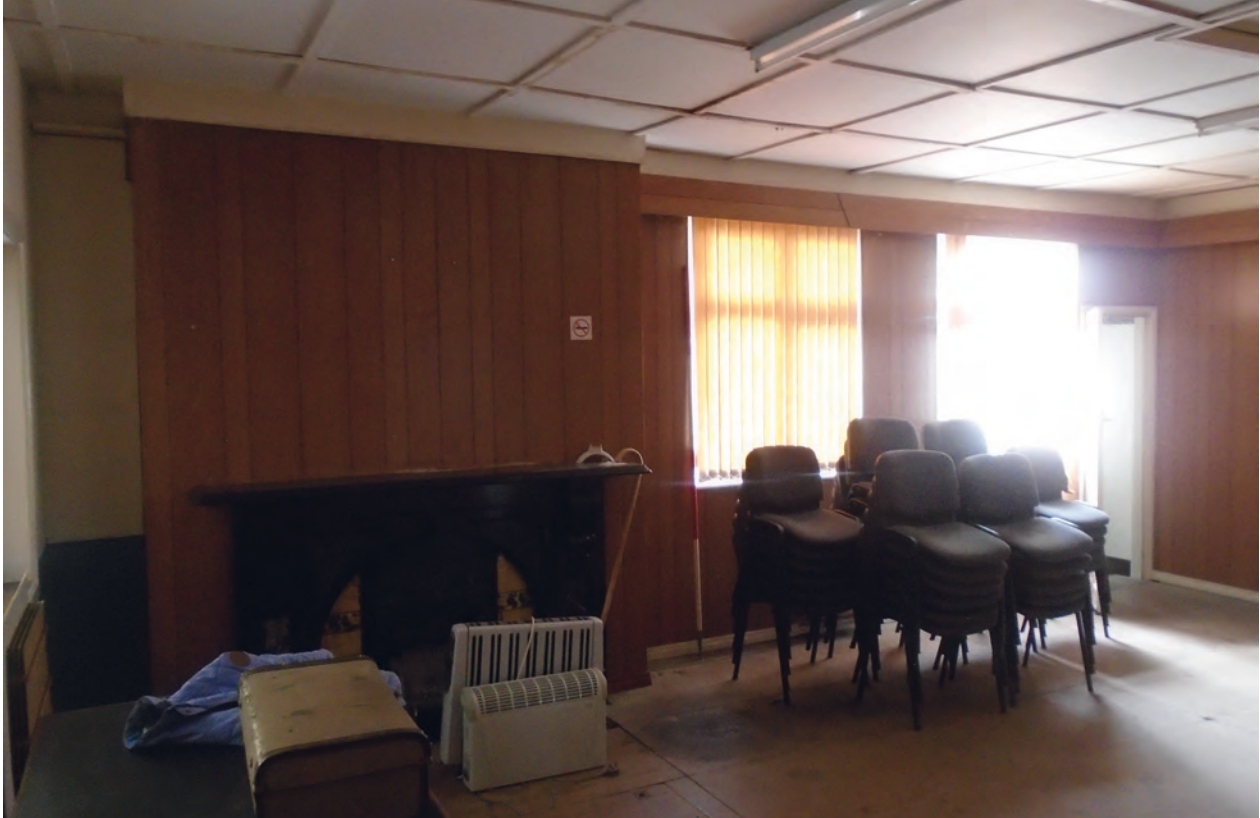
Figure 30 Room G7, facing south. Scale 1x2 m

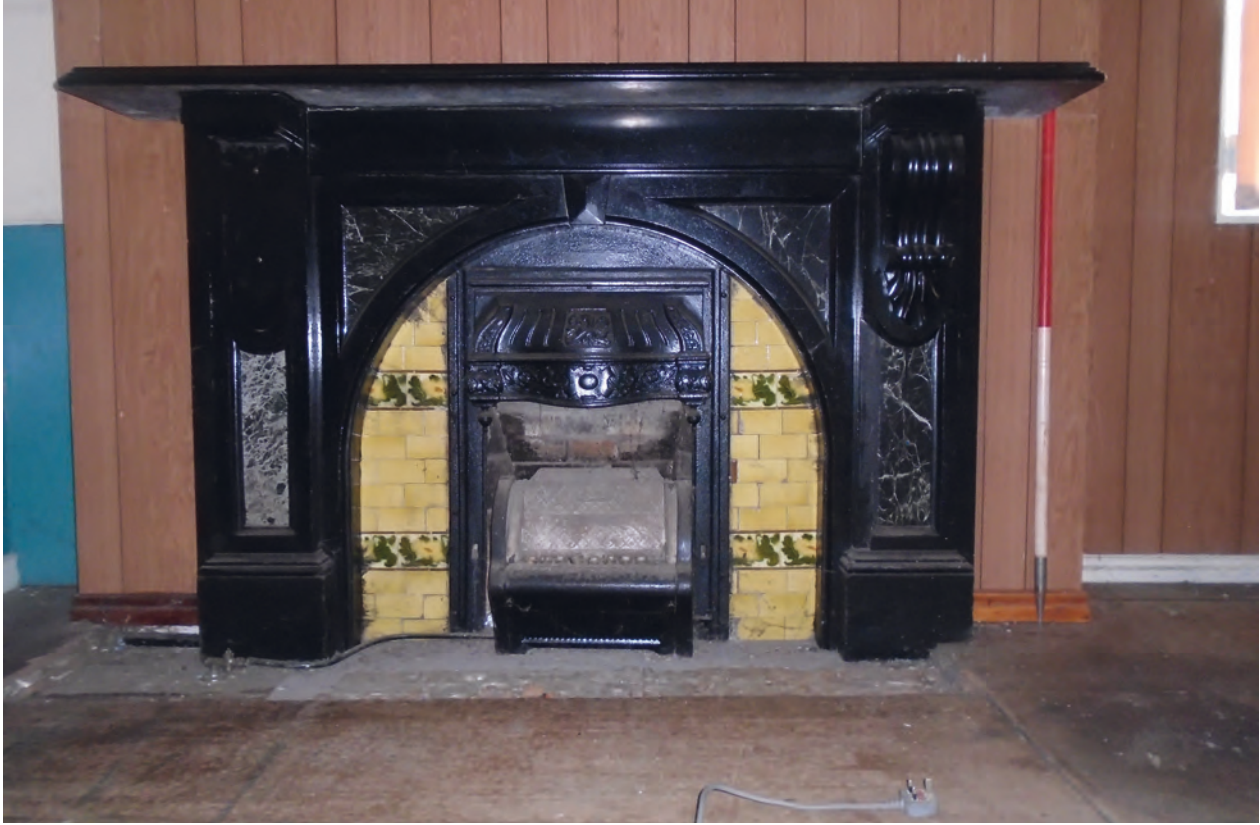
The fireplace appears to include a re-used Victorian, honed slate surround with a moulded mantel supported on two large, fluted, console-moulded corbels either side of a round arched opening with decorative keystone. The span-drels and uprights include recessed panels of black marble with white veining, one of which appears to have been replaced, to the left, with a mismatched grey marble. A cast iron insert is flanked by two tiled panels of plain, cream, rectangular tiles with two bands of repeating foliate tiles with a thin brown border (Figure 31). Some of the tiles appear to have been slightly displaced, with one having been replaced completely with a brown tile. This displacement, alongside the replacement of one of the marble panels and the incongruous probable date and style of the fireplace itself, all suggest that this attractive architectural feature has been re-used and was originally part of an earlier building elsewhere. Despite this re-use, the fireplace is the most architecturally significant item within the building given its date and the quality of its manufacture in comparison with the rest of the structure and its fittings.

Figure 31 Detail of re-used Victorian fireplace. Scale 1x1 m

The build date of 1938, noted on the keystone of the entrance porch, is supported by the general architectural style and materials present within the building, although much of its interior has been modernised over time. One significant anachronism is the grand Victorian fireplace present within the building. Clearly a re-use from an earlier building, this is the finest architectural feature within the building and should be considered for removal and further re-use before the building is demolished. Aside from this, the building is typical of its type and period, being cheaply constructed with basic materials and to a simple design intended to fulfil a communal function, no doubt accommodating a variety of such uses (The Northern Echo 2016).

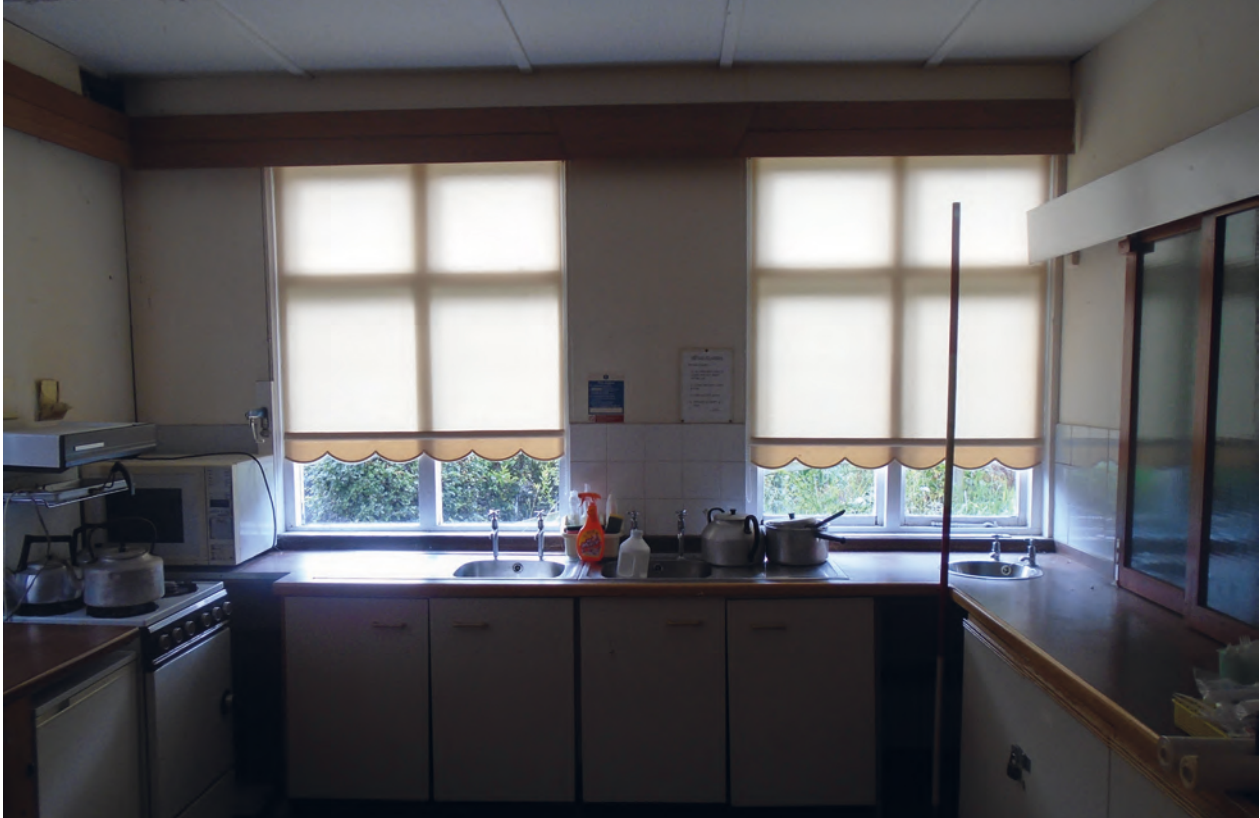
Room G8 is separated from Room G7 by a large glazed serving window and a set of double doors at its south-west side (Figure 33). The south-east wall includes two large four-light casement windows (Figure 32), whilst the north-east wall has a large central eight-light window. The north-west wall includes a set of centrally-placed double doors (Figure 34). The room includes a fitted kitchen of probable 1970s-1980s style and was probably built as a kitchen or bar originally.

Figure 32 Room G8, facing south-east. Scale 1x2 m

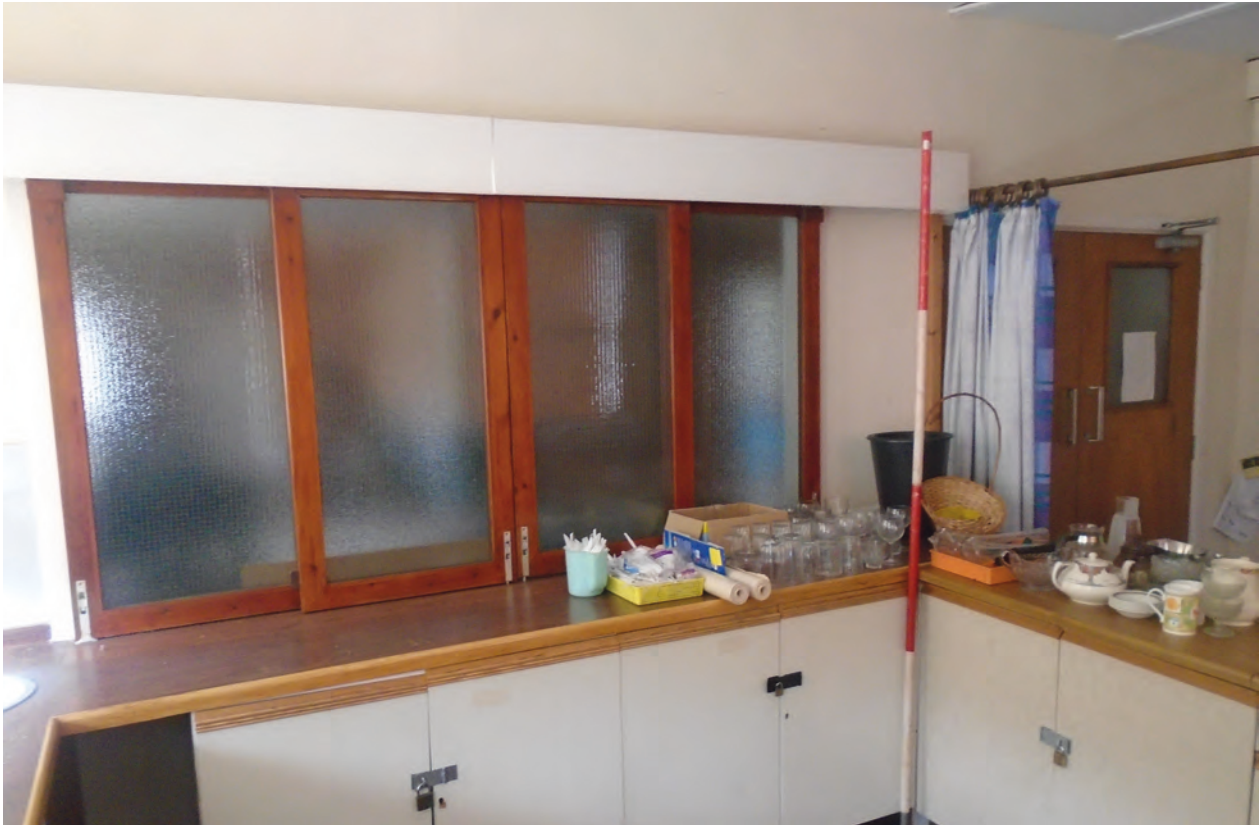
Figure 33 Room G8, facing west. Scale 1x2 m

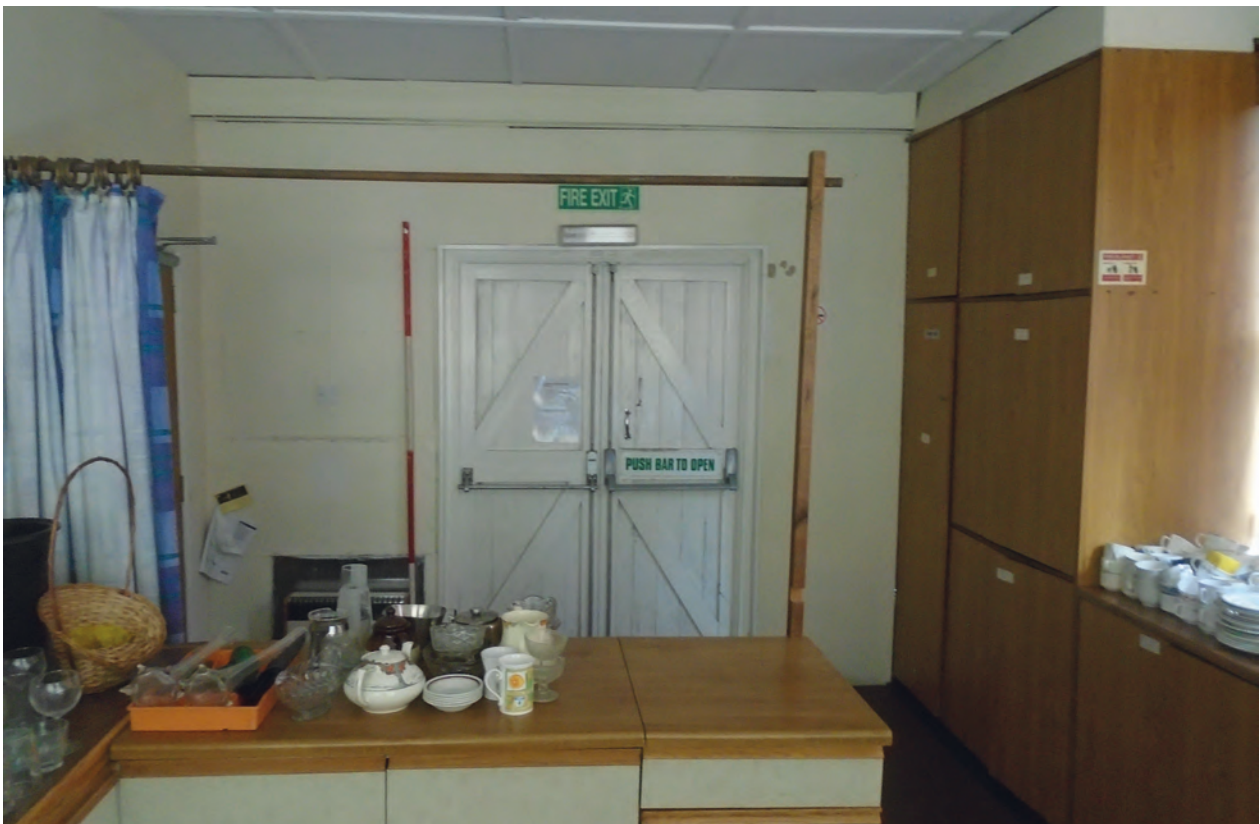
Figure 34 Room G8, facing north-west. Scale 1x2 m

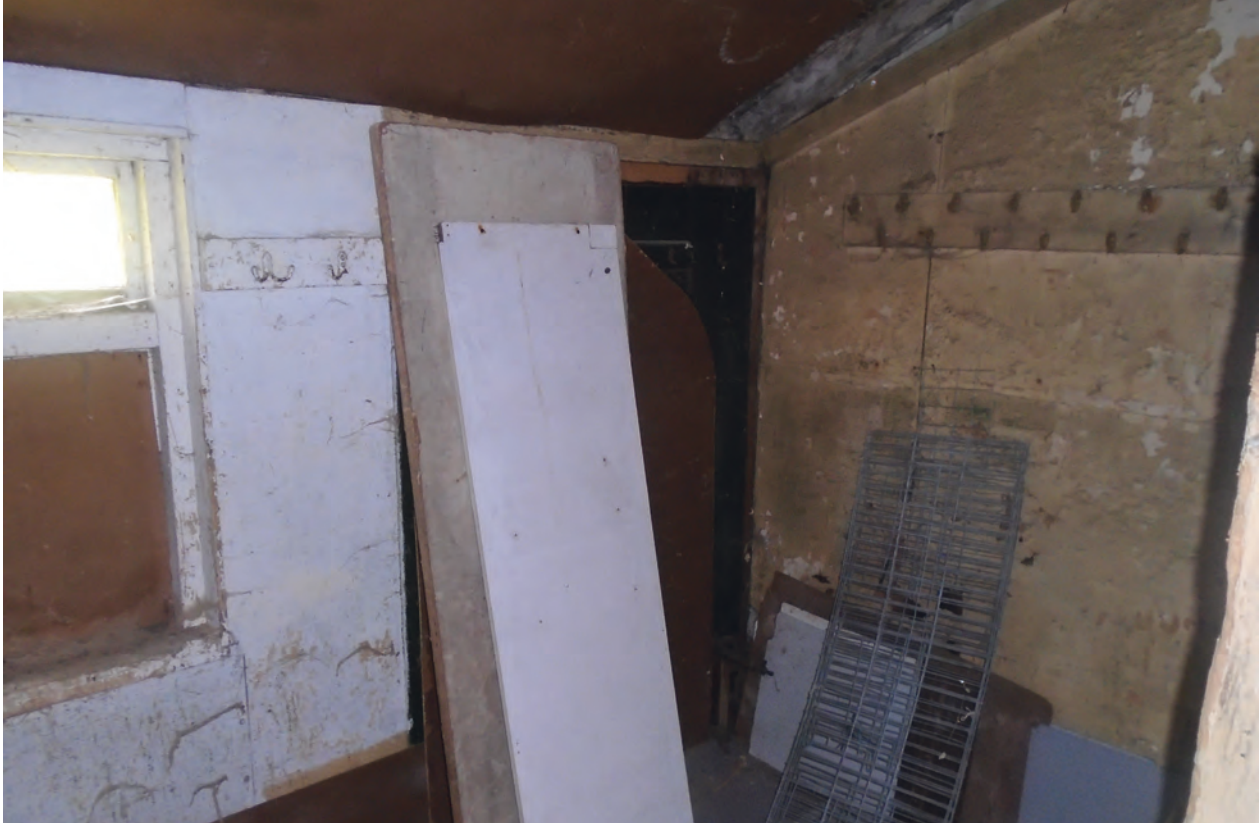
Room G9 is accessed by a single central doorway at its north-east side from Room G7. The room includes a blocked double door at its north-west corner, immediately to the north of a two-light casement window (Figure 35). Around the room are several rows of coat hooks mounted on wooden battens, suggesting the room may have been originally intended as a cloak room or changing room (Figure 36).

Figure 35 Room G9, facing west. No scale

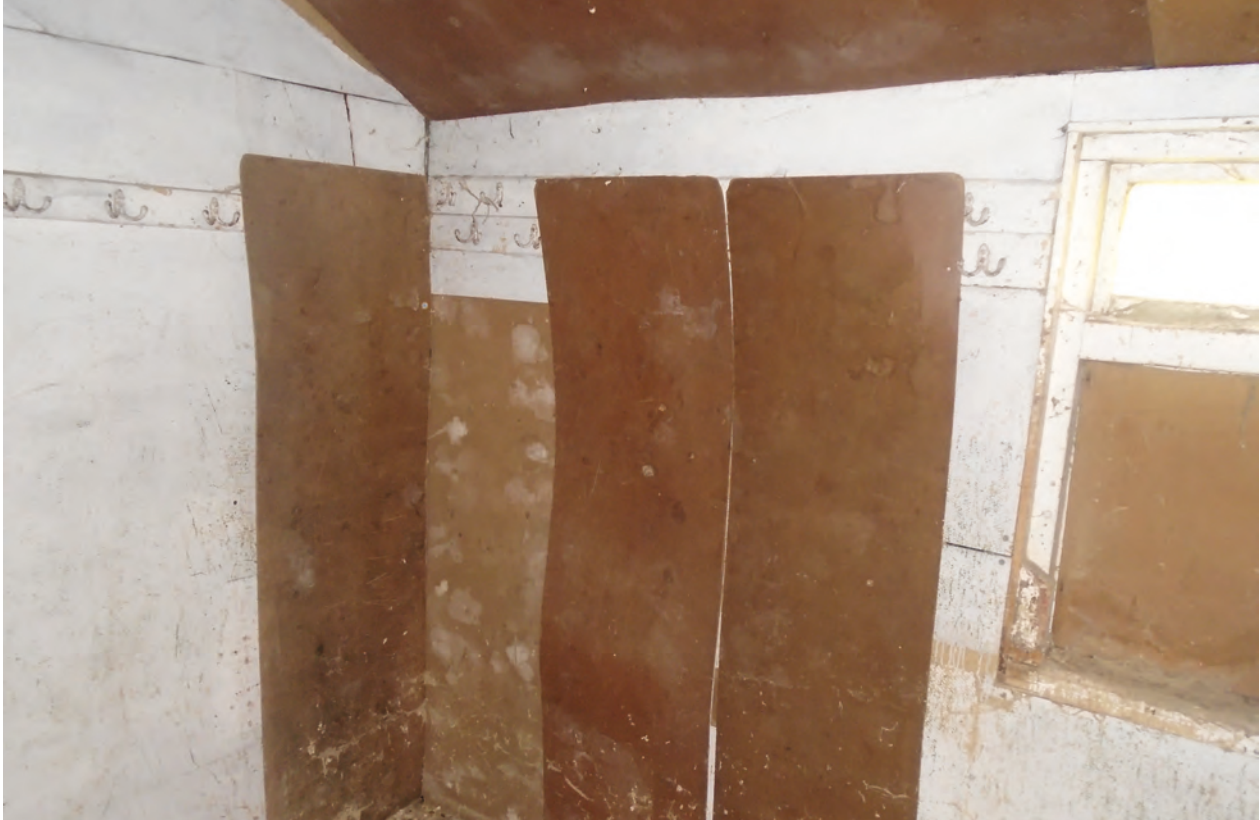
Figure 36 Room G9, facing south. No scale

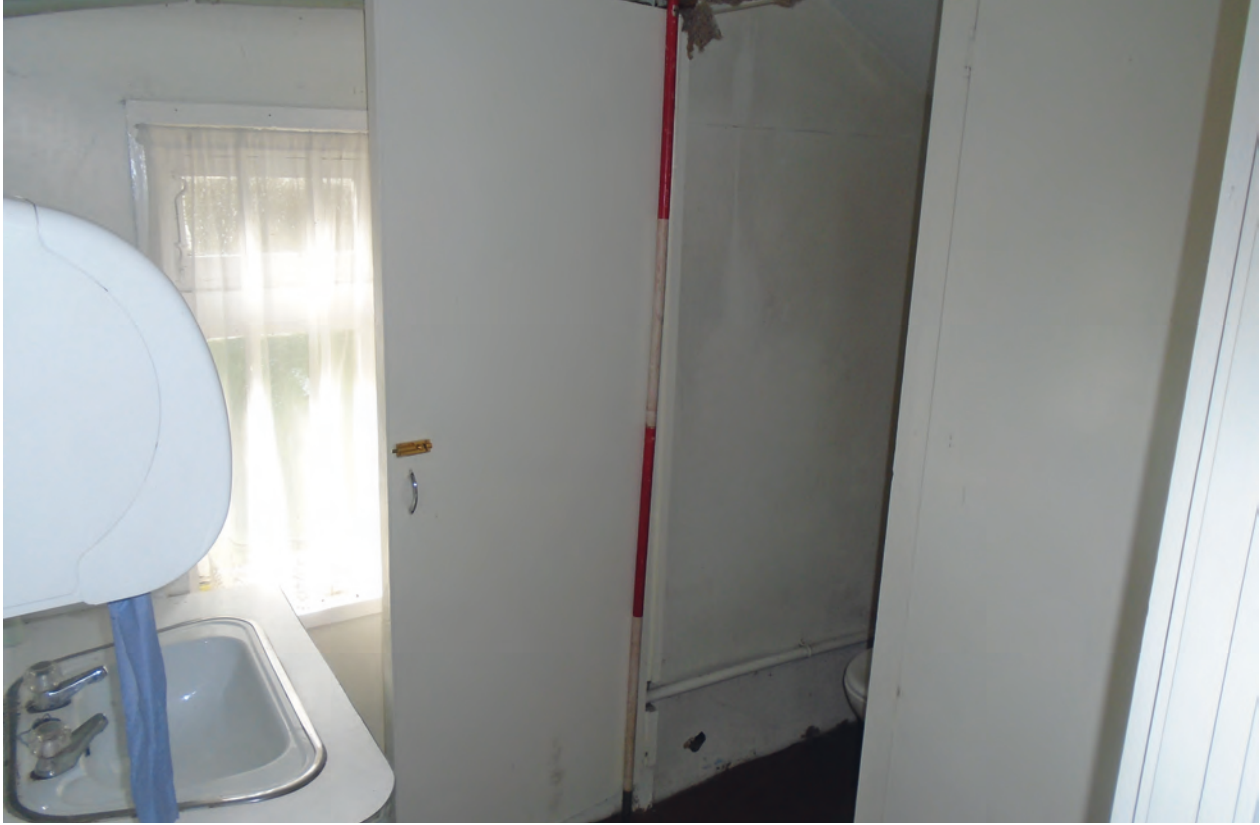
Room G10 is an inserted ladies' toilet containing two W.C. cubicles, a single window and a hand basin. The room is contained within the later asbestos sheet extension at the southern corner of the former social centre (Figure 37).

Figure 37 Room G10, facing south. No scale

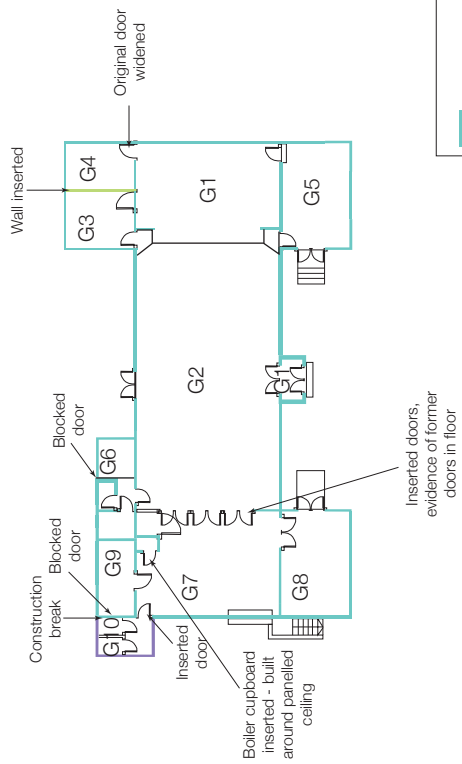
Project	Bentley Wynd, Yarm, North Yorkshire Historic Building Recording
Drawing	Figure 38 Phased plans and elevations

The results of the historic building survey are presented below, with exterior elevations described first, followed by interior rooms. This account identifies all features, fixtures and fittings relevant to the original and subsequent uses of the site. Phased construction plans, derived from architect's plans, have also been produced and are included with elevations in Appendix 1.
