# Bellister Castle, Haltwhistle, Northumberland

## Archaeological Watching Brief

Prepared for:	Mark Newman MA MCIfA FSA Archaeological Consultant The National Trust North Region (East)
Prepared by:	Chris Scott BA (Hons), MA, MCIfA Solstice Heritage Crabtree Hall Business Centre Little Holtby Northallerton North Yorkshire DL7 9NY
Checked by:	Jim Brightman BA (Hons), MLitt, MCIfA
Project Reference:	SOL1718-28
Document Reference:	DOC1718-25
Dates of Fieldwork:	July 2017
Date of Document:	August 2017

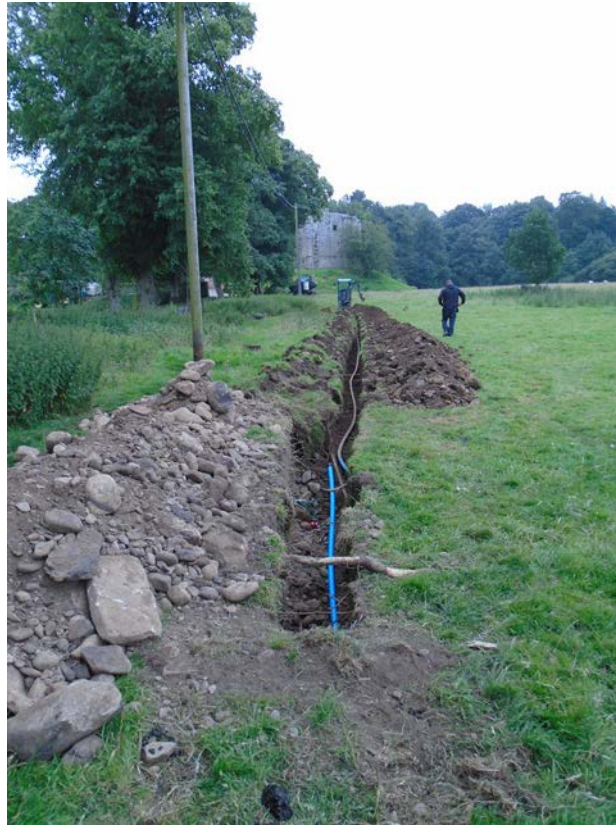
A c. 43 m length of open-cut trench was monitored within the field to the north-west of the castle (Figure 2). The trench was c. 43 m in length, 0.4 m wide and an average of 0.8 m deep. The trench was cut in line with the main driveway leading to the castle, c. 7 m into the field from the driveway boundary and extending north-west from a point c. 41 m north-west from the fence surrounding the castle mound. The trench was cut through a well-developed, dark brown, fine loam topsoil (001), which had a thickness of 0.4 m. This overlay a fine, light brown, silty subsoil (002), with a thickness of 0.4 m. In patches, the glaciofluvial coarse, orange sand and gravel substrate (003) was noted within the base of the trench. Occurring in distinct NE-SW aligned bands within the subsoil (002), the sand and gravel substrate (003) was overlain with thickly compacted deposits of large sub-angular and rounded river cobbles (004), suggesting that this area has played host to former river channels (Figure 3). These cobble bands were interspersed with areas where very few stones were present within the subsurface deposits, suggesting the location of these former channels. There was no evidence that these varying deposits were archaeological in origin. No archaeological finds, features or deposits were noted during excavation of the open-cut trench.

Figure 2 Open-cut trench, looking south-east towards Bellister Castle. Note cobbles in spoil to left. No scale

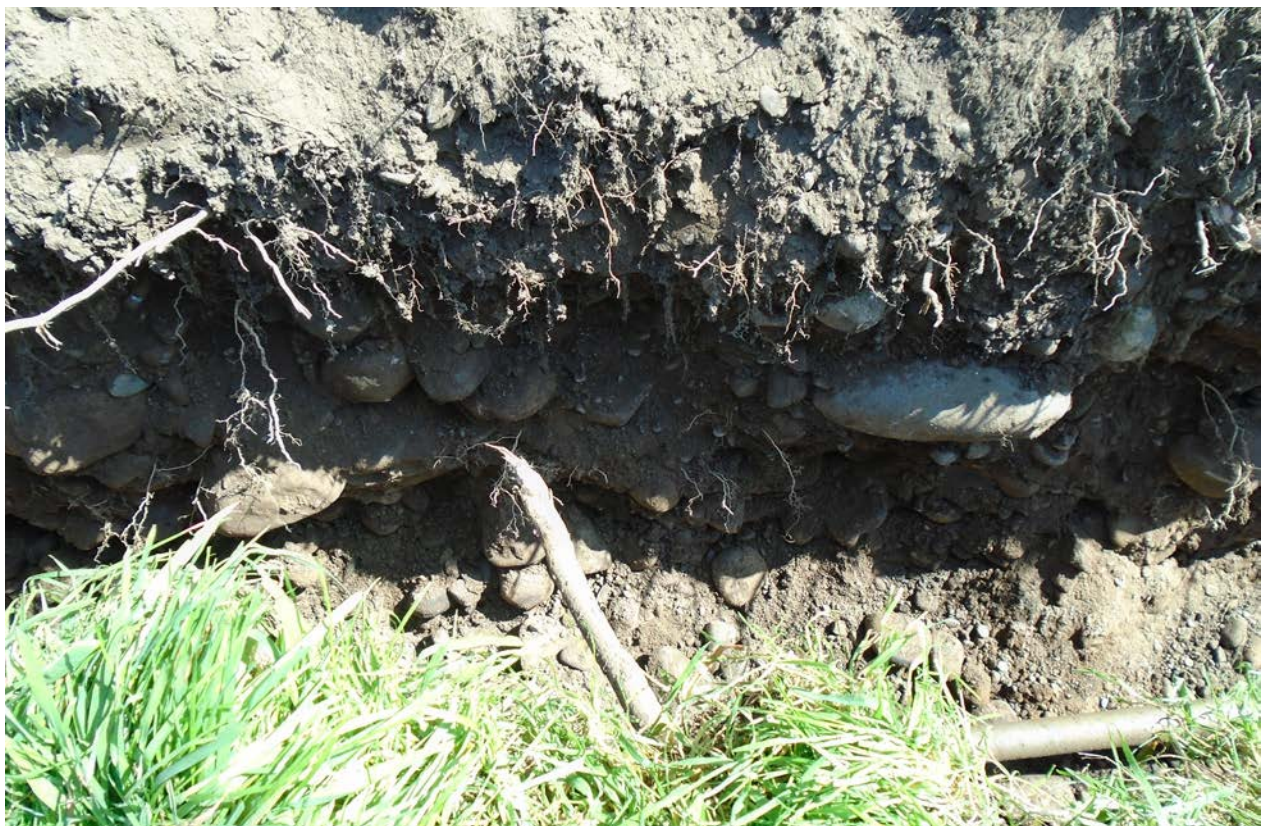
Figure 3 Representative shot of cobbles within subsoil. No scale

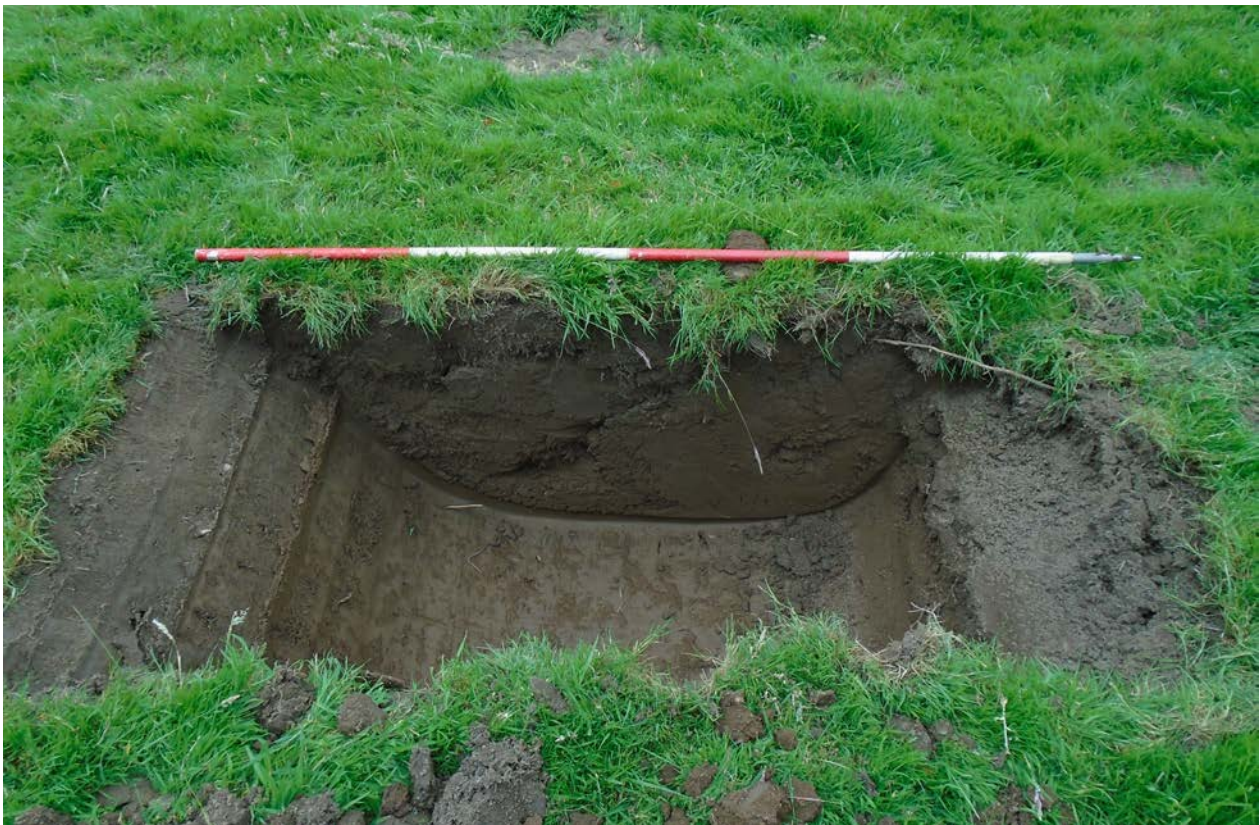
The send and receive pits monitored within the field to the north-west of the castle consisted of four 1.5 m x 1 m x 0.70 m excavations (Pits 1-4), carried out by machine, along the length of the intended route of the new water service. All of the pits were cut through a well-developed, dark brown, fine loam topsoil (001), which had a thickness of 0.4 m (Figure 4). This overlay a fine, light brown, silty subsoil (002), which was generally excavated to a depth of c. 0.3 m, but not excavated to its full thickness. None of the pits was dug into an area containing significant deposits of cobbles, as noted during the excavation of the open-cut trench. No archaeological finds, features or deposits were noted during excavation of the pits.

Figure 4 Representative example of pits excavated within field. Scale 1x2 m

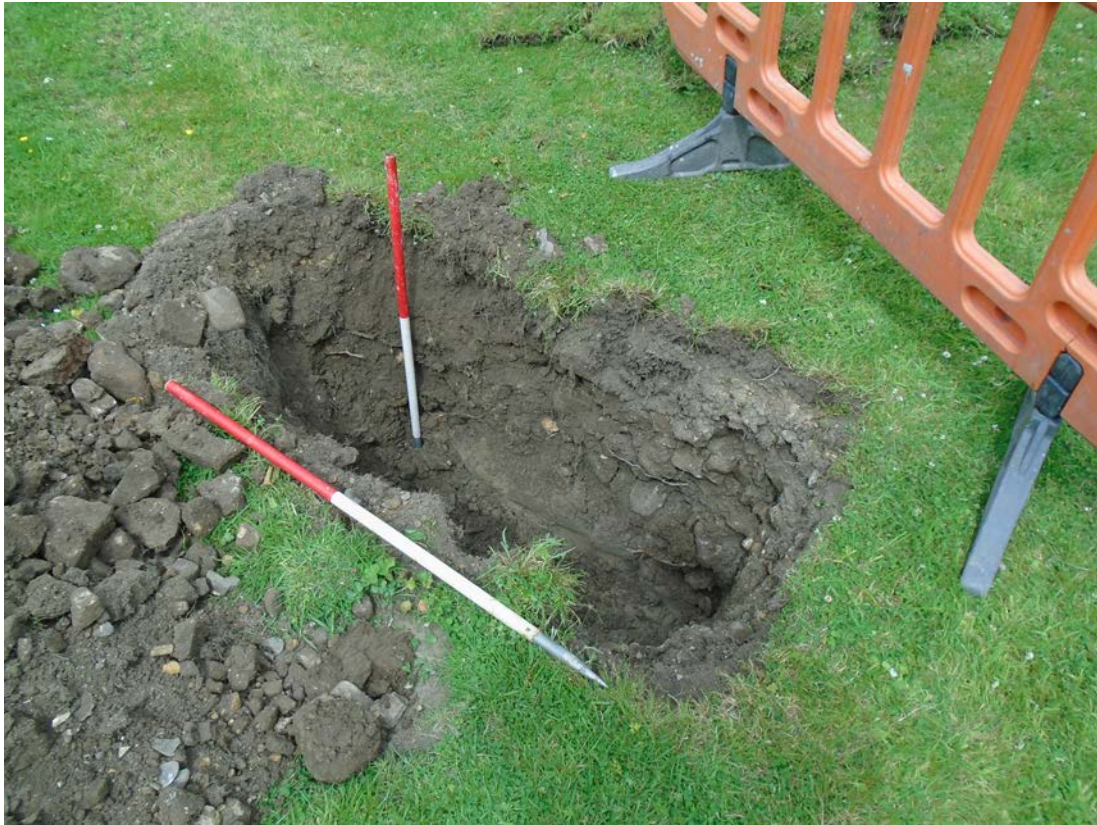
Pit 5 was cut through a disturbed, dark brown, fine loam topsoil (001) with inclusions of medium sized rounded cobbles, which had a thickness of 0.4 m (Figure 5). This overlay a fine, grey-brown, clay (006), which was excavated to a depth of c. 0.15 m, but not excavated to its full thickness. As this pit was excavated on the approximate line of the earthwork 'moat' surrounding the castle mound it is considered that these deposits may represent silting and natural infilling of this feature, however, the limited scale of the excavation and its uneven sides, as well as the lack of a clear earthwork continuing up to this point, did not allow for clear, or certain, interpretation of these deposits.

Figure 5 Pit 5, looking south-west. Scale 2x1 m

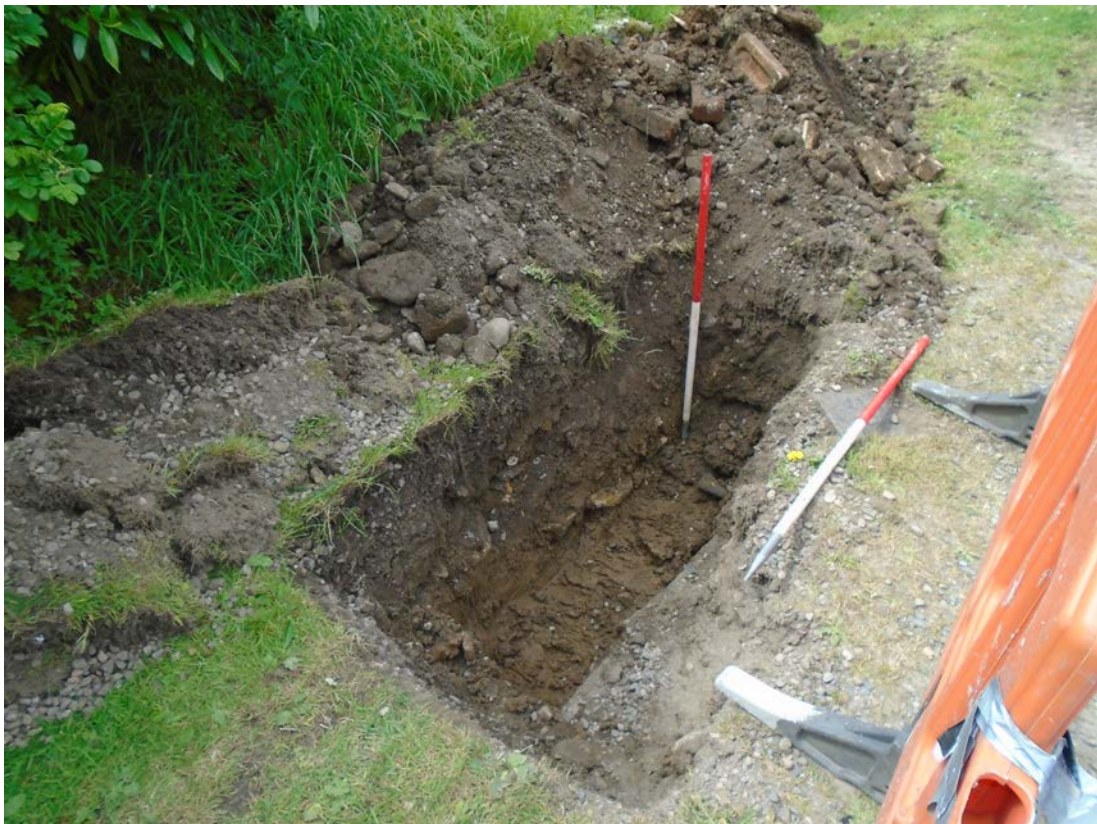
Pit 6 was cut through a disturbed, dark brown, fine loam topsoil (007) with inclusions of small stones, which had a thickness of 0.3 m (Figure 6). This overlay a fine, naturally-deposited mid-brown clay (005), which was excavated to a depth of c. 0.3 m, but not excavated to its full thickness. As this pit was excavated on the slope of the castle mound it is considered that these deposits represent a reworked modern topsoil overlying a natural clay till. The incised nature of the modern driveway is most likely to be the reason for the shallow nature of the natural clay deposit at this point.

Figure 6 Pit 6, looking north-west. Scale 2x1 m

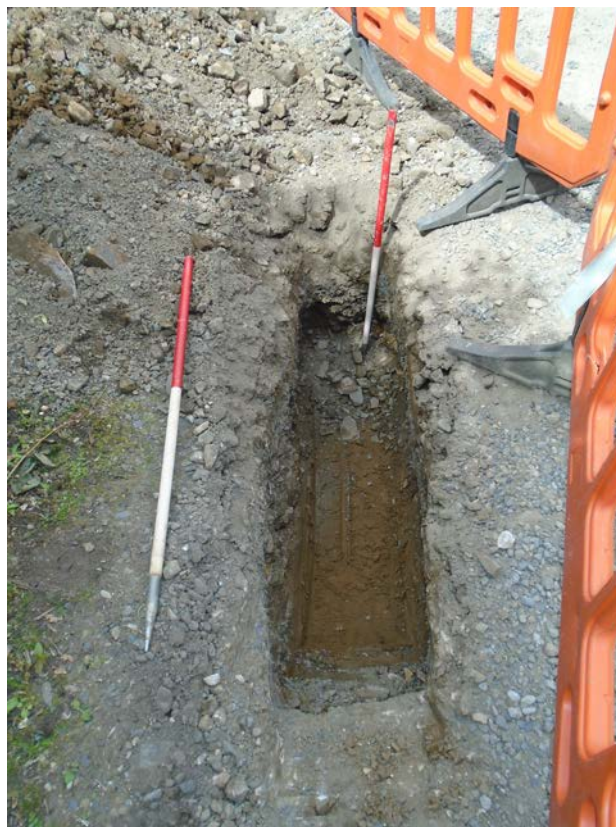
Pit 7 was cut through a modern pebble and disturbed, silty soil driveway deposit (008) with a thickness of 0.2 m (Figure 7). This overlay a fine, naturally-deposited, mid-brown clay (005), which was excavated to a depth of c. 0.45 m, but not excavated to its full thickness. As this pit was excavated on the slope of the castle mound it is considered that these deposits represent a modern driveway surface overlying a natural clay till. The incised nature of the modern driveway is most likely to be the reason for the shallow nature of the natural clay deposit at this point.

Figure 7 Pit 7, looking north-west. Scale 2x1 m

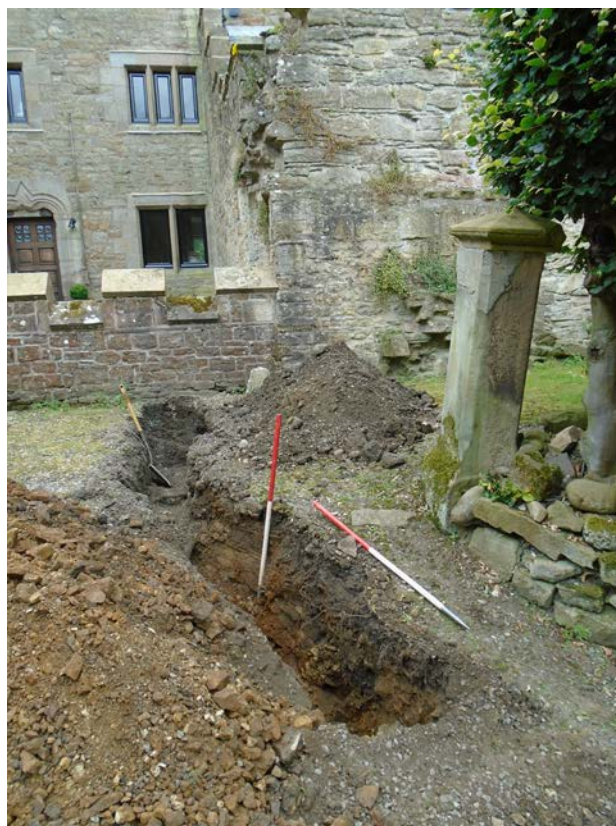
Pit 8 was cut through a modern pebble and disturbed, silty soil driveway deposit (008) with a thickness of 0.2 m (Figure 8). This overlay a degraded in-situ bedrock (mudstone?) (009), which was excavated to a depth of c. 0.5 m, but not excavated to its full thickness. As this pit was excavated at the top of the slope of the castle mound it is considered that these deposits represent a modern driveway surface overlying a natural, degraded bedrock. The incised nature of the modern driveway is most likely to be the reason for the shallow nature of the natural bedrock at this point, with no intervening deposits present. This trench was extended by a distance of 2 m to reach the castle forecourt at its south-west extent. This extension was excavated through modern backfill deposits on the line of existing services.

Figure 8 Pit 8, looking south-west. Scale 2x1 m

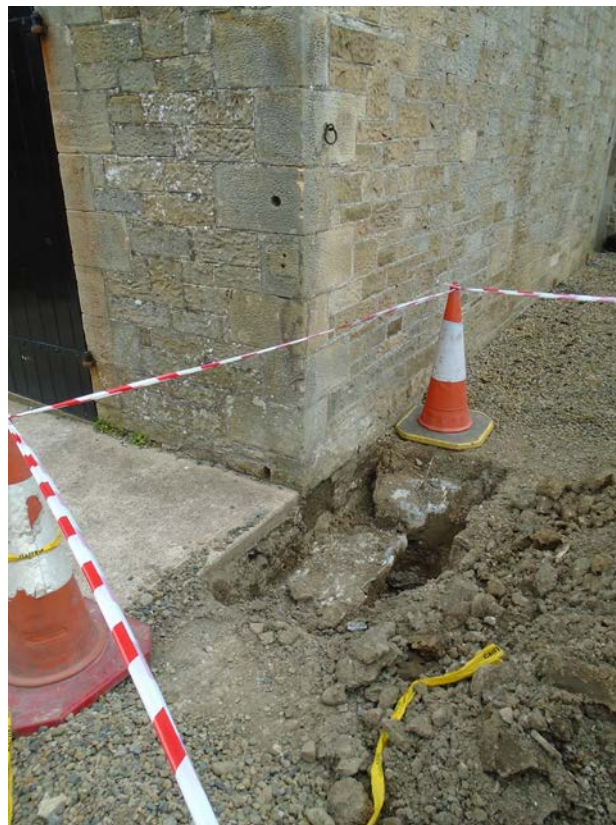
The send and receive pit (Pit 9) monitored at the south-west corner of the crowstepped gable end of the coach house extension to the listed farm buildings consisted of one 1.5 m x 0.5 m x 0.70 m excavation, carried out by machine (Figure 9). This pit partially exposed the modern concrete underpinning of the gable end, within which it was possible to note previous structural movement. This concrete underpinning had been laid within a trench cut into a fine, naturally-deposited mid-brown clay (005), which was excavated to a depth of c. 0.5 m, but not excavated to its full thickness. Overlying the natural clay (005) was the modern gravel yard surface (010), with no intervening deposits. No archaeological finds, features or deposits were noted during excavation of the pits.

Figure 9 Pit 9, adjacent to coach house, looking north-east. No scale
