Bolingbroke Castle  
Bolingbroke, Lincolnshire

Archaeological Watching Brief

Prepared for:	Kate North Properties Curator (East) Curatorial Team English Heritage 24 Brooklands Avenue Cambridge
Prepared by:	Jim Brightman BA (Hons), MLitt, MCifA Solstice Heritage LLP Crabtree Hall Business Centre Little Holtby Northallerton North Yorkshire DL7 9NY
Checked by:	Chris Scott BA (Hons), MA, MCifA
Project Reference:	SOL1718-66
Document Reference:	DOC1718-65
Dates of Fieldwork:	December 2017
Date of Document:	December 2017

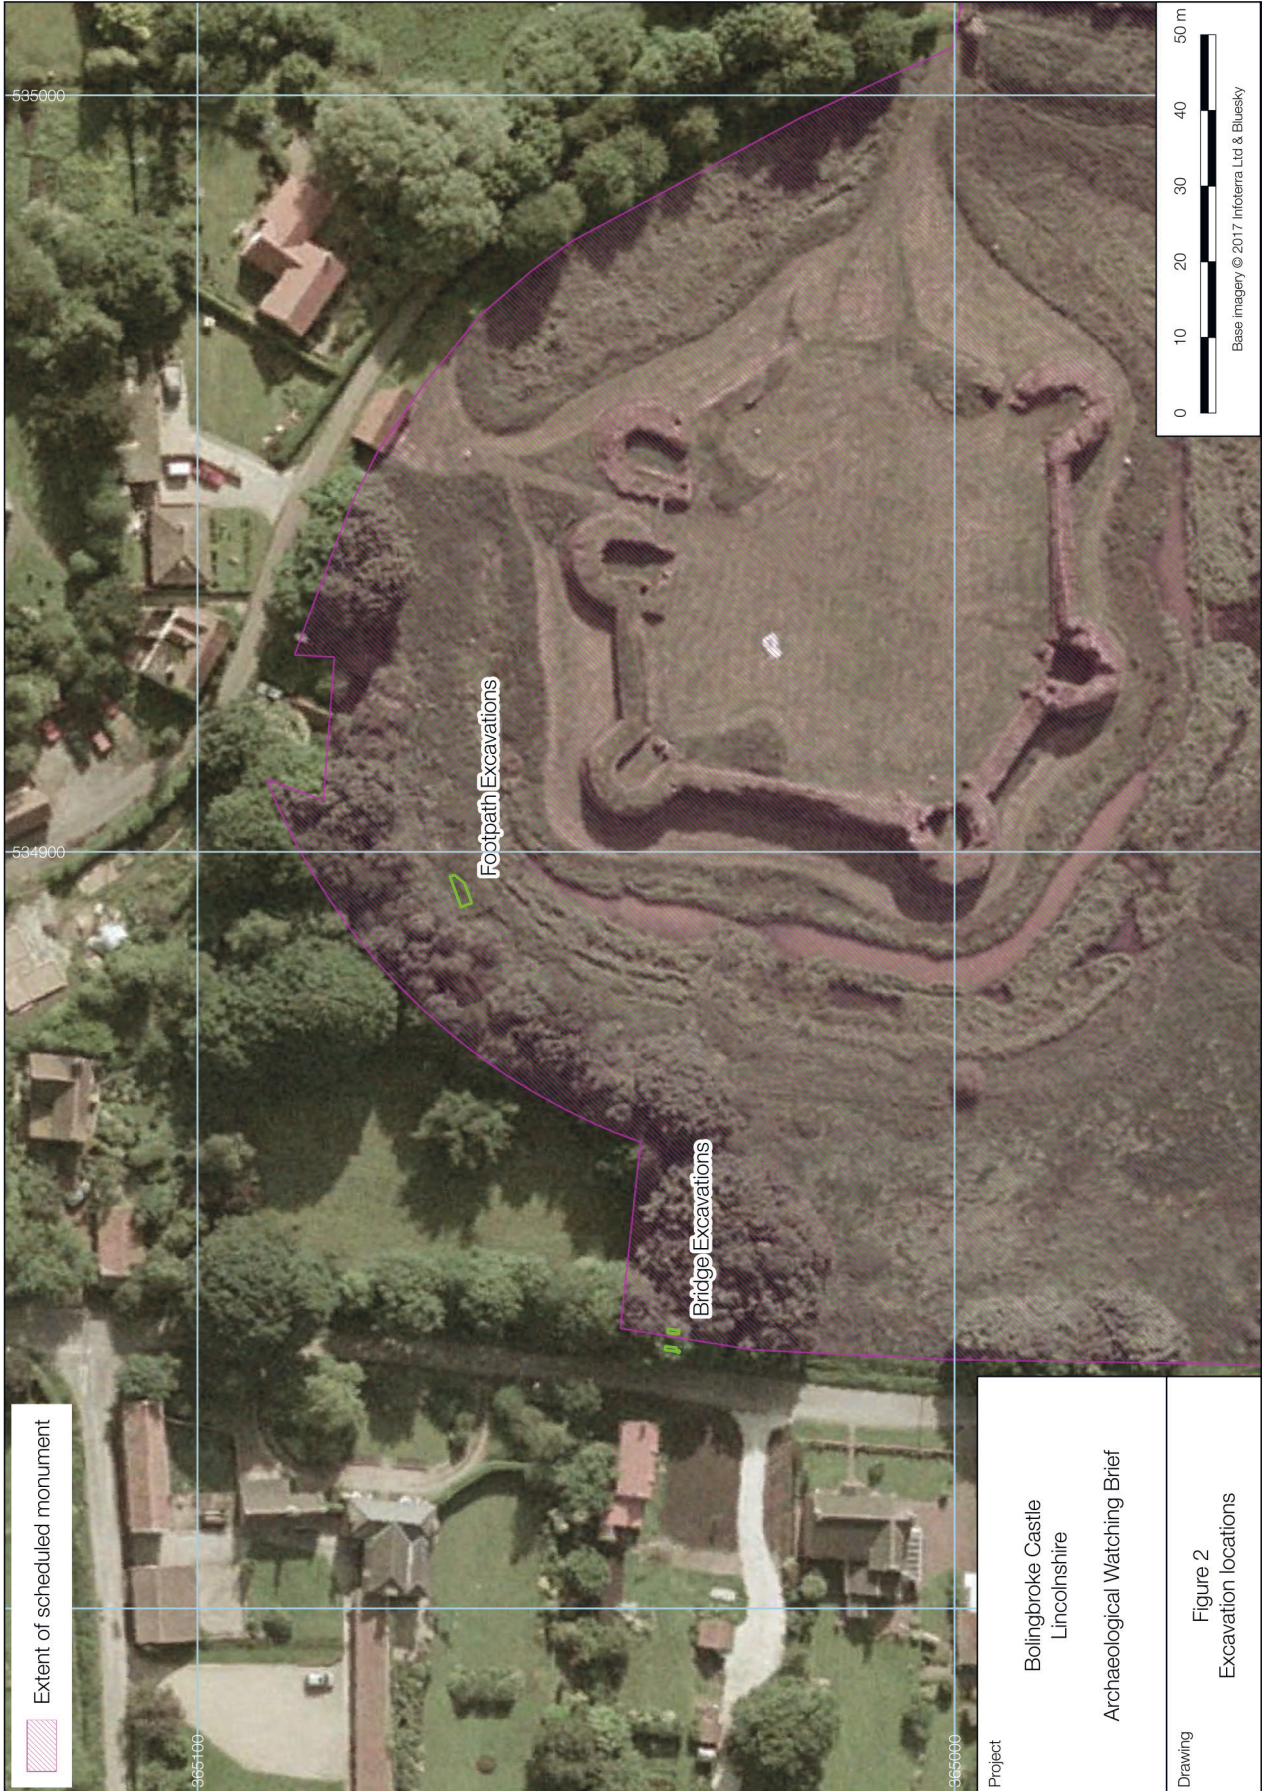
The monitored works were situated within the area of Bolingbroke Castle (NHLE 1309023), centred at grid reference NGR TF 34925 64931. The castle is a scheduled ancient monument (NHLE 1008318) and Grade I listed building (NHLE 1309023). Four separate excavations were monitored, split between two areas: the bridge and signpost excavations, and the footpath/stairs excavations (see Figure 2 below for location).

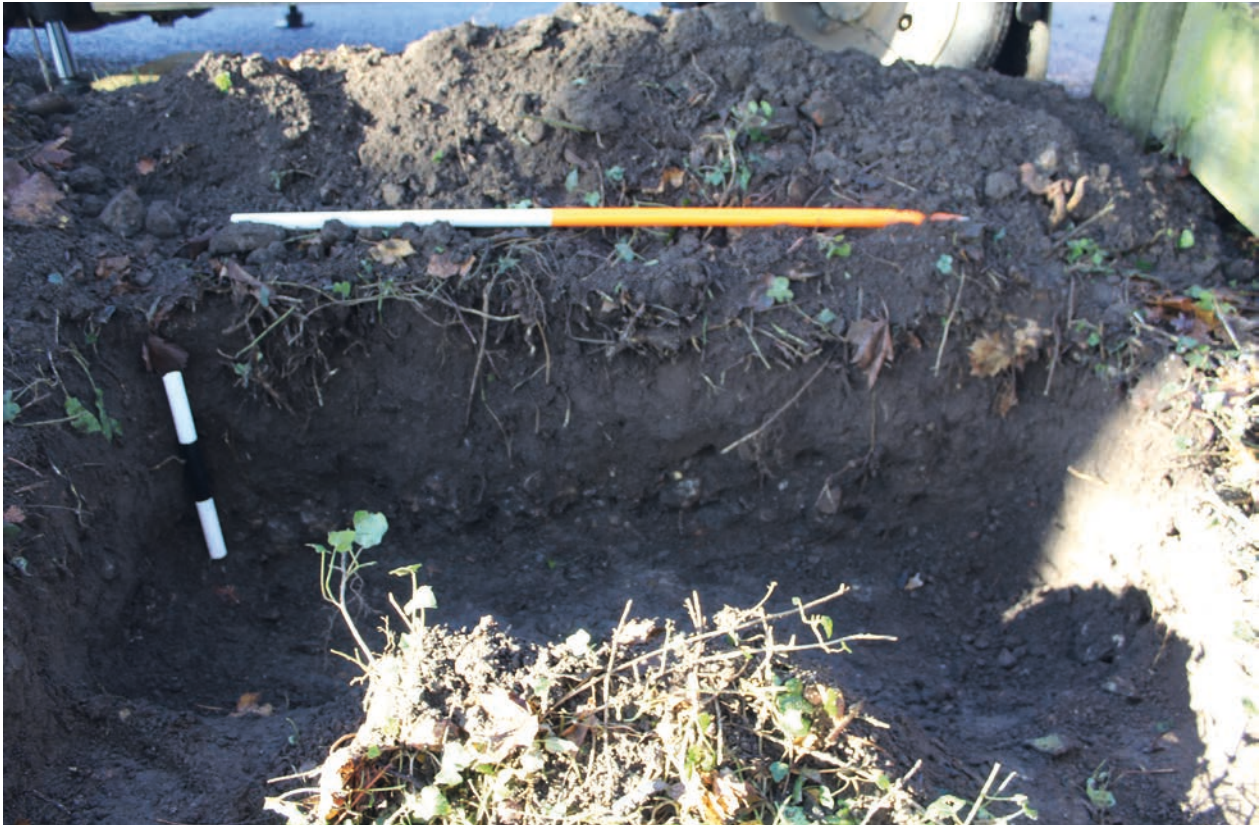
The eastern excavation was cut entirely into a loose sandy topsoil (001) with a considerable fraction of organic rotting leaf mould deriving from the adjacent sycamore plantation. The western footing cut through the same topsoil deposit (001), showing it to have a maximum thickness of 0.3 m. Beneath this, there was a mixed deposit of crushed brick, stone and flint nodules in a dense clay matrix (002) which continued to the base of the excavation at 0.4 m below ground level. This deposit most likely represents bedding or foundation spread for the adjacent road.

Figure 3 Western bridge footing excavation facing west. The bedding deposit for the adjacent road can be seen at the base of the facing section. Scales = 1 m and 0.3 m

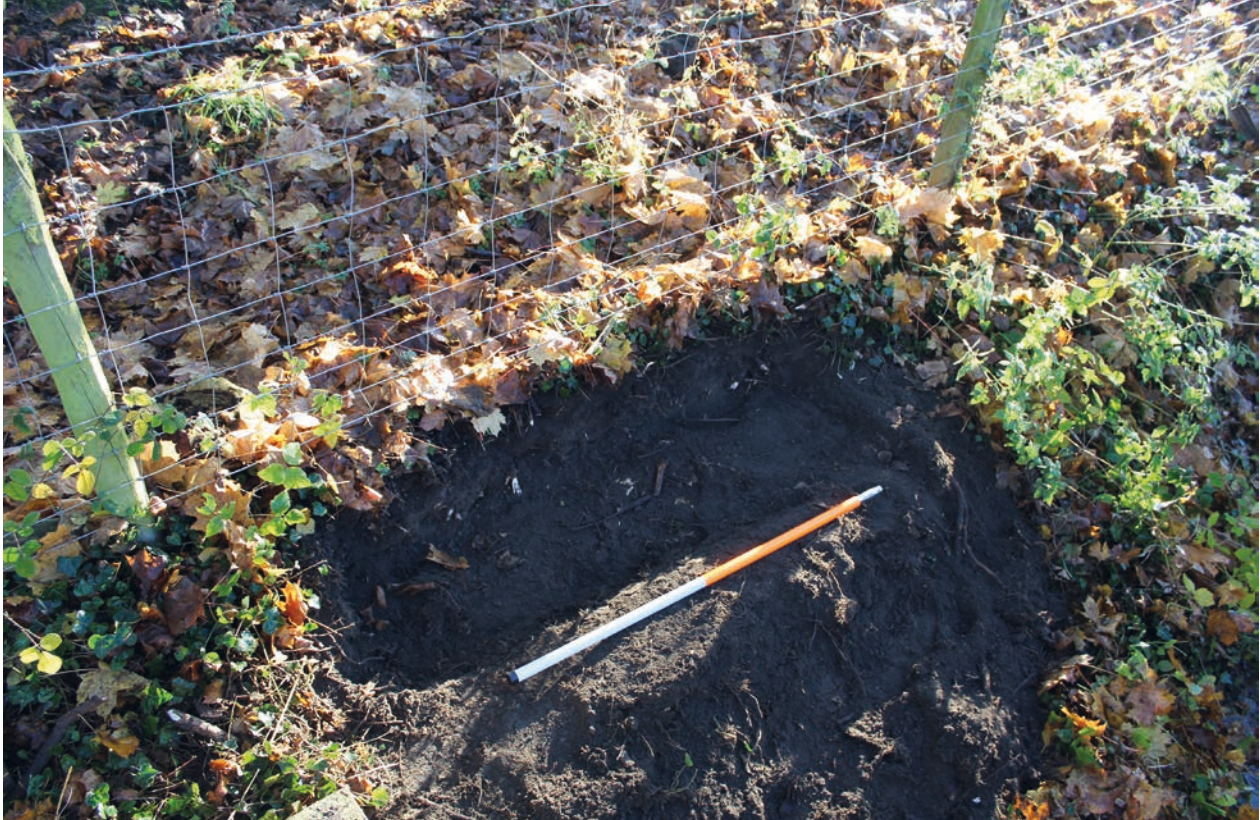
The excavations for the bridge footings comprised two separate rectangular cuttings, one on each side of the deeply incised north-south-aligned drainage ditch on the western boundary of the scheduled monument. Each cutting measured 1.5 m x 0.5 m in plan, with the roadside (western) excavation dug to a maximum 0.4 m in depth and the eastern excavation against the boundary fence dug to a maximum depth of only 0.25 m.

Figure 4 Eastern bridge footing excavation facing south-east. Scale = 1 m

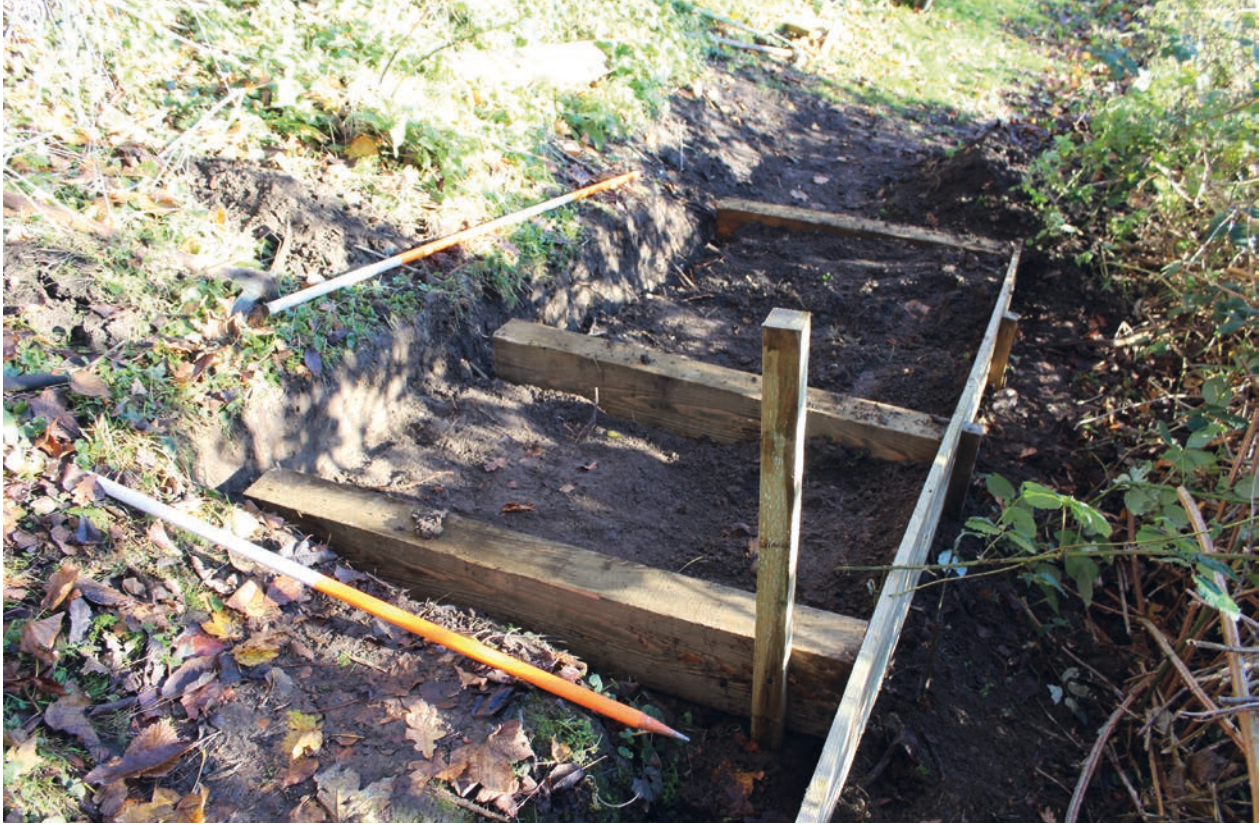
The excavation for the new footpath steps comprised an irregular area in plan with a total length of 4.3 m and a maximum width (at the western end) of 0.9 m. It was cut at an angle to the adjacent earthwork bank (part of the outer works of the castle), meaning that only the northern side of the 'trench' required excavation. The removed material was then banked into the southern side of the 'trench' to create a level series of steps divided and edged by wooden boarding. The excavation revealed a thin silty topsoil of a maximum thickness of 0.25 m (003) overlying a compact clayey silt deposit with crushed brick inclusions (004). The angle of the excavation in plan meant that deposit (004) was only exposed in part of the trench, but it is considered likely that it represents the upper layer of the earthwork bank. There were no small finds recovered and the fragments of brick recovered were too small to be diagnostic, though the internal structure of one piece inspected suggested it was handmade.

Figure 5 Overall view of the footpath trench following excavation and insertion of the wooden boards. The angle of excavation shows the cut into the bank to the left of shot and the filled material to the right-hand side of the excavation. Scales = 1 m and 2 m
