Heworth Hall, Gateshead  
Tyne and Wear

Archaeological Watching Brief

Prepared for:	Aspire Technology Solutions Heworth Hall Shields Road Gateshead NE10 0UX
Prepared by:	Chris Scott BA (Hons), MA, MClfA Solstice Heritage Crabtree Hall Business Centre Little Holtby Northallerton North Yorkshire DL7 9NY
Checked by:	Jim Brightman BA (Hons), MLitt, MClfA
Project Reference:	SOL1617-72
Document Reference:	DOC1617-52
Dates of Fieldwork:	December 2016 to January 2017
Date of Report:	January 2017

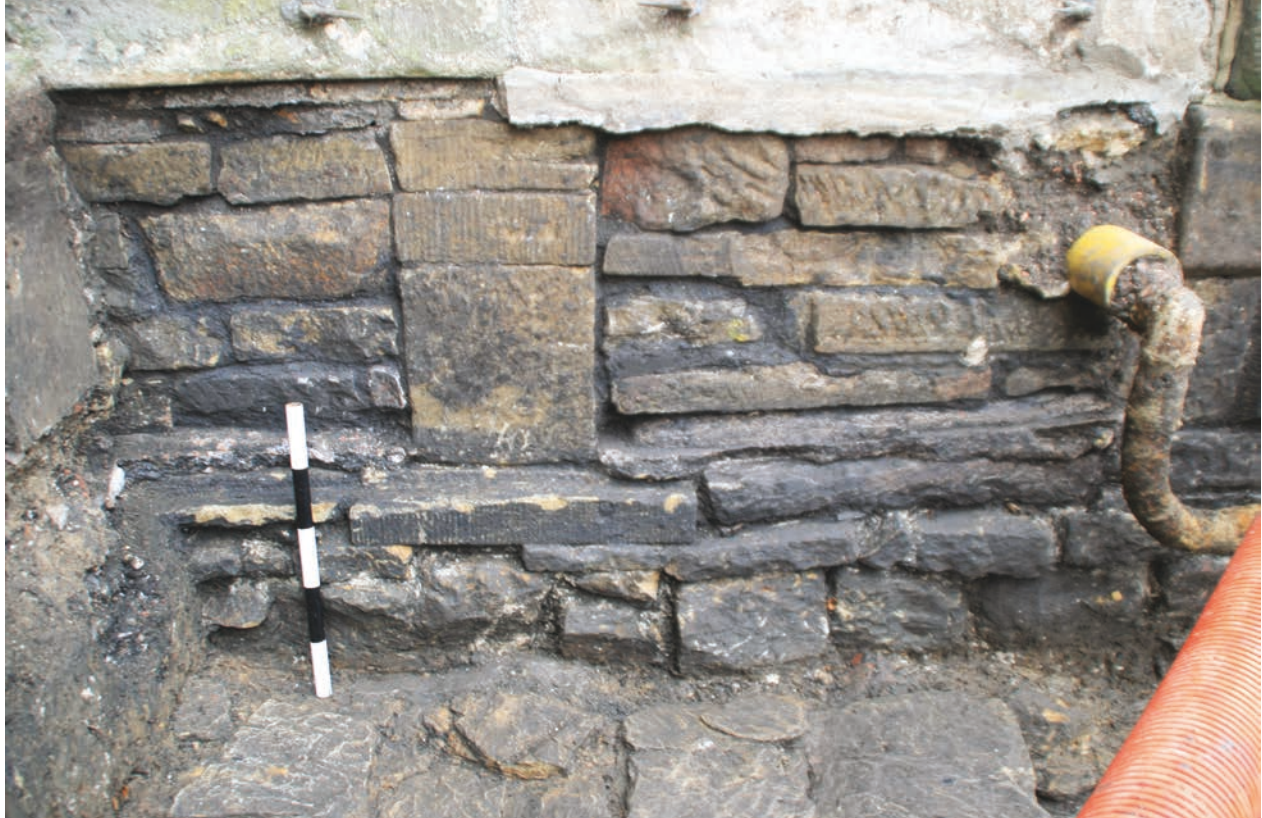
The single-storey outshot extension to the west side of the building (see Town 2011 - Building D) was previously thought to represent a coal house, although this attribution was uncertain (Town 2011, 56). Uncovered within the north elevation of the outshot, two latterly blocked openings, either side of a central pier with stone lintels including iron pins to hold hinges for lifting wooden doors (Figure 2), suggest that the extension was actually created as a traditional 'two-seater' outside toilet and is most likely to be early 19<sup>th</sup>-century in date.

The blocking of the two openings for removing waste from the outside toilet had been subsequently built against by the 1929 stairway extension to this side of the Hall (Figure 2), indicating clearly that it was no longer in use for its original purpose by that date.

Figure 2 North elevation of outshot at west side of Heworth Hall after ground reduction. Scale 1x25cm

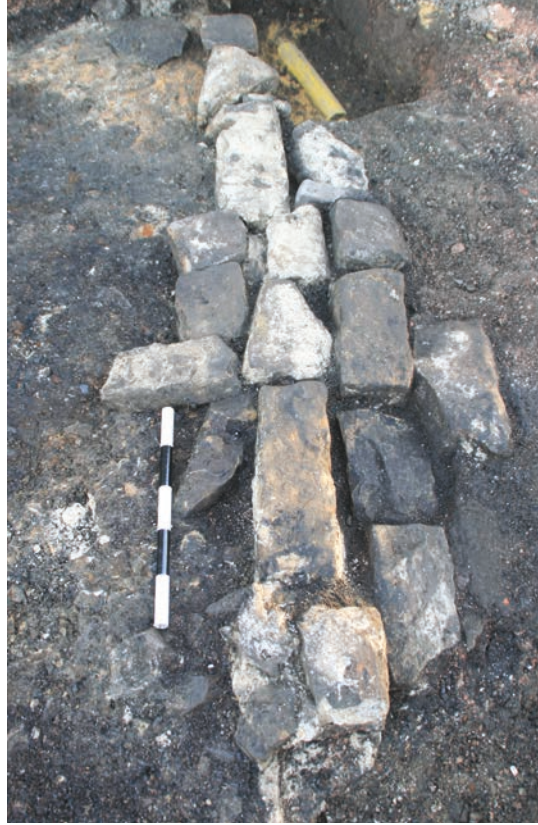
Wall foundation (003) consisted of a 2.1 m length of stone blockwork foundation, exposed at the south-east corner of the excavation for the new office extension foundations (Figure 3). The foundation included one surviving course of masonry in roughly shaped sandstone blocks, the largest of which was approximately 0.44 m x 0.16 m x 0.11 m. Traces of a white, chalky lime mortar were evident across the upper surface of the stones and in patches immediately around them. The foundation construction was of two leaves with two areas of collapse/construction debris (005, 006), one noted on either side of the wall course. Deposit (005) consisted of redeposited yellow/brown till (boulder clay) with inclusions of lime mortar, charcoal flecks and crushed mortar, as well as patches of mid-brown clay silt. The deposit measured 0.6 m x 0.65 m x 0.05 m. Deposit (006) was similar to (005) but more mixed. It consisted of a mixed grey silt clay with frequent inclusions of stone fragments, mortar, slate, charcoal flecks and brick fragments.

Figure 3 Wall foundation (003), looking south-east. Scale 1x50 cm

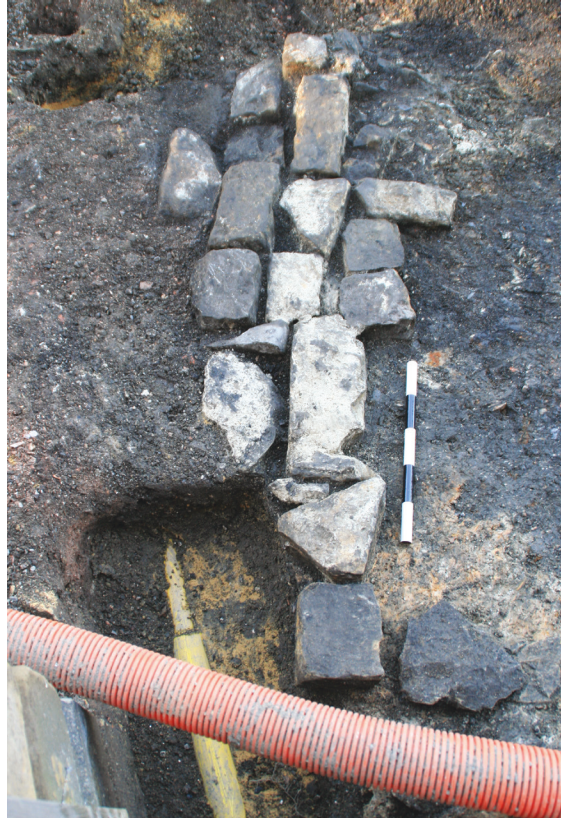
The wall foundation (003) was cut by the trench for a modern gas pipe (007) at its south-eastern extent, immediately to the north side of the north-west corner of the outshot extension on this side of the main Hall building (Figure 4). The foundation (003) overlay a firm mid/dark grey clay with moderate inclusions of brick, mortar and pebbles (004). This layer, which was present across the site, was interpreted as a probable disturbed or reworked clay substrate, perhaps representing a 19<sup>th</sup>-century construction/levelling layer. This deposit overlay the natural clay substrate (009).

Figure 4 Wall foundation (003), looking north-west. Note corner of outshot extension and cut with modern gas pipe. Scale 1x50 cm

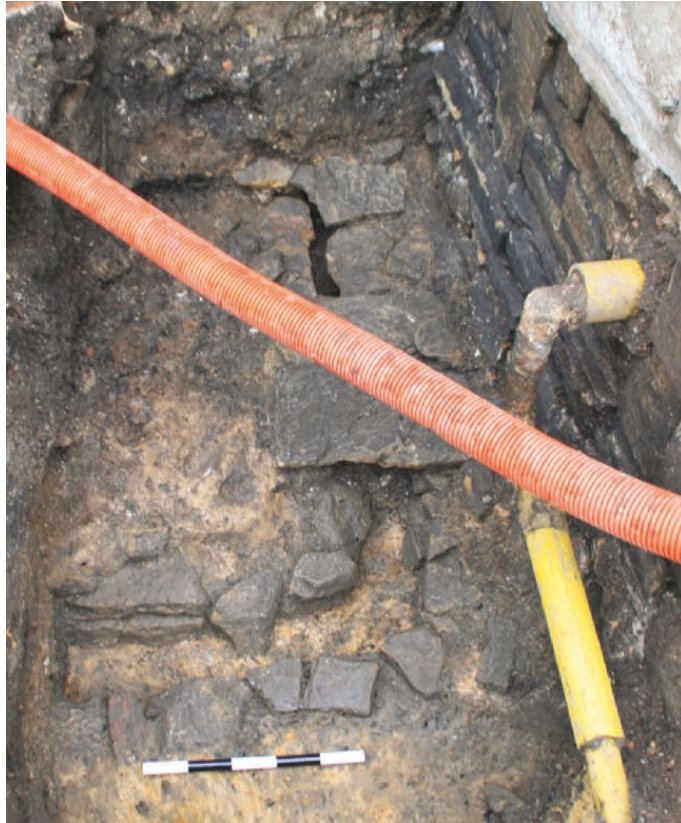
Immediately to the east of the wall foundation (003), but cut into the natural substrate (009) at a lower level, was a stone-lined culvert or drain (011) (Figure 5). This drain was initially exposed at the south-east corner of the site, immediately to the north side of the outshot from the main Hall building. At its eastern extent, the drain ran beneath the foundation of the 1929 stairway extension to the main building (Town 2011, 34-36). From that point it ran for 1.5 m to the west before turning 90° to run directly north. 0.6 m of this northern extension was observed within the monitored excavation (Figure 6).

Figure 5 Culvert/ drain (011), looking east. Note north wall of outshot to right. Scale 1x50 cm

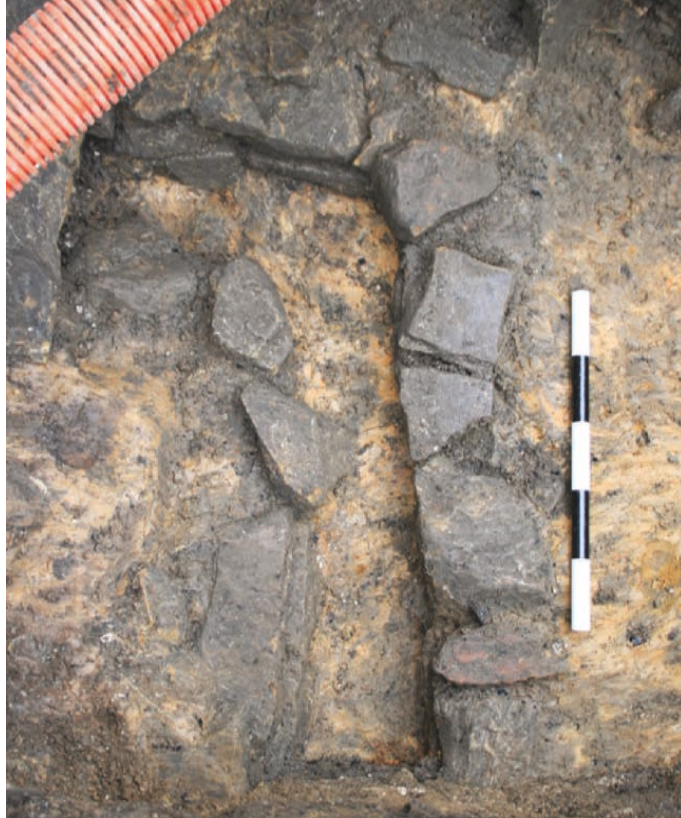
The culvert itself was 0.6 m wide, comprising sandstone rubble walls up to 0.22 m in width and approximately 0.20 m high. These rubble walls included up to three courses of mostly small unshaped rubble stone and were typically c. 0.07 m – 0.08 m per course. There was no mortar used within the construction. The walls of the drain sat within a linear construction cut (013), and were wedged closely against the vertical sides of this tight cut, sitting directly upon its flat base. The roughly square channel of the drain was found to be c. 0.2 m wide and around 0.25 m high. The channel was covered by partially surviving slabs of laminated sandstone, the largest of which was 0.52 m x 0.36 m x 0.025 m. These covering stones only survived in position at the eastern end of the structure but presumably once extended across its entire length. The channel of the drain was filled with a loose grey silt fill (012), which presumably represented silting of the drain during and after its use. The purpose and date of the drain is uncertain; however, it presumably post-dates the construction of the nearby outshot, given that it respects the line of that building.

Figure 6 Detail of northern extent of culvert (011). Scale 1x50 cm

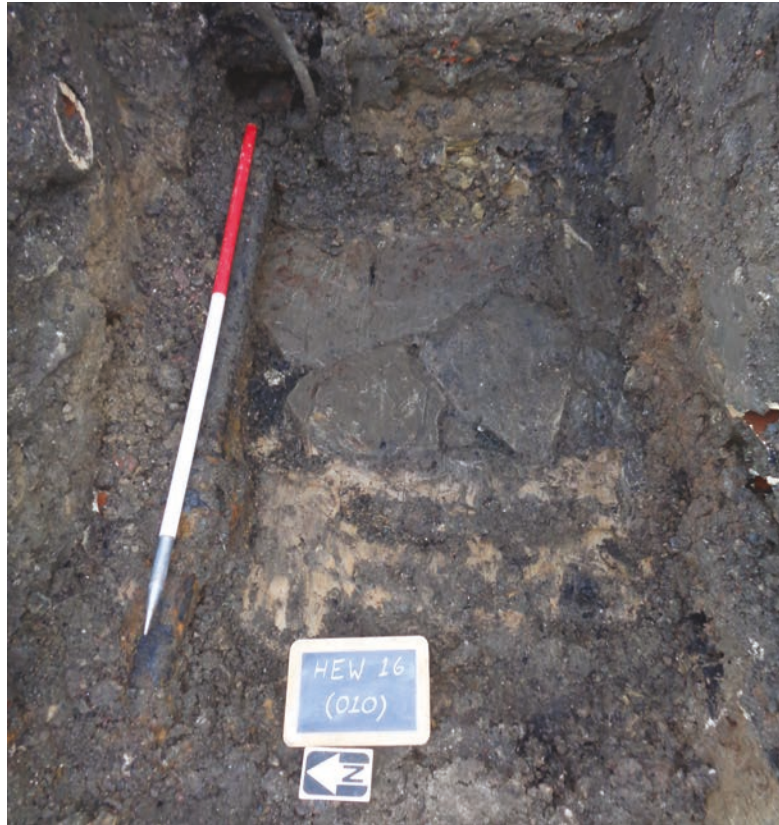
Immediately to the west of the west wall of the 1929 stairwell addition to the main Hall building (Town 2011, 34-36), and partially underlying its foundation, was a flagged stone surface (010) (Figure 7). Two sections of this surface were encountered during the monitoring of underpinning works to the west wall of the standing building (Figure 8). The flagstone surface was formed from irregular flat sandstone slabs, closely spaced with no pattern. A distinct straight edge was observed at the western side of the surface but its eastern extent was not confirmed beneath the standing building foundation, which it underlay. The average flagstone was c. 0.04 m thick and c. 0.3 m across. The surface was partially overlain by the disturbed grey clay (004) considered to represent a 19th-century levelling deposit; it was lain directly onto the natural boulder clay (009). The surface is considered most likely to represent an exterior garden path or paved area running north to south, contemporary in date with the earlier phases of the Hall and clearly earlier than 1929.

Figure 7 Southern section of paved surface (010), looking east. Note distinct straight edge at western extent. Scale 1x1 m

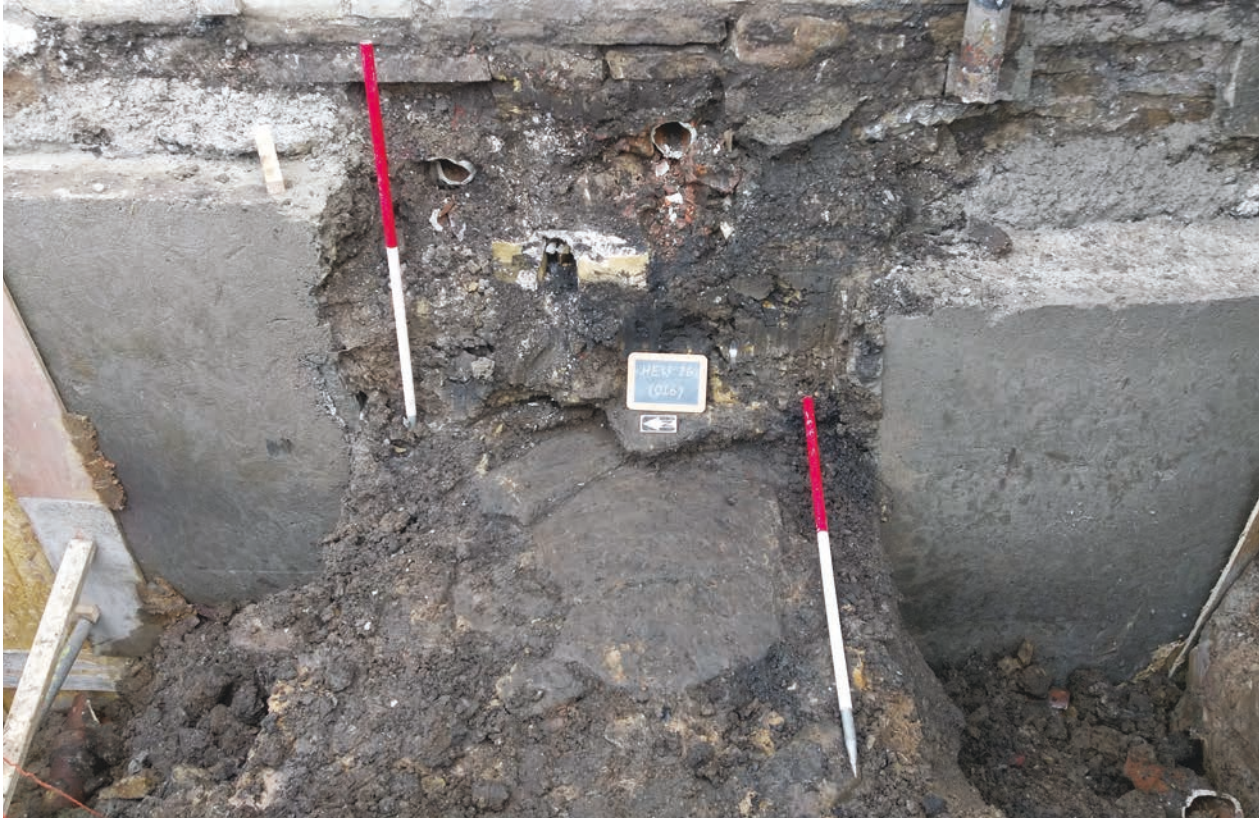
Figure 8 Northern section of paved surface (010), looking east. Scale 2x 1 m

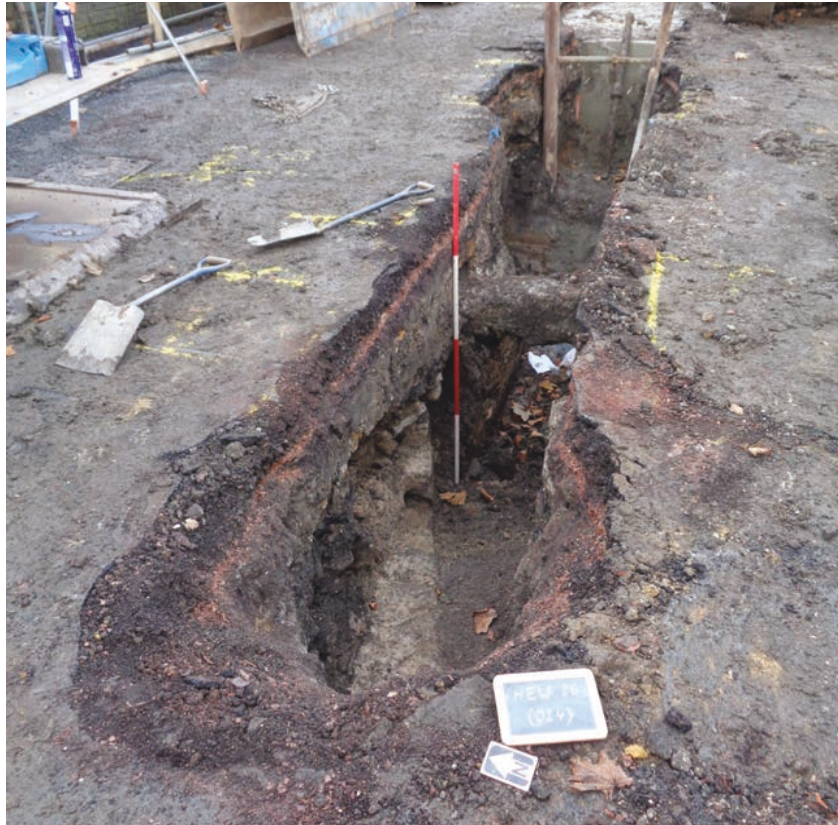
Within the northern central part of the site a well-coursed sandstone wall (014) was encountered within the excavations for the foundations of the new office extension (Figure 9). The wall was made of rectangular masonry blocks (c. 0.3 m x 0.1 m x 0.2 m) set in a chalky, white lime mortar. Neatly cut facing stones were present to both sides of the 0.6 m wide construction, which was filled with a mortar and rubble core. The wall was shown to survive to at least five courses in height (c. 0.65 m) and was aligned north-east to south-west, with around 2-2.5 m of its course exposed within the excavation (Figure 10). The wall was bedded directly onto the natural clay substrate (009), and no construction cut was visible within the surrounding disturbed later levelling layer (004), which was dumped around and over the partly demolished wall. It is not clear from the historic mapping which wall this might represent; however, it seems clear that it is a boundary wall of likely 19<sup>th</sup>-century construction. Although not certain, a short length of cast-iron post found within the adjacent backfill (004) suggests that this wall may have been topped with inset iron railings.

Figure 9 Wall (014), looking north-east. Scale 1x2 m

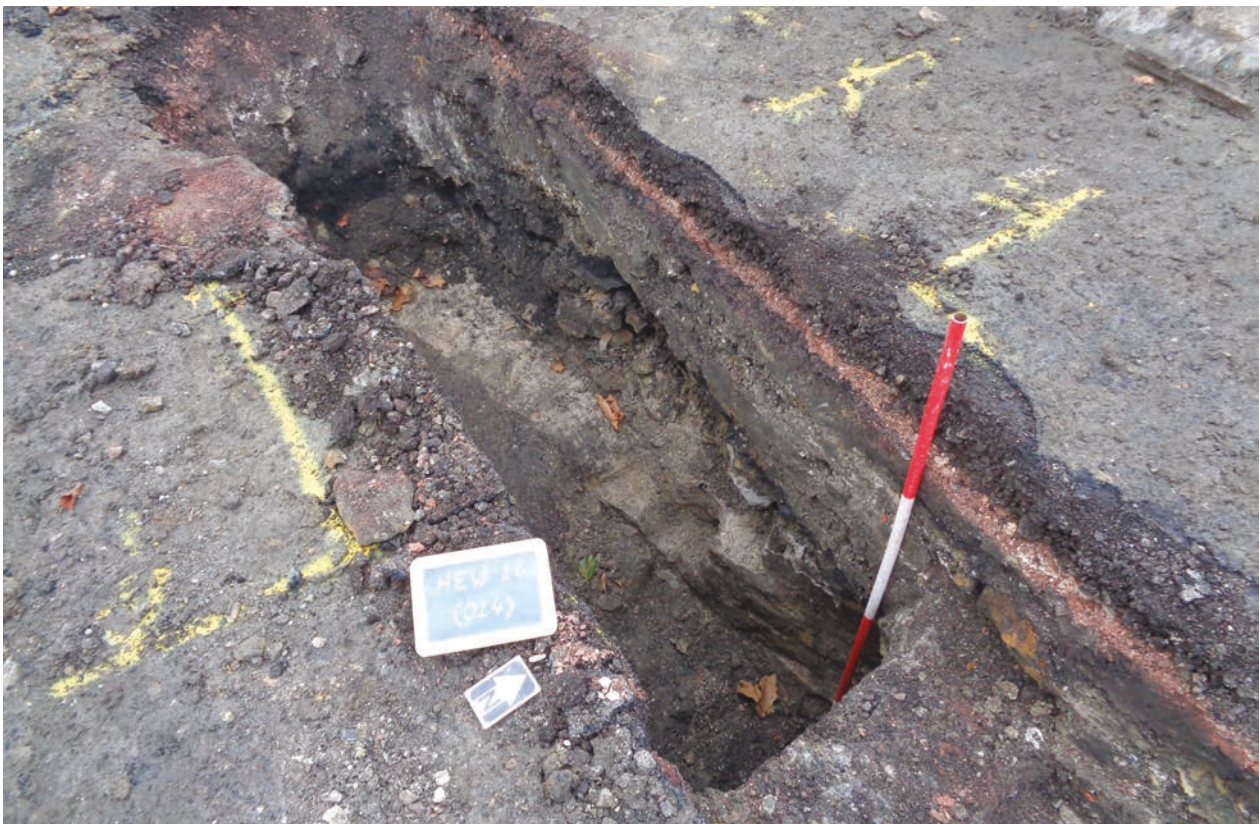
Figure 10 Wall (014) looking north-west. Scale 1x2 m

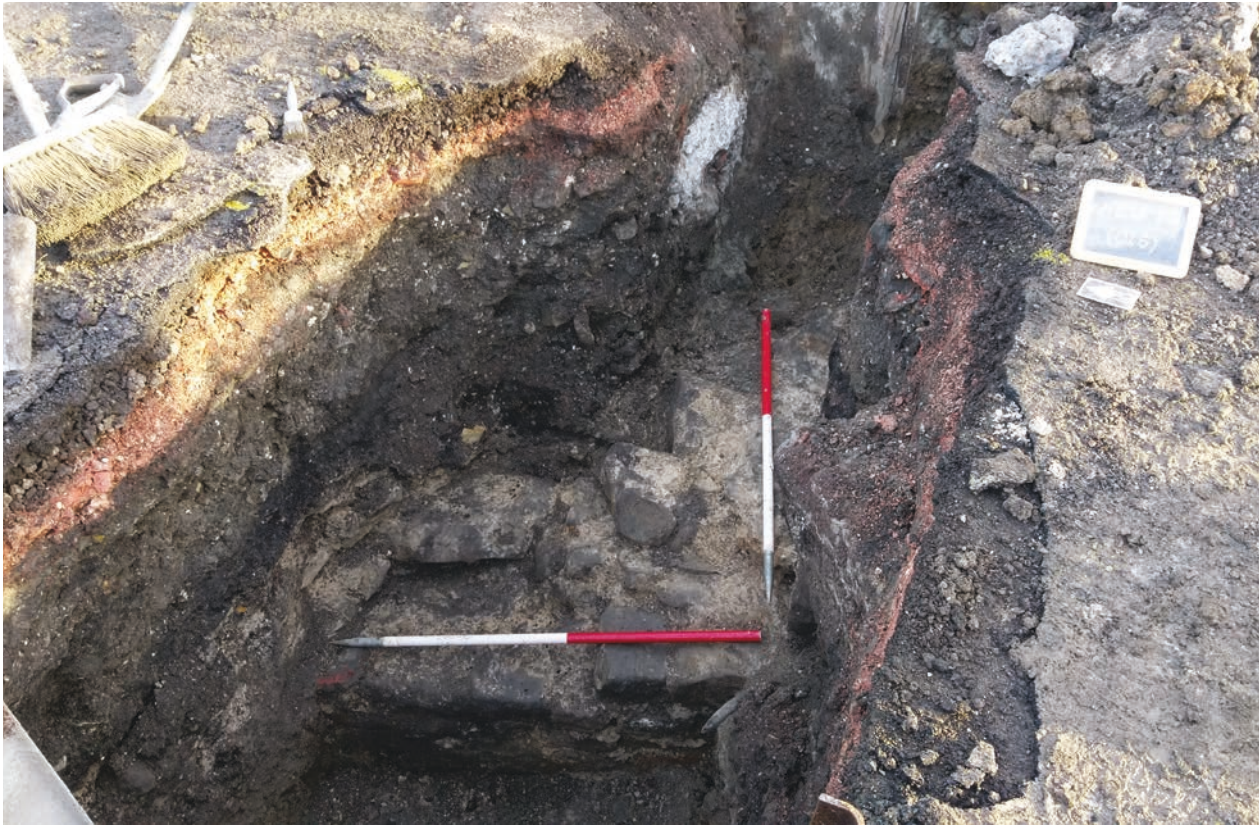
At the western extent of wall (014), it was found to include a 90° return to the north-west. This return was initially given a separate context number (015) but was later found to be part of (014) (Figure 11). As with (014), wall (015) was found to have a width of 0.60 m and survived to a height of 0.7 m. Around 1.0 m of the length of this wall section was exposed within the foundation excavation. It appeared that the wall continued to the north-west beyond the limit of excavation, but it was not possible to ascertain whether this was a true corner, or whether it was the junction of two contemporary walls and (015) continued past this point further to the south-east (Figure 12).

Figure 11 Right-angle return of Wall (014/015), facing north-east. Scale 2x1 m

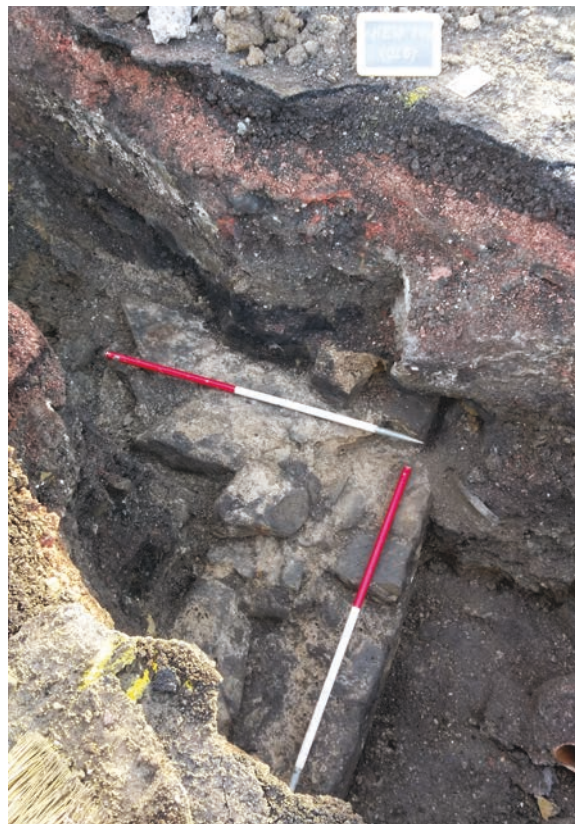
Figure 12 Wall (014/015), looking south-east. Scale 2x1 m
