'Gandhi's Temple' Shelter and Public Lavatories  
Sea Road, South Shields

Historic Building Recording

## Historic Building Recording

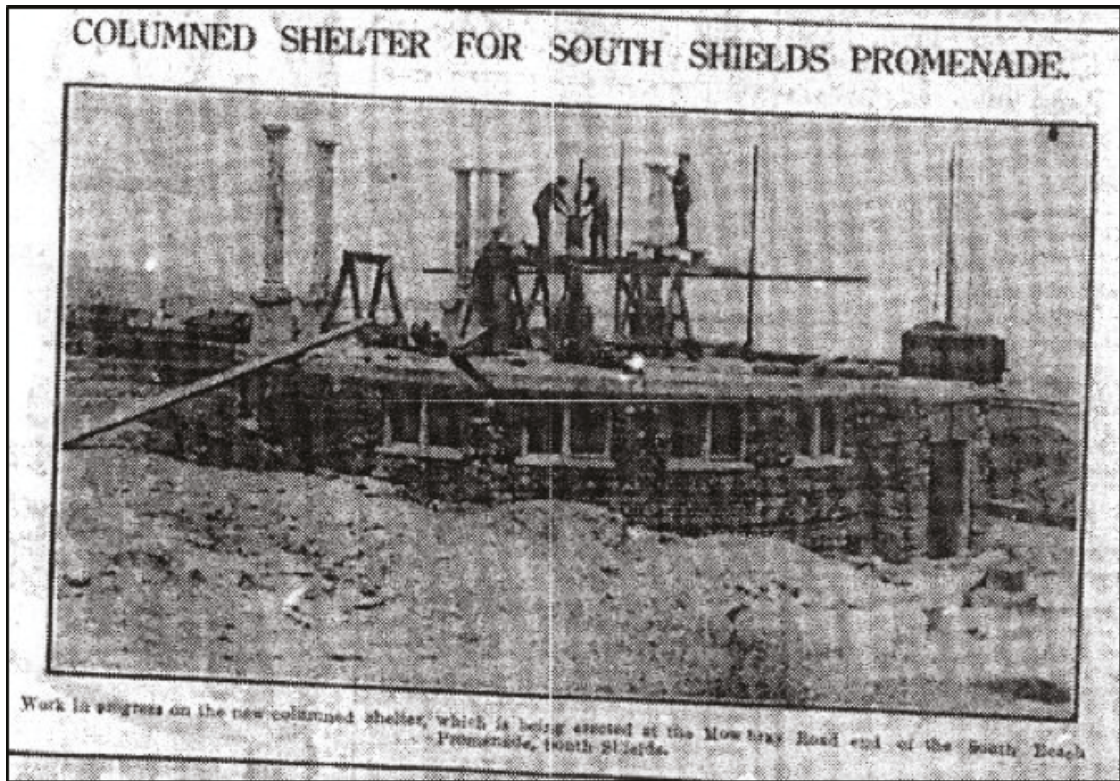
Figure 2 Photograph of work in progress on the new columned shelter being erected at the Mowbray Road end of the South Beach Promenade. From The Shields Daily Gazette and Shipping Telegraph (The Shields Gazette), published 1st July 1931

The building was originally constructed in 1931, with the *Gazette* carrying a picture of its construction well underway on 1st July 1931 (Figure 2). On 18th September 1931 the *Gazette* carried a further picture of the building 'nearing completion' (Figure 3), with a caption stating that the building would be officially opened the following day, giving Saturday 19th September 1931 as the official opening date.

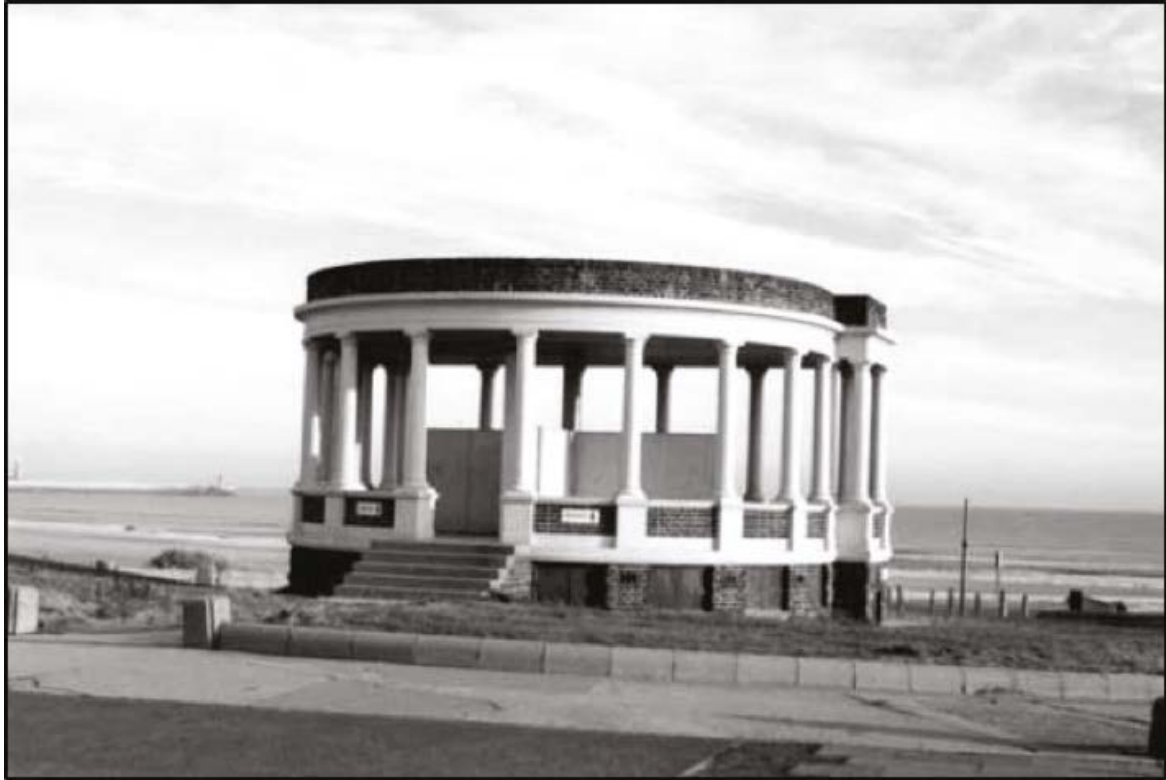
Figure 4 Photograph taken in 1982, showing internal T-shaped partitions for seating still in place. (South Tyneside Libraries)

The main significant alteration, and perhaps the reason for the citing within the Local List of the building as a bandstand, has been the removal of seating and partitions from within its upper storey, as shown by the *Gazette* photo on 18th September 1931 (Figure 3) and as surviving in 1982 (Figure 4). This partitioning appears to have originally been glazed within its upper portions (no longer in place, or boxed over, in 1982), presumably to allow unrestricted views, whilst at the same time providing a windbreak for users within the open-sided upper storey. The provision of this partitioning makes sense of the two square columns centrally placed within the upper storey of the building (Figure 23), which clearly would have fulfilled a function in supporting that partitioning, as well as the roof, but do not work well in creating the open space and sightlines required of a bandstand. Further to this, the provision of a shelter and public convenience at this location makes significant planning sense when considering the building's position close to the end of the developing South Beach Promenade (Figure 7), at a significant distance from comparable facilities provided closer to the centre of South Shields in and around North and South Marine Parks to the north. The provision of a bandstand at this point makes much less sense, particularly given the building's proximity to the road at its western side.

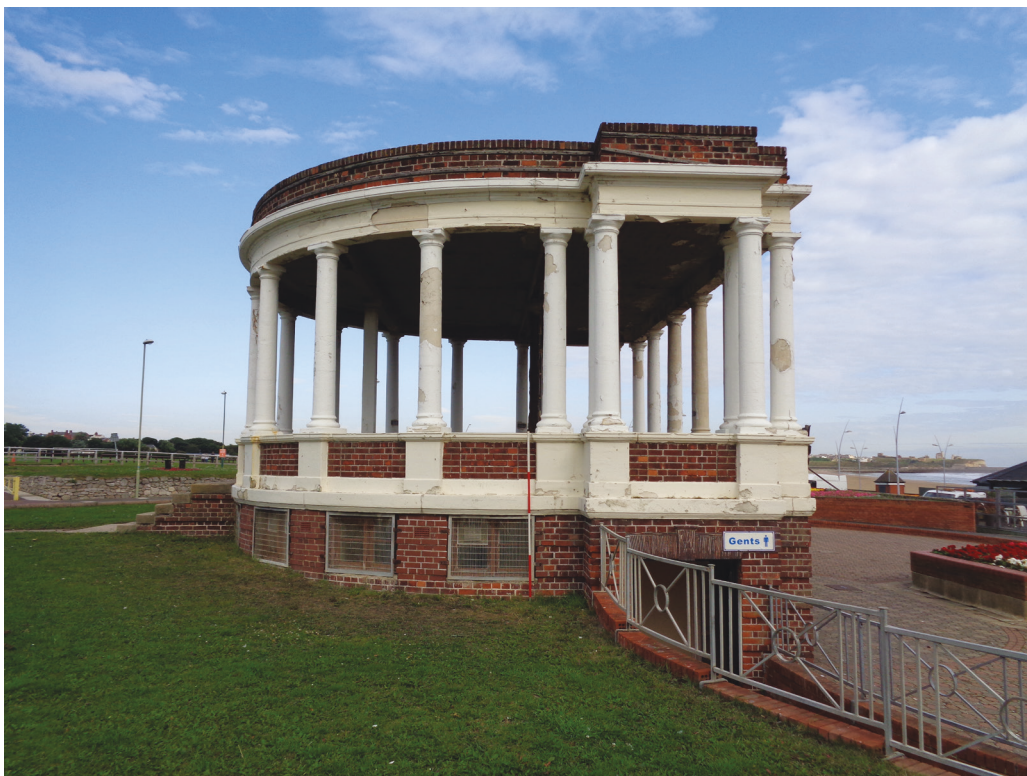
This elevation is one of two, symmetrical, side elevations of the building. This elevation comprises four windows to the lower ground floor, all of which have original wooden frames, with replaced concrete sills where the original woodwork has apparently rotted (Figure 8). To the east of this, is a lower doorway with flat arch constructed in decorative tile, accessed by a curving, ramped entranceway with later brick retaining walls and steel balustrade. The doorway, giving access to the gents' toilets within is contained within a two-storey projecting square bay. The brickwork of the structure is of red textured bricks, arranged with horizontal stepped detailing. The first floor comprises a colonnade of Doric columns carried on square dies over a stepped plinth. Above this is a simple plain frieze below a square cornice with plain attic parapet in brick. Between the columns is a low wall with inset brick panels topped by a moulded coping. The copings, as with the columns, frieze, cornice, dies and plinth, are all cast concrete. These have all been painted cream, but show Paton Watson's 'snowflake' finish beneath the paint, with white flecks in a buff concrete.

Figure 8 South-east elevation of Building A, facing north-west. Scale 1x2m

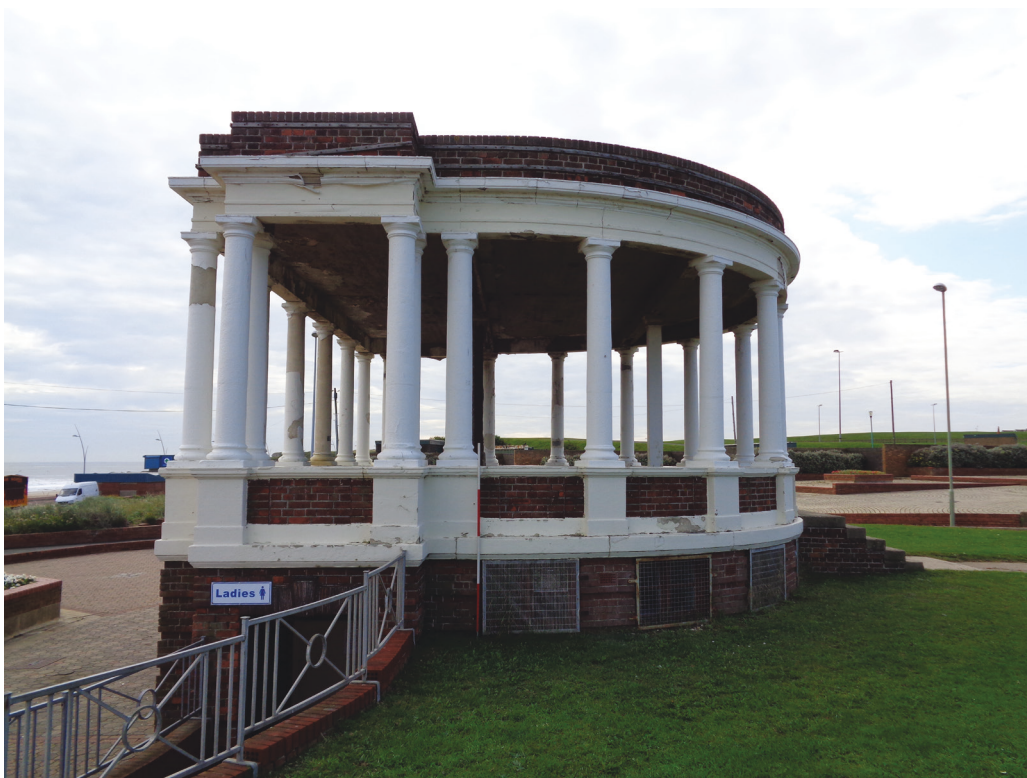
This elevation is one of two, symmetrical, side elevations of the building, matching that at the south-east side of the building. This elevation comprises four windows to the lower ground floor, all of which have original wooden frames, with replaced concrete sills where the original woodwork has apparently rotted (Figure 9). To the west of this, is a lower doorway with flat arch constructed in decorative tile, accessed by a curving, ramped entrance-way with later brick retaining walls and steel balustrade. The doorway, giving access to the ladies' toilets within, is contained within a two-storey projecting square bay, formed with coupled columns above. The brickwork of the structure is of red textured bricks, arranged with horizontal stepped detailing. The first floor comprises a colonnade of Doric columns carried on square dies over a stepped plinth. Above this is a simple plain frieze below a square cornice with plain attic parapet in brick. Between the columns is a low wall with inset brick panels topped by a moulded coping. The copings, as with the columns, frieze, cornice, dies and plinth, are all cast concrete. These have all been painted cream, but show Paton Watson's 'snowflake' finish beneath the paint, with white flecks in a buff concrete.

Figure 9 North-west elevation of Building A, facing south-east. Scale 1x2m

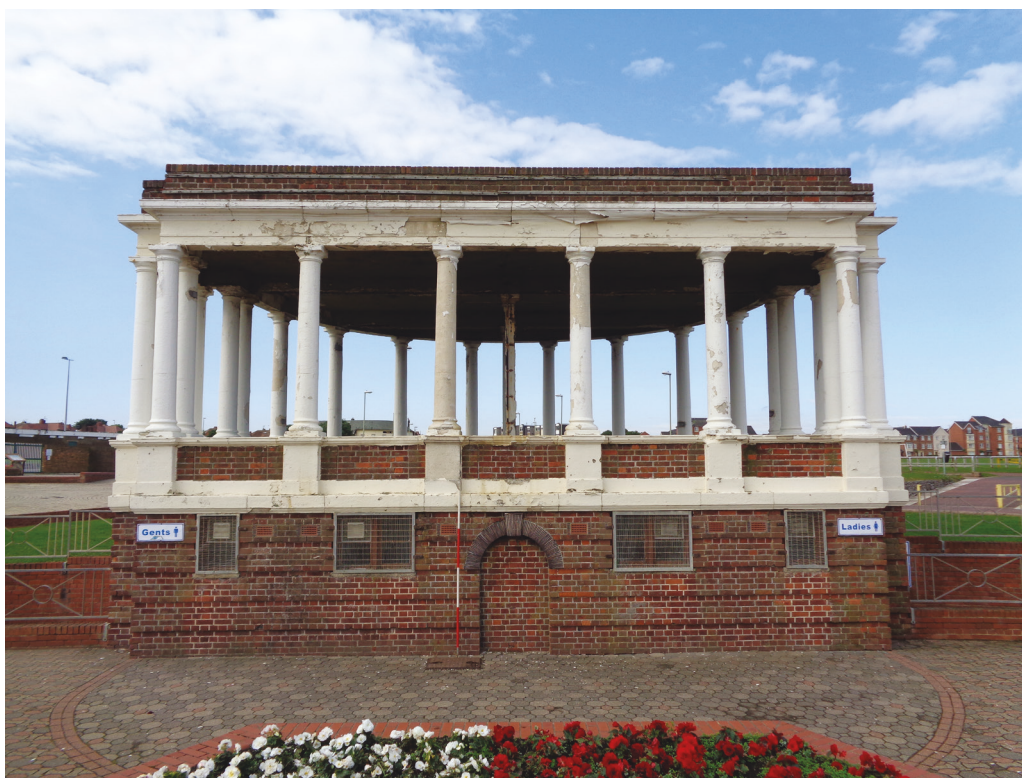
This flat elevation comprises four windows to the lower ground floor, all of which have original wooden frames, with replaced concrete sills where the original woodwork has apparently rotted (Figure 10). The two central windows are of four lights, with the two flanking windows each having two lights. Centrally a blind rounded arch is present constructed in decorative tile (Figure 11). The recessed archway presumably gave access to the drinking fountain marked on the Ordnance Survey map of the building in the 1940s, and the centrally located scars within the recessed brickwork presumably show where supports for this drinking fountain were located (Figure 11). The brickwork of the structure is of red textured bricks, arranged with horizontal stepped detailing. The first floor comprises a colonnade of six Doric columns carried on square dies over a stepped plinth. Above this is a simple plain frieze below a square cornice with plain attic parapet in brick. Between the columns is a low wall with inset brick panels topped by a moulded coping. The copings, as with the columns, frieze, cornice, dies and plinth, are all cast concrete. These have all been painted cream, but show Paton Watson's 'snowflake' finish beneath the paint, with white flecks in a buff concrete. At the corners of the building, the brickwork design gives the impression of rusticated quoins.

Figure 10 North-east elevation of Building A, facing south-west. Scale 1x2m

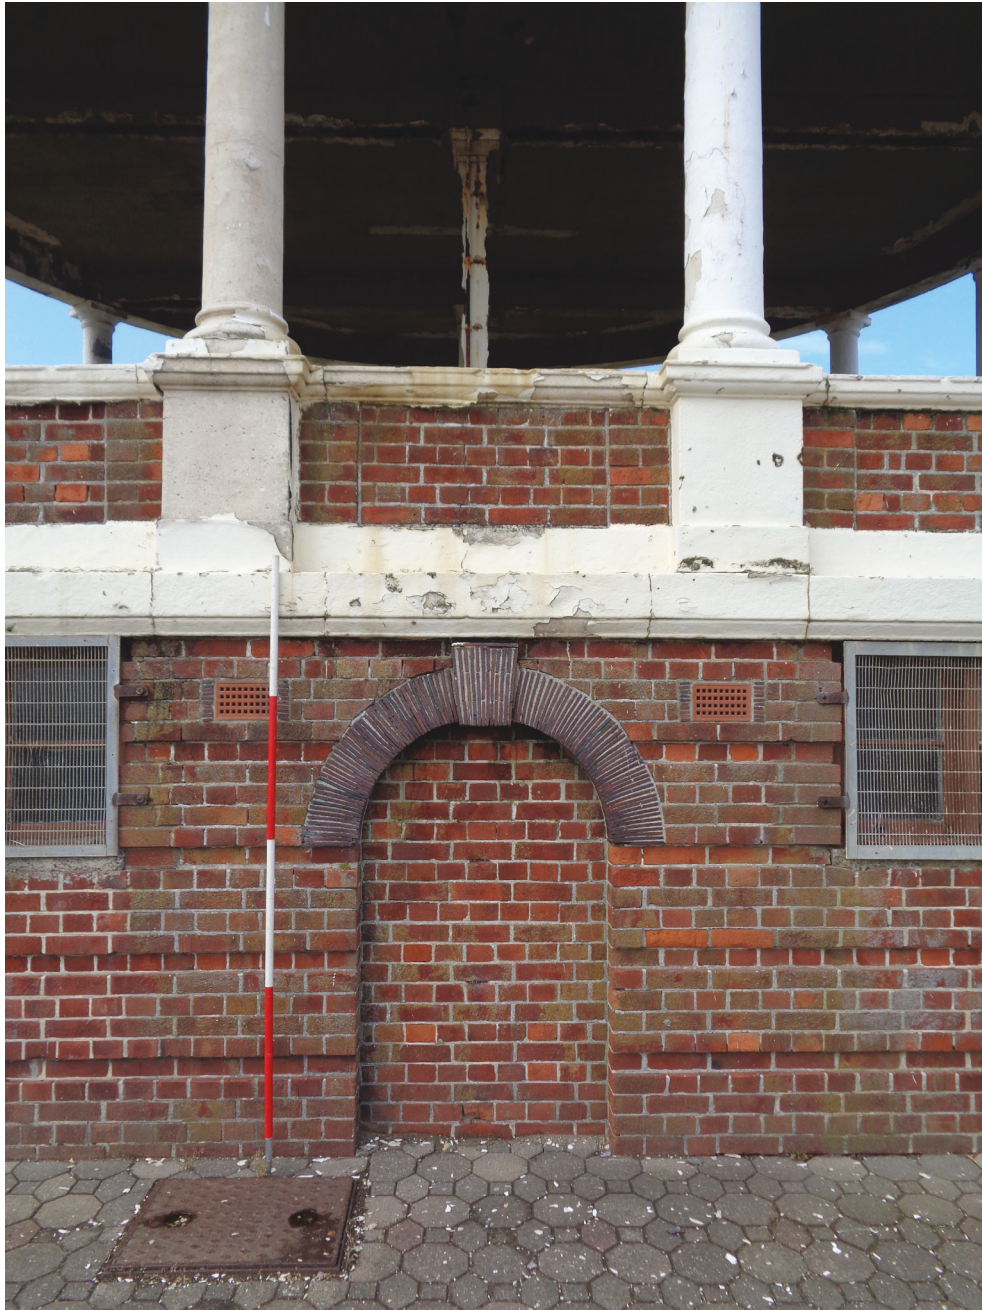
Figure 11 North-east elevation of Building A, detail of central blank arch, facing south-west. Scale 1x2m

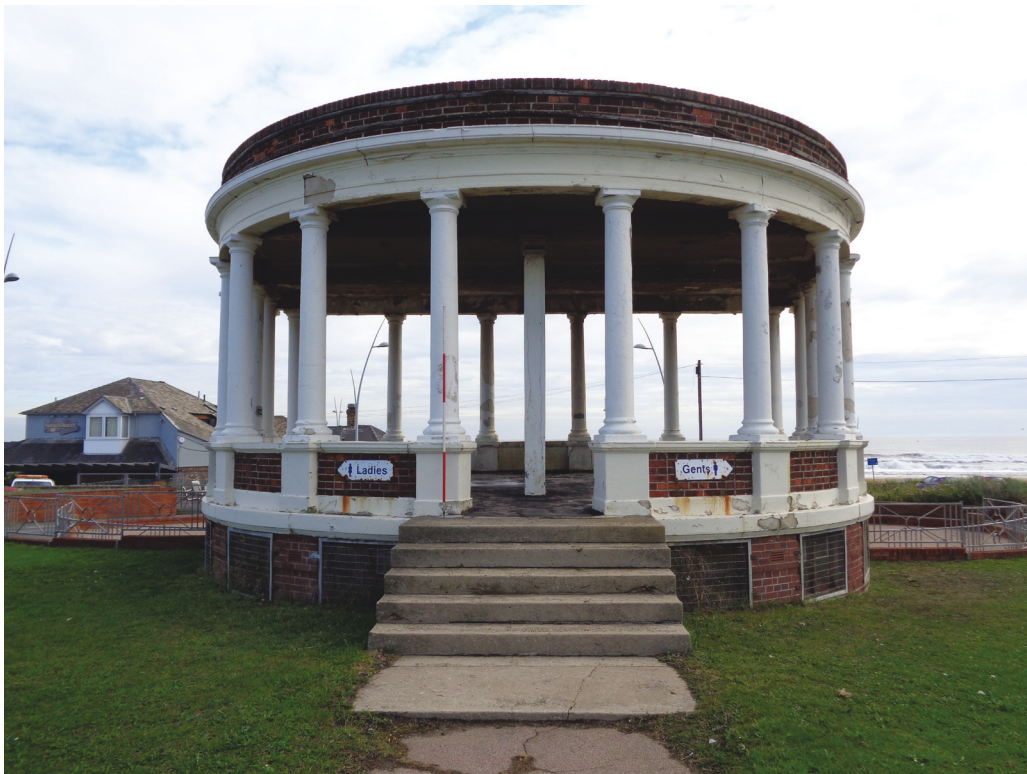
This principal, apsidal, elevation comprises windows (already described as part of other elevations) to the lower ground floor, all of which have original wooden frames, with replaced concrete sills where the original woodwork has apparently rotted (Figure 12). Centrally a stairway of five steps gives access to the upper storey. The brickwork of the structure is of red textured bricks, arranged with horizontal stepped detailing. The first floor comprises a colonnade of Doric columns carried on square dies over a stepped plinth. Above this is a simple plain frieze below a square cornice with plain attic parapet in brick. Between the columns is a low wall with inset brick panels topped by a moulded coping. The copings, as with the columns, frieze, cornice, dies and plinth, are all cast concrete. These have all been painted cream, but show Paton Watson's "snowflake" finish beneath the paint, with white flecks in a buff concrete.

Figure 12 South-west elevation of Building A. Scale 1x 2m

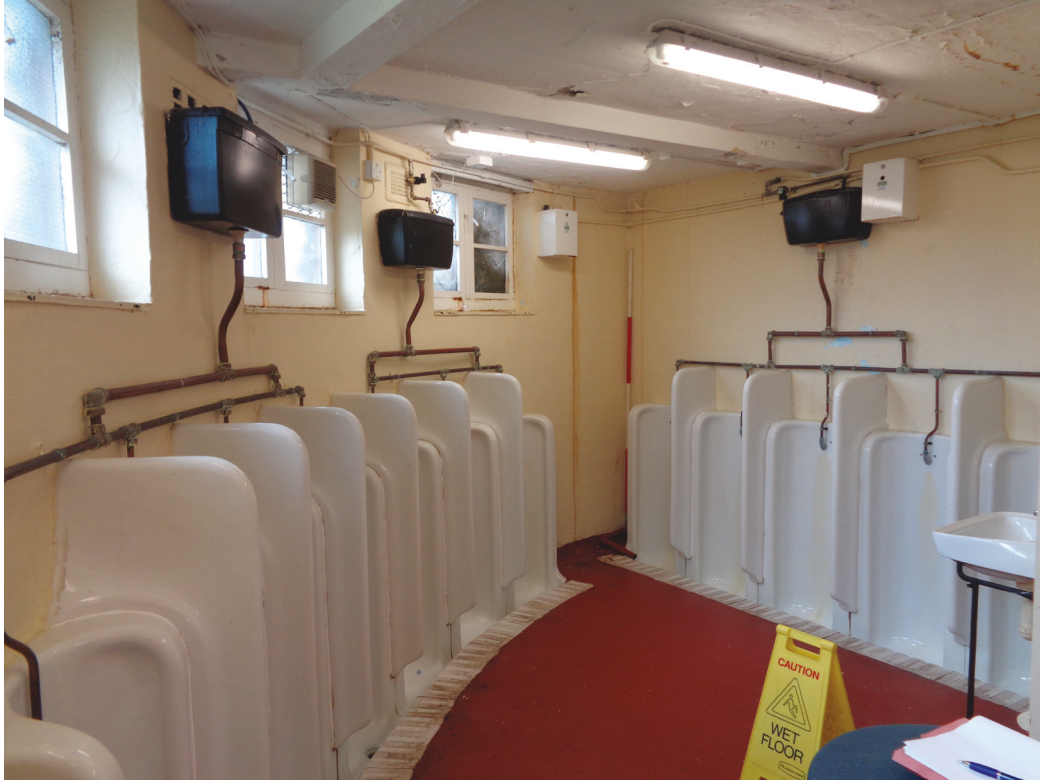
Room G1 includes an entrance at its south-eastern extent, leading to a curved corridor (Figure 14), which in turn gives access to a main space with porcelain urinals arranged against the curved south-west and straight north-west walls (Figure 13). To the east of this, and north of the entrance corridor, two internal masonry walls define an area enclosing three w.c. stalls with two hand-basins opposite (Figure 15). The stalls have two-panel doors, as original, with moulded wooden surrounds. At the north-east extent of this area a partially inserted wooden partition, incorporating the wooden partition of the eastern-most stall, separates Room G2. The door to Room G2 would appear to be a re-used stall door, as noted from the position of rebates to take the hinges of a door in the western wall of Room G2 (Figure 17). The urinals, windows and doors all appear to be original to the building, whilst the pipework, cisterns and sinks have been replaced. The ceiling and floor are of concrete and are original.

Figure 13 Room G1, detail of urinals, facing north-east. Scale 1x2m

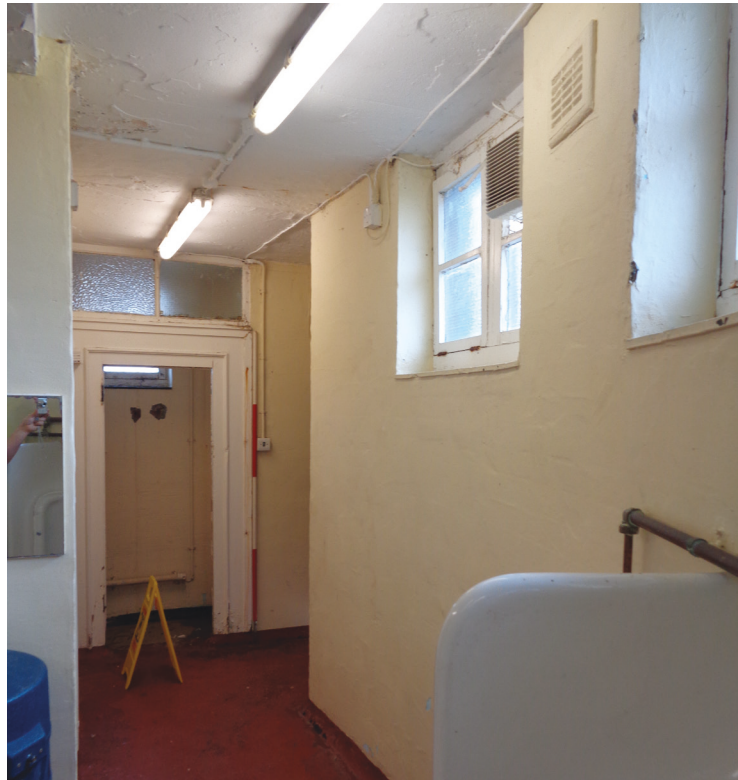
To the east of the main entrance doorway is a small cupboard, with a single window and inserted plywood shelving at its north side. The cupboard is accessed by a door with moulded wooden surround and transom light over (Figure 14)

Figure 14 Entranceway with cupboard. Room G1, facing south-east. Scale 1x2m

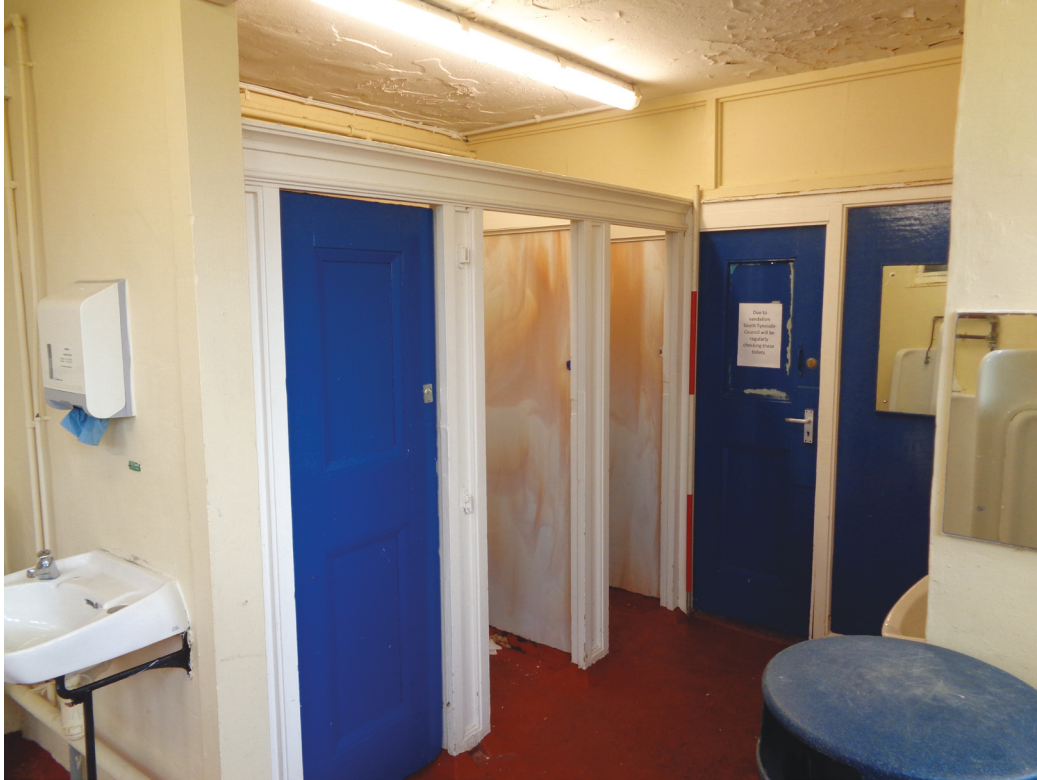
Figure 15 Stalls area with door to Room G2. Room G1, facing north-east. Scale 1x2m

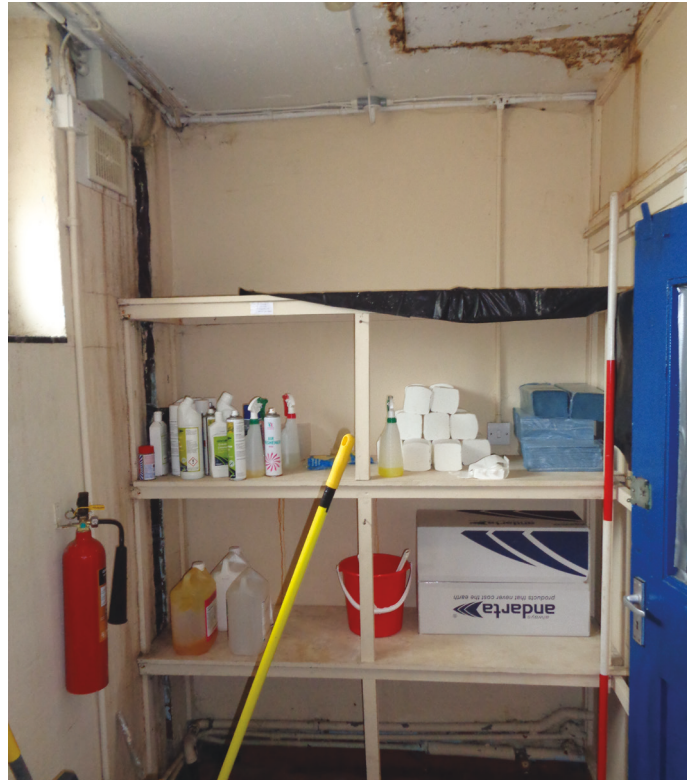
Room G2 includes an inserted entrance doorway at its western side, re-using a door from a w.c. stall, which previously hung in line with the other stalls in Room G1 (Figure 17). This suggests that this room has been inserted, by the creation of the timber partition at its western side, and the stalls in Room G1 would originally have been five in number, based on the space available. The room appears to have been inserted for the storage of cleaning supplies, and includes modern plywood shelving against its south wall (Figure 16).

Figure 16 Room G2, facing south-east. Scale 1x2m

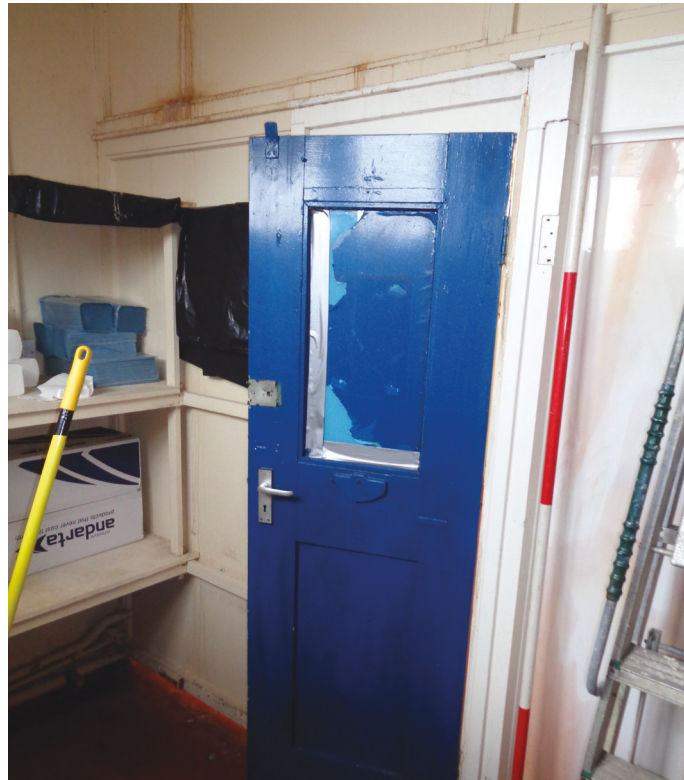
Figure 17 Room G2, facing south-west. Note location of previous hinges to right of current door. Scale 1x2m

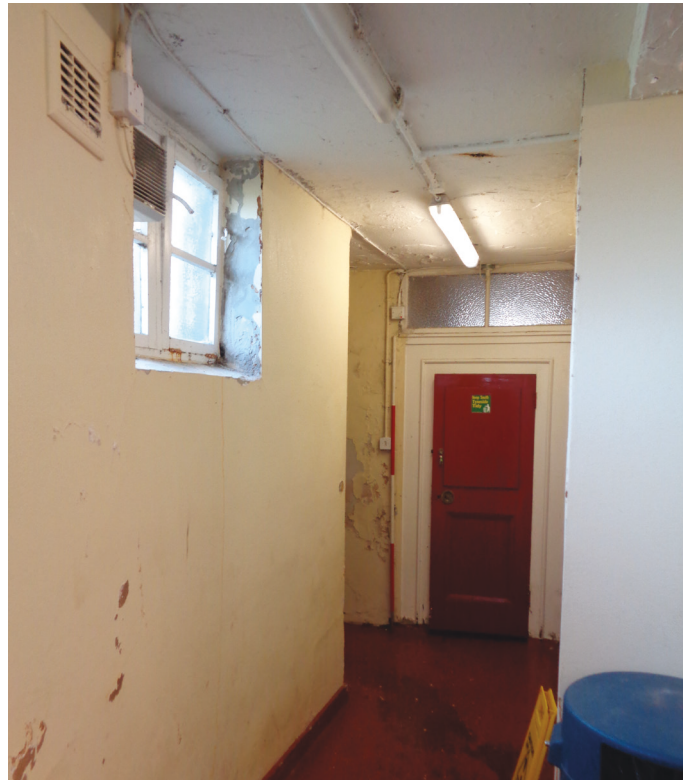
To the east of the main entrance doorway is a small cupboard, with a single window and inserted plywood shelving at its north and south sides. The cupboard is accessed by a door with moulded wooden surround and transom light over (Figure 18).

Figure 18 Room G3, facing north-east. Entranceway with cupboard. Scale 1x2m

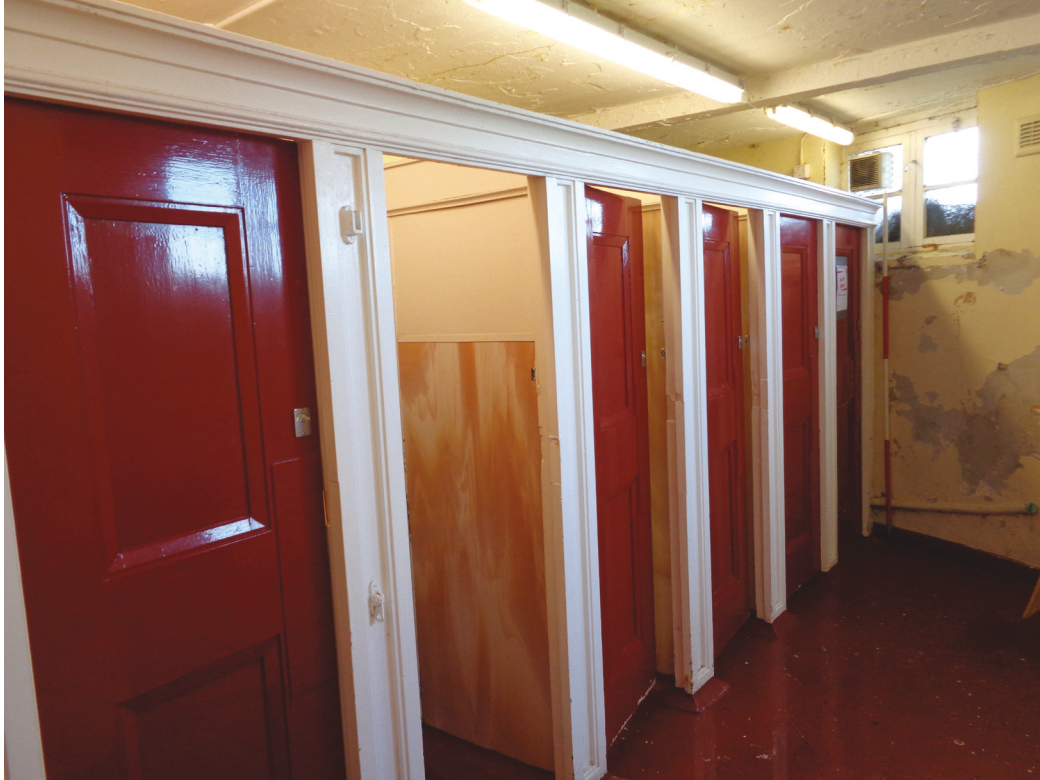
Room G3 is a perfect mirror image of Room G1 in plan, however the internal arrangement of features includes only stalls, located in a single row against the south-east wall of the room, without urinals, given its use as a female toilet. The room is accessed via an entrance at its north-eastern extent, leading to a curved corridor (Figure 18), which in turn gives access to a main space with w.c. stalls arranged against the straight south-east wall. An internal masonry wall defines an area enclosing two hand-basins opposite the stalls (Figure 19). The stalls have two-panel doors, as original, with moulded wooden surrounds. At the south-east extent of this area a partially inserted wooden partition, incorporating the wooden partition of the eastern-most stall, separates Room G4. The door to Room G4 would appear to be a re-used stall door, as noted from the position of rebates to take the hinges of a door in the western wall of Room G4, as in Room G2 (Figure 17). The stalls, windows and doors all appear to be original to the building, whilst the pipework, cisterns and sinks have been replaced. The ceiling and floor are of concrete and are original.

Figure 19 W.C. stalls within Room G3, facing south-west. Scale 1x2m

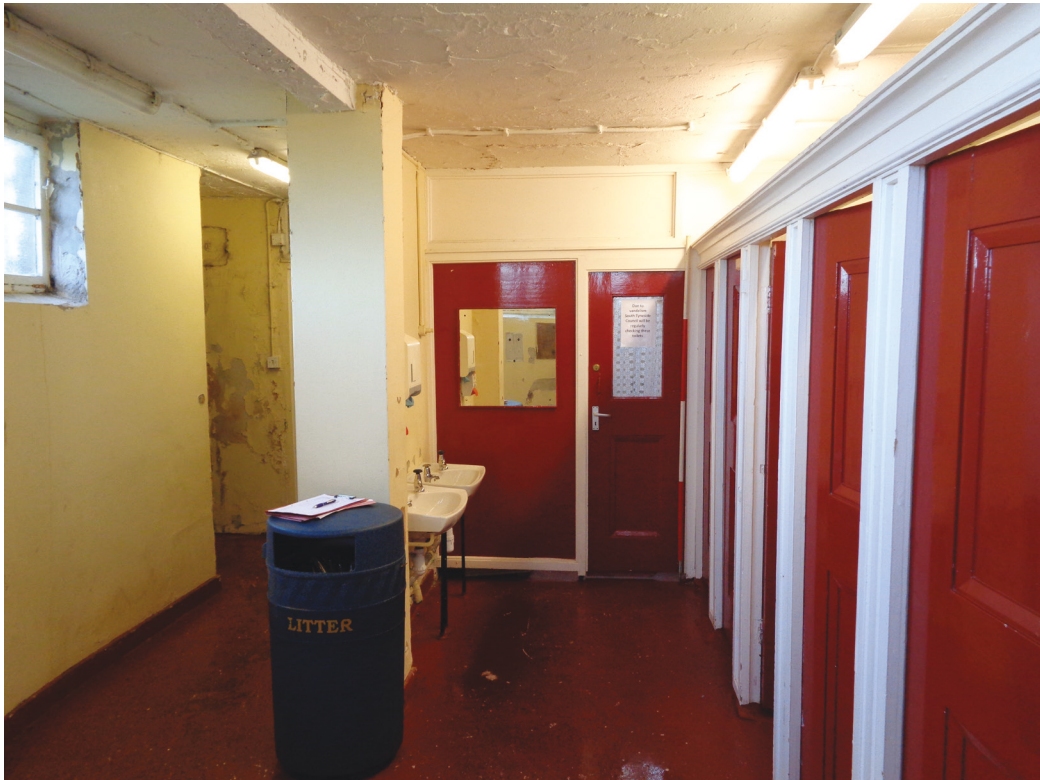
Figure 20 W.C. stalls and hand-basins within Room G3, facing north-east. Scale 1x2m

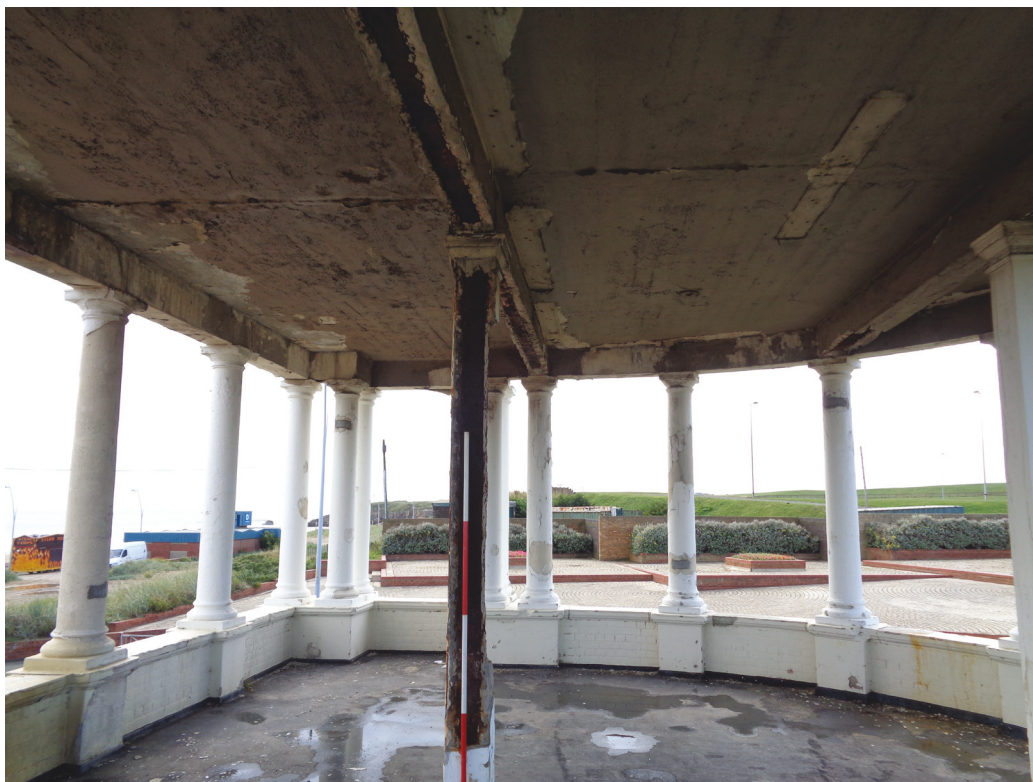
The first floor of Building A comprises a single open-sided space (Room F1), accessed from a set of steps at its south-east side. The layout of the space is symmetrical, with matching square bays with pairs of coupled columns at each rear corner and two central square columns aligned on its central east-west axis (Figures 22 and 23). There is little evidence of the previous partitions once present within the space, suggesting the floor has been resurfaced at least. The roof of the building can be seen to be shuttered concrete and the surrounding columns are painted cream. On the ceiling the building appears to have been latterly fitted with strip lighting, which has been subsequently removed (Figure 22).

Figure 22 Room F1, facing south. Scale 1x2m

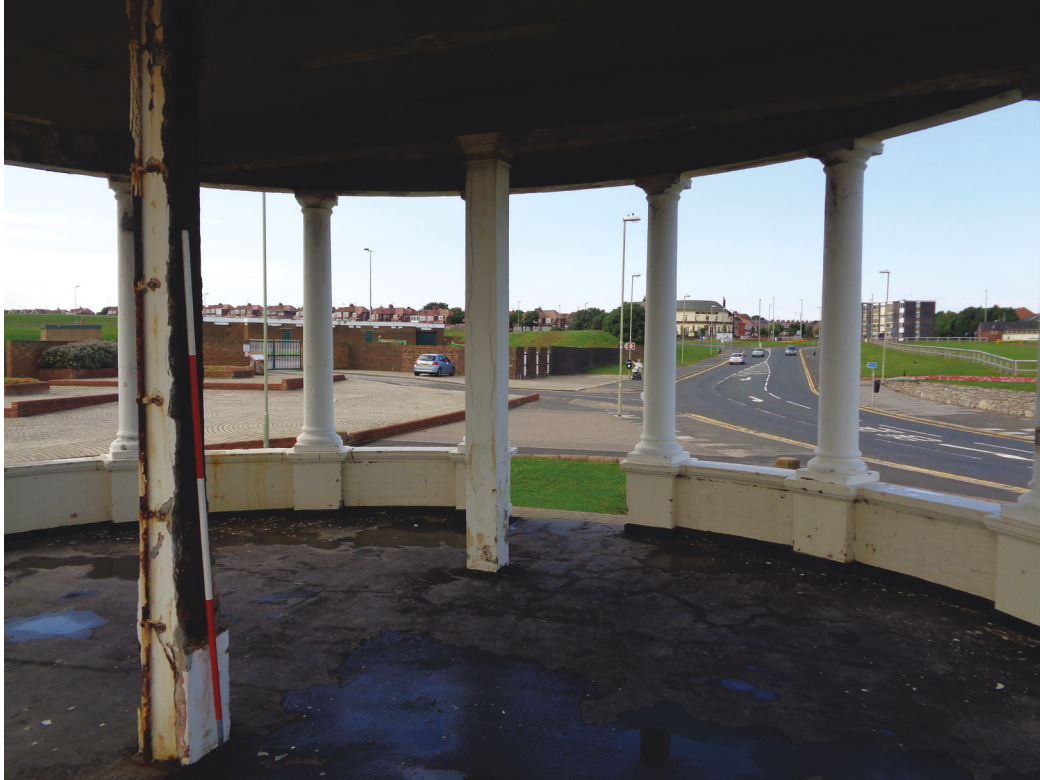
Figure 23 Room F1, facing south-west. Scale 1x2m
