East Kilns, Rosedale, North Yorkshire

Report on an Archaeological Watching Brief

Prepared for:	Tom Mutton This Exploited Land of Iron Programme Manager North York Moors National Park Authority The Old Vicarage Bondgate Helmsley York YO62 5BP
Prepared by:	Chris Scott BA (Hons), MA, MCIfA Solstice Heritage LLP Crabtree Hall Little Holtby Northallerton North Yorkshire DL7 9LN
Checked by:	Jim Brightman BA (Hons), MLitt, MCIfA
Set by:	Tiffany Snowden BA (Hons), ACIfA
Project Reference:	SOL1920-78
Document Reference:	DOC1920-61
Dates of Fieldwork:	September 2019
Date of Document:	September 2019
Document Version:	1.0

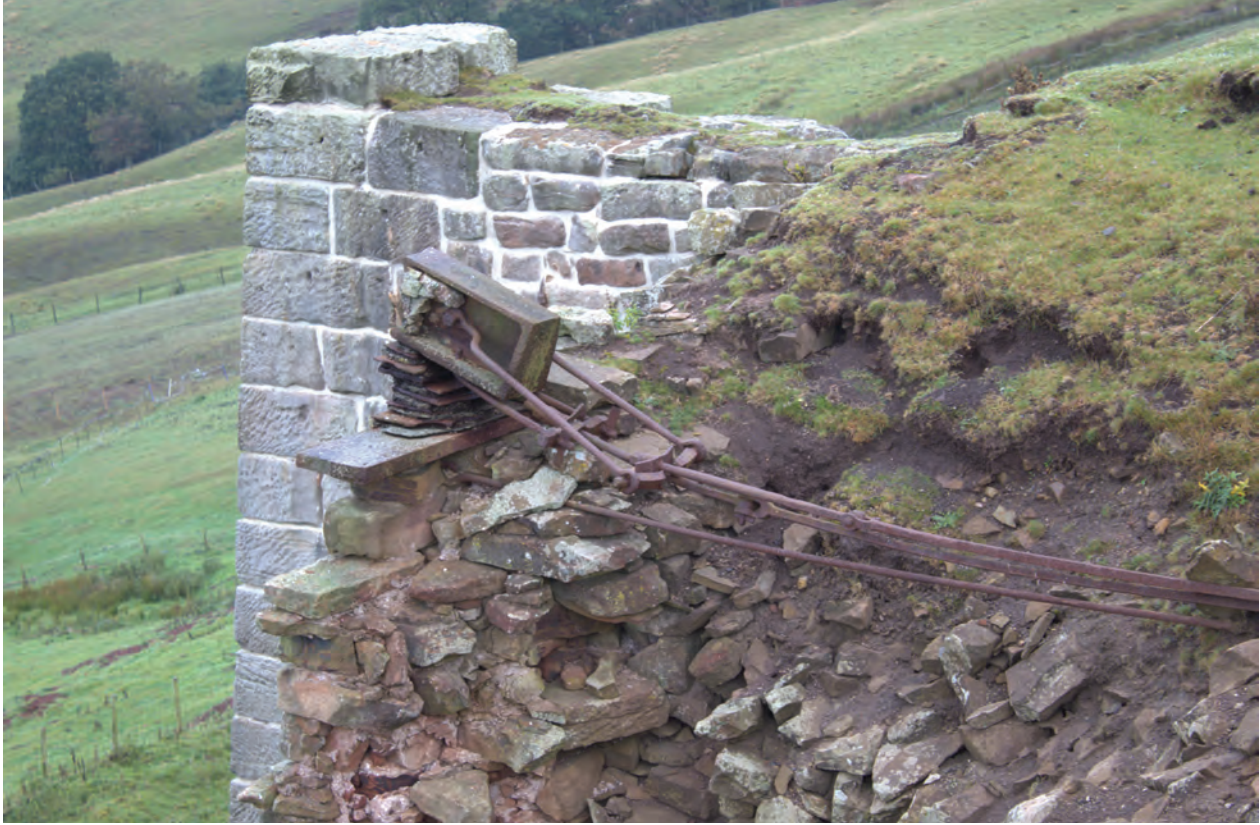
Figure 3 Location and arrangement of tie beam structure at south side of pier, prior to commencement of work, looking north-west. No scale

At the outset of the work, an original iron tie beam was present, sitting on top of an iron bearer at the upper extent of the masonry rear wall of the kilns at this location. The iron beam had been historically cut away or broken in line with the wall face and, presumably at the same time, had been raised up from its flat iron bearer to sit on a stack of shims apparently made of small irregular fragments of wrought iron plate (Figure 3). It seems most likely that this stack of shims most likely represented small sections of the former iron platework originally used to construct the kilns as it seems unlikely that such ironwork would have been imported to the site after the ironwork structures were scrapped following their abandonment (Historic England 2019). Below the iron tie beam, another wrought iron, round-section shaft was present which ran from the ground at the rear of the kiln into the masonry of the wall. It is presumed this represents a wall tie, which would have connected to a retaining plate on the front face of the rear wall of the kiln. Such ties are present elsewhere across the structure. Before work commenced it was also possible to observe the arrangement of connecting rods to the rear of the principal tie beam. It could be seen that the wrought iron rods which presumably anchor the tie beam back into the hillside behind the kiln had bolts and wedges allowing for some horizontal adjustment of the beam when in place. These connecting rods were also jointed to allow for movement vertically and horizontally (Figure 4). Presumably these features were intended to allow for expansion and contraction caused by heating and cooling when the kilns were in use. Given that this apparatus would have sat behind the masonry rear wall of the kilns when complete, the rods must have been accessed from above to allow for adjustments to be made, presumably sitting in a covered compartment. On the front face of the rear wall of the kiln, a number of cranked wrought iron ties were noted protruding from the masonry (Figure 5). These clearly illustrate the former presence of a firebrick lining which has been subsequently lost and are variously present across the rest of the monument.

The works commenced by winching the tie beam off its bearer and shims until it fell away to the south side of the masonry. This allowed the large iron bearer to be removed and the masonry of the rear wall to be reduced slowly from the top (Figure 7). A maximum length of c. 1 m of masonry was removed at the southern extent of this wall stub in order to remove clearly loose and dangerous stonework. The work was ceased when a relatively stable section of wall was reached which could be safely consolidated (Figure 8). No structures or included features were encountered within the rear wall during this work and the structure of the projecting pier was unaffected. It was noted that the rear wall of the kilns consisted of coursed, squared masonry to the front and rear faces of the wall, with a rubble core. This wall batters out towards its base and retains a large volume of unconsolidated loose fill behind it. This fill is formed of silty, ashy soil and common, large, angular fragments of sandstone, possibly construction debris (Figure 8).

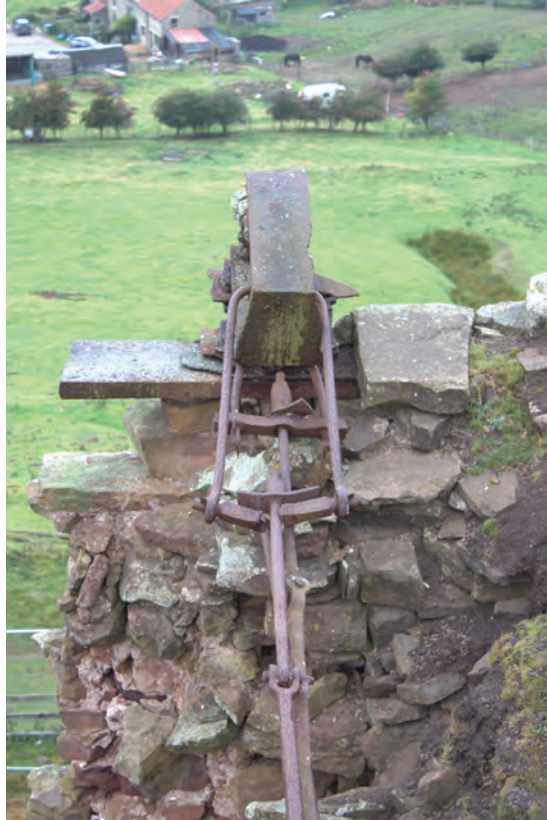
Figure 4 Arrangement of adjusting bolts and articulating joints to rear of tie beam at south side of Pier 3, looking west. No scale

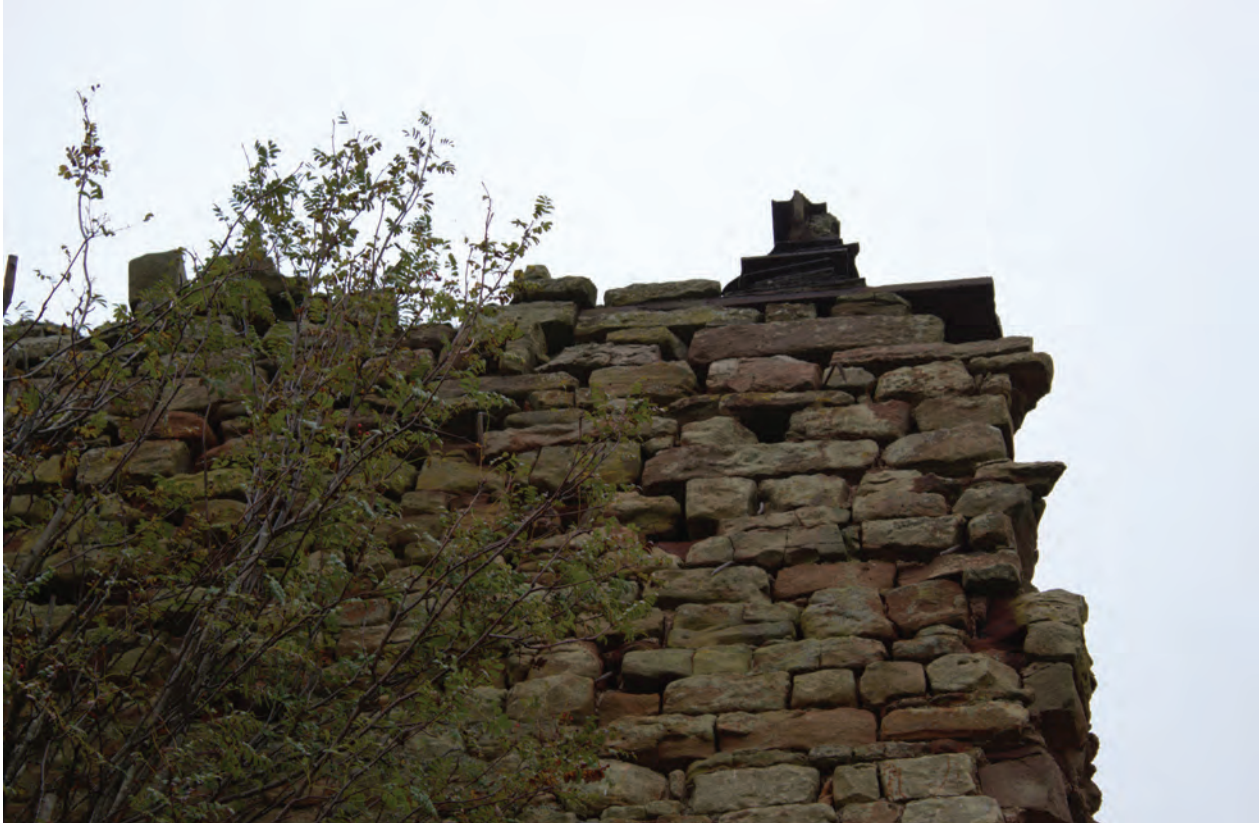
Figure 5 Detail of upper section of rear kiln wall prior to work commencing. Note thin wrought iron ties protruding from wall face at upper right. No scale

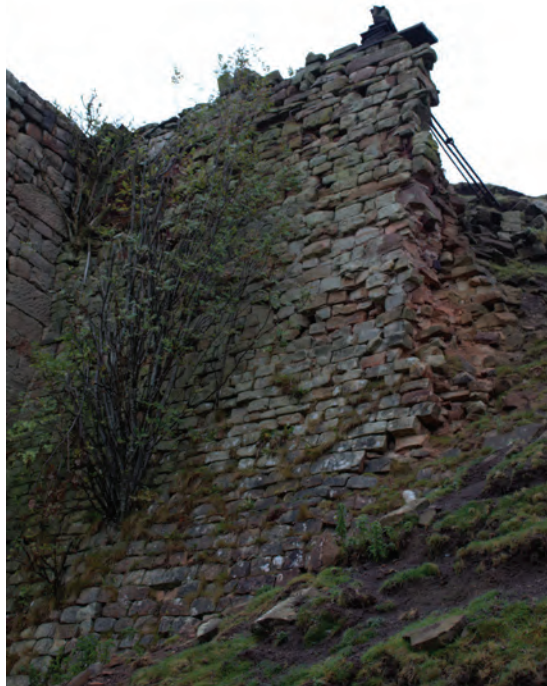
Figure 6 Area of work at south side of Pier 3 prior to commencement of work, looking north east. No scale

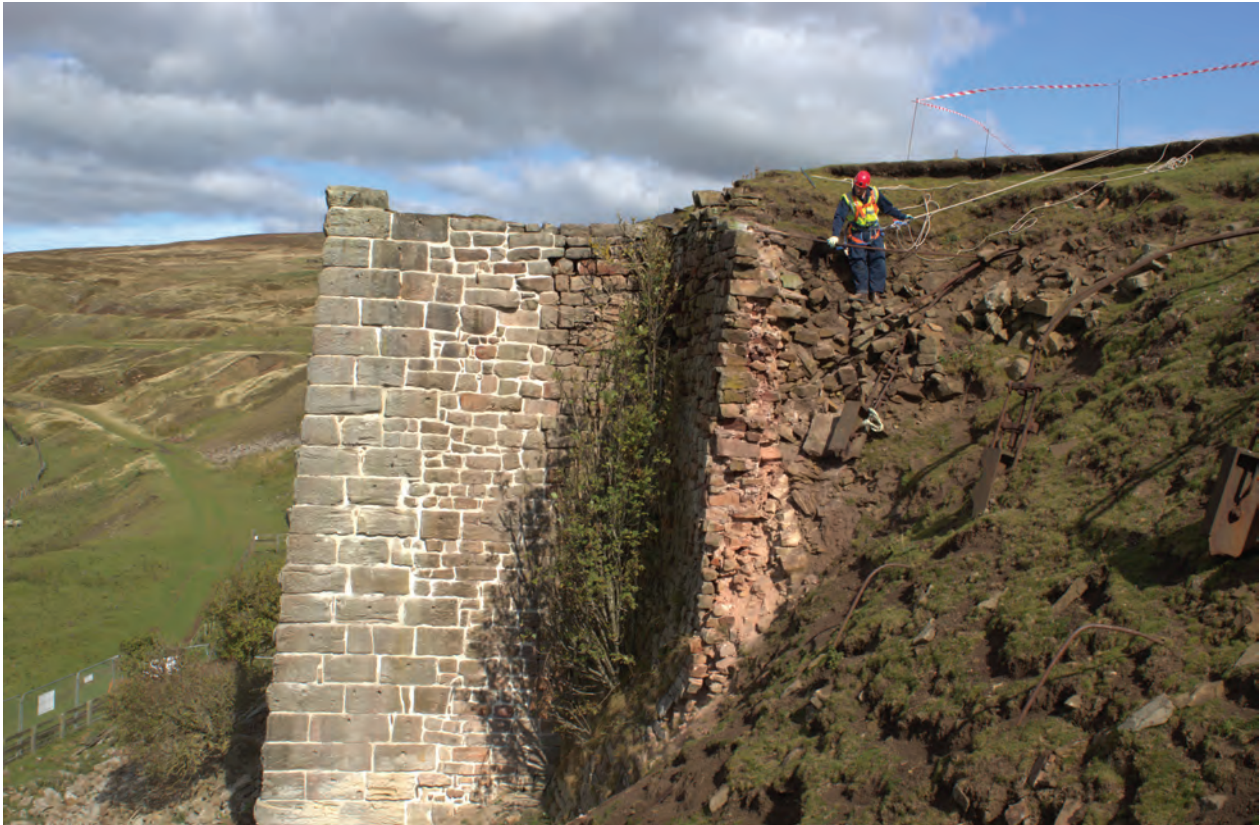
Figure 7 Takedown works being carried out to the south side of Pier 3, looking north

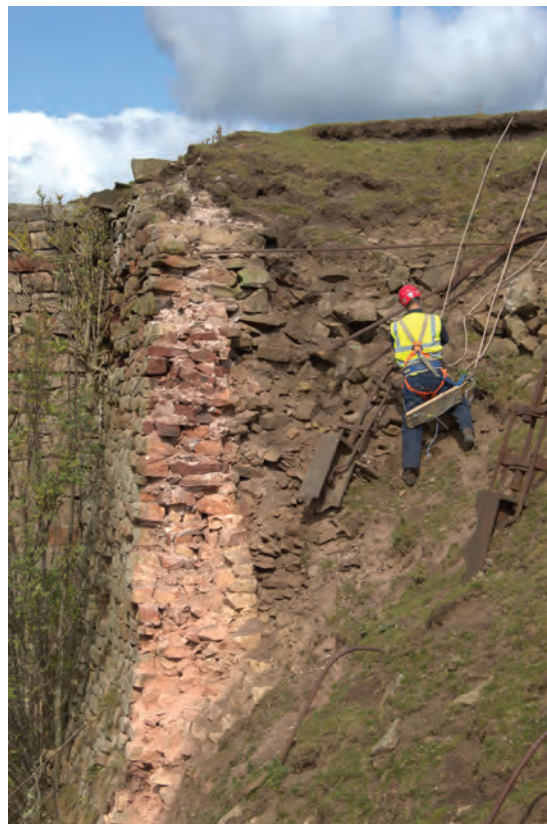
Figure 8 Work area at south side of Pier 3 at completion of the works, looking north

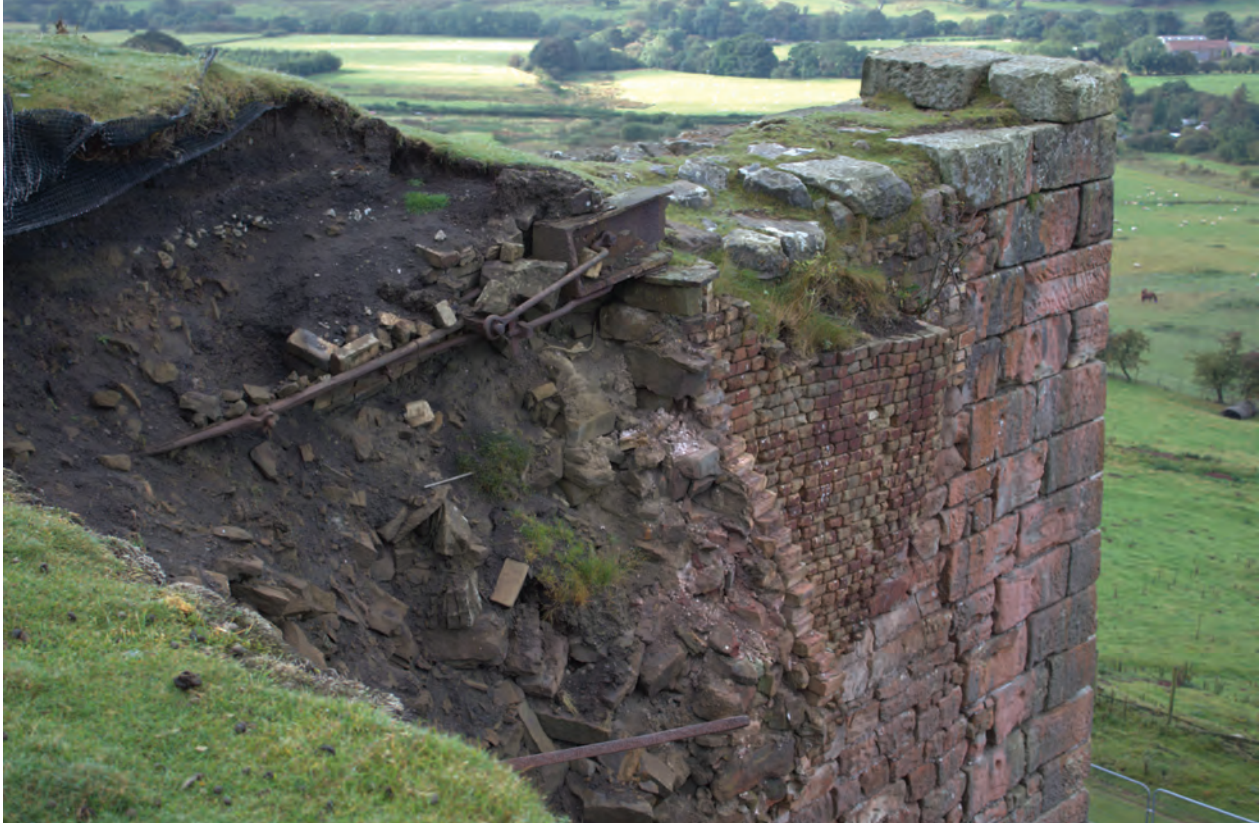
Figure 9 Area of work to north of Pier 3, prior to commencement of works, looking south-west. No scale

At the outset of the work, an original iron tie beam was present, sitting on top of an iron bearer at the upper extent of the masonry rear wall of the kilns at this location. The iron beam had been historically cut away or broken in line with the wall face (Figure 9). Before work commenced it was also possible to observe the arrangement of connecting rods to the rear of the principal tie beam. It could be seen that the wrought iron rods which presumably anchor the tie beam back into the hillside behind the kiln had bolts and wedges allowing for some horizontal adjustment of the beam when in place. These connecting rods were also jointed to allow for movement vertically and horizontally. Presumably these features were intended to allow for expansion and contraction caused by heating and cooling when the kilns were in use. Given that this apparatus would have sat behind the masonry rear wall of the kilns when complete, the rods must have been accessed from above to allow for adjustments to be made, presumably sitting in a covered compartment. Additional evidence for the presence of a compartment was present at this side of Pier 3, which had not been present to the south side. Prior to work commencing, it was noted that, to the rear of the rear retaining wall of the kilns, the tie beam arrangement was bounded by surviving brickwork executed in cream firebrick, possibly laid in English Garden Wall bond (Figure 10). This firebrick construction was presumably part of the structure of a compartment intended to allow for the heating and cooling of the tie beam arrangement, given the proximity to the heat of the kilns. All of the bricks within this construction were cream firebrick and stamped 'C & M'. Given that these bricks were buried to the rear of the rear wall of the kilns, it seems most likely that they were original to the construction of the kilns themselves.

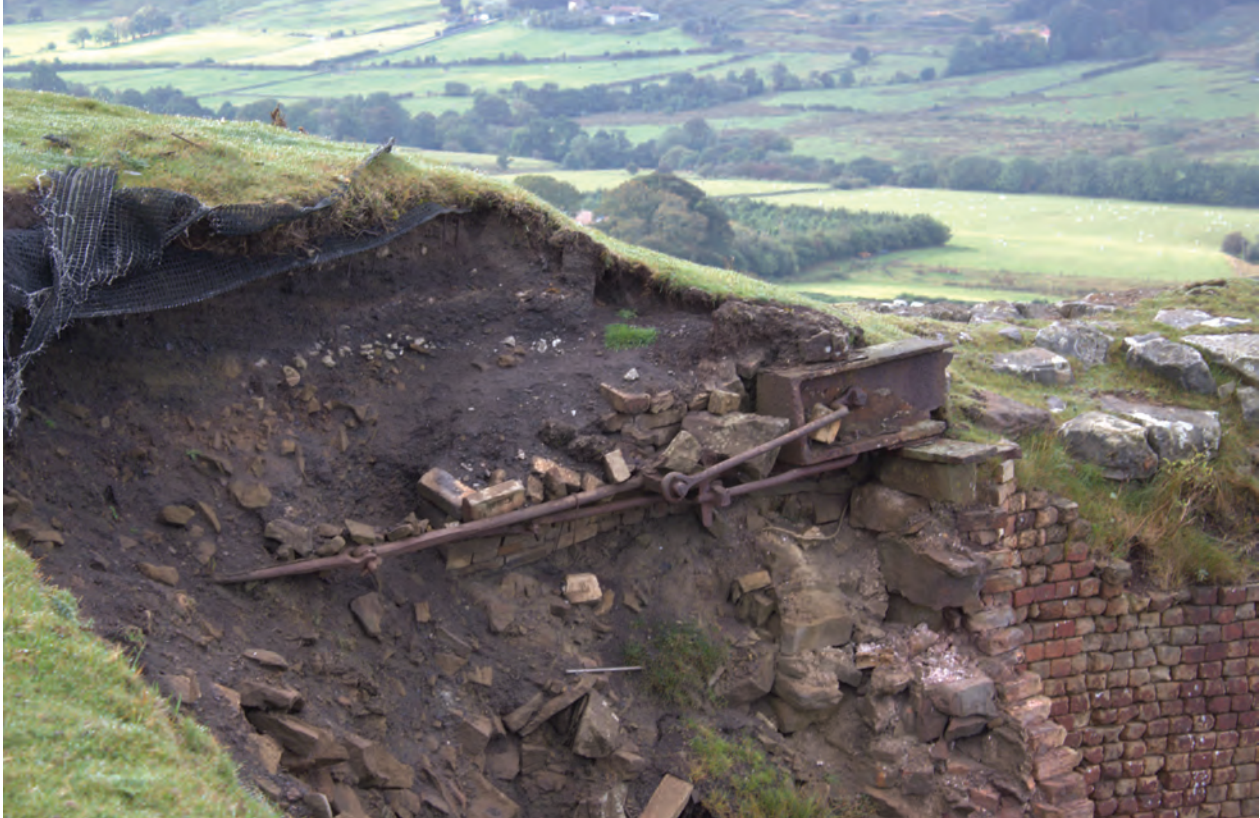
Figure 10 Detail shot of tie beam surrounded by firebrick brickwork behind the rear kiln wall, looking south-west. No scale

The works commenced by levering the tie beam off its bearer until it fell away to the north side of the masonry. This allowed the large iron bearer to be removed and the masonry of the rear wall to be reduced slowly from the top (Figure 11). A maximum length of c. 0.5 m of masonry was removed at the southern extent of this wall stub in order to remove clearly loose and dangerous stonework. Loose fill and the firebrick brickwork surrounding the iron tie beam was also removed from behind the rear wall and a section of the surviving firebrick skin which was adhering to the north side of the projecting pier was also removed. The work was ceased when a relatively stable section of wall was reached which could be safely consolidated (Figure 12). No structures or included features were encountered within the rear wall during this work and the structure of the projecting pier was unaffected. It was noted that the rear wall of the kilns consisted of coursed, squared masonry to the front and rear faces of the wall, with a rubble core. This wall batters out towards its base and retains a large volume of unconsolidated loose fill behind it. This fill is formed of silty, ashy soil and common, large, angular fragments of sandstone, possibly construction debris. It was also noted that, as more of the firebrick lining was removed from the north side of Pier 3, more of an area of irregular, patched fabric was exposed behind it. This 'patch' appears to consist of irregularly laid firebrick, some of which appears to have been re-used, and some roughly dressed blocks of sandstone (Figure 12). It seems possible that this incongruous area of fabric may represent a hastily repaired collapse or partial repair during the life of the structure, and it seems possible that the brickwork contained within it may contain useful evidence on the historic working life of the wider structure. After their removal, some of the firebricks from the lining were examined as part of the watching brief, and found to all be stamped 'EH BK'.

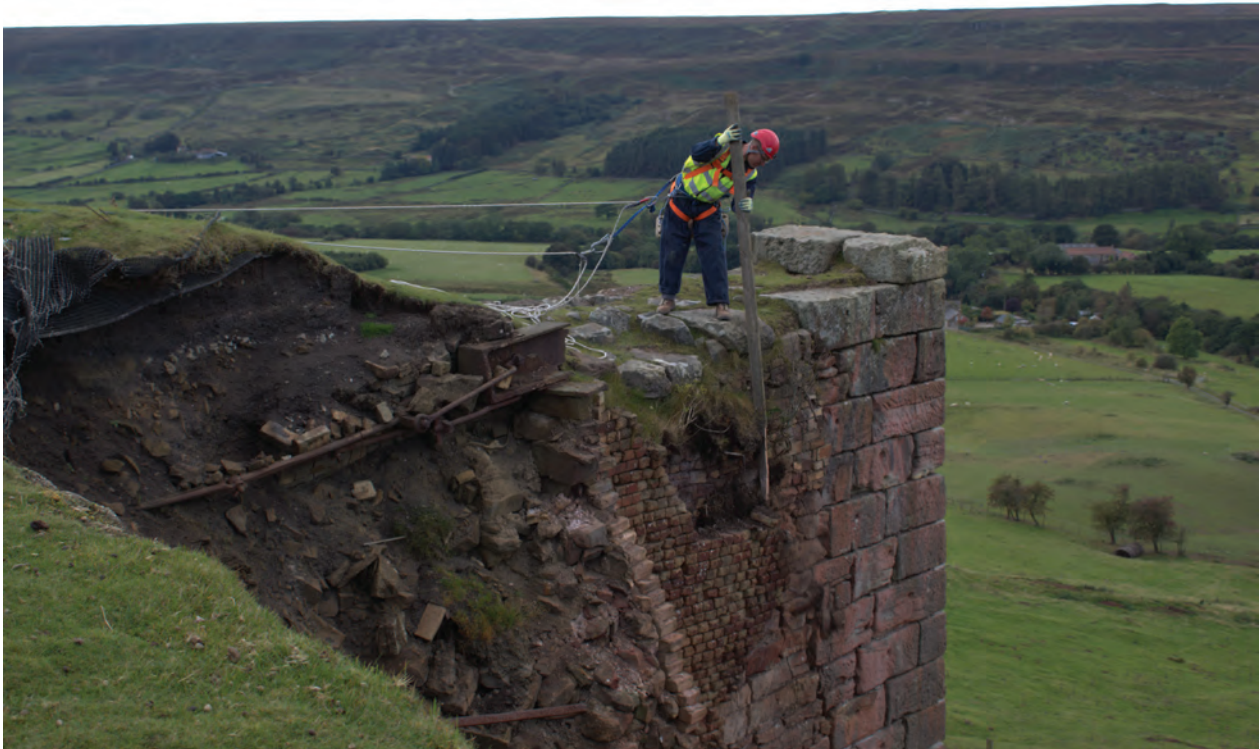
Figure 11 Work underway on the north side of Pier 3, looking south-west

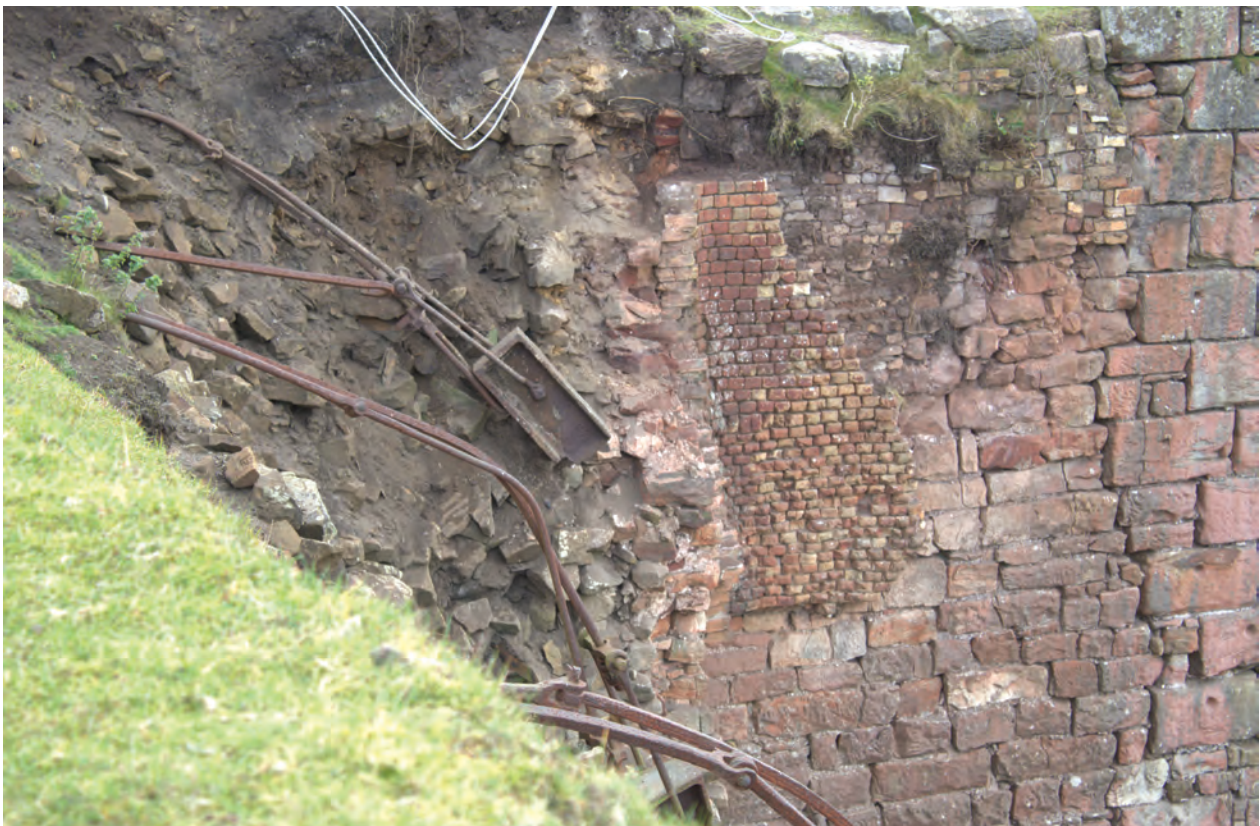
Figure 12 Area of work at north side of Pier 3 following completion of the works. No scale
