West Middleton Farm  
Hutton Magna, County Durham

Historic Building Recording  
Listed Building Consent: DM/21/00289/LB

## Historic Building Recording

Listed Building Consent: DM/21/00289/LB

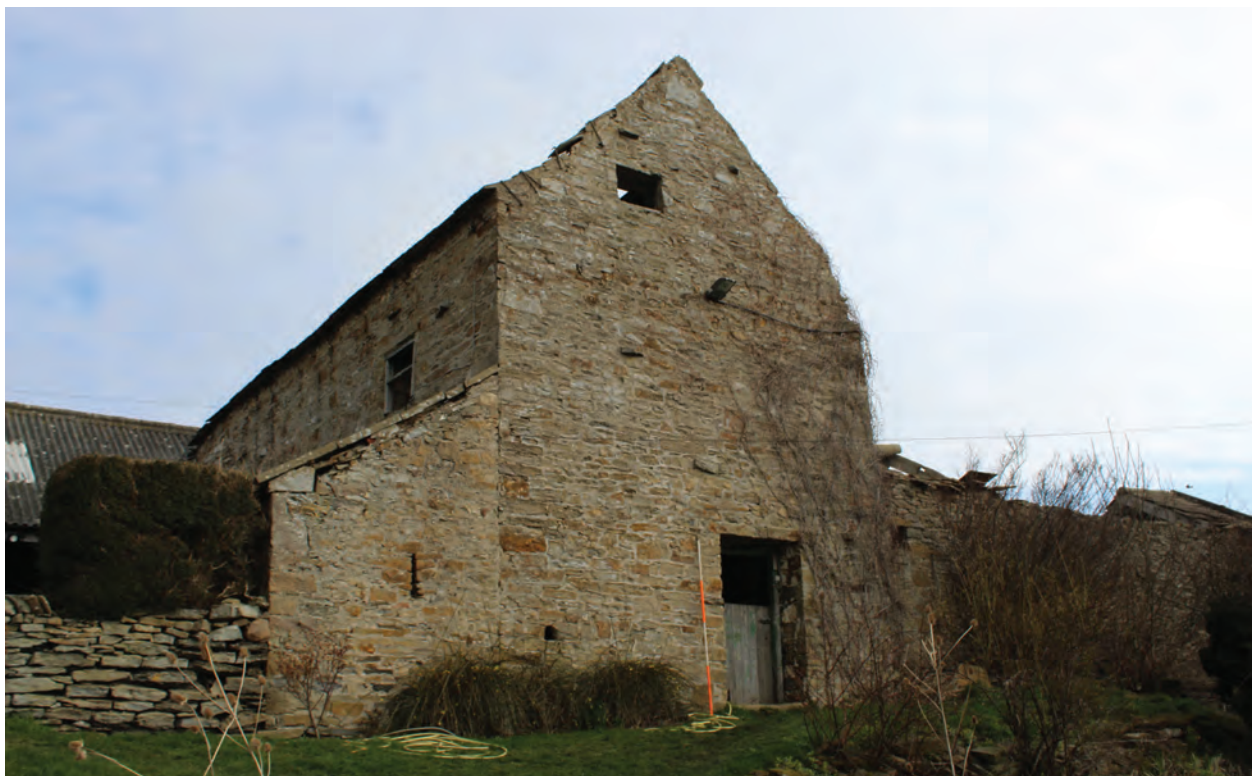
The external south-facing elevation of the principal barn range consists of a gable end elevation (Figure 2). This two-storey elevation is constructed of roughly coursed, rubble sandstone masonry and includes a wide original doorway with drawbar socket, stone lintel and threshold at the centre of the ground floor. Raised above the ground floor, but not fully to the height of the barn's first floor, is a blocked doorway, located to the west of the existing central door and presumably accessed when in use by a wooden external stair which has since been removed. Above the blocked door, within the gable, is a small original window. At the western side of the barn gable is a latterly attached lean-to, also in stone. The join between the two phases of work is marked by a clear construction break. The lean-to includes rough, tooled quoining and a stone water table, along with an original breather at its centre, suggesting the interior space was created for livestock use. The barn includes another latterly attached, single-storey farm building at its eastern side, which was not included within the scope of this study.

Figure 2 South-facing elevation of barn, facing north-east. Scale 1x2 m

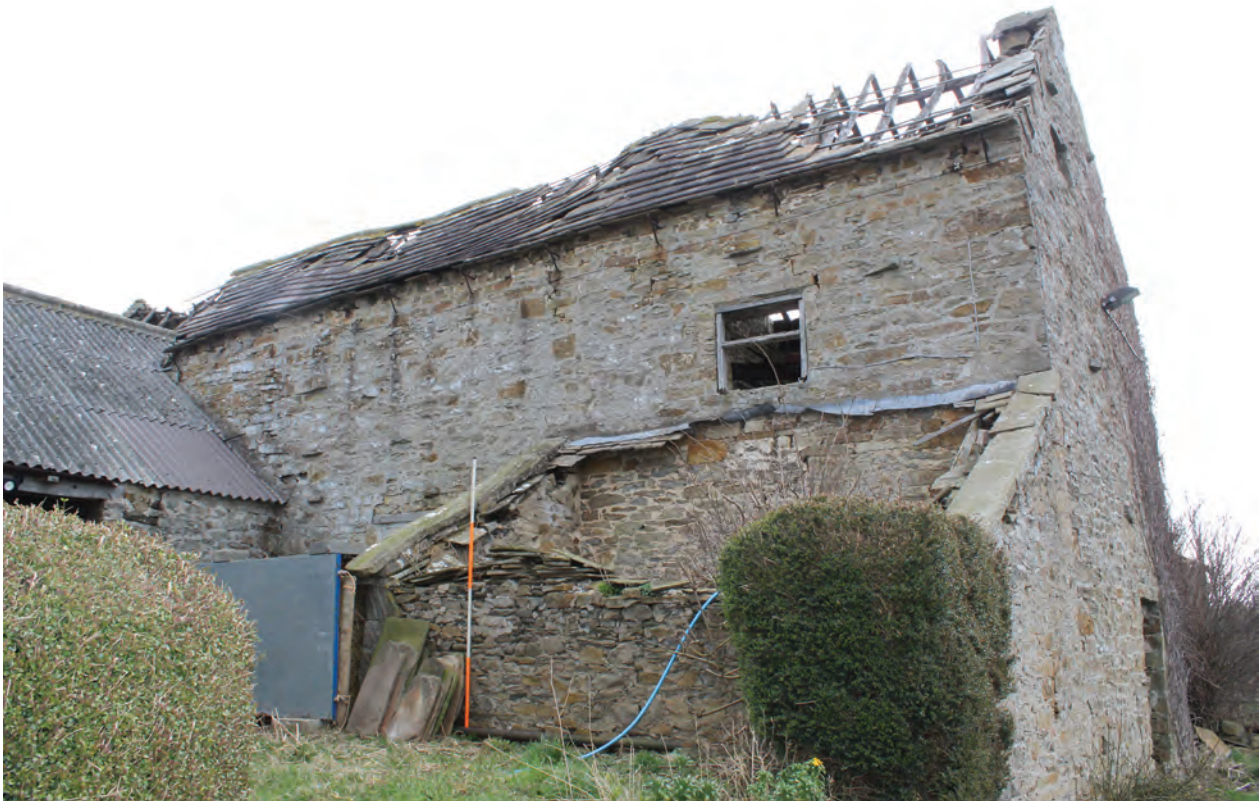
inserted (Figure 3). Beneath this inserted window is the stone slated lean-to roof, which includes stone water tables at either end. The western elevation of the lean-to is built of roughly coursed stone rubble walling and is featureless. The north elevation of the lean-to includes an original window with a timber lintel and timber casement frame. To the north side of the lean-to is an inserted window, which has been made from the smaller opening of an original breather through the insertion of a timber lintel and the removal of masonry to the south side of the breather to increase the size of the opening (Figure 4). Beyond the window, further to the north and just before the south facing elevation of the wheelhouse, a vertical construction break is visible, illustrating the position of the original reveal of a wide doorway at the centre of the main barn range at this side. As with the central cart entry within the east elevation of the barn, this doorway has been reduced in size by the addition of inserted infill stonework at its southern side. The southern wall of the wheelhouse has then, latterly, been constructed against this blocking forming a clear constructional sequence. The southern wall of the wheelhouse itself includes a central cart entry, which may have been widened at its eastern side from an earlier, original, narrower opening, although this is uncertain (Figure 5). Over the opening is a large timber lintel, which seems to be a reused structural timber. At the eastern end of this elevation is an original door opening with a stone lintel which has been latterly blocked. At the western end of the elevation, a set of original tooled quoins are present.

Figure 3 Southern extent of west-facing elevation, facing north-east. Scale 1x2 m

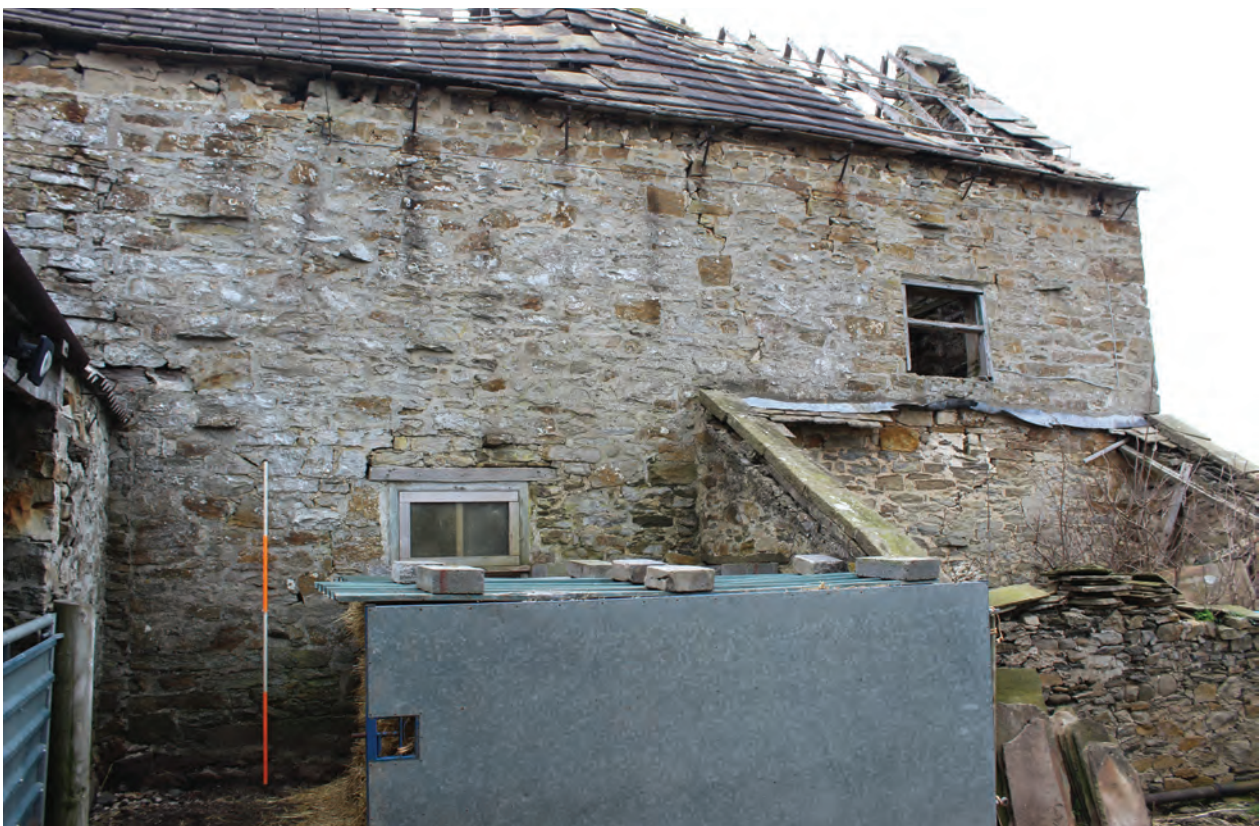
Figure 4 Central section of west-facing elevation, facing south-east. Scale 1x2 m

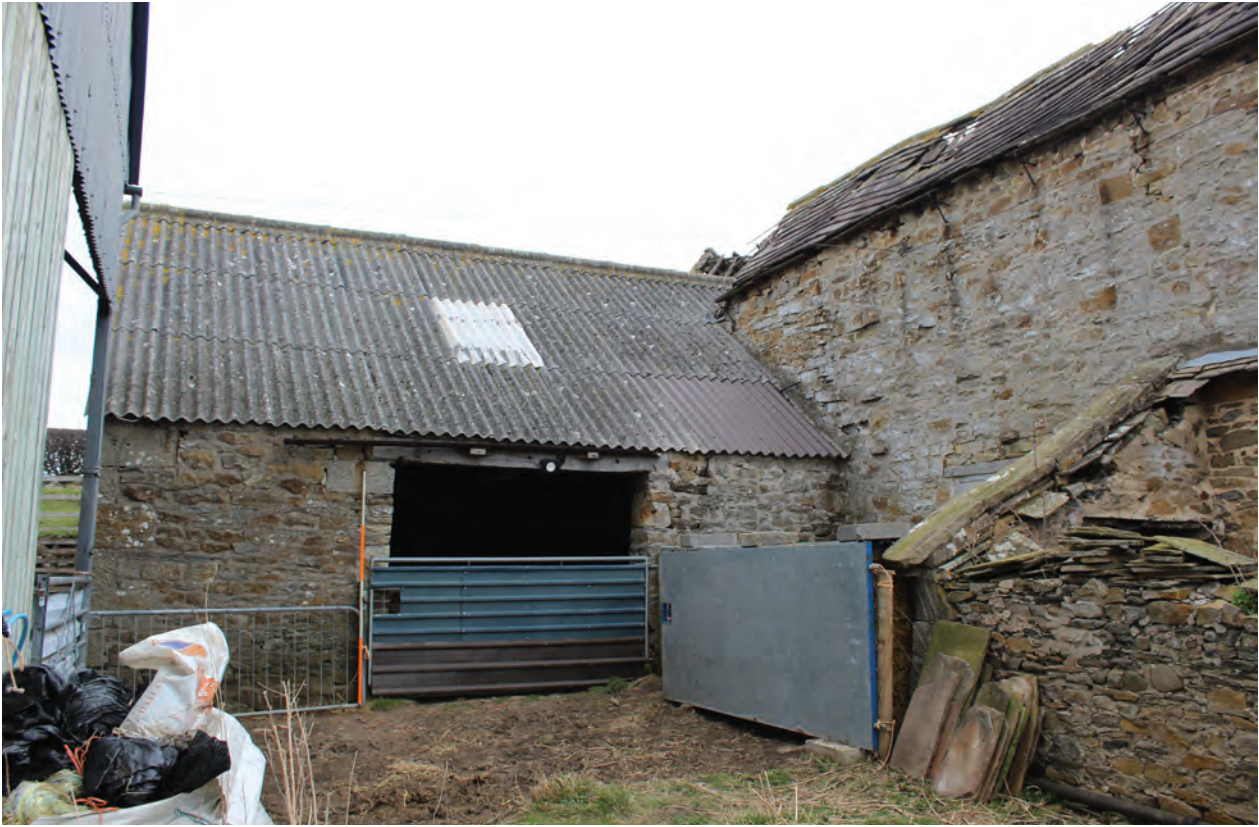
Figure 5 South elevation of wheelhouse, facing north-east. Scale 1x2 m

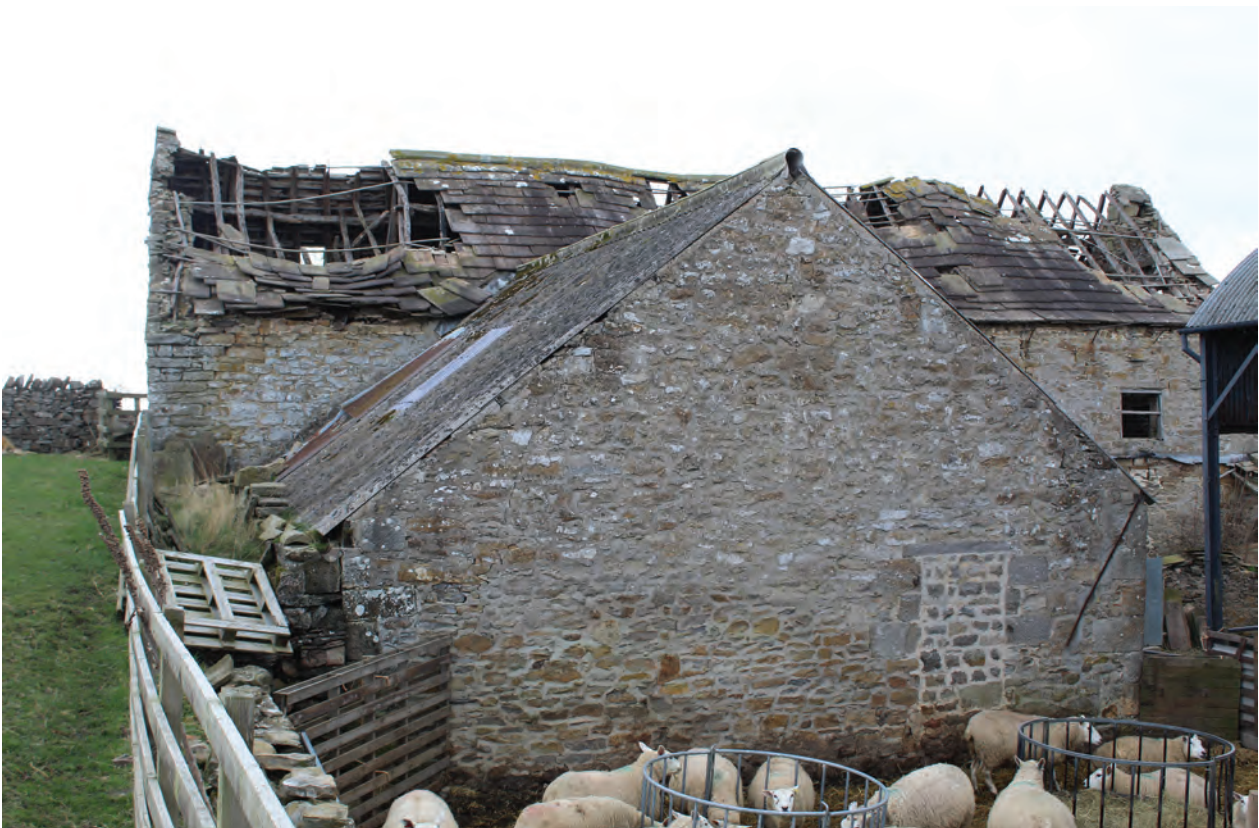
The gabled west facing elevation of the wheelhouse includes a further blocked doorway at its southern extent (Figure 6). The doorway itself may have been made from an original window, as the quoins on both sides only extend halfway down its height. It is possible that this lower quoining was robbed when the doorway was blocked, although this seems highly unlikely. Surviving pintles, and the blocking itself, illustrate that this opening was in use as a doorway before being blocked, but the original quoining clearly suggests it began life as a window opening. To the north of this opening, an area of refacing seems to be present, which is obscuring the remains of a blocked window noted internally. Given that no tooled quoins are present within the refacing, it is possible that this window was inserted before being blocked, or that its quoins were removed when this section of wall was refaced.

Figure 6 Northern extent of west-facing elevation, facing south-east. No scale

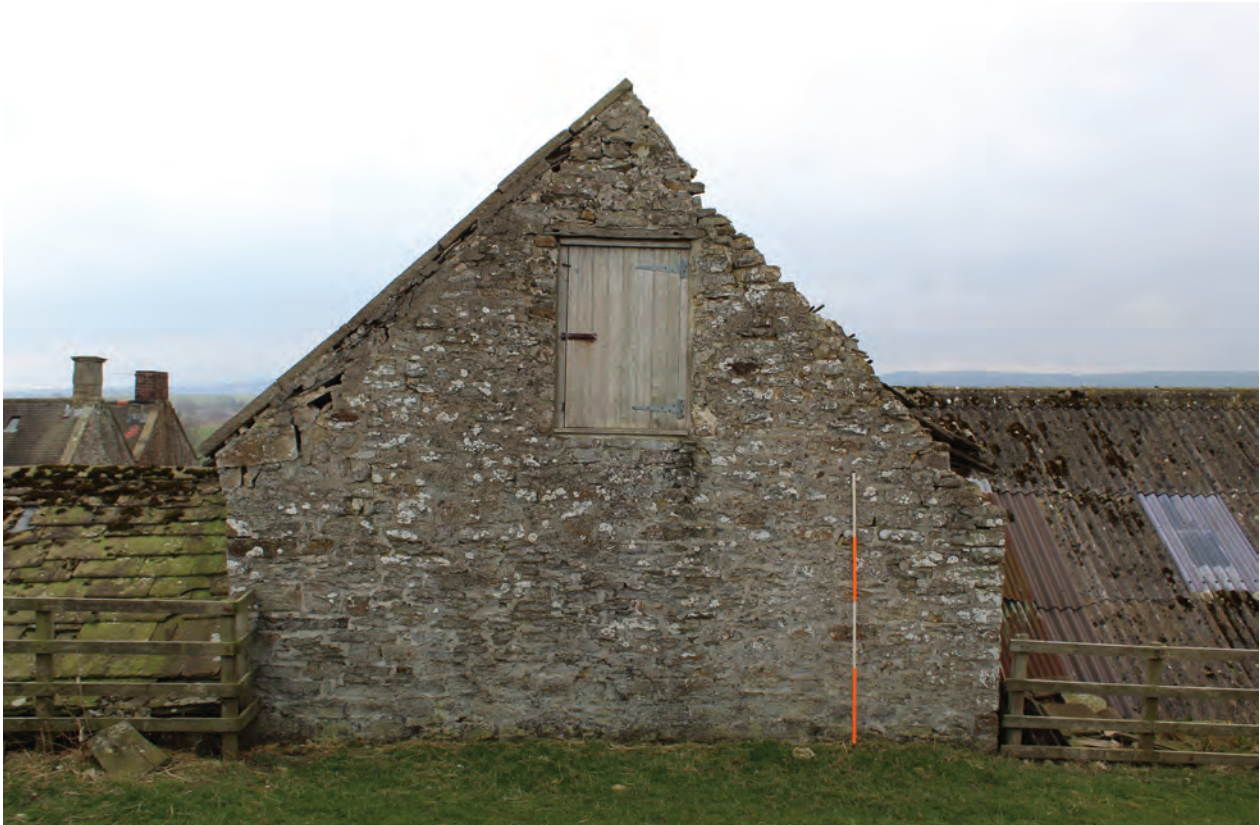
The external north-facing elevation of the principal barn range consists of a gable end elevation (Figure 7). This single-storey elevation, at the uphill end of the barn, is constructed in roughly coursed rubble stonework and includes a central, inserted forking/loading door at its centre. Above the forking door is a stone water table. No other features are present. The roof of the latterly attached gin wheelhouse is visible to the west of the barn's gable, but the sunken level of the building means that no external stonework of the wheelhouse's northern side is visible.

Figure 7 North-facing gable elevation, facing south. Scale 1x2 m

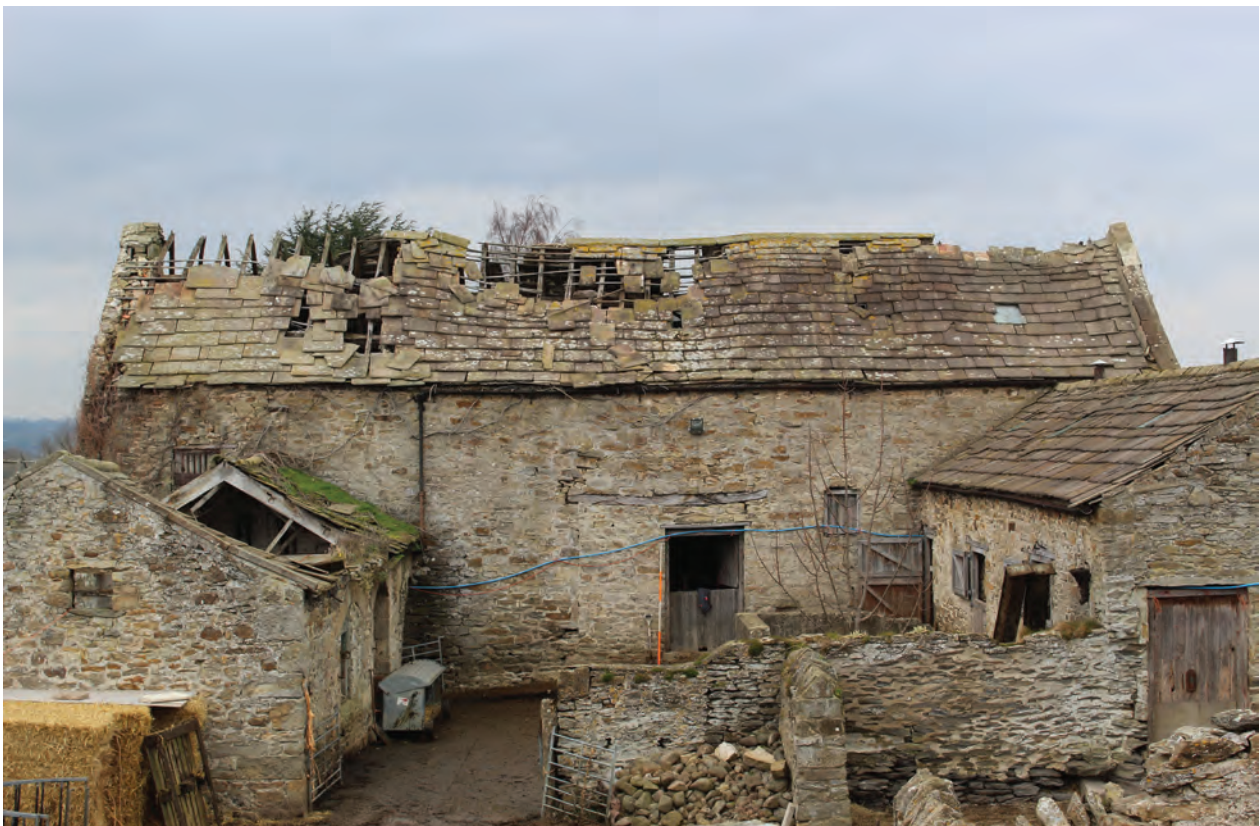
The external east facing elevation of the barn range is partially covered at its northern and southern extents by later attached outbuildings which were not part of the scope of this study (Figure 8). This side elevation is constructed in roughly coursed rubble stonework, topped with stone slates and stone ridge tiles. Centrally within the elevation is an original cart entry with a timber lintel, which may be reused in this context. The cart entry has been latterly reduced in size at its southern and upper extents to create a smaller doorway, also with a timber lintel (Figure 9). To the north of the reworked doorway is a small forking hole which has been formed from an original breather slit, its southern side being extended out to form the larger opening. At the upper extent of the southern end of the elevation is an original window with a slatted timber frame and lintel. In each of the areas covered by the two adjoining buildings is a blocked breather, with a further blocked breather present just to the south of the partially infilled cart entry. This would have given an original arrangement of a central cart entry with two breathers to the north side and one to the south, and a window at the elevation's upper southern extent.

Figure 8 East-facing elevation, facing west. Scale 1x2 m

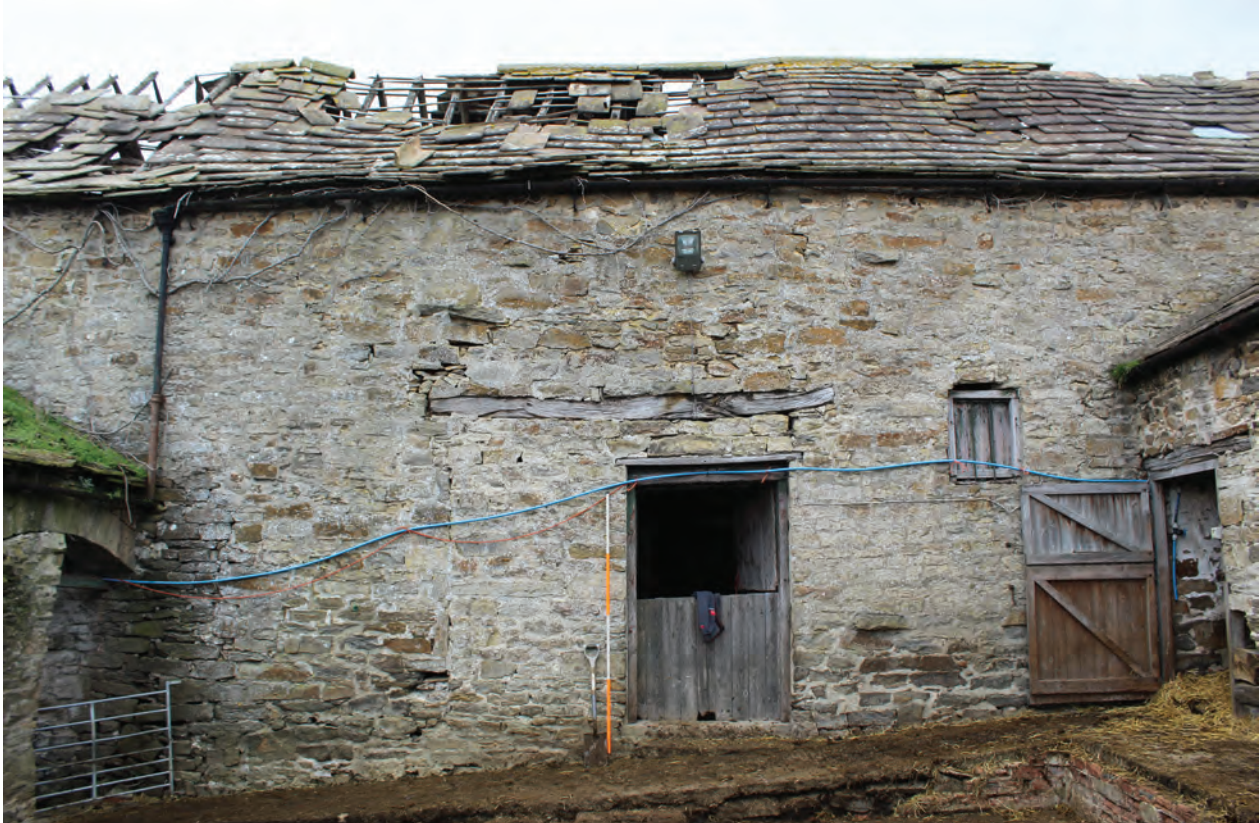
Figure 9 Detail of centre of east-facing elevation. Scale 1x2 m

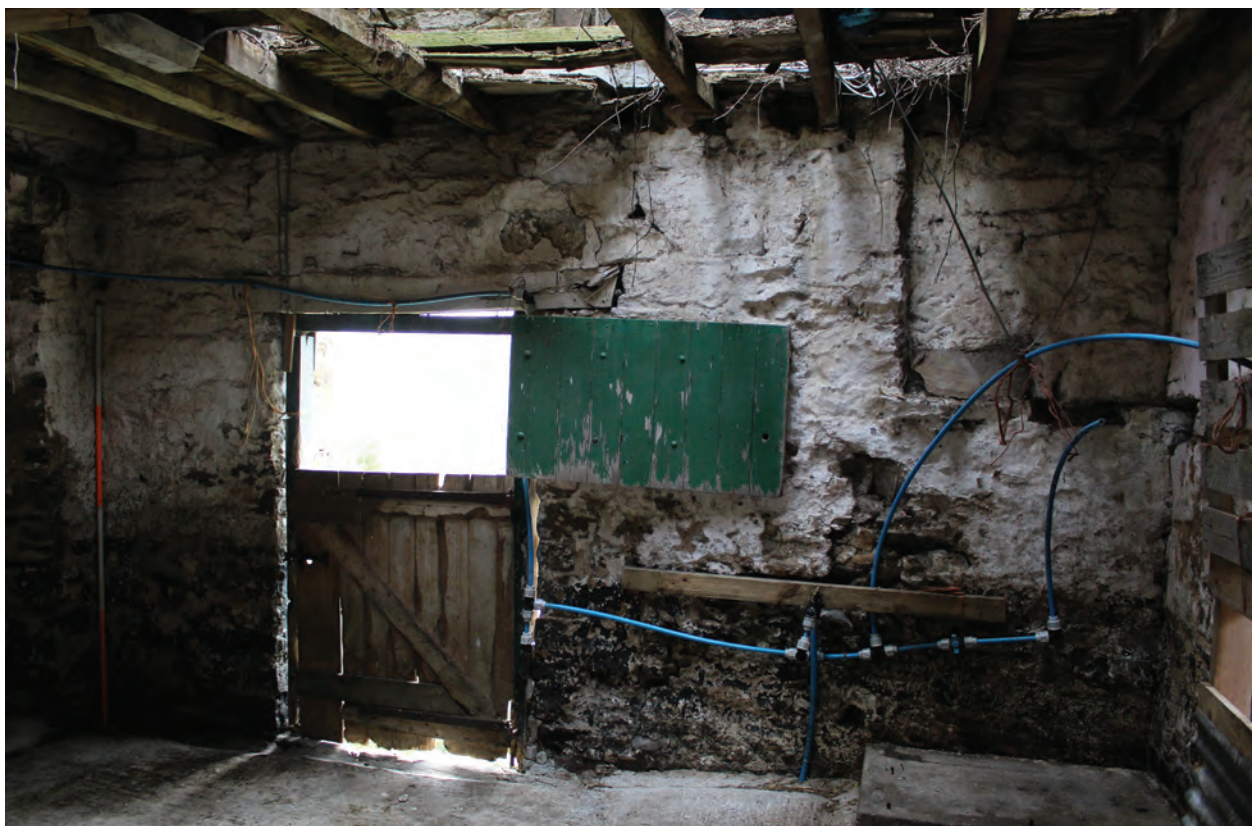
Room LG1 is located at the southern extent of the principal barn range and is accessed externally by a central doorway in its south wall. The doorway includes a timber lintel and a stable door, which is a modern replacement of an earlier door that would have been locked by an internal drawbar, and placed further forward in the reveal to clear the drawbar slot in the centre of the wall. The south wall has been whitewashed and is largely featureless aside from a recess at its upper western extent (Figure 10). The recess marks the location of a raised, blocked doorway noted externally in the building's south elevation and can be seen to straddle the existing floor level within this room (Figure 11). Examination of the central principal joist in this room shows that

Figure 10 South wall of Room LG1, facing south-east. Scale 1x2 m

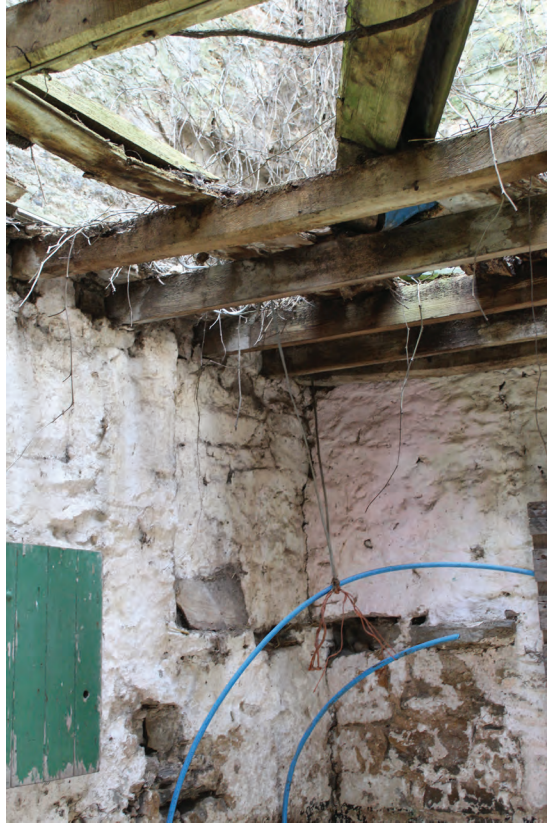
Figure 11 Detail of blocked doorway in south-west corner of Room LG1, facing south-west. No scale

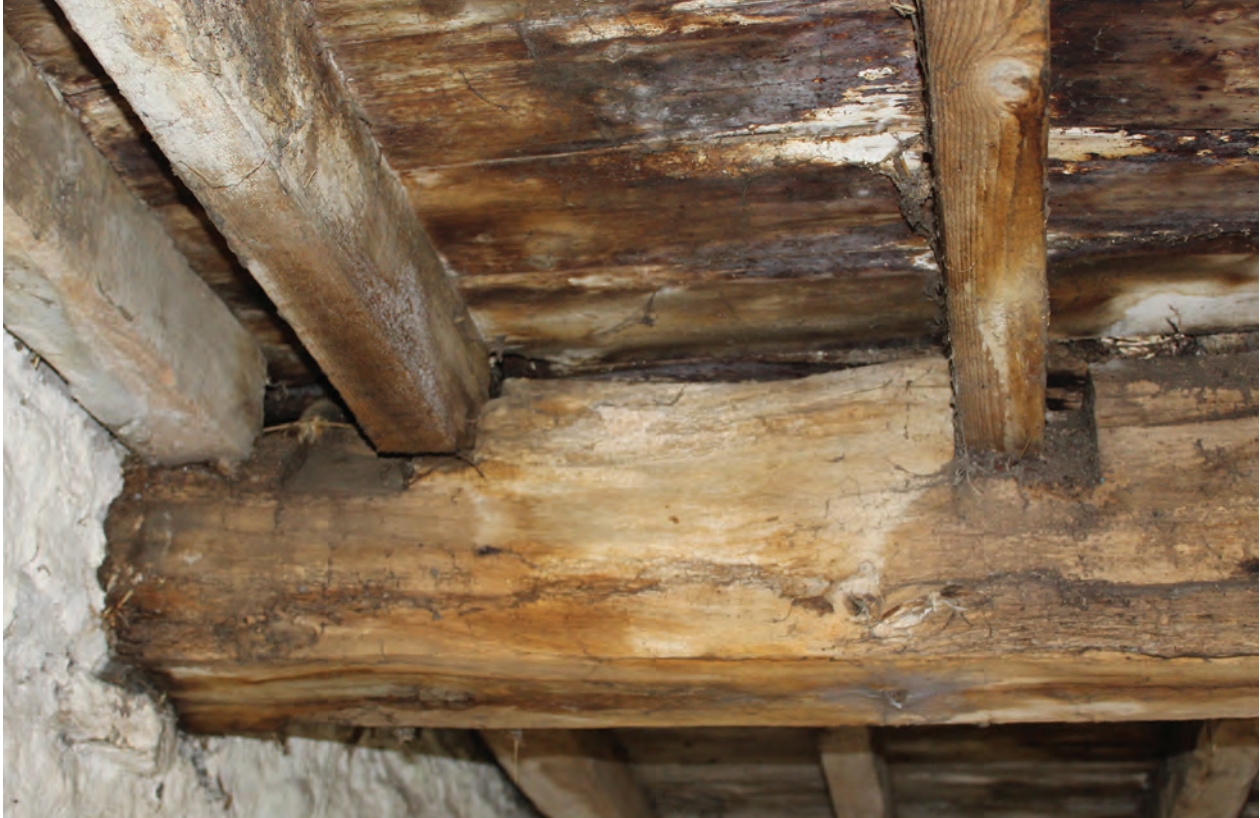
two angled sockets are cut into its southern face for the placement of staircase strings (Figure 12). Taken together, this evidence illustrates that the doorway gave access to a small internal raised landing within the south-west corner of the room, which then gave access to a short stair to Room F1 above, supported by two timber strings jointed into the existing floor joist. This whole construction, which may well have been original, has been subsequently removed. The presence of a relatively modern concrete machine base in this corner of the room may provide the answer to why it was removed. Given the size of the machine base it seems most likely that it would have been installed in the late 19<sup>th</sup> or early 20<sup>th</sup> century to host a cream separator or other dairying machine. The inserted concrete floor in this space, as well as the whitewashed walls, also suggests that this historic byre was latterly repurposed as a dairy.

Figure 12 Detail of angled sockets for staircase strings in southern face of principal floor joist, facing north-west. No scale

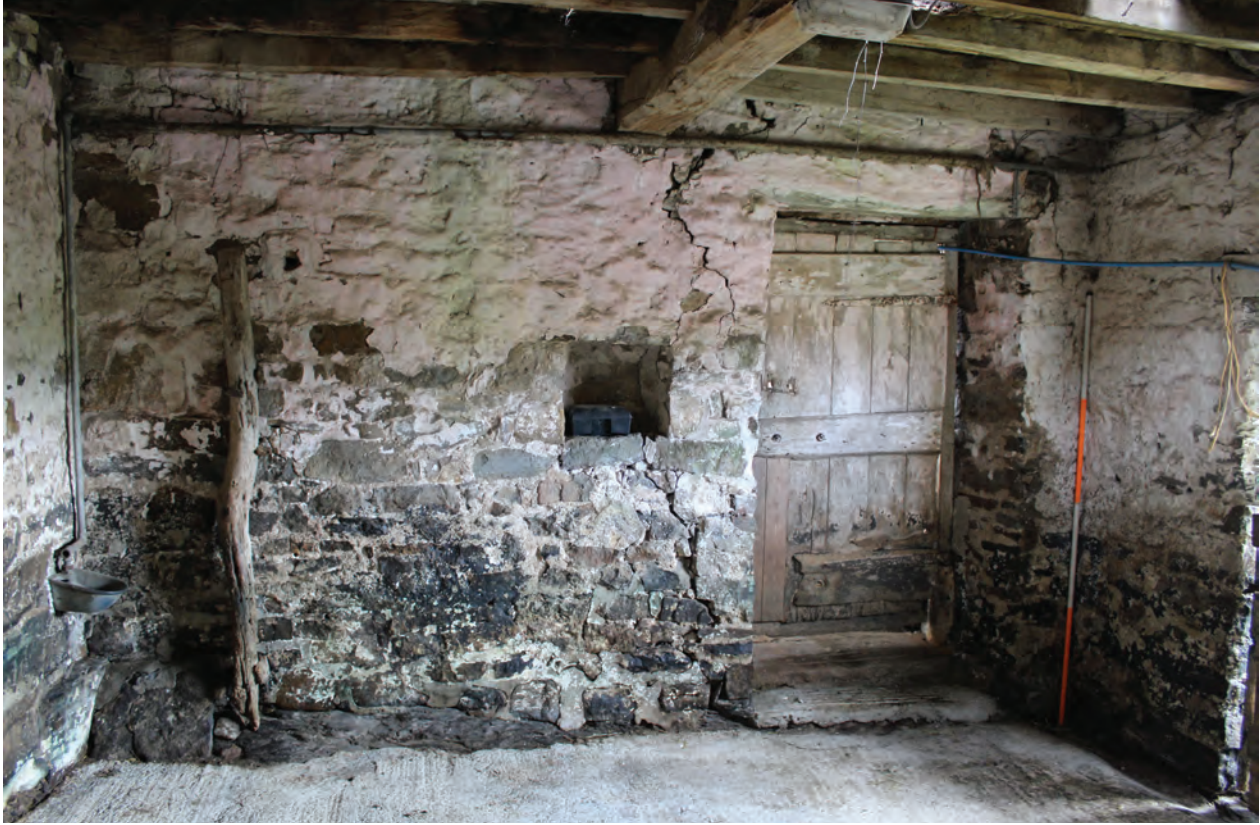
The room's east wall includes an original doorway at its southern extent, within which is an historic vertical plank door of at least 19<sup>th</sup>-century construction (Figure 13). To the north side of the door is an original square wall niche, a common traditional feature within byres. Beyond the niche is a vertical roundwood timber post, bolted to the wall, which almost certainly represents the remains of a feed rack and stalling against the room's north wall. Below the post, at the base of the wall's northern extent is a small section of exposed bedrock, illustrating that the barn has been likely constructed with this lower ground floor through cutting a step into the bedrock itself.

Figure 13 East wall of Room LG1, facing south-east. Scale 1x2 m

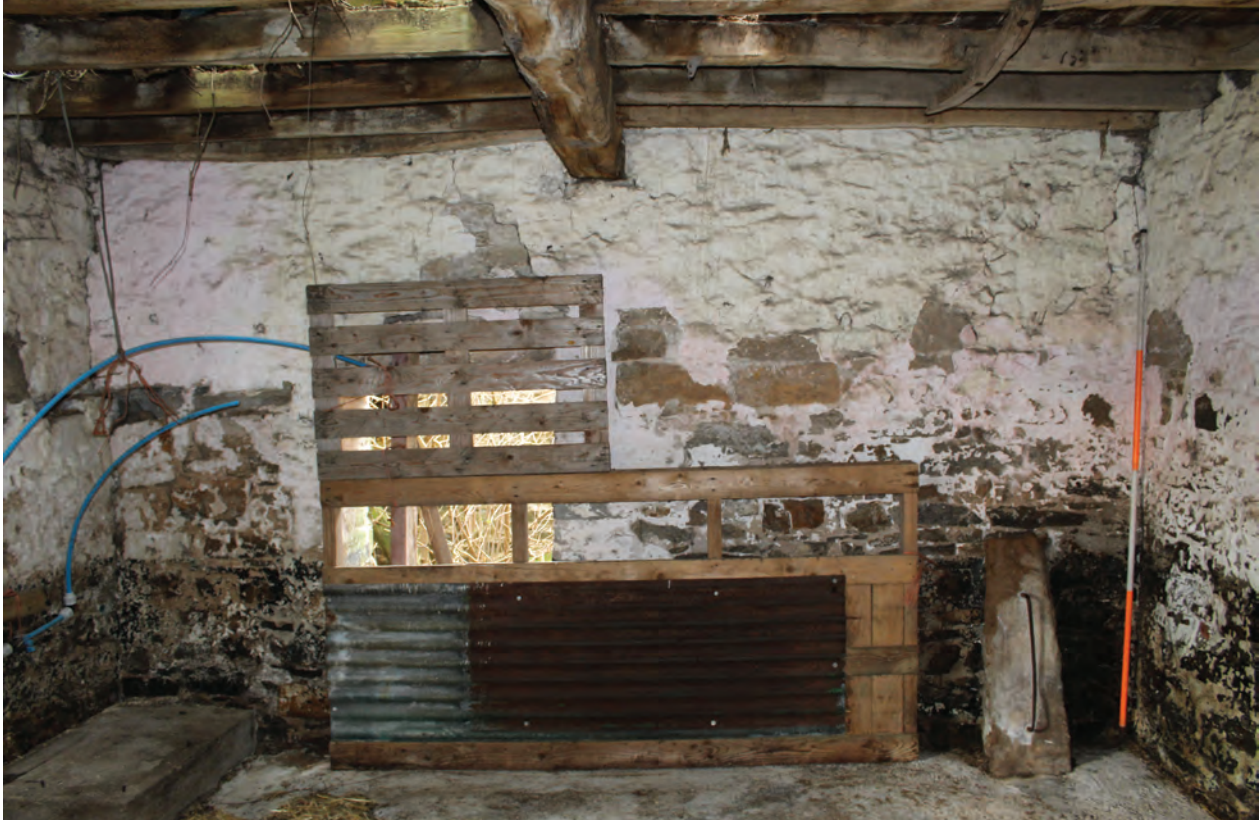
Figure 14 West wall of Room LG1, facing west. Scale 1x2 m

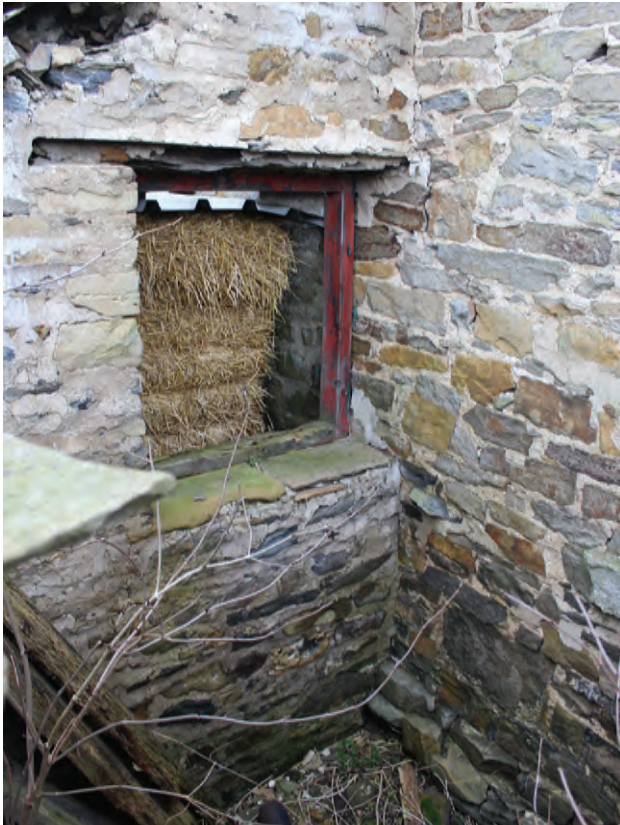
Room LG2 is contained within the western lean-to extension to the building, which historic mapping suggests was added between 1841 and 1857. The room could not be safely accessed at the time of survey but was viewed from outside through its collapsed roof. The room's south and west walls were featureless and constructed of roughly coursed rubble stonework. The north wall of the room contained an original window or forking hole opening with a timber frame and lintel (Figure 15). The room's east wall contains the doorway giving access to Room LG1 beyond (Figure 16). As described above, this original doorway has latterly been narrowed from a wider opening by the insertion of infill stonework at its northern side. It is possible this infill was added to further support the thin stone lintel above. No floor could be observed within the room and no ceiling or roof structure survived to be described.

Figure 15 North wall of Room LG2, facing north-east. No scale

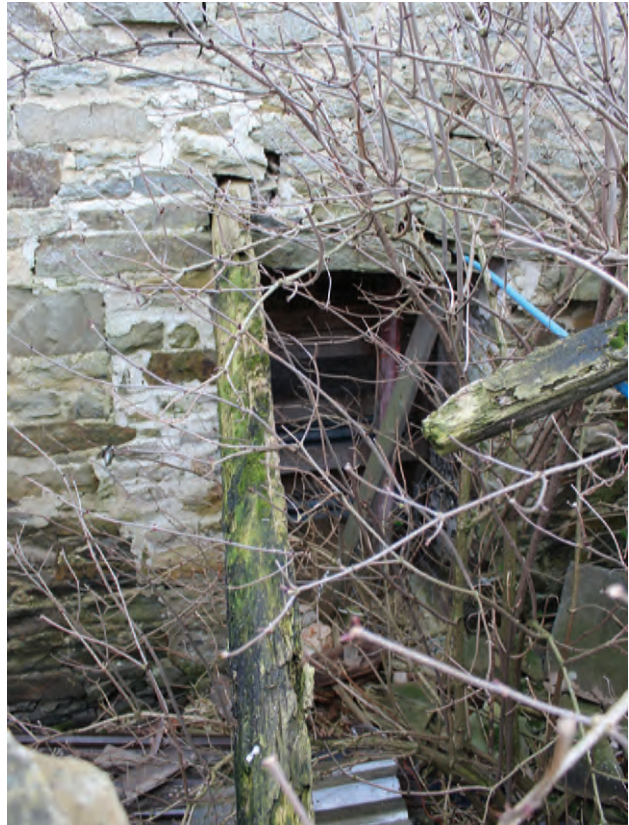
Figure 16 East wall of Room LG2, facing south-east. No scale

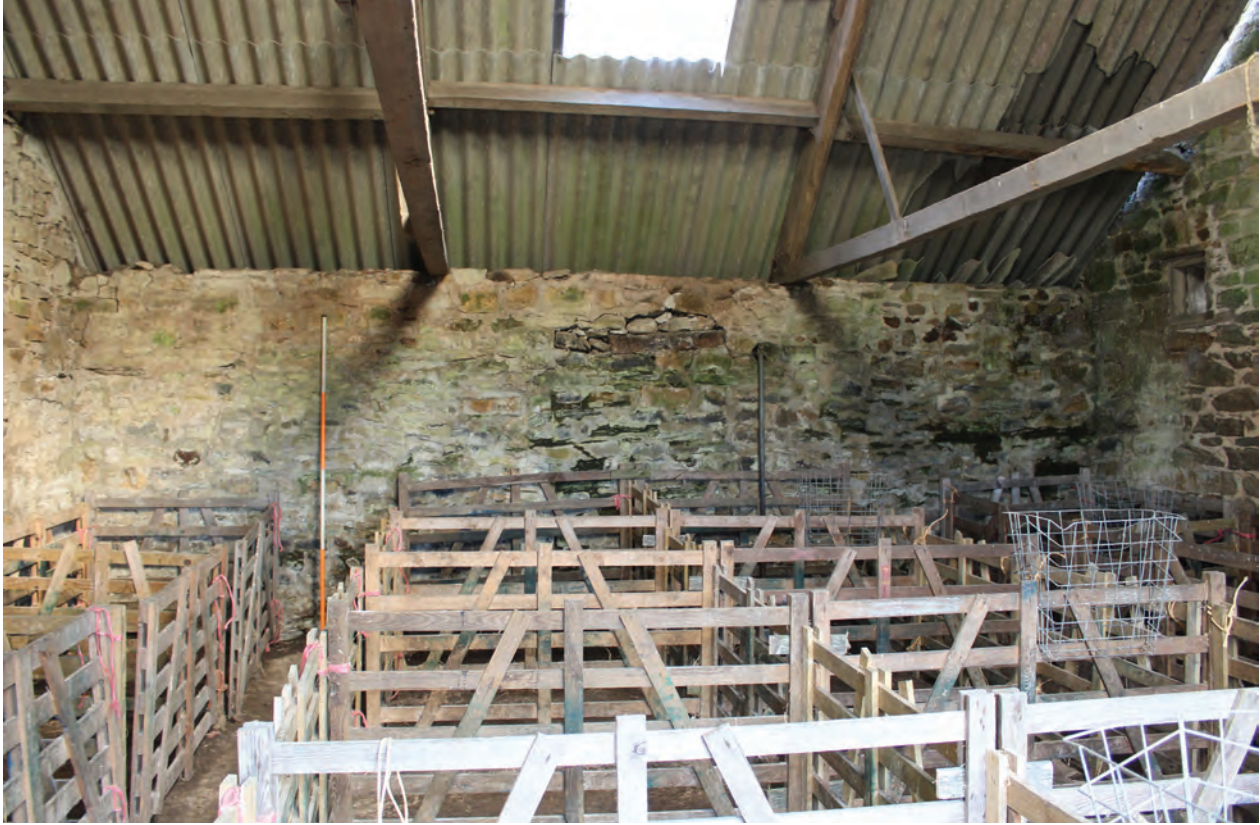
The north wall of the room, which retains the raised ground behind it, is largely featureless aside from a central blocked doorway, which was not visible externally (Figure 17). The doorway presumably led to a sunken set of steps leading uphill to the north, which have subsequently been infilled. At the wall's eastern extent, a clear construction break is visible, illustrating the join between the earlier external wall of the barn, which forms this room's east wall, and the other three walls, which form the wheelhouse extension. The west wall of the room also includes a blocked door, at its southern extent (Figure 18). As noted externally, the nature of the stonework of the reveals at each side of this former opening suggests that this opening was an original window, before being extended into a door, and then finally blocked. Above the blocked opening are four large, empty joist holes, which presumably original located timbers that provided support for the frame of the horse gin. To the north of the blocked door is

Figure 17 Room G1, facing north. Scale 1x2 m

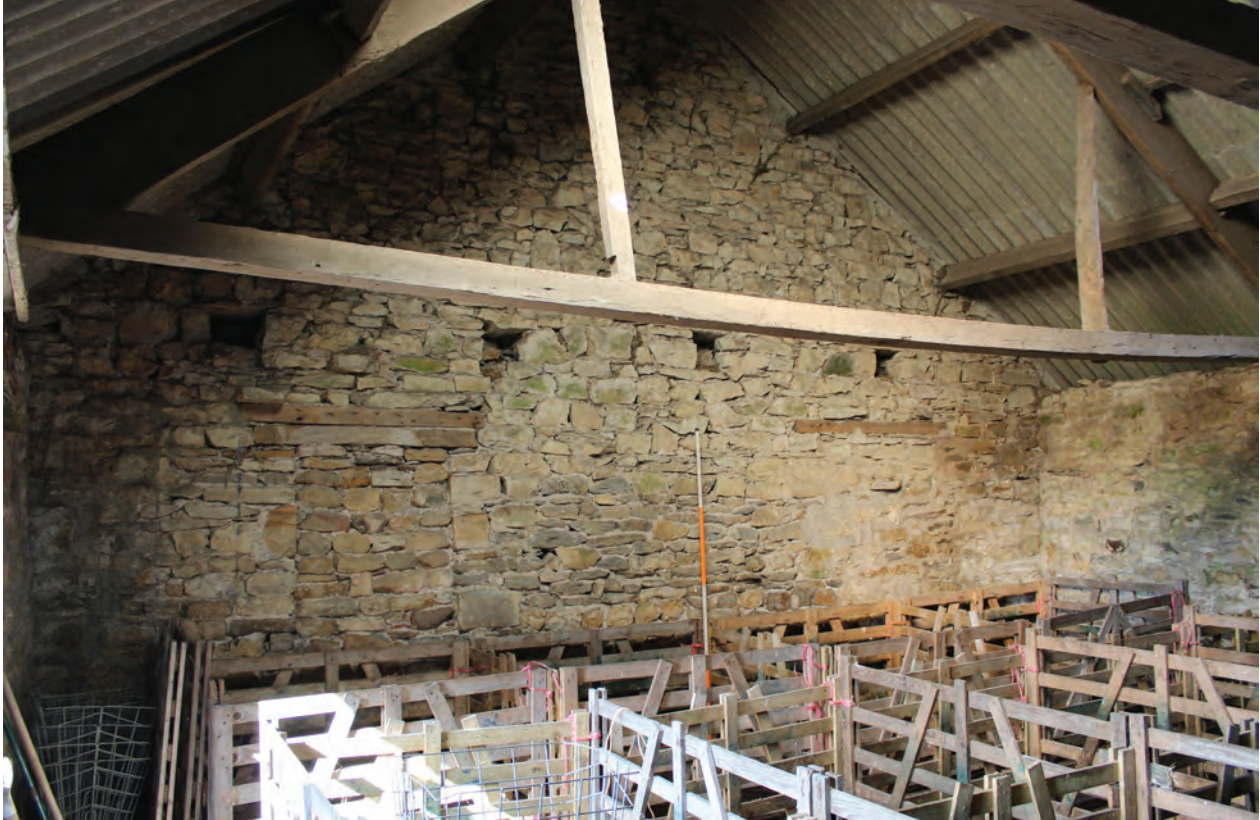
Figure 18 Room G1, west wall, facing north-west. Scale 1x2 m

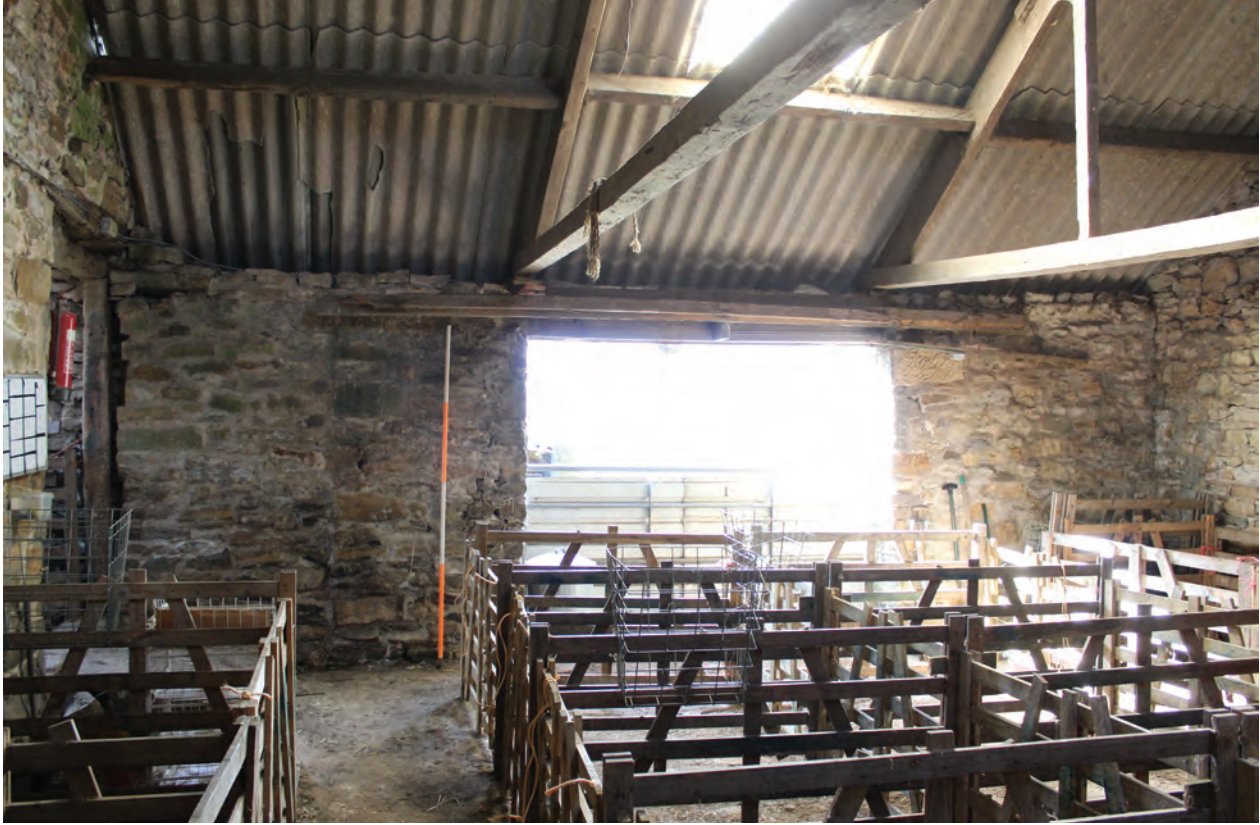
a timber lintel and area of disturbed stonework which provides the evidence for the location of another blocked window. The room's south wall includes a large central cart entry, which appears to have been altered, presumably enlarged, at its eastern side (Figure 19). It is possible that this entry may have begun life as a relatively normally sized doorway. To the east of this cart entry, at the wall's eastern extent, is a blocked, original doorway, the blocking of which has been built against the infilling of the large doorway in the western wall of the main barn, illustrating that that infilling occurred first.

Figure 19 South wall of Room G1, looking south. Scale 1x2 m

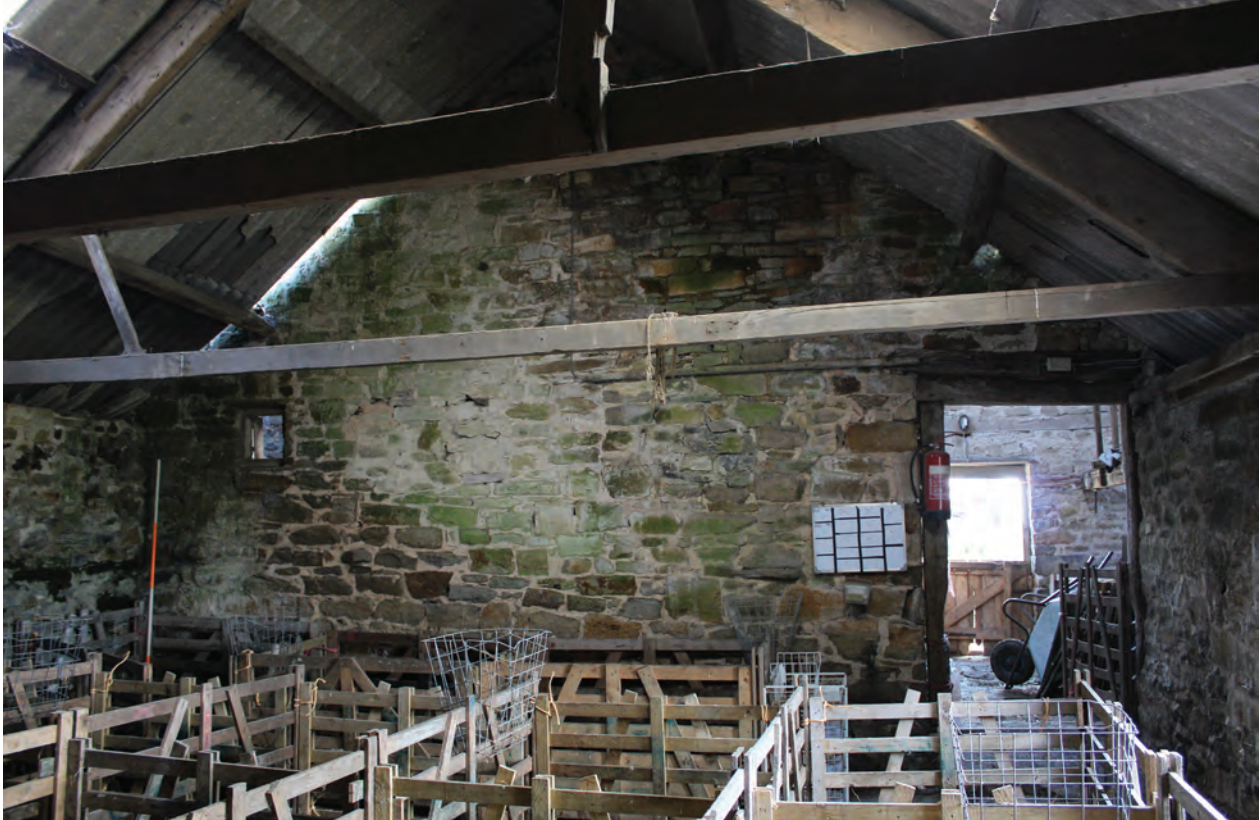
The east wall of Room G1 is formed by the earlier exterior west wall of the principal barn range (Figure 20). At its northern extent, this wall includes a small, square window which has been enlarged from an original breather. This seems most likely to have occurred after the wheelhouse was added, in order to provide a route of communication between the gin driver and the operator of the threshing machine it would have powered in the barn. Centrally within the wall, a number of infilled sockets are present, which illustrate the location of the shaft taking power to the threshing machine, as well as supporting framing timbers for the gin itself. At the southern extent of the wall is a doorway leading to Room G2 beyond. This wide doorway has been created from an even wider original opening into the main barn range, which has been reduced by the addition of infill stonework at its south side.

Figure 20 East wall of Room G1, facing east. Scale 1x2 m

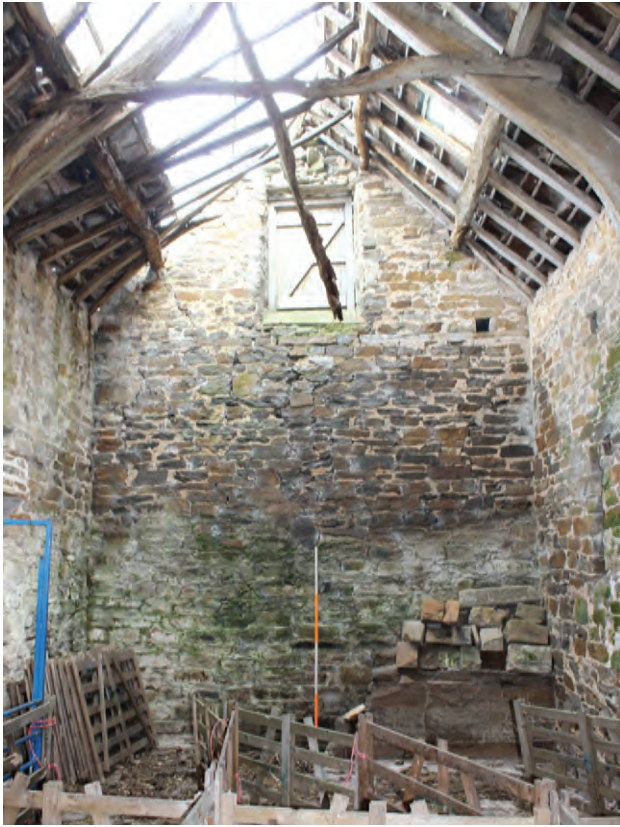
Room G2 is the main space within the principal barn range. The room's north wall includes an inserted forking door close to the peak of its gable, which was noted externally (Figure 21). The doorway includes a sloping sill, indicating it was intended purely for loading. To the right of the inserted forking door a socket for a timber is present, although it is unclear as to what purpose this may have had, unless used as a putlog hole during the construction of the building. At the lower east extent of the wall, a large section of bedrock has been left in place, with the wall built over it, presumably illustrating that preparation for the construction of the barn involved digging a step into the hillside to create a flat platform.

Figure 21 North wall of Room G2, facing north. Scale 1x2 m

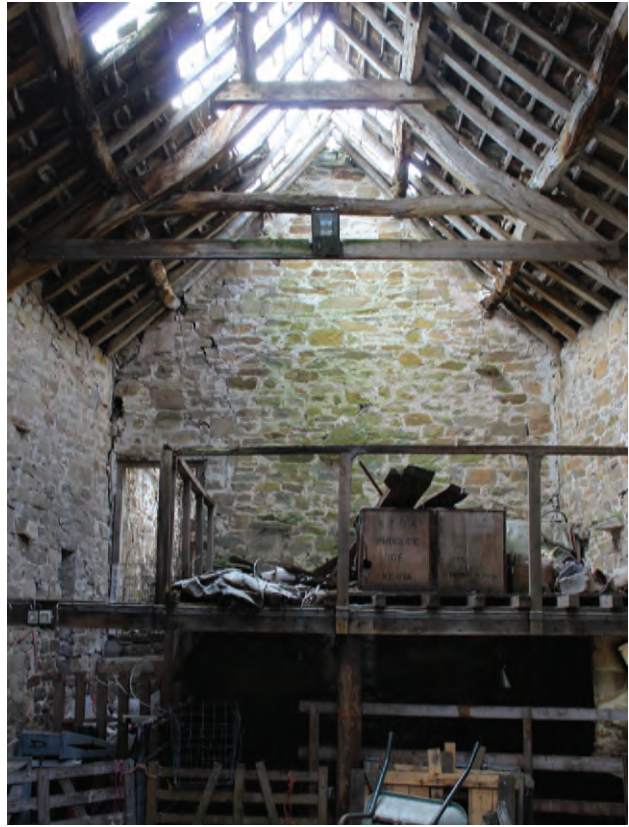
The room's south wall includes an original doorway at its eastern extent, accessed by an original stone staircase, leading to Room F1 beyond (Figure 22). In front of this wall is a modern timber mezzanine platform which appears 20<sup>th</sup>-century in date. The wall is otherwise featureless.

Figure 22 South wall of Room G2, facing south. No scale
