West Middleton Farm  
Hutton Magna, County Durham

Historic Building Recording  
Listed Building Consent: DM/21/00289/LB

## Historic Building Recording

Listed Building Consent: DM/21/00289/LB

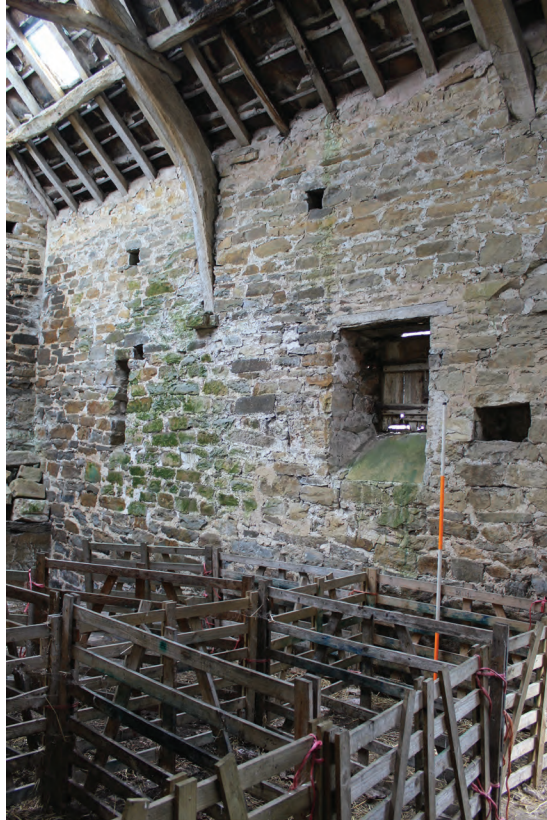
The east wall of the room includes an original breather at its northern extent, which sits close to two further probable putlog holes (Figure 23). To the south of this is an inserted forking hole, noted externally, which has been made from the smaller original opening of a breather. The inserted forking hole has a sloping sill indicating it was only ever intended for this purpose. Above the forking hole is a further putlog hole, and to its southern side is a small, square, original niche. To the south of the small niche is the partially infilled former cart entry noted externally (Figure 24). This formerly larger opening has been infilled with stonework to lower it and to narrow it from its southern side, creating a smaller, relatively standard-size doorway. Beyond this opening are two further putlog holes and a blocked original breather. Against the lower part of the southern extent of the wall is the stone staircase to Room F1.

Figure 23 Northern extent of east wall of Room G2, looking north-east. Scale 1x2 m

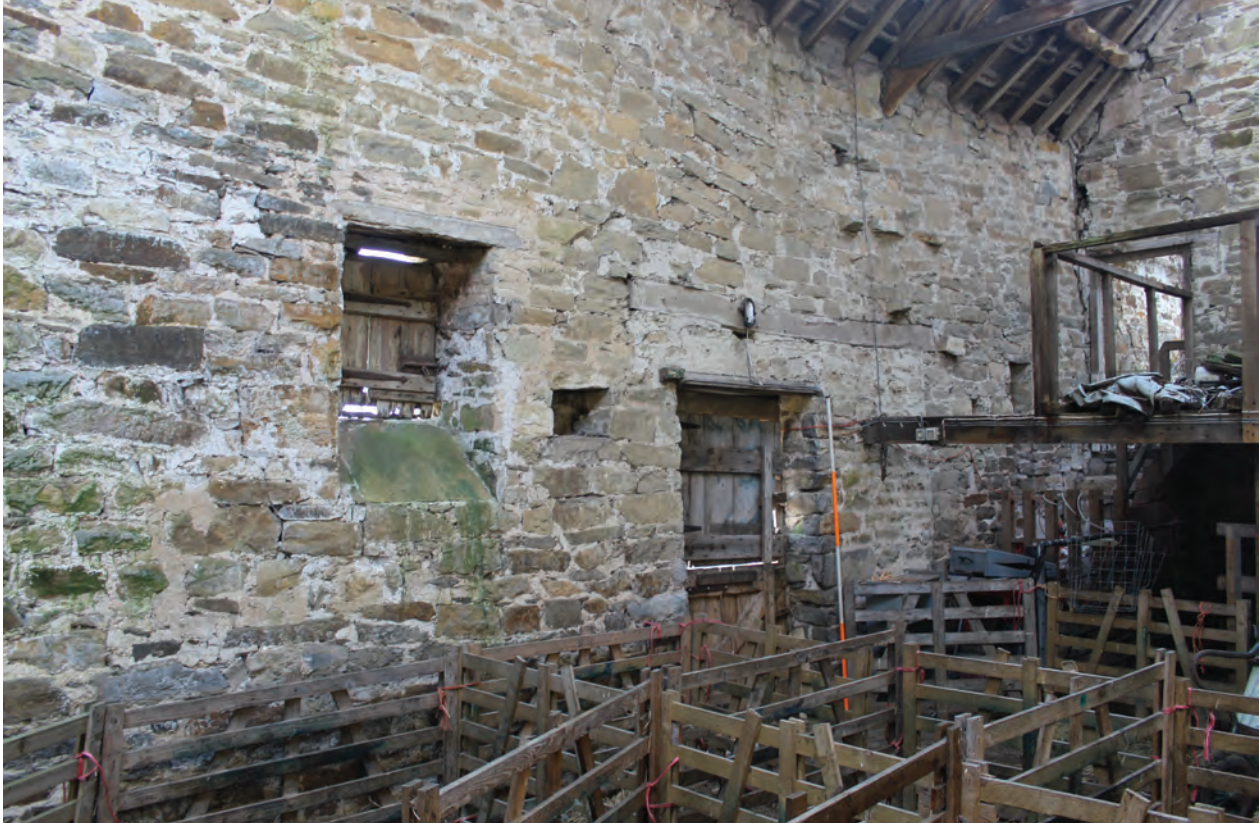
Figure 24 Southern extent of east wall of Room G2, looking south-east. Scale 1x2 m

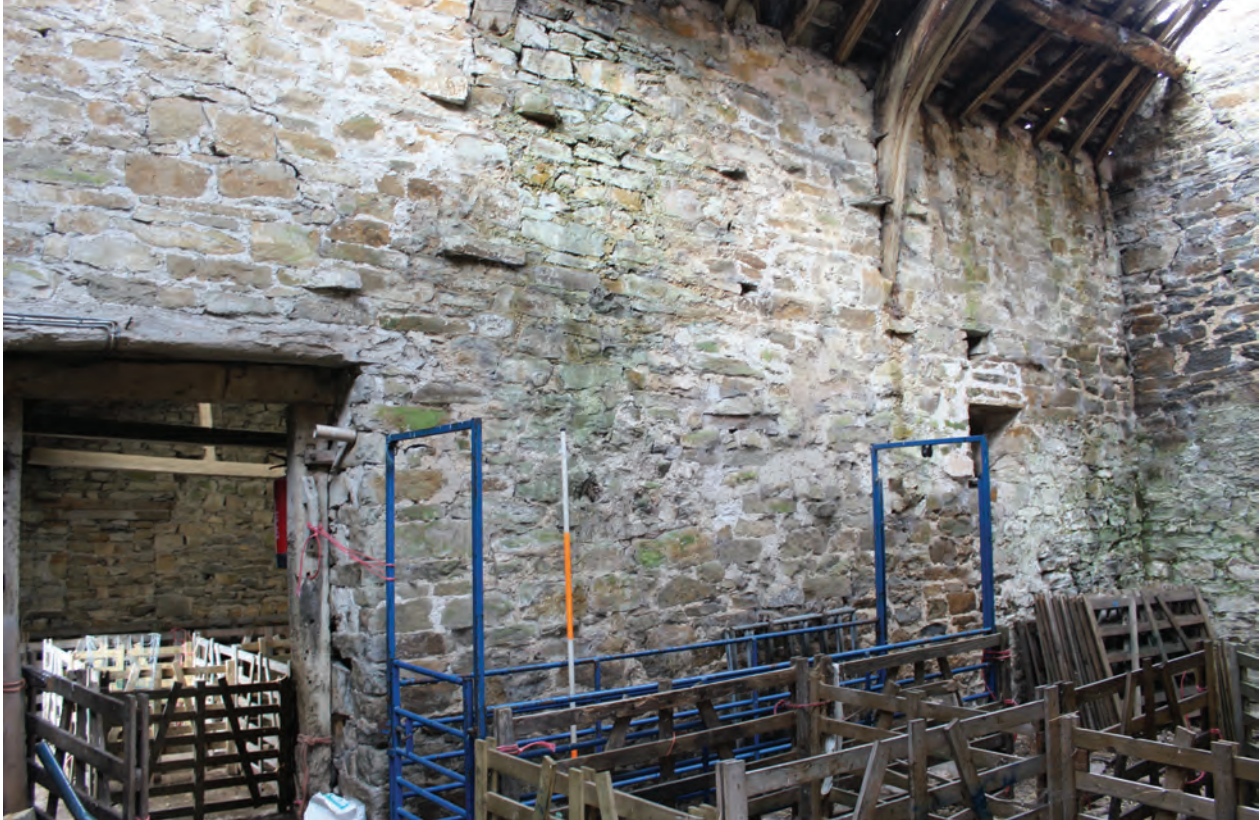
The west wall of the room includes an inserted window at its northern extent, created from the original opening of a breather (Figure 25). To the south of this is an area of patched stonework where the shaft transferring power from the horse gin in Room G1 would have passed through the wall. To the south again is the central doorway to Room G1 beyond (Figure 26). This doorway was originally larger and has been reduced in width by the addition of infill stonework at its south side. To the south of the doorway, a window has been inserted relatively recently to light the space beneath an inserted mezzanine platform at this end of the barn (Figure 27). The window appears to have been created using the original opening for a breather in this location.

Figure 25 Northern extent of west wall of Room G2, facing north-west. Scale 1x2 m

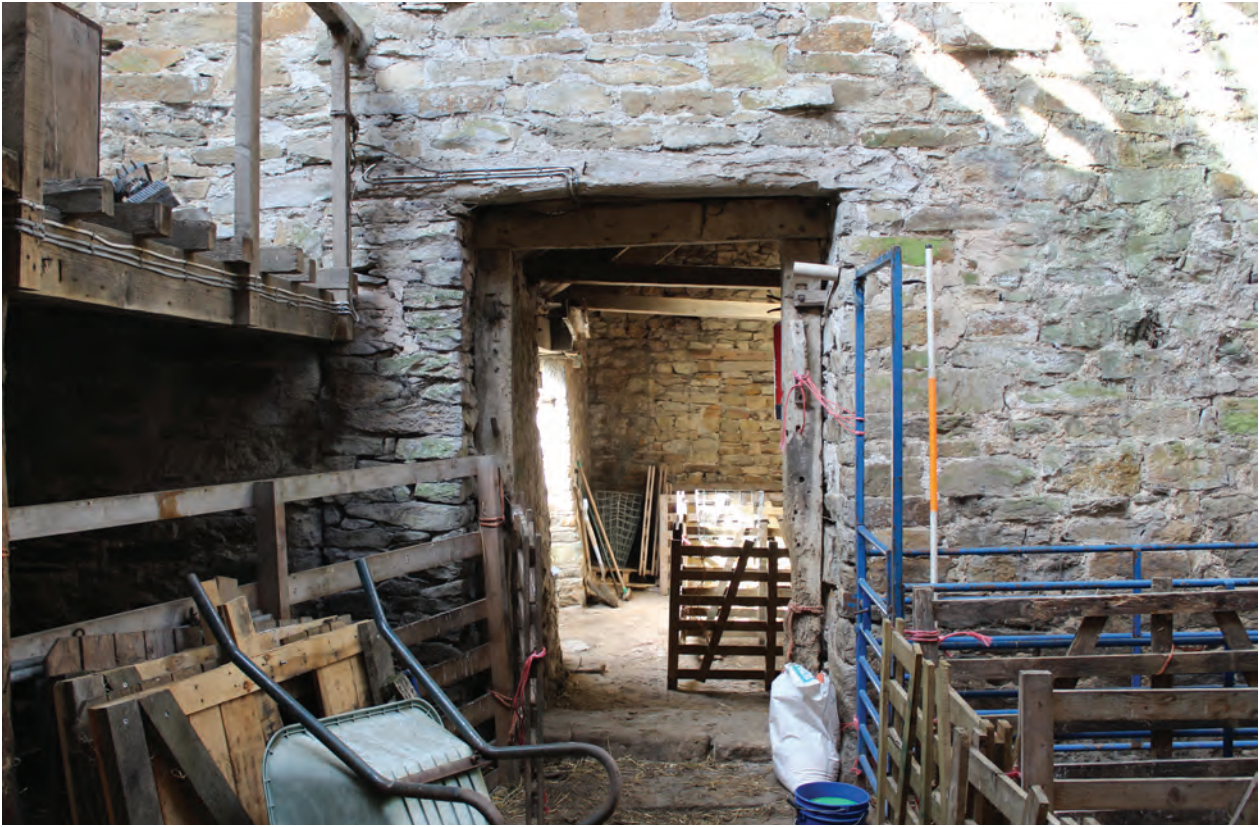
Figure 26 Central section of west wall of Room G2, facing west. Scale 1x2 m

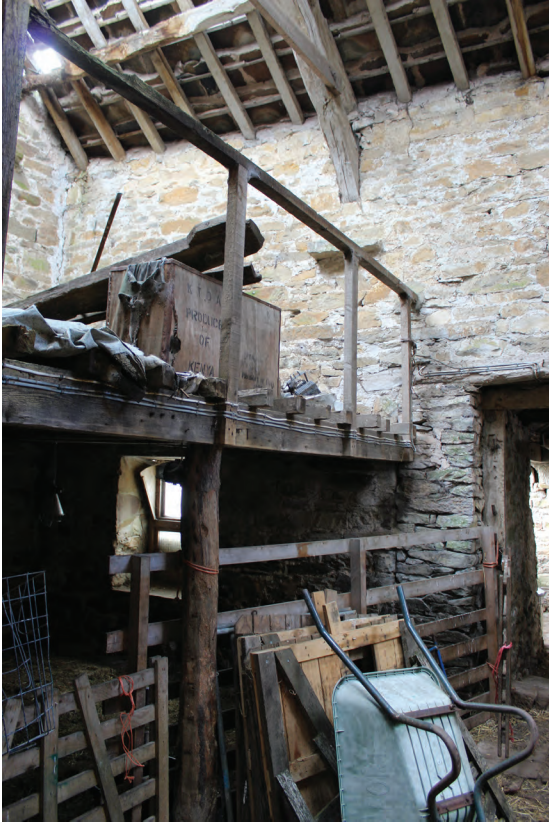
Figure 27 Southern extent of west wall of Room G2, facing south-west. Scale 1x2 m

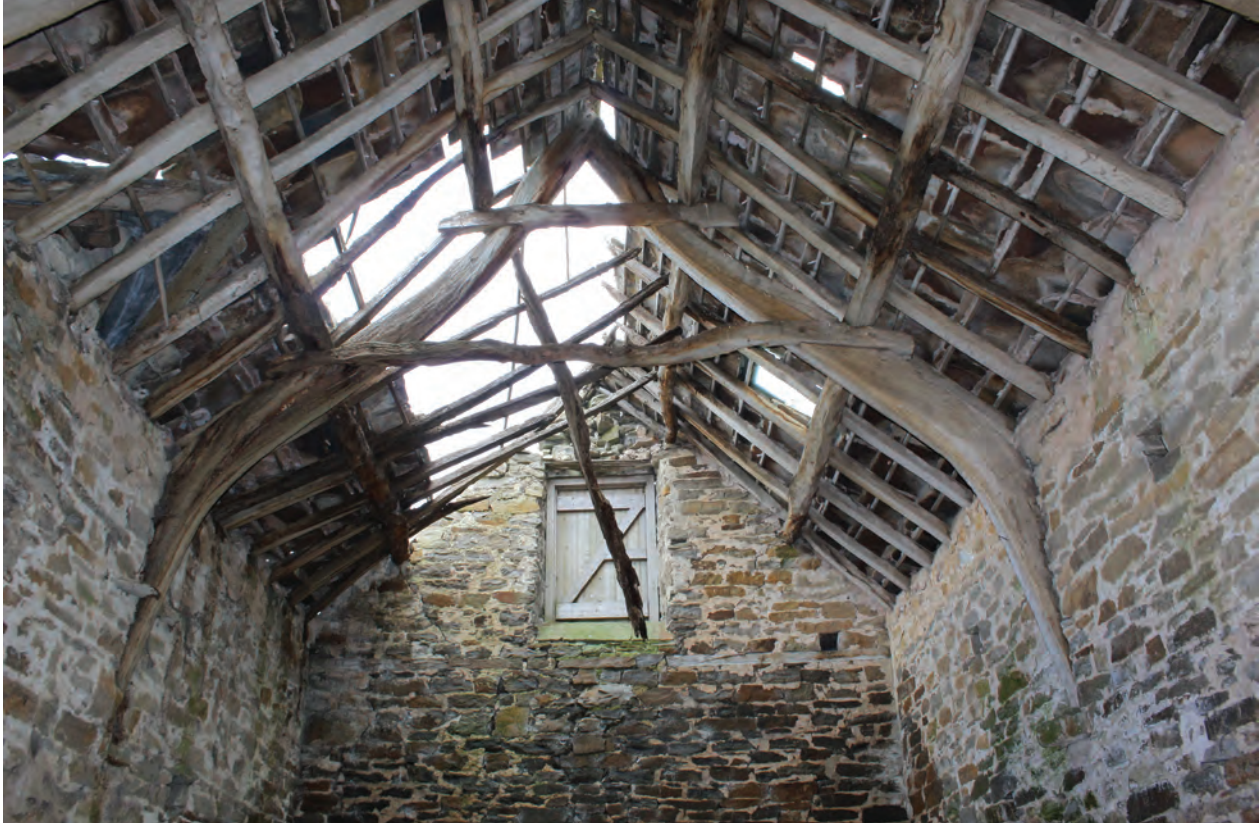
The roof of this room retains considerable interest, although it was in a very poor state at the time of survey. Within the room there are three main trusses, carrying two rows of purlins at each side. The northernmost truss includes two large, curving cruck blades, sunk into the stonework of the walls at their lower extents and carried on shallowly corbelled stone pads (Figure 28). The cruck blades are pegged to a lower and upper collar, both of which extend beyond the blades to carry a lower and upper line of lap jointed purlins. Above these, rafters support battens to which the stone slate covering is pegged. This full cruck truss does not match the other two trusses in this part of the barn, suggesting that all are a selection of parts, perhaps from more than one building, or, that the entire barn itself is a rebuilding of an earlier timber framed barn in stone. The central truss includes two squarer blades which are not chamfered, as the northernmost truss's are, and has upper and lower collars pegged to different sides of the blades, again, different to the northernmost truss (Figure 29). The southernmost truss in the room has elements which match the central truss closely, but its blades do not extend to the ridge and terminate at the upper collar. As with the central truss, this is pegged at the opposing side to the lower collar. A machine cut lower chord has been latterly added to this southern truss, presumably to act as a strengthening member.

Figure 28 Detail of northern section of roof structure in Room G2, facing north. No scale

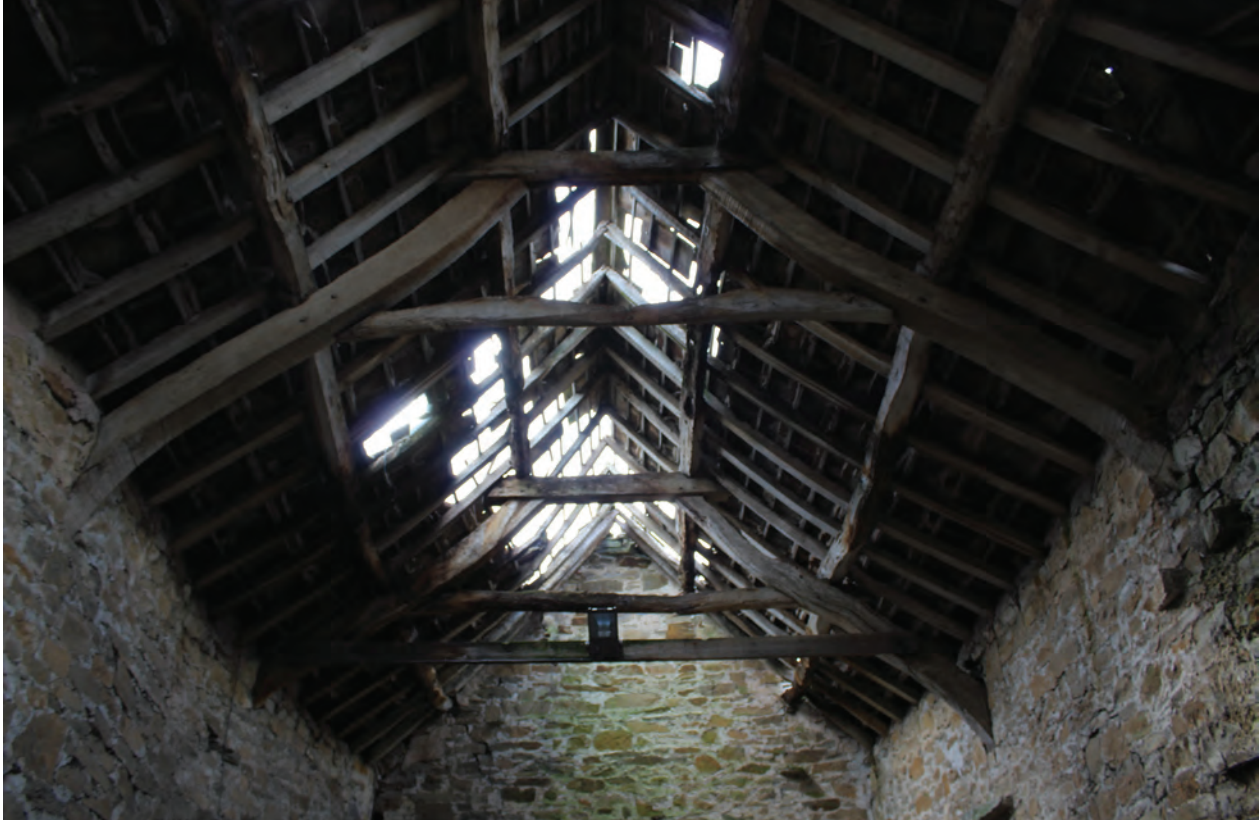
Figure 29 Detail of southern extent of roof structure in Room G2, looking south. No scale

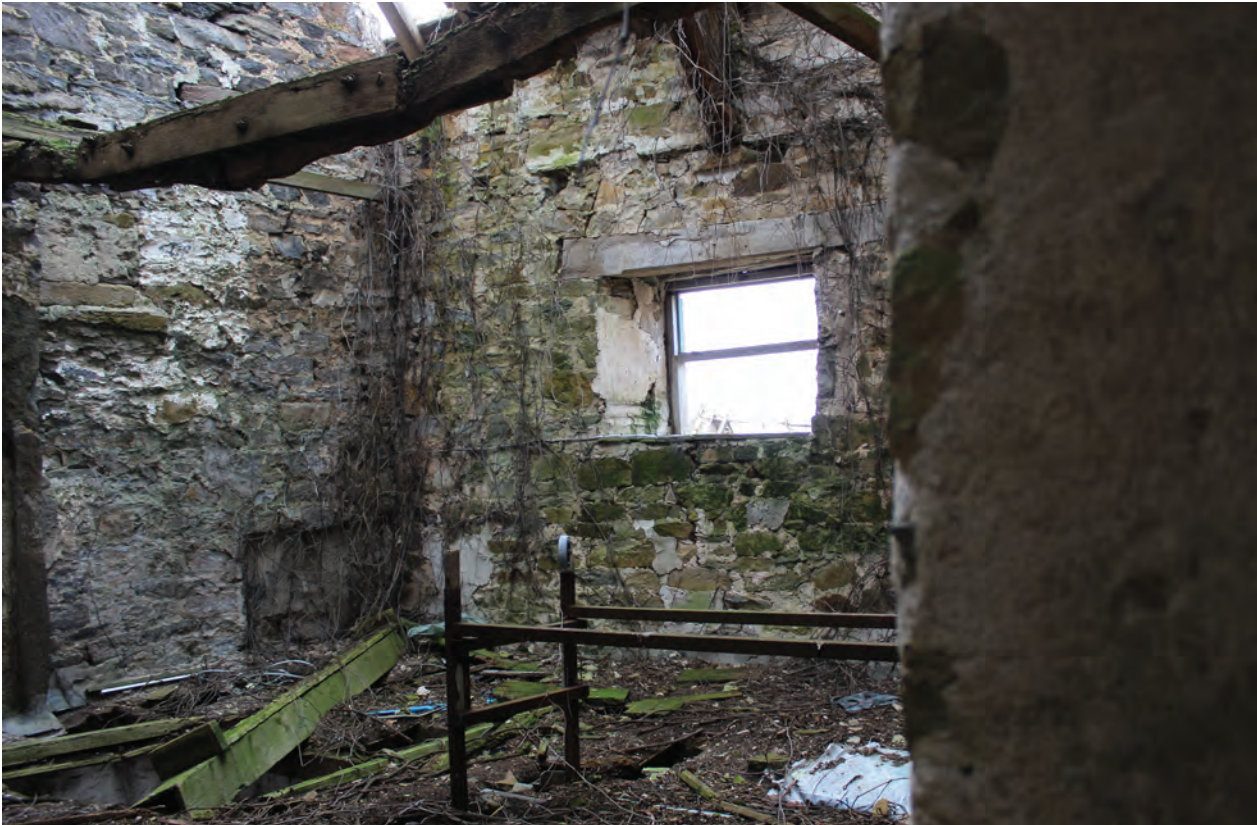
No safe access was possible to the interior of this room at the time of survey. As such, the room was observed only partially from the doorway. The room is accessed only from a doorway at its north-eastern corner, at the top of an original stone staircase within Room G2. Aside from the doorway, the room's northern wall could not be viewed and is assumed to be featureless. At its east side, the room has an original window, noted externally, which includes a slatted timber frame. The room's west wall also includes a window, which can be seen to have been inserted (Figure 30). At its south side, the room has an original central fireplace and chimneybreast formed with a stone surround and latterly blocked with infill stonework (Figure 31). At each side of the fireplace is an infilled, square niche, both of which appear original. To the west of the fireplace is the upper part of the blocked, raised doorway noted in Room LG1 below, and externally. That doorway would have originally provided access to this room. Within the roof of the room is a single supporting truss, with straight upper chords, rather than curving cruck blades. These straight upper chords have been made extremely thick, so as to enable them to be cut into to admit the passage of the purlins through them without creating a thin, weak section at each side. The suggestion of this truss is that not enough cruck trusses were available to make the barn to the required length, again suggesting they may well be a reuse from an earlier building, or more than one building. Below the truss, an original, central, north-south oriented, floor joist is present, supporting the remains of an upper floor in this area, created within the roof space. The combination of the upper floor, fireplace and windows in this area of the barn suggests that it was originally built as domestic accommodation for farmhands. All of the historic census data illustrate that hands lived on the farm, and so it seems likely they lived here with the lower floor intended as living space and the upper floor intended as a bedroom area. Presumably a ladder, which no longer survives, was used to gain access to the upper floor.

Figure 30 West wall of Room F1, facing south-west. No scale

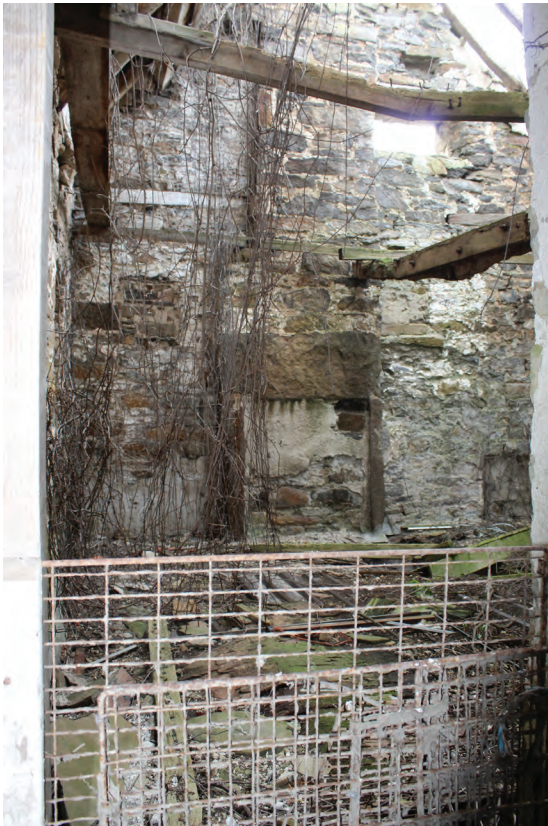
Figure 31 South wall of Room F1, facing south. No scale

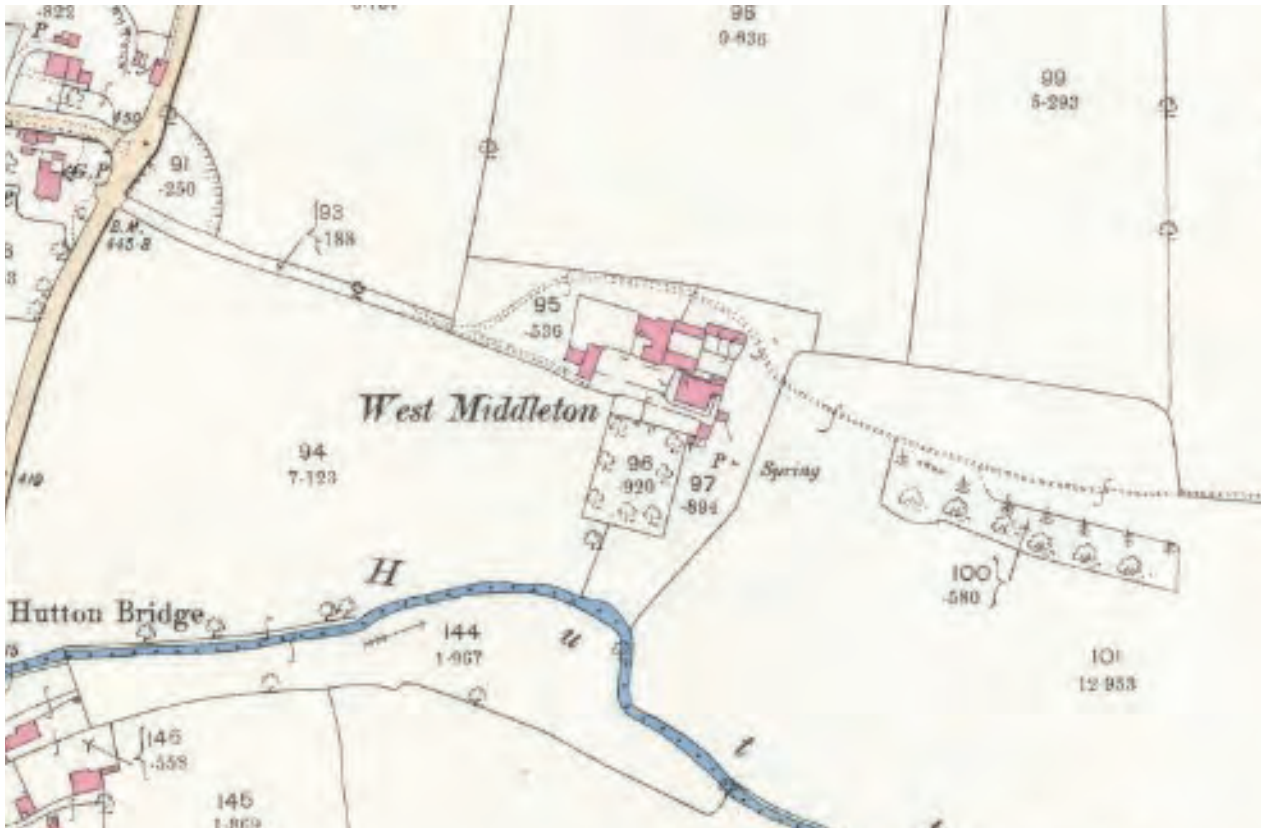
The 1892 25-inch Ordnance Survey map (Figure 36) is the first truly accurate and detailed map of the buildings at West Middleton. This map appears to show no alterations whatsoever to the buildings from the situation illustrated in 1857 and appears to show that no meaningful changes have occurred between then and now, with the buildings illustrated as they appear today.

Figure 36 1857 Ordnance Survey map
