**An Archaeological Standing Building Survey.
85 Hartwell Road,
Ashton,
Northamptonshire.
(NGR SP 76861 50027)**

November 2012

**Planning Permission No
S/2012/0967/FUL**

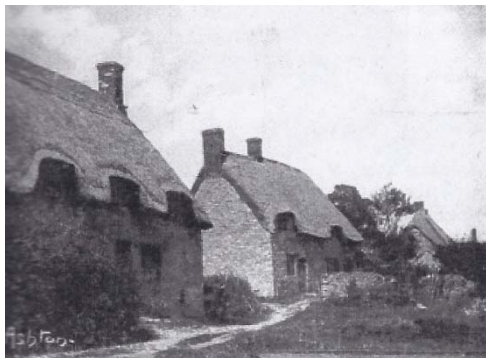
Figure 3
85 Hartwell Road, Centre.

Extensive modern re-pointing has obscured any potential evidence of building phases. The only potential evidence of this is a small straight joint adjacent to the western end of the principal elevation. However, this is more likely to relate to an alteration in the adjacent opening, possibly blocking an original window in order to insert the current doorway. Early 20th century photographs appear to show a window and door in this part of the building (*Figure 3*), the window now being blocked.

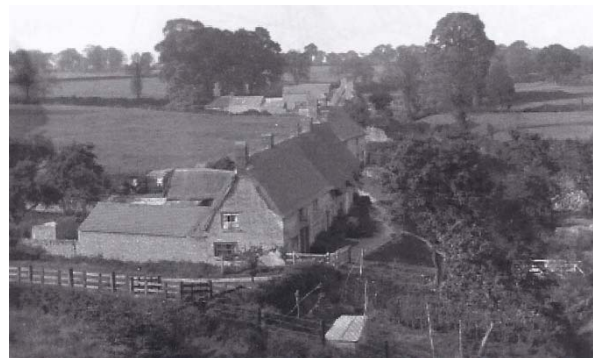
Figure 4
Hartwell Road, Demolished Cottages in Foreground.

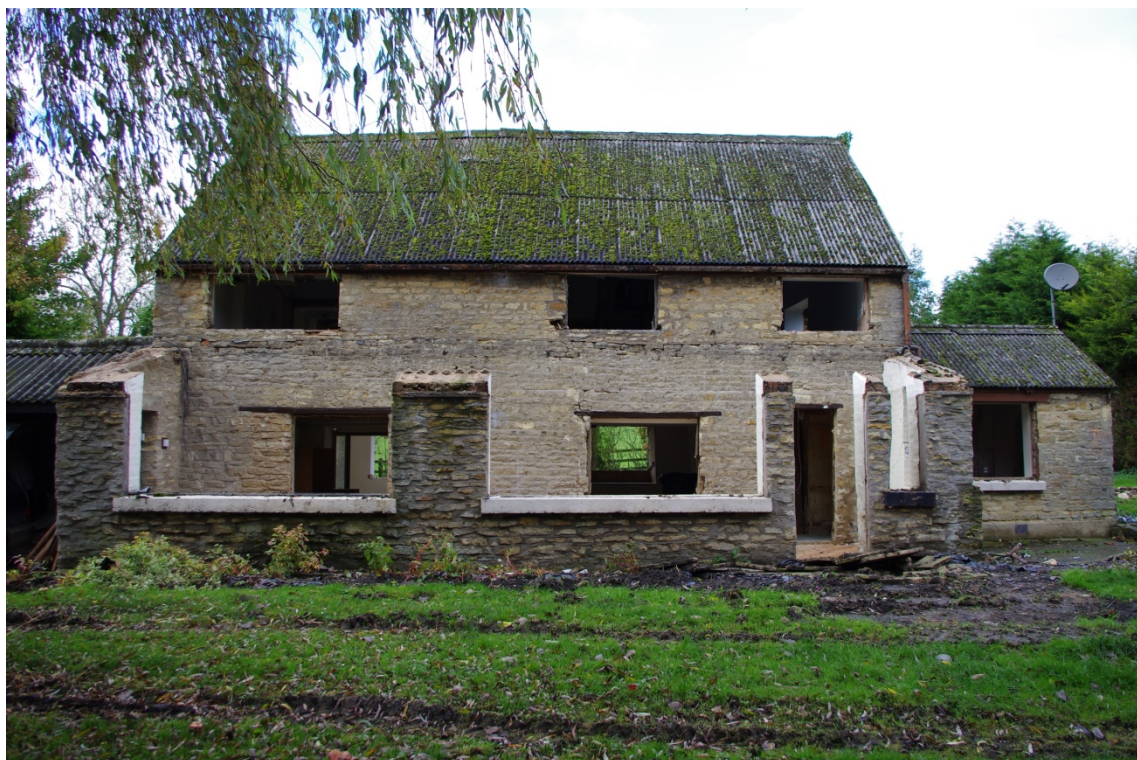
Figure 5
Principal Elevation (Looking North).

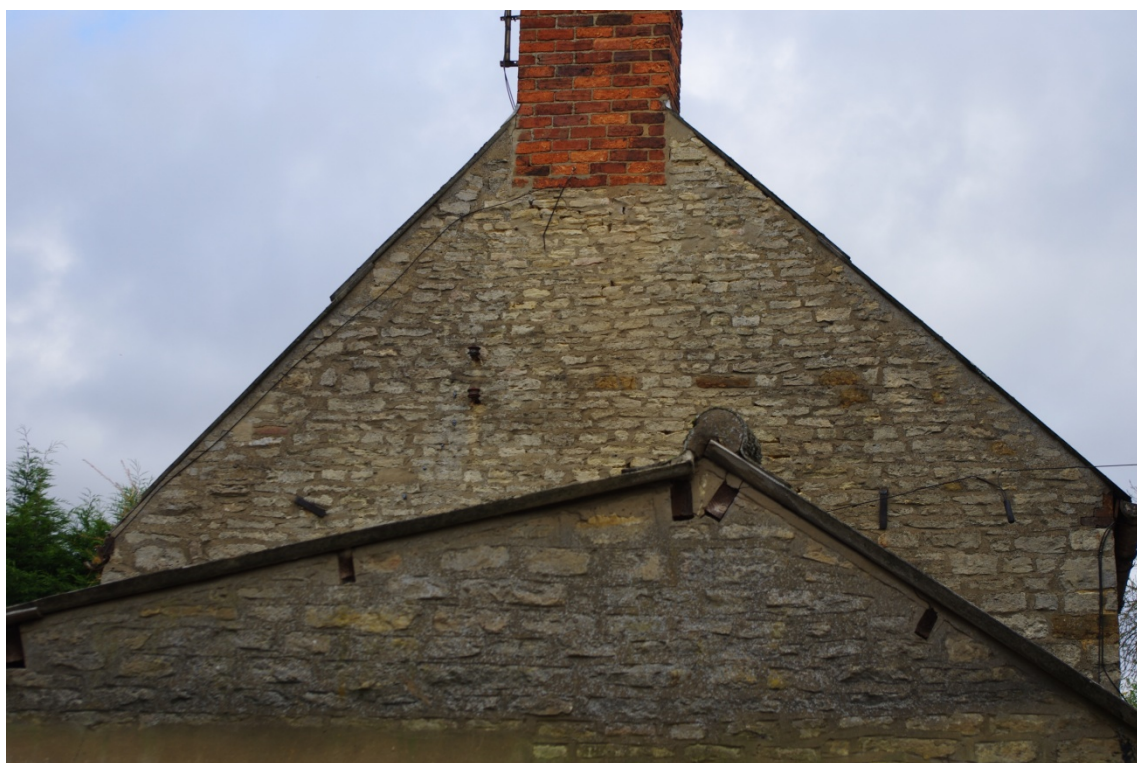
pointing all appears to be modern cement mortar. All windows and doors had been removed prior to the site visit; an examination of recent photographs supplied by Mrs Hill indicates that these were all modern replacements. The size of the window openings suggests that they are unlikely to be original. Although early photographs (*Figures 3 & 4*) do appear to show surprisingly large window openings for such early stone-built buildings. Evidence of the original steeply pitched roofline can be seen on both gables (*Figure 6*); there is no evidence of the roofline on either the principal elevation or the rear elevation.

Figure 6
Original Roof Line Seen in West Gable (Looking East).

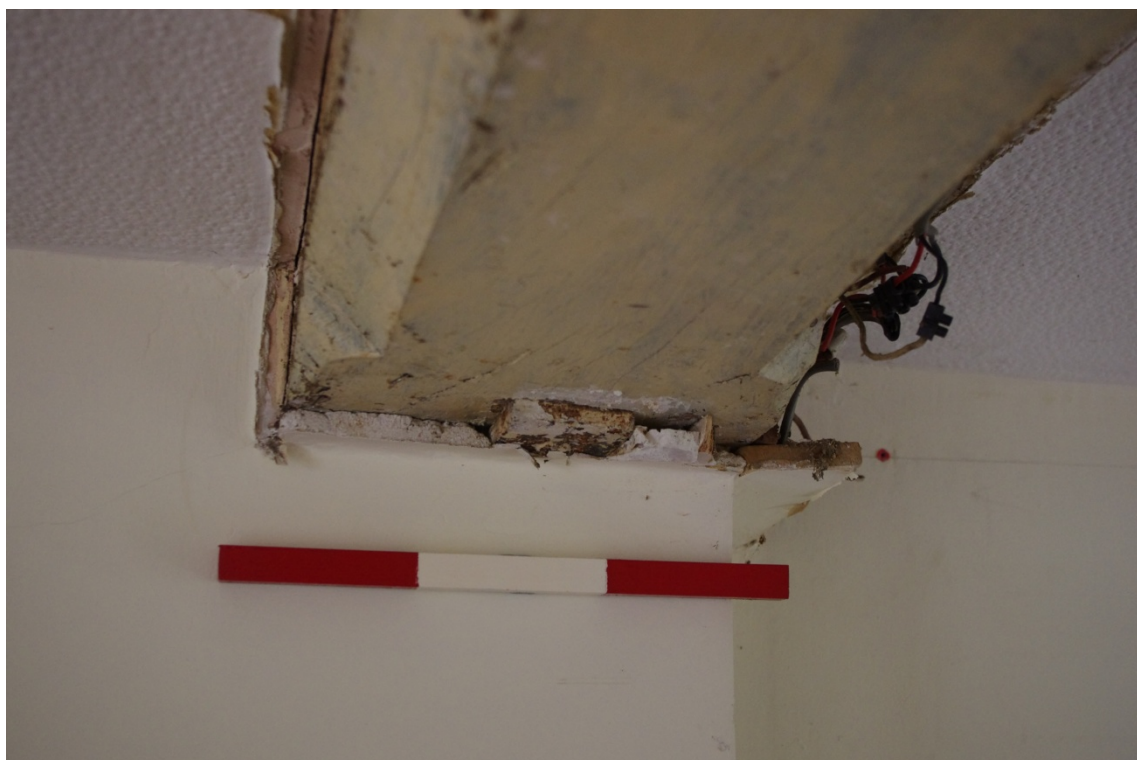
Internally, the building is much altered and modernised, leaving very little of architectural or historical interest. Modern decoration conceals all the walls and ceilings; the floor appears to be a poured concrete slab. There is a partially blocked chimney breast on the west gable. The first floor is supported by a full length axial beam, mostly boxed. Where this boxing has been removed (Room 01), the axial beam is revealed as a being chamfered with a straight cut step stop at the western end (*Figure 7*). Such stops were common in the late 17th and early 18th centuries (Hall 2005). The ceilings are all underdrawn; again where this has been partially removed the original joists can be seen and appear to be contemporary with the axial beam.

Figure 7
Chamfered Beam in Room 01 (scale is attached to west gable).

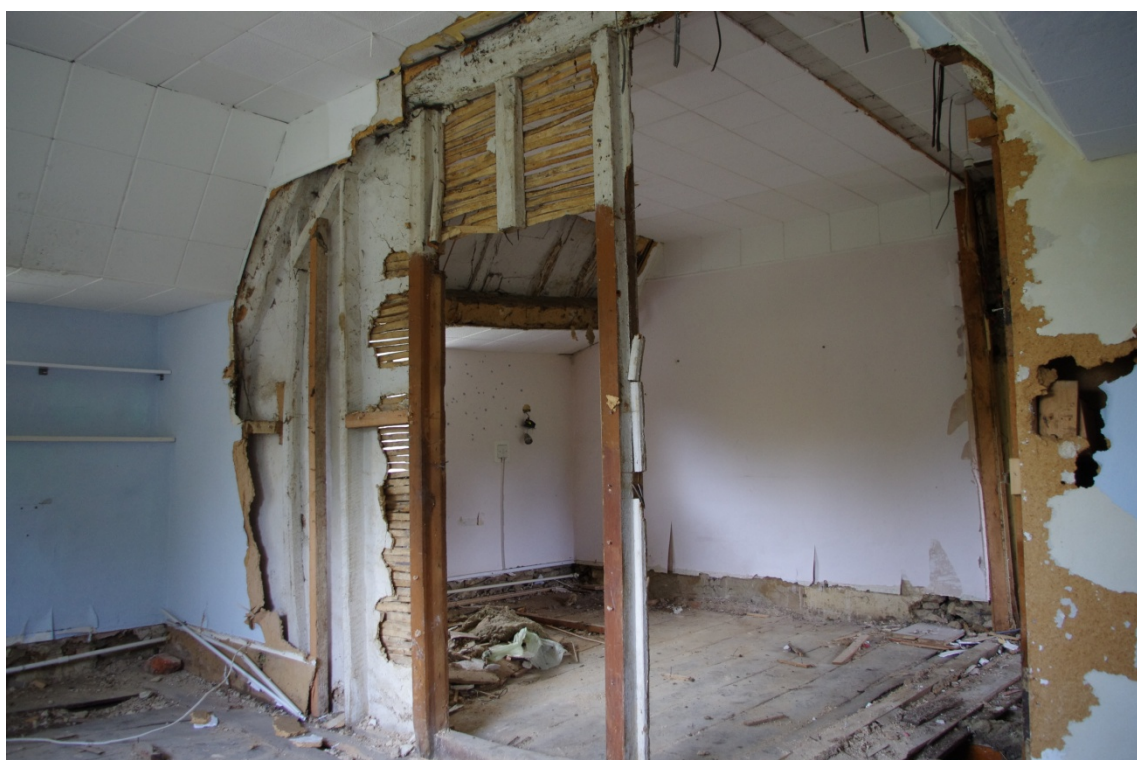
The partition between rooms 06 and 07 is a timber framed plaster and lathe wall (*Figure 8*), originally with a central doorway, a new doorway has been inserted towards the north of the building. It appears that the frame was originally exposed within room 07. The irregular nature of the framing suggests an early date.

Figure 8
Stud Wall, Room 07 (looking south west).

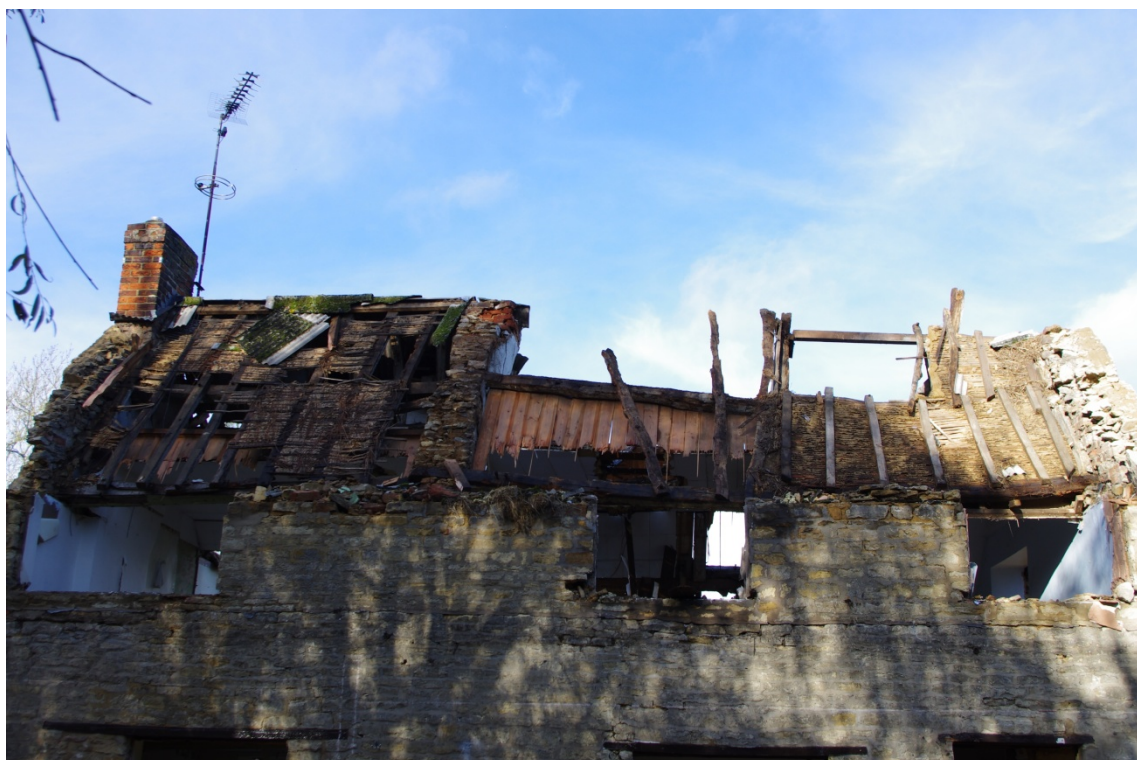
Figure 10
Southern Roof after Removal of Asbestos Roof.

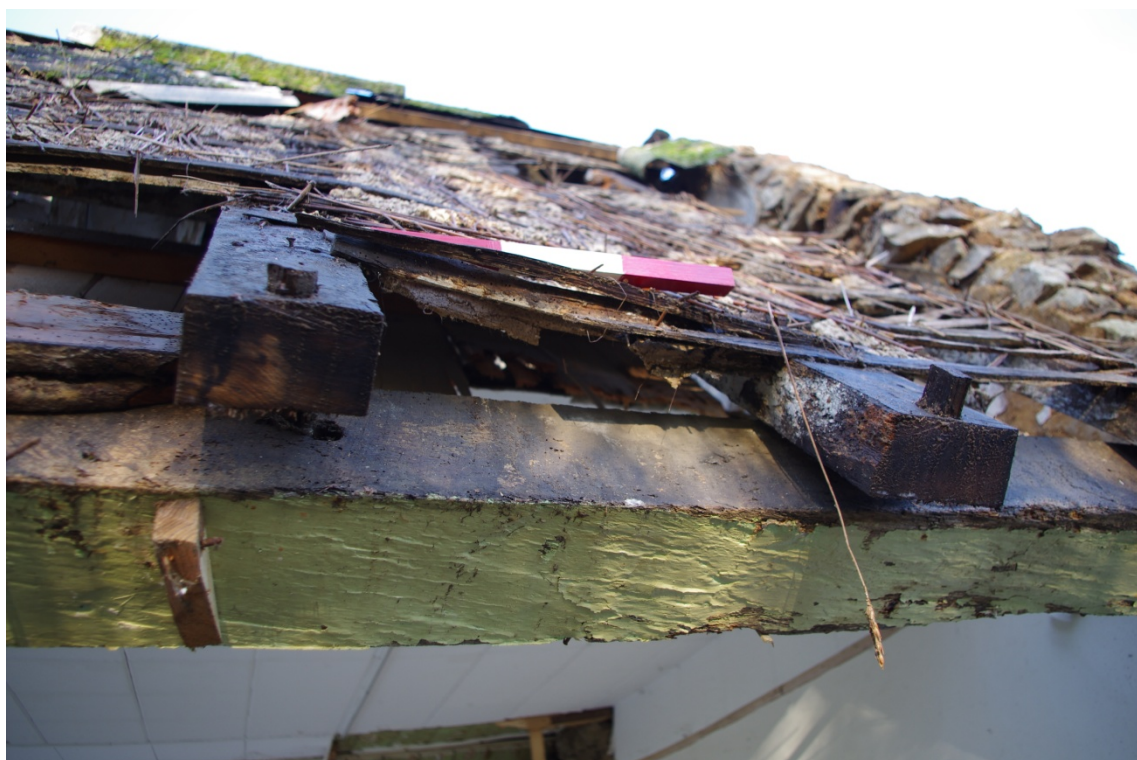
A limited view of some of the rafters exposed during initial stripping out suggested the roof structure may have been of some antiquity; therefore an additional visit was carried out after the removal of the corrugated asbestos cement covering to further record the roof. However, the removal of the modern roofing only revealed that the roof structure was made up of coupled rafters in mixed timber, both early hardwood and 20th century deal (*Figure 10*). Some rafters were little more than barely finished poles. The lack of any uniformity in the roof structure suggests that the timber is likely to be a job lot of second hand timber brought in from elsewhere or retained from the adjacent demolished cottages. These rafters were originally supported on purlins, probably original, since the construction of the modern roof covering the purlins seemed to have little structural purpose. A number of pegged rafters, clearly reused remained (*Figure 11*).

Figure 11
Pegged Common Rafters on South Facing Roof (Room 05).

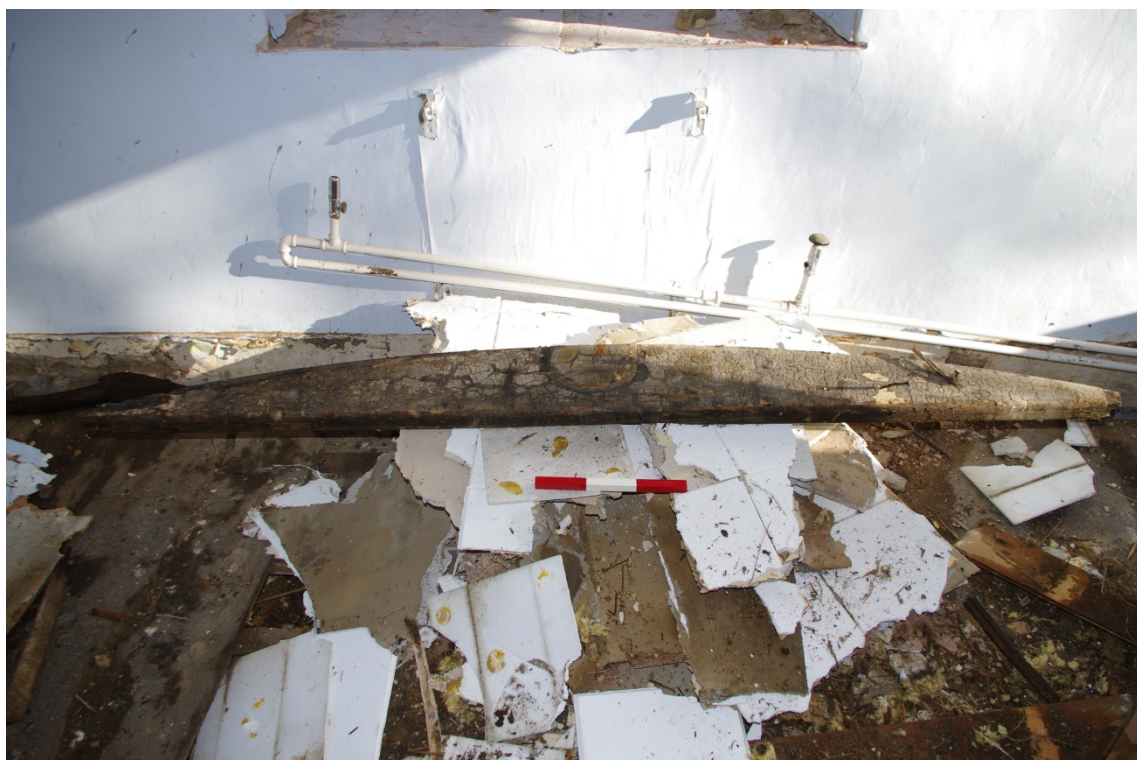
Two interesting timbers were recorded within the roof space. The first (*Figure 12*) is arched piece, likely to be the original lintel piece for one of the eye brow dormers seen on the building in historic photographs. Fragments of a second, apparently identical piece had been used to pack between the purlin and the common rafters on the southern roof of room 05 (*Figure 13*). The second is less easily identified (*Figure 14*) and consists of an oak plank with a raised rounded moulding on one end. It is possible that this timber is a barge board or eaves board dumped in the roof space when the original thatch was removed.

Figure 12
Eyebrow Lintel from Attic Space.

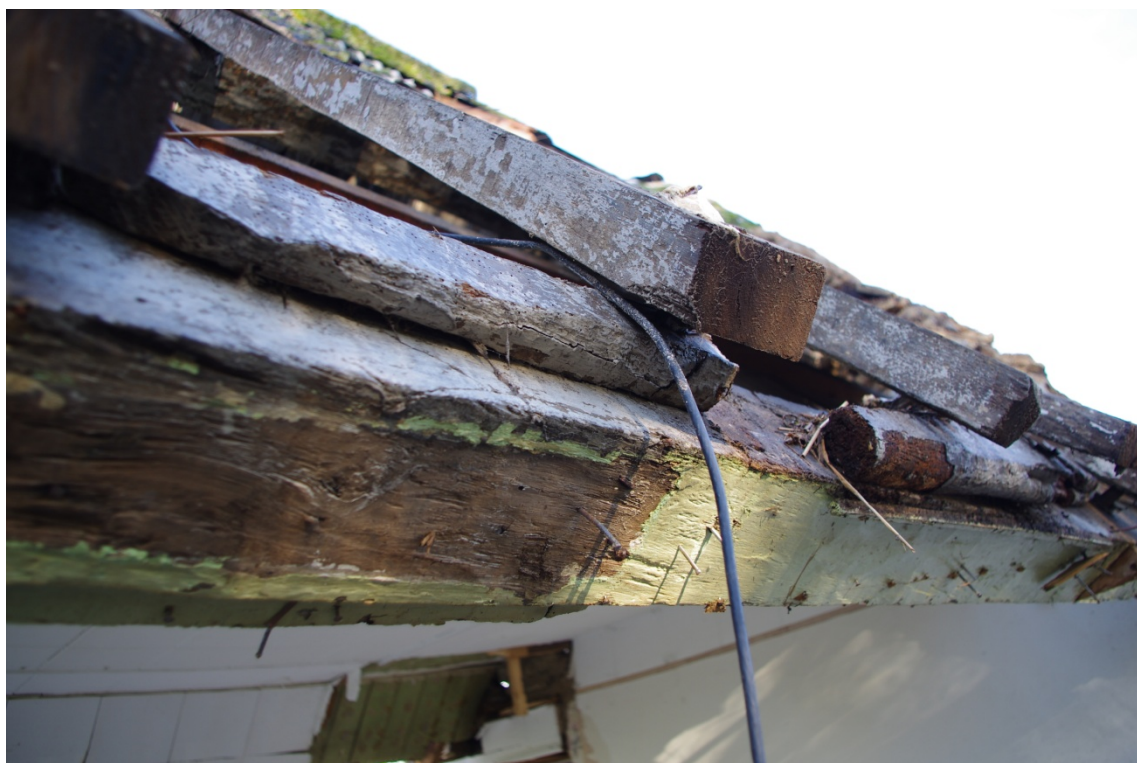
Figure 13
Eyebrow Lintel Piece Used As Packing on Top of Purlin (Room 05).

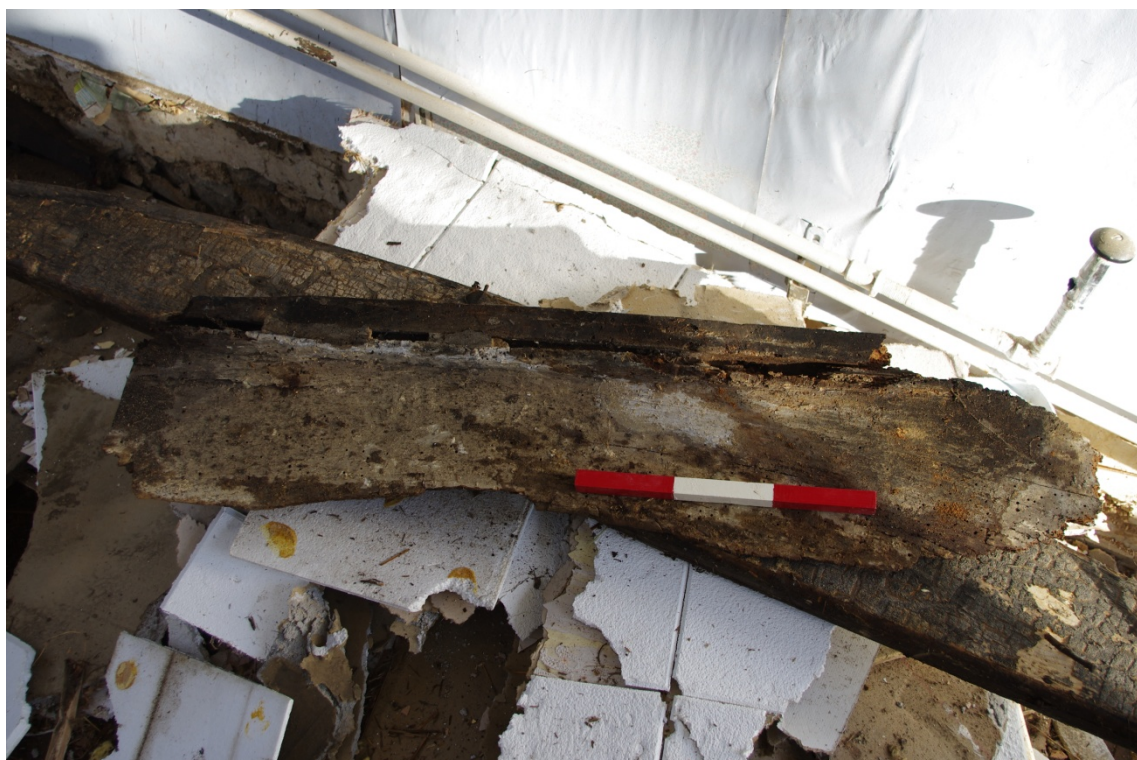
Figure 14
Barge Board/Eaves Board from Attic Space.
