**An Archaeological Standing Building Survey.
Dry Fields Farm,
Norton,
Northamptonshire.
(NGR SP 59953 62100)**

**Planning Permission No
DA/2013/0359**

ABRS Project No 2013-DFNN

**An Archaeological Standing Building Survey of an Outbuilding at Dry Fields Farm,
Norton, Northamptonshire (NGR SP 59953 62100).**

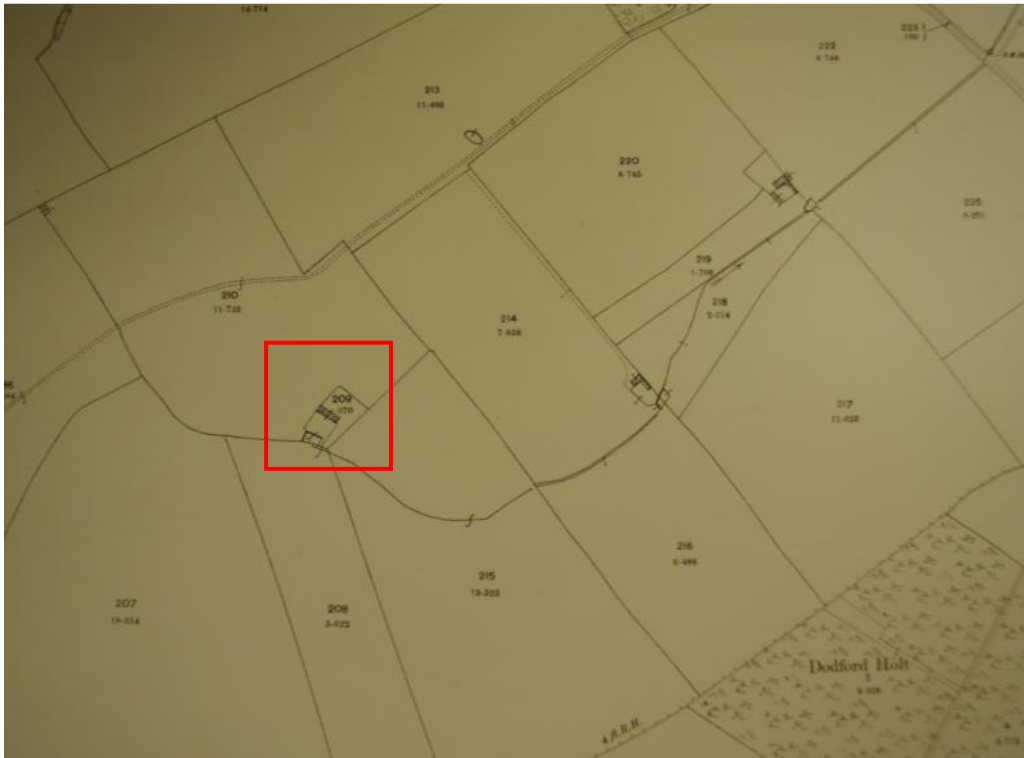
Figure 3
1900 Ordnance Survey XLIII.7 (1:2500)
Proposed Development Area Highlighted in Red.

The building is first recorded on the First Edition Ordnance Survey of 1885, the earliest edition available at Northamptonshire Records Office is the second edition, sheet XLIII.7 published in 1900 (*Figure 3*). The building is clearly identifiable within a yard and small paddock (Field 209) in the south eastern corner of field number 210. The building appears to be three bays. There are further two small complexes to the east of the proposed development area recorded by the Ordnance Survey, both of which are no longer in existence. The larger of the two is identified as being linked to the Glebe water supply (*Figure 4*), so although there is a lack of documentary evidence it is possible that this complex was a Glebe Farm.

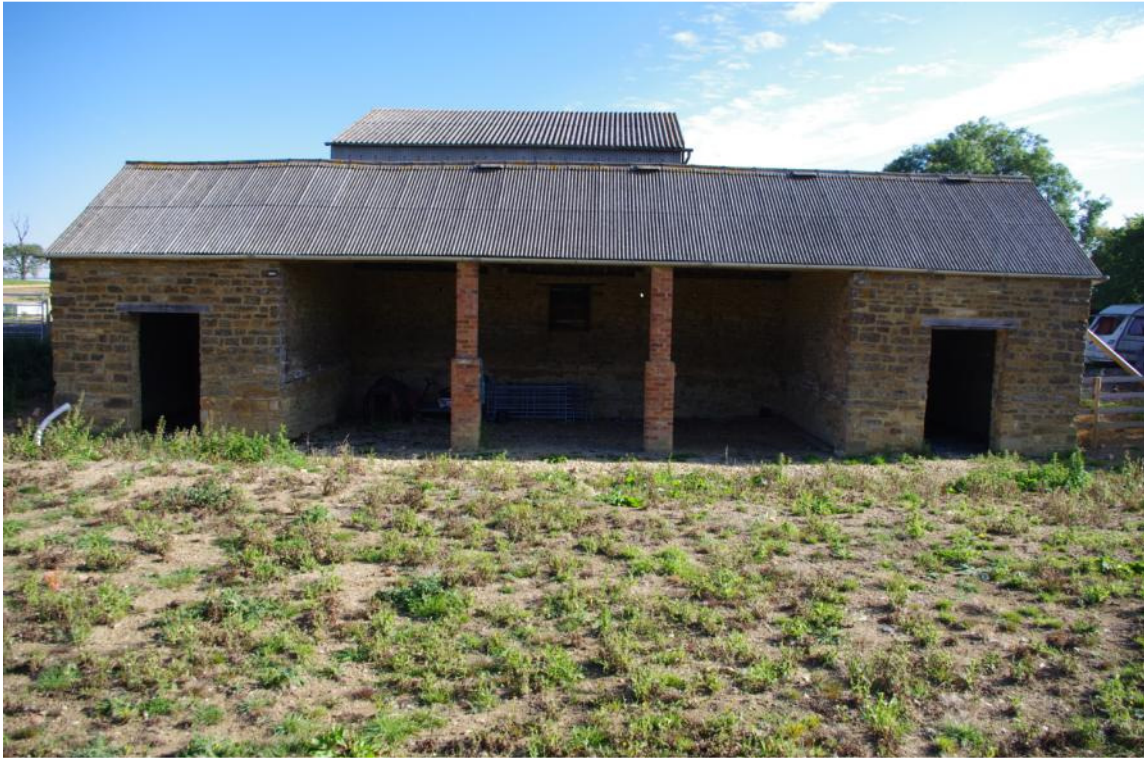
Figure 5
Principal Elevation (looking North East).

The building itself is a single storey stone-built building of local ironstone with a modern corrugated asbestos cement sheet roof. The stonework is roughly squared and coursed and the stones range in size from 50mm x 200mm up to 170mm x 450mm with extensive recent lime mortar pointing. The building consists of three central open bays and two loose boxes, one on each gable (*Figure 18*). As such the building has the appearance of a cart shed. The southern wall plate is carried on two brick-built piers brick dimensions 9inch x 3inch x 4inch (230mm x 76mm x 100mm), again with recent lime mortar pointing, the bricks are red bull nosed bricks probably locally made (*Figure 5*).

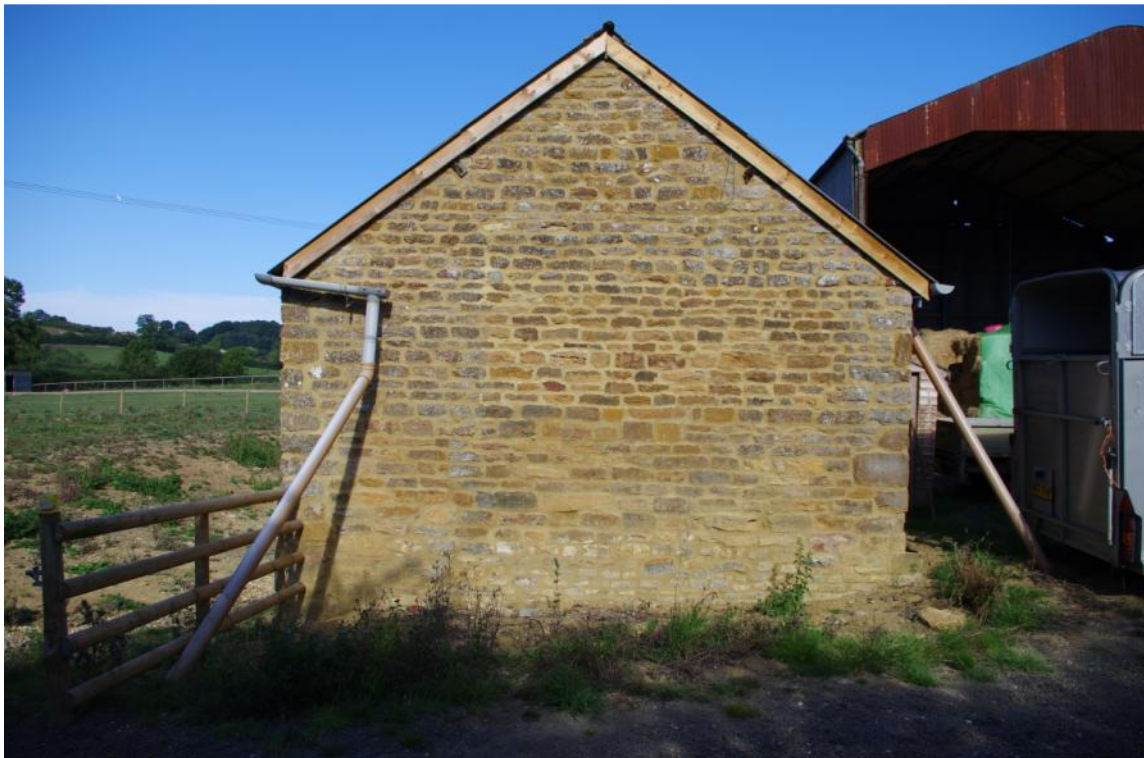
Figure 6
South East Facing Gable (looking North West).

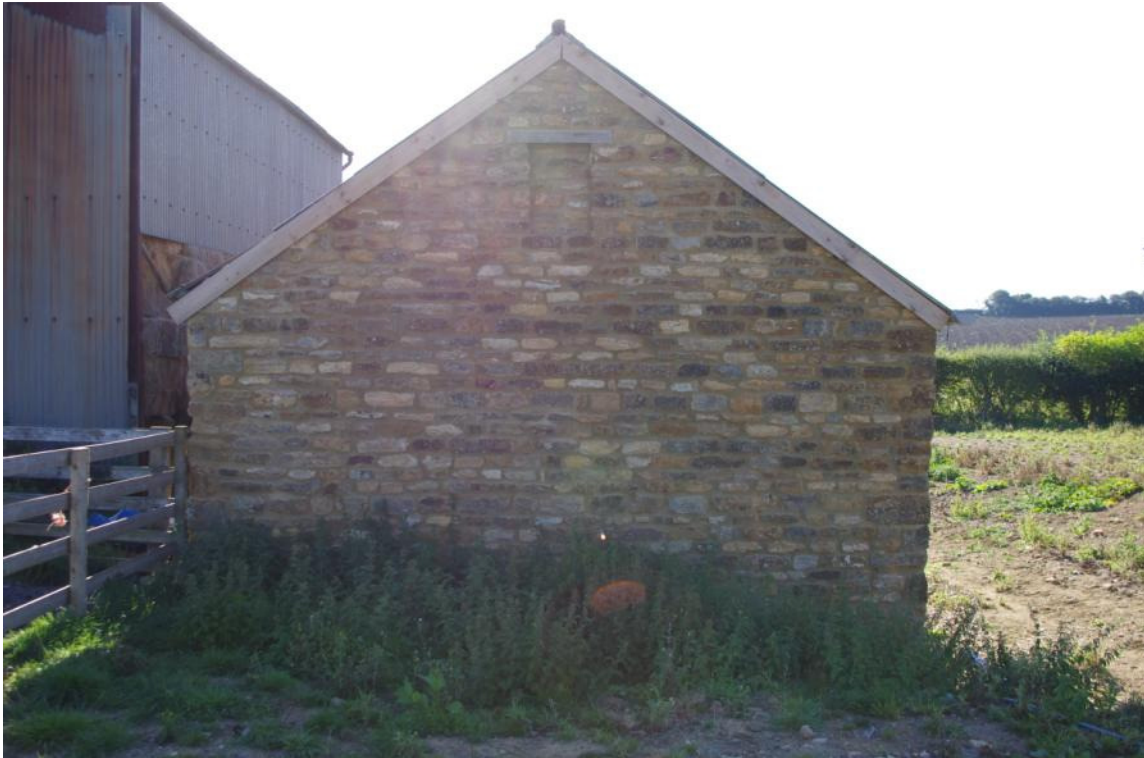
Figure 7
North West Facing Gable (looking South East).

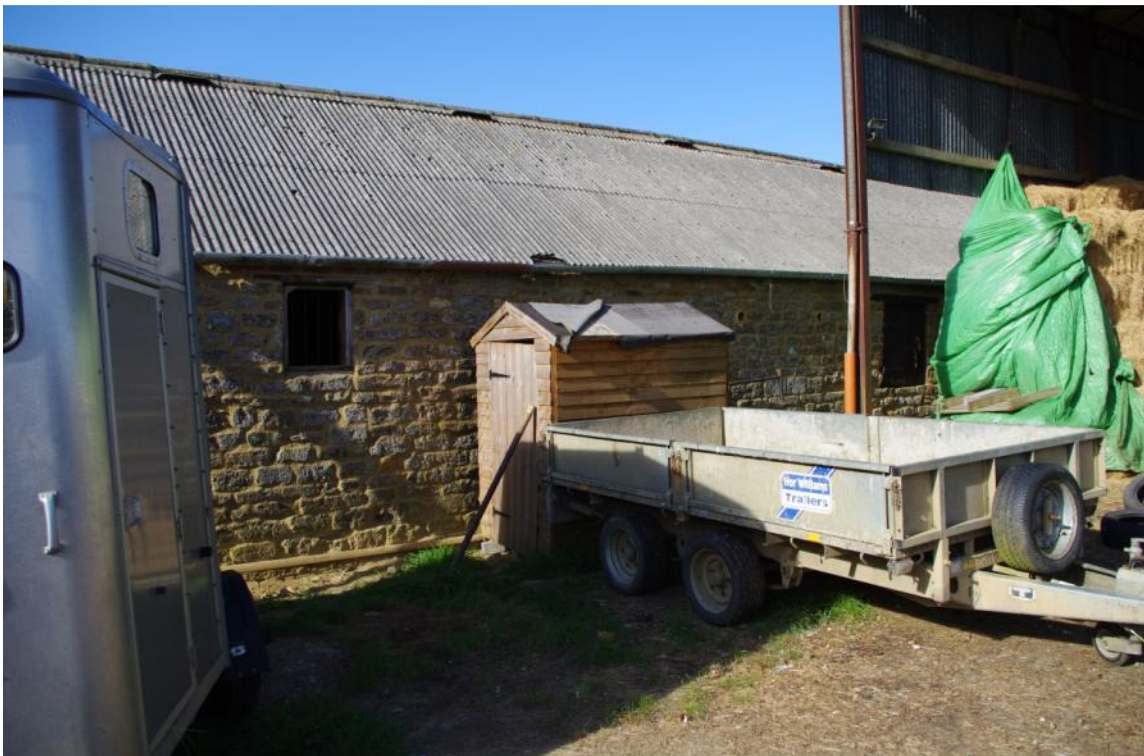
Figure 8
Limited View of Rear Elevation (looking West).

There are two openings on the north east (rear) wall, both near ground level externally but at approximately 2350mm above internal ground level (*Figure 8*). There is a window opening on the rear wall of the right hand loose box, it is likely that there would have been a similar opening in the left hand loose box, but no trace remains, however there is extensive recent pointing suggesting that this part of the building has been re-built, which may conceal the infill. On the north west gable there is a blocked opening at eaves level (*Figure 7*); such an opening may suggest this box originally had a loft, there is however, no internal evidence of this, and the loft space would have been limited, it is likely, therefore that this opening was also a window, perhaps instead of a window in the rear wall.

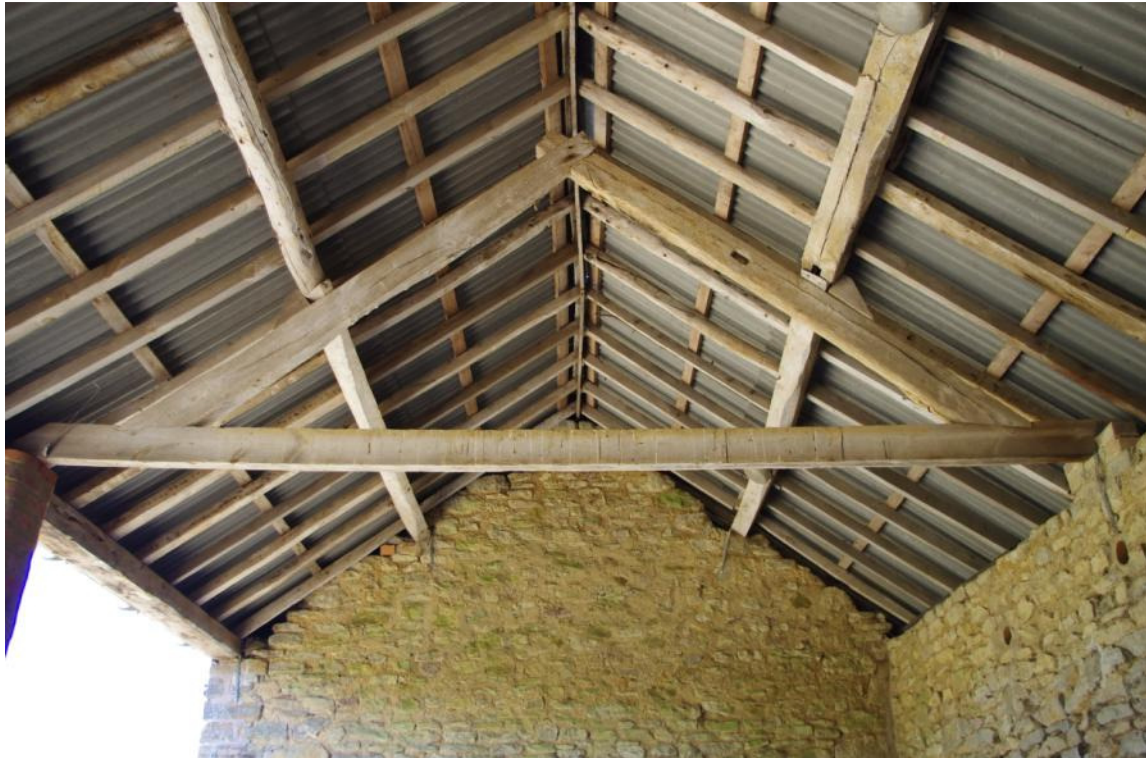
Figure 9
North Western Truss (looking North West).

The roof is carried on two plain tie beam trusses, lapped at the apex (*Figures 9, 10, & 17*) carrying a pair of trenched purlins, common for such a narrow building span. The trusses do not match; one is oak, while the other is mixed oak and deal. Some of the timbers are only roughly finished. There is extensive evidence of re-used timbers throughout the roof, the clearest evidence of which can be seen on the tie beam of the south eastern truss. On its north west face there are open peg holes, next to which are carpenters marks (*Figure 14*), numbering the peg holes front to back (in its current position) from two to four in Roman numerals. Further evidence of this tie-beam's re-use can be seen on its south east face, where adjacent to the rear wall a series of open tenons can be seen (*Figure 15*). Both the spacing of the tenons and the angle suggest they originally held common rafters and that this beam was originally a wall plate in a different building.

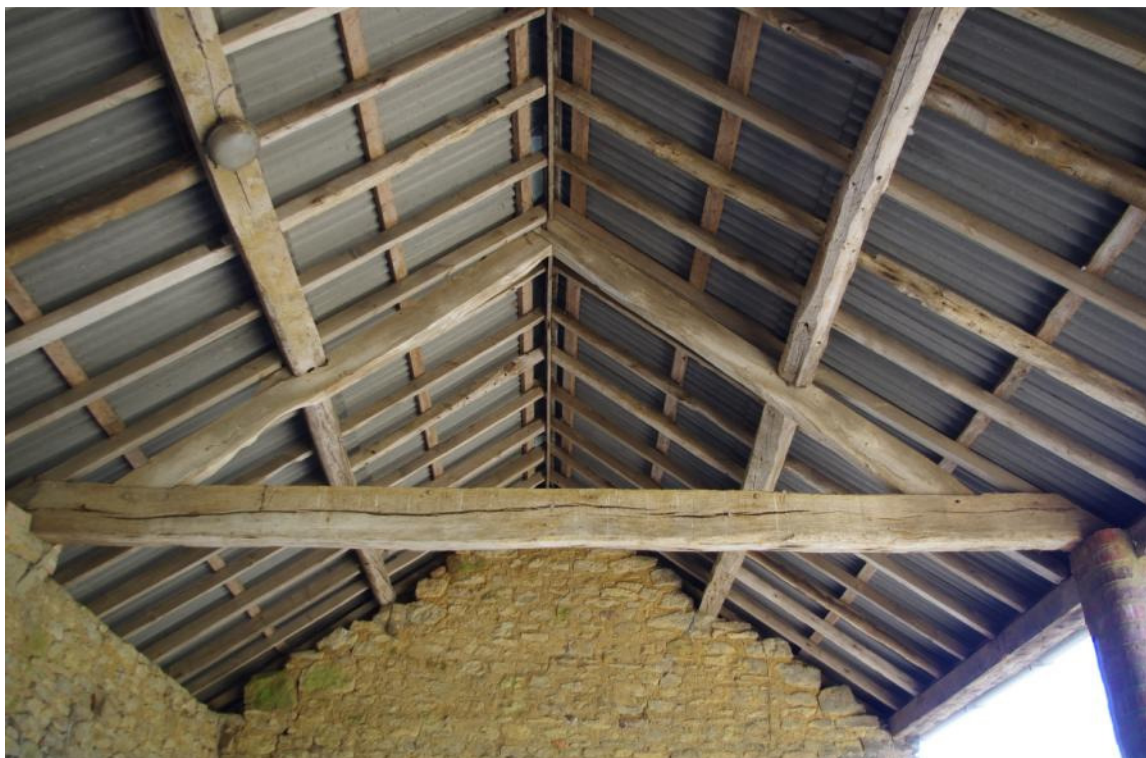
Figure 10
South Eastern Truss (looking South East).

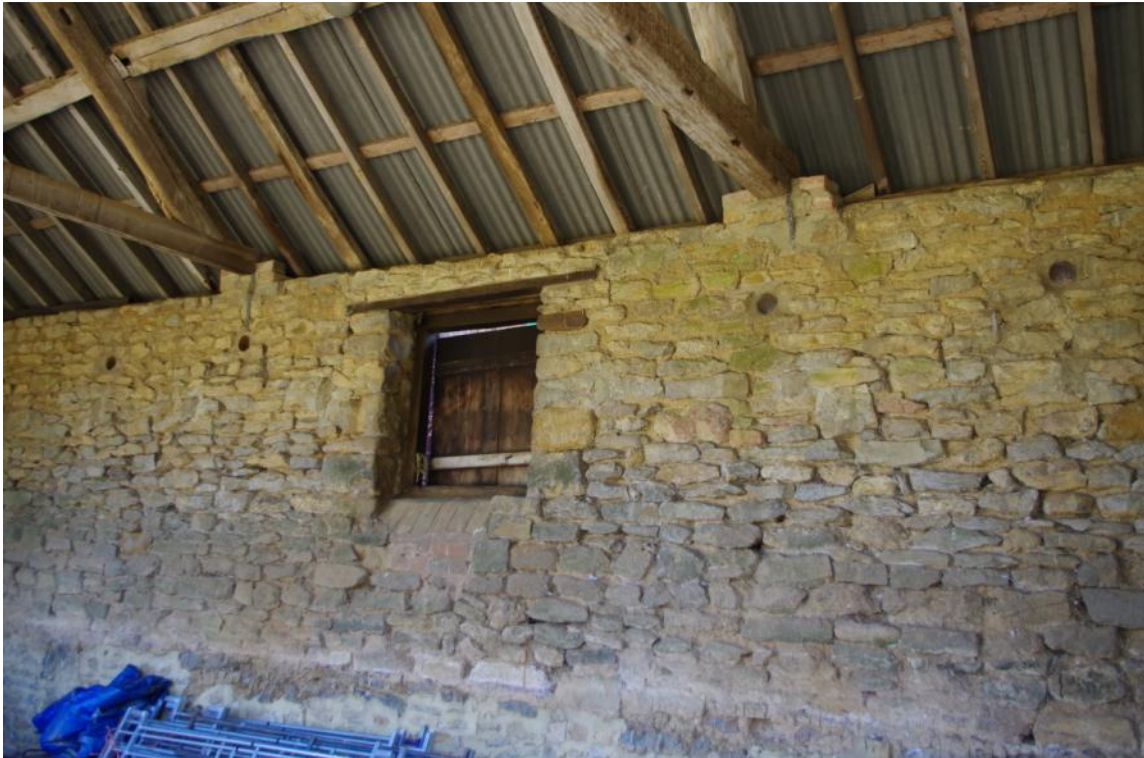
Figure 11
Rear Elevation (Internal) Showing Feeding Hole & Ventilation Pipes (looking North).

The size and location of the central opening (*Figure 11*) suggests it was originally a pitching, or feeding hole. In the 19th century feeding passages were incorporated into cow hovels allowing farmers to lay feed directly at the cows head speeding up the feeding and reducing waste because the farmer no longer needed to push pass the beasts from behind with the danger of dropped feed being fouled in the dung. Although there is clearly no feeding passage with this particular building, this central opening could have been used for the purpose of laying feed at the cows heads without having to pass the beasts themselves. This confirms documentary sources that the building was indeed, originally a cow hovel and not, as it appears now a cart shed. Further evidence of this are the ceramic ventilation pipes in the rear wall (*Figure 11*), such pipes are common in cow hovels providing fresh air to the cows heads.

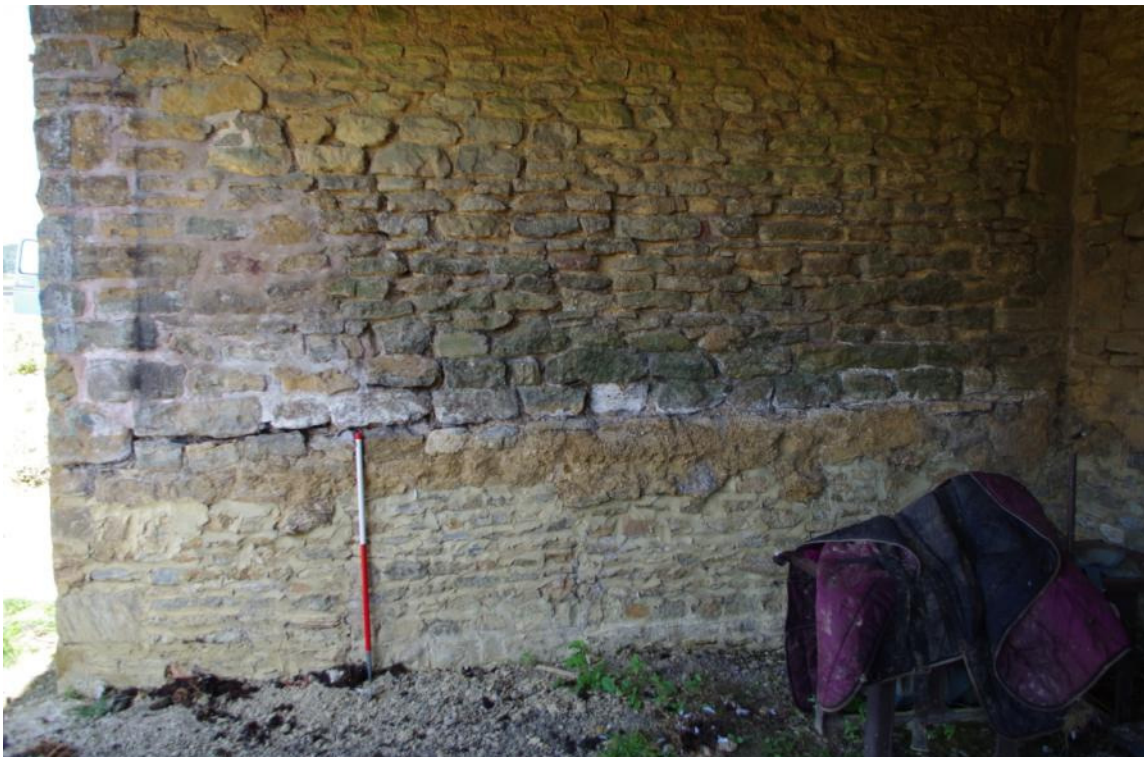
Figure 12
Probable Original Floor Level Showing on North West Wall (looking North West).

Internally, there is little of architectural or historical interest remaining; the internal north west gable and rear wall of the left hand box have been skinned in modern breeze blocks, further evidence that this part of the building may have been re-built, the remainder of the walls are the original rubble built faces. The floor appears to be modern disturbed material. There is evidence of what was likely to be the original floor level visible at approximately 800 to 1000mm above current ground level on the north west wall (*Figure 12*). It appears, therefore that the floor level has been reduced at some point. This recent change in floor level again confirms why the building has the appearance of a cart shed rather than a cow hovel. Cow hovels were originally built with low roofs to retain heat; cart sheds were built to include a loft over, and were therefore taller. Evidence of an originally higher floor level again confirms the building as a cow hovel.

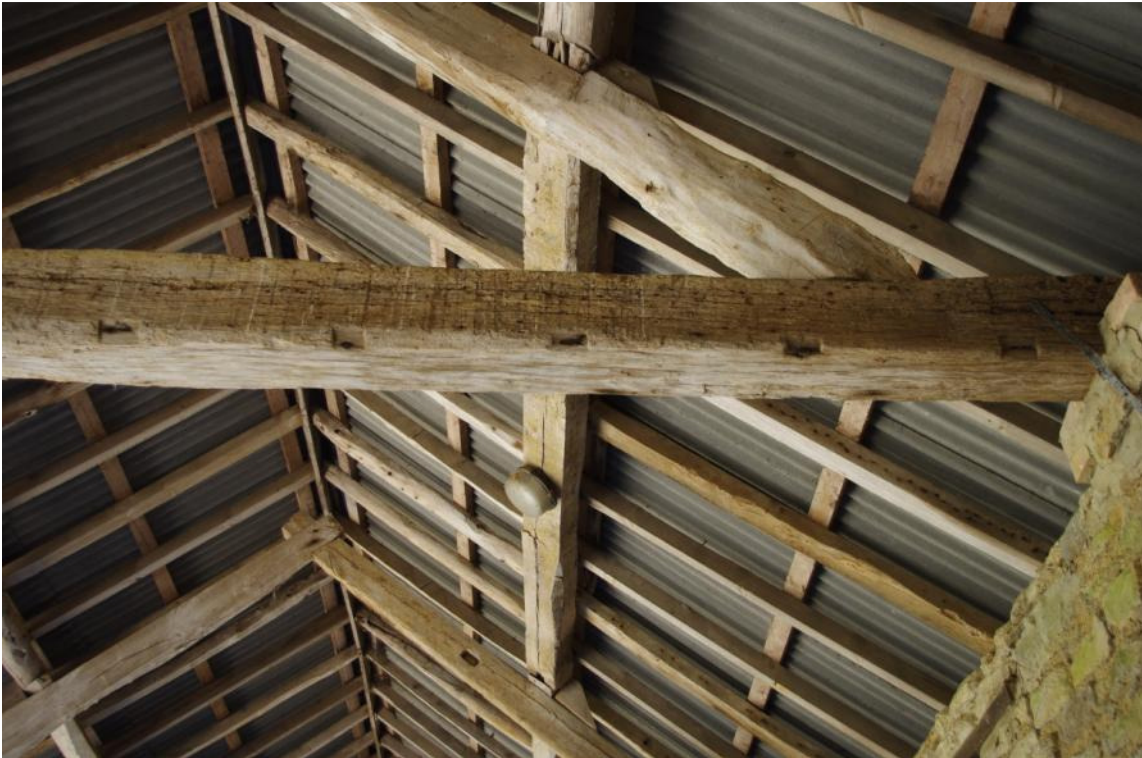
Figure 13
Empty Tenons on Tie Beam of South Eastern Truss.

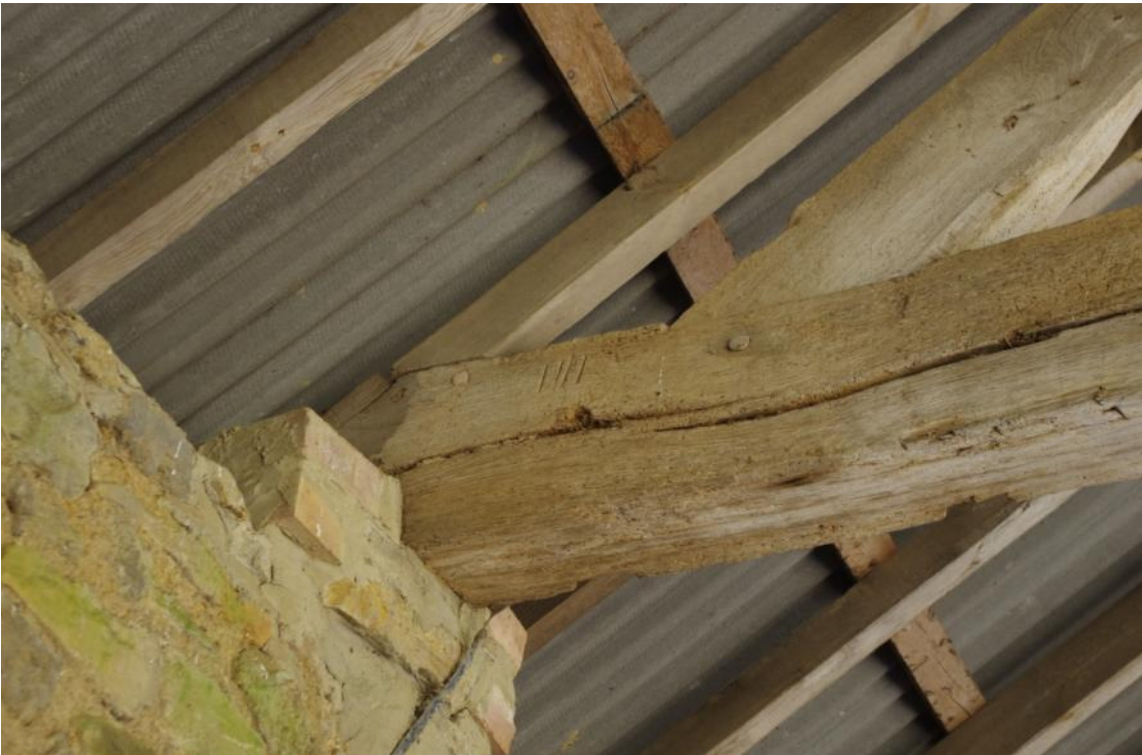
Figure 14
Carpenters Mark on Tie Beam of South Eastern Truss.

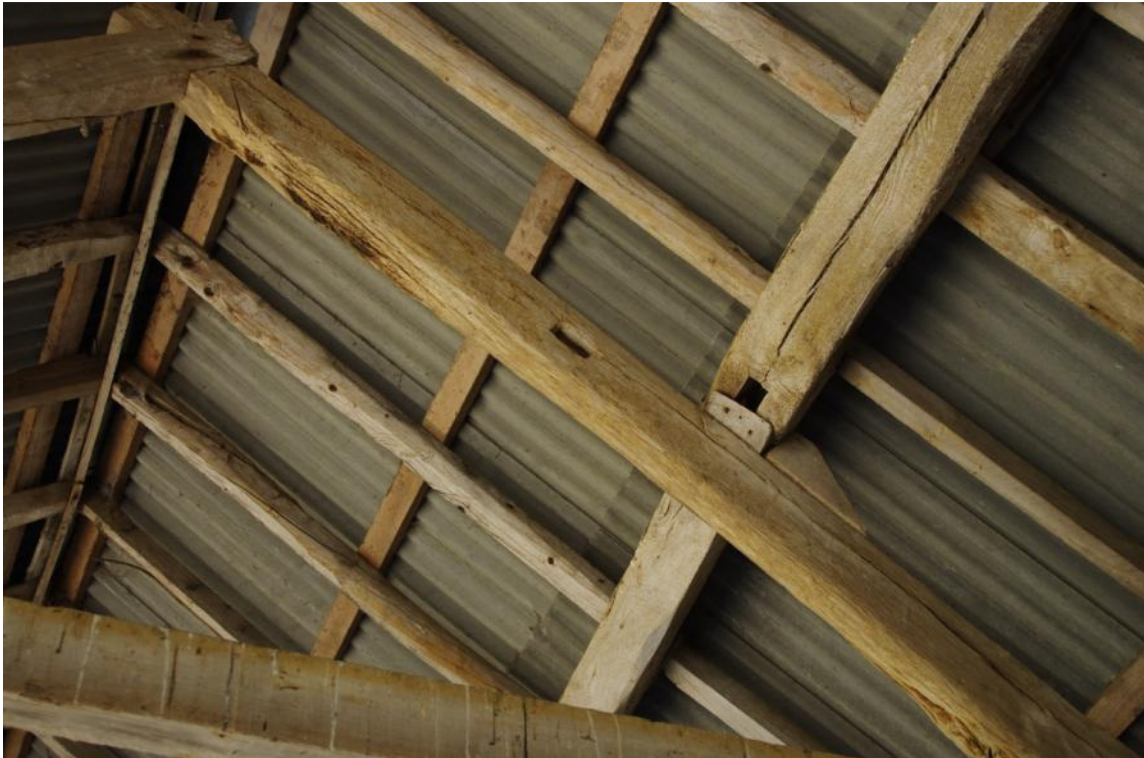
Figure 15
Empty Tenon on Principal Rafter, North West Truss.

The north westernmost truss is made of both hand finished oak (the principal rafters) and deal (the tie beam). The rear rafter contains an open tenon adjacent to the purlin (*Figure 15*). This location could suggest that there was originally a wind brace here, this is however,

unlikely given the small size of the roof and the lack of a corresponding tenon on the front rafter, and it is more likely that the rafter is again a re-used timber.

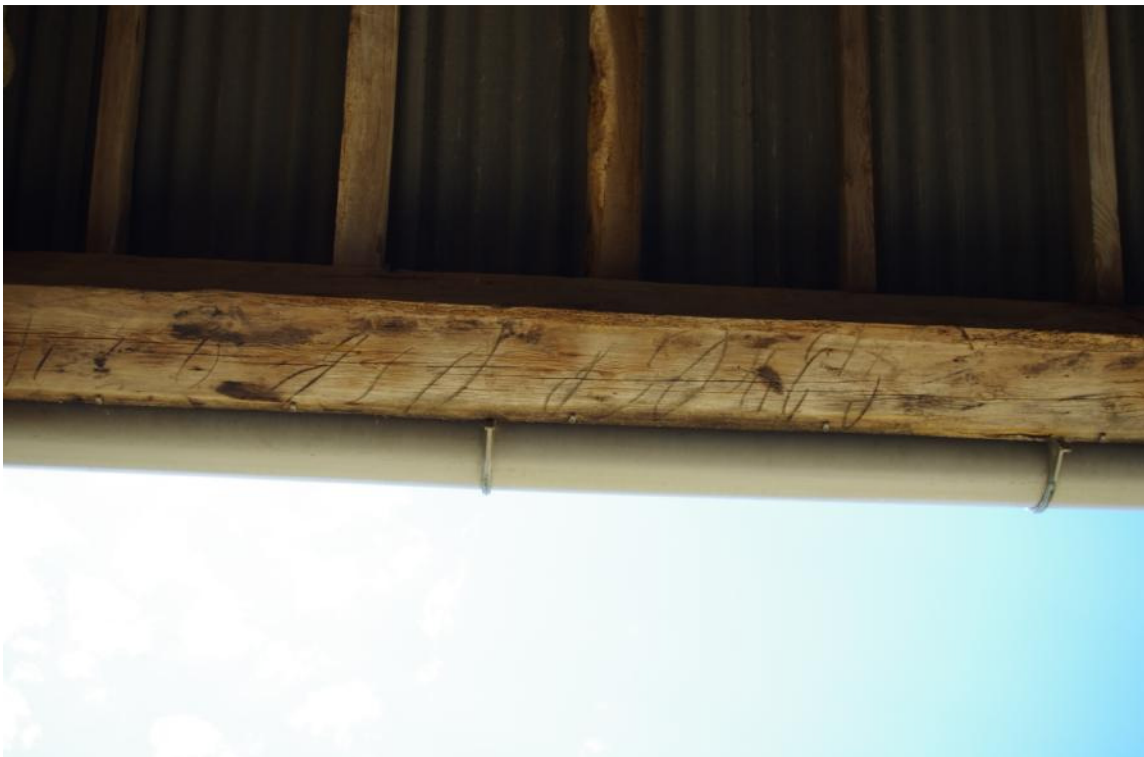
Figure 16
Rase Marks on Wall Plate.

The wall plate in the principal elevation appears to be deal and is likely to be original. A number of rase, or shipping marks can be identified on the underside of the timber (*Figure 16*). These marks would be scored into the timber using a rase knife either immediately after purchase or during shipping. Both Arabic and Roman numerals are known to have been used. Once the timbers have been cut interpreting such marks is extremely difficult as they no longer complete, although in this case the rase marks can be tentatively identified Arabic numerals, the number 4 can be clearly made out at the far left of figure 16. The marks are likely to represent ownership, order numbers, shipping information or other such information.
