**An Archaeological Standing Building Survey.
Heathencote Farm,
Heathencote,
Northamptonshire.
(NGR SP 471216 247942)**

**Planning Permission No
S/2012/0128/FUL**

ABRS Project No 2013-HFHN

**An Archaeological Standing Building Survey of Outbuildings at Heathencote Farm,
Heathencote, Northamptonshire (NGR SP 471216 247942).**

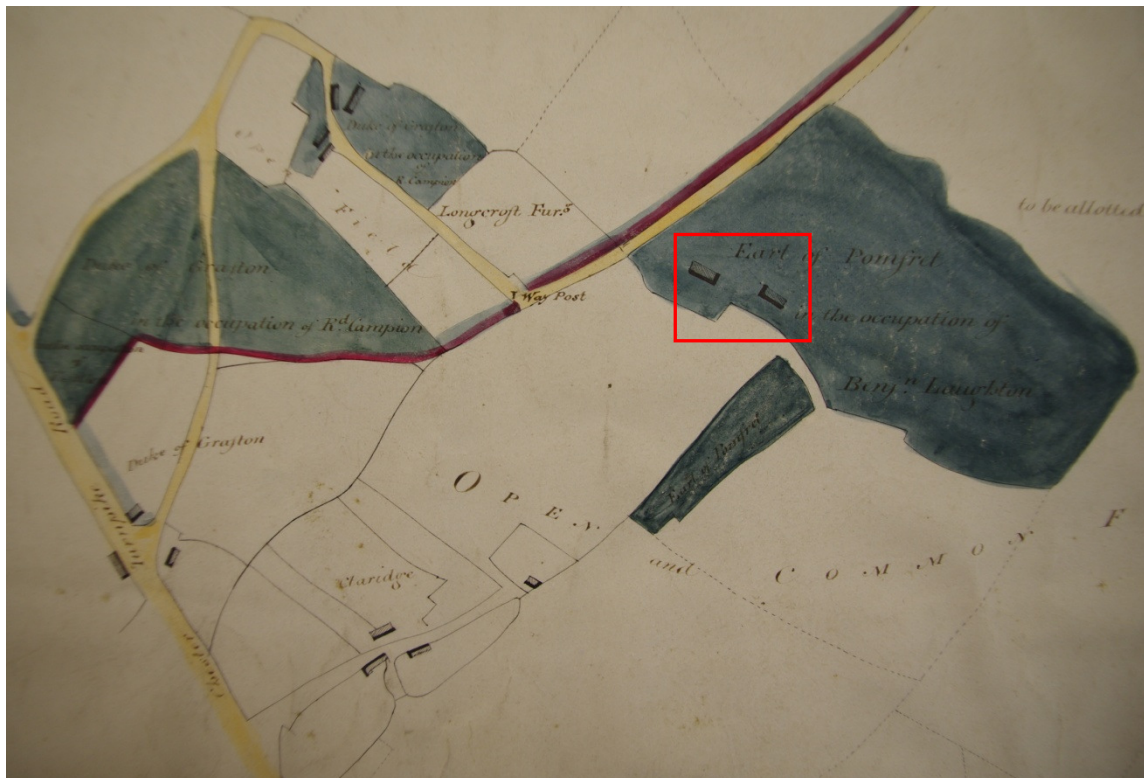
Figure 3
1819 Inclosure Map.

The 1819 Inclosure Map (*Figure 3*) records two buildings on the site of Heathencote Farm, both of which are on the same alignment as present Heathencote Farmhouse, so it is likely that one of the buildings is the farmhouse, there are no buildings recorded at the location of the outbuildings. It is possible that the outbuildings were built post 1844 after the farm became the property of the Grafton Estate.

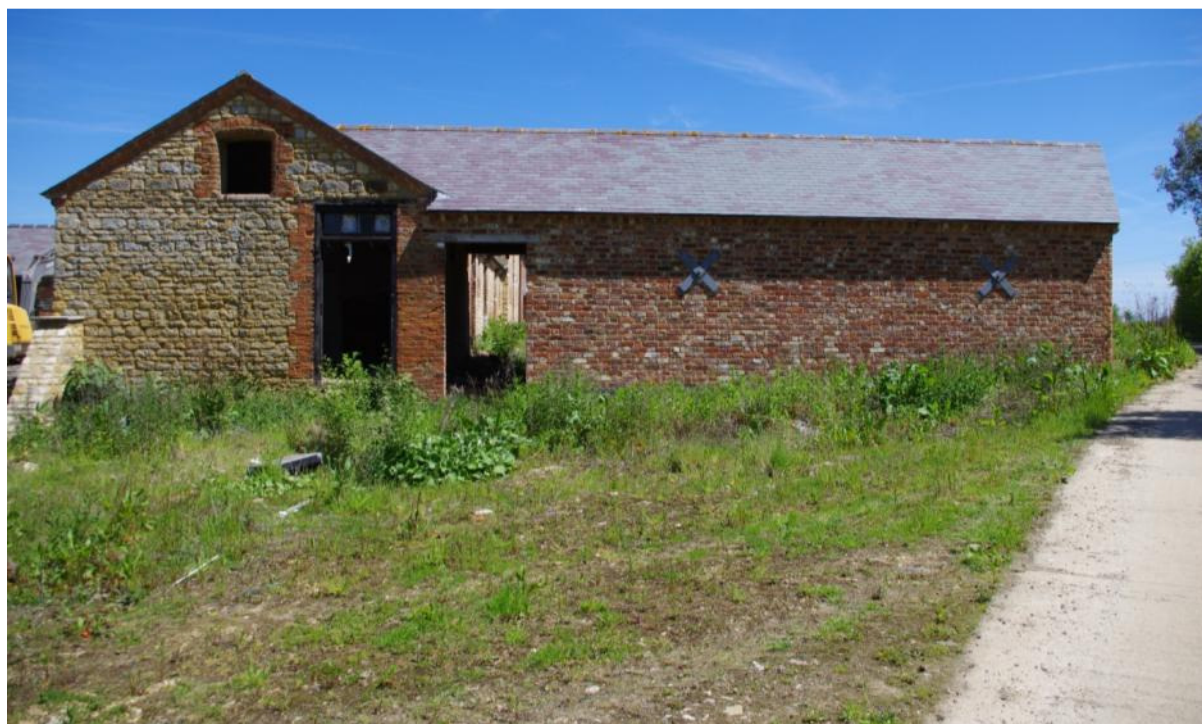
Figure 4
Building A, West Facing Elevation (Looking East).

Building a is the southernmost building (*Figures 2 & 20*); it is a north-south aligned open fronted (east) stone and brick-built single storey building under a pitched roof of new Welsh Slate. The west wall is brick-built, while the southern gable wall is local coursed stone, both with lime mortar. The building appears to have been largely re-built in the modern period. The interior of the building contains nothing of architectural or historical significance and the floor is earth and the roof structure in new timber.

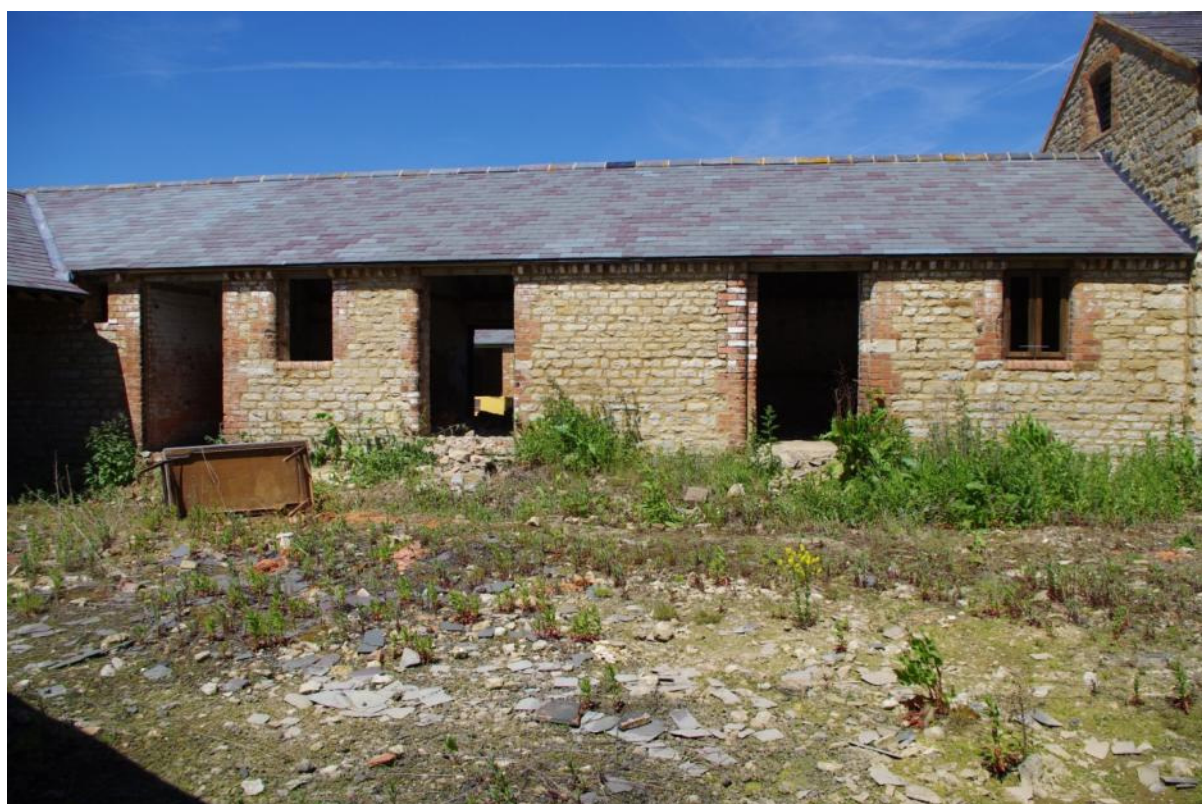
Figure 5
Building B, South Facing Elevation (Looking North).

Building b is the westernmost building in the central range, aligned east-west (*Figures 2 & 20*). The building is built of coursed and roughly squared local stone with red bull nosed brick corbels. Door and window reveals are built of local red bull nosed bricks; brick dimensions 9inch x 3inch x 4 ½ inch (220mm x 550mm x 110mm). The roof is again modern Welsh Slate and the roof timbers themselves are modern.

Internally the building is three bays, with access on the west gable and two doors on the north wall. The eastern bays have original looking widow openings, while, there is also an original window opening high in the west gable. One of the windows on the southern wall overlooks building a, again suggesting that buildings post dates the others. All internal walls are brick-built. The brick dimensions match those of the window and door reveals. The bricks are laid

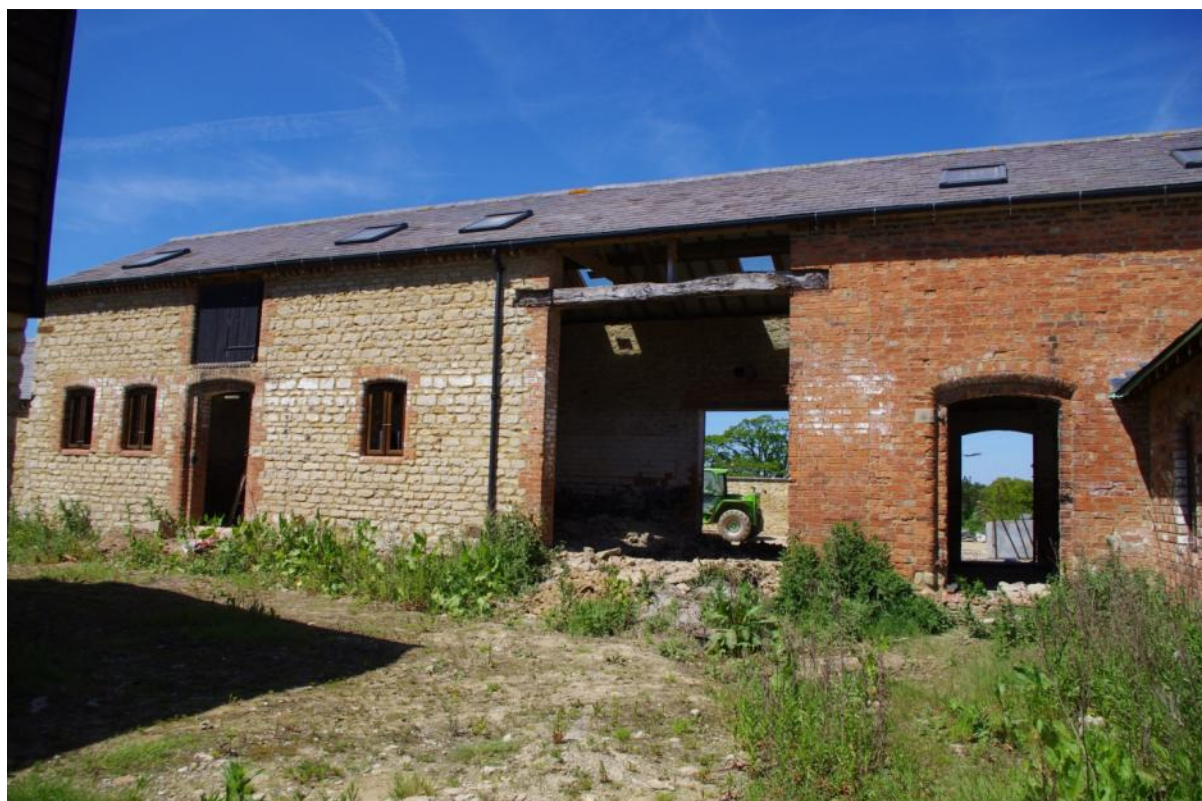
Figure 6
Buildings C & D, South Facing Elevations (Looking North).

Building c is located immediately east of building b (*Figures 2 & 20*). There is a brick-built partition between the two, the brick dimensions, 9inch x 3inc x 4 ½ inch (220mm x 550mm x 110mm) and the same English Garden Wall bond suggests the wall is original. The exterior walls are again coursed and roughly squared local stone with red bull nosed brick corbels. The door and window reveals are again red bull nosed bricks. The roof is again modern Welsh Slate and the roof timbers are also modern.

Building d is located immediately to the east of c (*Figures 2 & 20*), it is a small single bay divided into two unequal loose boxes. As with the rest of the buildings the walls are coursed and roughly squared local stone with red bull nosed brick corbels. The door and window reveals are again red bull nosed bricks. The roof is again modern Welsh Slate and the roof timbers are also modern. Unlike the other buildings, there is a loft. Unusually, there are four window openings, two on each north and south elevation, this unusual layout is perhaps an attempt to improve the ventilation to the boxes, restricted by the loft. The direct access between d and c, the cow house, suggests the loose boxes in d are calving pens.

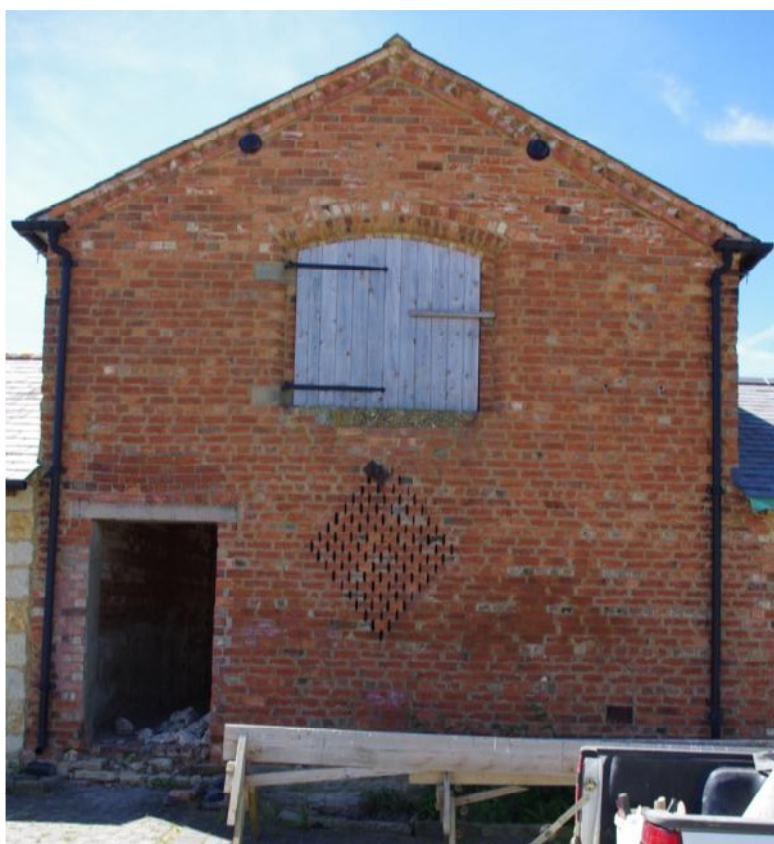
Figure 7
Building E, East Facing Gable (Looking West).

Building e is the largest of the buildings within the proposed development area and is the only one with clear evidence of phased building. Building e is a twin bay barn, the western bay (*Figure 20*) is built of coursed and roughly squared local stone with red bull nosed brick corbels. The door and window reveals are again red bull nosed bricks, the roof is again modern Welsh Slate and the majority of the roof timbers are also modern, the west truss, is, however original. The eastern bay is built of red bricks, brick dimensions 9inch x 3inch x 4 ½ inch (220mm x 550mm x 110mm), laid in an English Garden Wall bond (one course of header bricks to three courses of stretcher bricks) with saw tooth corbelling on the east gable along with a diamond vent (*Figure 7*). Again there is an original truss, as well as an original purlin surviving within the roof structure, possibly oak.

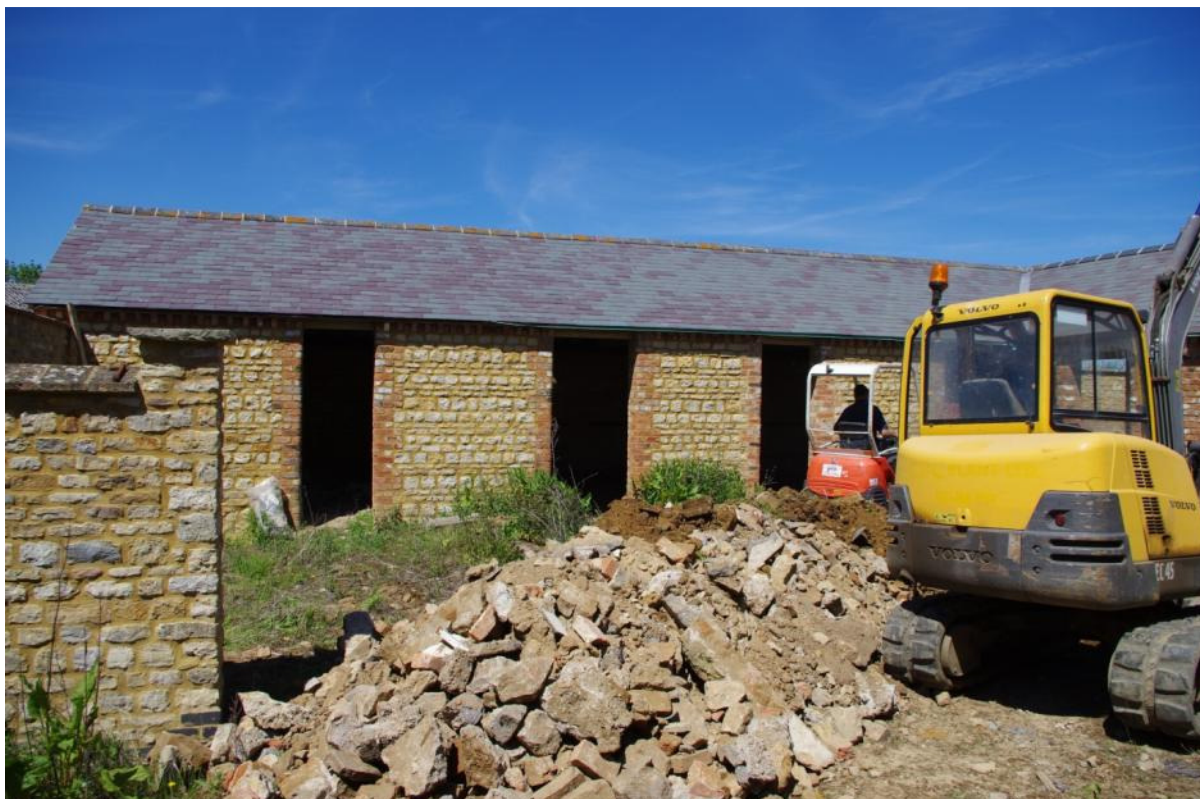
Figure 8
Building G, South Facing Elevation (Looking North).

Building g is located in the north westernmost corner of the group of buildings (*Figure 20*), forming the northern edge of courtyard 1, and facing building b. The south facing elevation is brick-built, brick dimensions 9inch x 3inch x 4 ½ inch (220mm x 550mm x 110mm), laid in an English Garden Wall bond (one course of header bricks to three courses of stretcher bricks) with bull nosed brick corbels. The north facing elevation is built of coursed and roughly squared local stone. The door and window reveal on the western gable are again red bull nosed bricks, the roof is again modern Welsh Slate and the roof timbers have been replaced.

The building consists of three bays, with brick –built partition walls; the western bays open onto yard 1 via four single doors while the easternmost bay has an open gable facing yard 2 to the east. There are two doors in the wall between the central bay and the eastern bay as well as a single door and window in the gable wall of the western most bay.

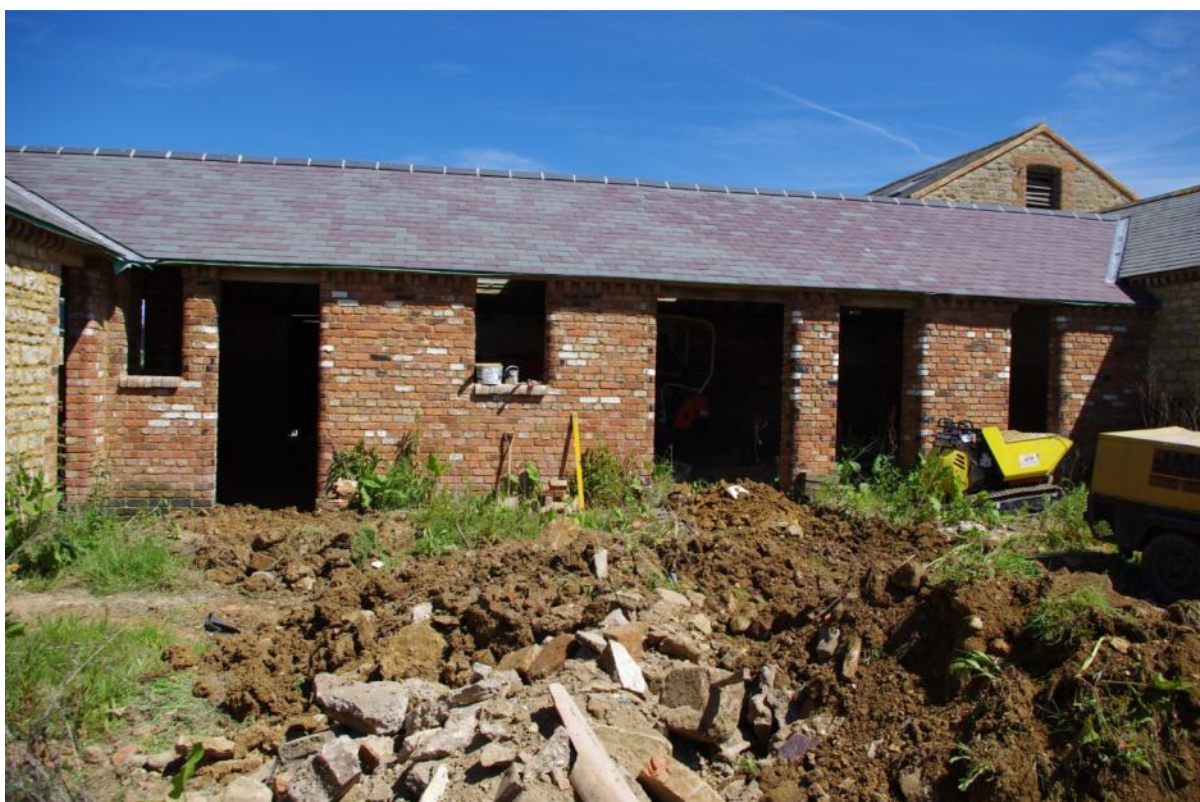
Figure 9
Building H, West Facing Elevation (Looking East).

Building h is located perpendicular to buildings c and g closing the eastern end of courtyard 1 and the western end of courtyard 2 (*Figure 20*). The building is brick-built, brick dimensions 9inch x 3inch x 4 ½ inch (220mm x 550mm x 110mm), laid in an English Garden Wall bond (one course of header bricks to three courses of stretcher bricks) with bull nosed brick corbels, the roof is again modern Welsh Slate and the roof timbers have been replaced.

The building is unusual in form with a central door on the west facing elevation with a second, smaller door only 870mm (approximately 2' 10") to the south. There is a central door in the north gable wall leading to a cross passage between to two yards. Although the building clearly abutts building c the recent re-pointing makes it difficult to establish whether the building post dates c or is contemporary.

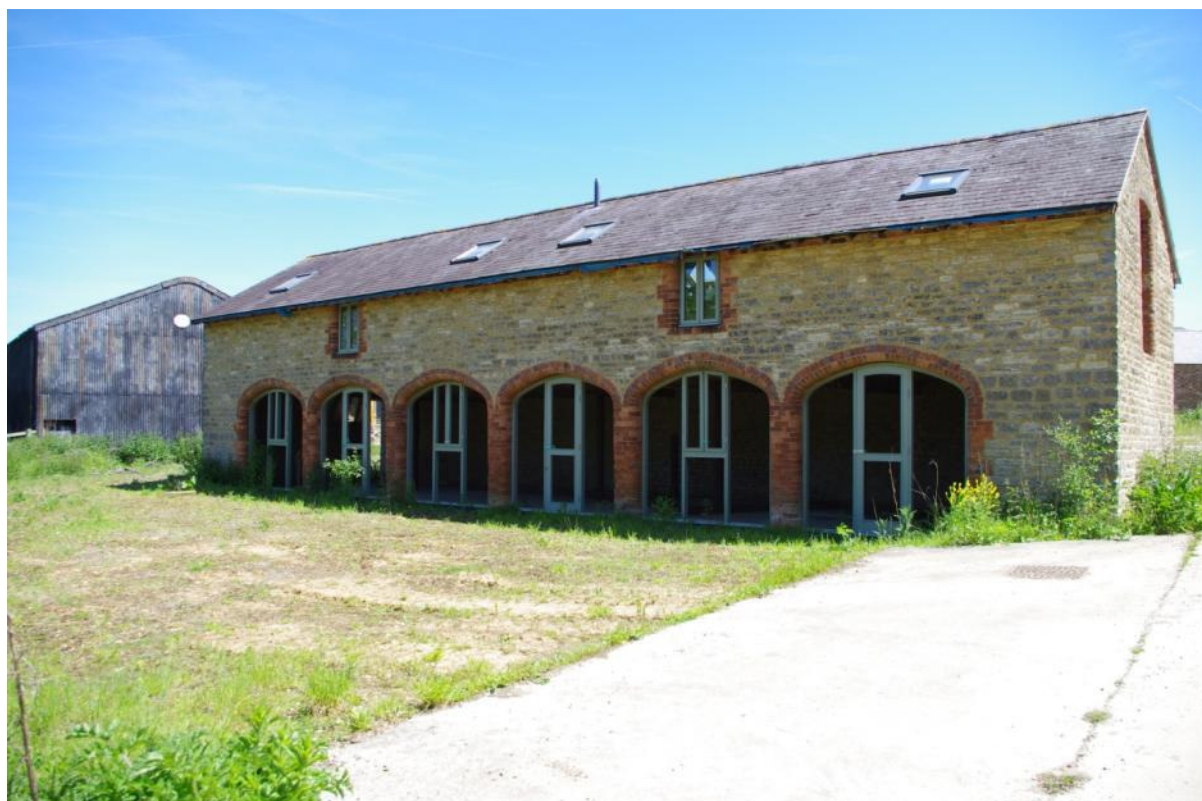
Figure 10
Building K, West Facing Elevation (Looking East).

The building itself is a two storey cartshed built of coursed and squared local stone, the door and window reveals are red bull nosed bricks, the roof is again modern Welsh Slate and is rather striking in appearance. The arched openings are brick (brick dimensions 9inch x 3inch x 4 ½ inch (220mm x 550mm x 110mm)), as are the piers and located on the west elevation, as is common the openings face away from the farmyard, with the intention that animals were less likely to enter the building from the yards and damage either themselves or the machinery. There is groundfloor access to the rear of the building via a door in the eastern end of the north gable (*Figure 21*).

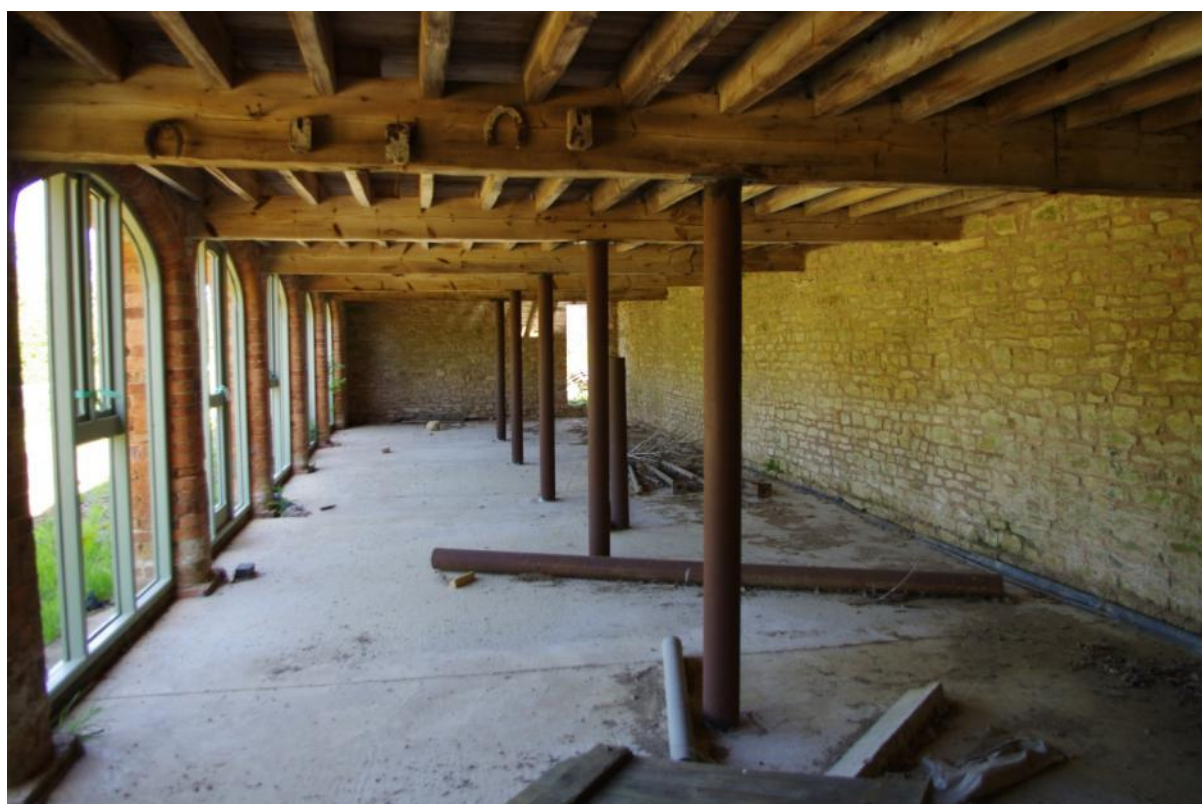
Figure 11
Building K Groundfloor (Looking North).

Internally, at groundfloor level, there little of architectural or historical interest remaining; the first floor is carried on substantial axial beams (*Figure 11*). Steel columns have been inserted to support these beams in the modern era. A number of rase, or shipping marks can be identified on the some of the beams (*Figure 15*). These marks would be scored into the timber using a rase knife either immediately after purchase or during shipping. Both Arabic and Roman numerals are known to have been used. Once the timbers have been cut interpreting such marks is extremely difficult as they no longer complete, although the rase marks on the far left of *Figure 15* can be tentatively interpreted as the numbers 8 and 7 in Arabic numerals and are likely to represent ownership, order numbers, shipping information or other such information.

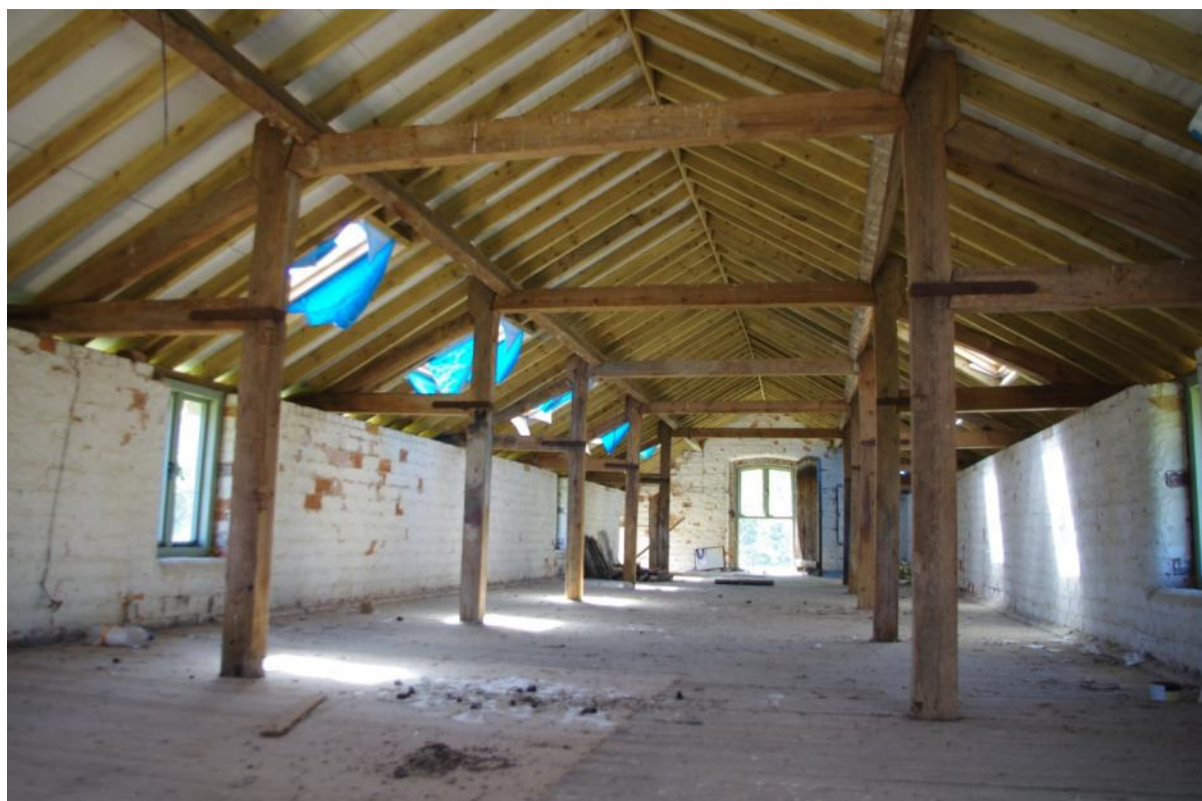
Figure 12
Building K First Floor (Looking South).

The roof structure remains largely intact and un-altered. The roof is carried on 5 queen post trusses (*Figures 12 & 21*). The advantage of the Queen Post Truss is its ability to span greater distances than the King Post truss and the “box” formed between the horizontal and vertical timbers allowed access along the length of the building within the roof space. In this case, confirming that the first floor was used as storage, almost certainly a granary. Interestingly the same finish of bricks laid on end seen in building e is again present within building k. Although the bricks themselves appear to be of a poorer finish and possibly handmade.

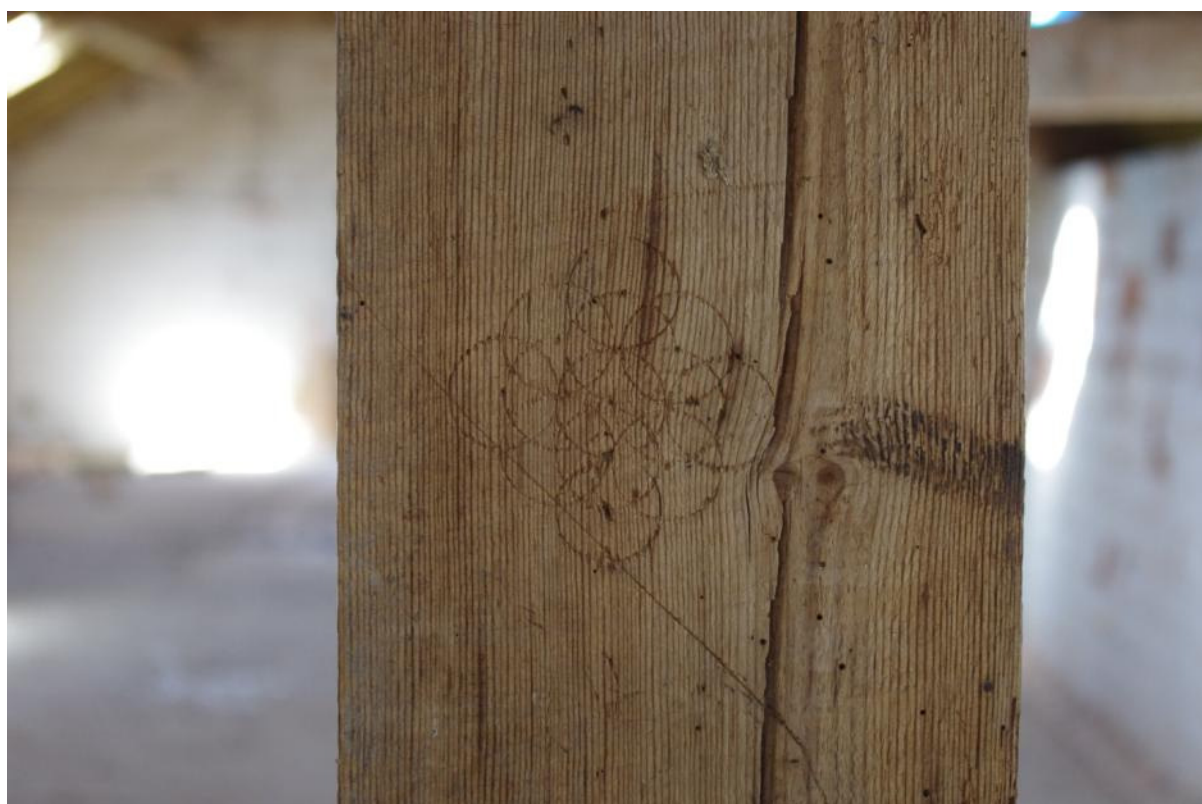
Figure 13
Apotropaic Mark, Building K.

A number of historical features still remain including original roof trusses, evidence of mechanisation, most probably a horse engine in yard 2 and a an incised Apotropaic Mark of overlapping circles on a queen post within the cartshed.

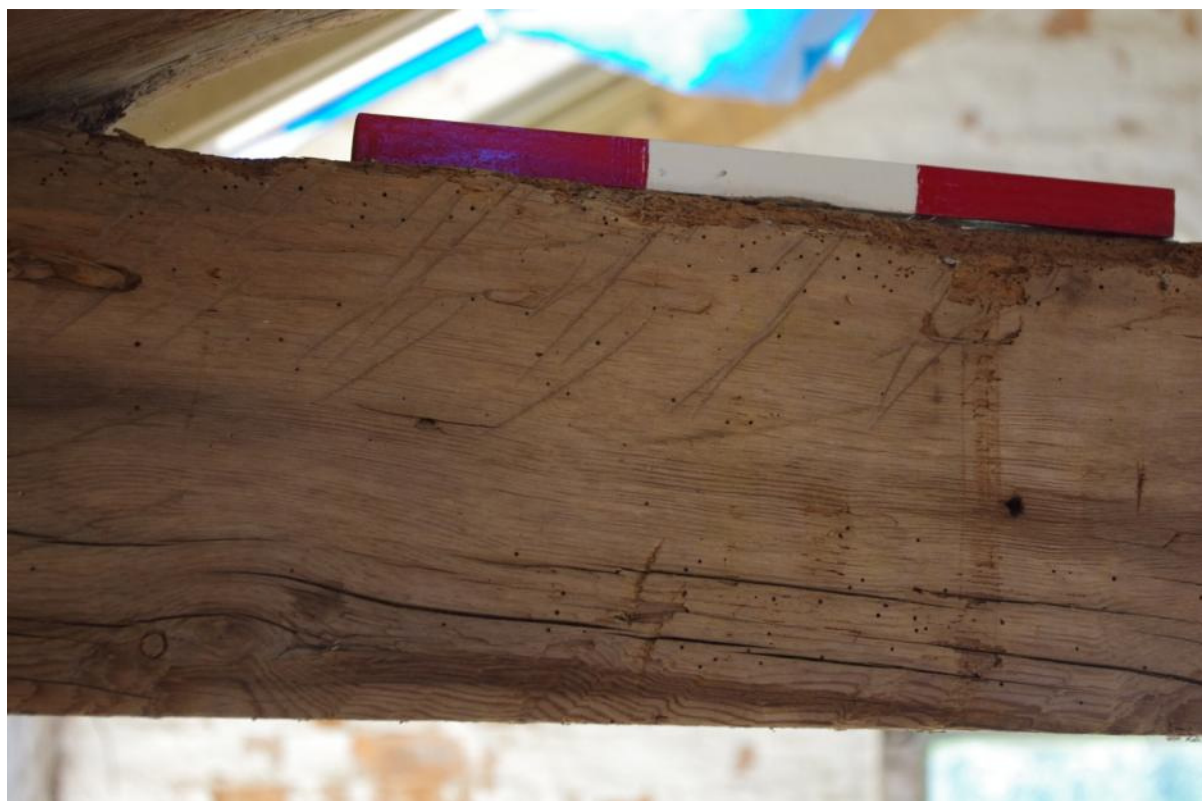
Figure 14
Rase Marks, Building K.

As with the timbers recorded on the groundfloor a number of rase marks could be seen on the timbers (*Figures 14 & 16*), one of which, *Figure 16* on the eastern purlin may be identifiable as a 1, a 8, a 0 and a fourth un-identifiable symbol. In addition to the rase marks a group of incised circles can be seen on the eastern queen post of the second truss (*Figures 13 & 21*). These circles form an Apotropaic (evil averting) ritual mark and became common from the 17th century; their aim was to protect the building from witches or their familiars and were frequently located near to fireplaces and doors. The most common pattern formed by these incised circles are “Daisy Wheels”, overlapping circles creating a six petal flower, in this example, however, only a four petal flower has been created, whether by accident or by design is unknown. Its location, on a Queen Post near the door suggests that the mark was used to protect the harvest stored in the granary from harm.

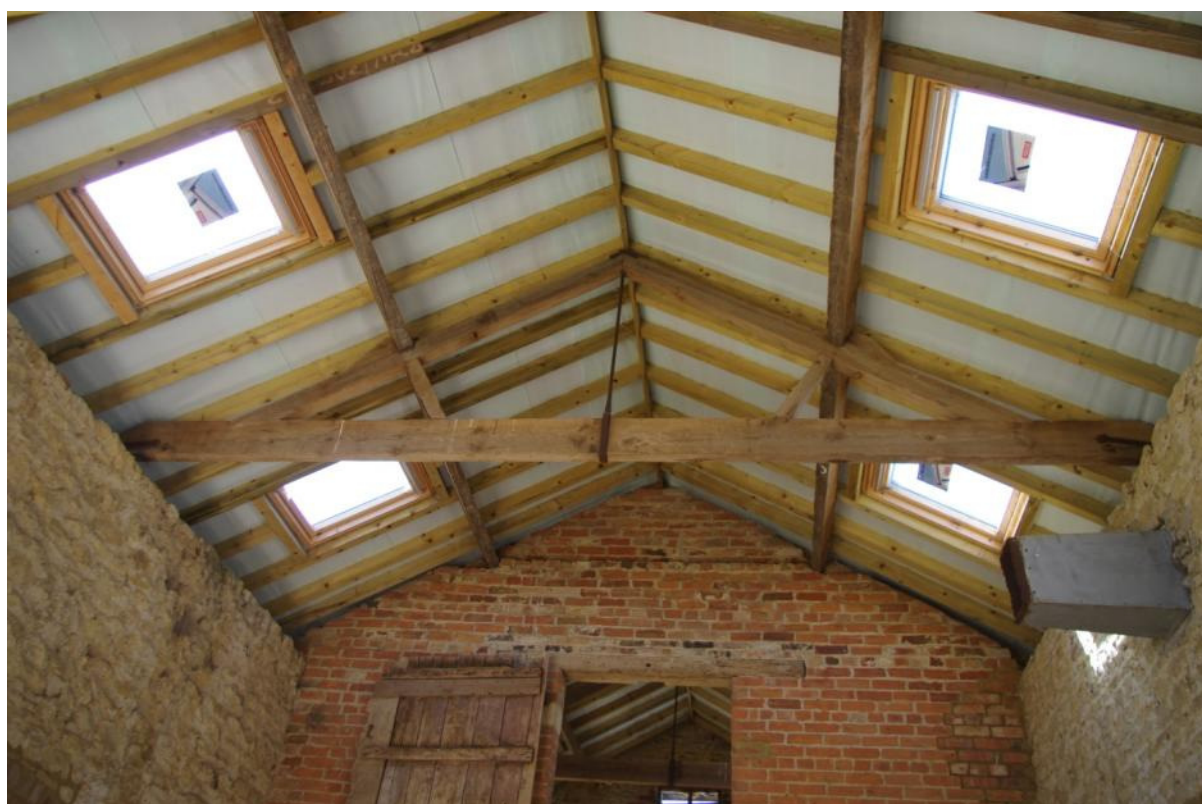
Figure 17
Original Truss, Building D.

The original truss (*Figure 17*) consists of an iron king post truss with raking struts, there is also an iron stirrup attached to both king post and tie beam. There is also an angled iron bracket on the apex of the principal rafters attached to both the king post and both rafters.

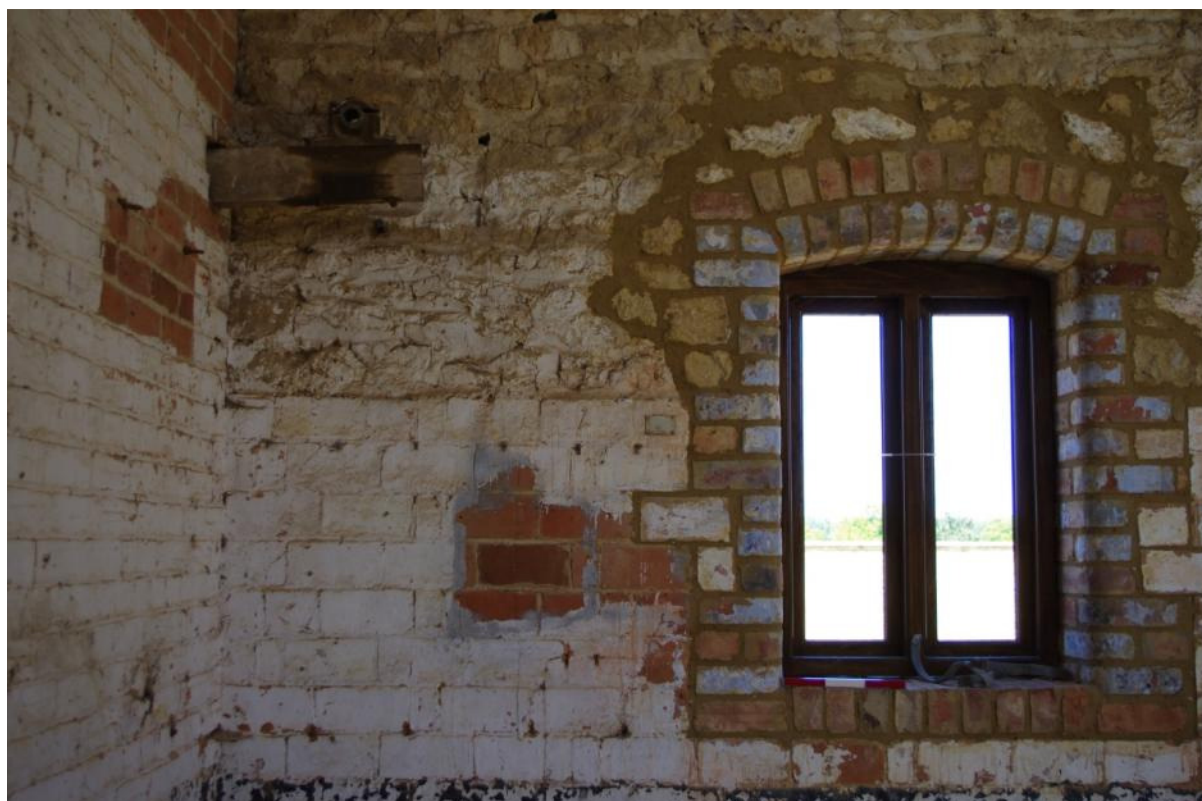
Figure 18
Bricks Laid on End & Shaft Bearing (Top Left), Building D.

Internally, there are a number of interesting features remaining. Within the west bay there is a bearing mounted on the timber projecting from the western wall indicating a belt drive, run either by a steam engine or a horse engine once operating within the barn. Secondly and more unusual are the bricks used to face the interior of the stone walls; either unusual sized bricks measuring 4 ½ inch x 9 inch have been used or common red bricks have been laid on end (*Figures 18 & 20*). This internal finishing is only used to approximately 2 metres above the existing floor level, the remainder of the interior is exposed stone. Laying bricks in this way undoubtedly consumed fewer bricks and was therefore cheaper, but may also have served as a form of pest control, creating fewer orifices in which rodents could nest close to the stored crops.
