**An Archaeological Standing Building Survey.
The Red Lion,
Thornby,
Northamptonshire.
(NGR SP 67046 75662)**

ABRS Report No 2013-RLTN

November 2013

**Planning Permission No
DA/2013/0325**

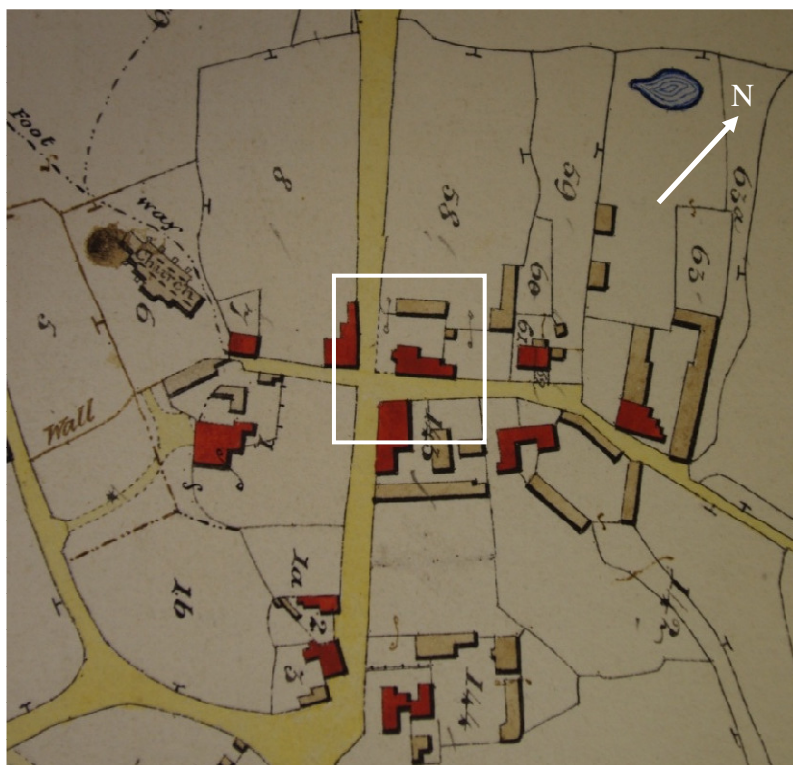
Figure 2 Tithe Map, Thornby Parish (1840).

The map and its accompanying apportionment (NRO Ref T.212) clearly record the public house building as well as the building subject to this historic building recording. The apportionment describes the plot as a house, garden and a close, which at the time was under pasture. The plot was tenanted by John Watts and owned by William Gee. Watts also tenanted a further 6 large fields within the parish. The first reference to John Watts as landlord occurs in *Kellys Directory of Northamptonshire* 1847; John Watts is listed as “farmer & Red Lion”.

Although no key is apparent attached to the map, domestic buildings appeared to be coloured red while out buildings are coloured yellow. The building subject to this building recording is shown as an outbuilding. The building appears to be larger than it currently stands, extending some distance to the east.

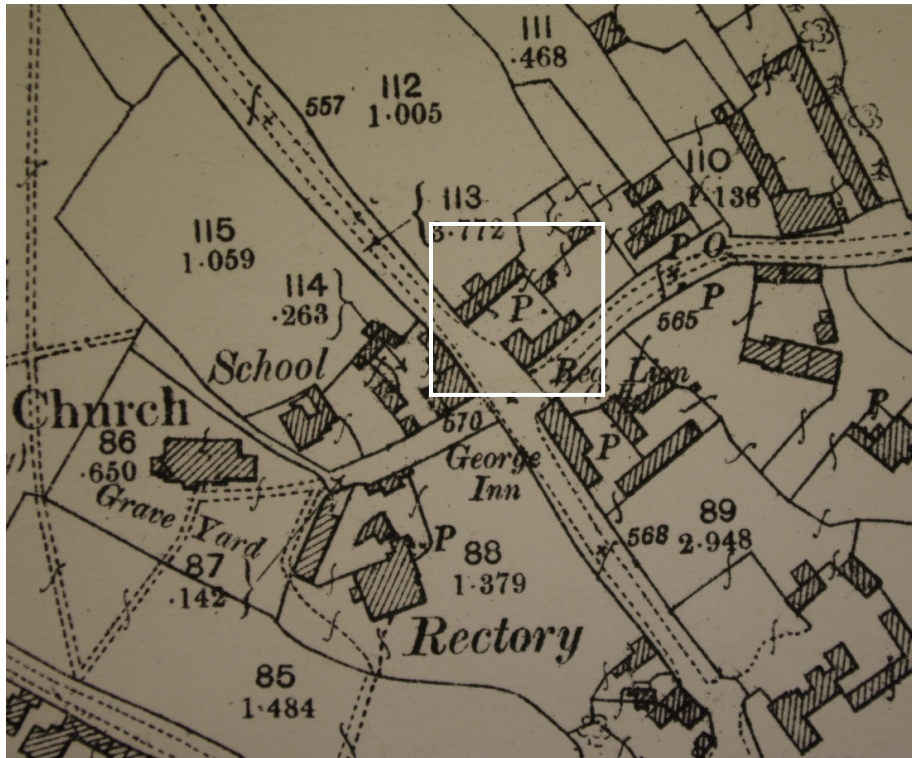
Figure 4
Second Edition Ordnance Survey (1900).
1:2500 Sheet XXX.2

By the time of the second edition Ordnance Survey, published in 1900 a small extension has been added to the rear of the building (*Figure 4*).

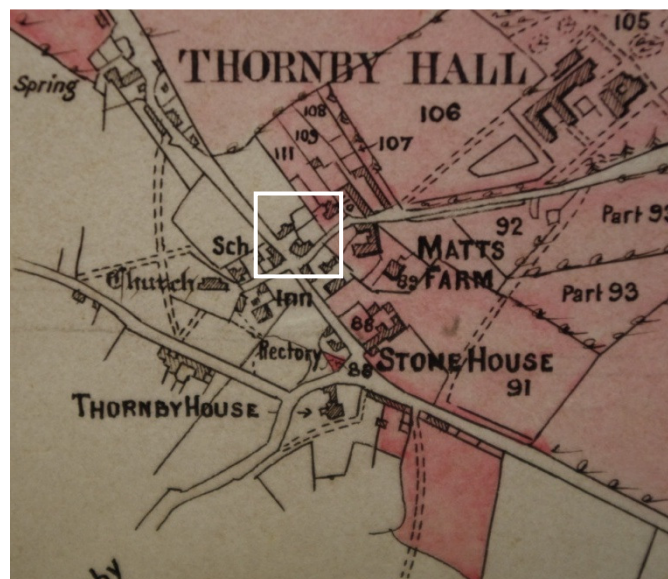
Figure 5
Thornby Hall Estate Map (1911).

The Thornby Hall Estate map produced in 1911 (NRO Ref ZB1158/71 (*Figure 5*)) again records the small northern extension. The map also confirms that the pub was not the property of the Hall at this time.

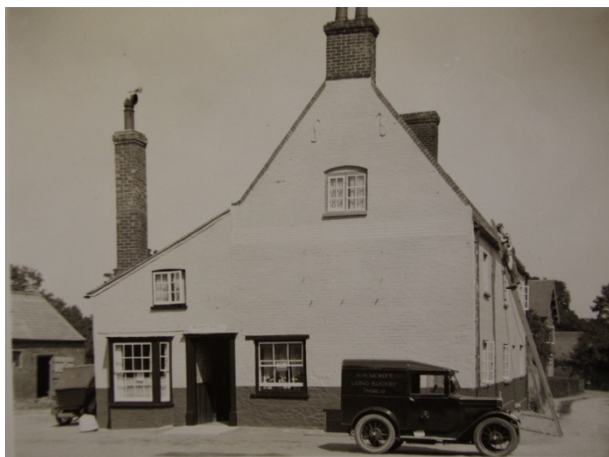
Figure 7

The Red Lion Photographed in 1932.

A number of photographs survive of the Red Lion and its environs, most, however focus on the pub itself. Only two (*Figures 7 & 8*) show the recorded building in any detail. In a photograph taken in 1932 (NRO Ref 1008-1010 (*Figure 7*)) part of the recorded building can be seen to the left, unfortunately this is likely to be the part of the building which no longer exists. In the second photograph (on display in The Red Lion (*Figure 8*)) the building is largely obscured by a preserved steam traction engine; however some detail of the building can still be seen. The building consists of two bays, the easternmost (since demolished) and originally the cowshed, as expected is lower. There is a pitching hole just visible to the left of the traction engine driver suggesting there was a loft within the building. The 'S' shaped tie plates can also be seen. The gable end fronting the road appears to have a steeper pitch than the current building, suggesting it has undergone some rebuilding.

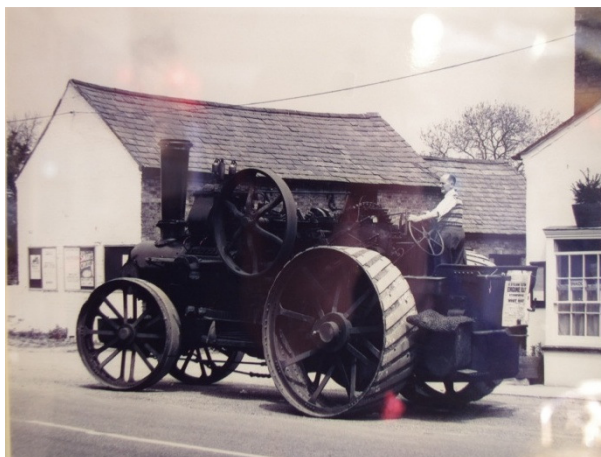
Figure 8

The Red Lion Photographed c.1955-1965.

Internally the building consists of a single bay. The roof is modern consisting of a tie beam carrying two short struts supporting the purlins. Below the tie beam there are two further beams, the exact purpose of which is unclear. Both are deal and are built into the long elevation walls, approximately 700mm below the eaves. It is possible that these two beams relate to an earlier roof structure, *Figure 8* appears to show a steeper pitched roof than

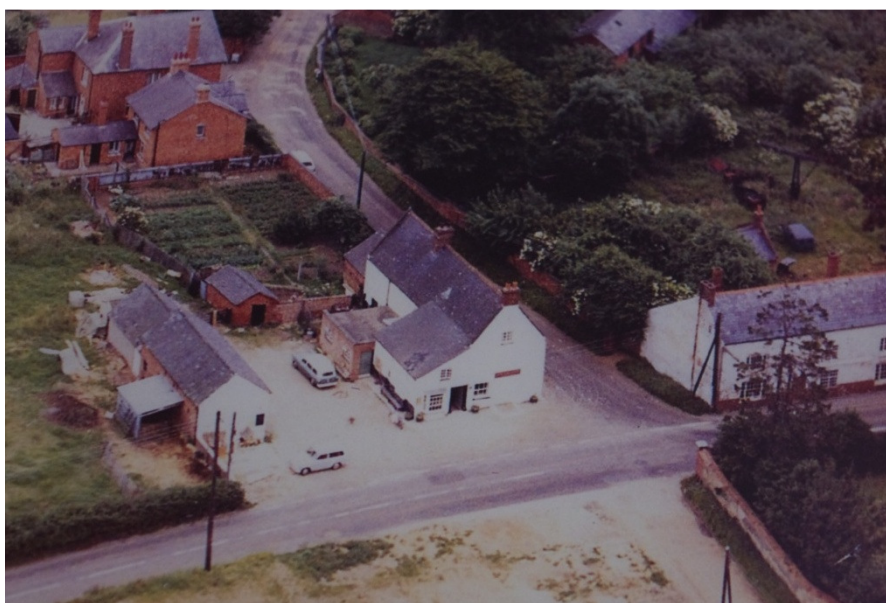
Figure 9

Aerial Photograph of Red Lion (believed to be post 1963).

An aerial photograph (on display in The Red Lion (*Figure 9*)), and believed to date to post 1963 shows the Red Lion and the recorded building. Very little detail is apparent, but the now demolished eastern bay is clearly visible as is the change in roof levels between the two bays.

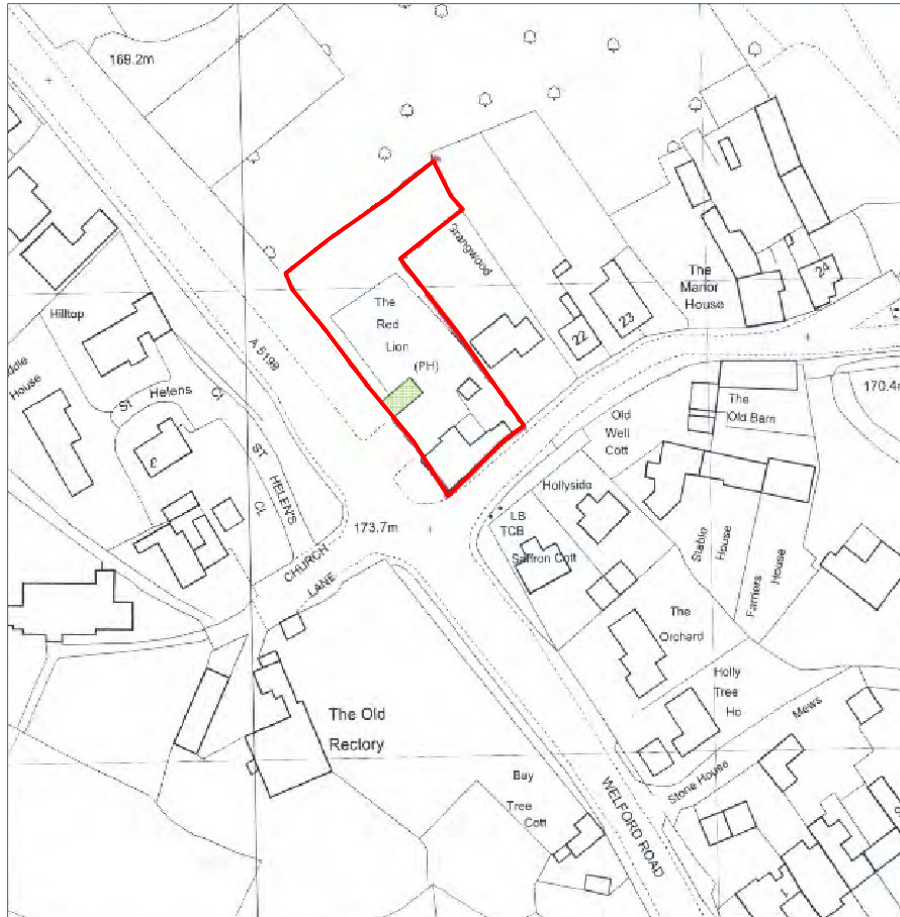
Figure 10
Plan of the proposed development area (in Red) Recorded Building in Green.
(Provided by client. Not to Scale).

Orientation: The long axis of the building is orientated approximately east-north east to west-south west (*Figures 10 & 23*), for ease of description this is taken hereafter to be east to west with the principal elevation, facing the Red Lion to the south. Where the terms ‘left’, ‘right’, ‘front’ and ‘back’ etc are used in the report, this is in relation to this principal elevation as viewed from the Red Lion.

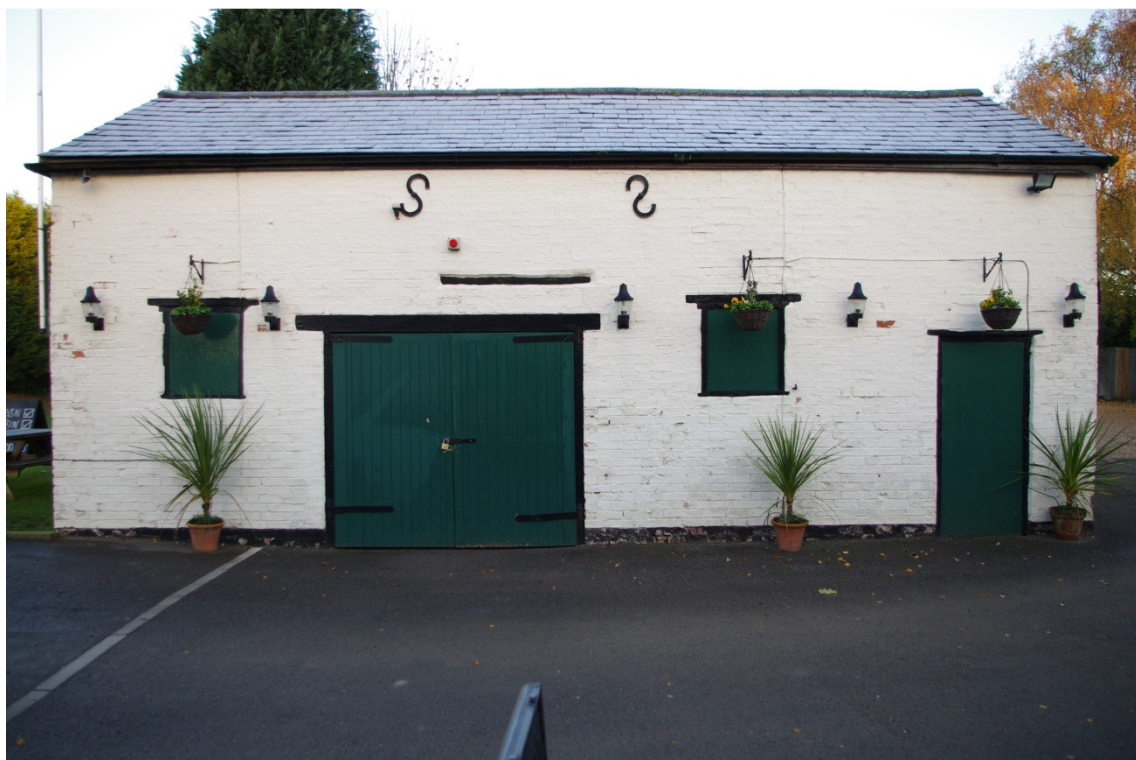
The building is located to the north of The Red Lion, forming part of what would have originally been a working farmyard. The building is aligned east - west, the principal elevation (*Figure 11*) faces the south towards the rear of The Red Lion.

The building itself is single storey, brick-built with a Welsh Slate roof. The current brickwork is painted, but where visible, the bricks are red; the bricks themselves are 9inch x 2 ¾inch x 4inch laid in a Flemish Garden Wall bond (3 stretchers to 1 header in each course). The painted finish prevented a closer examination of the pointing.

Figure 11
Principal Elevation (Looking North West).

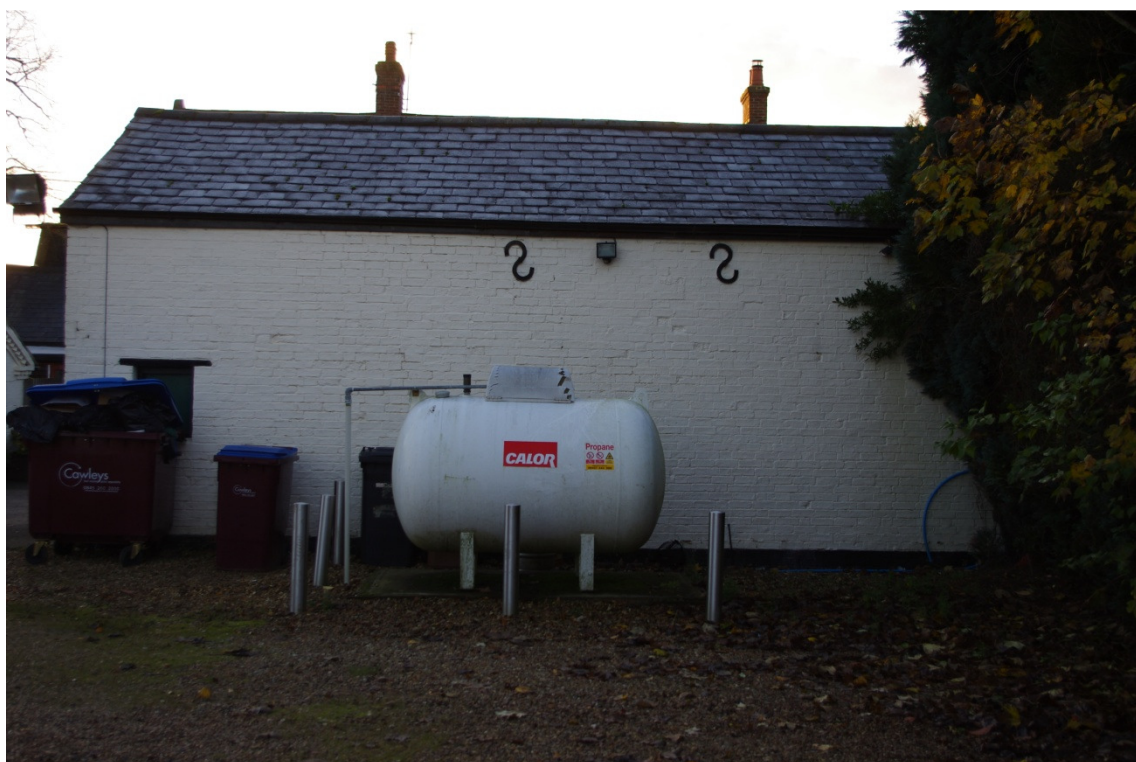
Both the western gable wall and the northern rear wall are plain brick with no significant features visible. The “S” shaped tie plates seen on the principal elevation are mirrored on the northern elevation.

Figure 12
Rear Elevation (Looking South East).

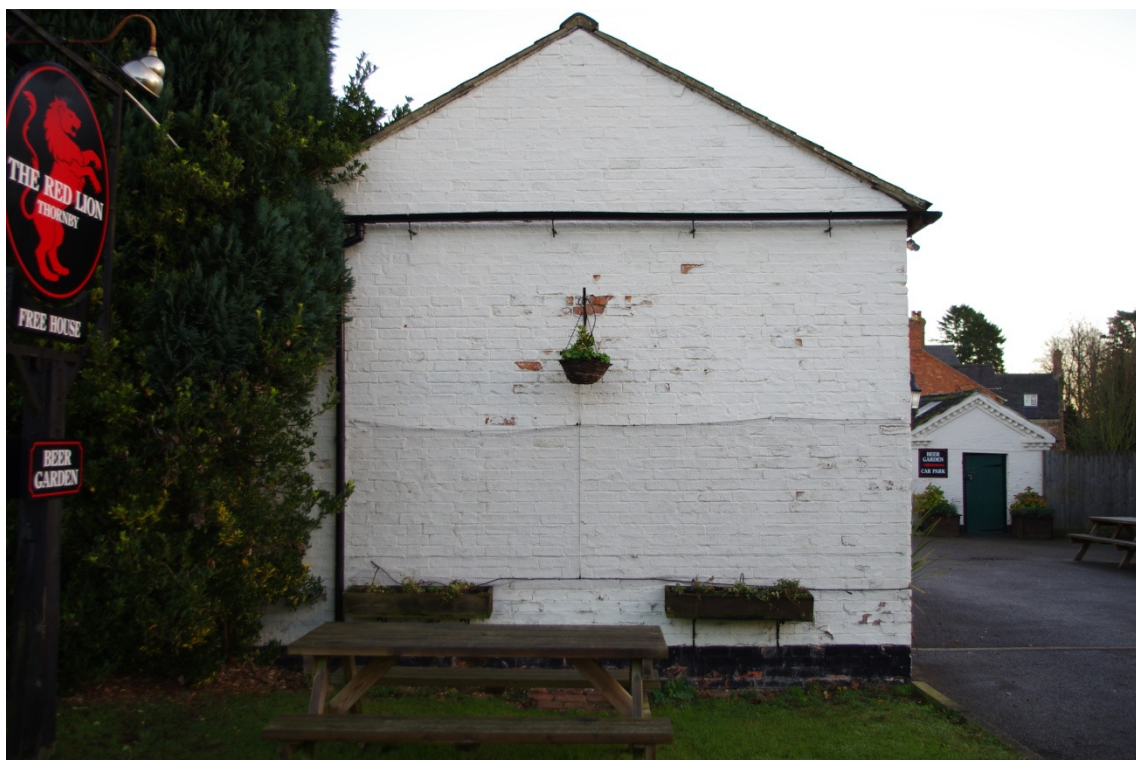
Figure 13
Western Gable (Looking North East).

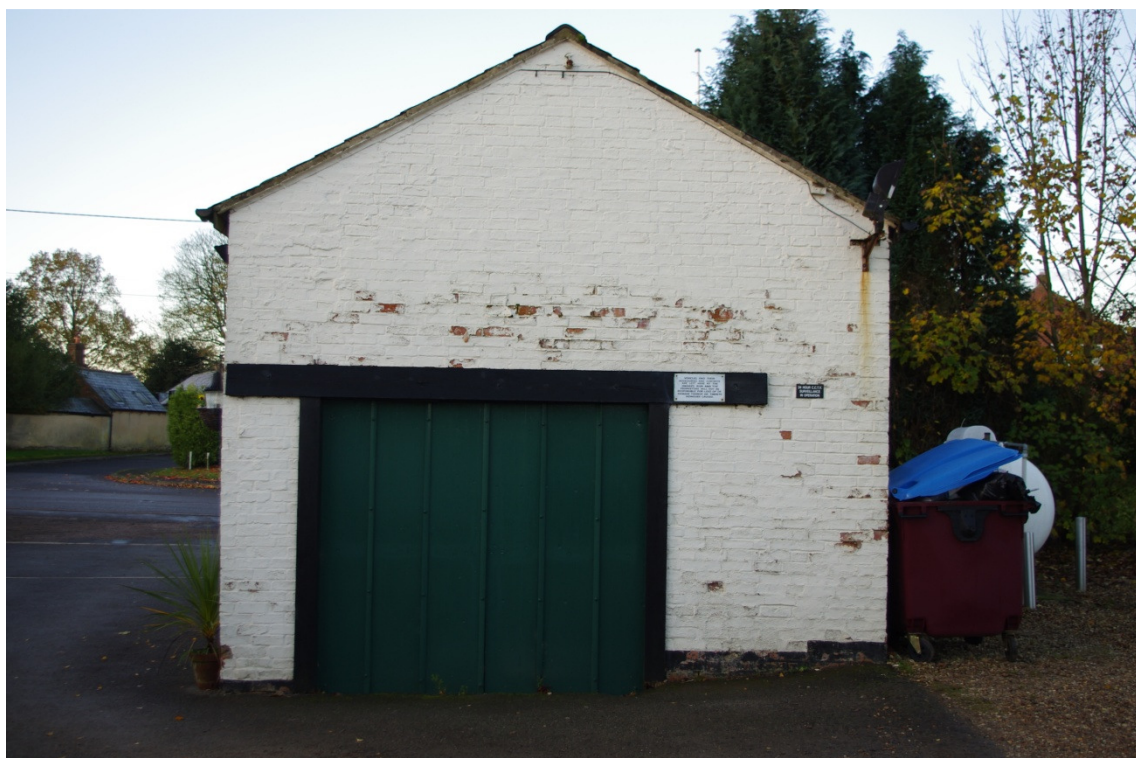
There is evidence of two blocked openings on the principal elevation also (*Figures 15, 16, 23 & 25*), one of which is the pitching hole seen in *Figure 8*; the other is smaller blocked window adjacent to the eastern door. On the east gable there is a second double door (*Figures 14 & 23*), this is almost certainly a later insertion as it has a rolled steel joist (RSJ) lintel. Above this door a faint trace of an earlier roofline can be seen (*Figures 17 & 25*), this is likely to be evidence of the shorter cow shed bay recorded on *Figure 6*.

Figure 14
Eastern Gable (Looking South West).

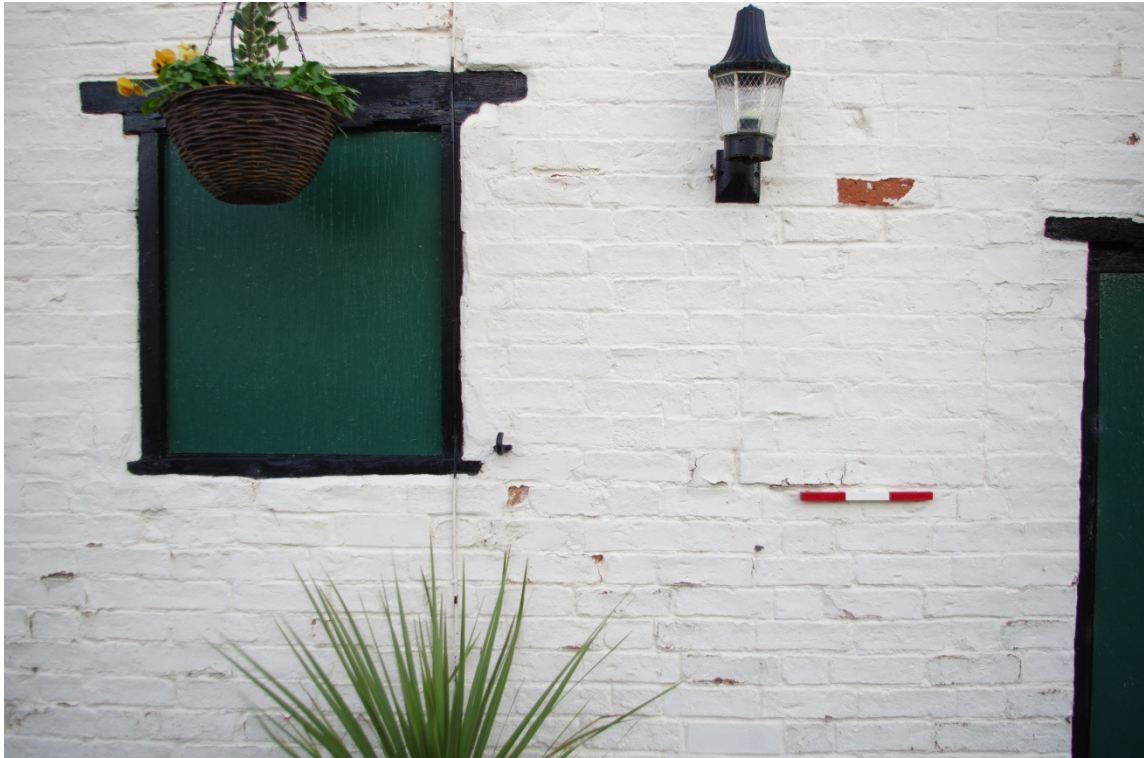
Figure 15
Detail of Blocked Window (Principal Elevation).

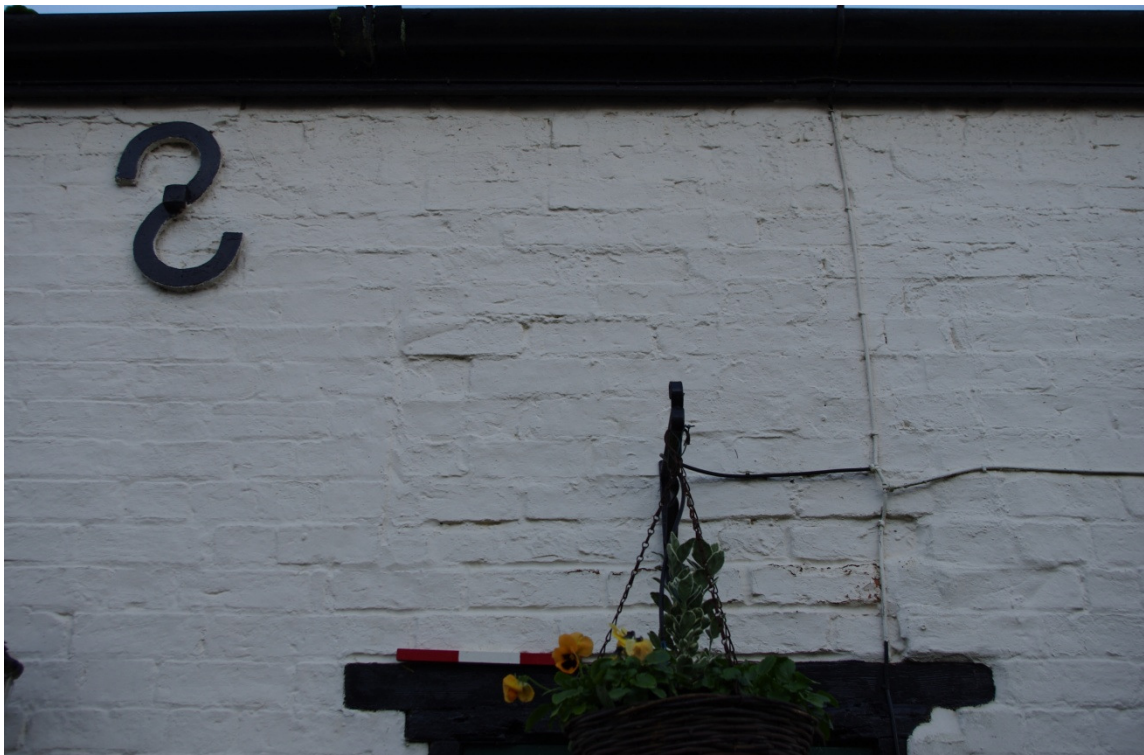
Figure 16
Detail of Blocked Pitching Hole (Principal Elevation).

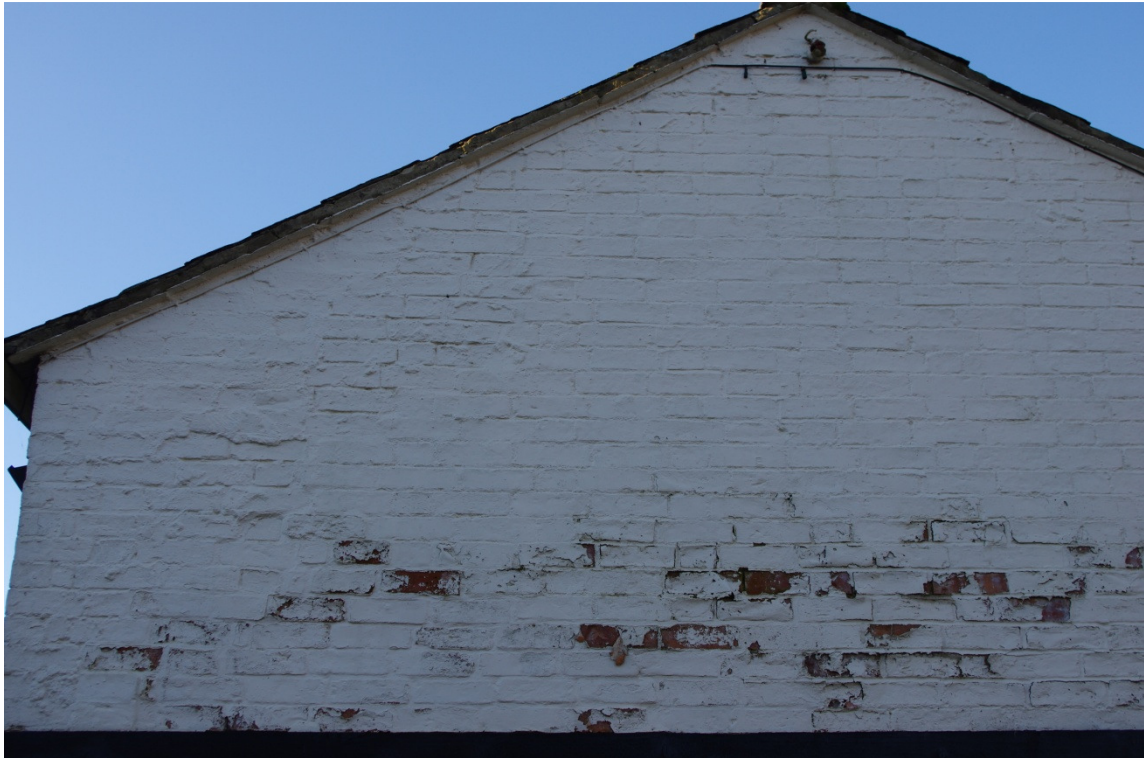
Figure 17
Early Roofline Visible on Eastern Gable.

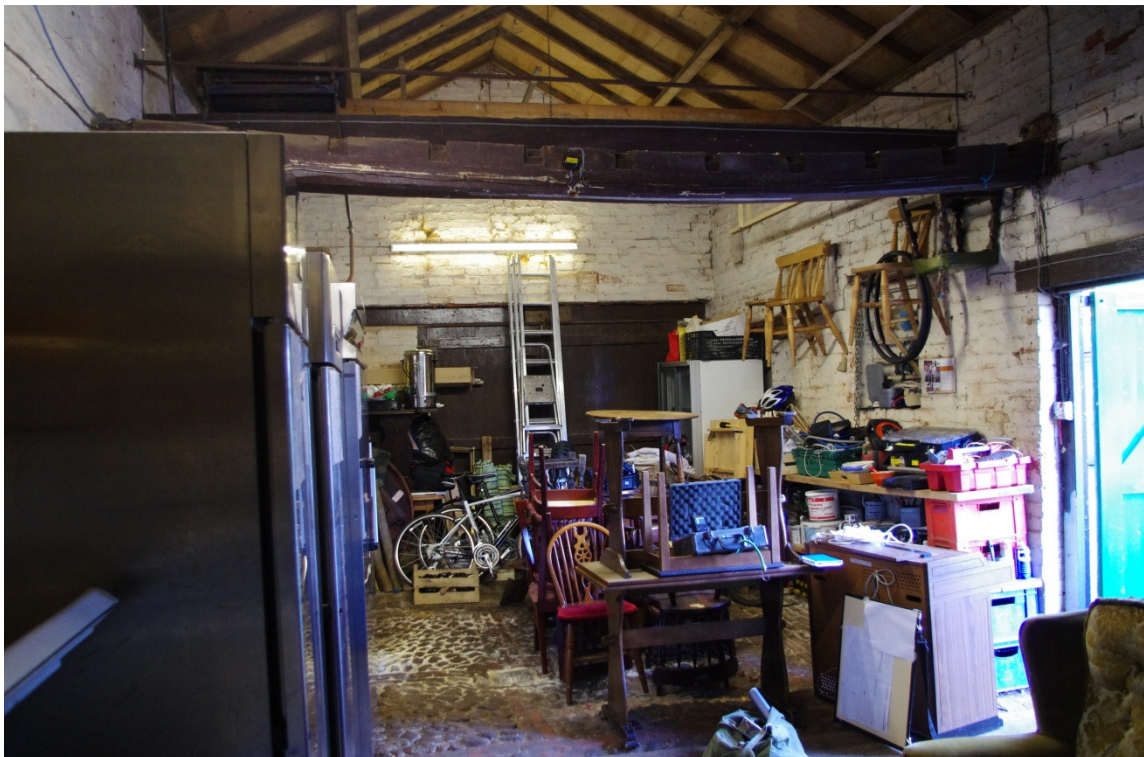
Figure 18
General View, Internal (Looking East - South East).

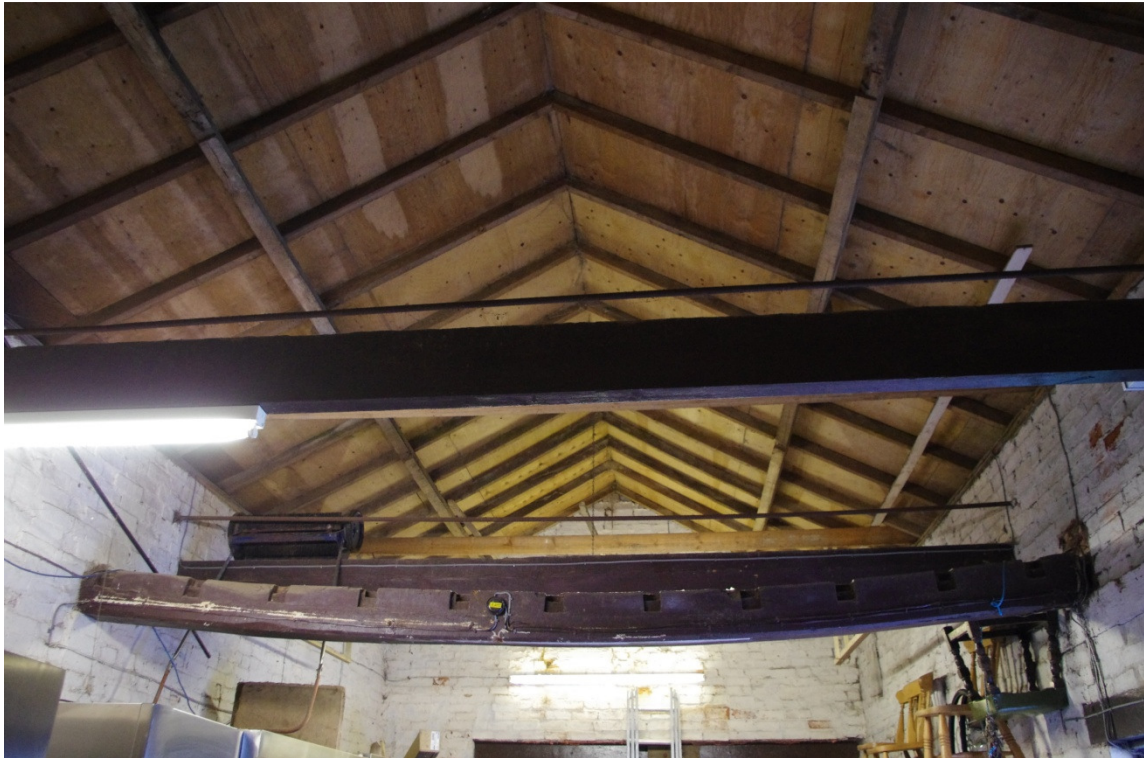
currently exists and these beams are earlier tie beams. Below both these deal tie beams is a third beam (*Figure 19*), this time an oak bridging beam. Measuring approximately 200mm by 200mm, the beam is chamfered and has open joist holes at approximately 400mm (16inch) intervals on each face. The chamfered finish suggests the beam may be re-used as it would be unlikely that such a finish would be used within an agricultural building. On the west gable there is evidence of blocked joist holes (*Figure 20*), again at approximately 400mm intervals, the same as those seen on the bridging beam. It is likely, therefore that the bridging beam is a remnant of a loft, evidence of which can be seen with the pitching hole on the principal elevation.

Figure 19
Roof Structure & Bridging Beam (Looking East – North East).

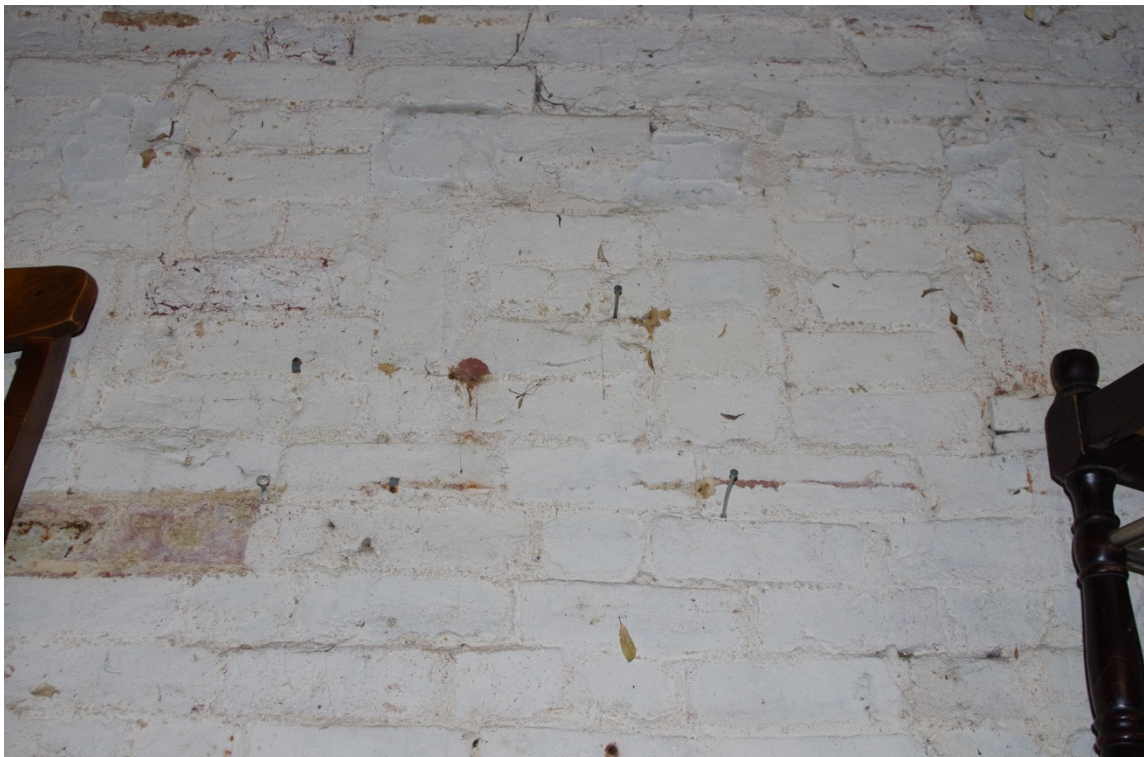
Figure 20
Blocked Joist Holes on Western Gable Wall.

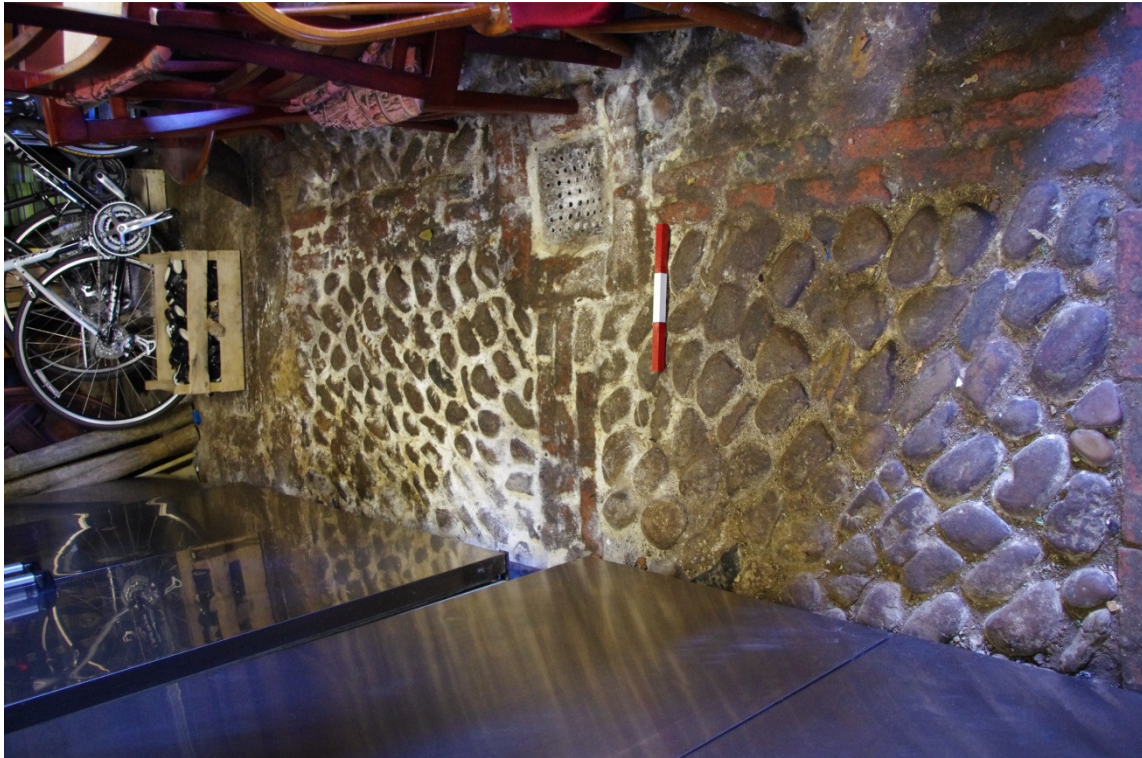
The floor consists of a cobbled surface with red brick gullies (*Figure 21*); the bricks themselves are handmade 2 ½inch x 4inch, probably early 19th or even late 18th century in date. The same bricks are laid along the front of the building, forming a level surface approximately 1100mm wide (*Figure 22*). The cobbles are laid in a herring bone pattern. Along the rear wall there is a modern poured concrete slab, approximately 480mm wide, possible evidence of troughs along the rear wall. There is another area of poured concrete along the east gable, approximately 1600mm wide. The change in flooring here may represent the small store bay recorded by Figure 6, the partition wall having been demolished.

These changes in flooring suggest the building was originally for animals, possibly stabling, a cow hovel or even a milking parlour. The brick surface along the southern wall along with evidence of troughs along the rear wall suggests it is more likely to be a cow hovel or milking parlour. Cows were commonly tethered with their heads to the rear wall with a corridor at their hind quarters to allow the farmer to pass. In which case, the small building which appears on the second edition Ordnance Survey (*Figure 4*) may have been a dairy; dairies were frequently located facing north to help regulate the internal temperature.

Figure 21 Cobbled Floor & Brick Gullies.

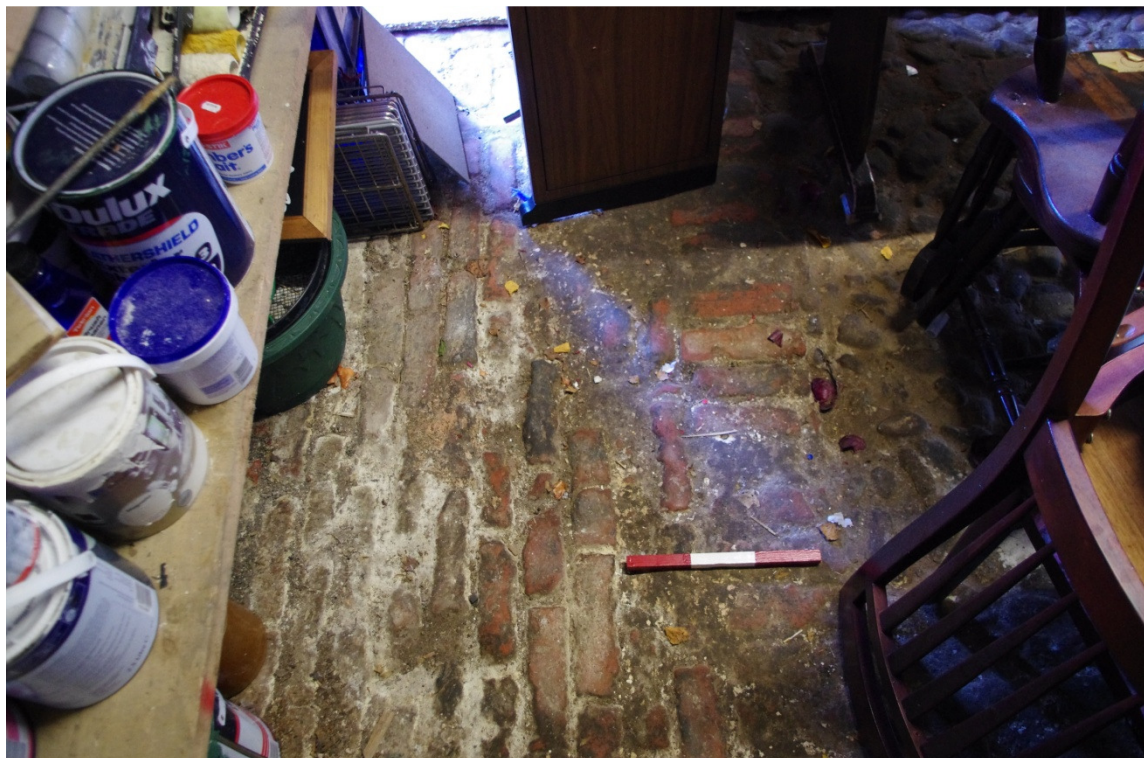
Figure 22
Brick Surface in Front of Building.
