**A Photographic Survey.  
Buildings Adjacent to 30 South Street,  
Asfordby Hill,  
Leicestershire.  
(NGR SK 72504 19337)**

**On Behalf of Cloyhouse Ltd**

**March 2013**

**ABRS Project No 2013-SSAL**

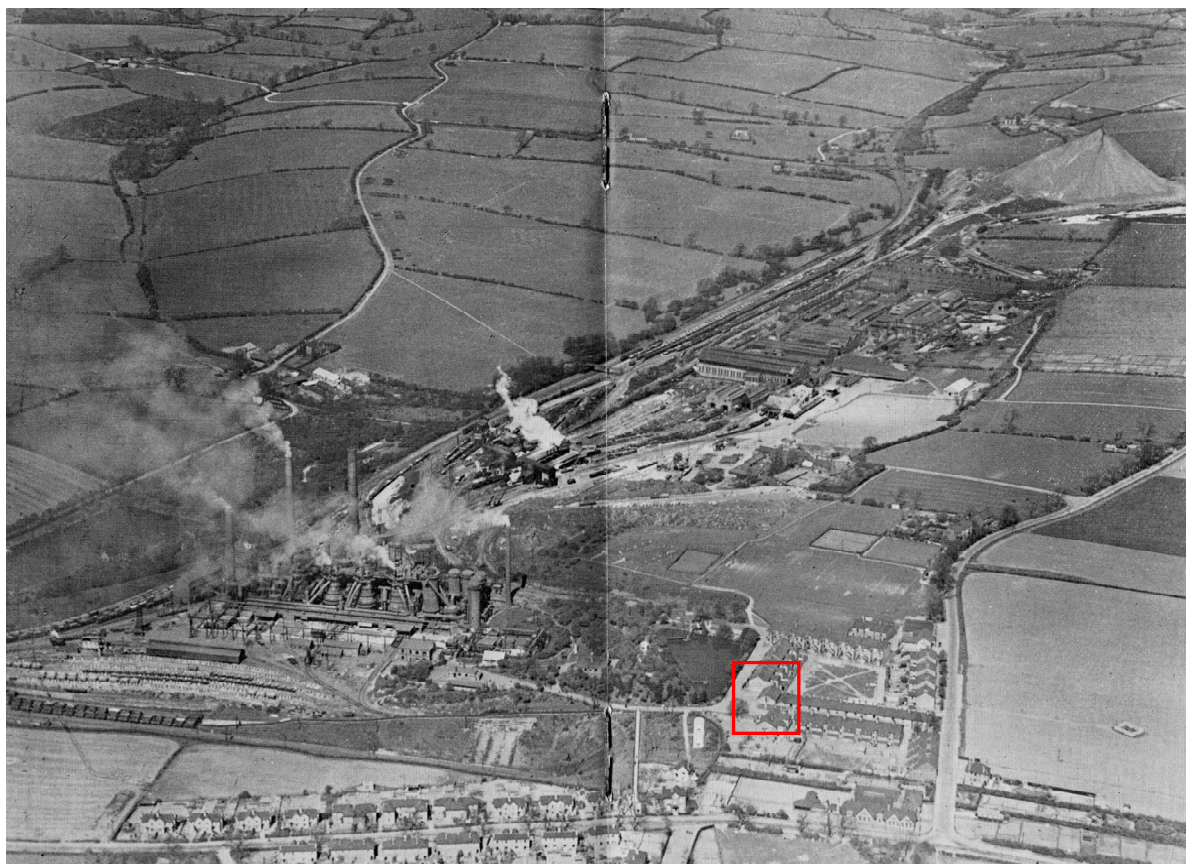
**Figure 3**

Mid 20th Century Aerial Photograph of Holwell Ironworks with Recorded Buildings Highlighted in Red.

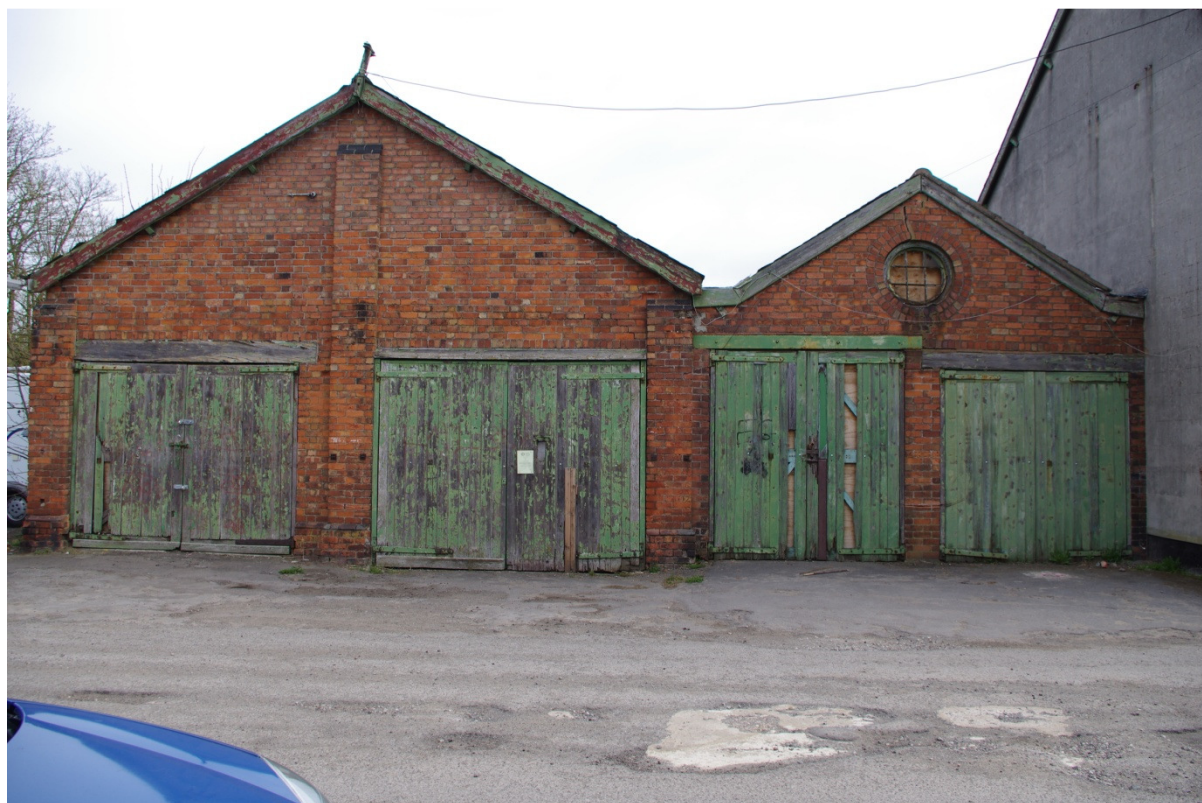
**Figure 4** Principal Elevation (Looking North).

The building is a brick-built single storey building of two bays, gable on to South Street (*Figures 2 & 4*); there are two pitched roofs mainly of Welsh Slate, although the easternmost slope is clad with concrete tiles, and clearly later in date. The brickwork is 9" x 3" x 4" (229mm x 77mm 102mm) red bricks laid in Flemish Garden Wall bond (3 stretchers to 1 header in each course) with a cement mortar.

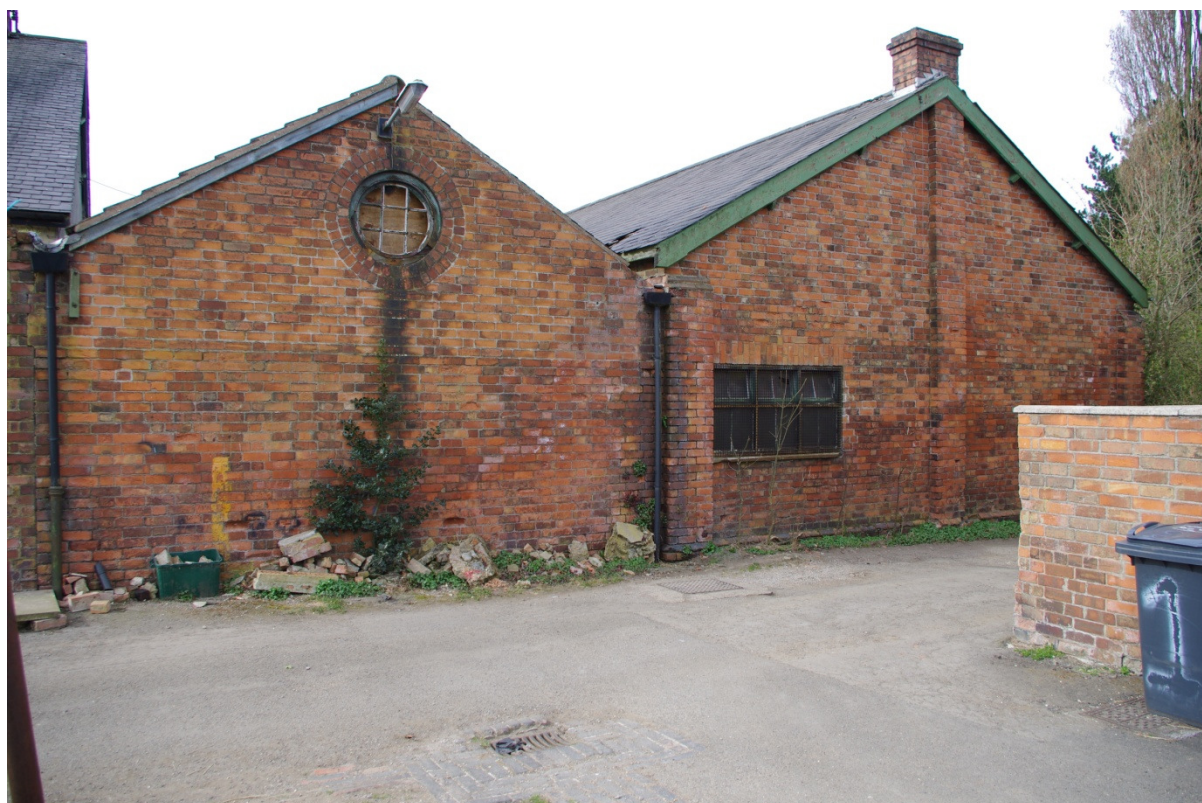
**Figure 5** Rear Elevation (Looking South).

There are clearly two phases of building, a fact supported by cartographic sources and the straight joint visible between the two bays. The earlier of the two is the western bay (*a* & *d*), the eastern bay (*e*) is a later in-fill. Bays *a* and *d* have a brick plinth capped with splayed red bricks on the southern and western elevations, the north (back) elevation is plain (*Figure 5*). There is a chimney on the north elevation.

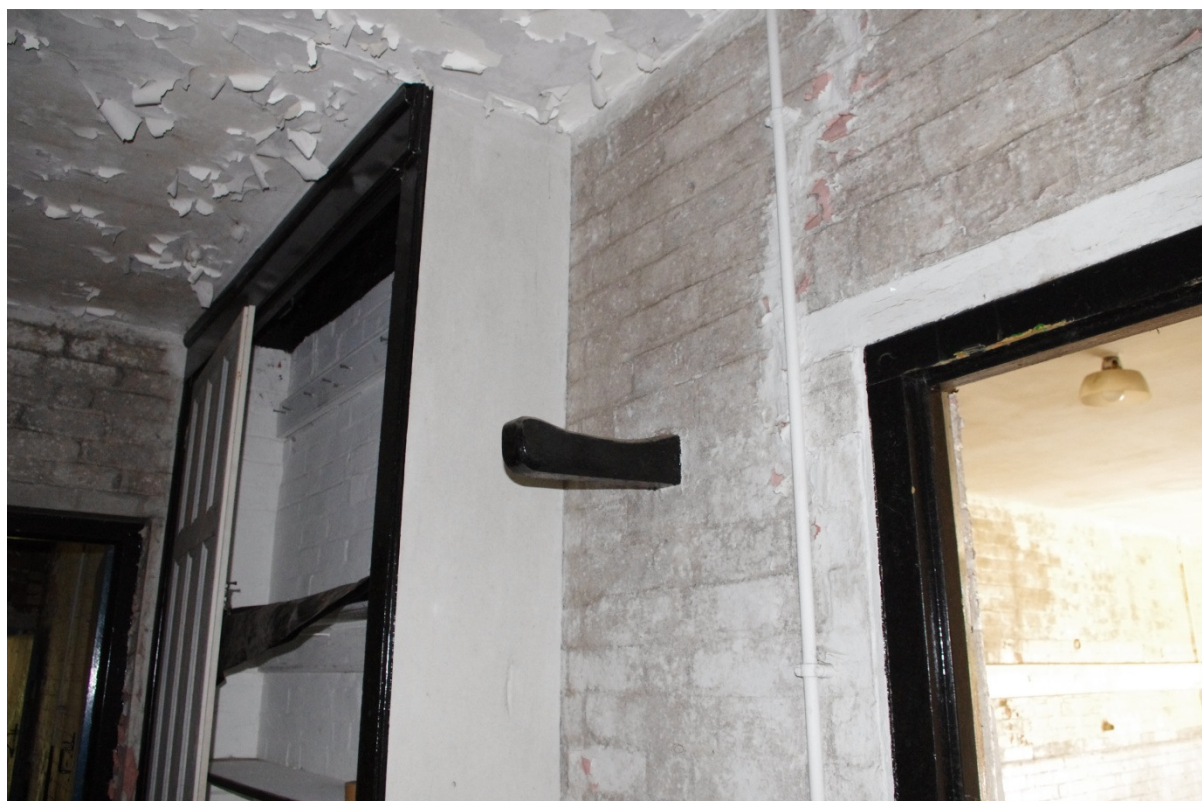
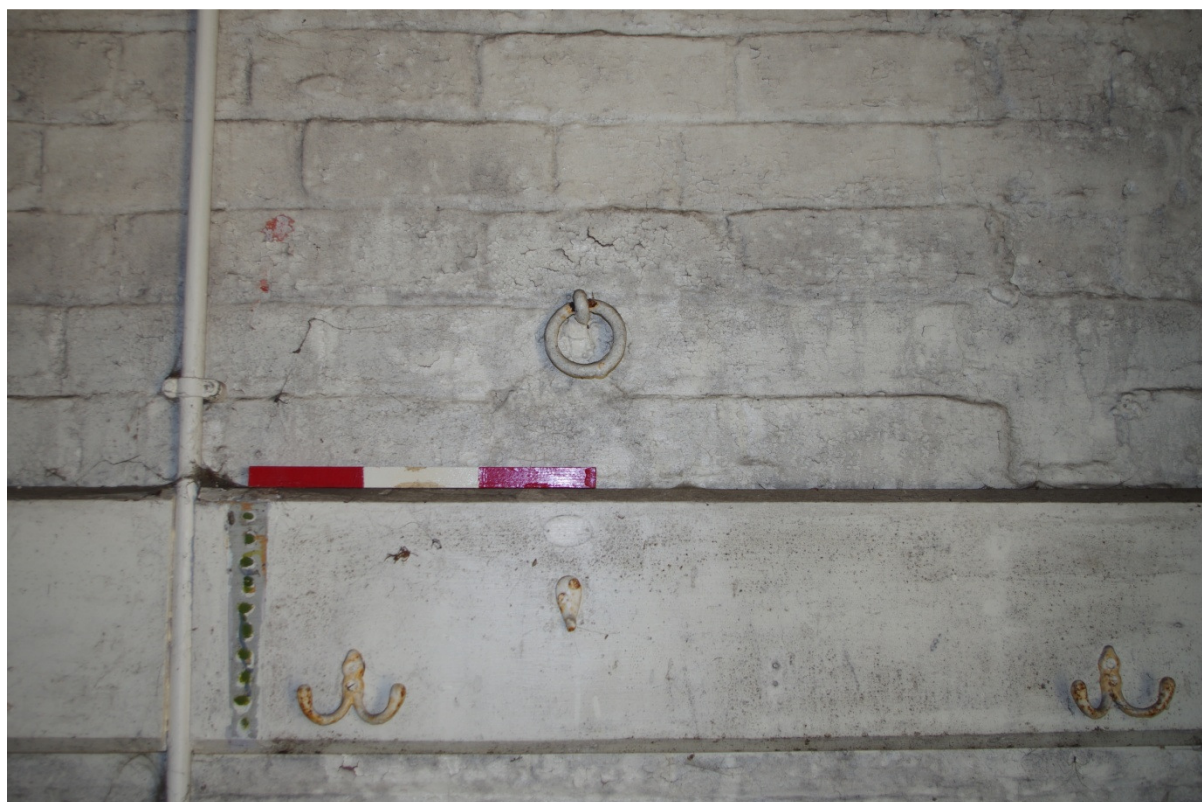
**Figure 6** Saddle Tree b.

There are occasional indications of the building's original and early use, most notably tether rings on the east wall of a, which along with a saddle tree/tack hook on the south wall of b suggests the building may have initially been used as stabling (*Figures 6 & 7*). Bull nosed brick door reveals may again be further evidence of this. Within b there is large wall-mounted timber cupboard, which, along with an angle chimney breast and fireplace in the north east corner (*Figure 10*) suggests this room may have originally had a more domestic use, perhaps as a mess room. There is another fireplace in north west corner of c, in this case a mid 20th century tiled fireplace remains (*Figure 11*), suggesting this room remained in a more domestic use longer than b.

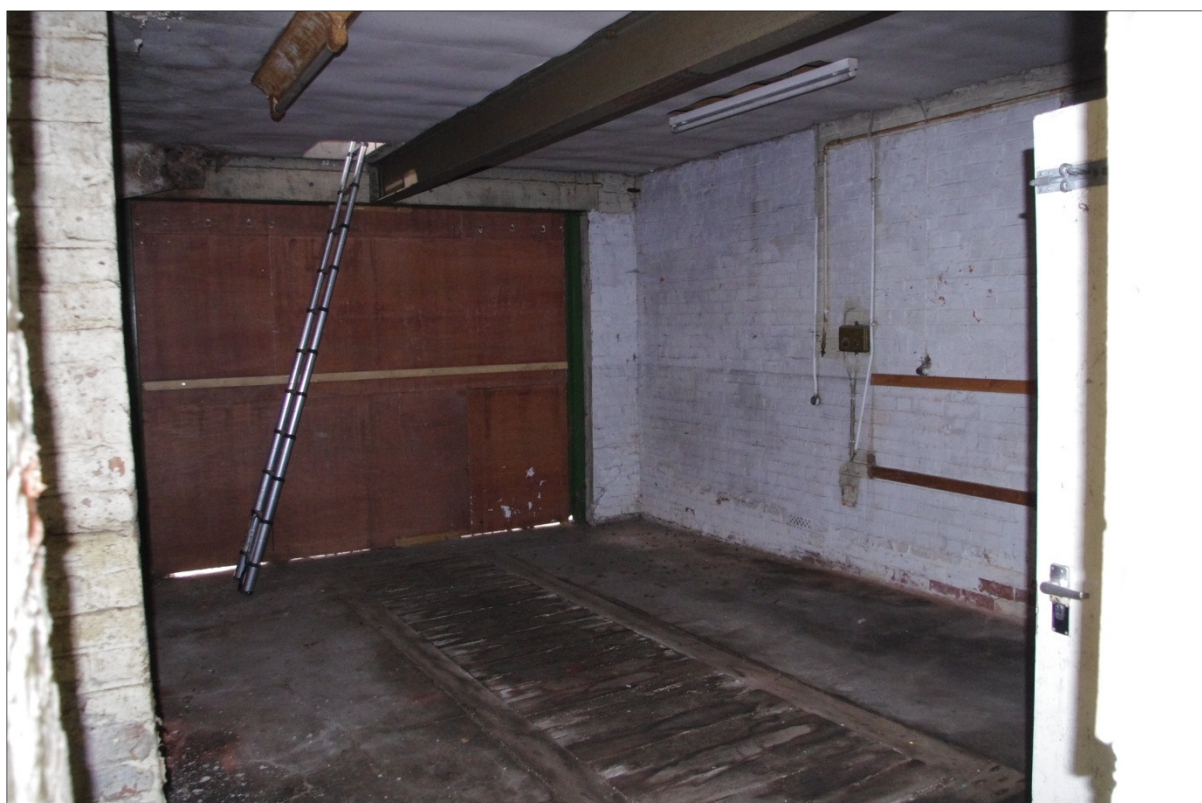
**Figure 8** Room d (Looking South).

Internally, all the bays are largely devoid of features of historical or architectural significance. All the walls, with the exception of easternmost of e are unfinished painted brick, the easternmost wall of e is cement rendered. Floors, with the exception of b are modern poured concrete slabs, b has the original blue brick pavoids. There is a vehicle inspection pit within d (*Figure 8*). It was not possible to view the construction of the pit to confirm whether it was original.

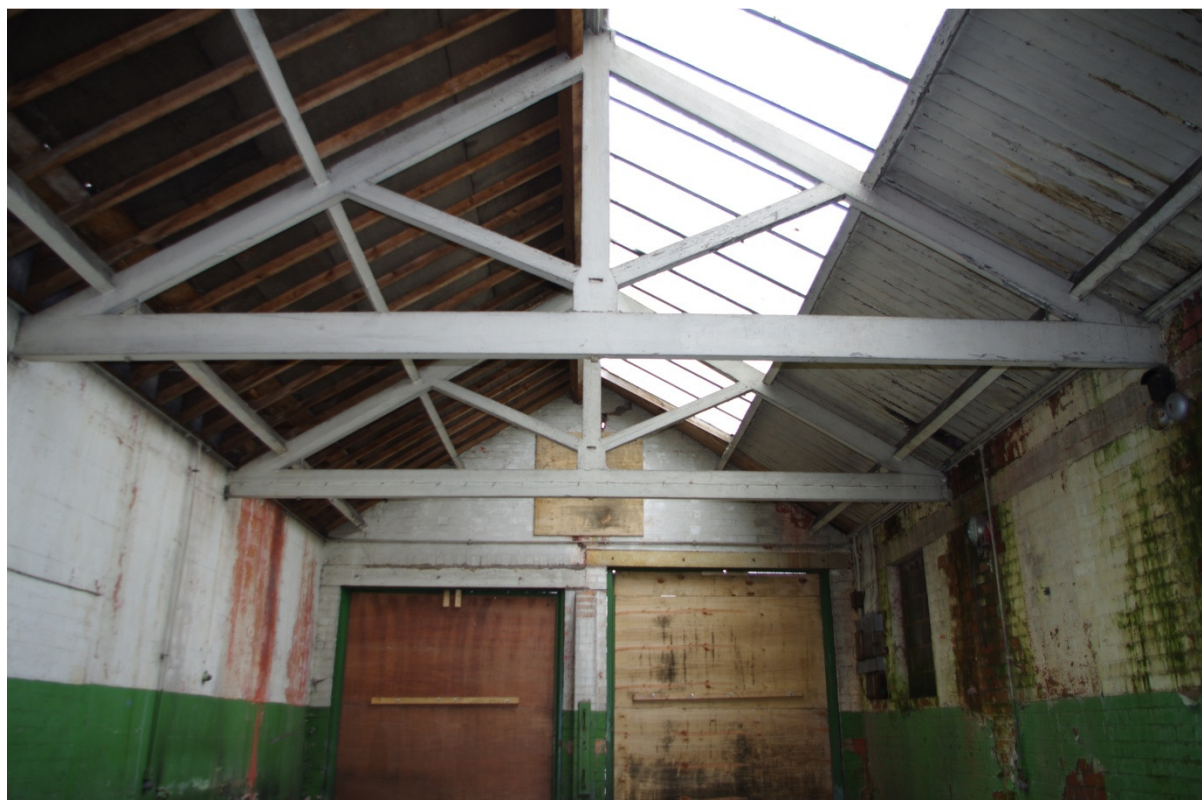
**Figure 12** Trusses, Room e (Looking South).

The roof of the westernmost bay is carried on three fan trusses of angle steel (*Figure 13*) supported by a single axial rolled steel joist (RSJ), possibly inserted. The roof of easternmost bay is carried on three bolted king post trusses with raking struts, in deal (*Figure 12*). The roof is built directly onto the gable of number 30 South Street.
