**An Archaeological Standing Building Survey.  
The Former Methodist Chapel,  
Tower Square,  
Tunstall,  
Stoke on Trent.  
(NGR SJ 85897 51218)**

**October 2013**

**ABRS Project No 2013-MCTS**

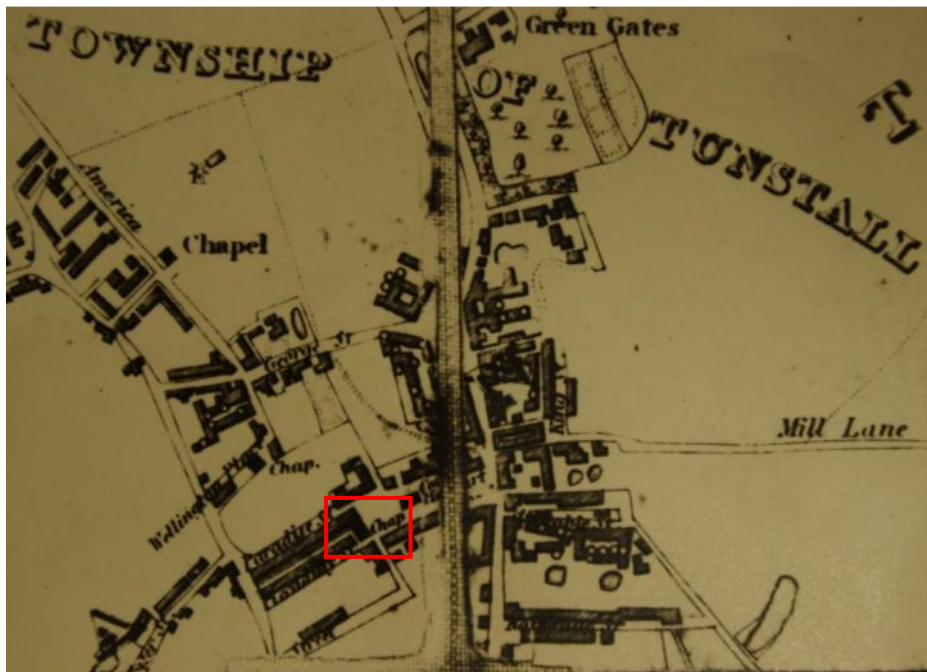
**Figure 3**

Hargreaves's map of the Potteries, 1832 (6 inch to 1 mile): Ref. No.: SM 14 A

The Chapel is clearly recorded on Hargreaves's map of the Potteries drawn in 1832 (*Figure 3* (Ref No. SM14 A)). The Chapel, however does not appear to be as large, east to west as it currently stands, suggesting that it may have been extended at some point in the past. Another notable feature is the lack of an alley between the Chapel and the building to the north. The alley separates the current building from number 29 Tower Square and runs the full length of the block. Hargreaves's map shows the alley turning through ninety degrees to the rear of the Chapel and joining Piccadilly Street to the south. This again suggests the Chapel recorded by Hargreaves has been altered significantly.

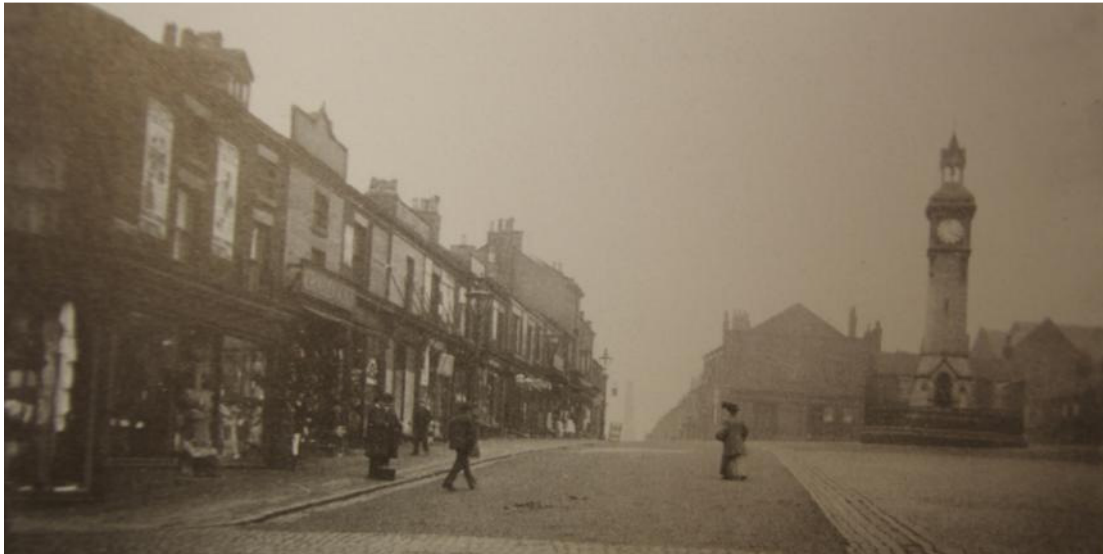
**Figure 4**

Tower Square c.1900, Chapel Right of Centre.  
(Henshall, D. Images of England, Tunstall (2006))

Following its closure as a Chapel and subsequent sale Mount Tabor was subdivided into two units, becoming numbers 27 and 28 Tower Square (*Figure 6*). The building continued in use as retail units. A shop front was added to the Tower Square elevation (*Figure 4*). An examination of the Trustees Minute Book (1888-1954) held by Staffordshire Records Office (Ref D5481/2/17/8-10) lists the assets held by the Chapel in the mid 1920s, the old building is not included, confirming its sale prior to this date.

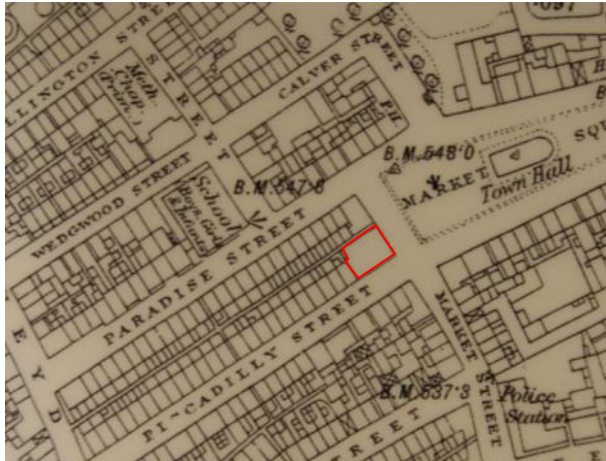
First Edition Ordnance Survey 1882  
(Sheet XI.8)

First Edition Ordnance Survey 1899  
(Sheet XI.8)

The early edition Ordnance Survey maps (*Figures 5 & 6*) record the outline of the now former Chapel building. However, it is not until the second edition, 1899 that the building is recorded as being two buildings. There had also been some alterations to the western (rear) of the building, both since Hargreaves's map and between the two Ordnance Survey editions. Evidence again that the building is likely to have undergone some degree of structural alteration. The building recorded by the 1899 edition is identical to the current building.

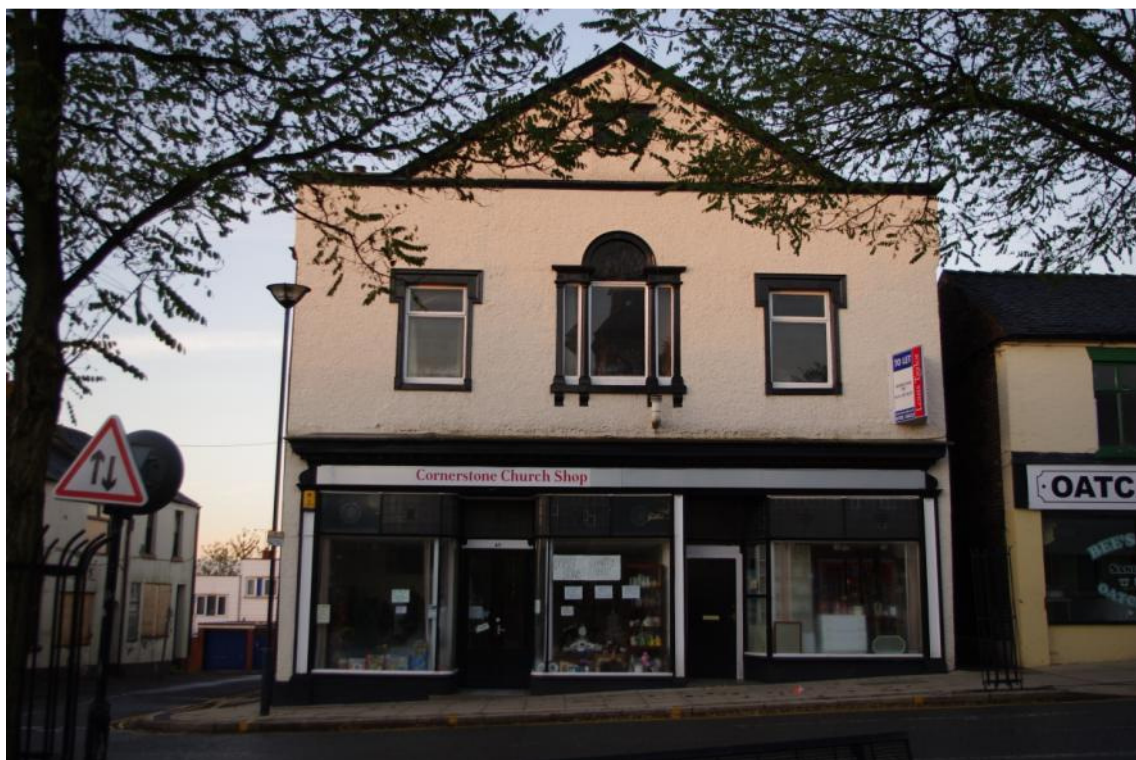
The principal elevation appears to consist of the original Chapel frontage with its pediment and central Palladian window with stuccoed architrave above; there are two flanking windows with shouldered architraves. The plaque on the pediment is inscribed 1821, apparently contradicting documentary evidence that the Chapel was built in 1824. The date may therefore, relate to the founding of the Chapel rather than the actual construction of the building. The later inserted shop front ground floor consists of a continuous dentilated fascia with windows which have attractive leaded upper lights with geometrical design decorative glazing. A photograph taken in c.1900 (*Figure 3*) shows this same shop front suggesting it dates from the late 19th century and is largely original. The first floor windows are timber framed, the flanking windows are top hinged casements, the Palladian window is non-opening, and none of the frames are original.

**Figure 7**  
Principal Elevation (looking West-North West).

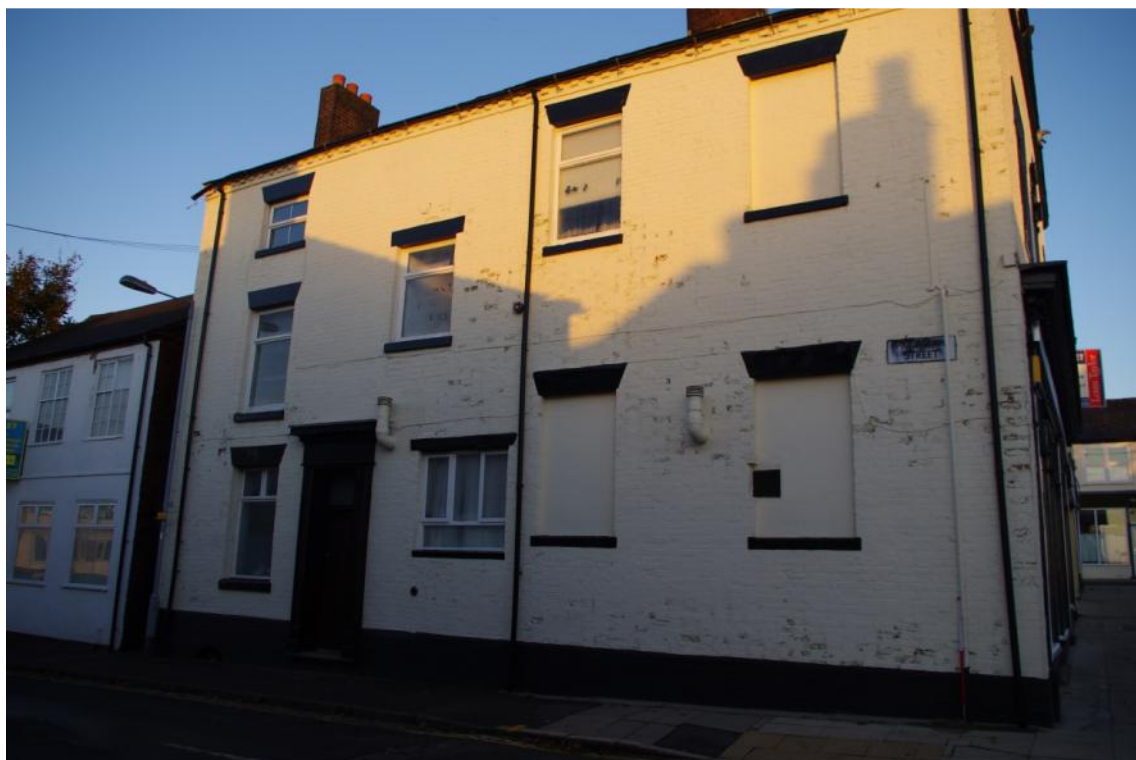
**Figure 8**  
Piccadilly Street Elevation (looking North).

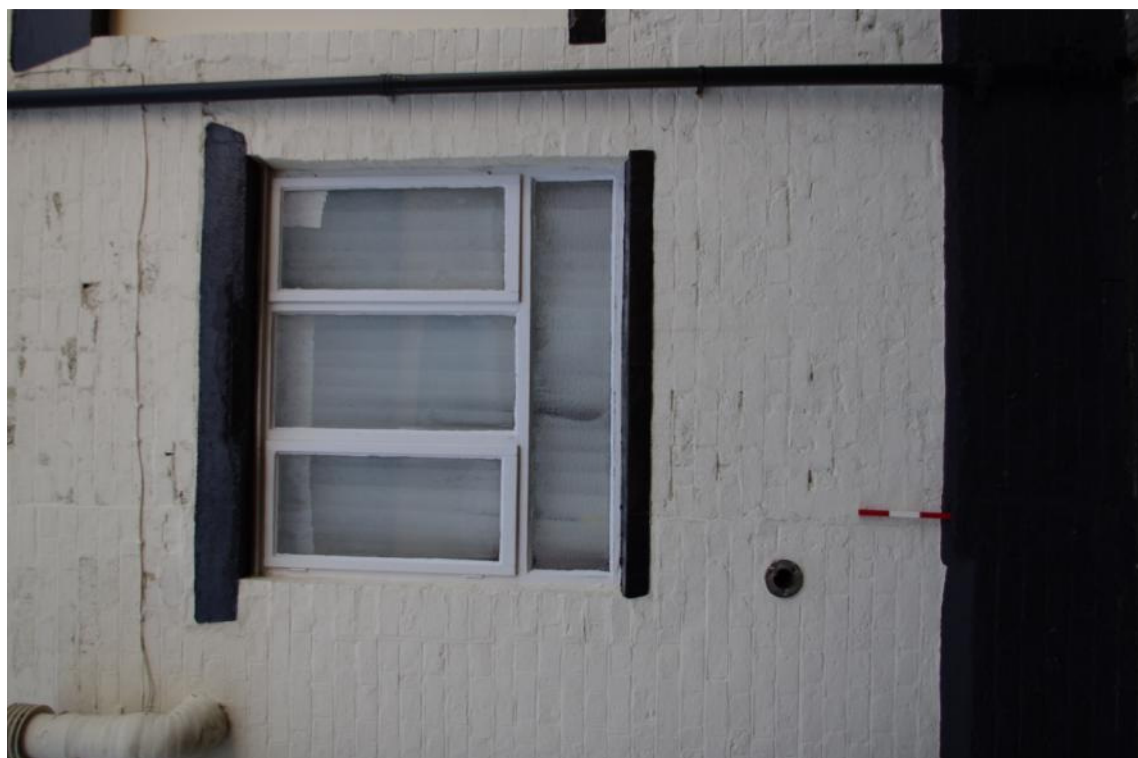
with the second floor of this bay. The flat arched head of both these windows match those seen on the other windows indicating the windows are contemporary. There are three blind windows towards the east, two on the ground floor and a one on the first floor. The brickwork appears to be the same as the building as a whole so it appears these blind windows are a design feature rather than later alteration work, all have flat arched heads. The two remaining windows are clearly later insertions as they neither match the original windows in style, dimensions and level, and indeed both straddle the straight joint (*Figures 10 & 21*).

**Figure 10** Straight Joint Visible on  
Piccadilly Street Elevation (left of  
scale).

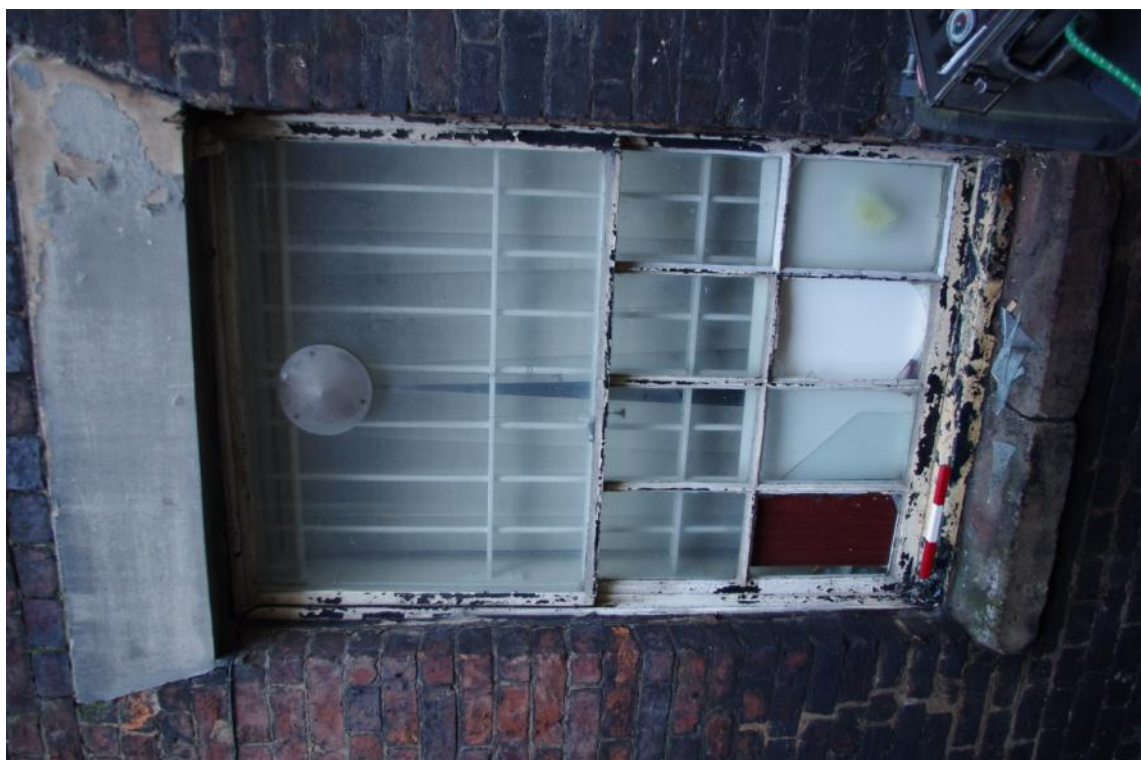
**Figure 11** Early Window on North Facing Elevation, Ground Floor.

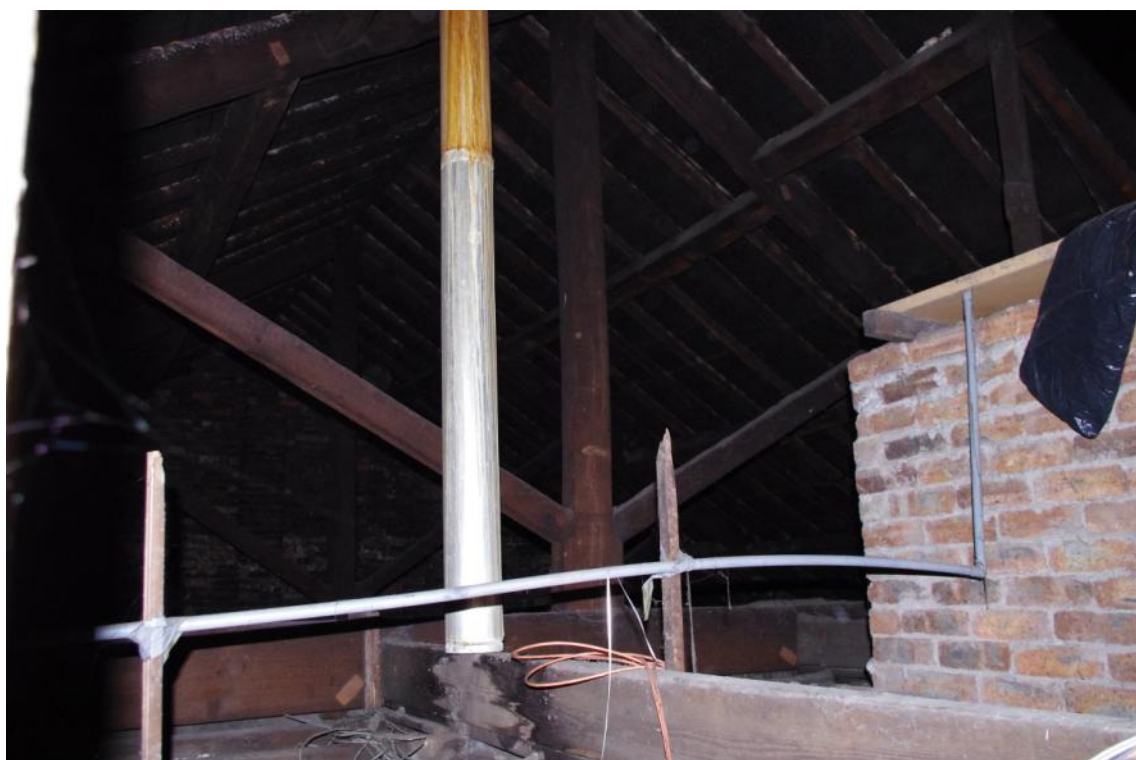
At the time of this survey, there was only limited access to the attic over the western part of the building. The roof is carried on a pair of deal king post trusses with raking struts (*Figure 12*).

**Figure 12**  
Roof Truss (looking South East).

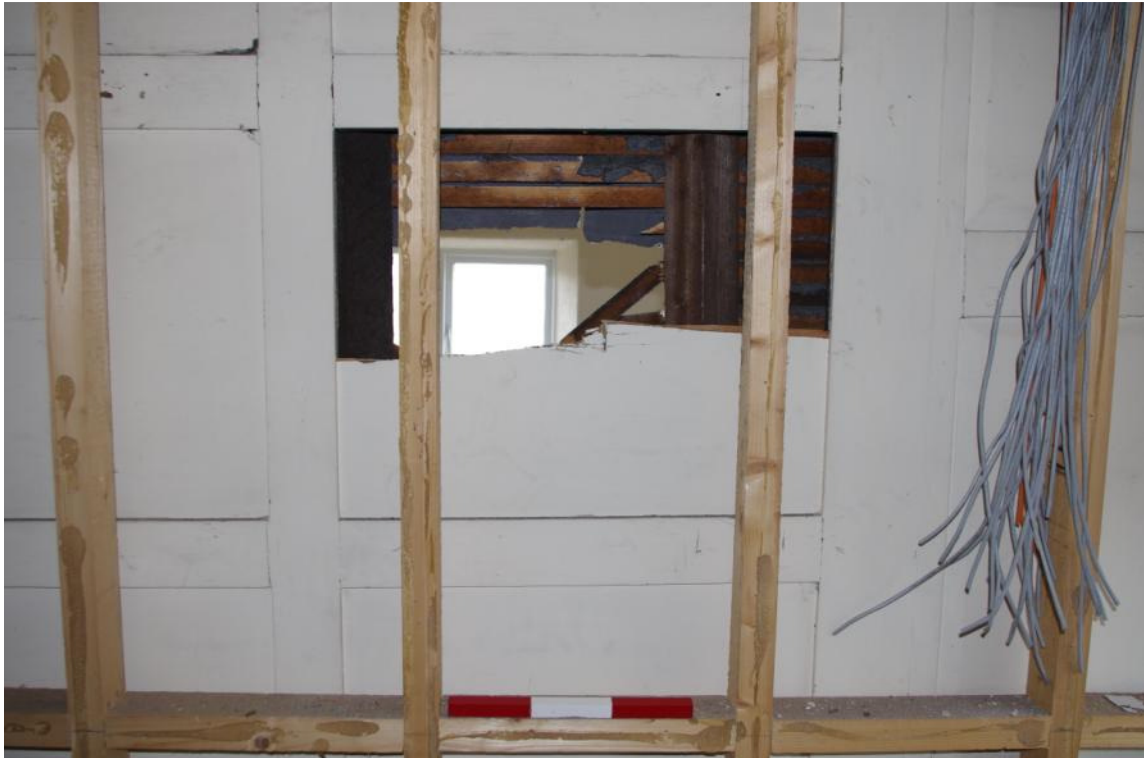
The second floor is divided into 3 main rooms, all which appear to be original and may, therefore date to the Chapel. There is clear evidence of a blocked fireplace in the southern room (O) and a likely chimney breast in northern room (P). It is likely, therefore, that both of these rooms were heated. Damage to the partition wall between P and Q has revealed early plaster and lathe walling as well as mock panelling of thin plyboard (*Figure 13*), indicating that this may be an original wall.

**Figure 13**  
Room Q (Second Floor) Early Partition Walls.

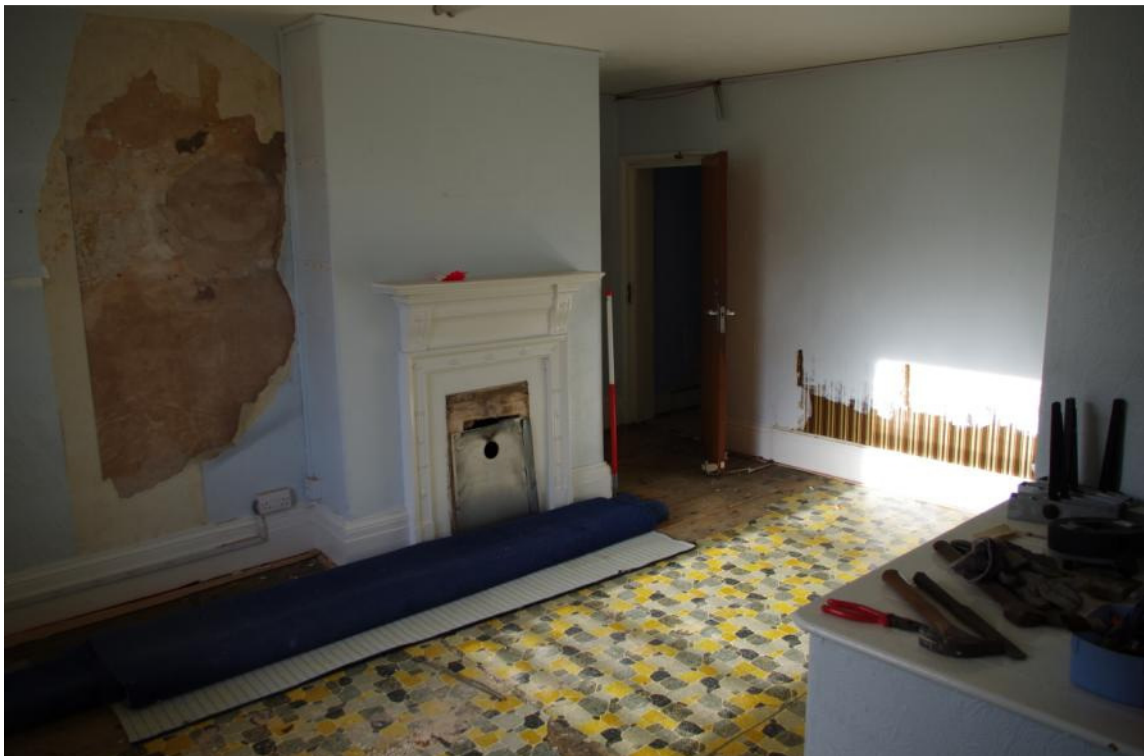
**Figure 14**  
Room Q, (First Floor) General View & Fireplace (looking North-North West).

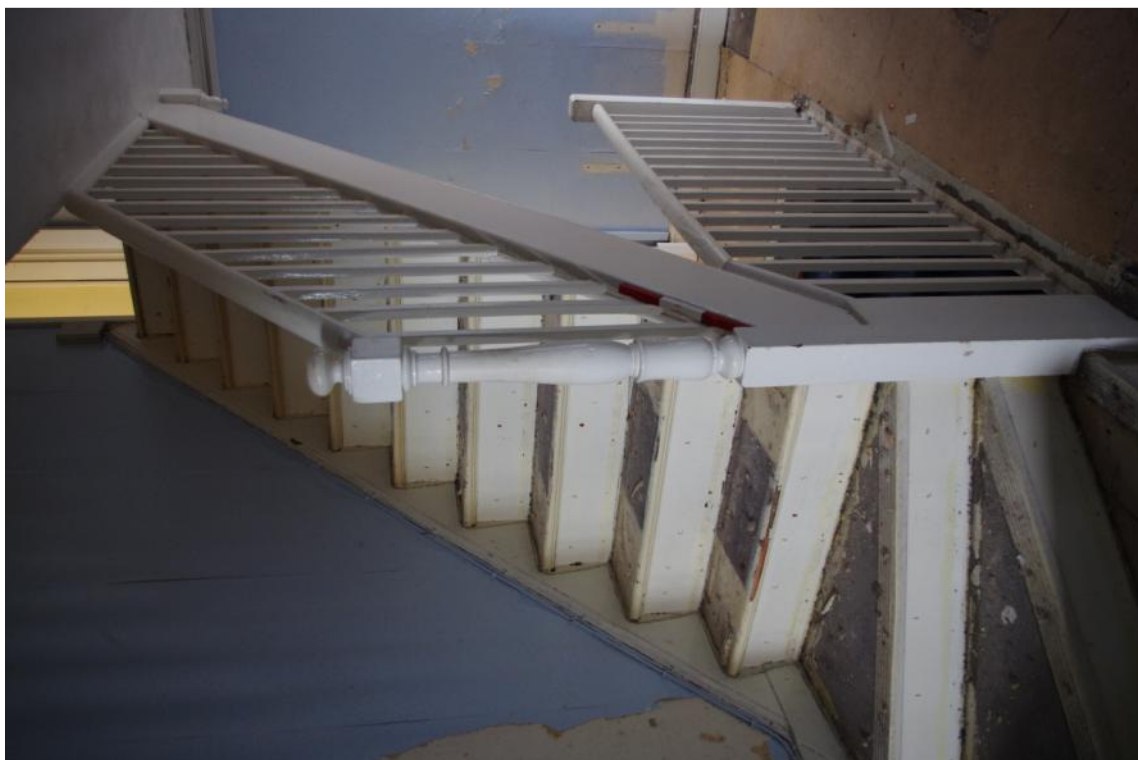
Access to the second floor is via a timber built straight flight stair with a bottom winder (*Figure 15*). It has a turned newel post and stick balusters. Such plain designs became popular from 1800 and remained popular until the late Victorian period when greater ornamentation re-appeared (Hall 2007). It is possible, therefore, that this stair is original to the early 19th century.

**Figure 15** First-Second Floor Staircase.

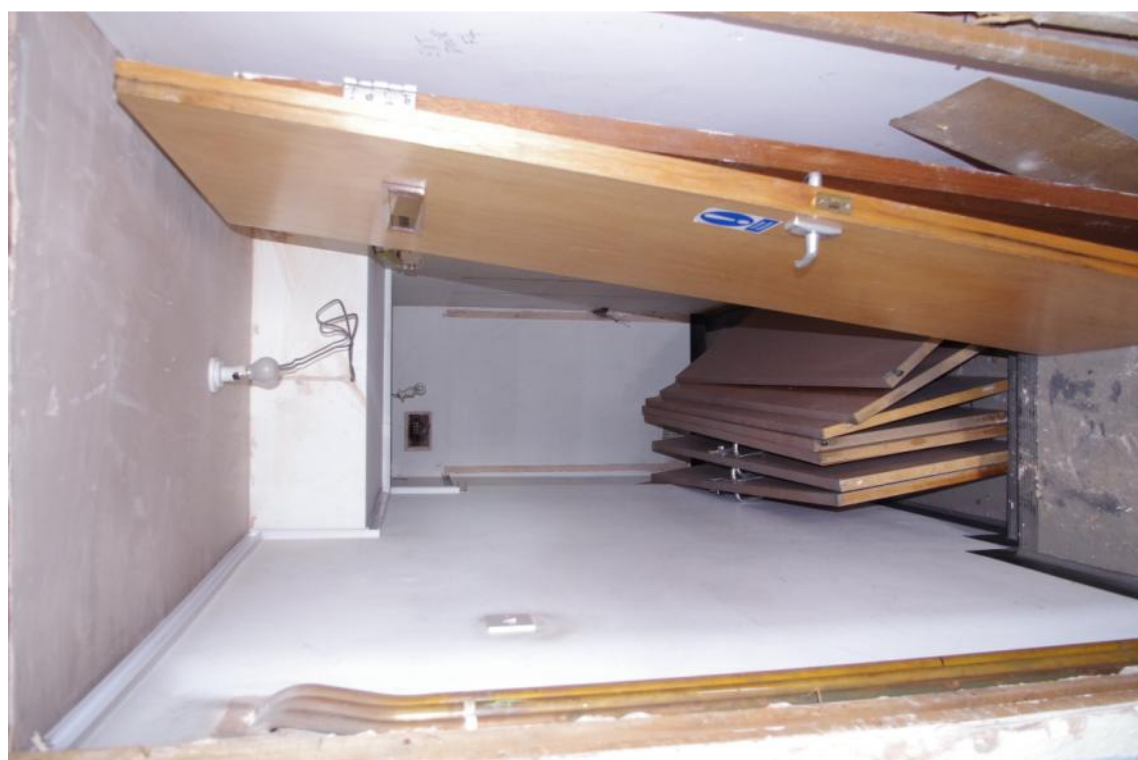
As with the ground floor there is a narrow room (L) towards the centre of the building on its north side (*Figures 16 & 22*). The walls of room L align with the walls between rooms C and D on the ground floor, it is likely therefore that room L was an earlier stairwell. If this and the masonry stairs to the south are contemporary it suggests that the first floor was also sub-divided, but it is likely that the two stairwells are not contemporary and relate to different phases of use of the building.

**Figure 16** Room L (First Floor), Possible Location of Earlier Staircase.

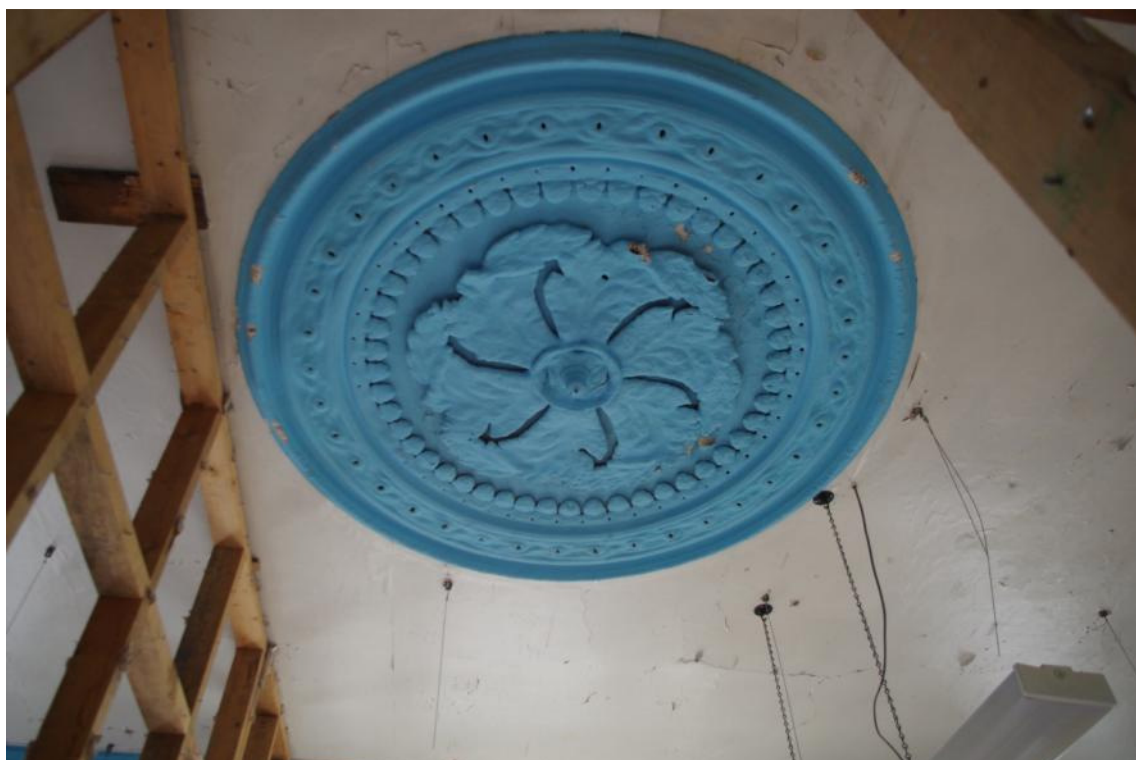
**Figure 17**  
Room J Ceiling Rose.

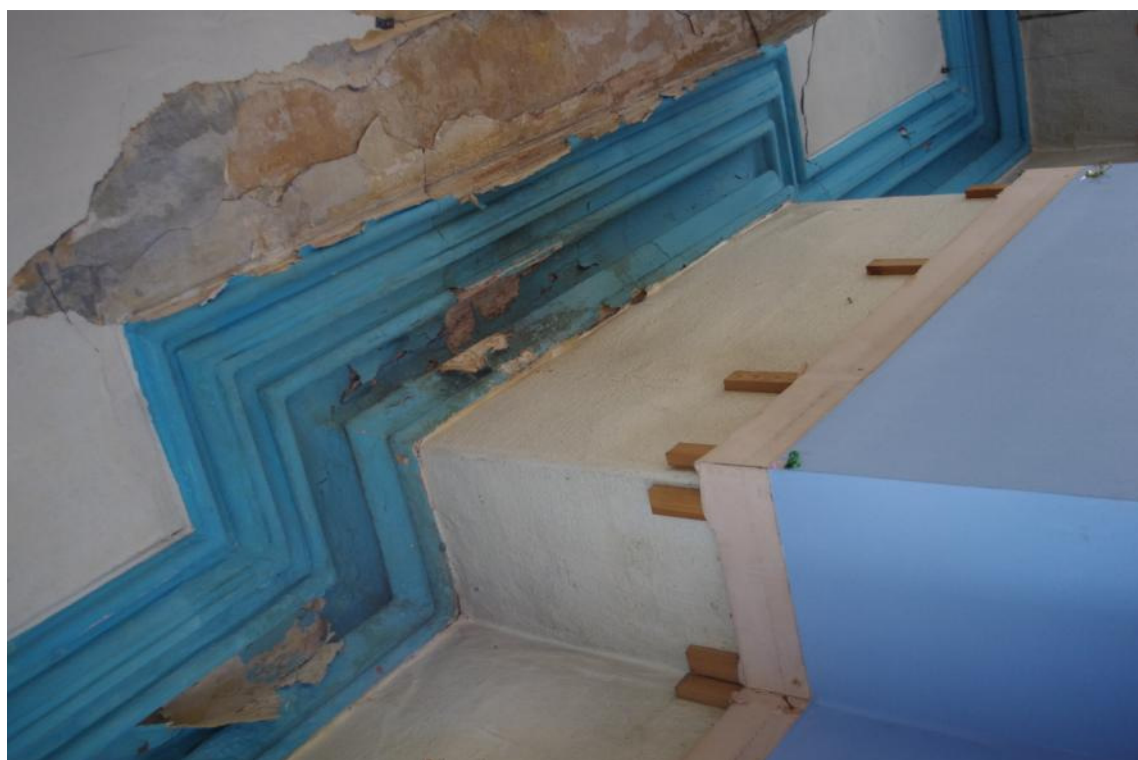
On the north and south walls in rooms J and K, there are chimney breasts, the plaster cornice follows these breasts. It is possible that the chimneys are original to the Chapel, a fact supported by the external blind windows which overlap the chimney.

**Figure 18** Room K Plaster Cornice &  
Chimney Breast.

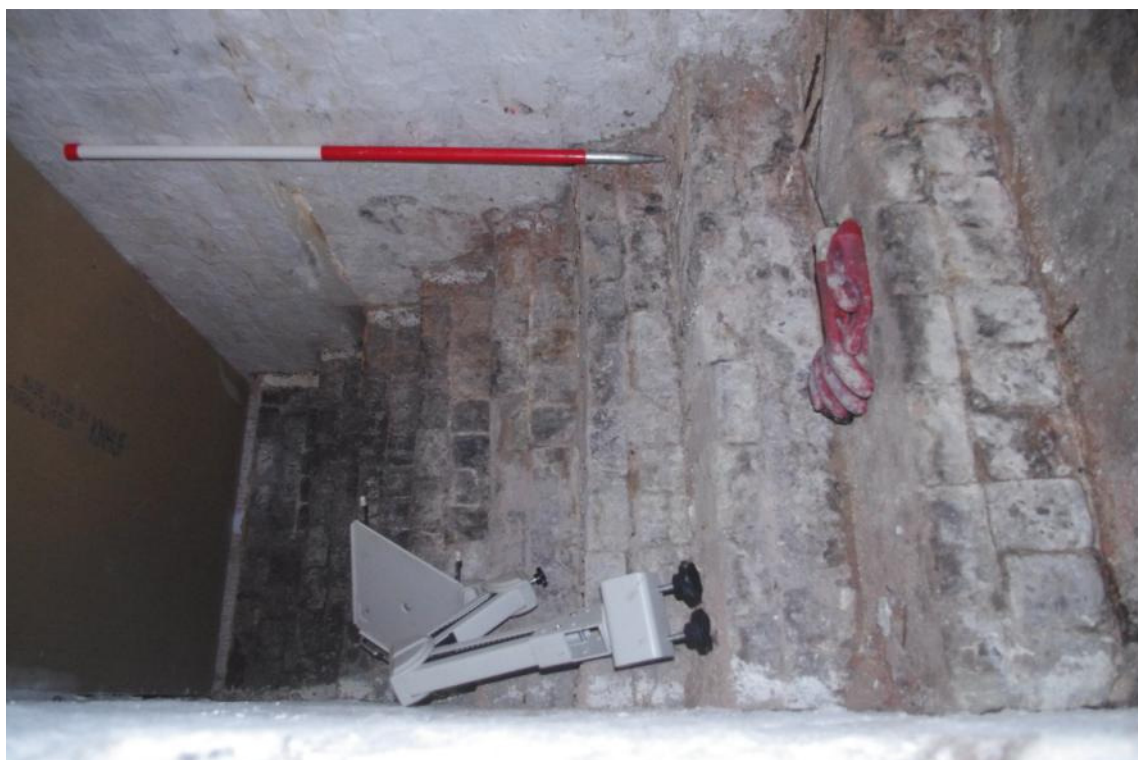
In the north east corner of the cellar are the original brick-built stairs rising north to south, the stairs are now blocked (*Figures 19 & 20*). To the east of the stairs is a small brick vaulted cellar (*Figure 20*). There is nothing of architectural or historical significance remaining

**Figure 19** Original Brick Stairs in Cellar (looking West-South West).
