**An Archaeological Standing Building Survey.  
Hardwick Lodge,  
Hardwick,  
Northamptonshire.  
(NGR SP 83689 70139)**

**April 2014**

**ABRS Project No 2013-HLHN**

**An Archaeological Standing Building Survey of Outbuildings at Hardwick Lodge,  
Hardwick, Northamptonshire (NGR SP 83689 70139).**

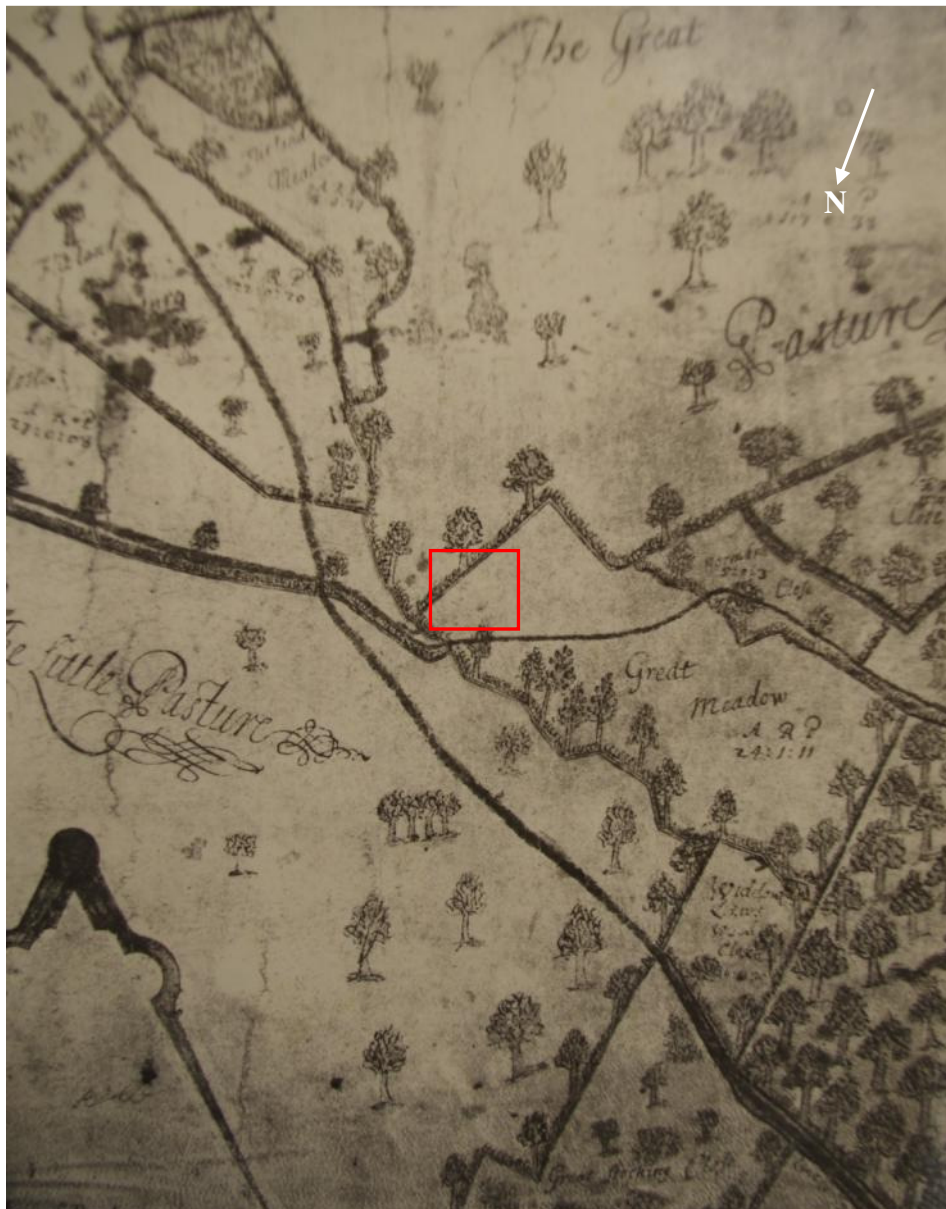
**Figure 2**

There is no clear evidence of when the parish's open fields were enclosed, but it had certainly taken place by 1684 and perhaps significantly earlier, since Bridges, writing in 1791 (*The History and Antiquities of Northamptonshire*), states that in 1720 the parish had been enclosed for "about 100 years". A map of Hardwick "with surrounding fields showing lands owned by Lord Mordaunt and Francis Nicholls" drawn in 1587 (NRO Map 2992 (Figure 2)) records three open fields, Moore, Wood and East Fields. Hardwick Wood is also clearly identifiable, but Hardwick Lodge Farm itself is not recorded.

A map of Hardwick with surrounding fields showing lands owned by Lord Mordaunt and Francis Nicholls (1587). Approximate Location of Hardwick Lodge Highlighted in Red.

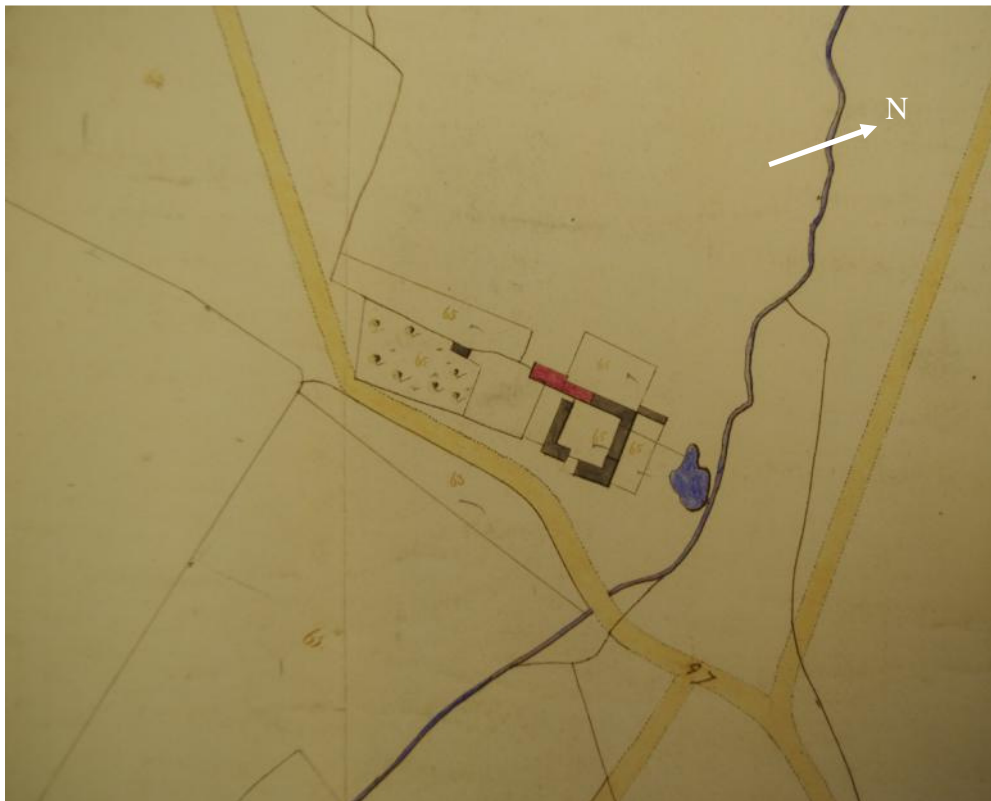
**Figure 3**  
Tithe Map, Hardwick Parish (1839).

The first map to show Hardwick Lodge Farm is the tithe map of 1839 (NRO T229 (*Figure 3*)). The farmhouse is recorded in red, while the outbuildings are recorded in grey. The accompanying apportionment records that the farm was owned by Lieutenant General William Thornton, a descendent of the daughter of William Lock, who had bought the lands including Hardwick from William and Robert Ward. The Wards had bought the manor from William Gage, who had bought the manor in 1649 from Richard, Viscount Lumley, who had bought the manor from James, the brother of John, Lord Mordaunt for £3,000 in 1638. In the latter half of the 19th century the manor was held by a Mrs. McKenzie, following her death the manor and the lands were held in trust by a board of trustees.

The farm was occupied by a William Sharman, the farm is described as farmhouse and yards, and there appears to be an orchard to the south of the house. The farm buildings are clearly identifiable arranged around a central yard and are shown attached to the north easternmost gable of the farmhouse. Only the northernmost projecting range is shown beyond the core buildings indicating that the other two projecting ranges are later in date.

Building C is, according to cartographic sources the earliest of the projecting ranges standing adjacent to the north easternmost corner of the linear range having been recorded on the 1839 Tithe Map (*Fig. 3*), it is the north westernmost range (*Figure 20*). The building is again red brick with a modern slate roof, possibly imported (*Figure 9*). The bricks themselves are 9 inch x 3 inch x 4 inch laid in a Flemish Garden Wall bond (3 stretchers to 1 header in each course) with modern lime mortar pointing. The building is a four bay open-fronted building, with the adjacent yard area now grassed over; the building was originally built as a cow hovel, with the open front facing the yard to the south east. There is a single door on the north east gable.

The smaller brick dimensions suggest that building D is an earlier building, either early 19th century or late 18th century, brick dimensions became more standardised at 3 inches from the 1830s onwards. The 1839 Tithe map (*Fig. 3*) indicates the building was originally adjoined to the farmhouse range, there is an outline of the gable of a lost bay on the farmhouse wall supporting this and it is unclear when this bay was removed. The brickwork of the south westernmost gable wall of D does not match the remainder of the brickwork, so it is likely that this gable is modern.

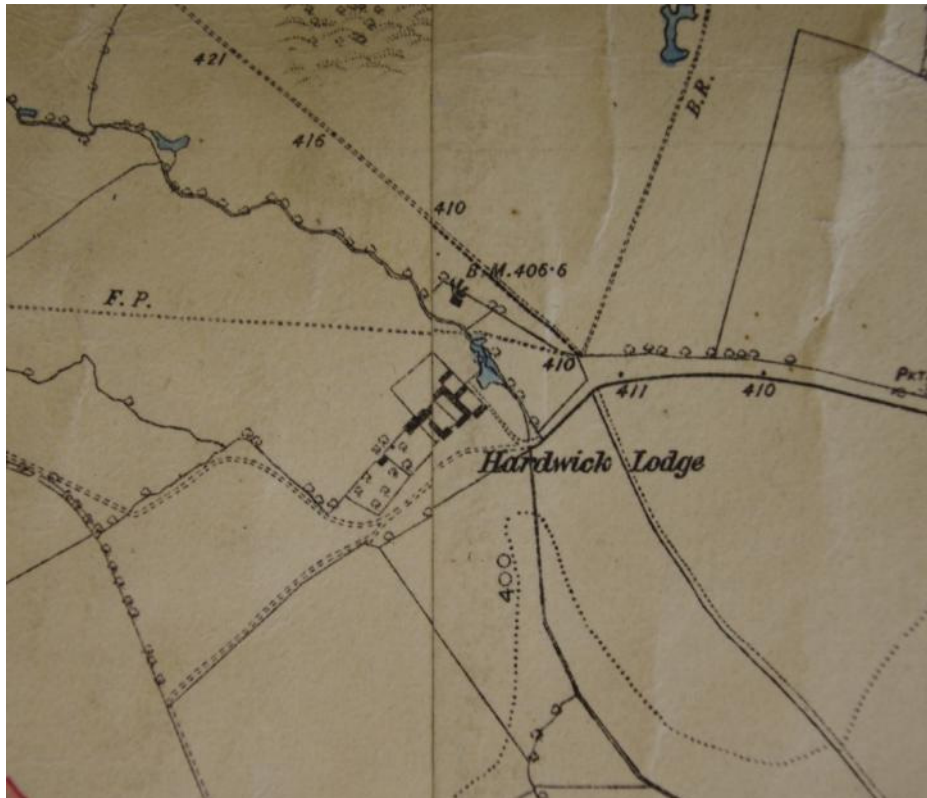
**Figure 4**

The next available map of Hardwick Lodge Farm is the six inch Ordnance Survey, first edition, 1884 (NRO XXXIX.1 (*Figure 4*)). The now distinctive outline of Hardwick Lodge Farm is now clearly visible; the two additional projecting ranges have been added to the north easternmost facing elevation.

First Edition Ordnance Survey (1884).  
6inch, Sheet XXXIX.1

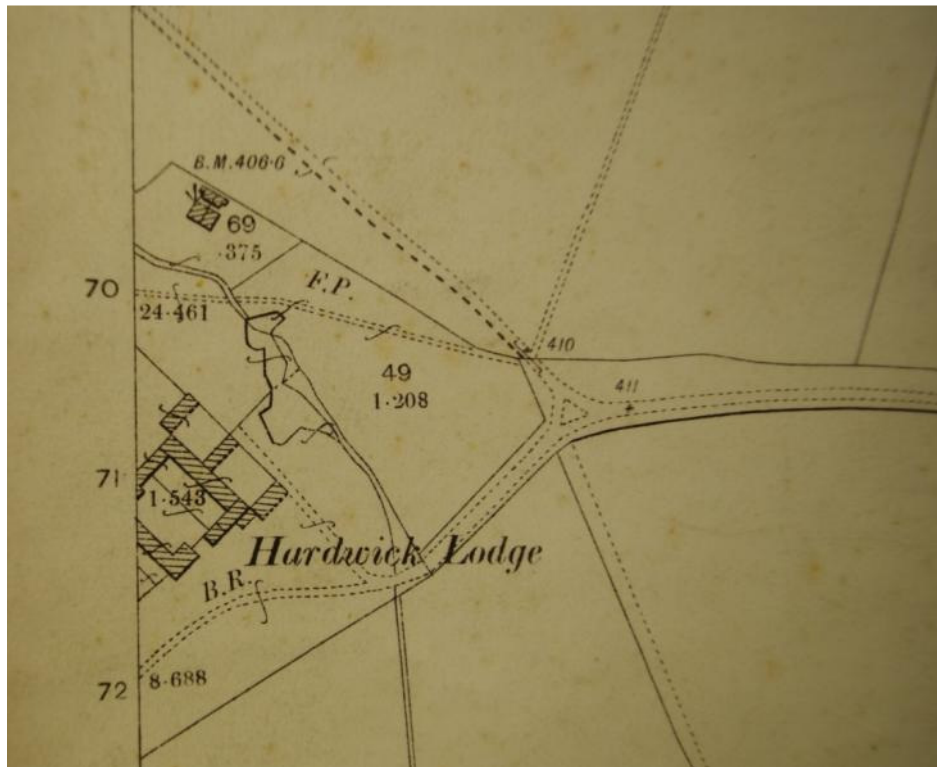
**Figure 5**  
Second Edition Ordnance Survey (1900).  
1:2500, Sheet XXXIX.1

The 1900 second edition Ordnance Survey, 1:2500 (NRO XXXIX.1 (*Figure 5*)), although not including Lodge Farmhouse, records the majority of the outbuildings in sufficient detail to establish the layout of the working farm. The projecting ranges to the north east are recorded as open-fronted. The two north westernmost buildings are open-fronted with yards, it is likely, therefore that these were cow hovels. The south easternmost building is open-fronted, but with no yard, it is almost certain that this building is a cartshed, as was common the openings face away from the farmyard, with the intention that animals were less likely to enter the building from the yards and damage either themselves or the machinery.

The remainder of the buildings are not shown with any significant detail to establish possible functions. The main north west – south east aligned linear range, based upon its size is likely to be a barn.

The second edition Ordnance Survey (*Figure 5*) appears to show building B as open fronted, open to the south east. There is no evidence of this within the standing building, it is likely,

therefore that the building has been extensively re-built in the past and these openings blocked.

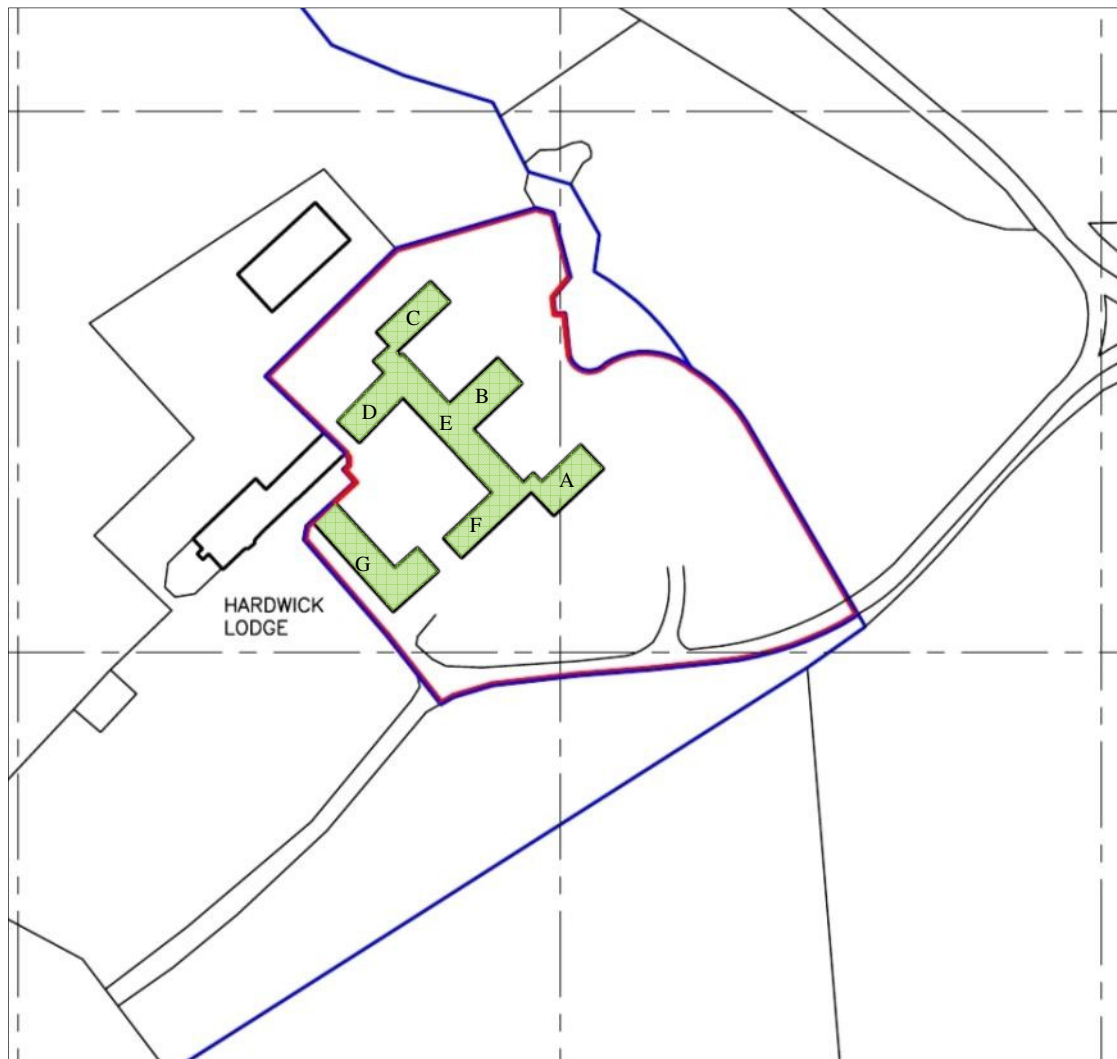
**Figure 6**

Plan of the proposed development area (in Red) Recorded Buildings in Green, Including Principal Divisions.  
(Provided by client. Not to Scale).

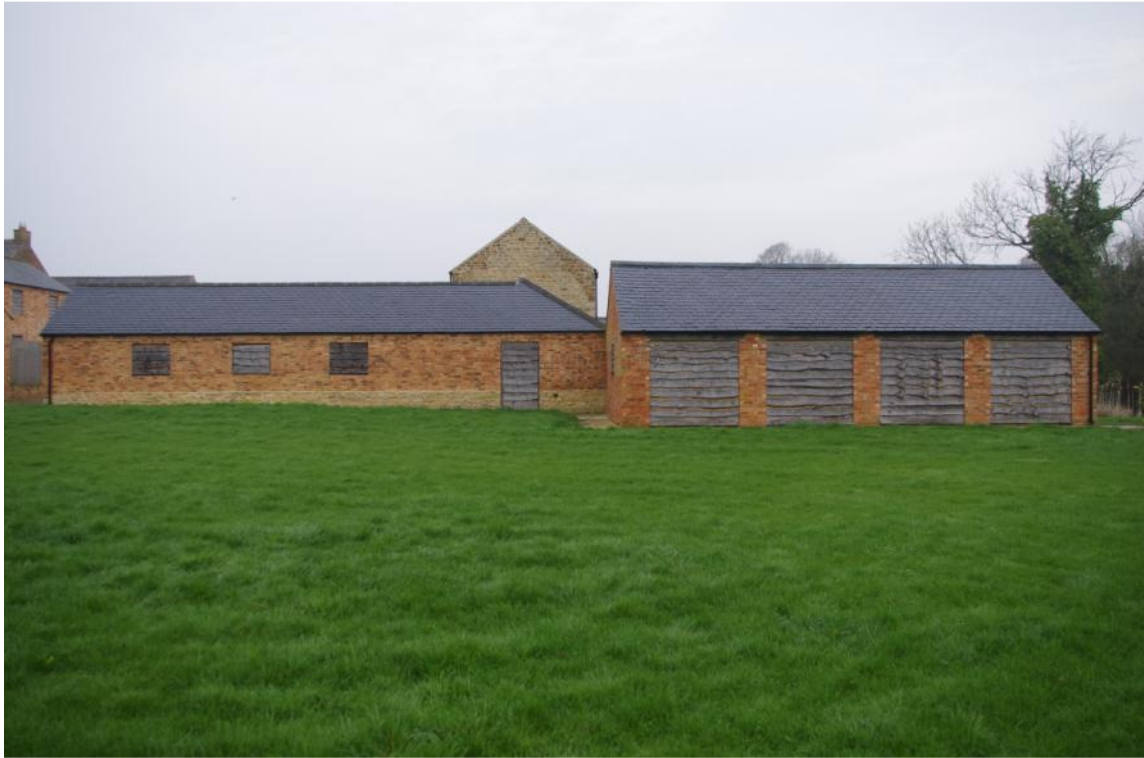
Building A is the south easternmost building within the proposed development area (*Figure 20*), it is one of the later projecting ranges built in the late 19th century. The building is red brick with a modern slate roof, possibly imported (*Figure 7*). The bricks themselves are 9 inch x 3 inch x 4 inch laid in a Flemish Garden Wall bond (3 stretchers to 1 header in each course) with modern lime mortar pointing. The building is a four bay open-fronted building, in all probability originally built as a cart shed, with the open front facing to the south east. There is a door on the north east gable as well as a window on the south western gable. All of the openings have temporary feather edge cladding.

There is a straight joint between the westernmost corner of the building and the linear range to the west (Building F), confirming cartographic sources (*Figs. 3, 4 & 5*) indicating the building post dates the linear range.

Internally the building has been renovated; the walls have an internal skin of modern block-work which has been rendered with modern cement mortar. The roof is carried on three Queen post trusses, all are modern. It is unclear whether these trusses are copies of the original roof or not. The floor is also modern make up.

**Figure 7**  
Buildings A & E, South East Facing Elevations (Looking North West).

Building F forms the south eastern range of the inner farmyard (*Figure 20*). The building is again red brick with the same modern slate roof (*Figures 7 & 15*). The bricks themselves are 9 inch x 3 inch x 4 inch laid in a Flemish Garden Wall bond (3 stretchers to 1 header in each course) with modern lime mortar pointing, unlike previous buildings, there is a stone plinth visible on the south eastern elevation (*Figure 7*), it is possible that the building was built on earlier footings. The building consists of three bays, there are three large openings, on the north west facing elevation, so the building may have originally been open-fronted. There is a fourth opening on the south west facing elevation.

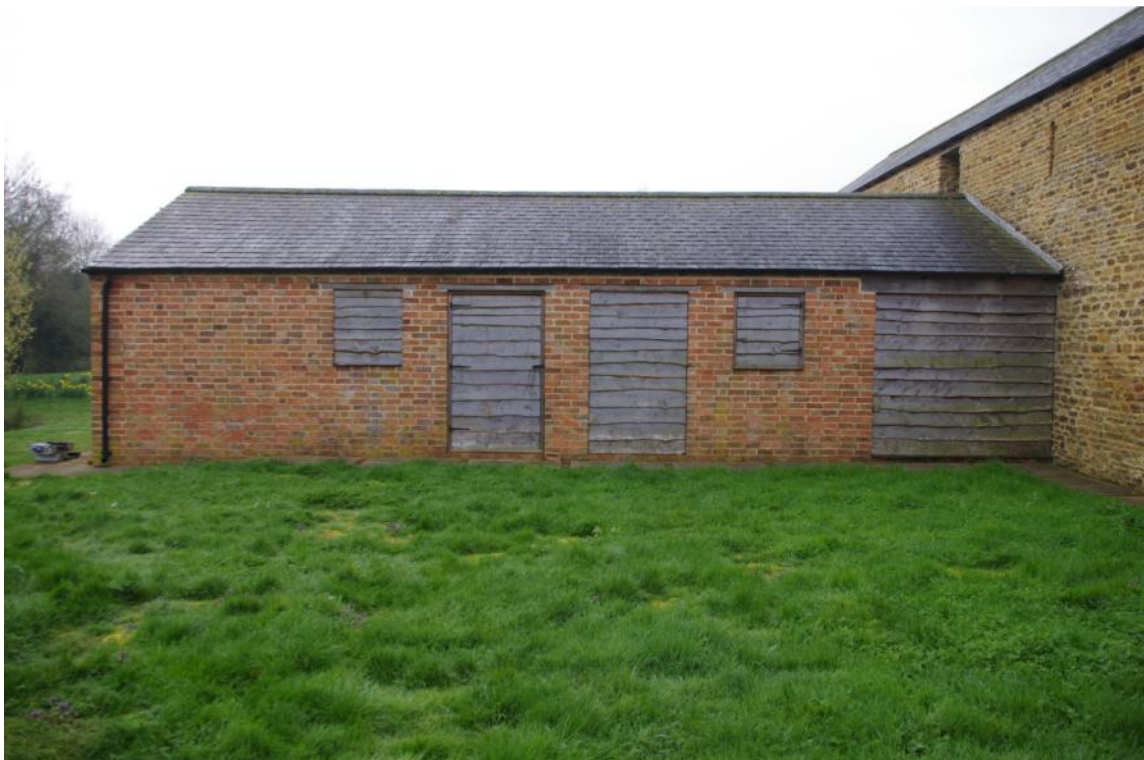
Building B is the central projecting building (*Figure 20*). The building is again red brick with a modern slate roof, possibly imported (*Figure 8*). The bricks themselves are 9 inch x 3 inch x 4 inch laid in a Flemish Garden Wall bond (3 stretchers to 1 header in each course) with modern lime mortar pointing. There is a door on the north eastern gable as well as three double door-sized openings on the north west facing elevation, as well as two windows.

The interior, as with building A has been renovated, there is an internal block-work skin and cement render. There is also the same modern Queen Post truss roof.

There is a straight joint between B and the linear range E to the south west again supporting cartographic sources which indicate that the range is later in date.

**Figure 8**  
Building B, North West Facing Elevation (Looking South East).

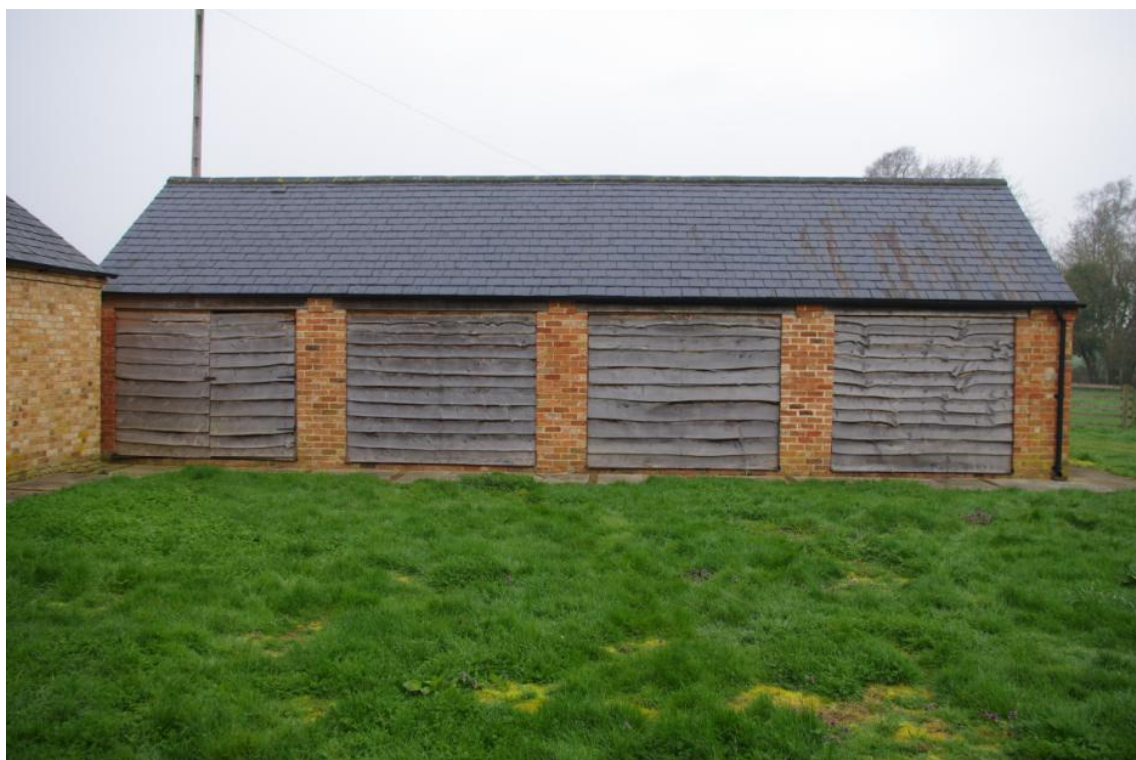
The interior, as with the previous buildings has been renovated, there is an internal block-work skin and cement render. There is also the same modern Queen post truss roof.

**Figure 9**  
Building C South East Facing Elevation (Looking North West).

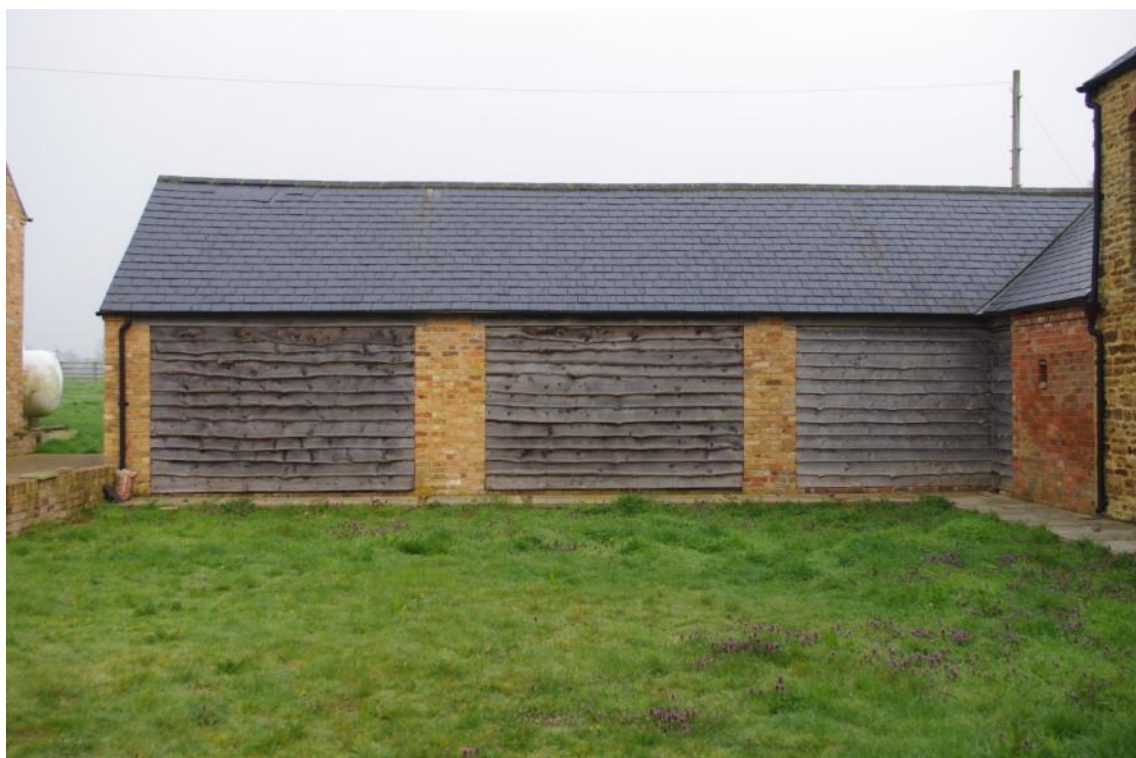
Building D forms the north westernmost range of the inner farmyard (*Figure 20*). The building is built of buff red bricks with the same modern roof slate as previous buildings (*Figure 10*). The bricks themselves are 8 ¾ inch x 2 ½ inch x 4 inch laid in a Flemish bond (1 stretcher between headers, with the header centred over the stretchers in the course below) with modern lime mortar pointing. The building is open-fronted, facing the yard to the south east and in all likelihood built as a cow hovel. There are three window openings on the north west elevation, possibly feeding holes as well as a double sized door opening.

There is a straight joint between D, which is brick-built, and building E which is stone-built. The modern re-pointing prevents any indication of whether this reflects phasing or a simple joint between two different building materials.

**Figure 10**  
Building D, South East Facing Elevation (Looking North West).

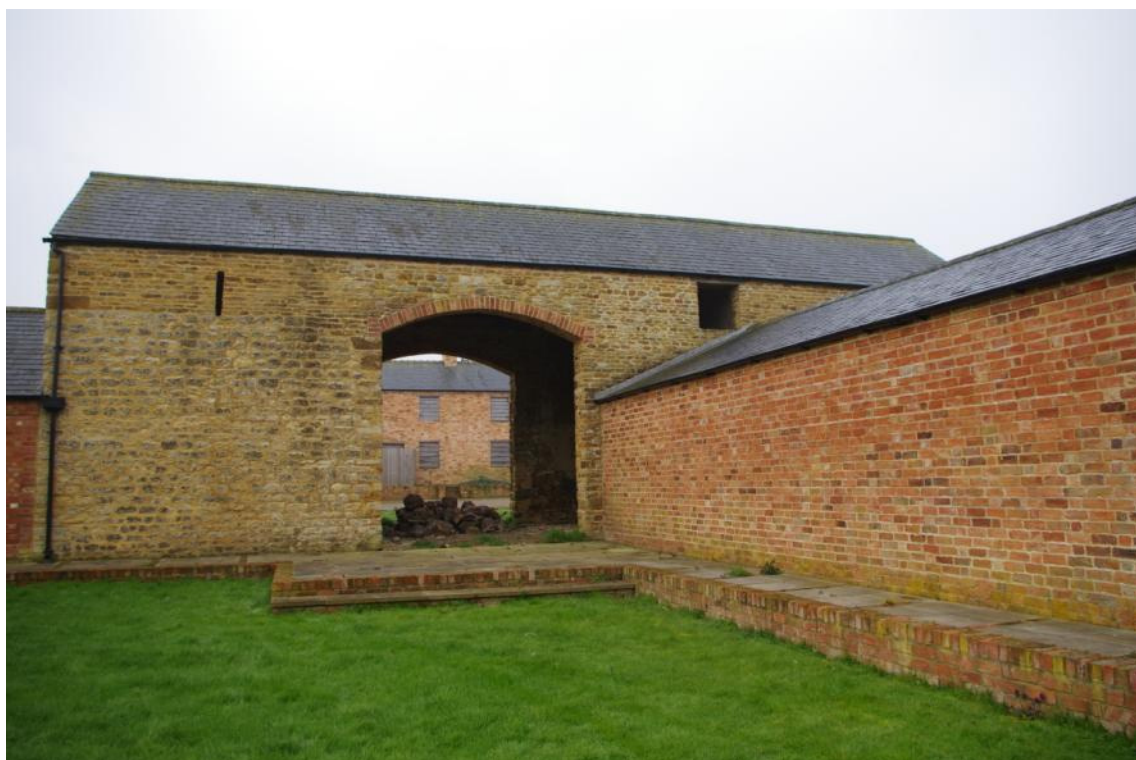
Building E is the largest of the buildings within the proposed development area; the building is a stone-built threshing barn with a modern slate roof (*Figure 20*) aligned north west – south east with the off centre threshing doors (*Figure 11*) and a smaller pedestrian door to the north west on the south west elevation (*Figure 12*). The building has been extensively re-pointed with modern lime mortar, but there is some limited evidence of potential phasing visible, most notably at eaves level and on both gable walls (*Figures 13 & 14*), suggesting the roof has been raised at some point in the past. Each threshing door has a segmental brick arch, there is no evidence of the original doors. There are four arrow slit openings, three on the south west elevation and one on the north eastern elevation. There is also a pitching hole towards the centre of the north east elevation and a hanging door at the north western end of the south west elevation. Access to the pitching hole is now blocked by building B, confirming that B post dates building E.

**Figure 11**  
Building E, North East Facing Elevation (Looking West).

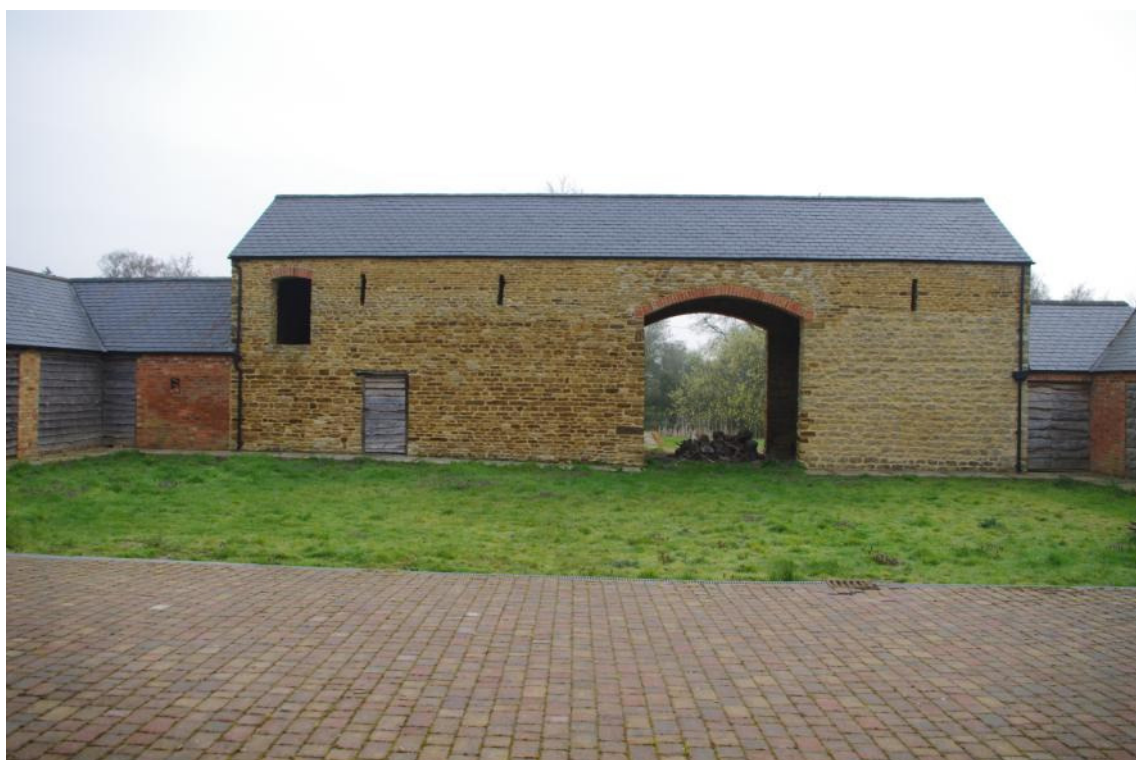
**Figure 12**  
Building E, South West Facing Elevation (Looking North East).

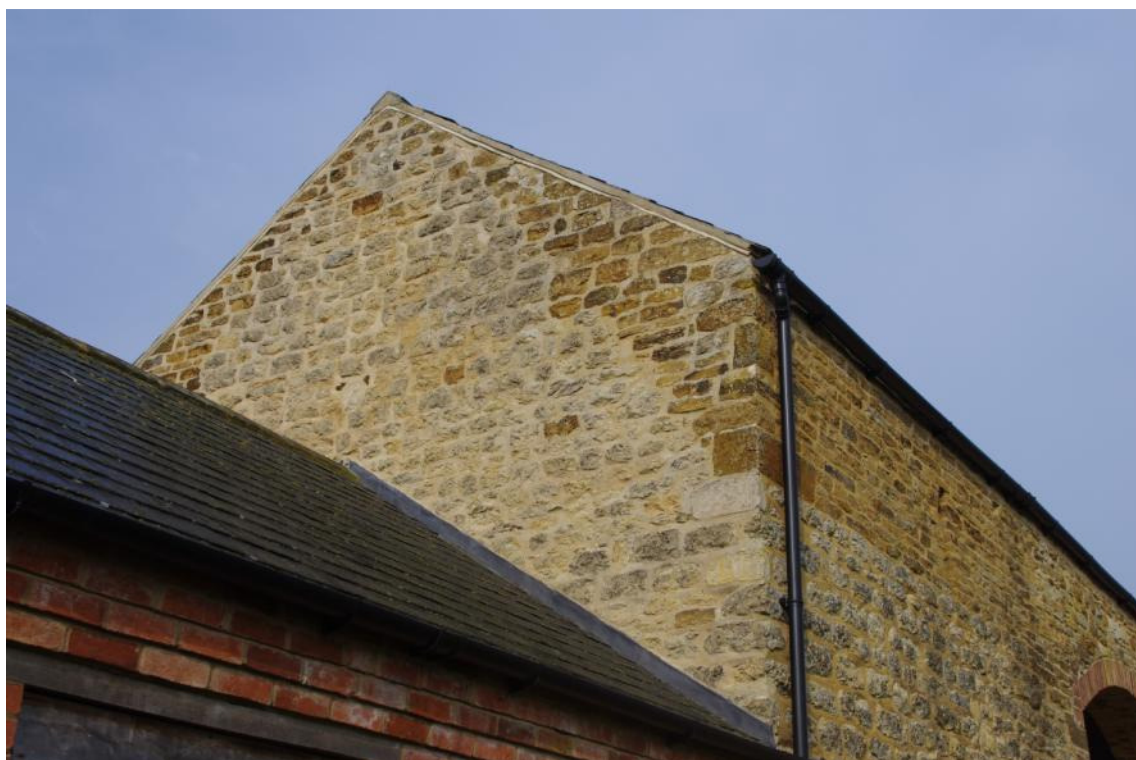
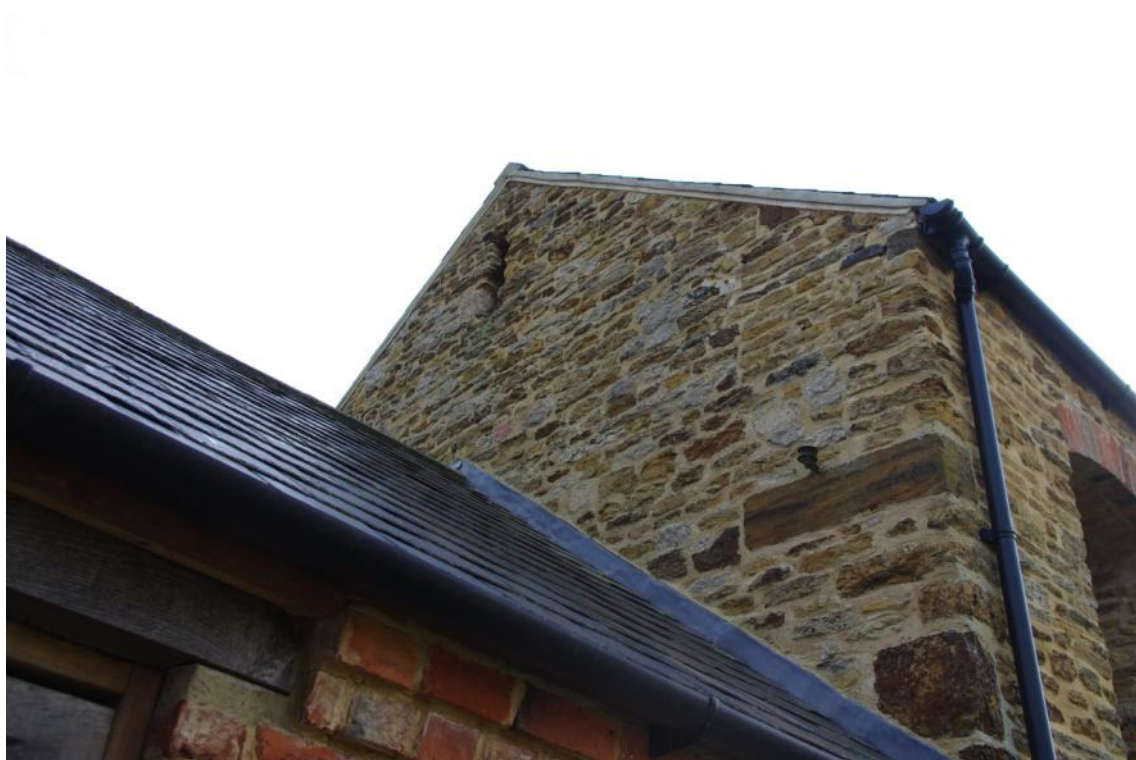
**Figure 13**  
Building E, Early Roofline Visible on South Eastern Gable.

**Figure 14**  
Building E, Early Roofline Visible on South Eastern Gable.

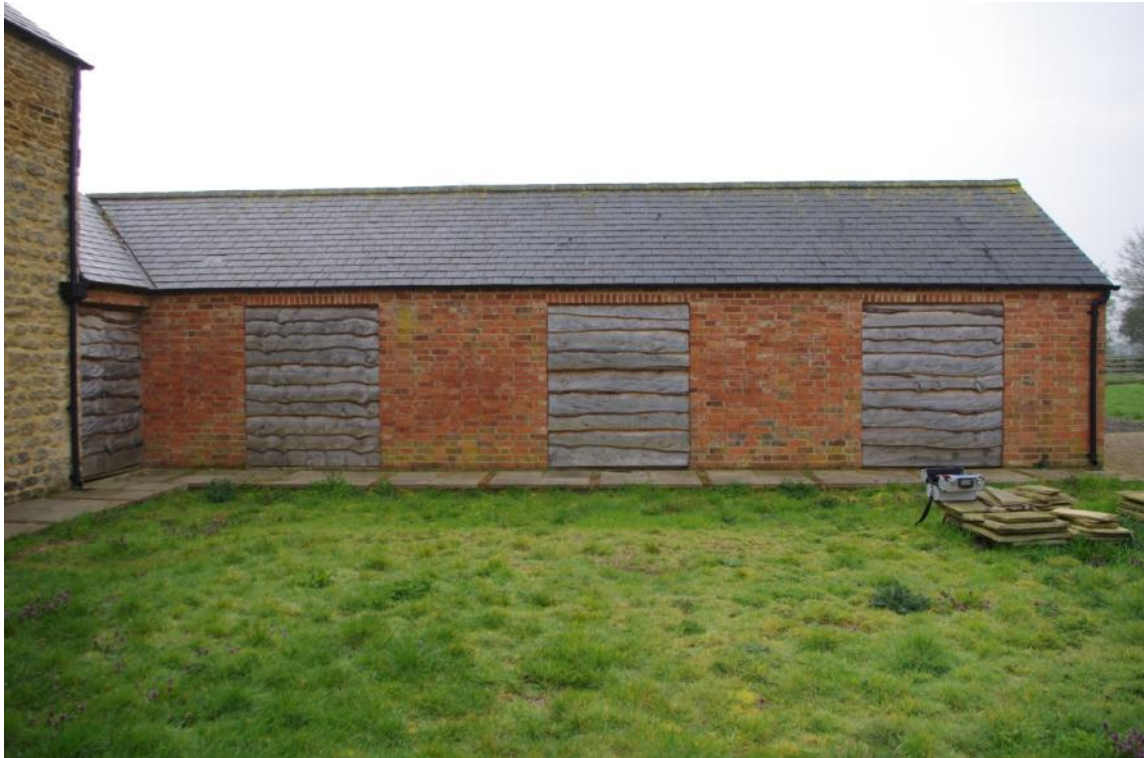
Internally, as with the previous buildings, F has been extensively renovated, there is again a block-work skin and cement render. The roof is carried on modern Queen post trusses. There is an inserted wall on the angle between (1) and (2), as with building D it is unclear whether it is an inserted wall or replaced an earlier wall on the same alignment.

**Figure 15**  
Building F, North West Facing Elevation (Looking South East).

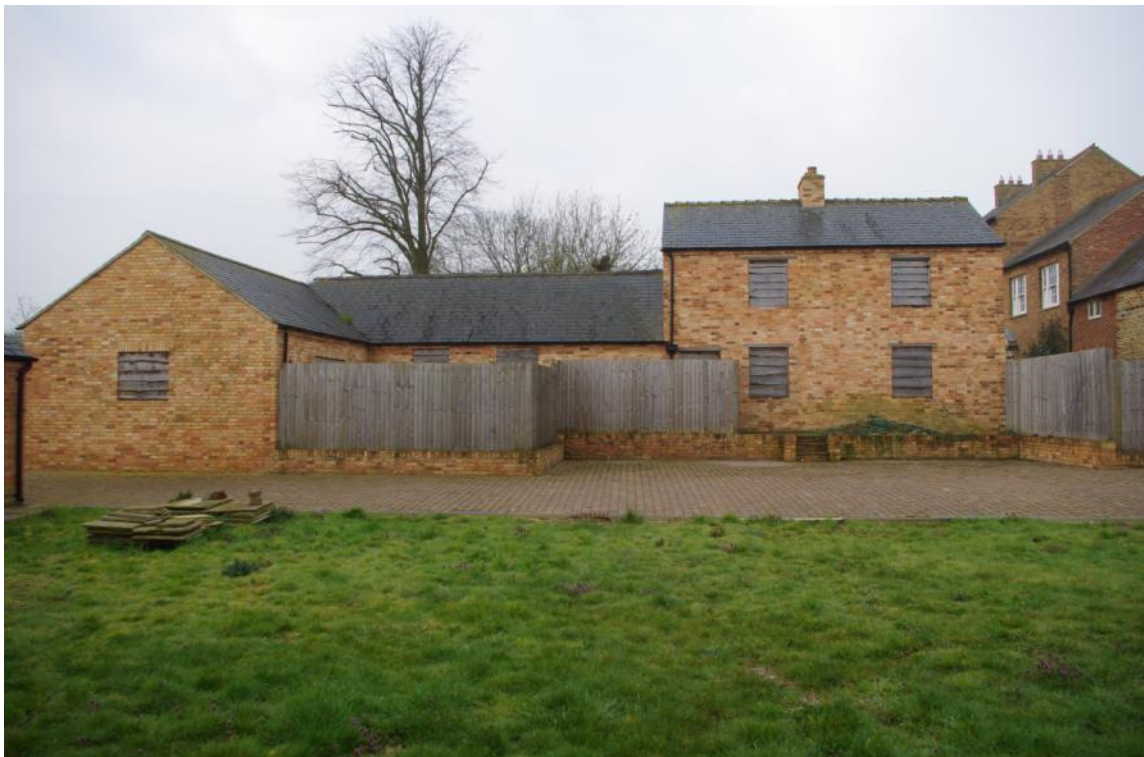
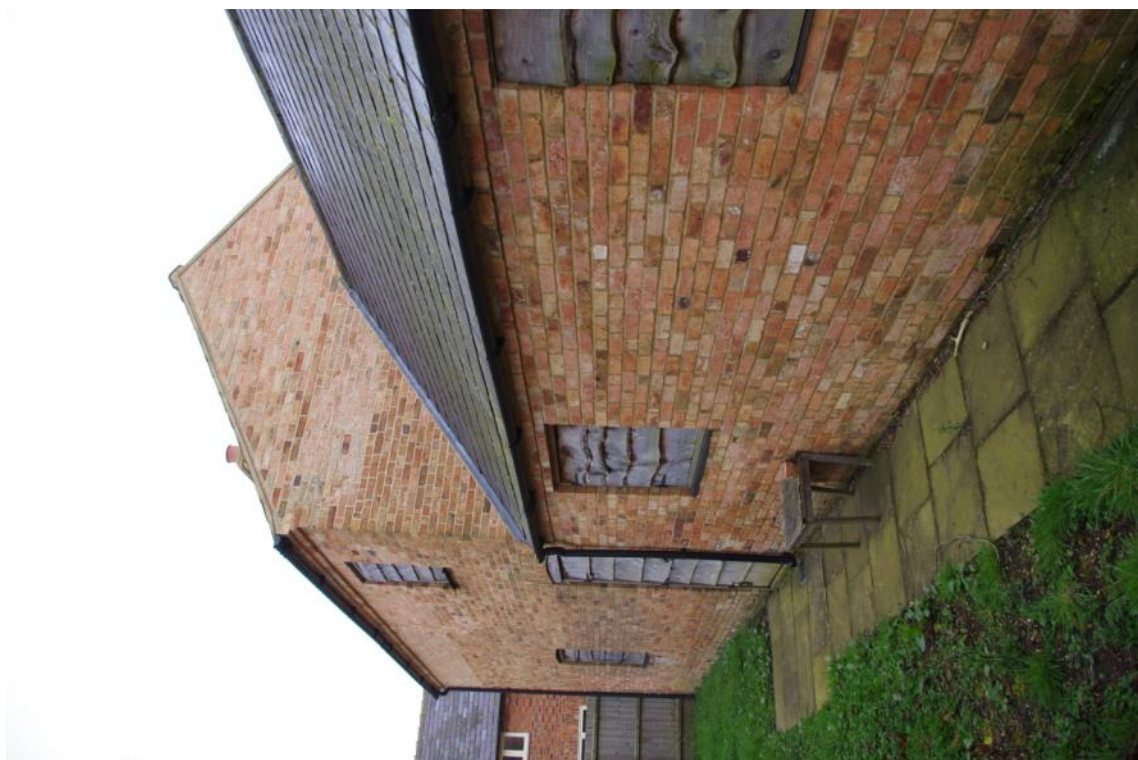
Building G is located to the south west of the previous buildings (*Figures 6 & 20*). The building appears to be largely re-built (*Figures 16 & 17*), with only limited areas of

potentially original brickwork on the south east elevation. The building is a three bay building, the north westernmost bay is two storied with a central chimney stack (*Figure 20*), it is likely, therefore, that if original, this bay had a domestic role, which is likely given its proximity to the farmhouse. There are a number of openings, both for doors and windows on each elevation, but none give any indication of the original layout or function of the building.

Internally, the building again has been extensively renovated, there is block-work and in places brickwork skin all under modern cement render. The roof of the single storey bays is carried on modern Queen post trusses. The roof of the two storey bay is carried on purlins, again modern timber. The first floor is also all modern timber.

**Figure 16**  
Building G, North East Facing Elevation (Looking South East).

**Figure 17** Building G, South East Facing Elevation, Oblique View.

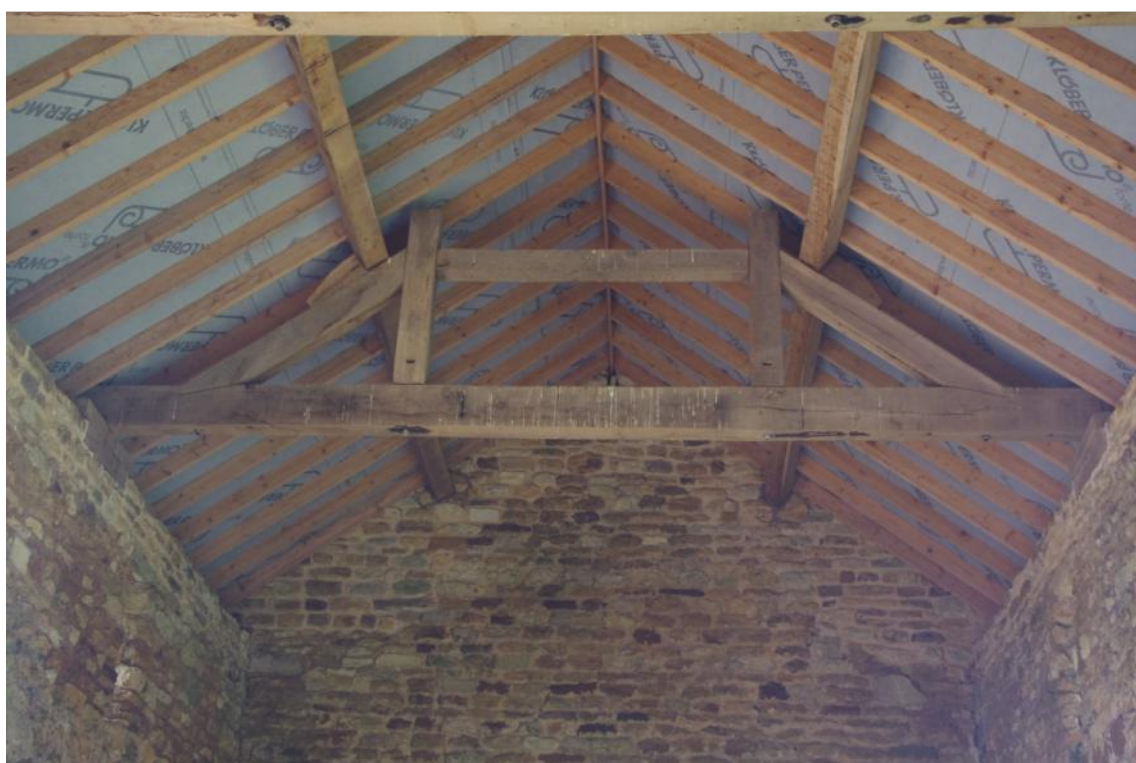
Internally, building E has fared better than the previous buildings, the internal fabric of the building is still exposed, however, there is little of historic significance; this is limited to a niche to the left of the south western threshing door. The roof is modern Queen post trusses (*Figure 18*). There is a modern inserted wall dividing the north western third of the barn.

There are a number of remaining features within the north western part of the barn; there are the remains of a loft abutting the north western gable, the timber joists appear original, the loft was originally accessed by a hanging door on the south west elevation. It is possible that this loft was originally a granary. On the north west gable there is a ground level door, the reveal is poorly finished, suggesting it is a later insertion. There is also a ground level door on the north east elevation, now providing access to building B. To the north west of this door is rubble infill and a straight joint, this straight joint is the same alignment as the door on the south west elevation, suggesting this was originally a cross passage through the barn. It is likely therefore that this opening was altered with the construction of B.

**Figure 18**  
Building E, Modern Queen Post Truss Roof.

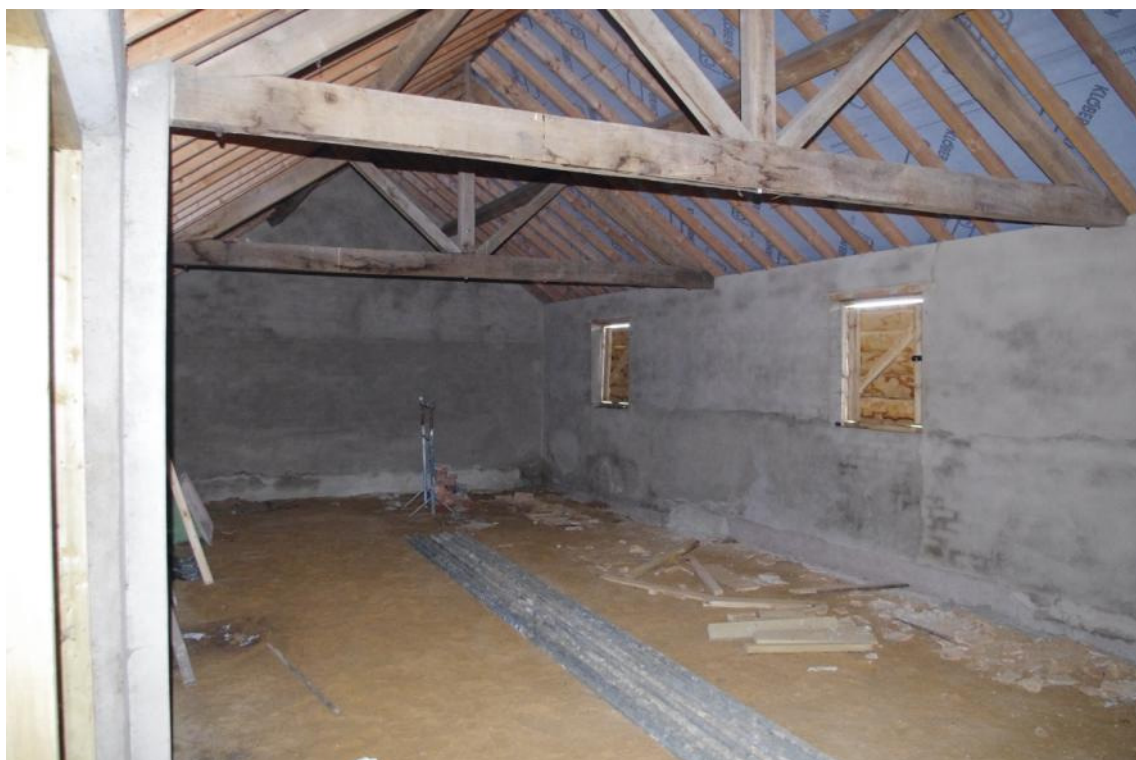
The interior, as with the previous buildings has been renovated; there is an internal block-work skin and cement render (*Figure 19*). There is modern block-work wall in the angle between the north east (1) – south west (2) bays, although clearly a modern wall, it is unclear whether it is an inserted wall or replaced an earlier wall on the same alignment. The roof of (2) is carried on two King post trusses, again modern (*Figure 19*). The roof of (1) is carried on Queen post trusses, again modern.

**Figure 19**  
Building D, Modern King Post Truss Roof & General View.  
(All interiors were similarly finished)
