**An Archaeological Standing Building Survey.  
Hardwick Lodge,  
Hardwick,  
Northamptonshire.  
(NGR SP 83689 70139)**

**April 2014**

**ABRS Project No 2013-HLHN**

**An Archaeological Standing Building Survey of Outbuildings at Hardwick Lodge,  
Hardwick, Northamptonshire (NGR SP 83689 70139).**

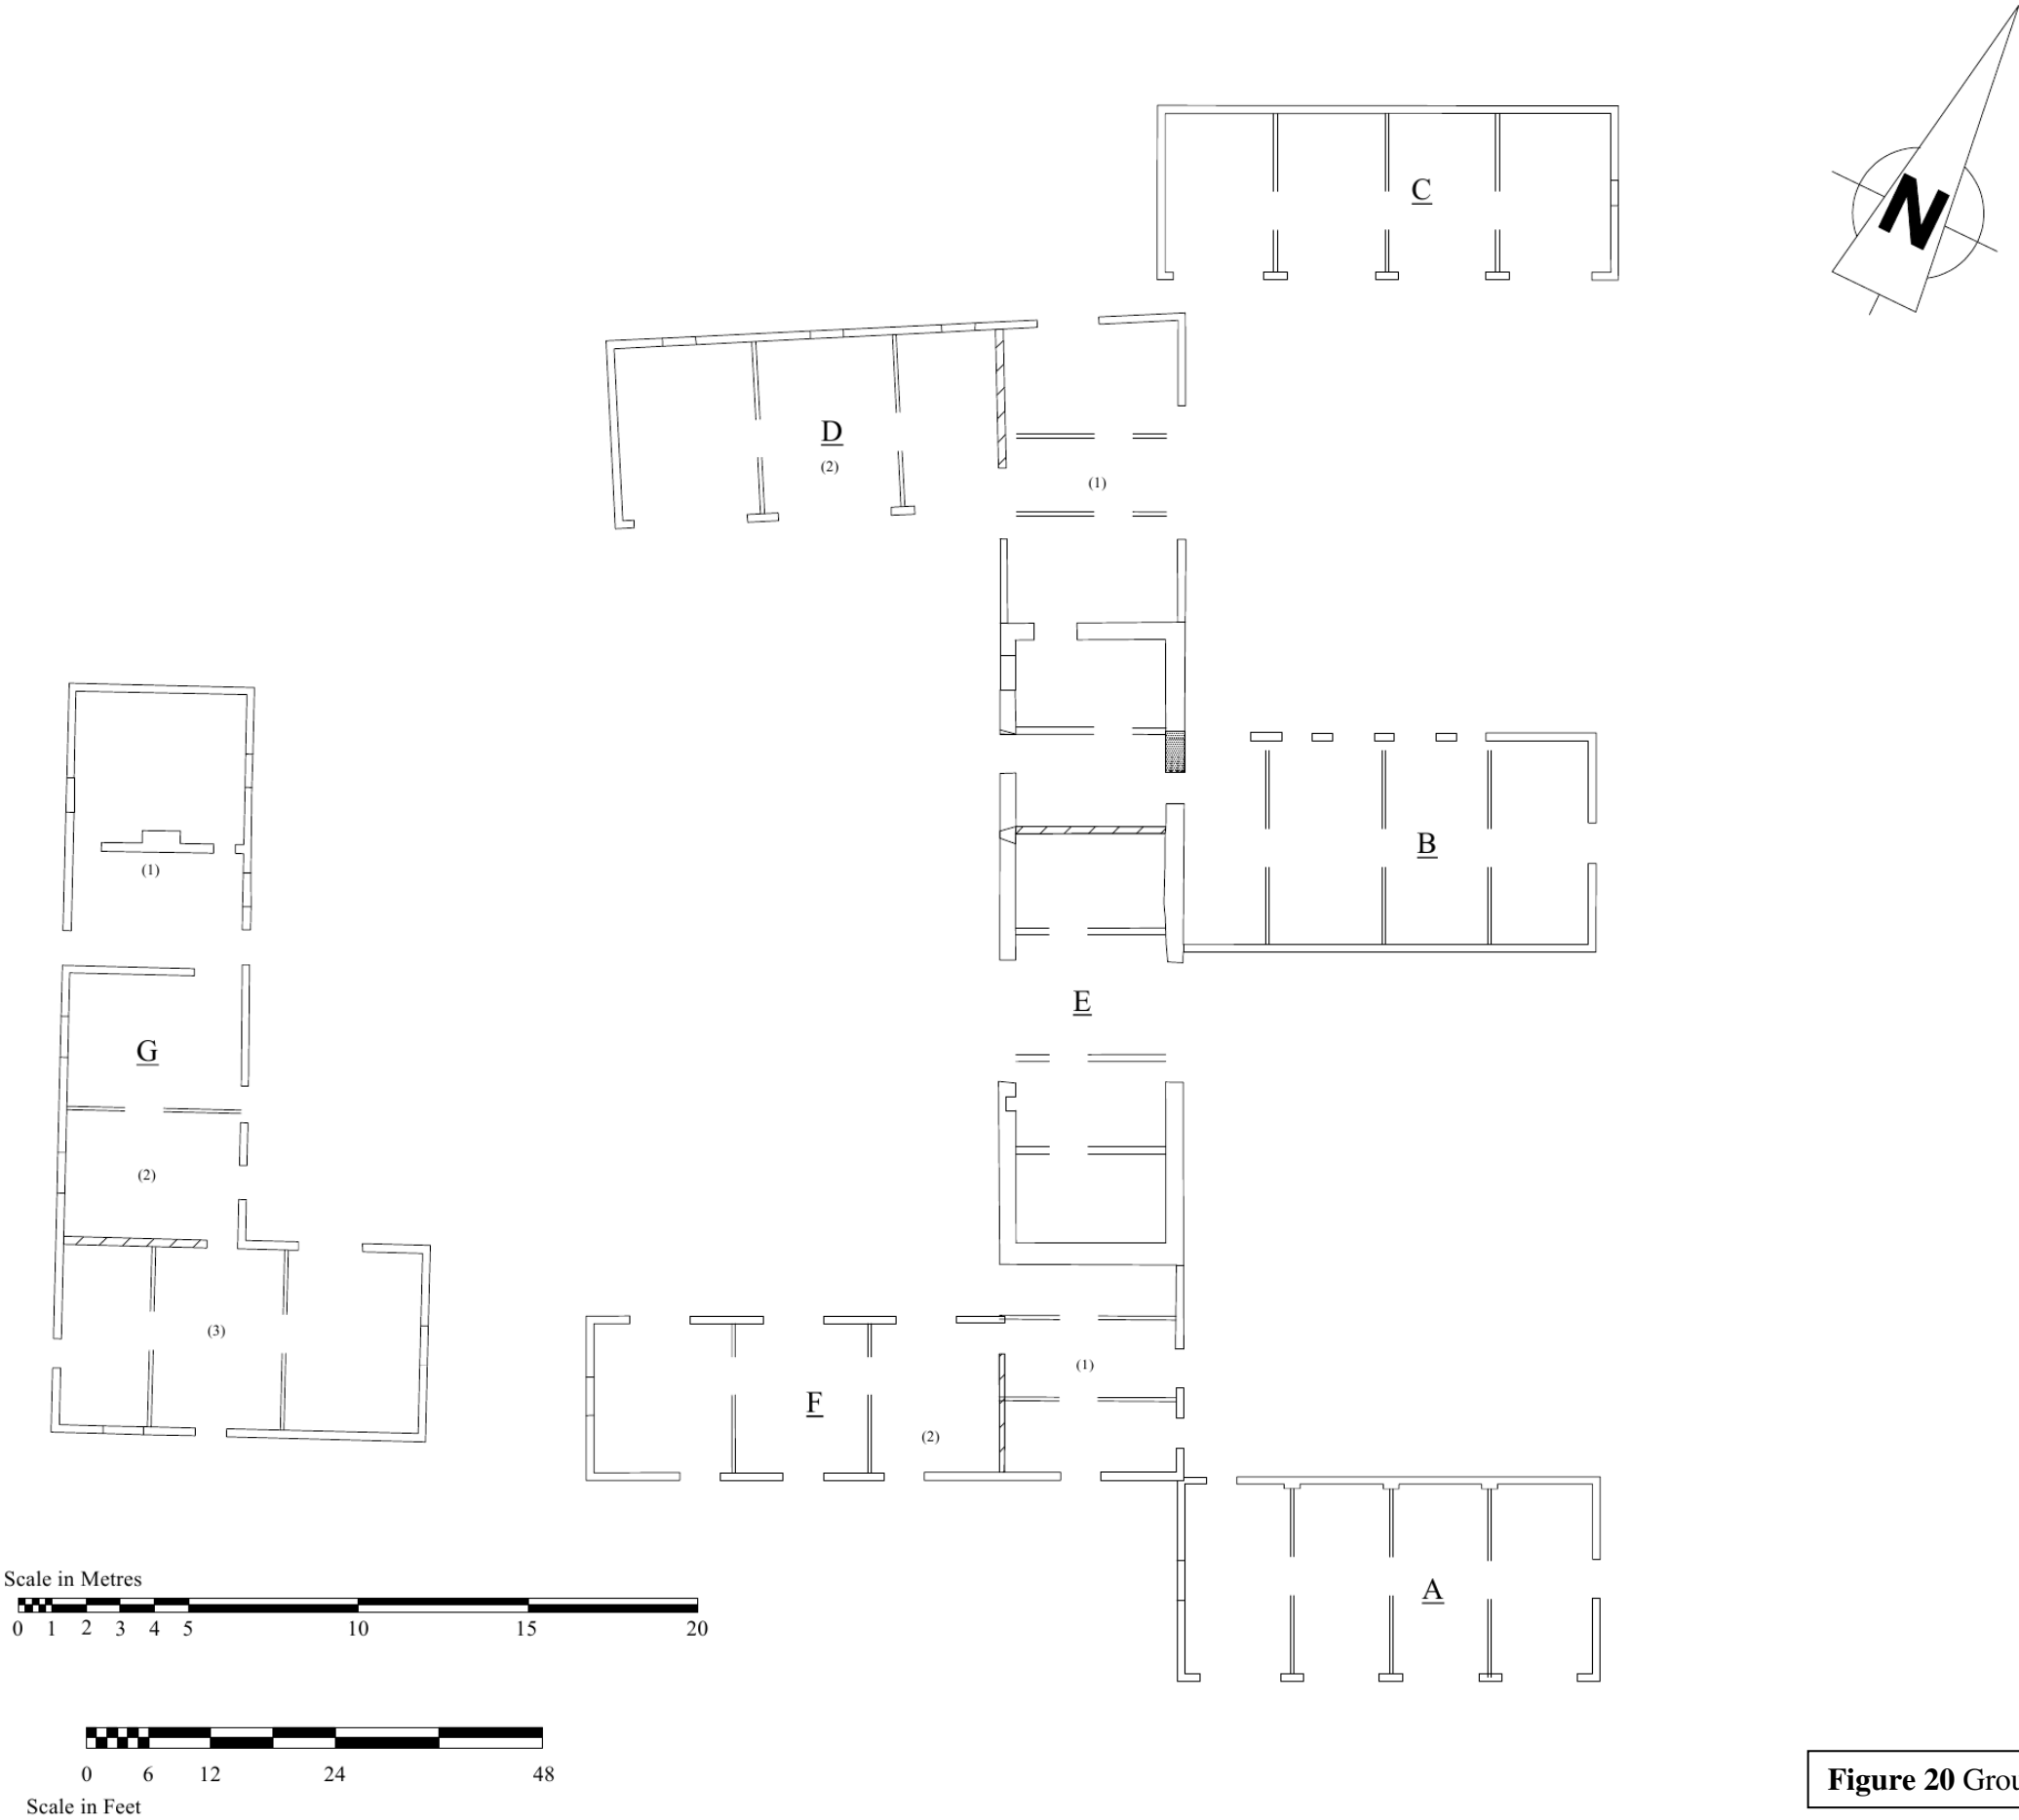
Figure 20 Ground Floor Plan.

*Orientation:* There are two groups of buildings subject to this historic building recording, one is “L” shaped, while the second is “E” shaped. Both buildings are largely linear in plan, the

long axis is orientated approximately north west-south east (*Figures 6 & 20*), with the principal elevations facing Hardwick Lodge to the south west. Where the terms 'left', 'right', 'front' and 'back' etc are used in the report, this is in relation to this principal elevation as viewed from Hardwick Lodge farmhouse. For the purposes of this historic building recording a letter prefix has been allocated to each building and a number prefix added for significant partitions where required.
